## National Transportation Safety Board

# Memorandum

**From:** Michael Huhn  
**Date:** June 14, 2018  
**Subject:** IIC Notes Regarding Piper Comanche, N244TW, KSJC exam

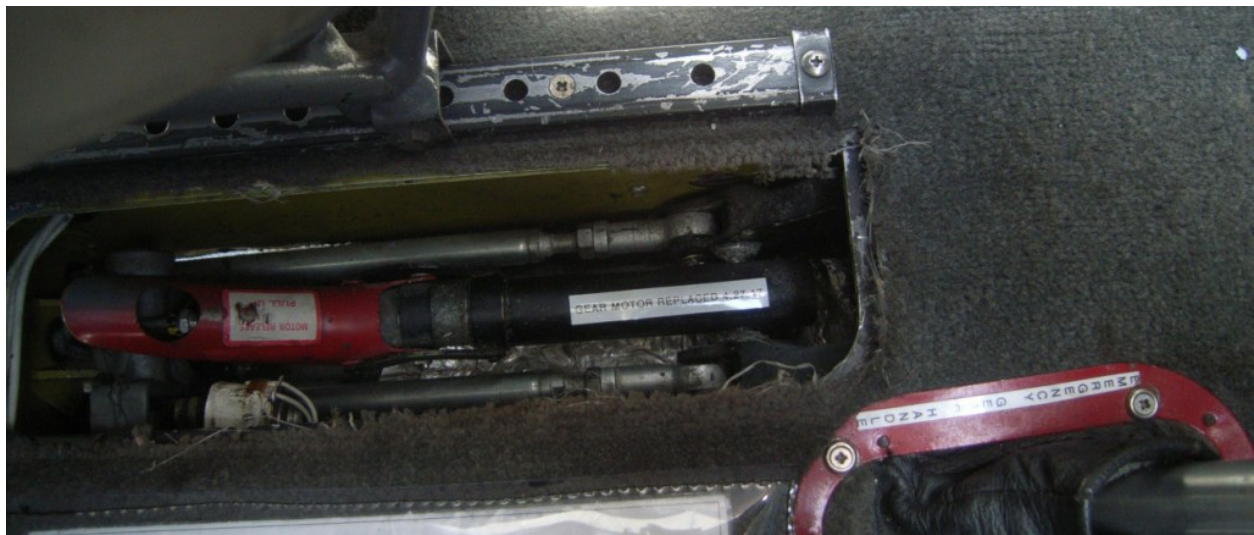
- Inside the cockpit, the access cover to the sub-floor bay which contained the emergency gear extension release handle & mechanism had been removed
  - o Mr. Steve Frost, of Corporate Aviation Technology at KSJC, was the primary executor of the recovery of the airplane after the event. He stated that, for his and others' safety during the recovery, ' he had removed the access cover to ensure that the system was still connected, which it was

- The emergency gear handle was in the aft/down (system not disconnected) position
- There was about 1/8" lateral/vertical play in the black shaft forward of the red disconnect handle

- All other components in that bay were attached, immovable, and showed no evidence of failure or disconnect
- The red activation/release handle was free to move, but it was not actuated because the airplane was supported only by its landing gear

*Figure 1 – Emergency Gear Release Bay (airplane forward is frame right)*

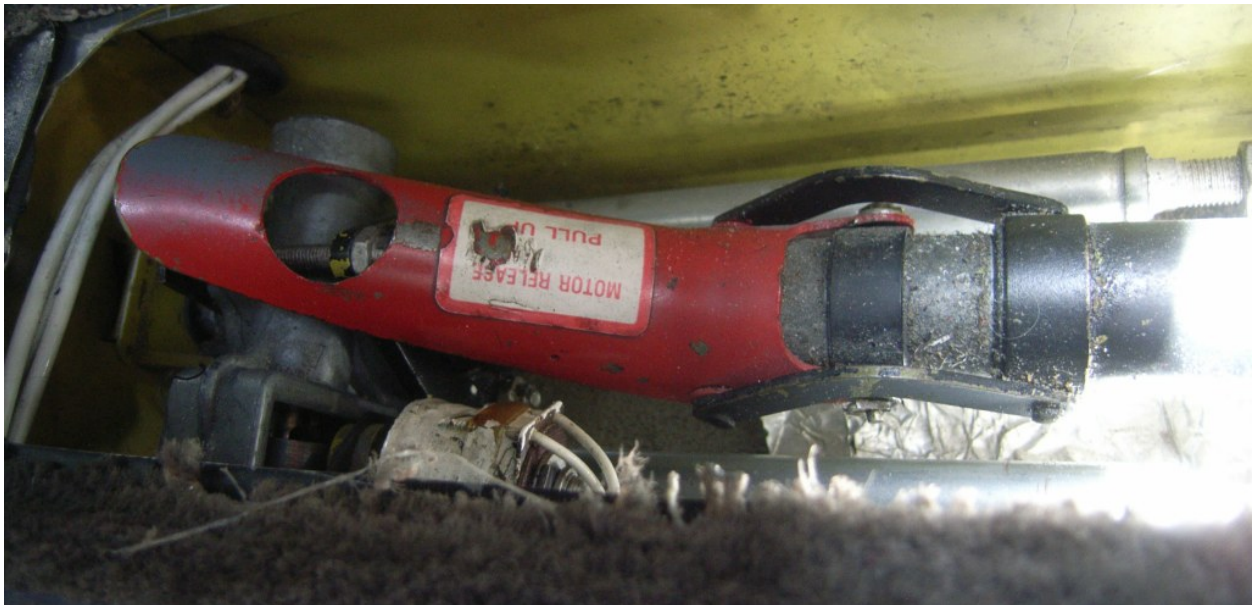
*Figure 2 - Close Up of Release handle (rest position)*

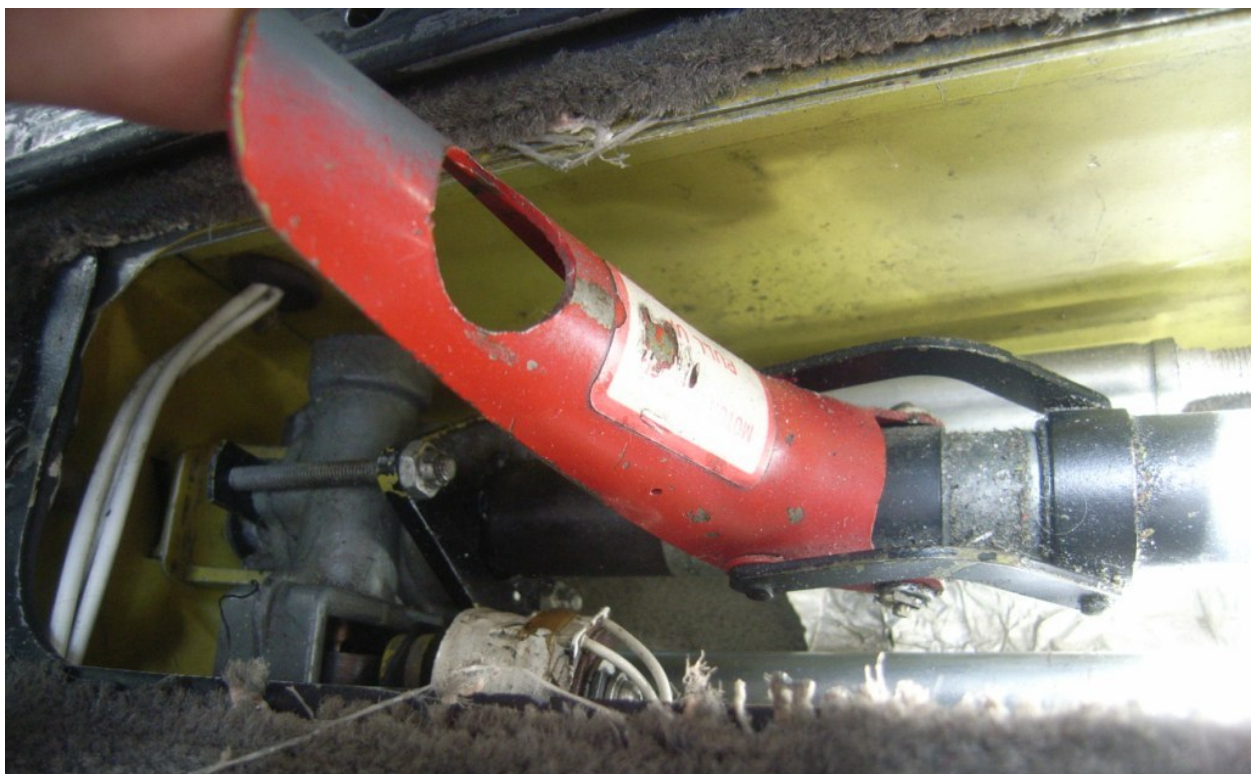
*Figure 3 - Close Up of Release Handle (lifted but not actuated)*

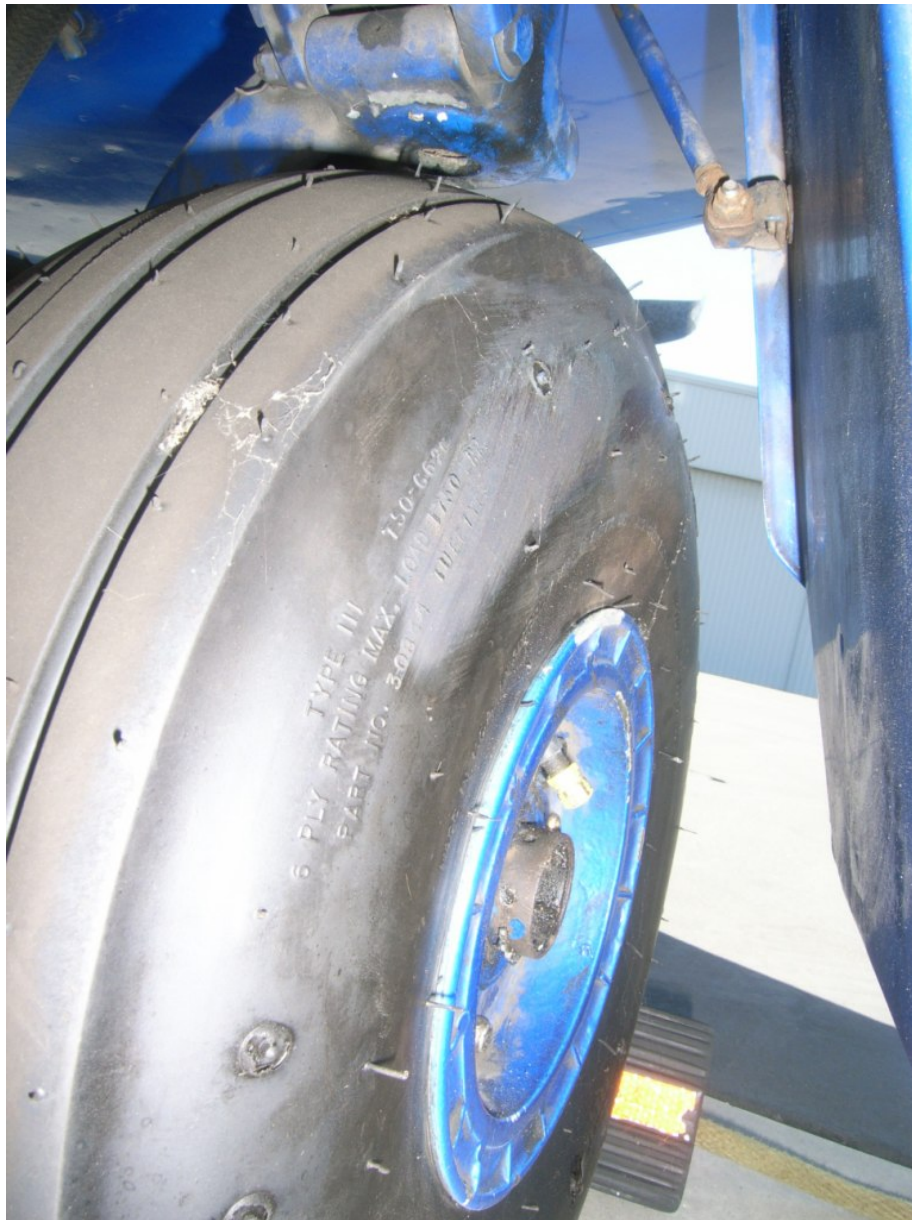
- The airplane was still parked on the 'south ramp' of Atlantic Aviation at KSJC
- The airplane was standing on its gear
- The RMLG tire and wheel had scuff marks on their outboard side

*Figure 4 - RMLG Tire and Wheel Scuff Marks*
