## **NATIONAL TRANSPORTATION SAFETY BOARD**

### **LANDING GEAR OPERATIONAL CHECKS KSJC**

**WPR18LA153**

Location: KSJC  
Date: May 20, 2018  
Aircraft: Piper PA-24 N244TW, Serial # 24-554  
NTSB IIC: Michael Huhn

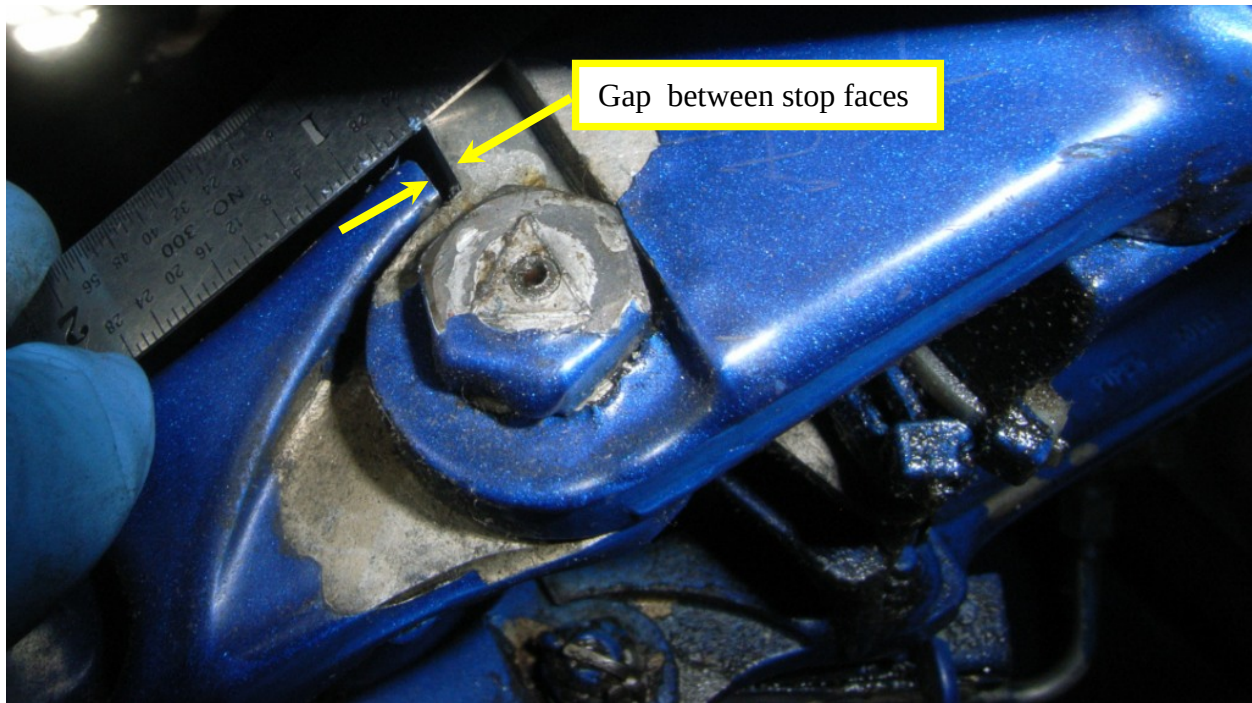
- A non-adjustable hard stop mechanism for NLG gear extension was integral to the left and right rotating junctions of the forward and aft drag links
  - These stops were formed by machined flats on the forward and aft drag links that mated/met to prevent further joint rotation

- As found, neither stop was functioning as a stop; A gap of about 1/16" remained in the left stop, and a gap of about 1/8" remained in the right stop

**Figure 1 – NLG Left Drag Link Joint Stop Gap**

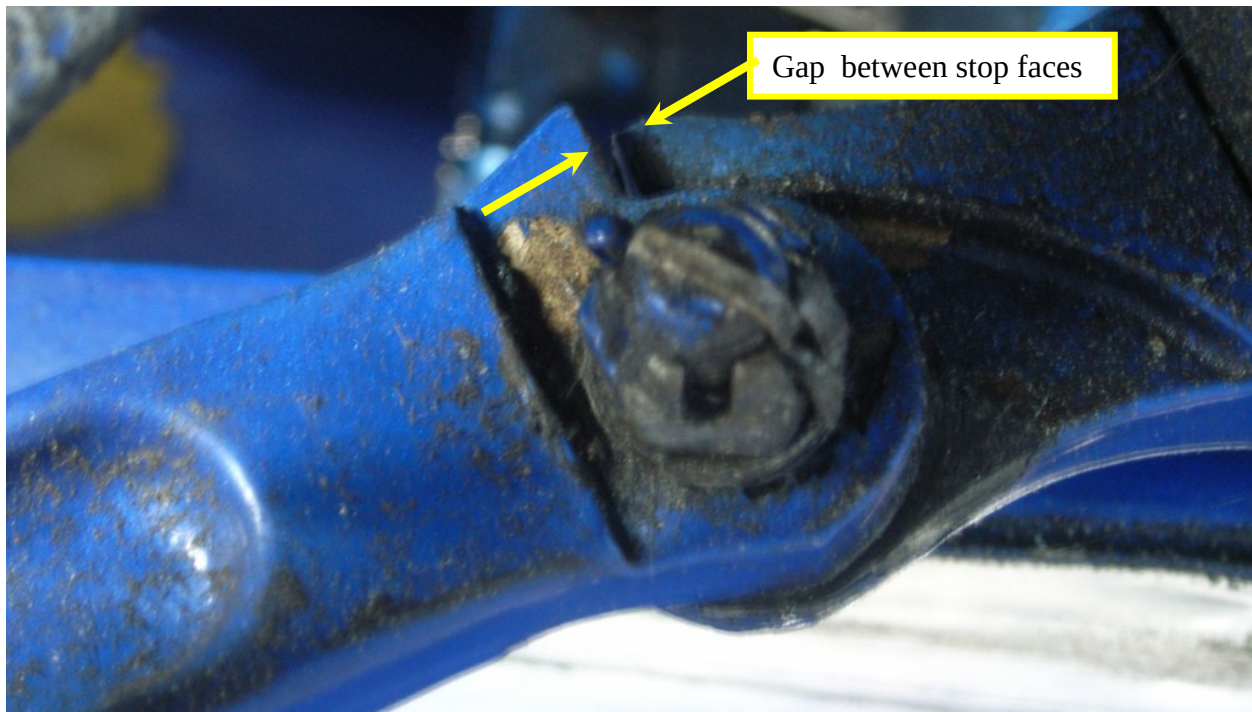
**Figure 2 - NLG Right Drag Link Stop Gap**

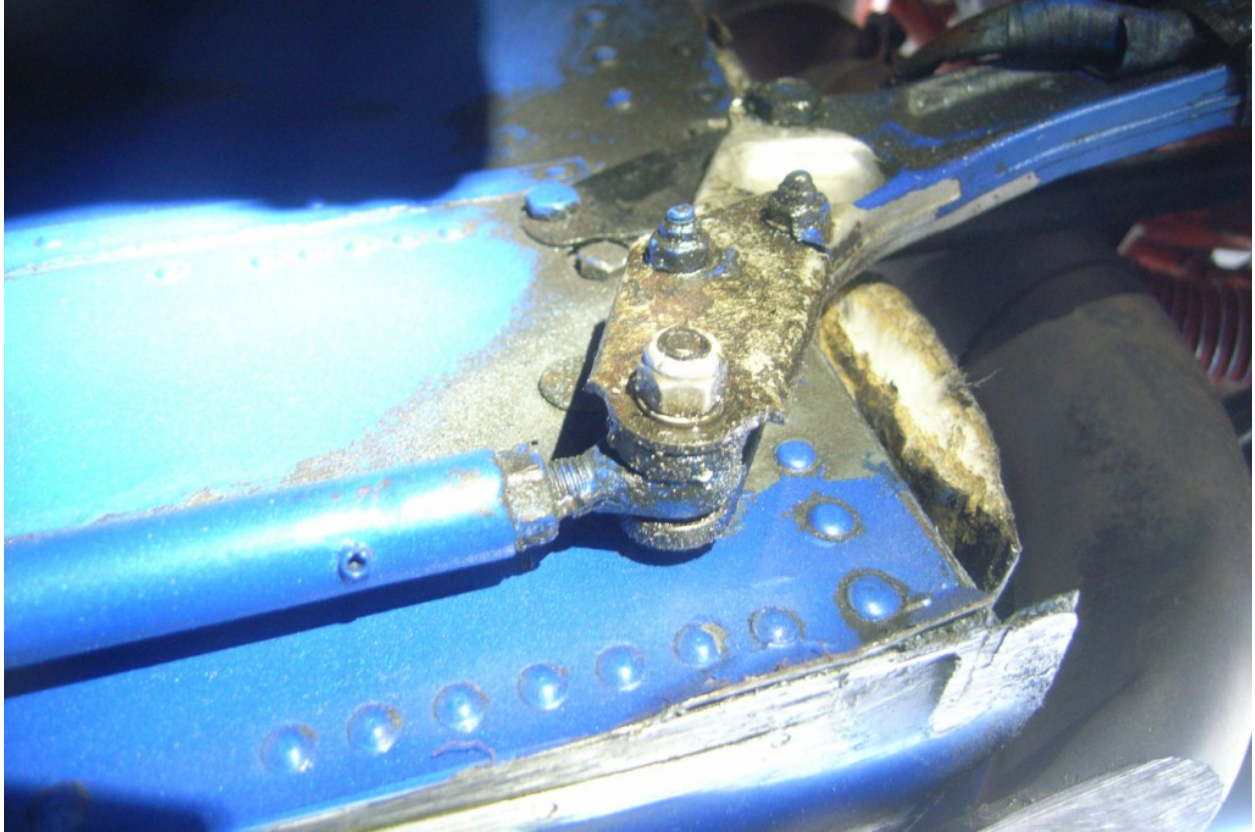
- Neither forward pressure nor kicks to the NLG altered the gaps
  - The gaps appeared to be able to be alterable by adjustment of the NLG actuating rod and rod end assembly that extended forward from the landing gear motor/transmission assembly

- That rod, rod end, and locknut assembly did not appear to have been altered since the airplane was painted (the paint was non-original)
- Each landing gear was equipped with a microswitch and actuation tab assembly (tab depresses microswitch button) when the gear was fully extended

**Figure 3 - NLG Actuating Rod with Adjustable Rod End**

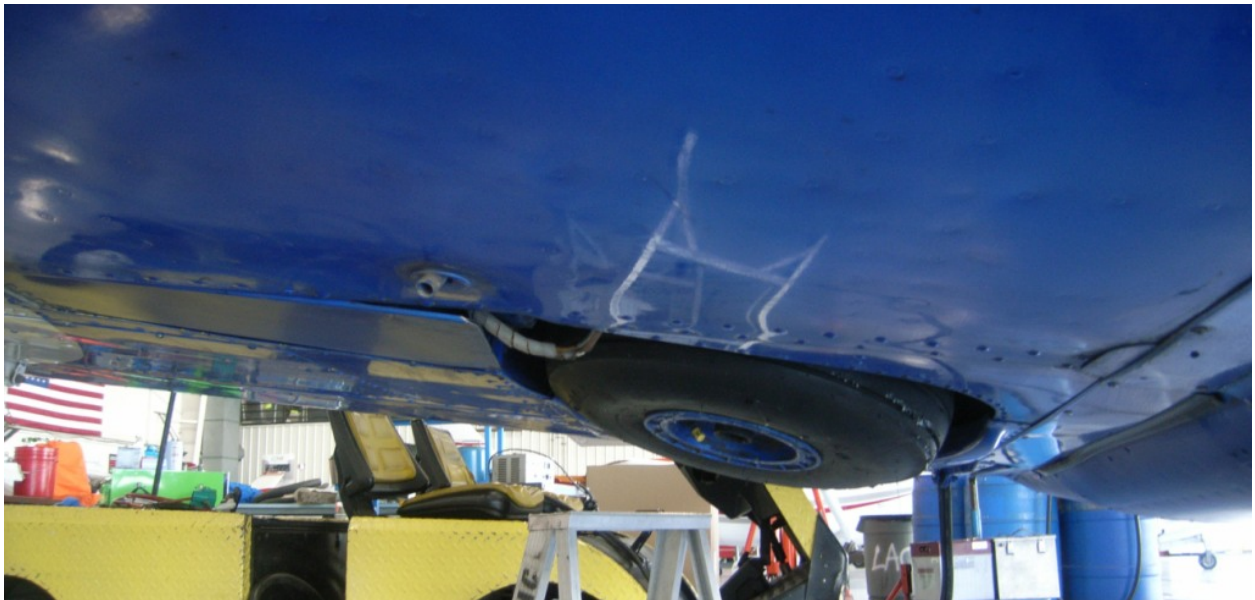
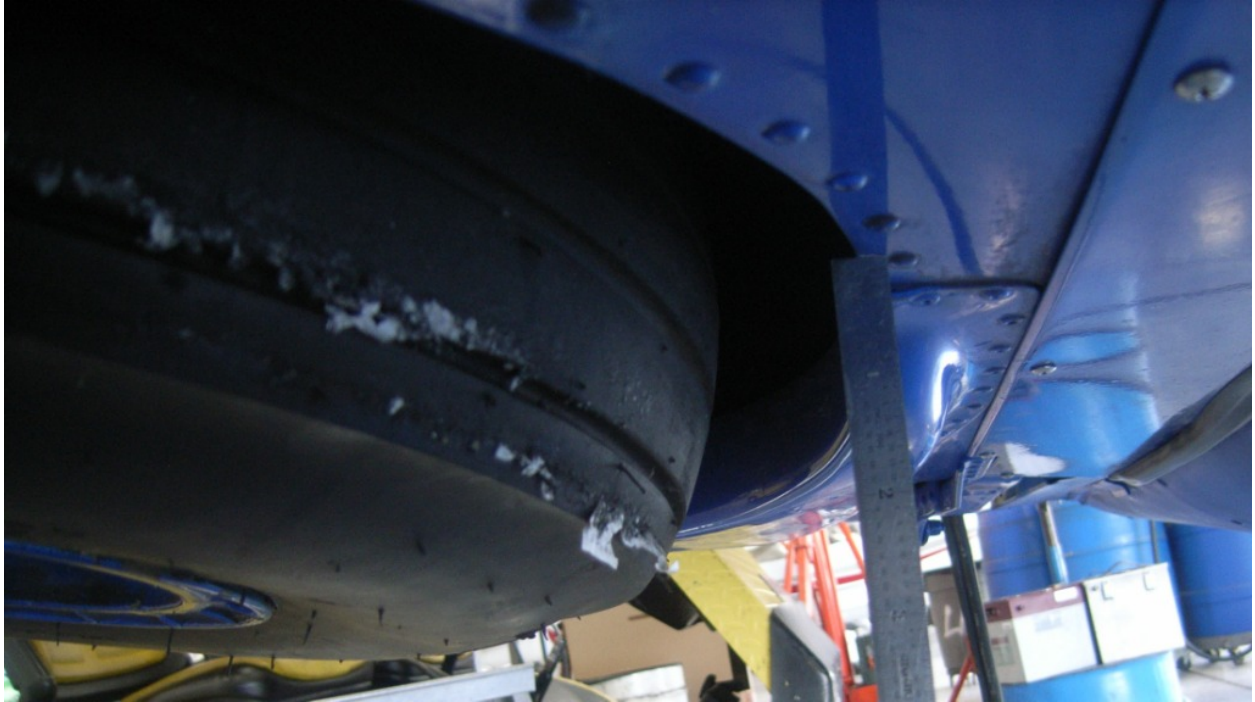
- When the gear was retracted by the normal system, the NLG fully retracted and the NLG door fully closed; however both MLG tires protruded about 2 – 2 ½ inches from the lower wing surface at their most inboard points.

- The MLG doors were within ~ 1/2 to 1/4 inch of fully closed/sealed at their most inboard edges
- No other system operational or appearance anomalies were observed

**Figure 4 - RMLG Retracted by Normal System Operation**
