## **NATIONAL TRANSPORTATION SAFETY BOARD**

# **LANDING GEAR SYSTEM EXAMINATION**

**WPR18LA153**

Accident Date: May 20, 2018  
Exam Date: July 24, 2018

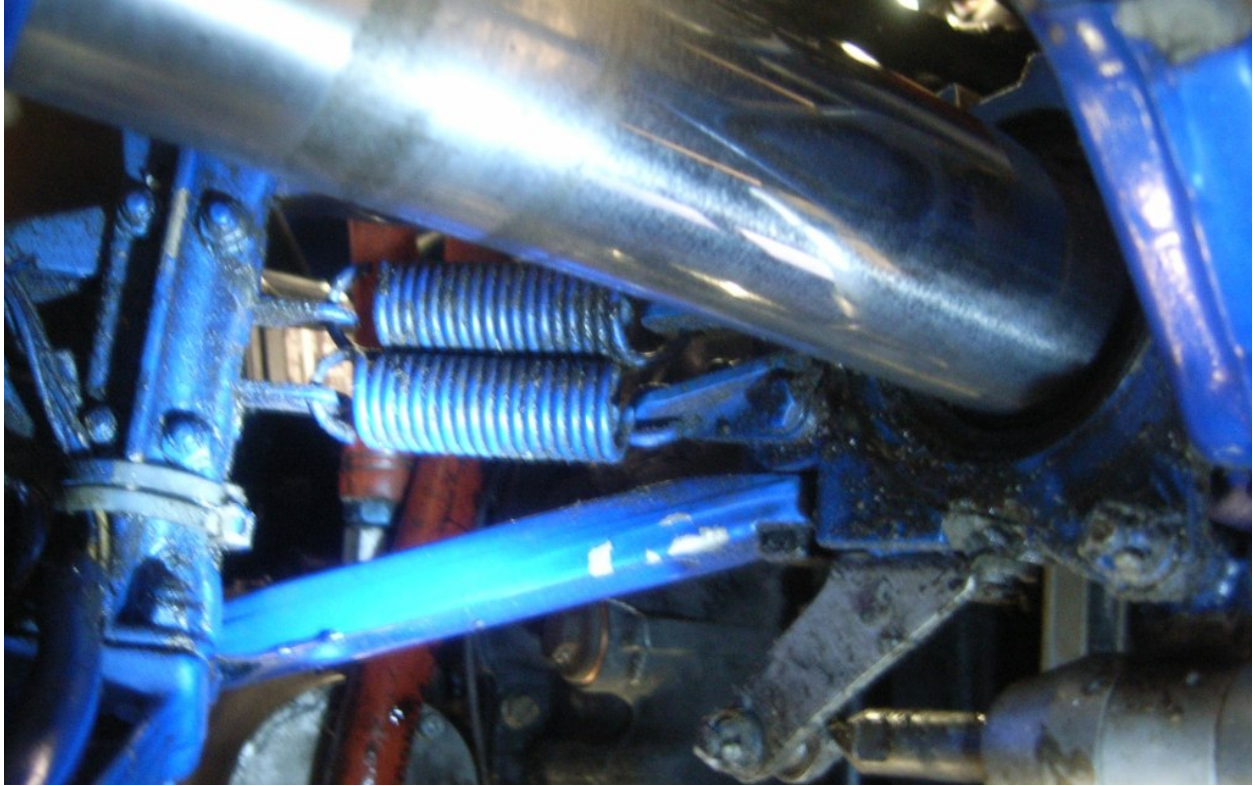
- All 3 landing gear assemblies were observed to contain their respective downlock springs
  - Each MLG had a single spring
  - The NLG was equipped with 2 downlock springs

**Figure 1 - Dual NLG Downlock Springs**

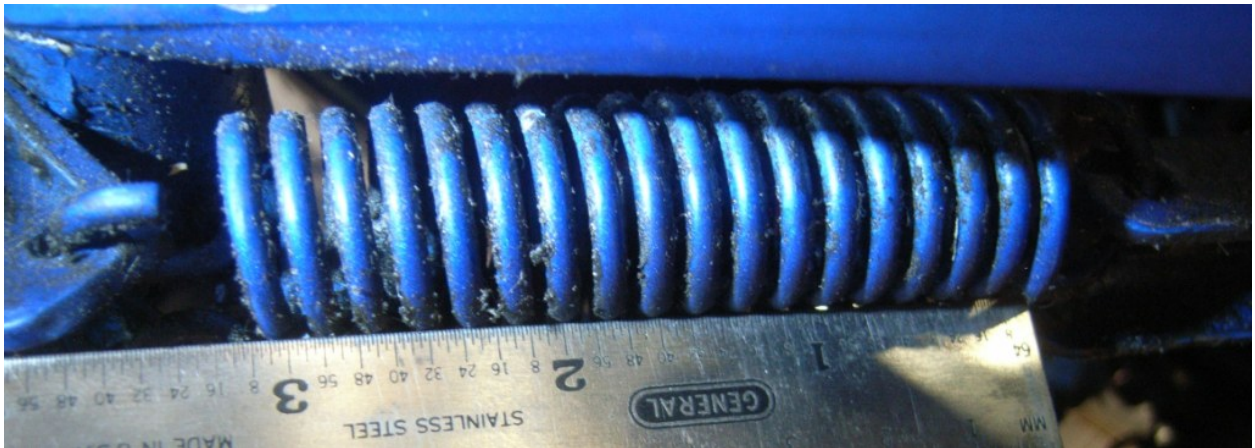
- The NLG spring extension was measured; the spacing between adjacent spring coils was measured to be about 4/64 inches
  - The manufacturer's nominal NLG spring extension value was not determined, and it is not known whether the manufacturer specifies that value or any other measure of spring condition

**Figure 2 - NLG Downlock Spring (NLG fully extended)**

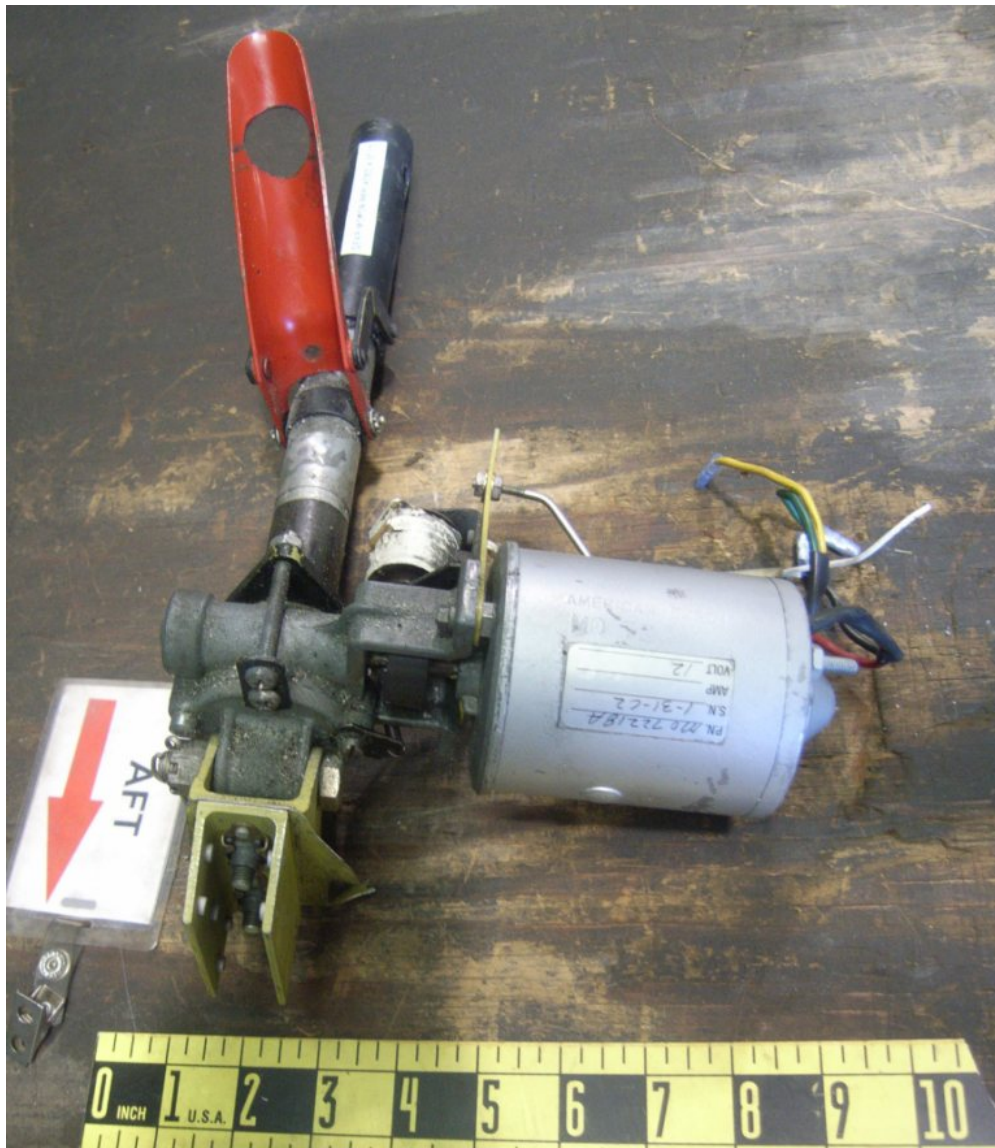
Figure 3 - Gear Motor and Transmission

- The motor and transmission assembly was removed from the airplane and examined
  - All components were intact and exhibited no external damage
  - All transmission gears were well lubricated, rotated readily, and meshed well

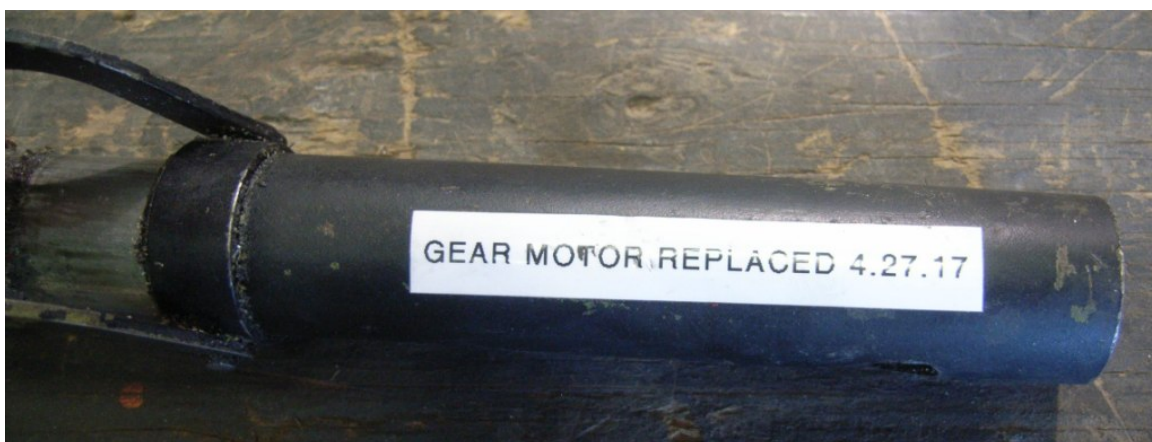
Figure 4 - Placard on Emergency Gear Handle

- A placard on the emergency gear lever stated that the landing gear motor was replaced on April 27, 2017, but there was no corresponding entry in the maintenance records

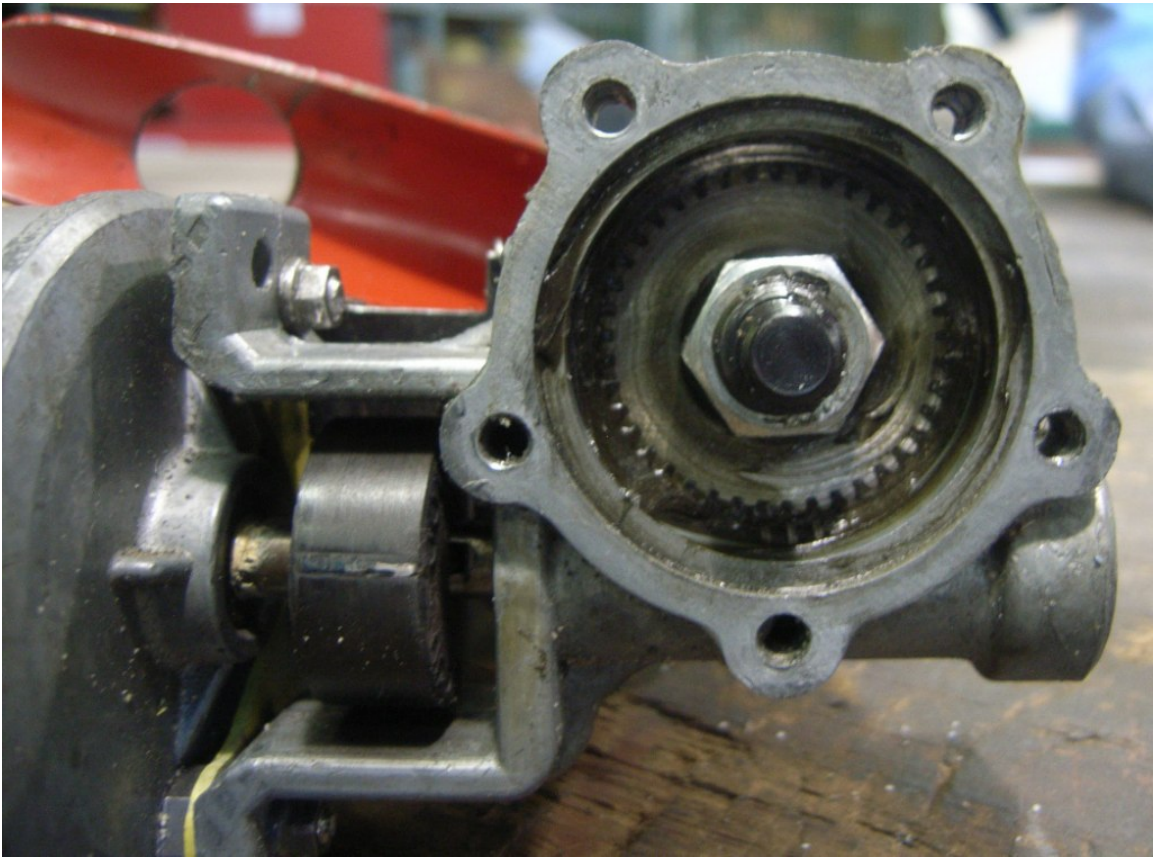
- No metal shavings or fragments were observed in the gear lubricants or housings
  - No transmission gears exhibited any signs of damage or wear
- The rod, lever, and bellcrank assemblies just downstream of the motor/transmission assembly were all undamaged, and did not exhibit any visible wear

**Figure 5 - Transmission Internal Gears**
