## **NATIONAL TRANSPORTATION SAFETY BOARD**

### **AIRFRAME EXAMINATION**

**WPR18LA156**

Location: Tonopah, Nevada  
Date: May 30, 2018  
Aircraft: Beech A36, N191HL, SN: E-1437  
NTSB IIC: Elliott Simpson

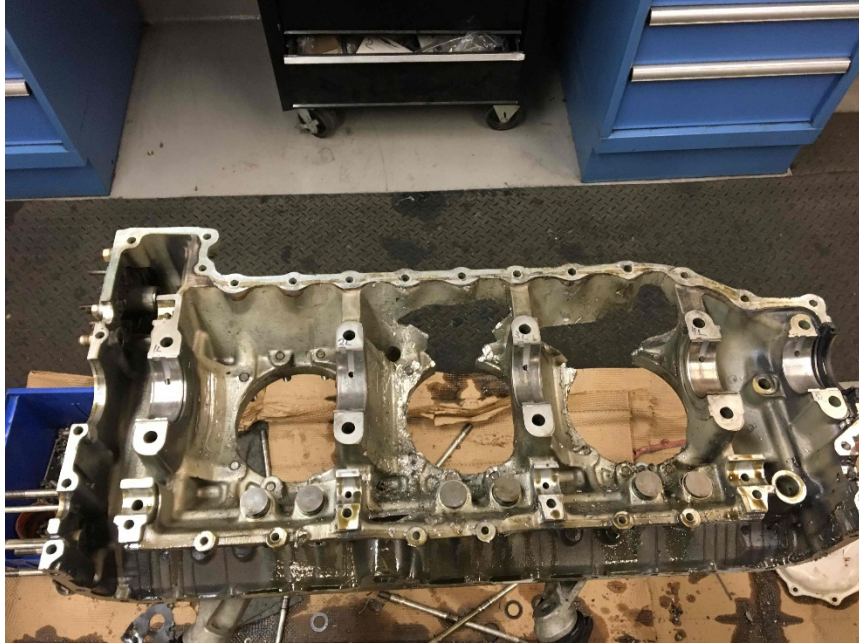
Photo 1 – Crankcase

- Crankcase side A exhibited three large holes, two above the piston bores and one below (Photo 1).
- Crankcase side B exhibited two large holes above the piston bores (Photo 2).

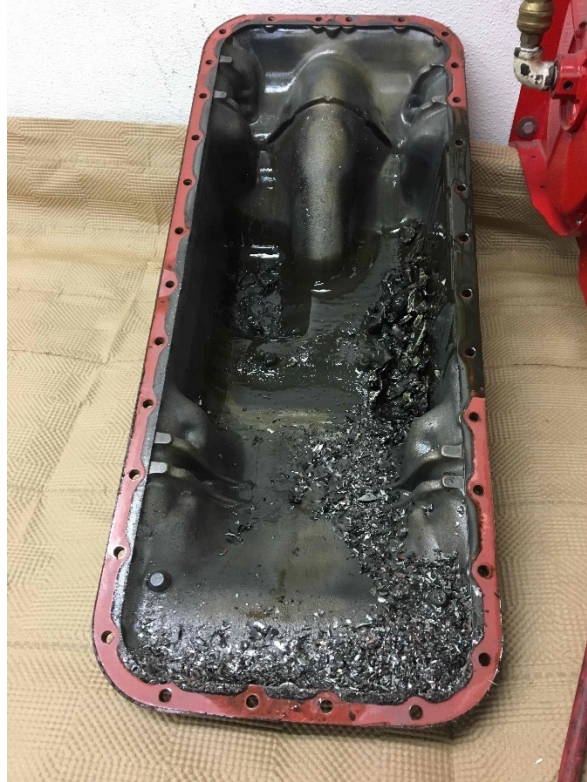
Photo 3 – Oil Sump

- Numerous gouges found throughout the internal walls of both engine cases.
- Large quantities of metallic fragments were found in the oil pan (Photo 3).

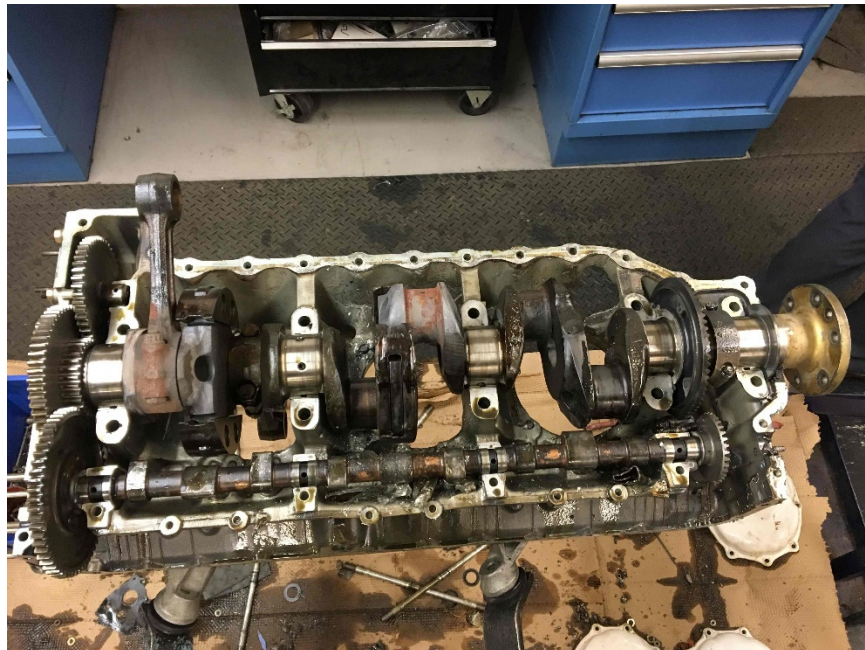
Photo 4 - Crankshaft

- Piston rods 3, 4, 5, 6 had separated from the engine crankshaft. Rods 1, and 2 remained attached. (Photo 4) The bearing surface for rod number 2 was intact, the surface for rod number 1 exhibited evidence of oil starvation.

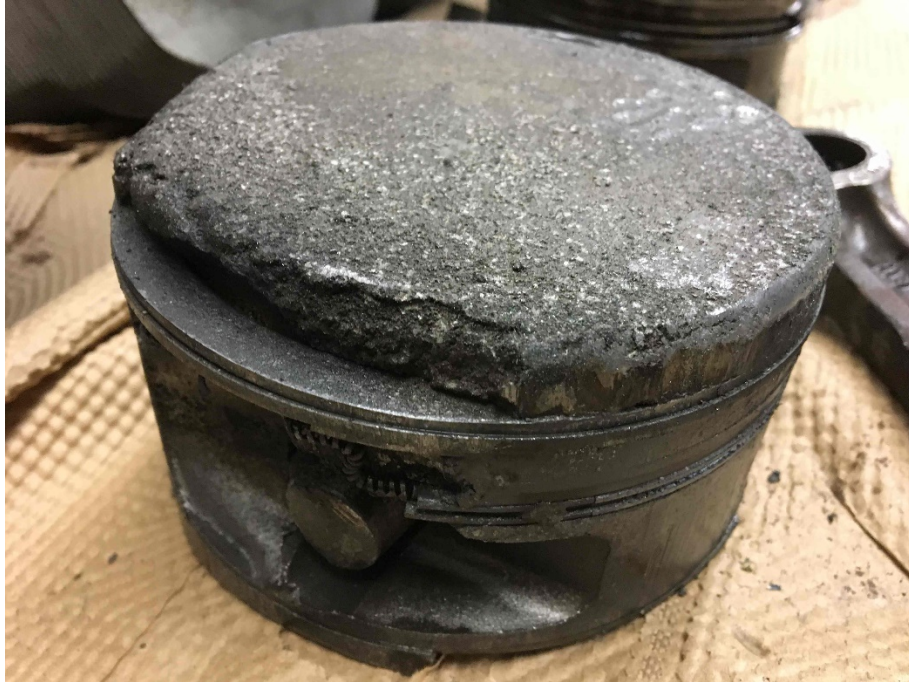
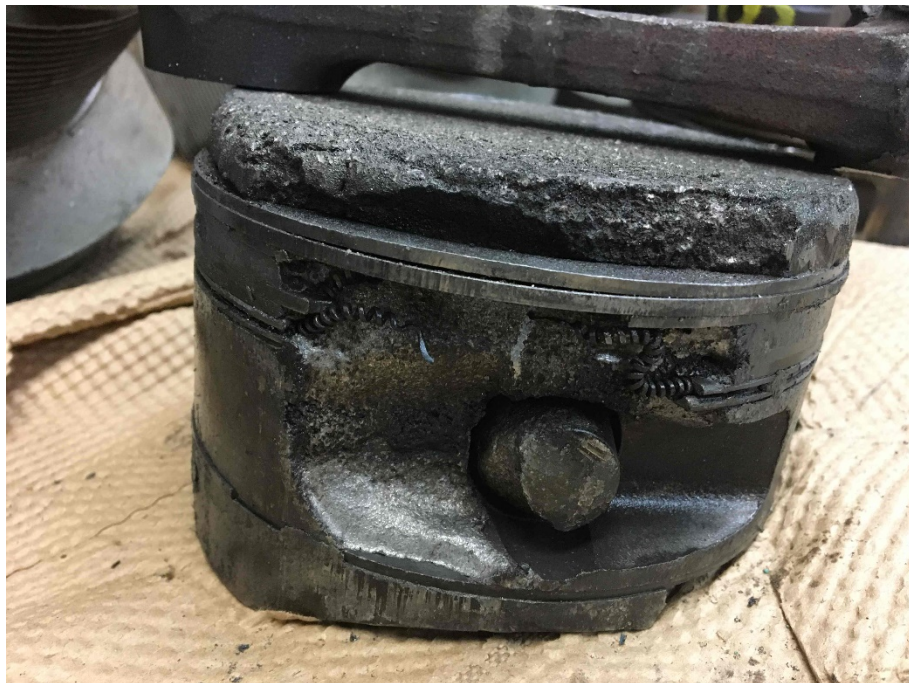
- The number 4 piston displayed evidence of detonation/pre-ignition to its crown characterized by burn through from the top surface through to the piston skirt. (Photo 5,6)

- The remaining five piston crowns and cylinder heads exhibited were clean, free of deposits, and exhibited a sand-blasted appearance, consistent with the effects of detonation/pre-ignition.

Photo 5 – Piston Number 4

Photo 6 – Piston Number 4
