# NATIONAL TRANSPORTATION SAFETY BOARD

## MATERIALS LABORATORY FACTUAL REPORT

Report No. 19-017

Place : San Manuel, Arizona  
Date : May 21, 2018  
Vehicle : Rhoads Autogyro MTO Sport, N574BR  
NTSB No. : WPR18LA158  
Investigator : Samantha Link, AS-WPR

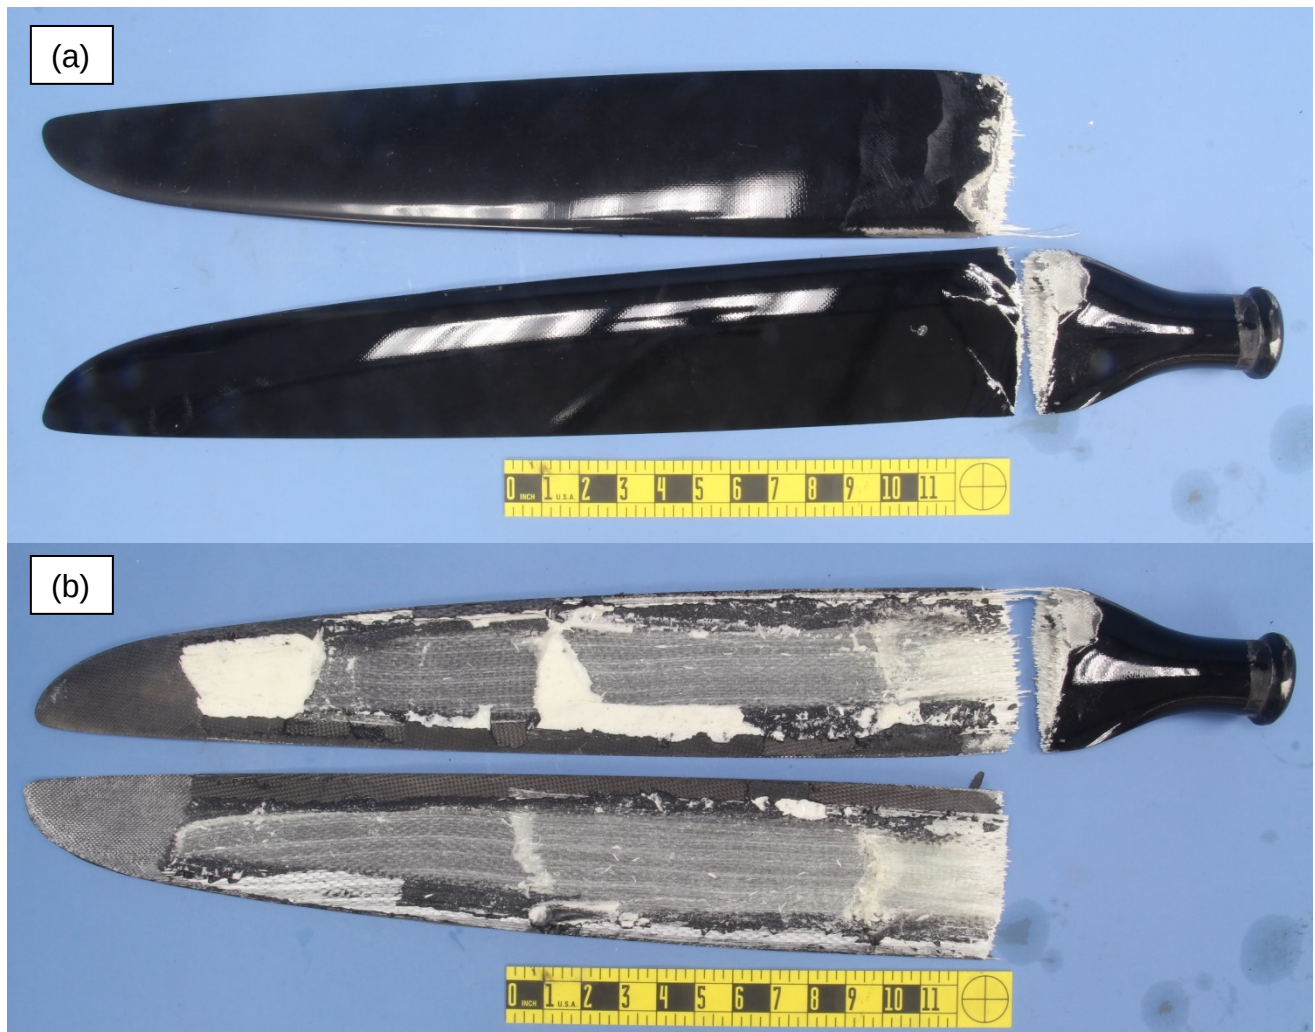
Figure 1 shows the fractured propeller blade, as received. The propeller material was consistent with a fiber-reinforced composite. The blade had fractured in two locations: a transverse fracture across the blade cross section located approximately 5.5 inches from the base, and longitudinally through the foam core in the center of the blade. The longitudinal fracture of the blade was generally interlaminar in nature (between plies of the composite) but was not exclusively confined to one location—this fracture alternated between different plies, consistent with overstress separation.

Figure 1 – View of the fractured propeller blade viewed from (a) the outer surfaces and (b) in internal, longitudinal fracture. The blade also exhibited a transverse fracture 5.5 inches from the root base.

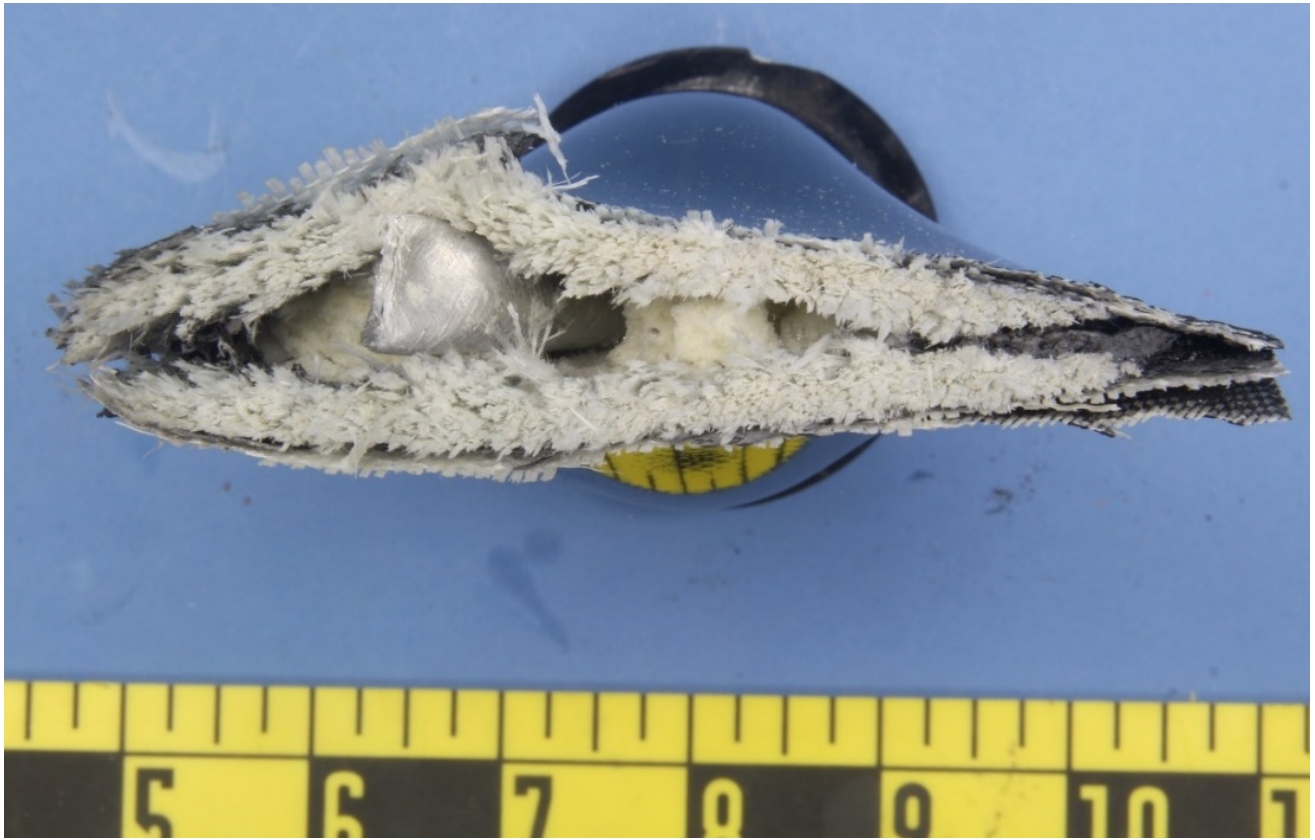
Figure 2 shows the transverse fracture surface from the root side. This fracture exhibited fiber pullout and fractures at multiple heights, along with a central metallic tube that had buckled and collapse. The fracture of the internal tube exhibited a rough surface texture, and a general 45° slant in orientation. The tube material adjacent the tube fracture

had thinned (necked) but also exhibited deformation in multiple locations. These features were consistent with overstress fracture under variable loading orientations, consistent with typical subsequent fractures in airplane accidents. Figure 3 shows the root of the blade. The periphery of the angled root seat exhibited chatter marks, consistent with repeated load impulses on the part from contact with the adjacent hub seat.

Figure 2 – The transverse fracture surface of the propeller blade, showing fiber fraying and pullout, with tearing of the skin and internal foam core.

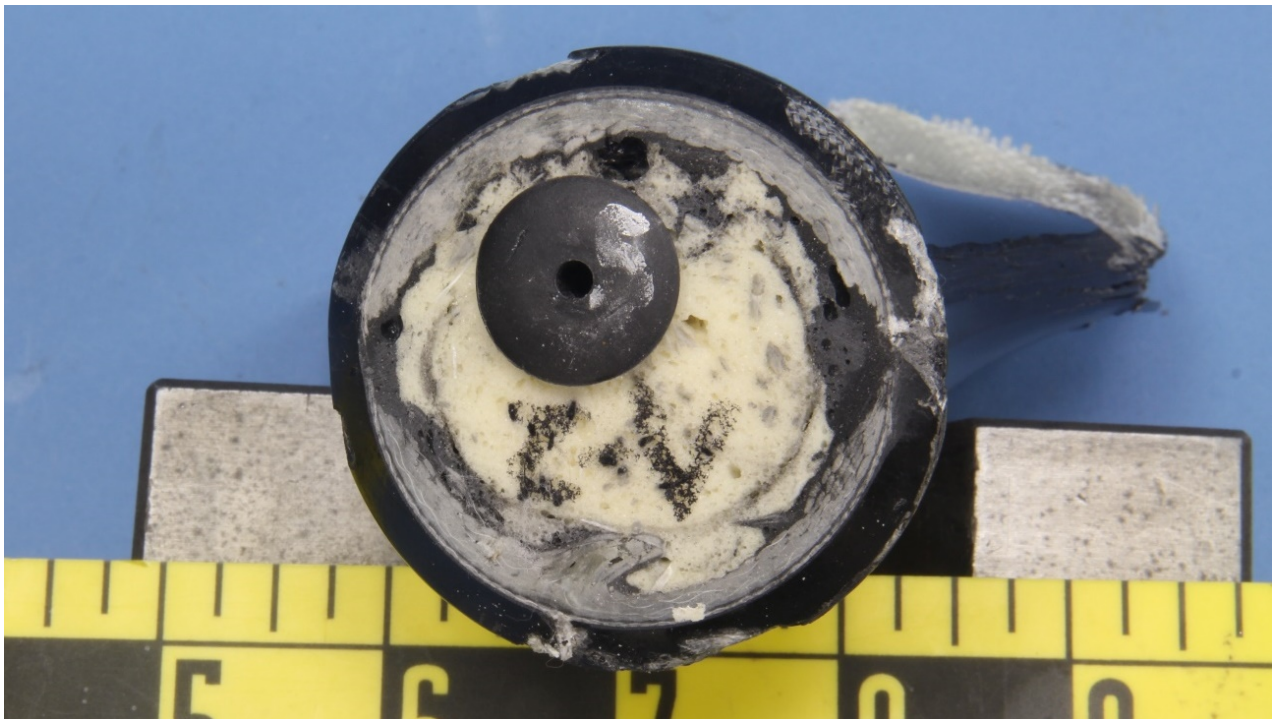
Figure 3 – The base of the fractured propeller blade, showing chatter marks on the seat ridge.

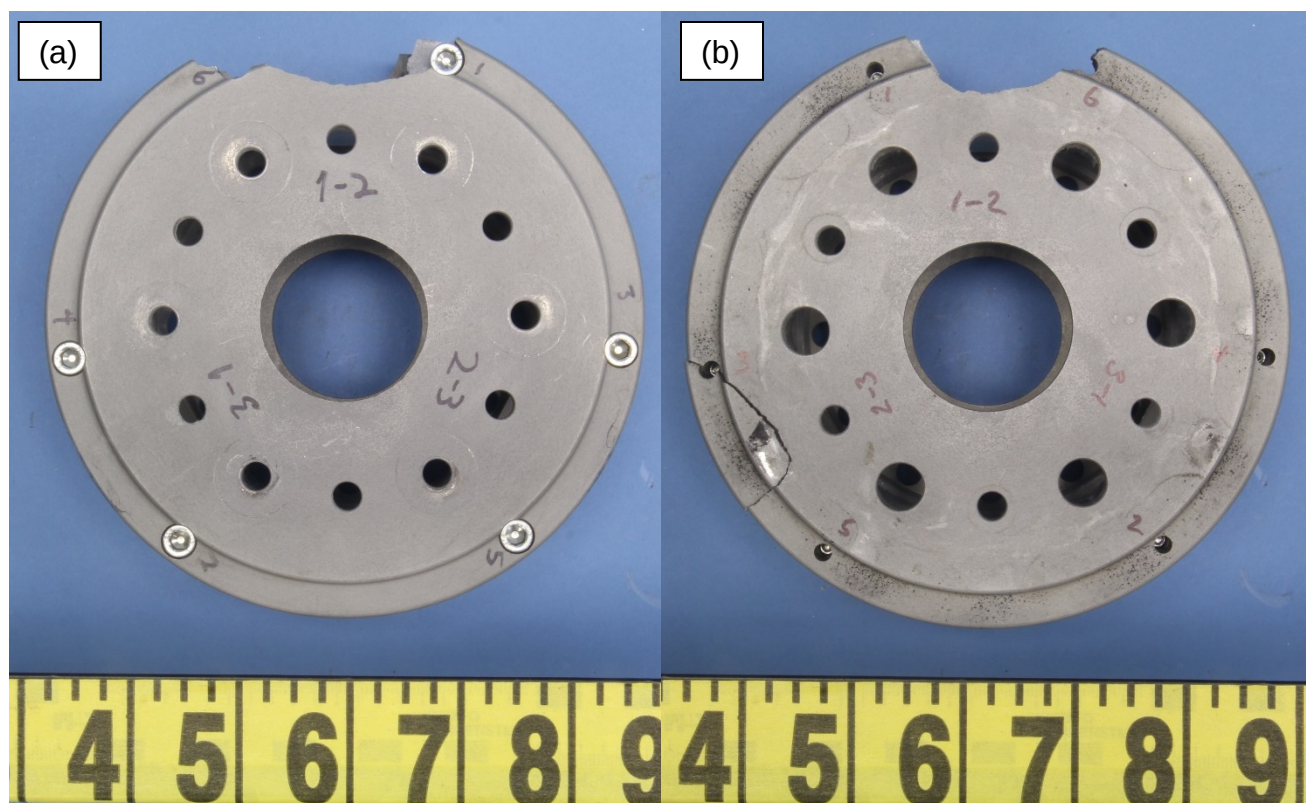
Figure 4 shows the forward and aft faces of the propeller hub remnant, as received. The three propeller blade root seats had been labeled “1-2”, “2-3”, and “3-1” upon receipt. In addition, the locations of the bolts that connected the aft and forward halves of the hub had been labeled 1 through 6. This nomenclature was retained for the purposes of this report.

As shown in Figure 4, the hub had fractured about the 1-2 location where one of the propeller blades had sat. In addition, there was a large crack about the 2-3 position, illustrated in Figure 4b. The fracture about the 1-2 position is shown in Figure 5. The fracture occurred inboard of the #6 bolt position, such that that bolt and material outboard had separated. Figure 6 shows a closer view of the 1-2 crack, showing crack arrest (or beach) marks, consistent with progressive cracking. In addition, this fracture surface exhibited ratchet marks, consistent with multiple crack initiation sites.

Figure 4 – The remnants of the propeller hub, as received from (a) the forward face and (b) the aft surface. The propeller blade seats had been labeled 1-2, 2-3, and 3-1.

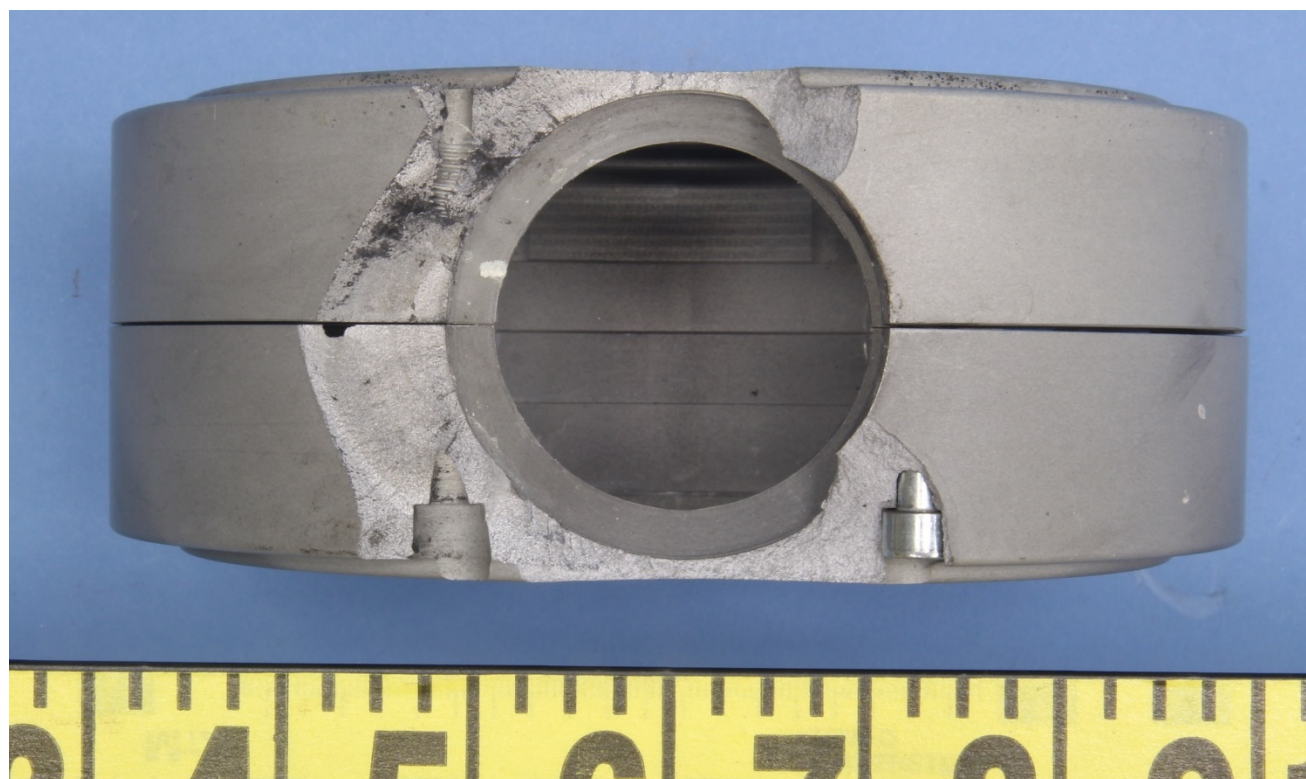
Figure 5 – View of the fracture surface from the blade seat in position 1-2.

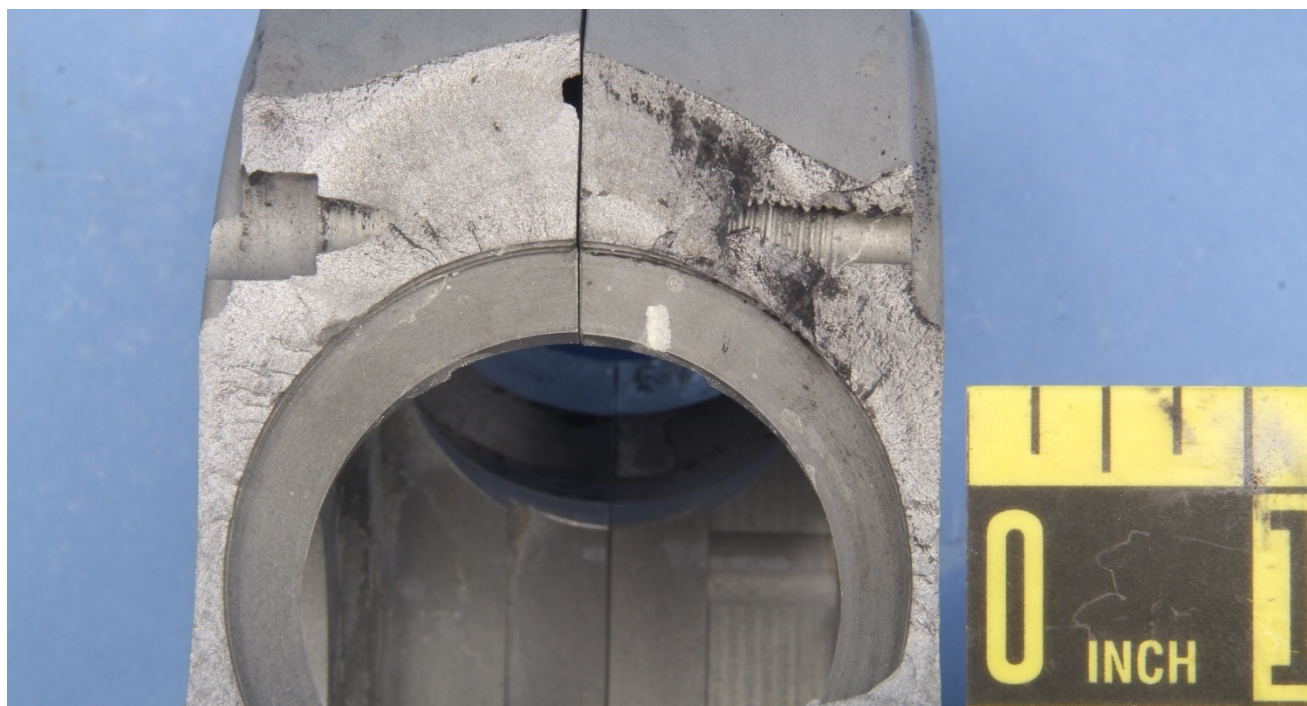
Figure 6 – View of the progressive region of the 1-2 fracture, showing crack arrest and ratchet marks.

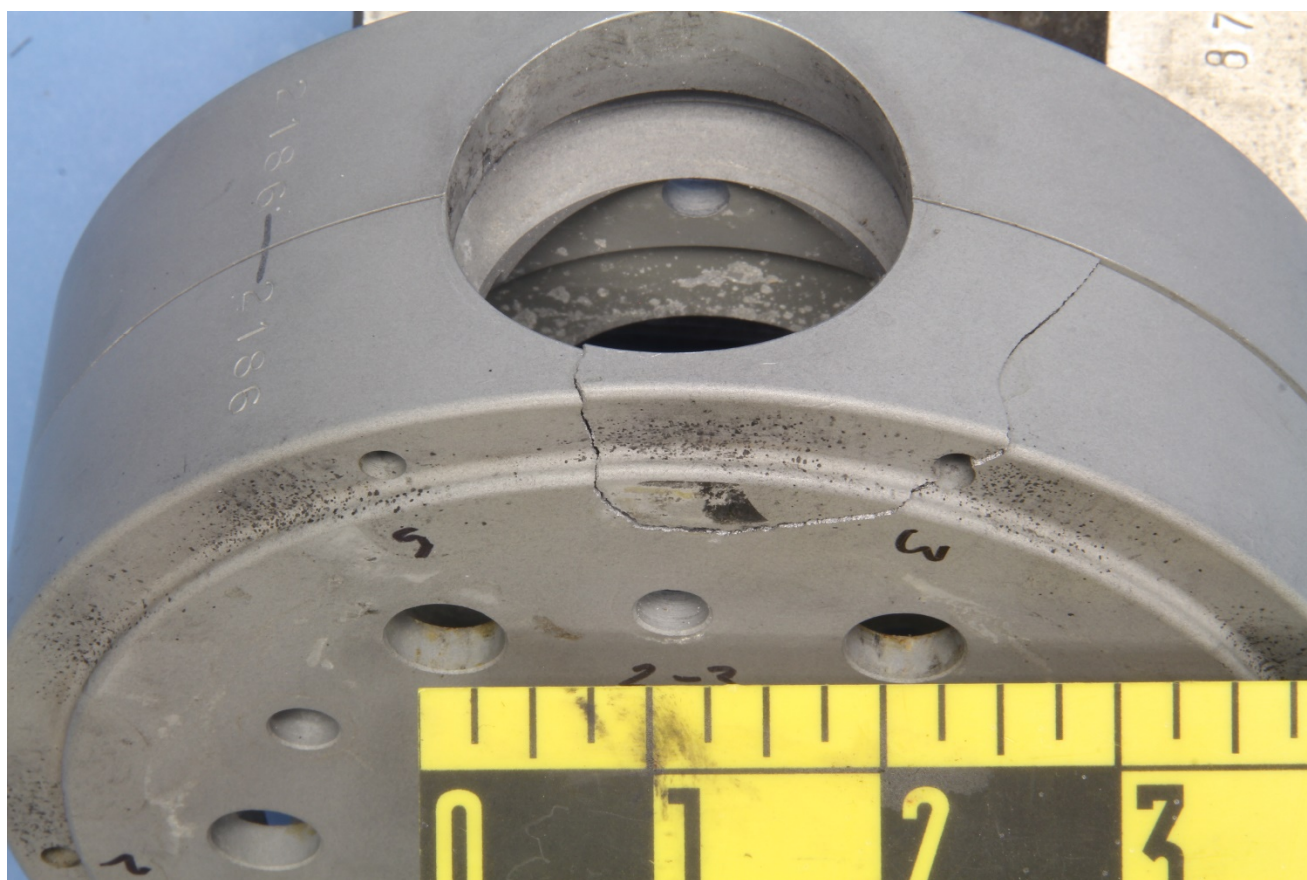
Figure 7 shows a closer view of the 2-3 crack present that was on the aft half of the propeller hub. The remaining bolts were removed, the hub halves were separated, and the cracked hub section at the 2-3 position was intentionally overstressed (laboratory opened) to reveal the mating crack faces (displayed in Figure 8). Similar to the 1-2 fracture, the 2-3 crack faces exhibited features consistent with progressive fracture. Figure 9 shows a closer view of one of the 2-3 crack initiation sites, located at the propeller blade root seat.

Figure 7 – View of the cracked hub from the 2-3 blade seat position, viewed from the aft side.

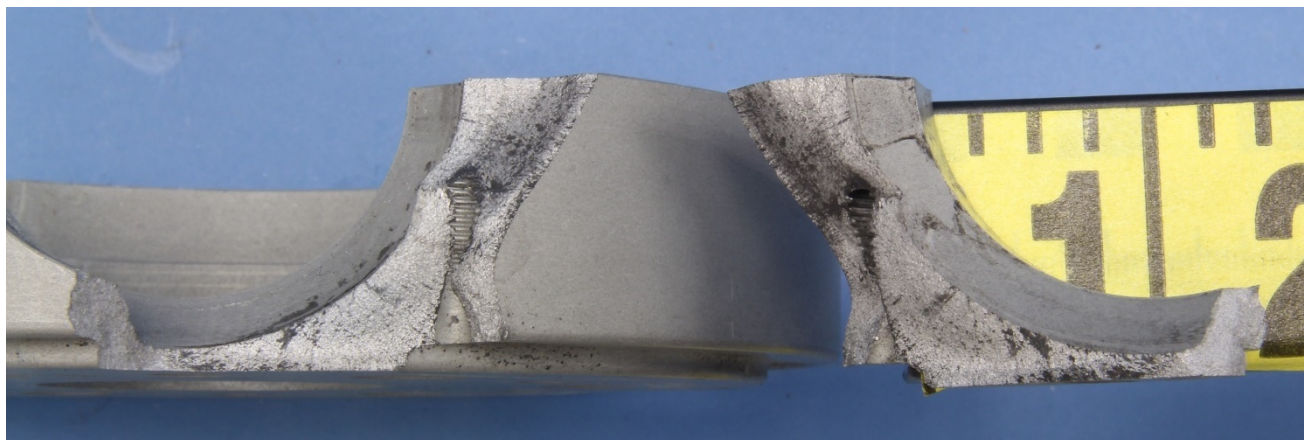
Figure 8 – Mating faces of the 2-3 fracture after separating the hub halves and lab opening the crack.

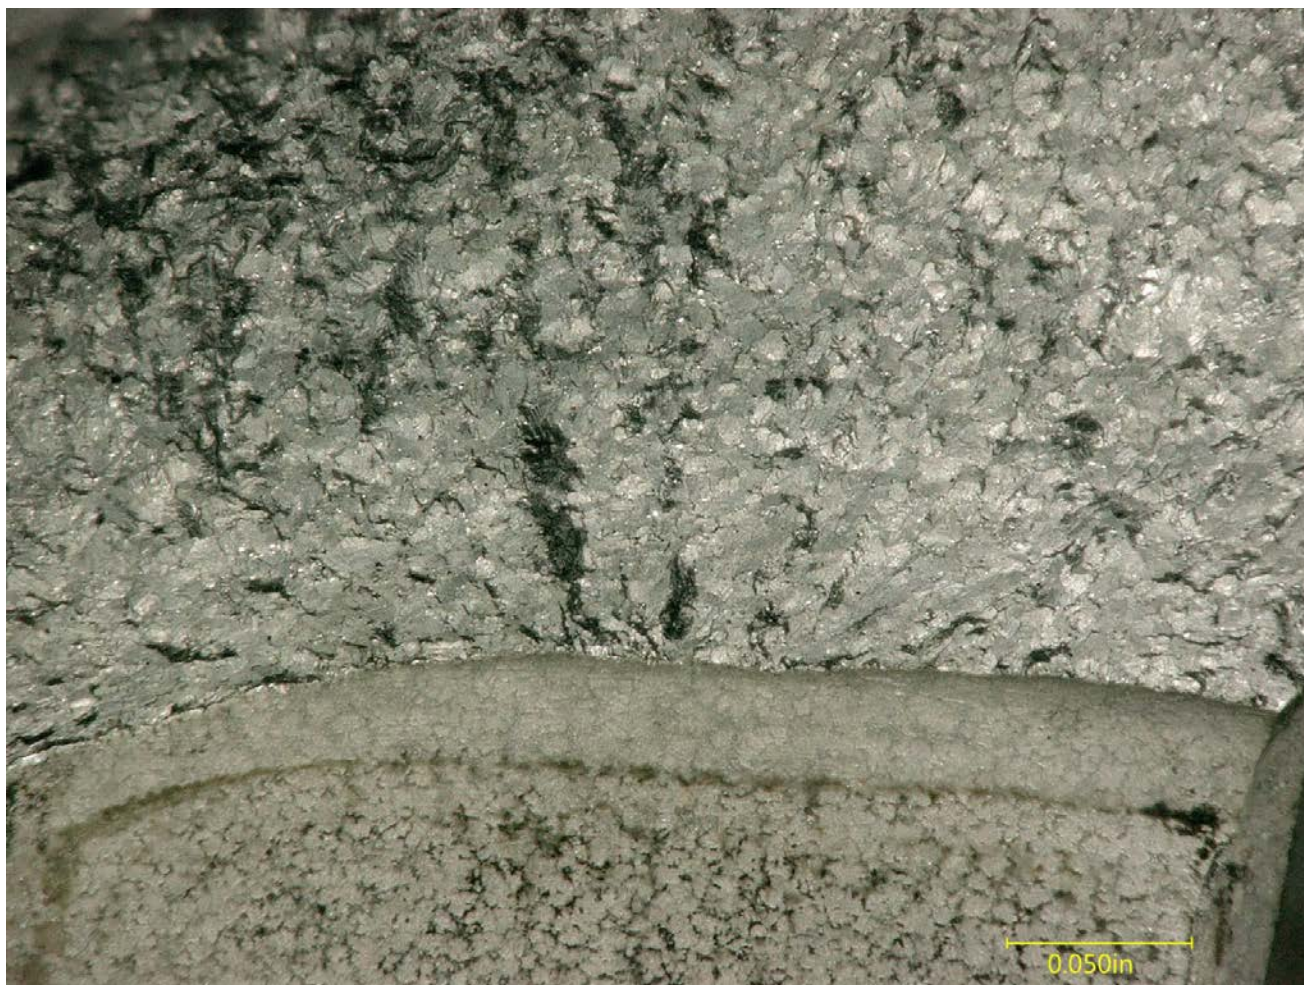
Figure 9 – Closer view of a crack initiation site on the 2-3 fracture surface, adjacent to the propeller blade root seat.

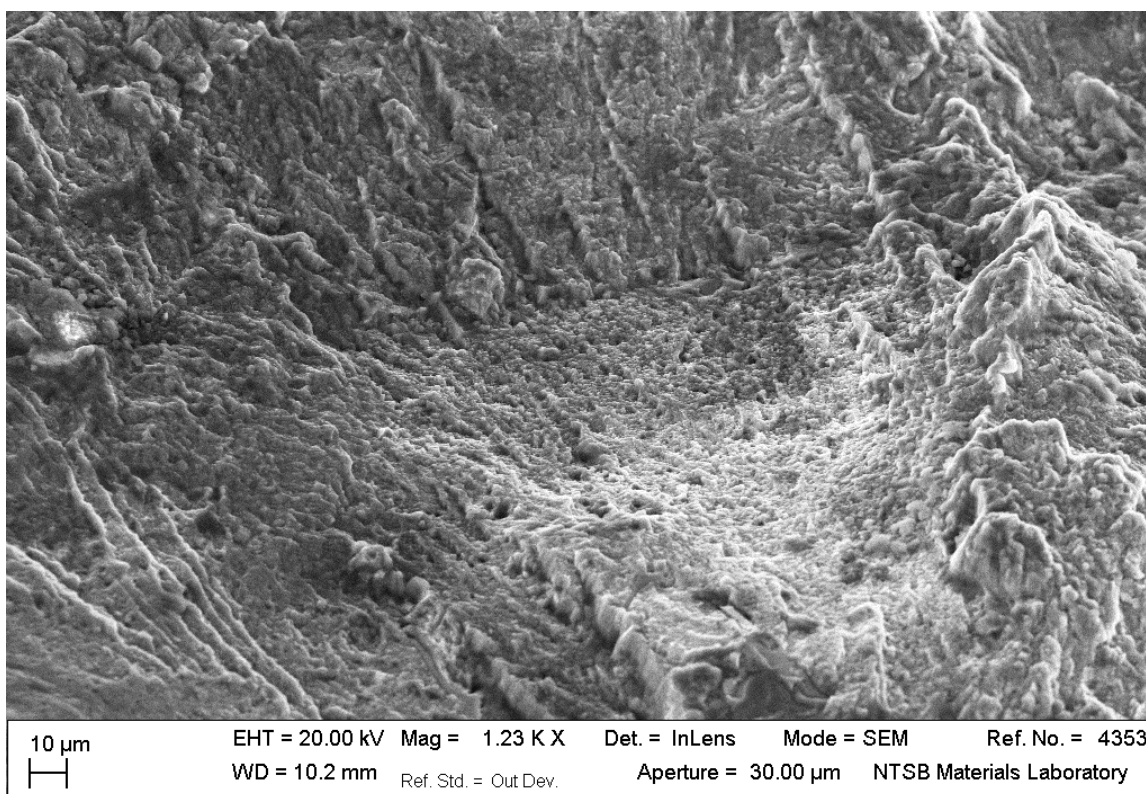
Both the 1-2 fracture surface and the 2-3 crack were further sectioned and cleaned with acetone in order to examine them using a scanning electron microscope (SEM). Figure 10 shows a typical area of the progressive region of the 1-2 fracture. This area exhibited fatigue striations, consistent with fatigue crack propagation. A closer view of the striations is shown in Figure 11. These striations were also present towards the end of the fatigue crack, along with secondary (out of plane) cracking, as illustrated in Figure 12. A closer view of the striations at the end of the fracture is shown in Figure 13—the finely spaced striations were consistent with high-cycle fatigue (typical of repeated high-RPM propeller loads).

Figure 10 – Secondary electron (SE) micrograph of fatigue cracking near an initiation site of the 1-2 fracture surface.

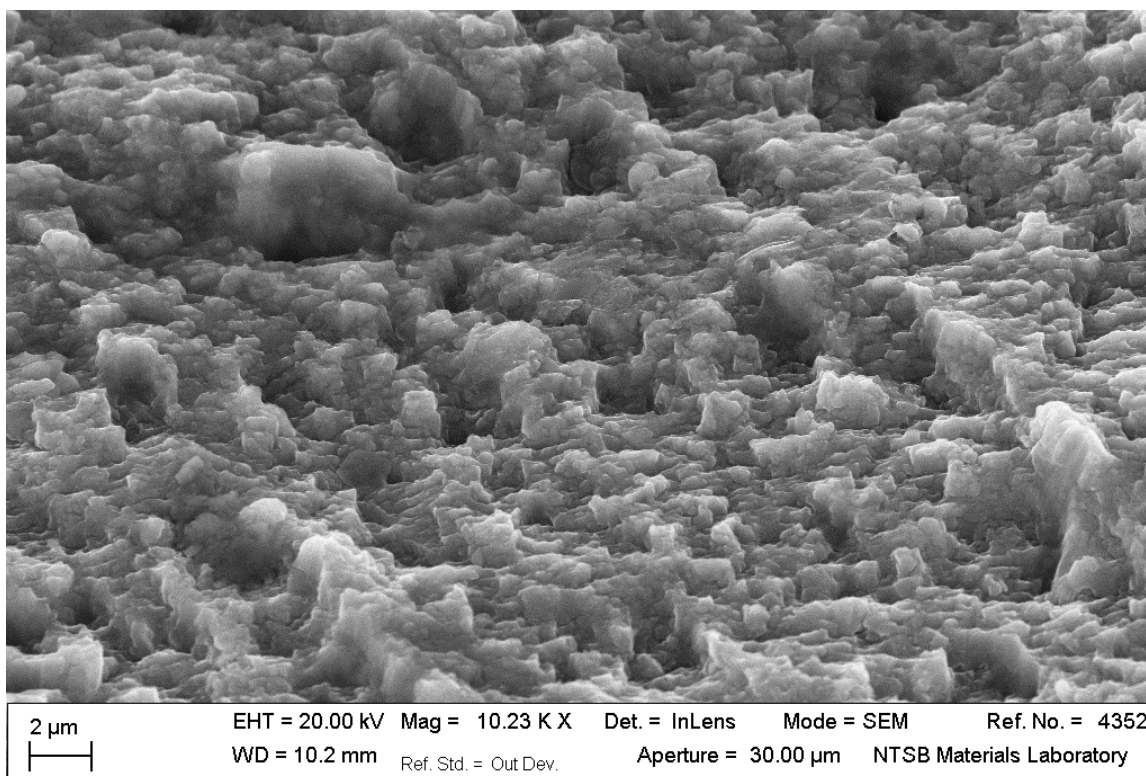
Figure 11 – SE micrograph of closer view of Figure 10, showing fatigue striations.

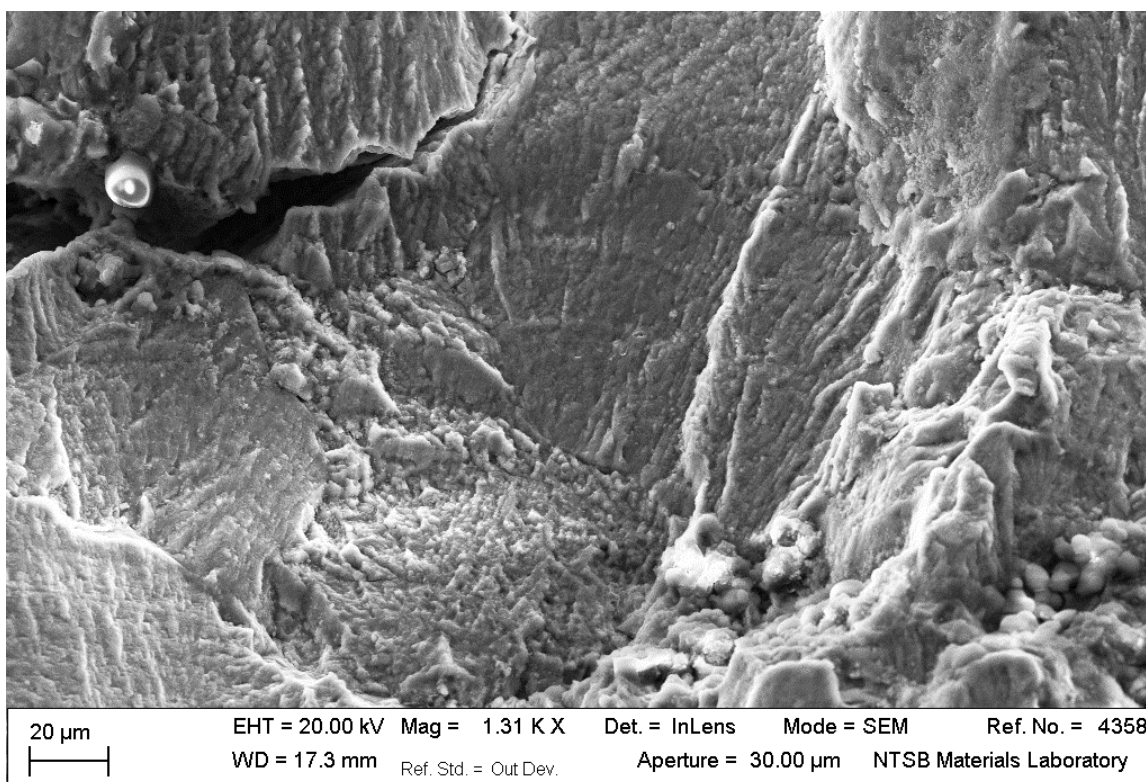
Figure 12 – SE micrograph of fatigue striations toward the end of the 1-2 fracture surface.

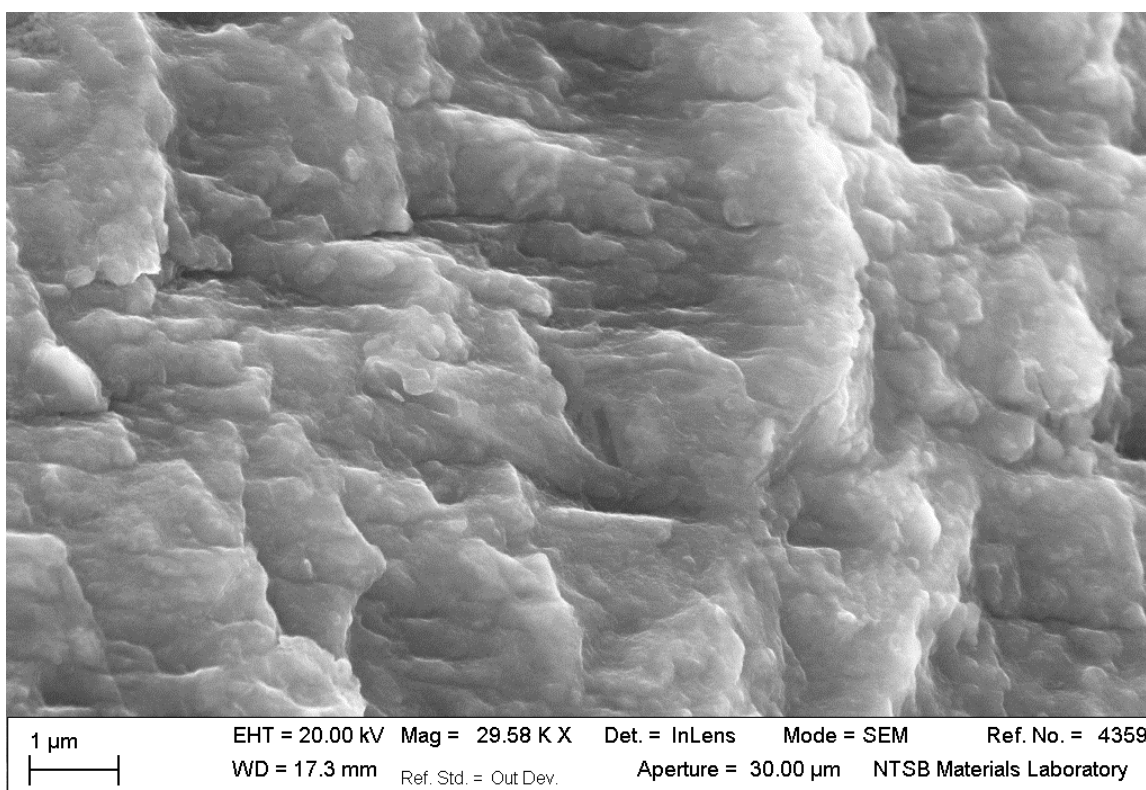
Figure 13 – SE micrograph of the fatigue striations in Figure 12.

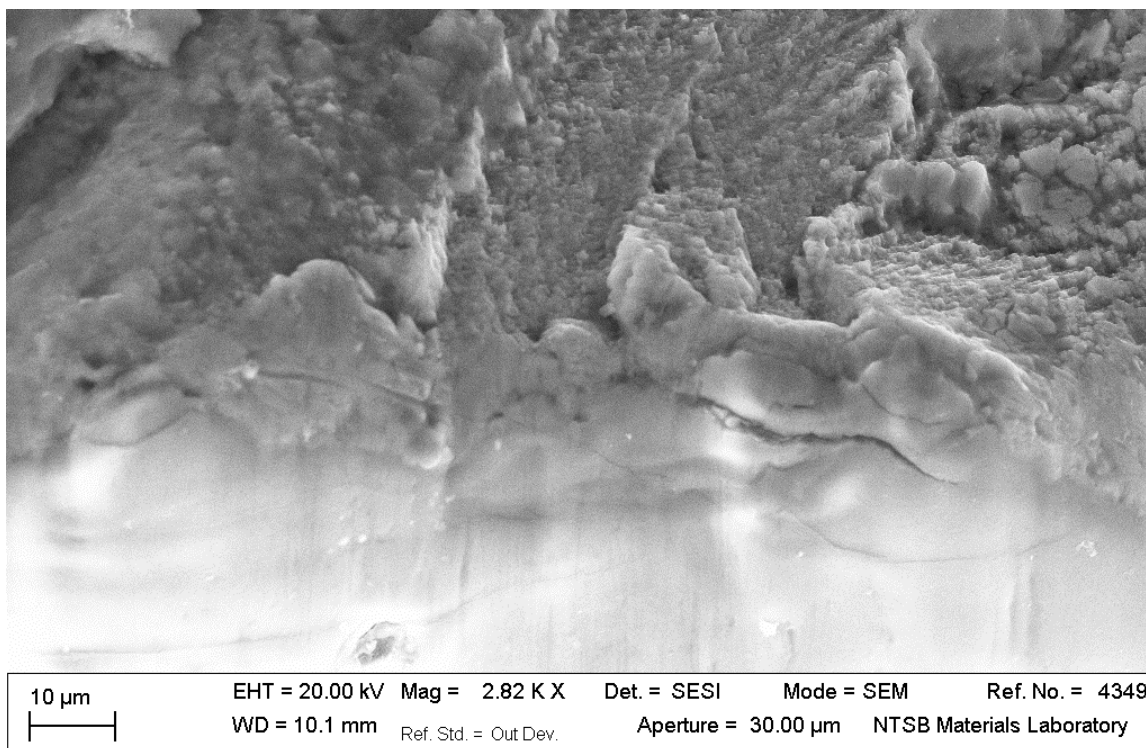
One of the 1-2 fatigue crack initiation sites is illustrated in Figure 14. The crack initiated at the 1-2 blade root seat. As shown in the figure, there were other smaller secondary cracks below the main fracture, consistent with the multiple crack initiation sites seen on the rest of the fracture. A closer view of the blade root seat at the 1-2 position is shown in Figure 15. This surface exhibited a network of corrosion pits. These pits often contained small cracks, as illustrated in Figure 16.

Figure 14 – SE micrograph of a crack initiation site on the 1-2 fracture surface, showing parallel cracking on the seat surface.

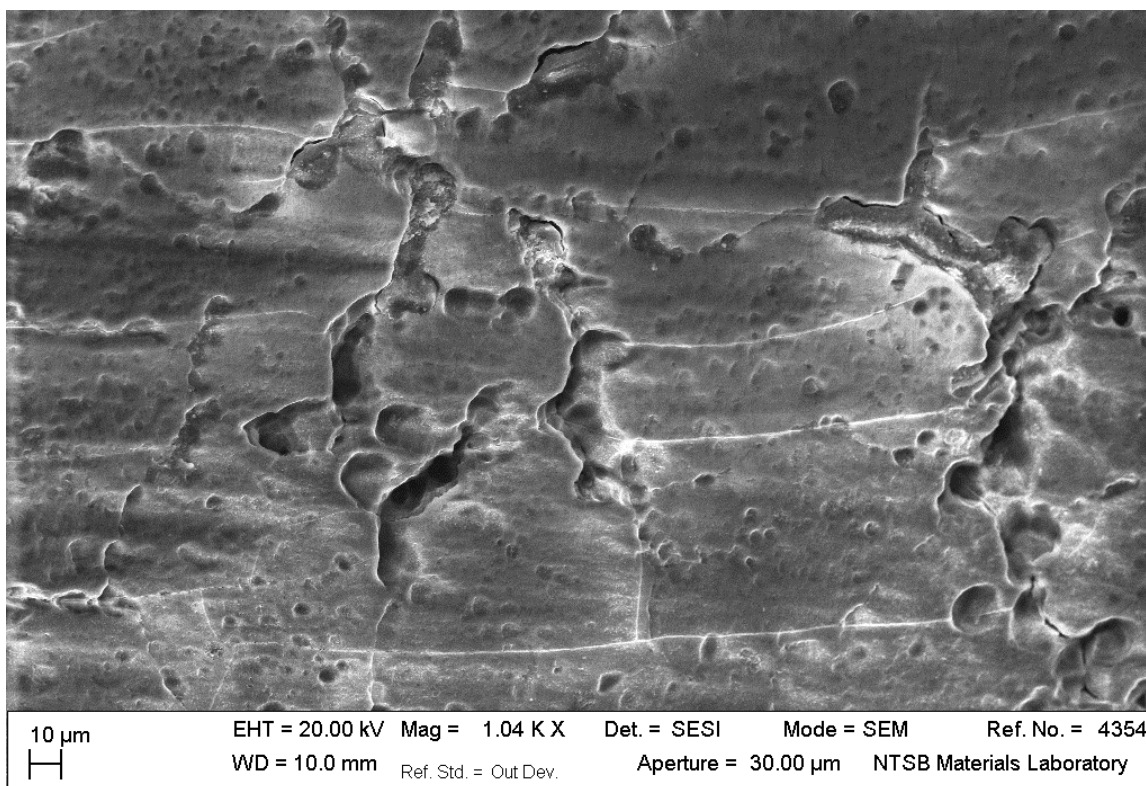
Figure 15 – SE micrograph showing the blade root seat of the 1-2 hole, revealing corrosion pitting.

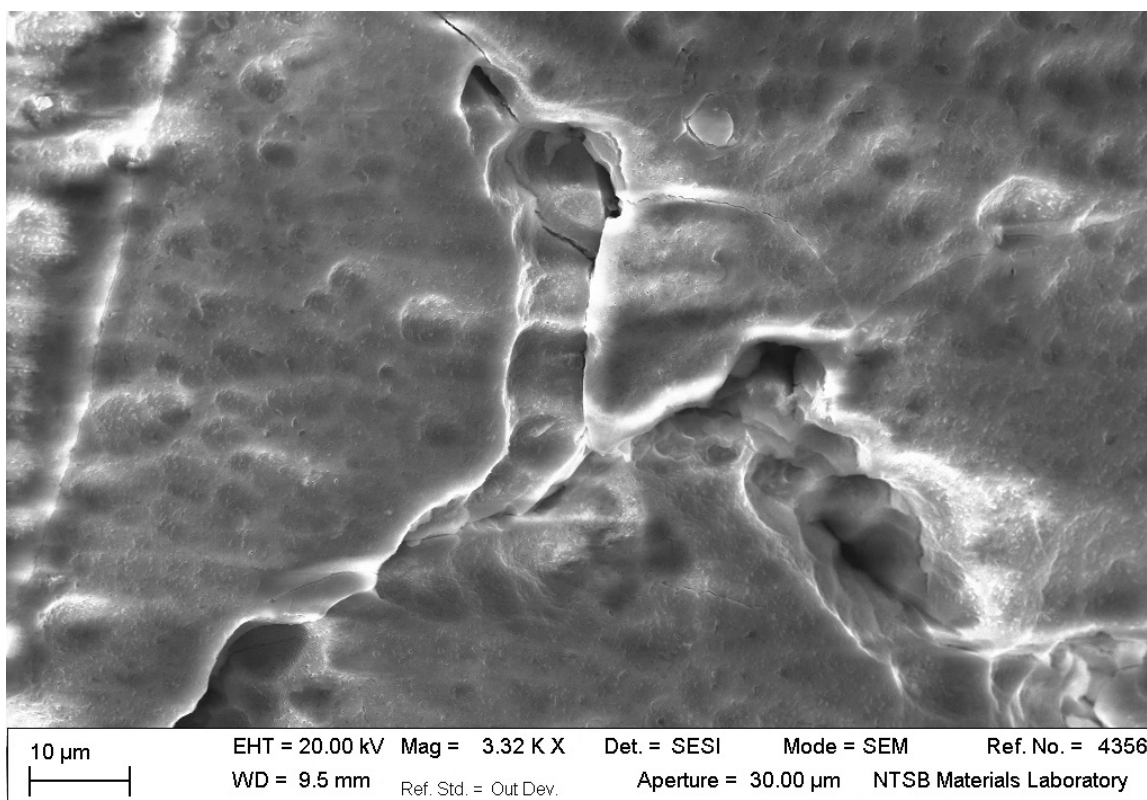
Figure 16 – SE micrograph of a closer view of corrosion pits on 1-2 blade seat.

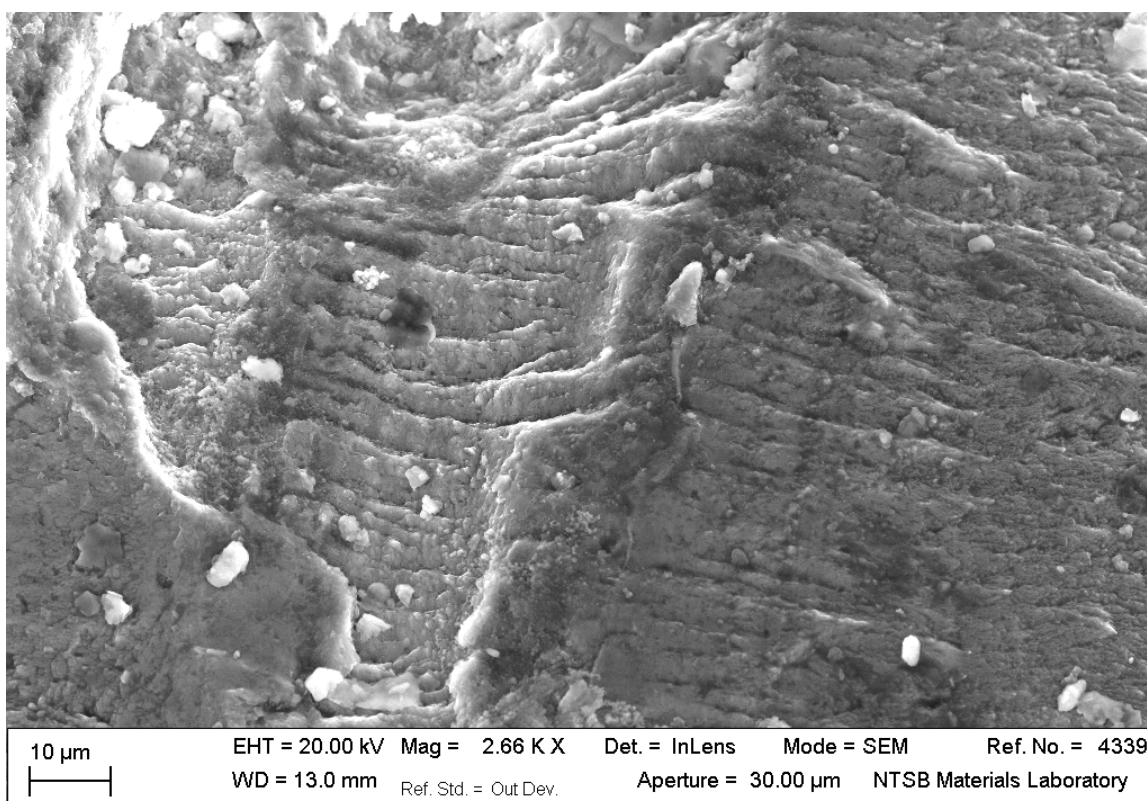
Examination of the 2-3 crack revealed similar features—fatigue striations were found throughout the progressive regions of the opened crack, as typified in Figure 17.

Figure 17 – SE micrograph of fatigue striations on the 2-3 crack, after lab opening.

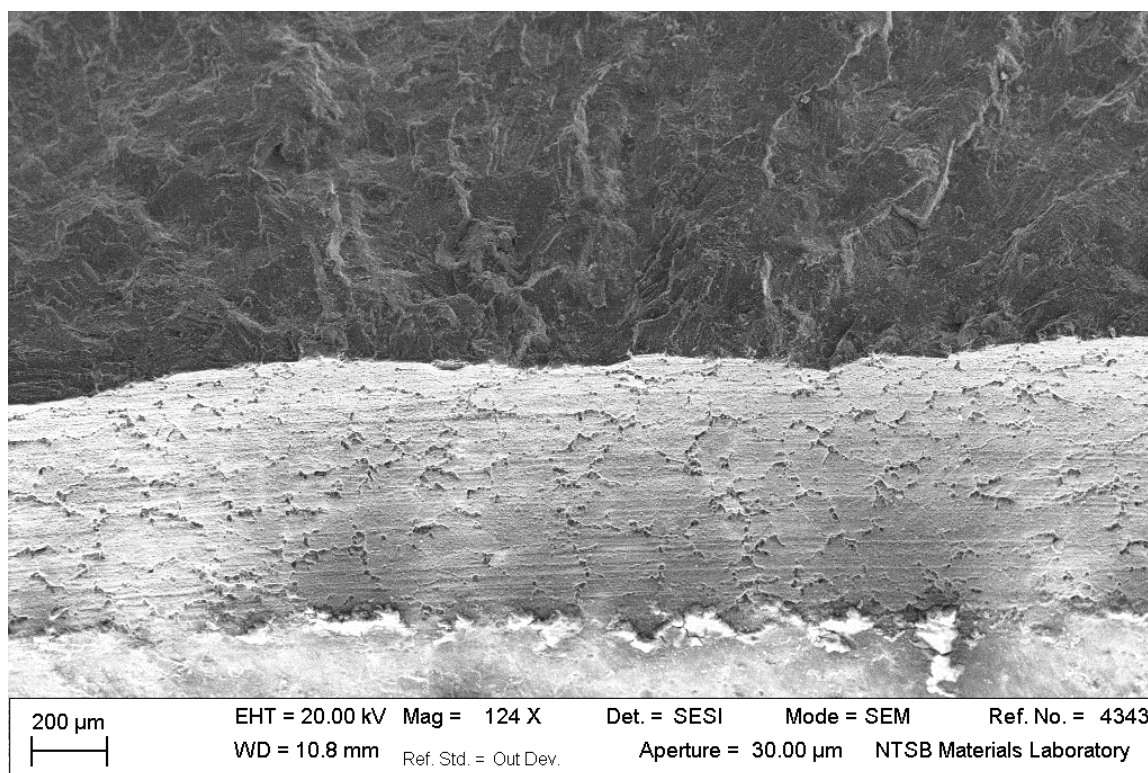
The fatigue crack initiated at multiple locations, such as displayed in Figure 18. As shown in Figure 19, this fatigue crack initiation site was located at a corrosion pit. Much like on the 1-2 blade root seat, the 2-3 blade root seat contained a network of corrosion pits (Figure 20 and Figure 21).

Figure 18 – SE micrograph of a fatigue crack initiation site on the 2-3 fracture surface.

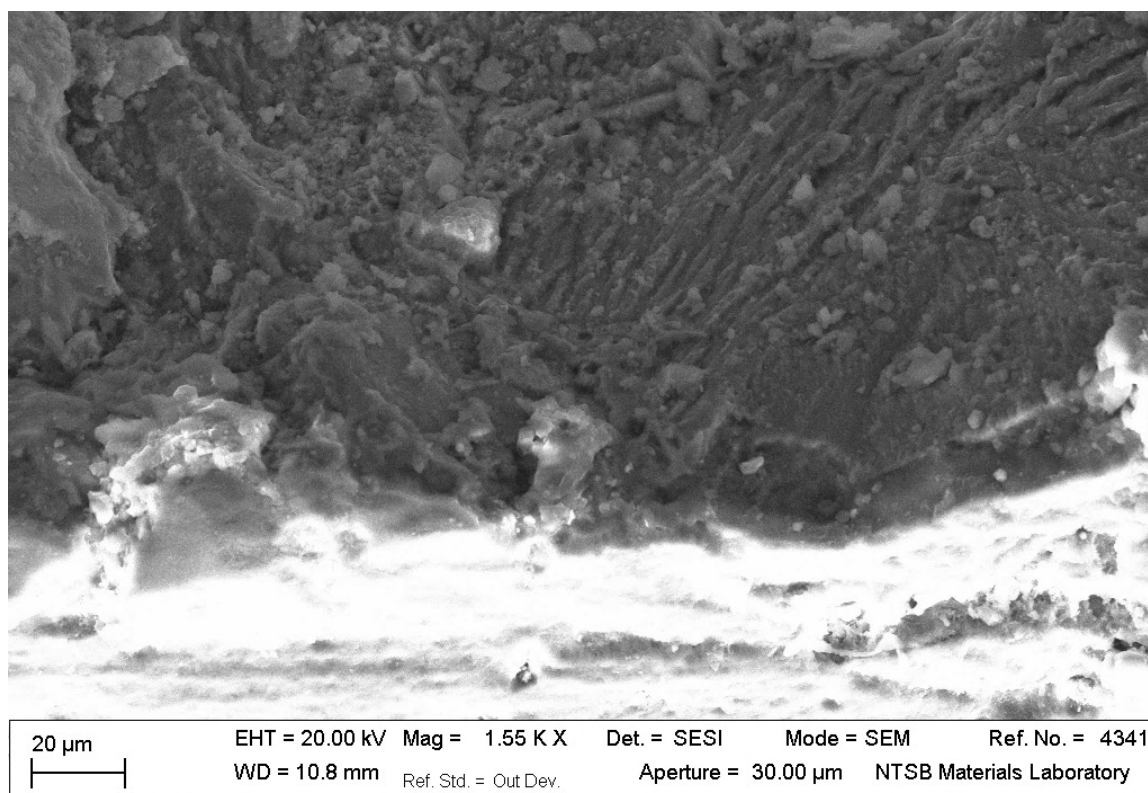
Figure 19 – SE micrograph of a fatigue initiation site on the 2-3 fracture.

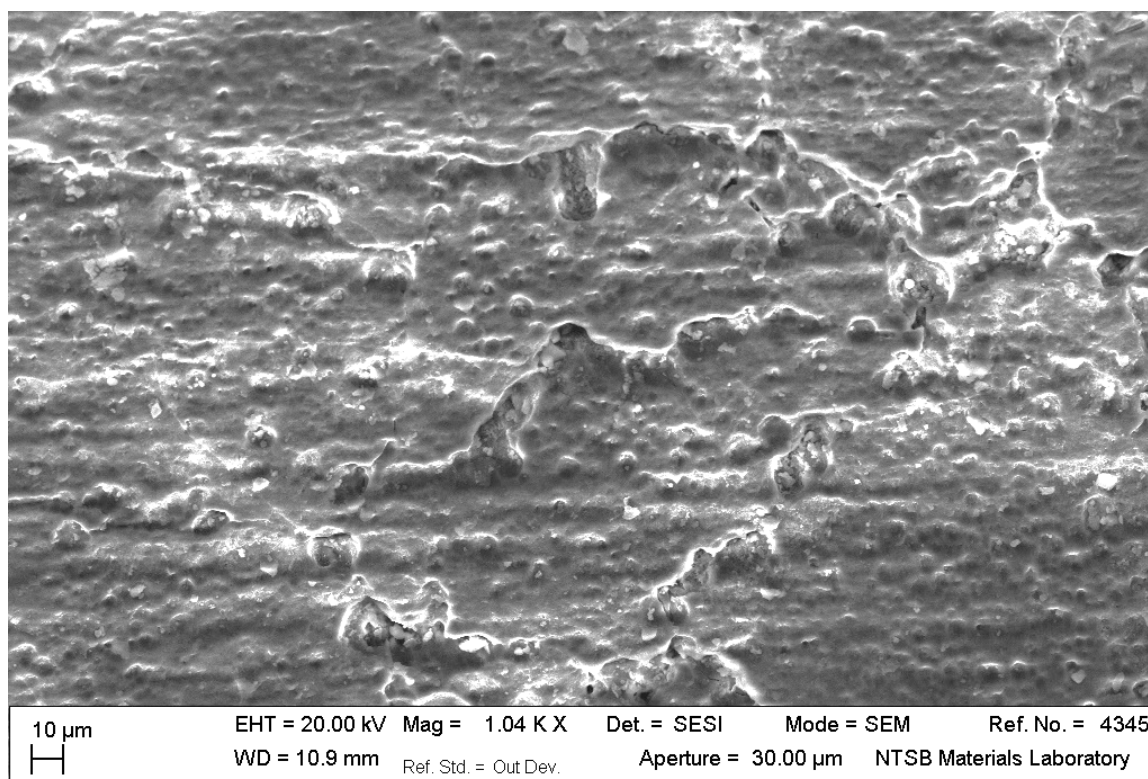
Figure 20 – SE micrograph of the blade root seat in the 2-3 position.

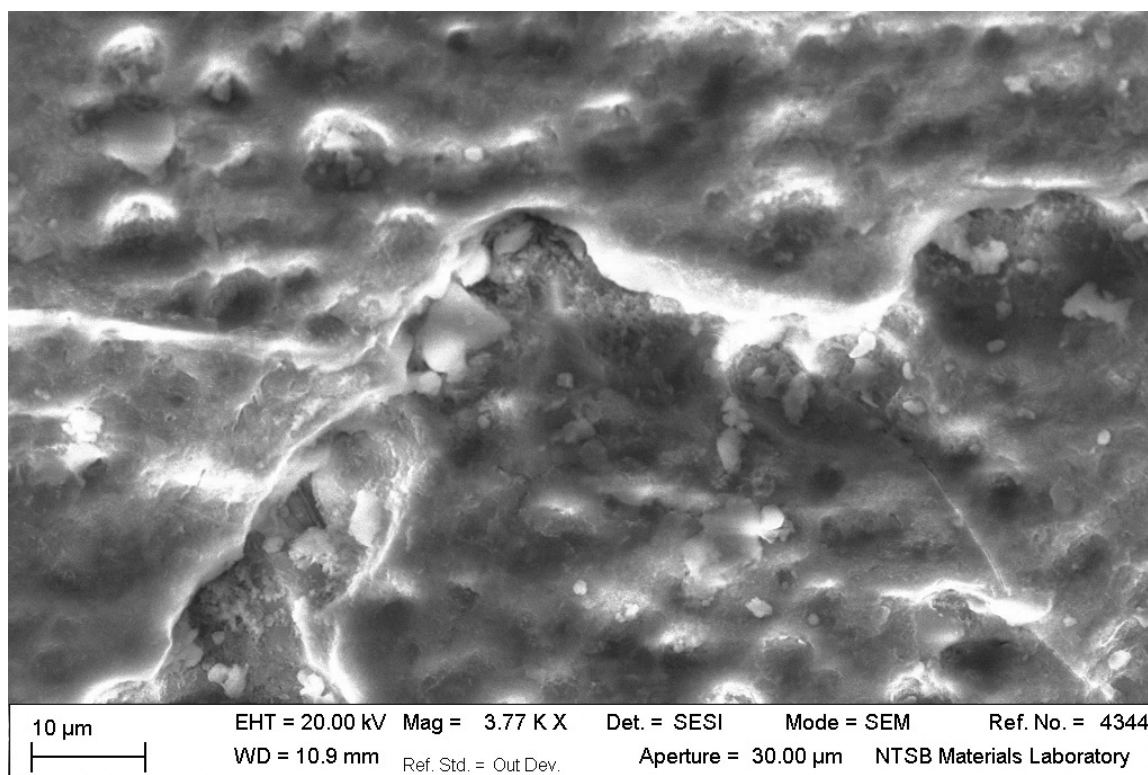
Figure 21 – SE micrograph of corrosion pitting on the seat of the 2-3 position.

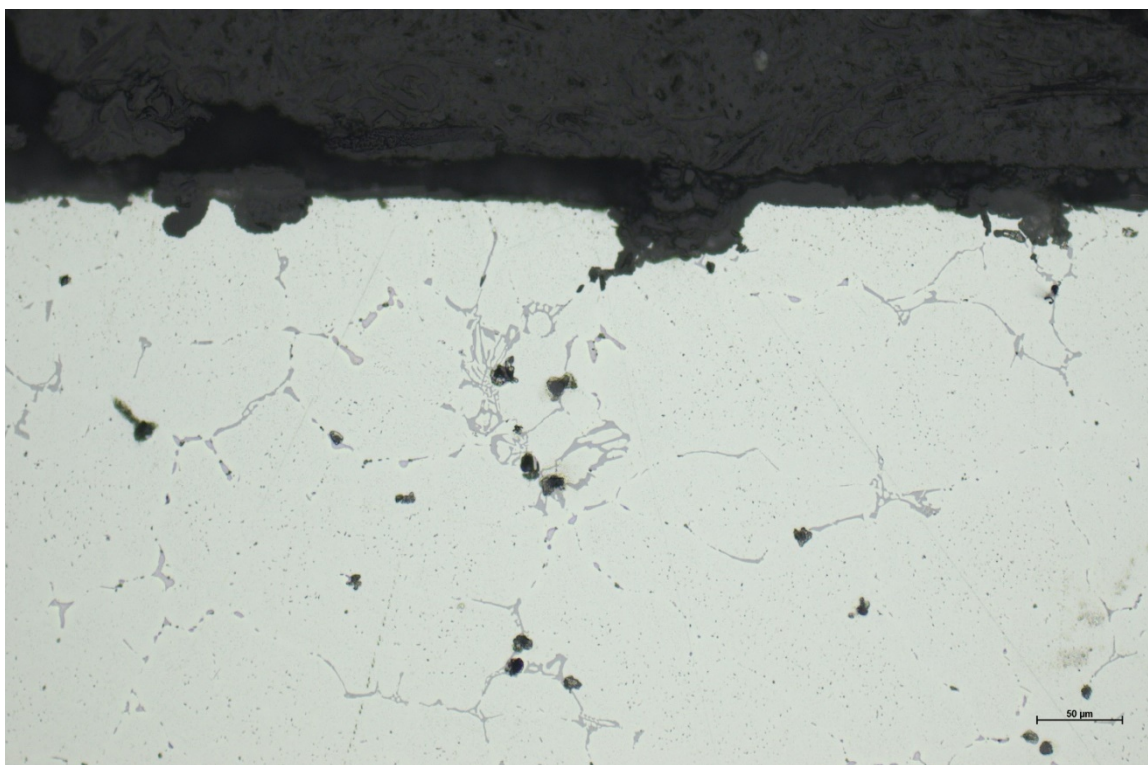
Part of the 2-3 fracture surface was cross-sectioned, mounted, and polished. A typical area of a cross section of the blade root seat surface is illustrated in Figure 22 and Figure 23. Corrosion pits were prevalent along the surface, typically located where grain boundaries intersected the surface. Subsurface cracks were observed, consistent with having propagated from the surface inward along grain boundaries (see Figure 23). These cracks were consistent with having initiated at surface corrosion pits.

Figure 22 – Bright field (BF) optical micrograph of a cross section of the 2-3 hub bore surface, showing corrosion pits on the surface (~200X, as-polished).
