# NATIONAL TRANSPORTATION SAFETY BOARD

## MATERIALS LABORATORY FACTUAL REPORT

Report No. 19-017

Place : San Manuel, Arizona  
Date : May 21, 2018  
Vehicle : Rhoads Autogyro MTO Sport, N574BR  
NTSB No. : WPR18LA158  
Investigator : Samantha Link, AS-WPR

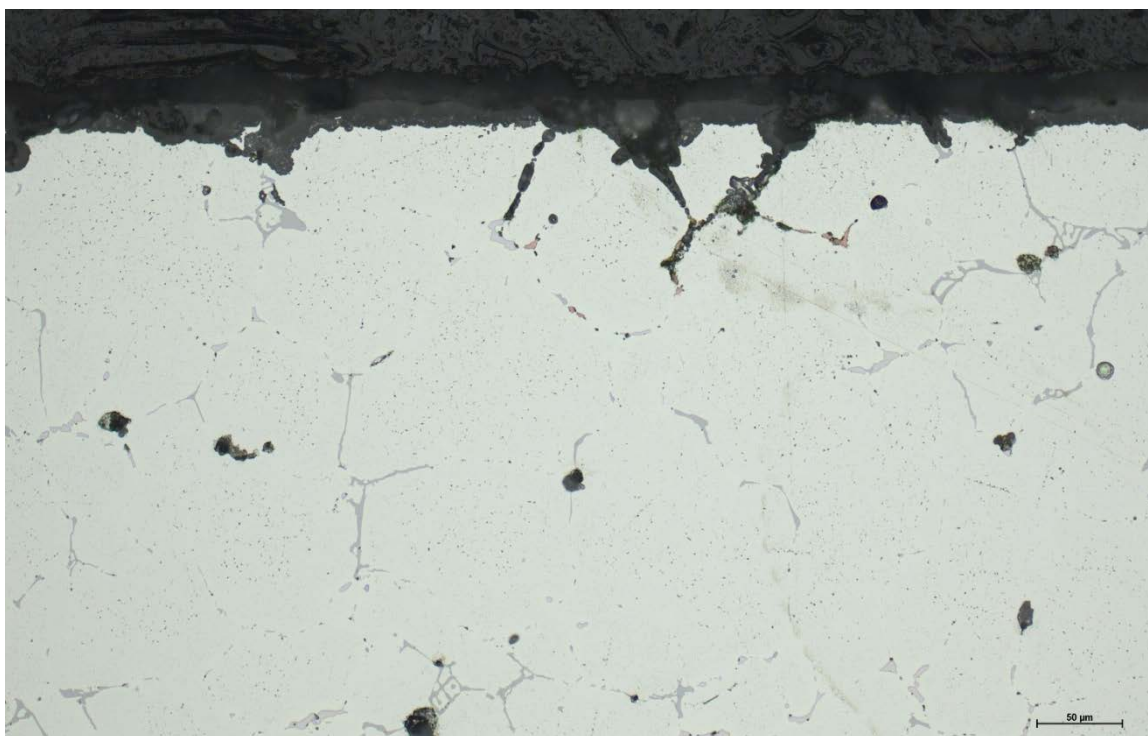
Part of the 2-3 fracture surface was cross-sectioned, mounted, and polished. A typical area of a cross section of the blade root seat surface is illustrated in Figure 22 and Figure 23. Corrosion pits were prevalent along the surface, typically located where grain boundaries intersected the surface. Subsurface cracks were observed, consistent with having propagated from the surface inward along grain boundaries (see Figure 23). These cracks were consistent with having initiated at surface corrosion pits.

Figure 23 – BF optical micrograph of another area of the 2-3 blade seat surface, showing pitting and intergranular attack (~200X, as polished).

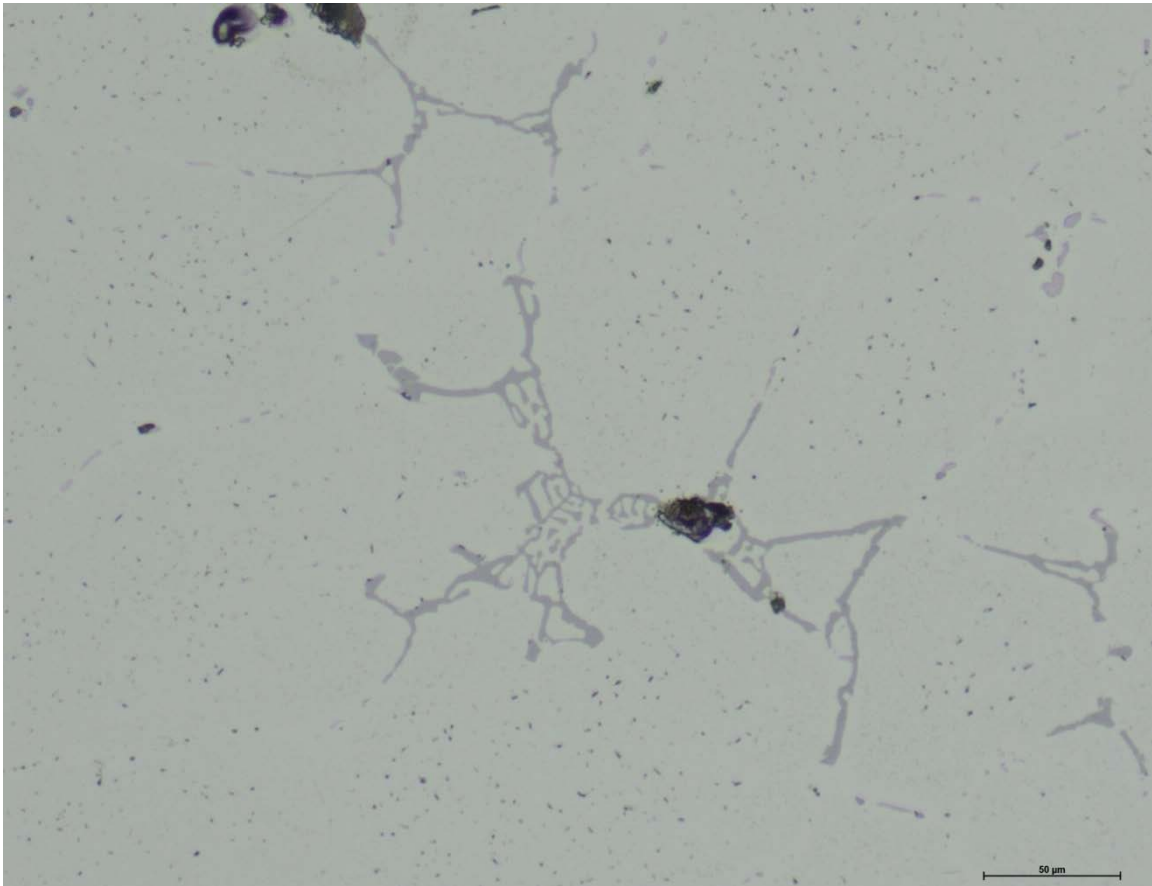
The chemical composition of the mounted and polished hub cross section was inspected using energy dispersive x-ray spectroscopy (EDS) and x-ray fluorescence (XRF). The composition was consistent with a 300-series aluminum casting alloy. The hardness of hub was inspected per ASTM E18, and the electrical conductivity was inspected per ASTM E1004.<sup>1,2</sup> The hardness averaged 39 HRBW. The conductivity averaged 41.2 %IACS. These data were consistent with those typically reported for as-fabricated cast aluminum products of this composition.<sup>3</sup> A typical area of the internal hub microstructure is shown in Figure 24. The microstructure exhibited a dendritic morphology with bluish-colored interdendritic phases, typical of this alloy in the as-cast condition.

Figure 24 – BF micrograph of a typical area of the hub microstructure (~500X, as-polished).
