# N574BR – Prop Hub Failure HTC CCW-3B-172-CG

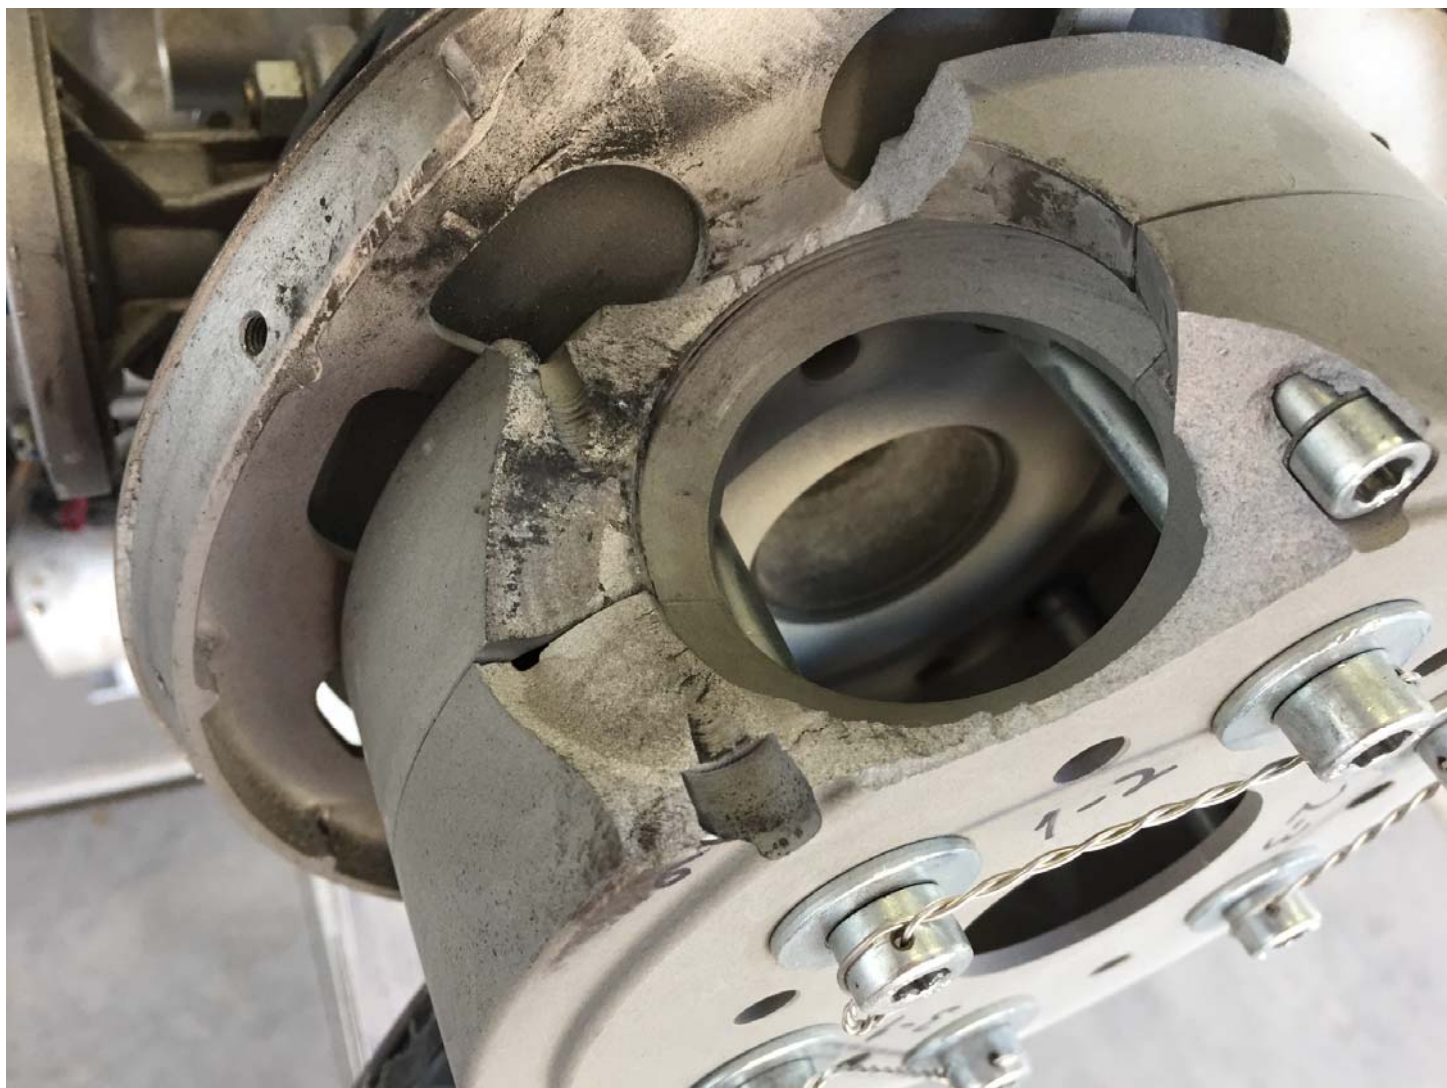
Clean break to right of red line, not so much to the left of red line

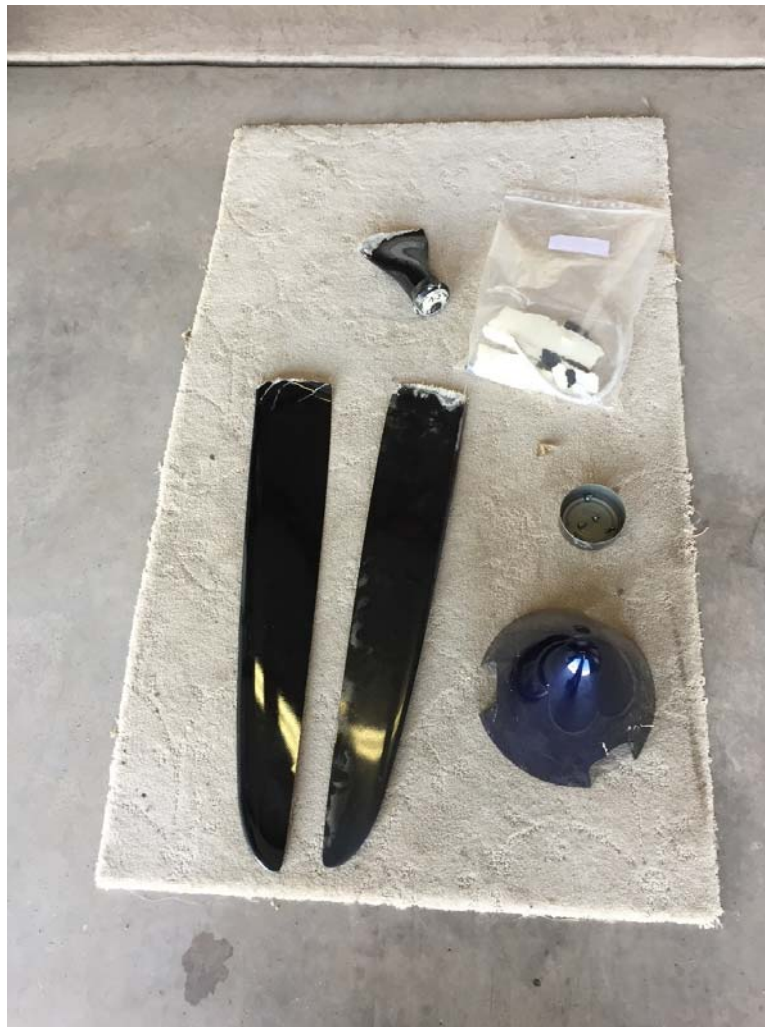
Separated blade was recovered, spinner removed

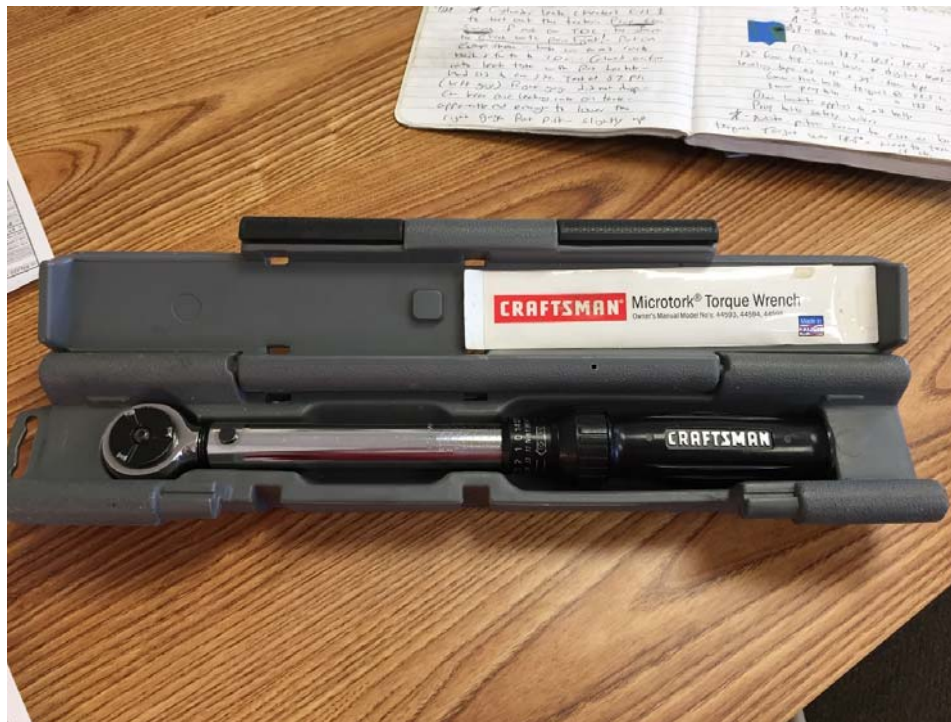
Missing portion(s) of hub were not recovered.  
New prop was installed and the torque on all bolts  
was applied with a non-calibrated torque wrench
