## **NATIONAL TRANSPORTATION SAFETY BOARD**

### **Specialist's Factual Report**

# **METEOROLOGY**

WPR18LA163

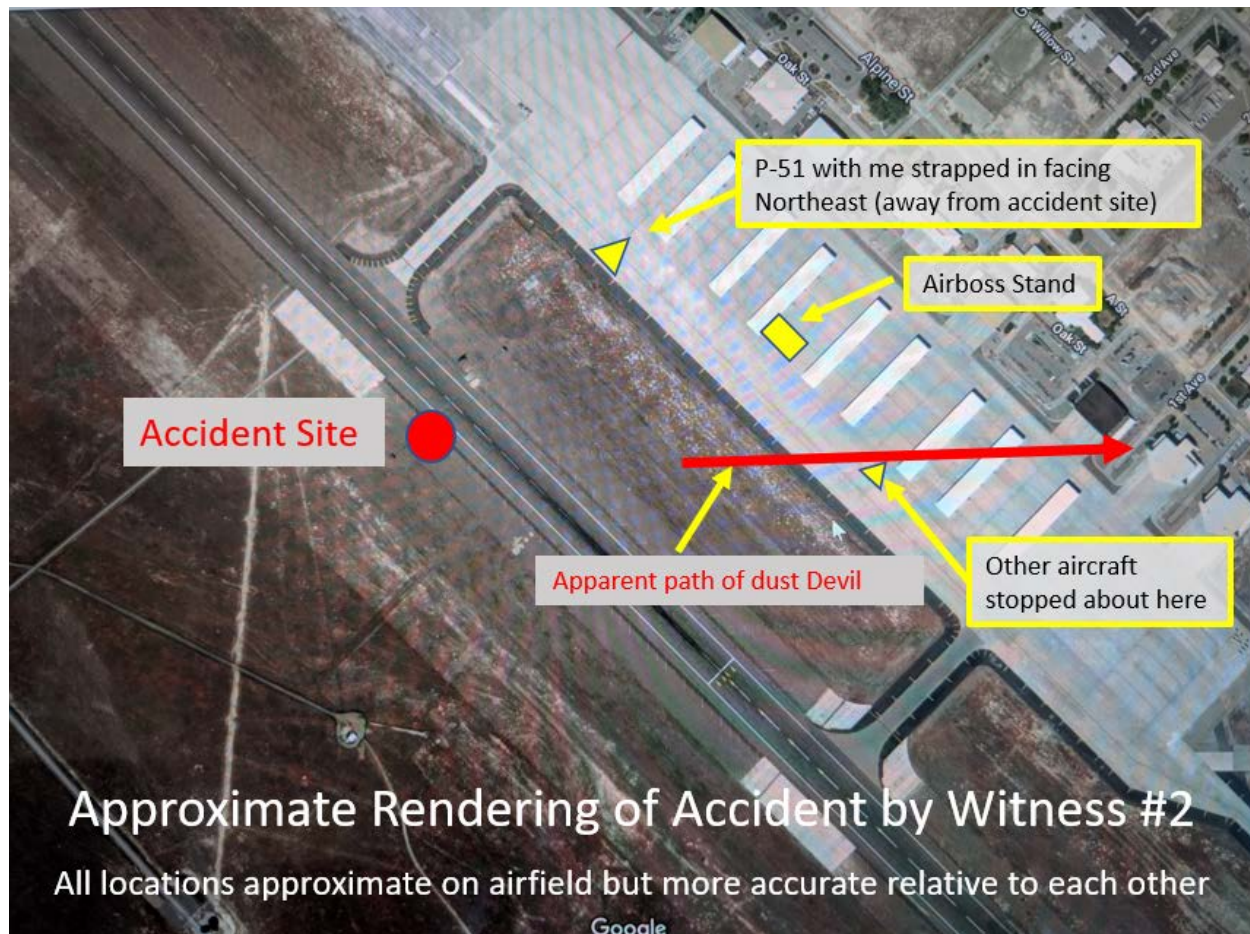
Figure 11 – P-51 performer's position and path of observed dust devil

The witness provided an image (figure 12) to show his position on the airport and the approximate position of the dust devil's path he observed and his position relative to the accident site. He also indicated that the dust devil he observed had a diameter of 40 to 80 ft and extended from 300 to 1,000 ft high. He described it further as somewhat of a "lazy" dust devil, in that it was not tight and obvious. However, he did observe it blowing dust, and disturbing paper or flyers,

hats being grabbed by people in the crowd, and the like, but not picking up tents and other larger objects. He was able to observe the slow-moving dust devil for about 5 to 10 minutes before losing sight of it as it moved towards the parking lot.

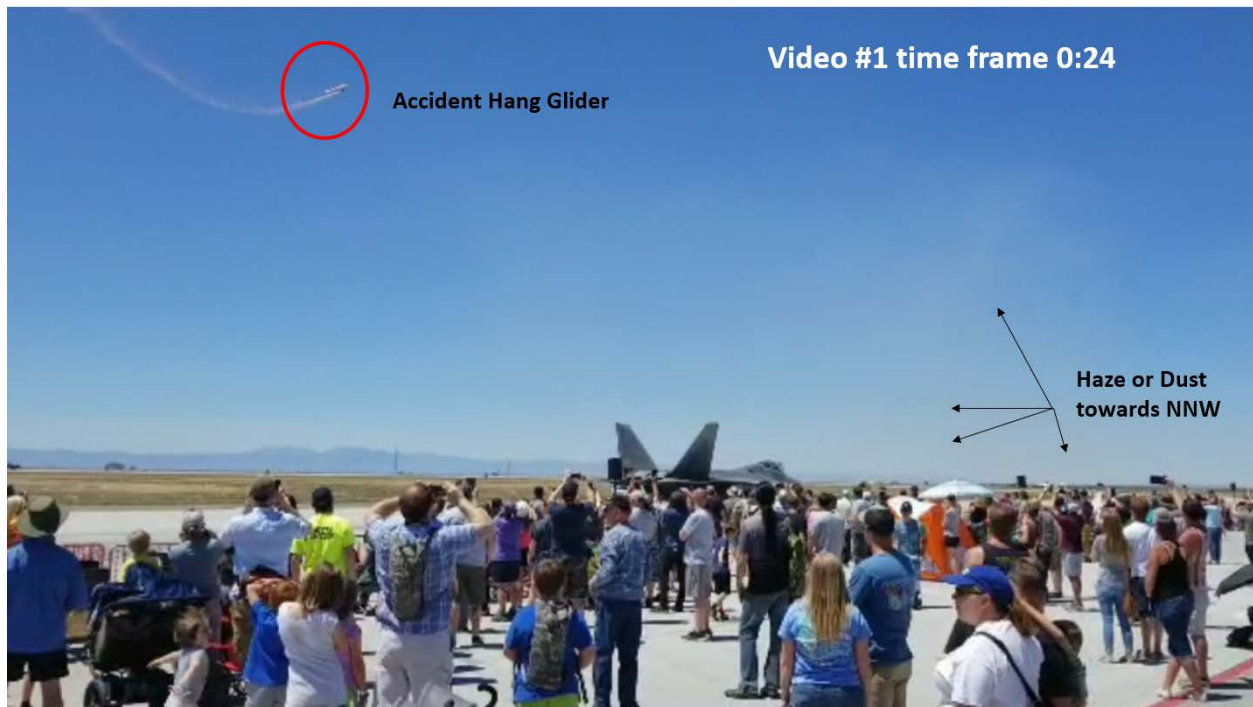
Figure 12 – Video #1 frame 0:24 looking northwest

Video #1 showed the USAF F-22 “Raptor” taxi out from a position immediately left (south) of a P-51 “Mustang”, and in the final seconds of the video captures the hang glider crash behind the P-51. Figure 13 is a still from the video #1 looking northwest with dust and/or haze noted to the north-northwest (right side of frame) obscured the higher terrain in the distance in figure 13. The video captures the hand glider in a left bank in figure 14 looking southwest behind the P-51 Mustang’s position.

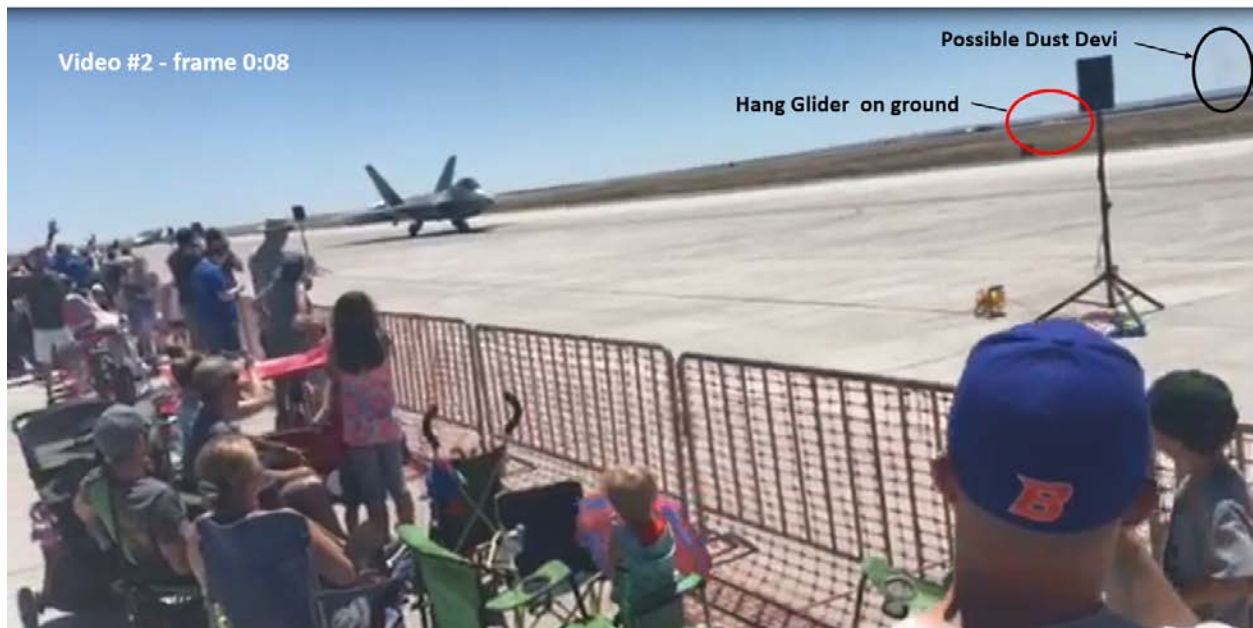
Figure 14 – Video #2 of possible dust devil

Video #2 was a 0:38 video that was also concentrating on the F-22 taxiing past the viewing area and captured the accident in the background. Figure 15 is a frame of video #2 at 0:08 with the accident glider having impacted the ground. As the F-22 taxis to the right looking northwest dust obscures the horizon in the distance. The video does not show any indication of any wind in the viewing area or on the field.

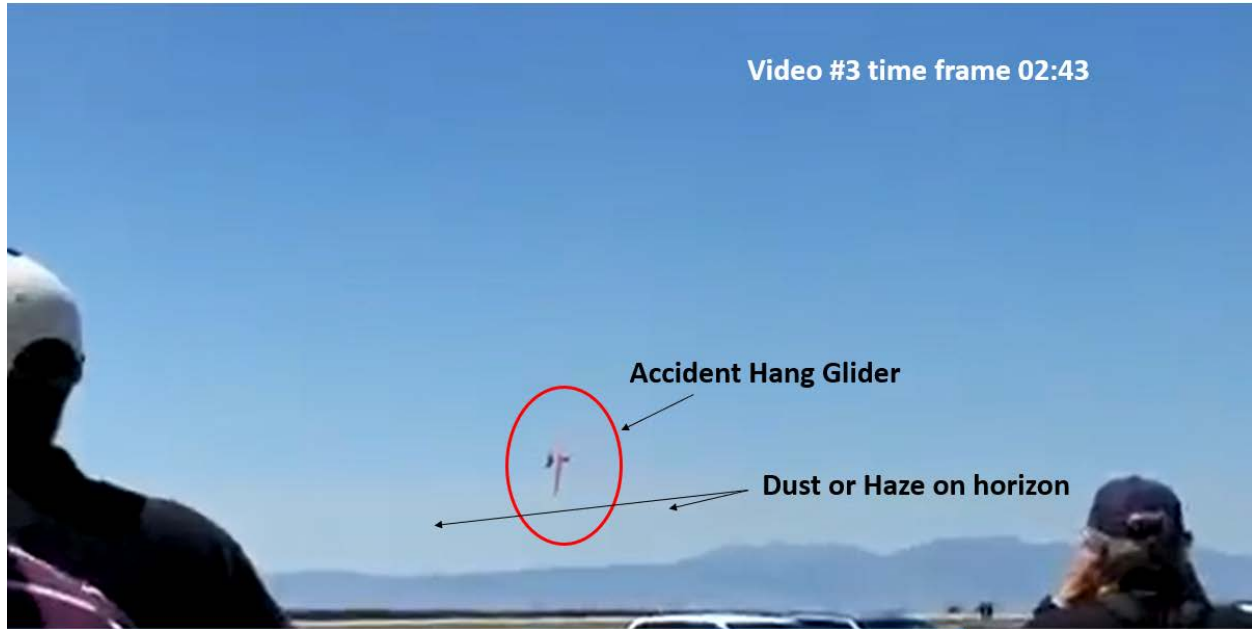
**Figure 15 - Video #3 time frame 02:43 looking southwest**

Video #3 shows the accident hang glider make a low approach and banks left over 90° and drop vertically to the ground (figure 16). Dust or haze is observed low on the horizon. The video shows that once the accident glider had made ground contact it appears to be lifted or blown to the southwest (leftward) with the wind for a moment after the initial impact. The smoke tracers also continue to be blown to the southwest or opposite of the direction of the reported surface winds at the time. The video continued after the accident and noted two emergency response vehicles traveling from the southwest near the tower converge on the accident site, with dust behind the vehicle blown or drifting to the southeast in the video (figure 17). The dark burn area from the pyrotechnic show is also observed west of the field. Other than the wind blowing the glider, dust, and smoke flares, there was no indicated of any wind were the spectators were located at this time. The video also pans to the northwest towards where the Thunderbirds were parked and shows the higher terrain obscured to the northwest by dust as in the previous video.

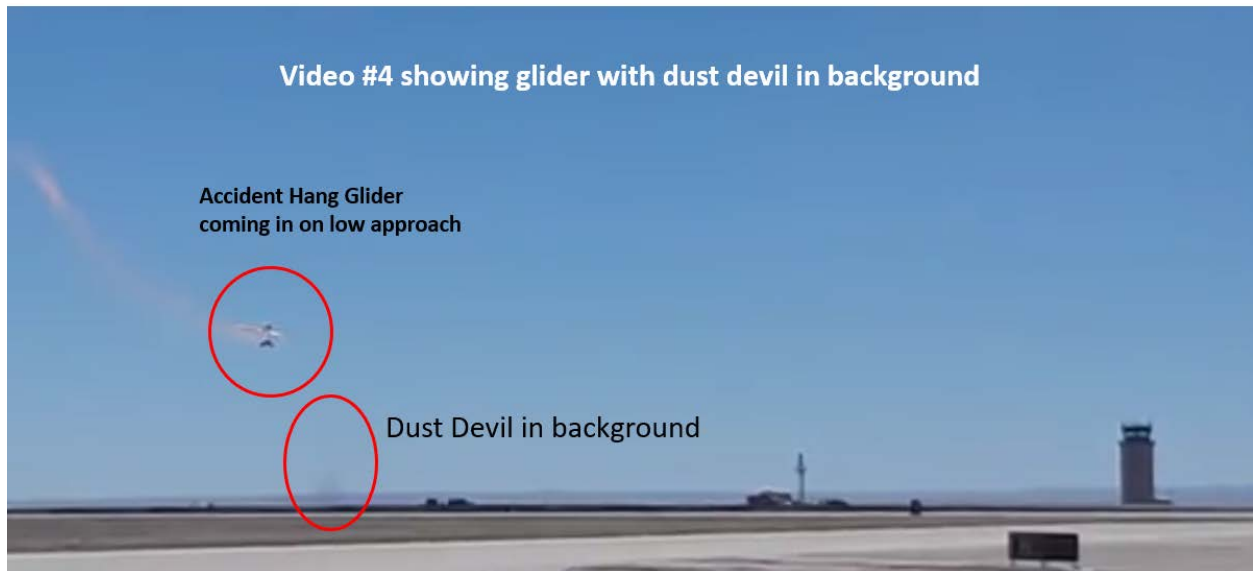
**Figure 17 - Video #4 with dust devil in background**

Video #4 of the accident shows a defined dust devil in the distance south of the control tower and behind the accident location to the southwest of the viewing location (figure 18). The video ends at the time of impact.

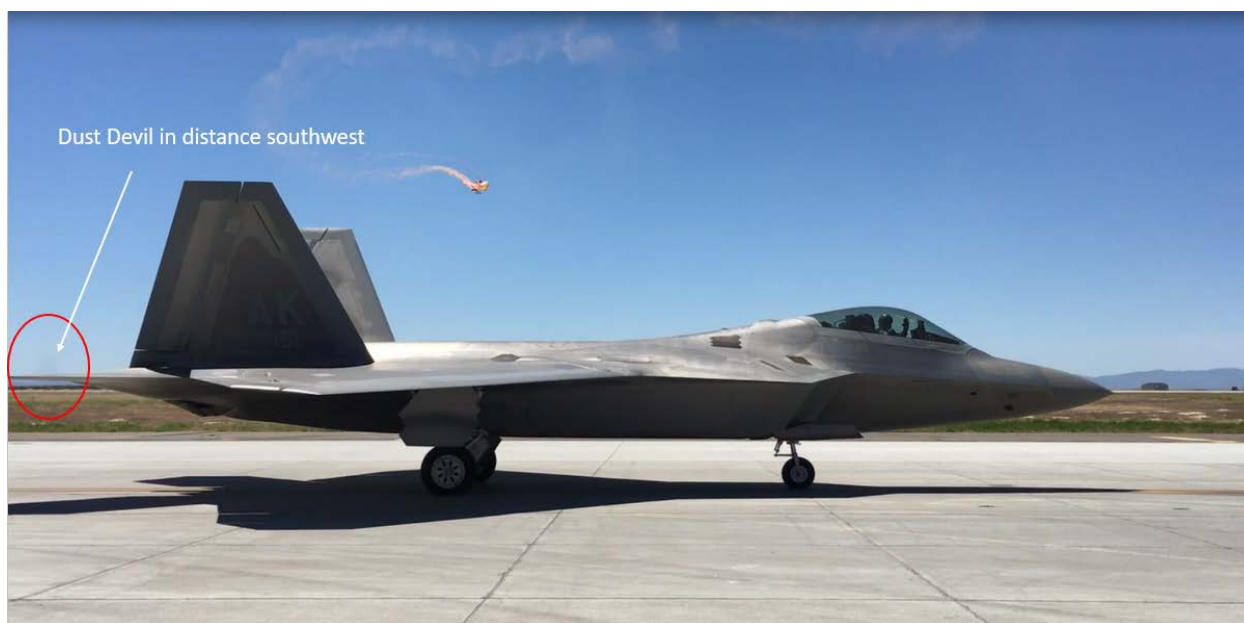
**Figure 19 – Video #5 of F-22 and dust devil**

Video #5 was only 0:03 seconds long and concentrated on the F-22 passing, it also captured a dust devil to the south of the tower in the left portion of the frames with very little dust being lifted into the core of the system. The dust devil height was as high as the control tower as noted before and was located to the southwest. The accident glider was captured in the background prior to impacting the surface in figure 19.

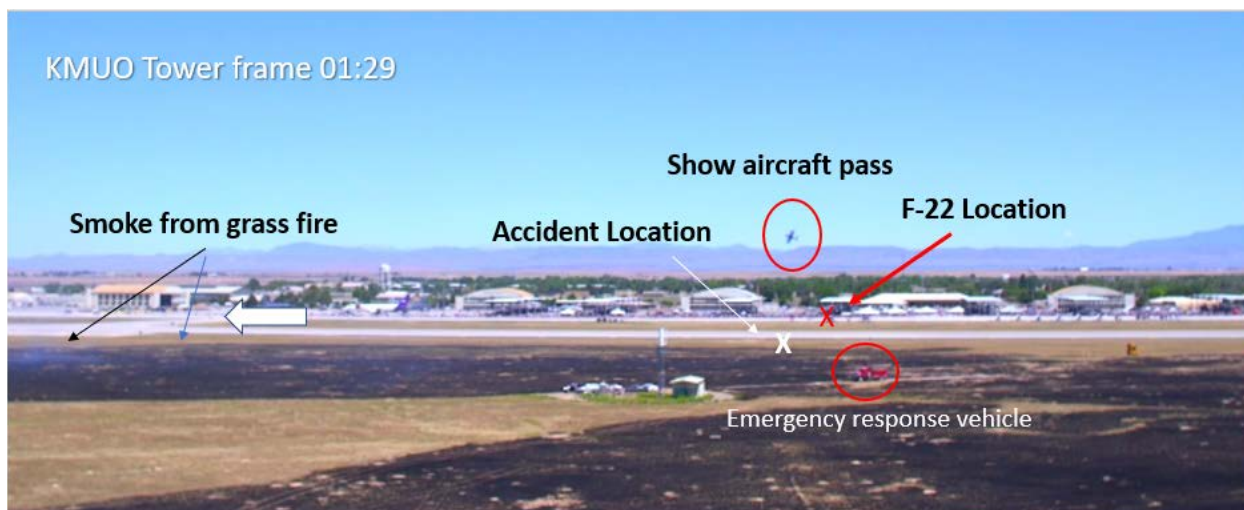
Figure 20 - KMUO tower video #6 at frame 01:29

A high resolution 8:35 long video #6 from the control tower looking northeast also captured the accident hang glider. The burnt area associated with the pyrotechnic display is evident between the tower and the runway and accident site, with small smoke plumes observed rising and drifting to the left or towards the northwest. Visibility is unrestricted with the higher terrain clearly visible in the distance approximately 22 miles from the tower. The video at frame 01:29 (figure 20) captures the aircraft performing with the glider making a low pass over the runway. The F-22's departure from the ramp was immediately northwest of the accident site and is identified at frame 02:47, with the accident being captured at frame 03:35. The accident hang glider is also observed after the initial impact, the glider appears to be blown towards the right or the south with the wing structure blowing in the wind. The emergency response vehicles are seen responding from near the tower and the small antenna at the bottom of the frame 03:48 (figure 21) and travel northeastward across the burn area to the accident site. Dust is observed behind the emergency response vehicles initially blown to the left or northward on the far side of the field and as the approach the accident site the dust cloud is blown to the right or towards the south (figure 22). The smoke flares from the accident hang glider are also observed blowing to the south during this period.

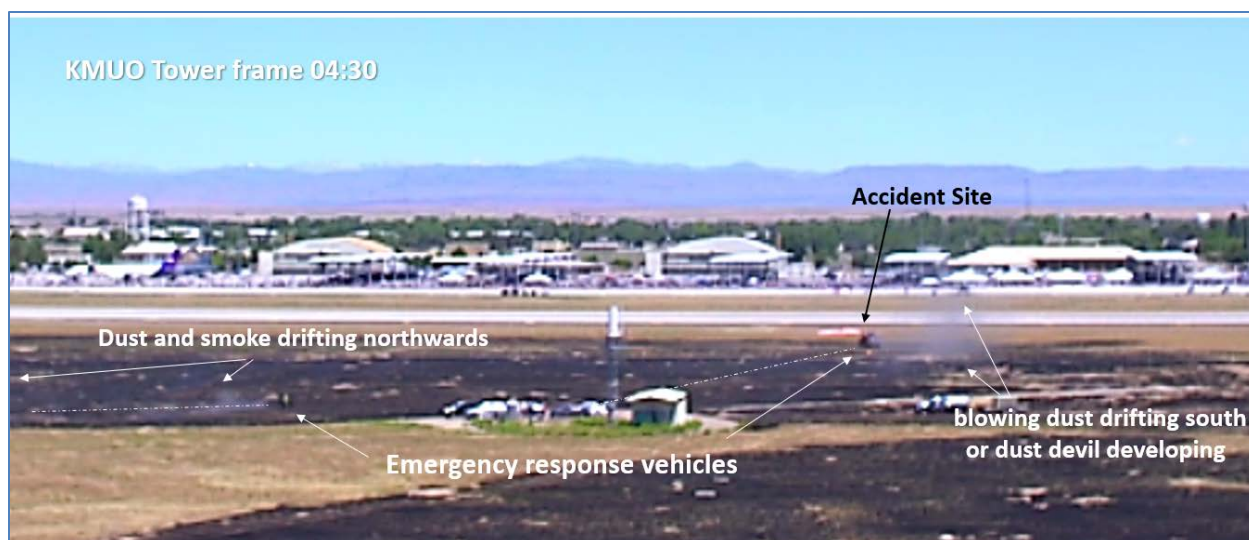
Figure 19 - KMUO Tower video at frame 04:30

Near the end of the video in frame 07:41 the smoke from the flares rises vertically at the accident site and drifts to the north or to the left.
