## **NATIONAL TRANSPORTATION SAFETY BOARD**

### **AIRFRAME EXAMINATION**

**WPR18LA163**

Location: Mountain Home, Idaho  
Date: June 2, 2018.  
Aircraft: Buchanan (North Wing) Pulse 10 Meter, N62073  
NTSB IIC: Elliott Simpson

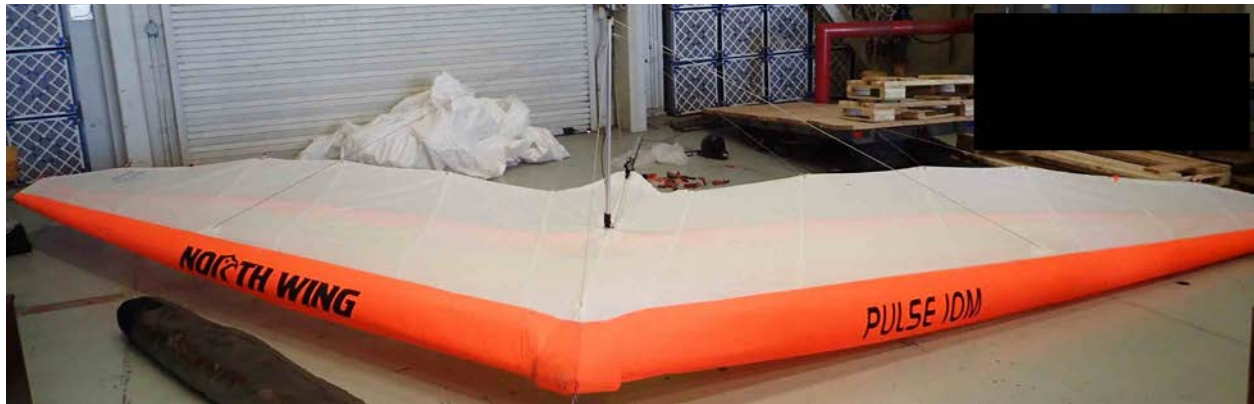
Photo 1 - Sail

The sail was intact and remained attached to both the left and right leading edge tubes, and all of ribs (Photo 1). The sail was undamaged, except for scratches and serrations at its nose, adjacent to the nose junction (Photo 2).

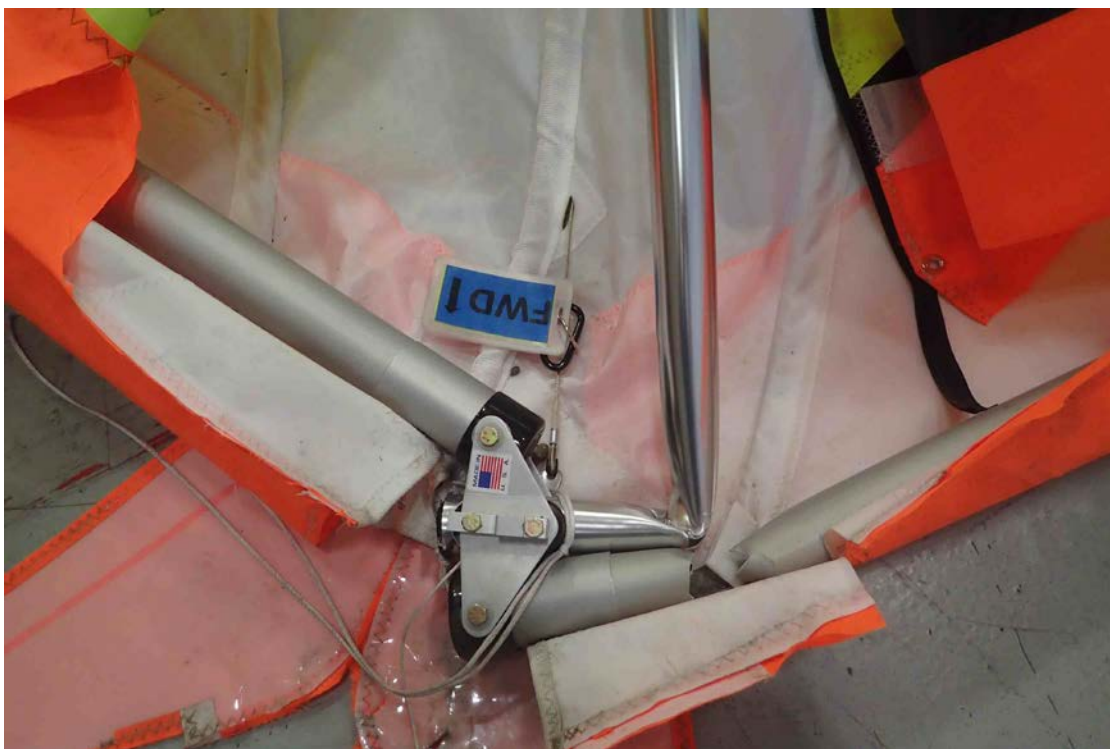
Photo 3 – Nose Junction

The left leading-edge tube was undamaged and remained attached to the nose junction joint and the crossbar (Photo 3).

A six-inch-long section of the right leading-edge tube remained attached to the nose plate, which had bent about 90 ° to the left along with the keel beam. The tube separation exhibited bending failure signatures, and the remaining outboard section was undamaged and remained attached to the crossbar (Photo 3).

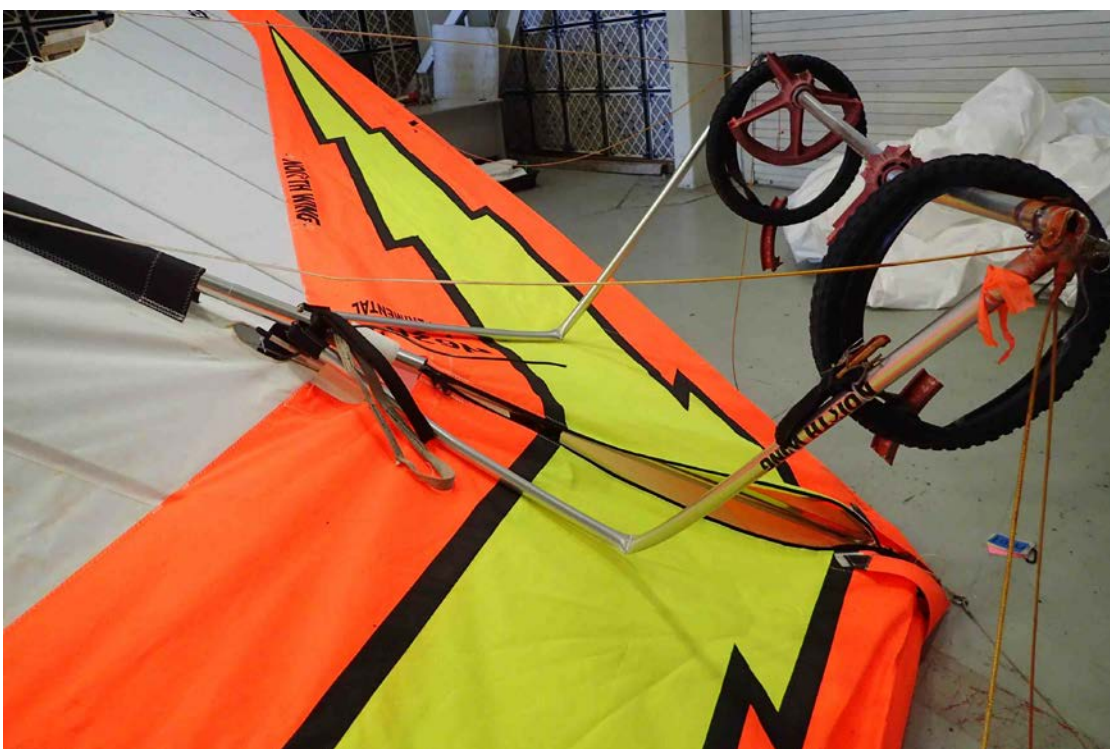
Photo 4 – Downtubes and Wheels

Both crossbars were intact and remained attached to the keel beam. Both downtubes remained attached to the base tube, keel, and their respective rigging cables. Both downtubes were bent about

70 ° aft, midspan (Photo 4). The base tube was bent about 10 ° midspan, and both wheels remained partially attached but their hubs had shattered.

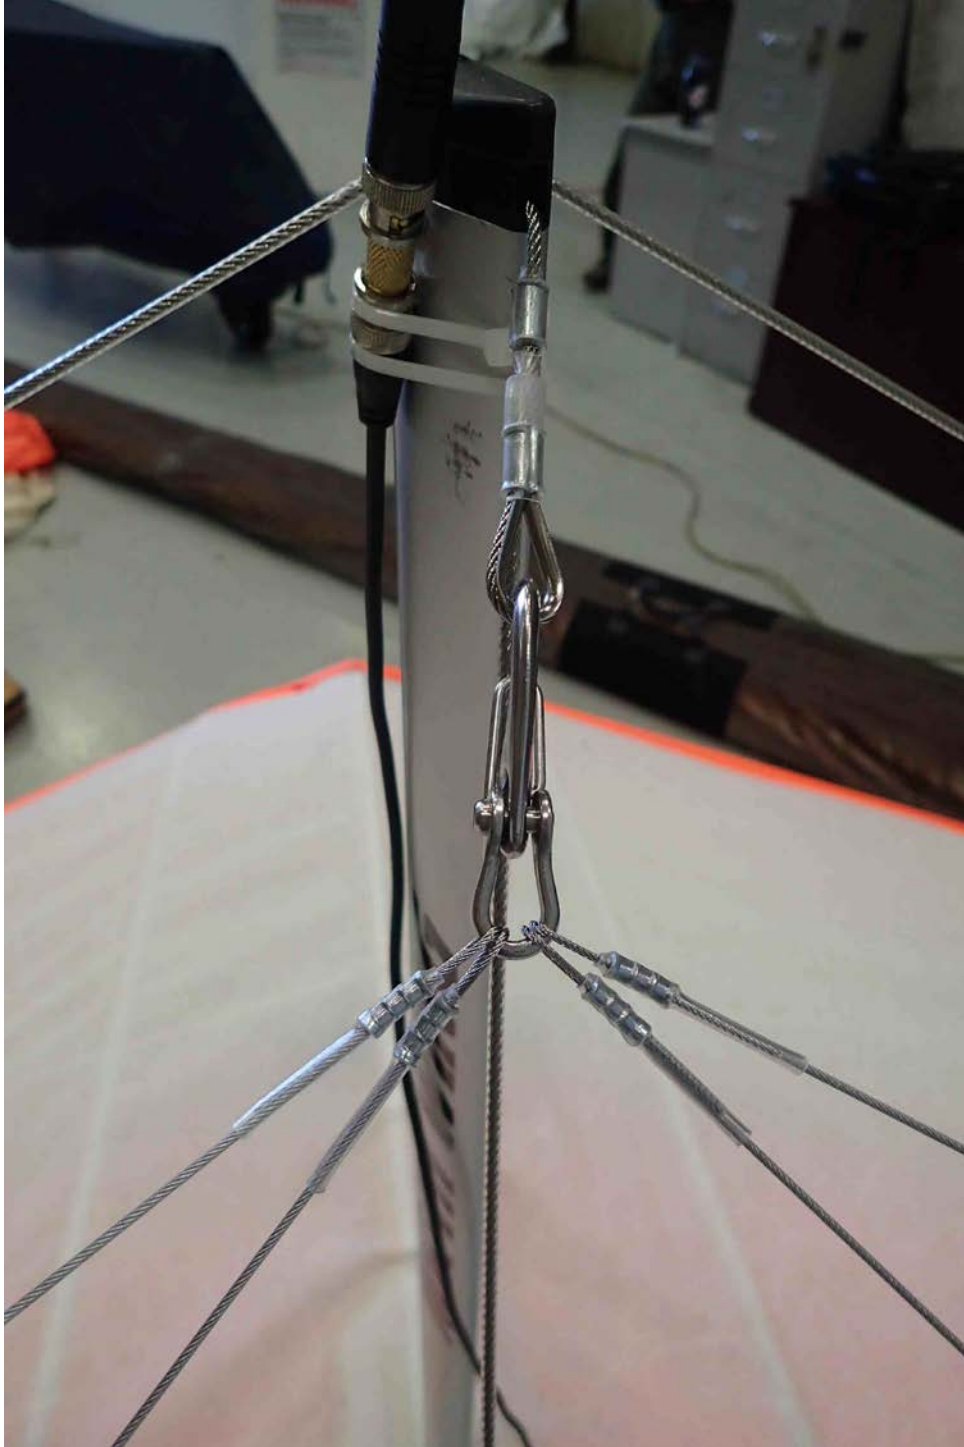
Photo 5 – King Post

The king post remained attached to the keel (Photo 5), and except for the front lower cable, all cables were intact, undamaged, and connected at their respective fittings. The left and right front lower cables remained connected to their respective leading-edge tubes, and to each other their steel hoop. The ring had come away from the nose hook, which had bent 90 ° left with the nose plate (Photo 6).

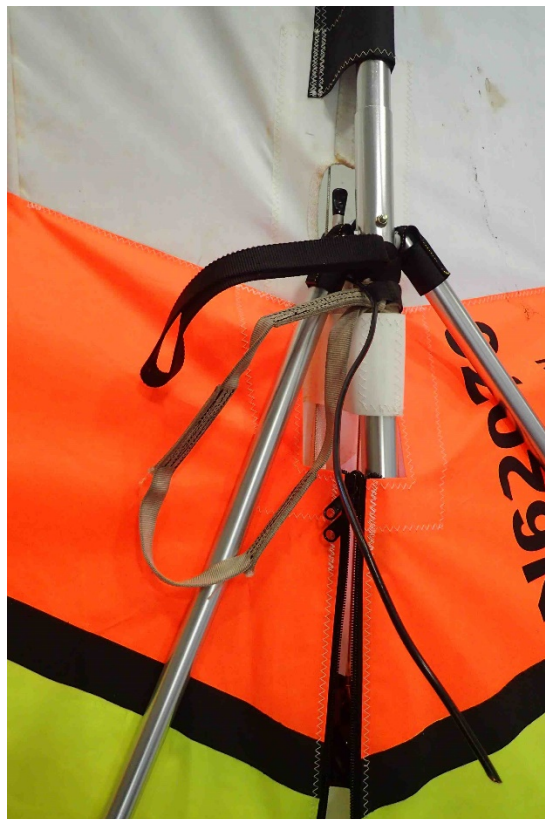
Photo 7 – Harness Straps

The two harness straps appeared undamaged and remained attached to the apex junction (Photo 7).

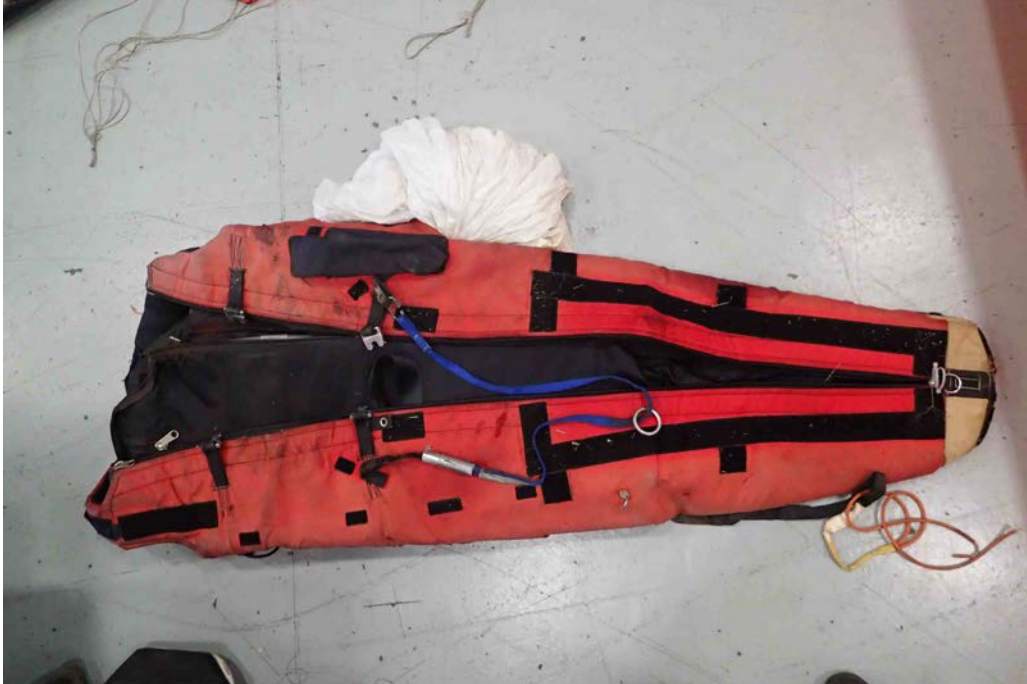
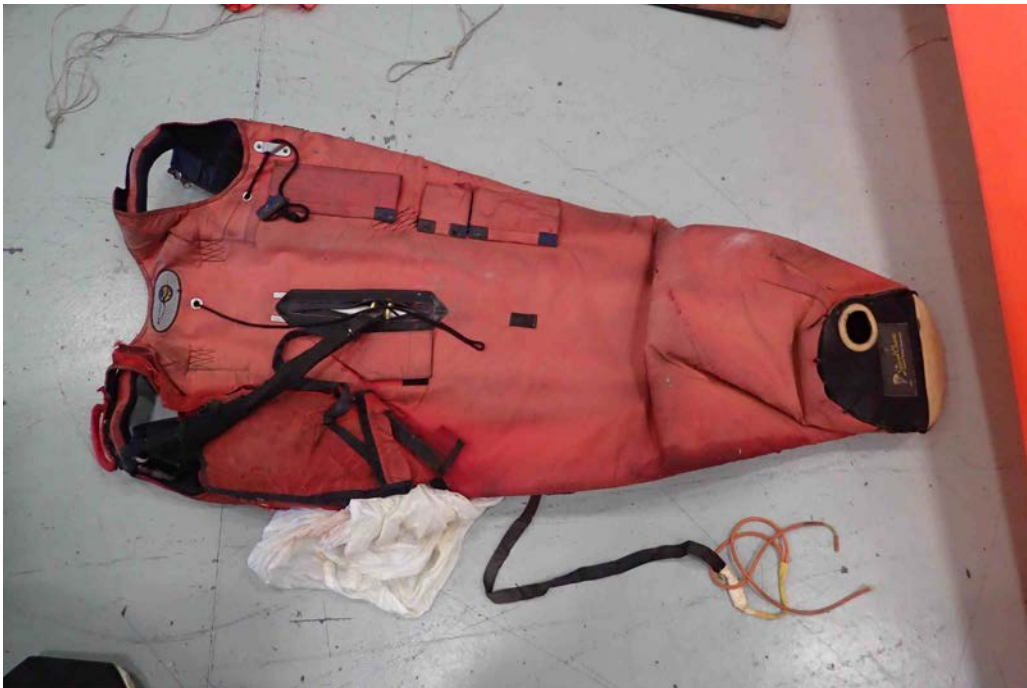
The harness appeared to be manufactured Moyes Delta Gliders (Australia), and although no serial or model number was present, it appeared to be similar to the “Contour” design (Photo 8, 9).

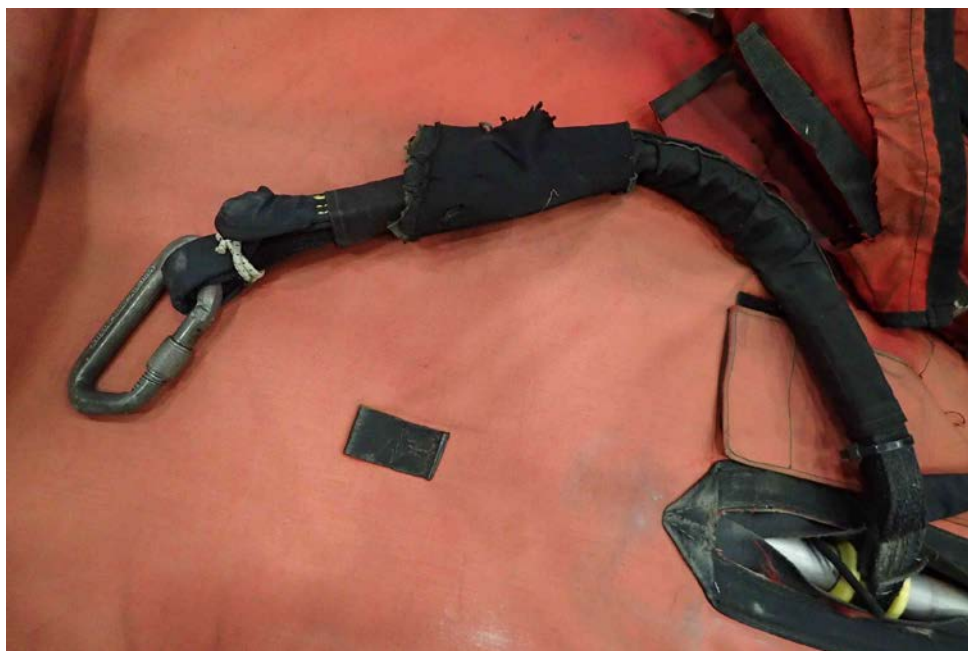
Photo 10 – Suspension Strap

The main suspension strap remained attached to the slider bar (Photo 10). The outer detangle strip of the strap exhibited fraying. The tilt rope loop was intact at the top of the harness, and continuous around the pulley and through to the adjustable tilt cleat. The inner sling frame and slider assembly appeared to have sustained pre-existing damage to the frame extension tubes, breaking them away at the junction with the rear compression spreader bar (Photo 11). The extension tubes had been repaired with aluminum angle and hose clamps. The remaining webbing members of the suspension system were intact.

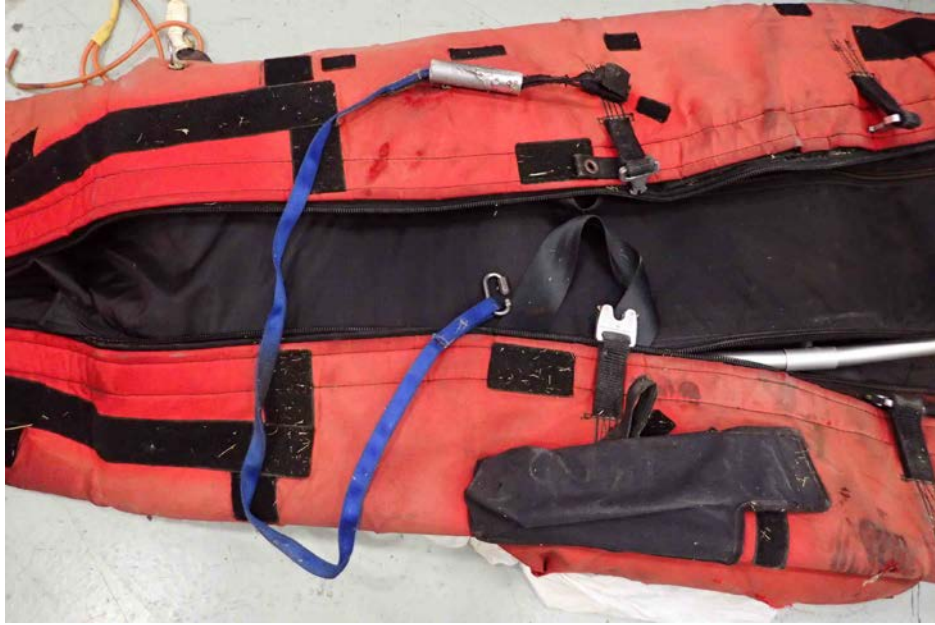
Photo 12 – Tow Strap

The center-mounted towing loops remained attached to the main straps. The blue towing strap remained attached to the right loop, and the quick-release tube was in the locked (unreleased) position (Photo 12). The other side of the strap had been disconnected from the loop at the threaded carabiner, which was unlocked. Examination of the quick-release revealed that it could be activated normally by hand.

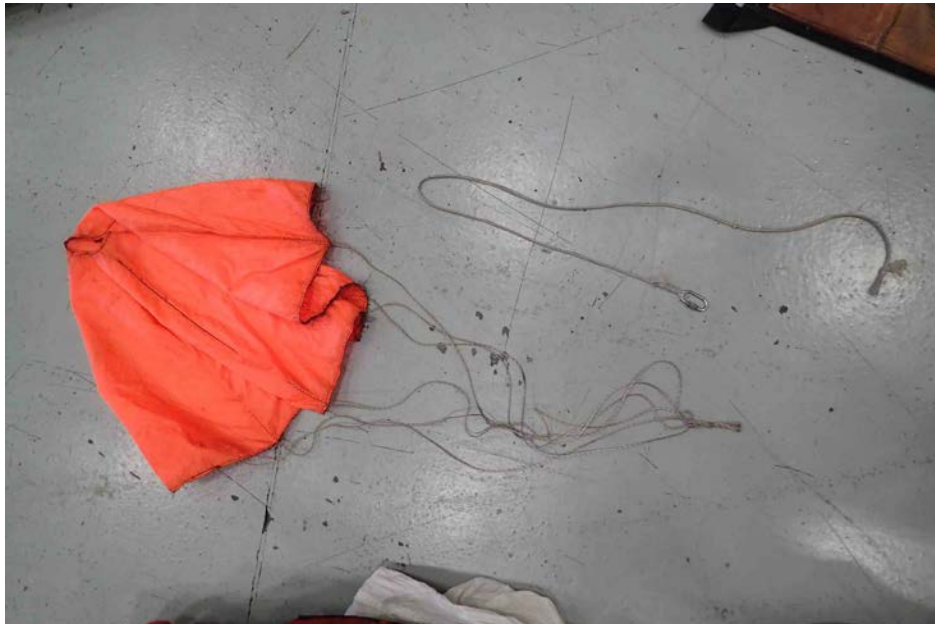
Photo 13 – Tow Cord Parachute and Link

Both the tow cord parachute, and the tow cord to parachute interconnect line were found intact and separate from the harness (Photo 13). What appeared to be remnants of the tow rope weak-link were found in the flatbed of the winch trailer.
