## **NATIONAL TRANSPORTATION SAFETY BOARD**

# **AIRFRAME AND ENGINE EXAMINATION**

**WPR18LA164**

Aircraft: Bell 206B / N518Z / serial number: 3991

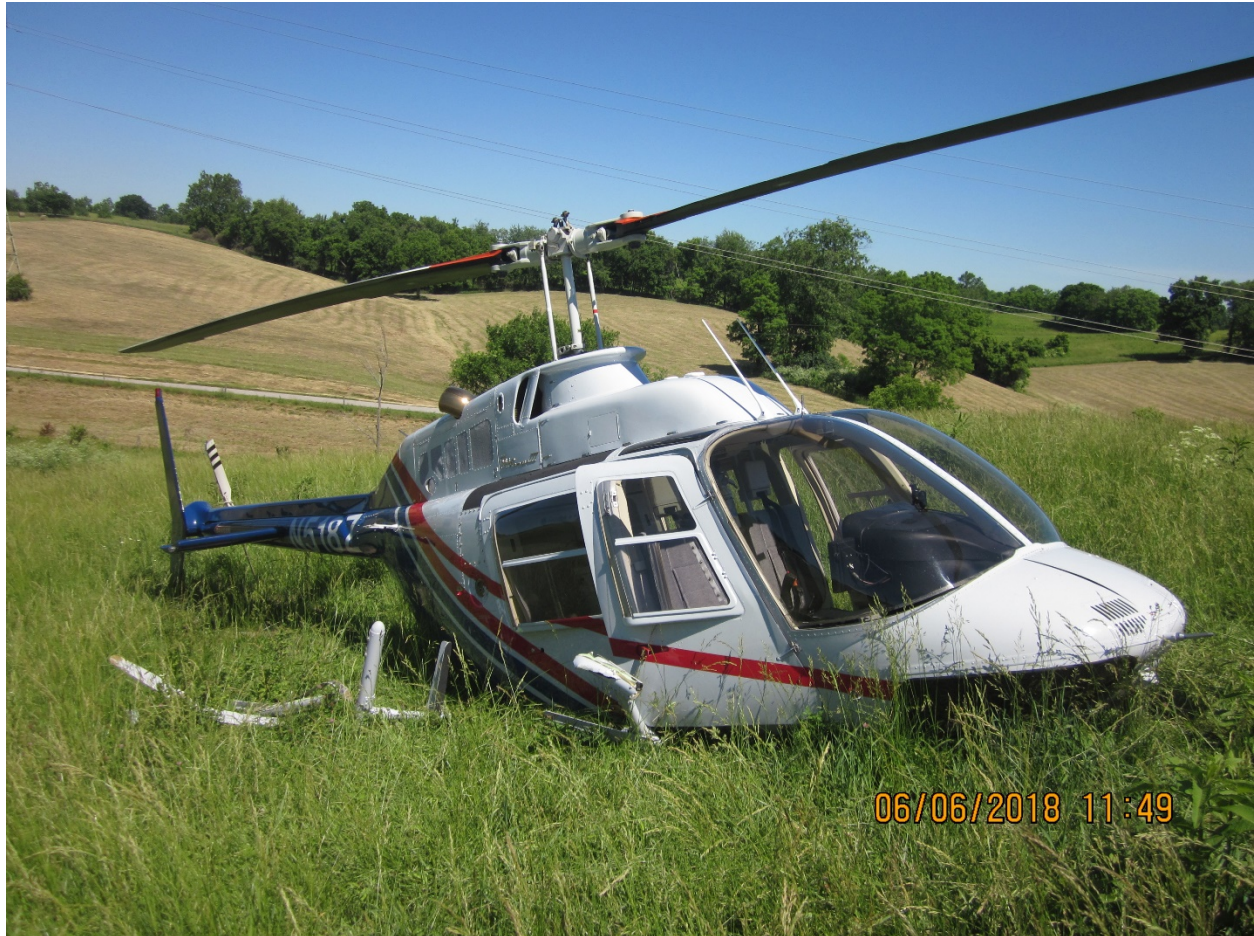
**Figure 1. N518Z, right front view while at the accident site. Photo courtesy of the FAA.**

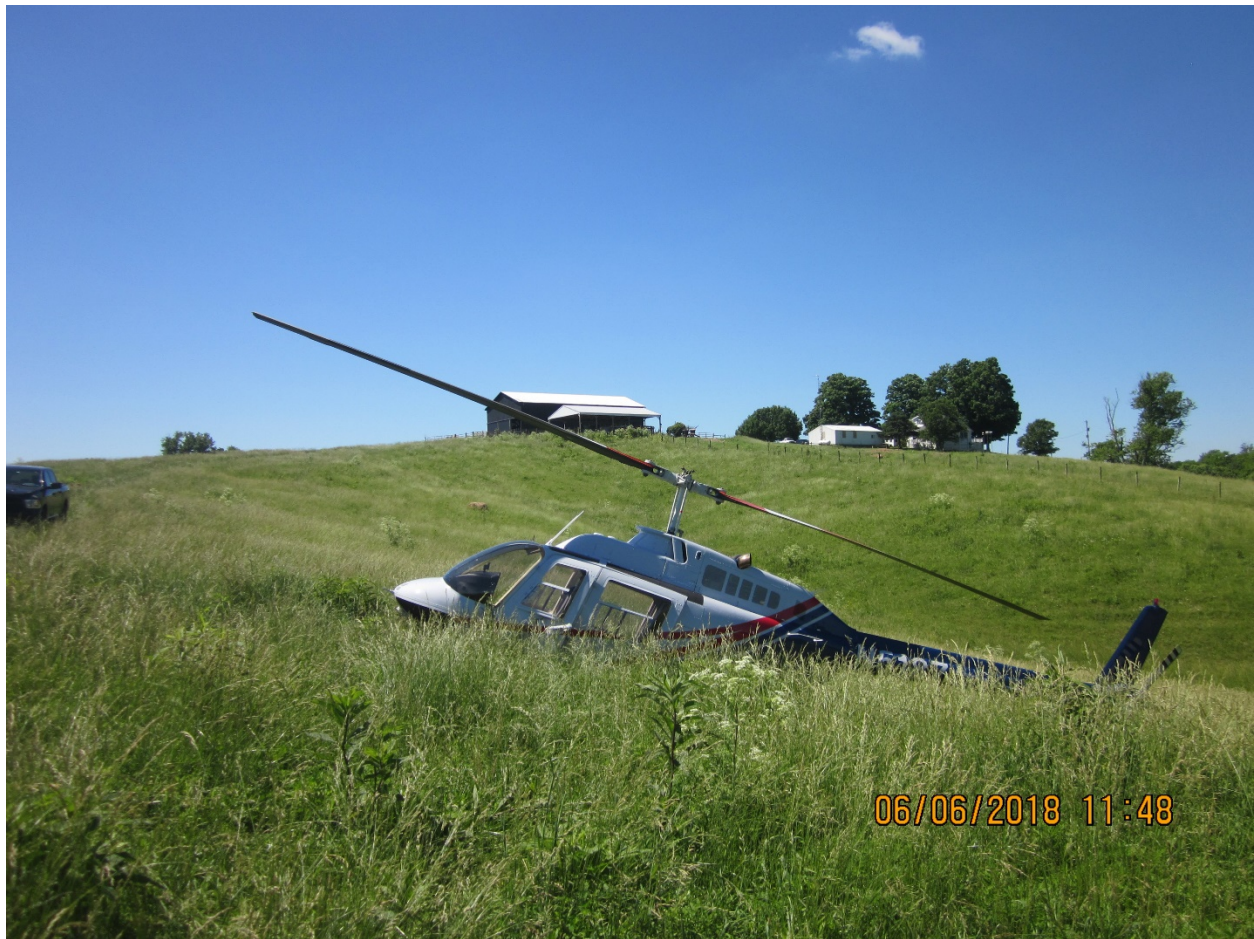
**Figure 2. N518Z, left view while at the accident site. Photo courtesy of the FAA.**

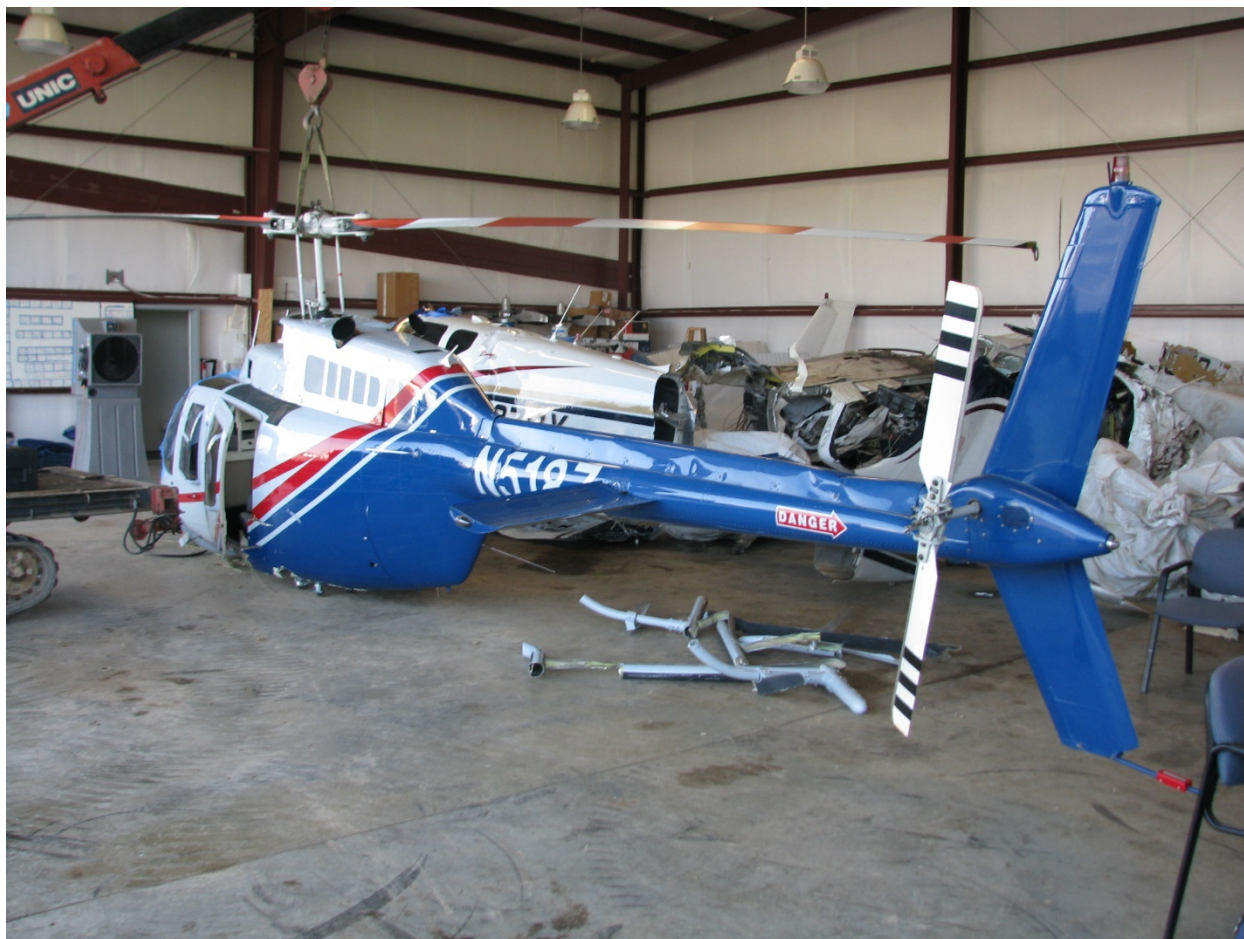
**Figure 3. N518Z, at the recovery site.**

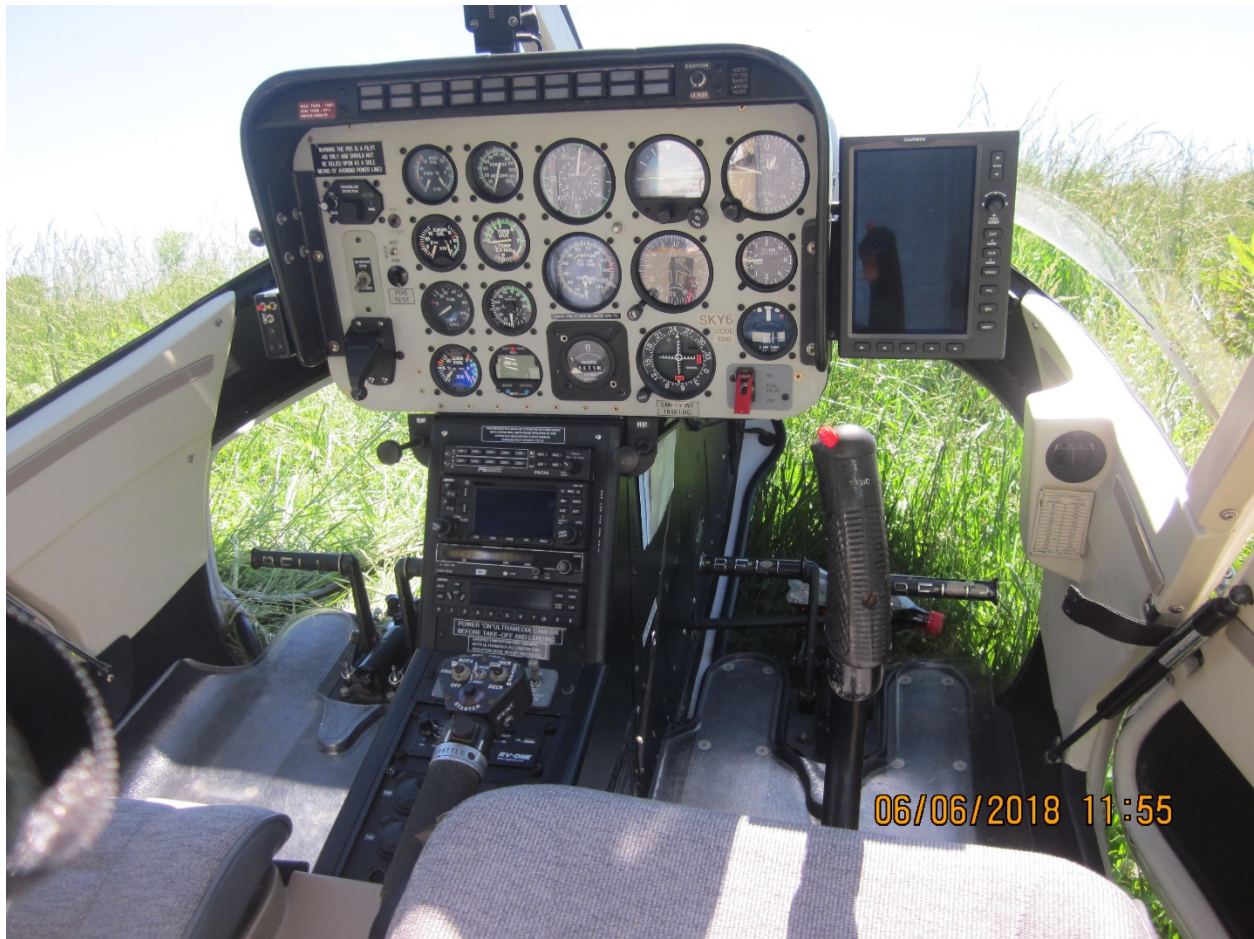
The collective Hobbs meter was 5825.1 hours and the Hobbs in the nose was 3720.9 hours. The throttle was observed to be at idle and the fuel shutoff switch was in the off position. The hydraulic system switch was on. The battery was reattached, and the switch was turned on and the following caution lights illuminated: Fuel Pump, Trans Oil Press, ENG OUT, and Rotor Low RPM.

**Figure 4. N518Z, instrument panel. Photo courtesy of the FAA.**

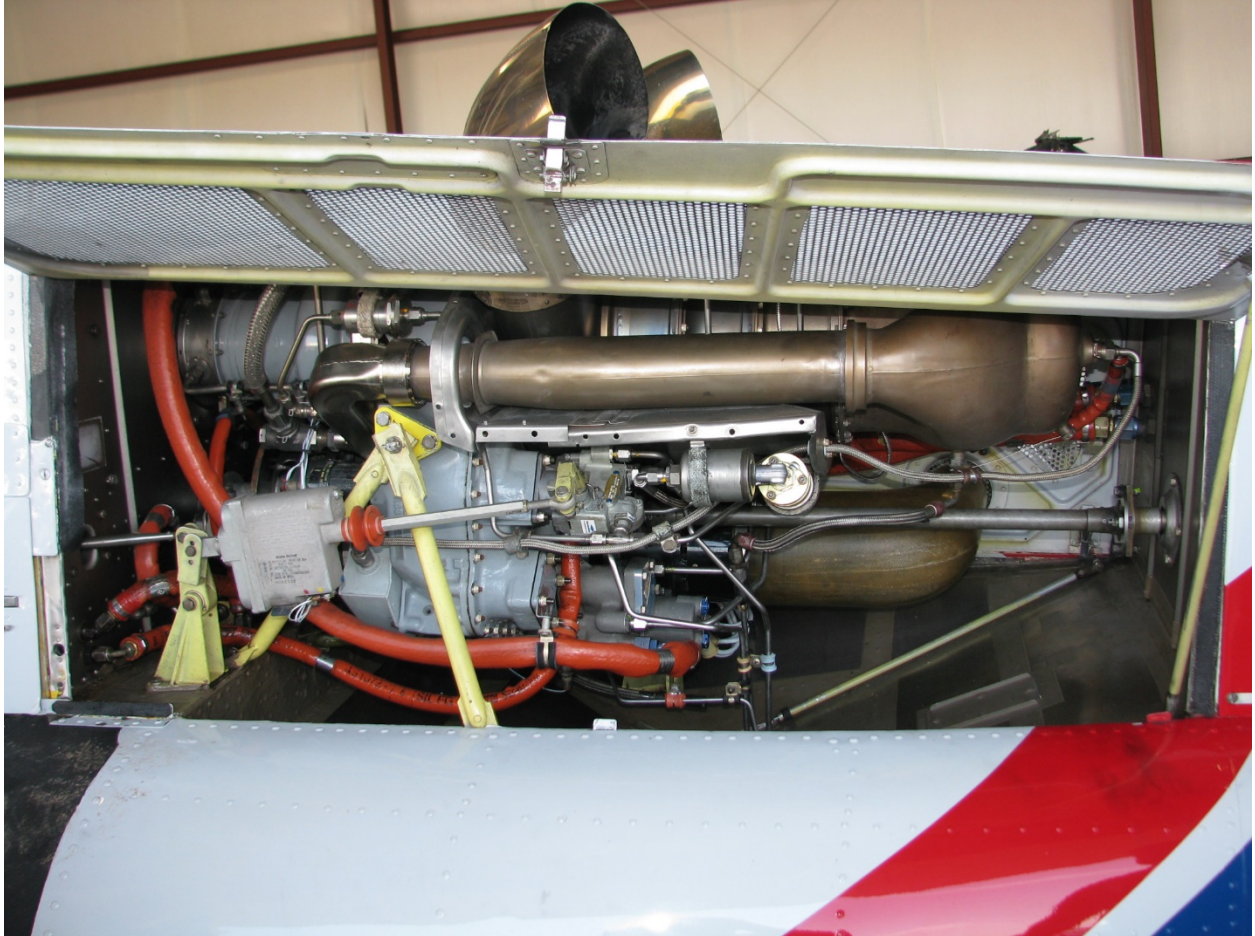
**Figure 5. Left-side view of the engine.**

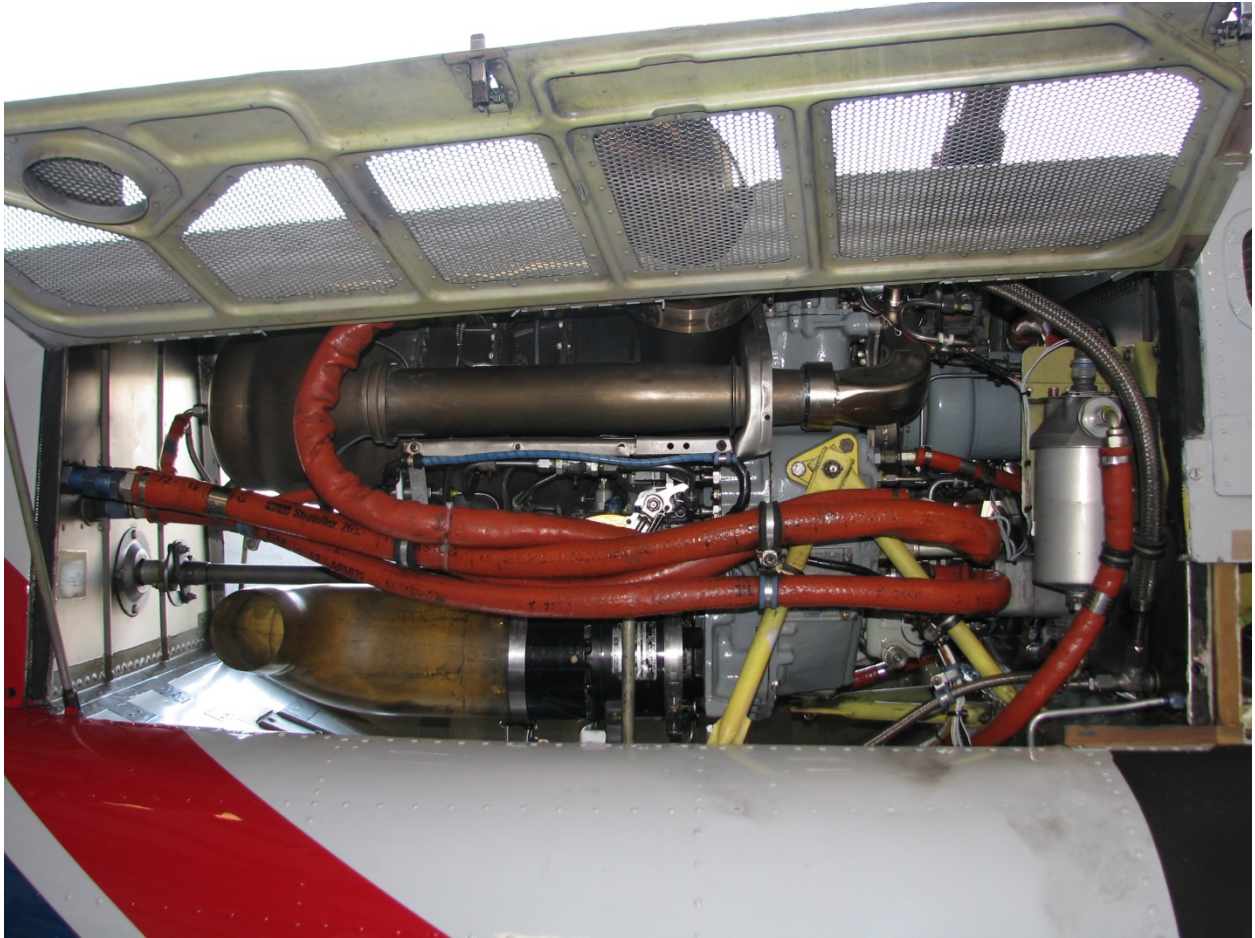
**Figure 6. Right-side view of the engine.**

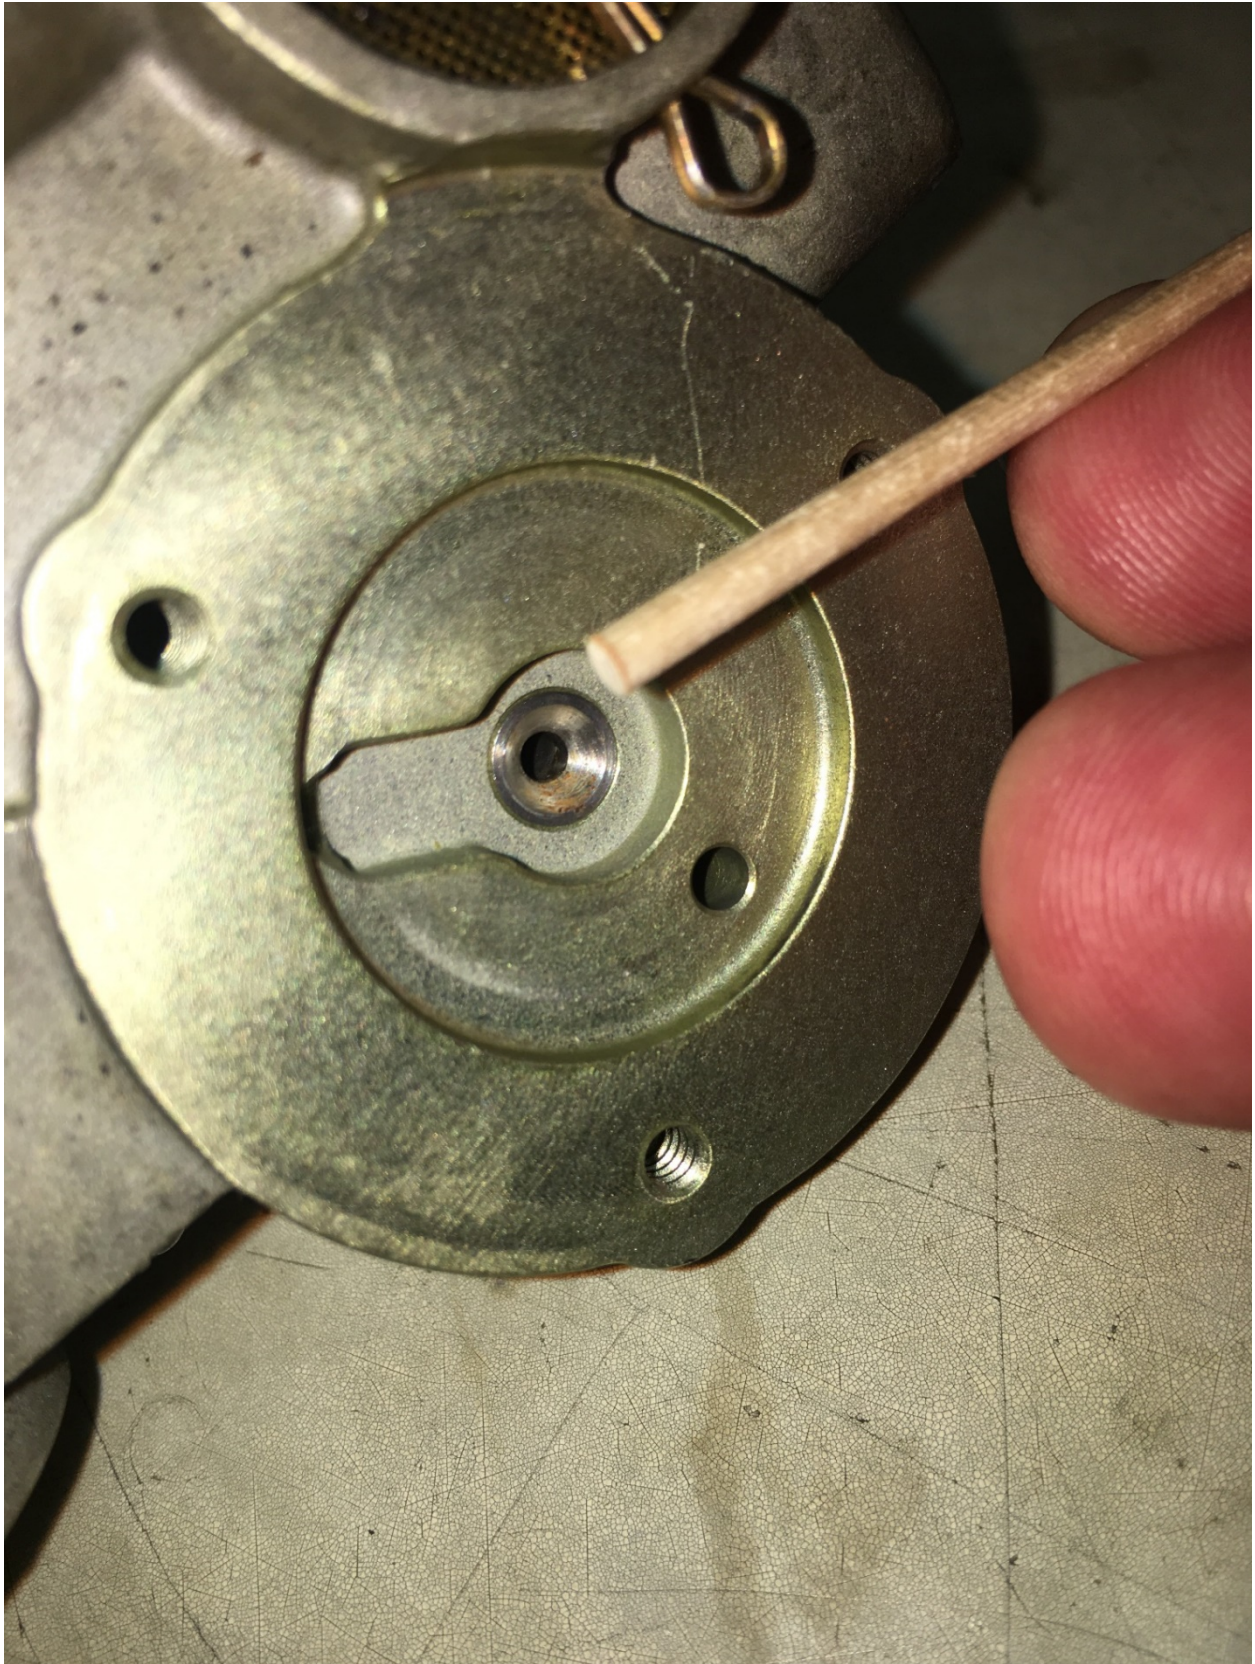
1. Debris was noted in the restrictor and filter assembly
2. Metallic debris was found on the fuel side of the diaphragm speed limiter
3. Corrosion was noted on the tip of the regulator valve

**Figure 7. Corrosion noted.**

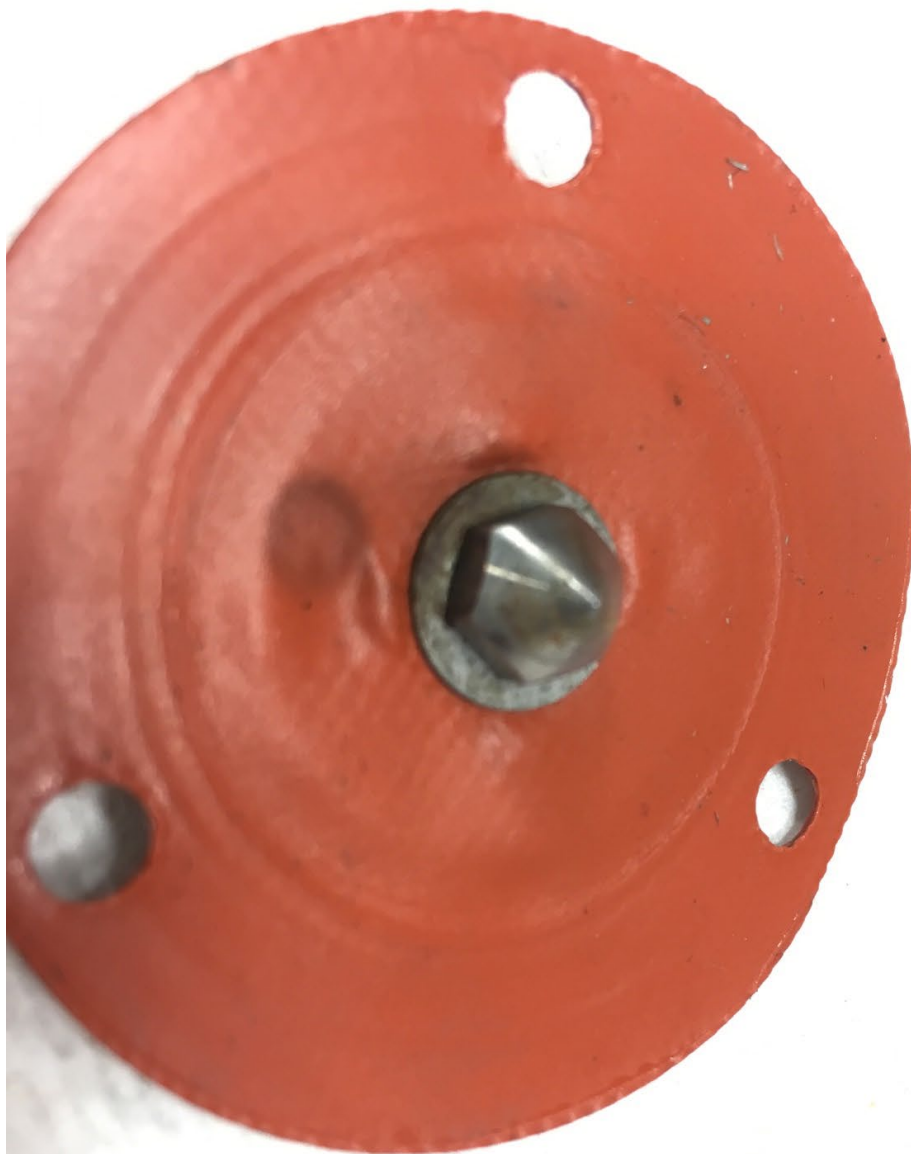
**Figure 8. Metallic debris found on the fuel side of the diaphragm speed limiter**

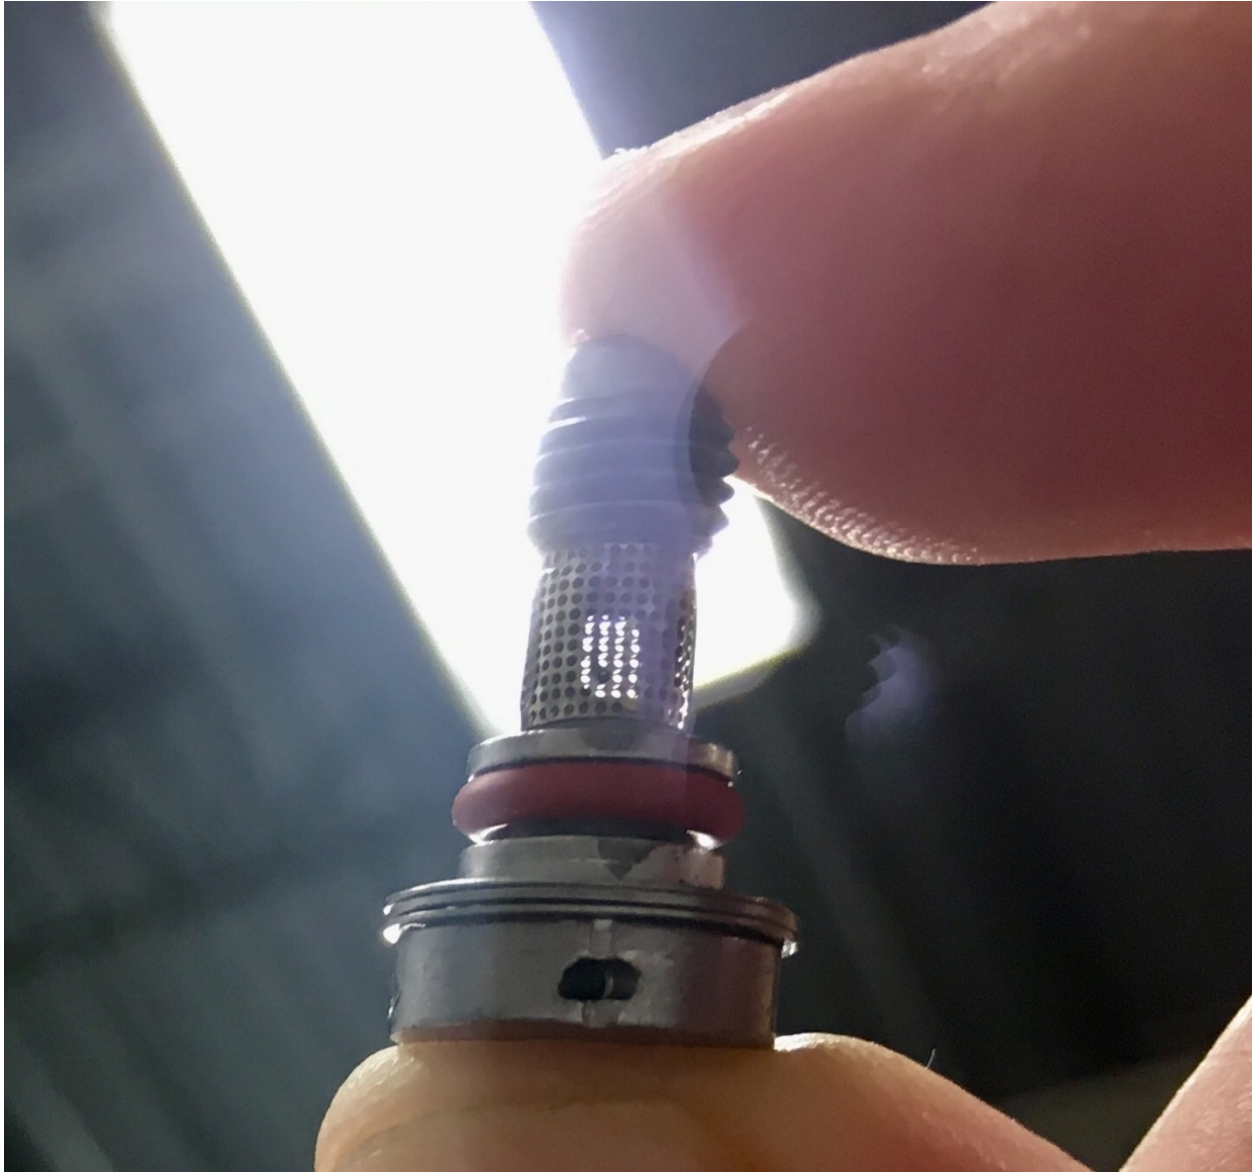
**Figure 9. Debris noted in the restrictor and filter assembly.**
