**Photo 1 – Right-rear view of N518Z at the accident site. Photo courtesy of the FAA.**

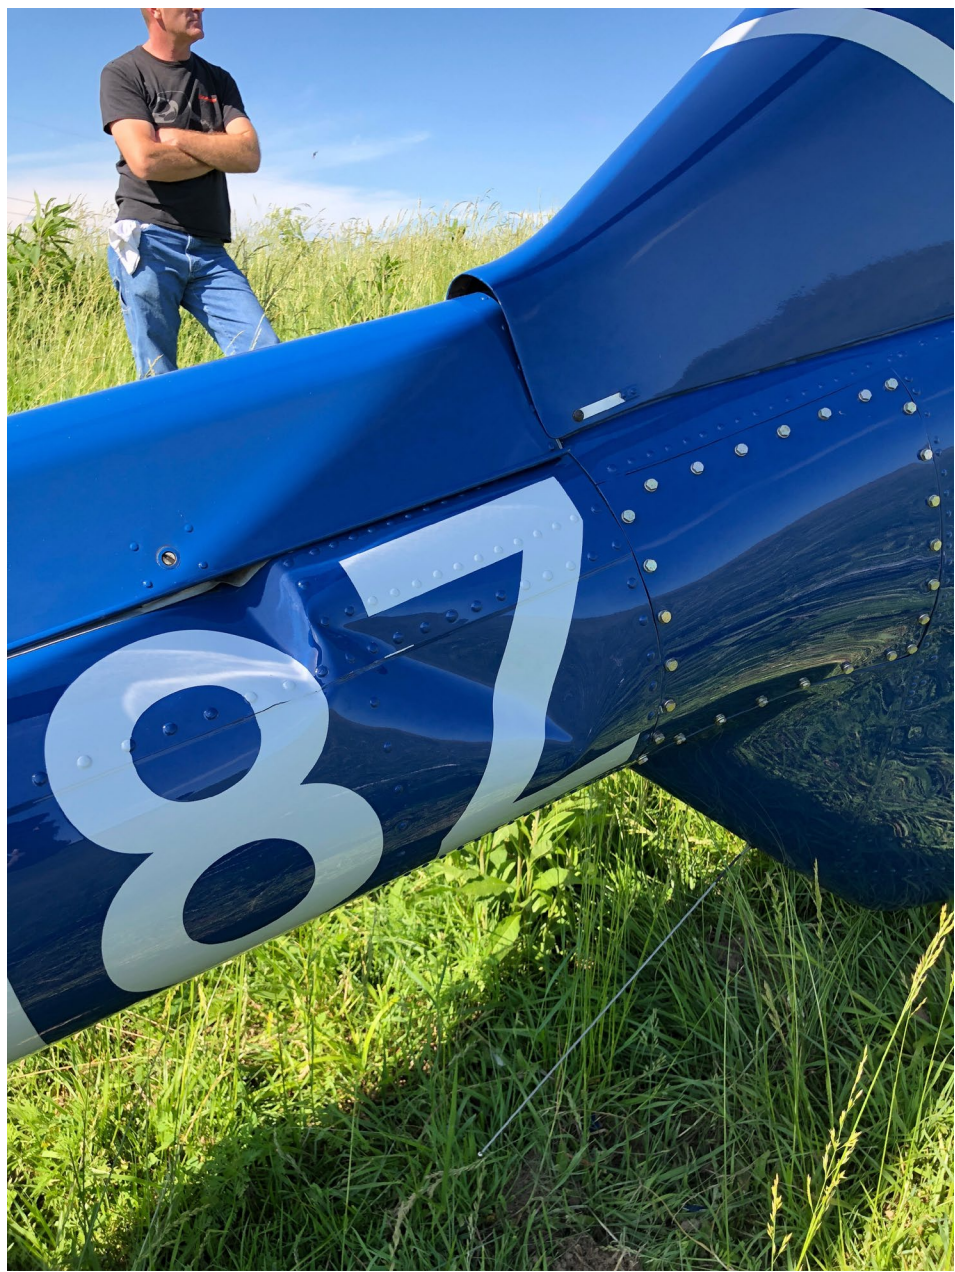
**Photo 2 - View of tail boom damage. Photo courtesy of the FAA.**

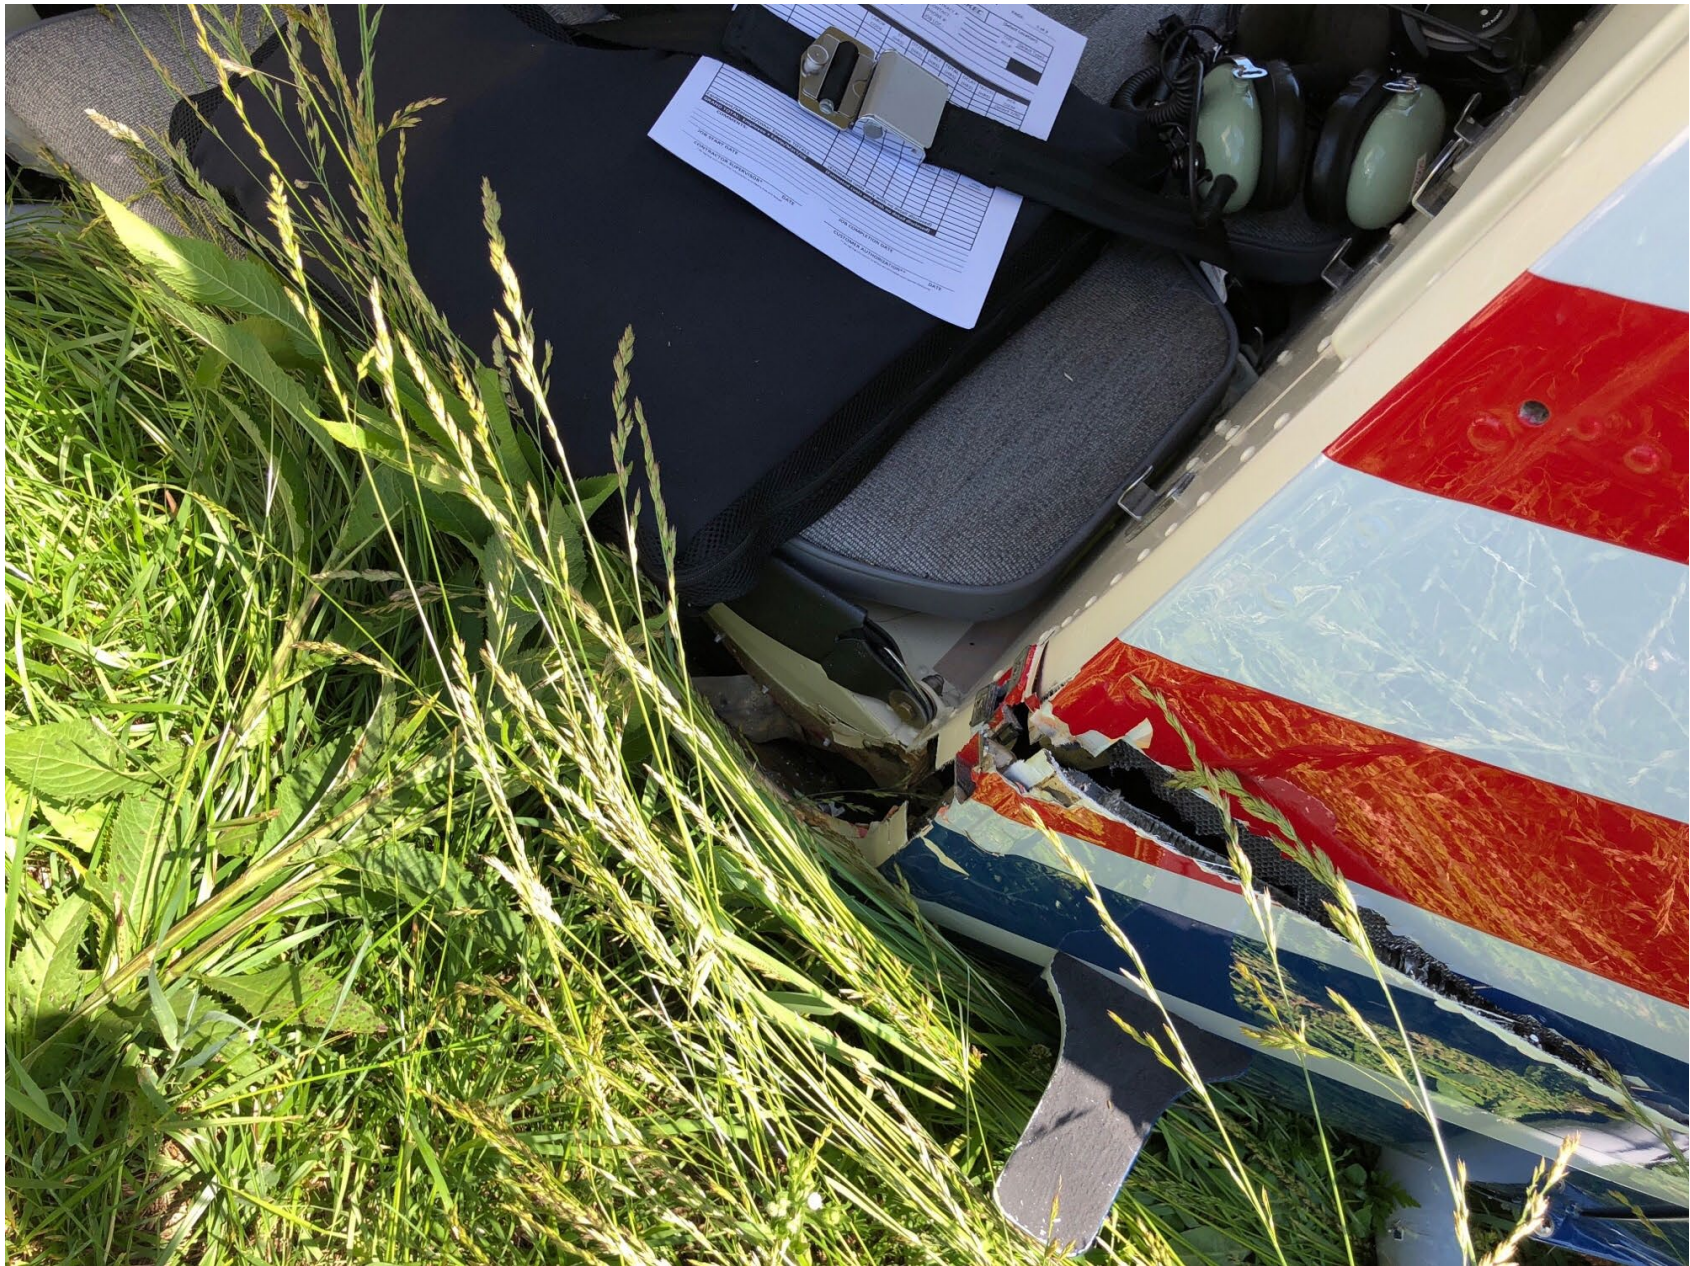
**Photo 3 - View of fuselage damage. Photo courtesy of the FAA.**

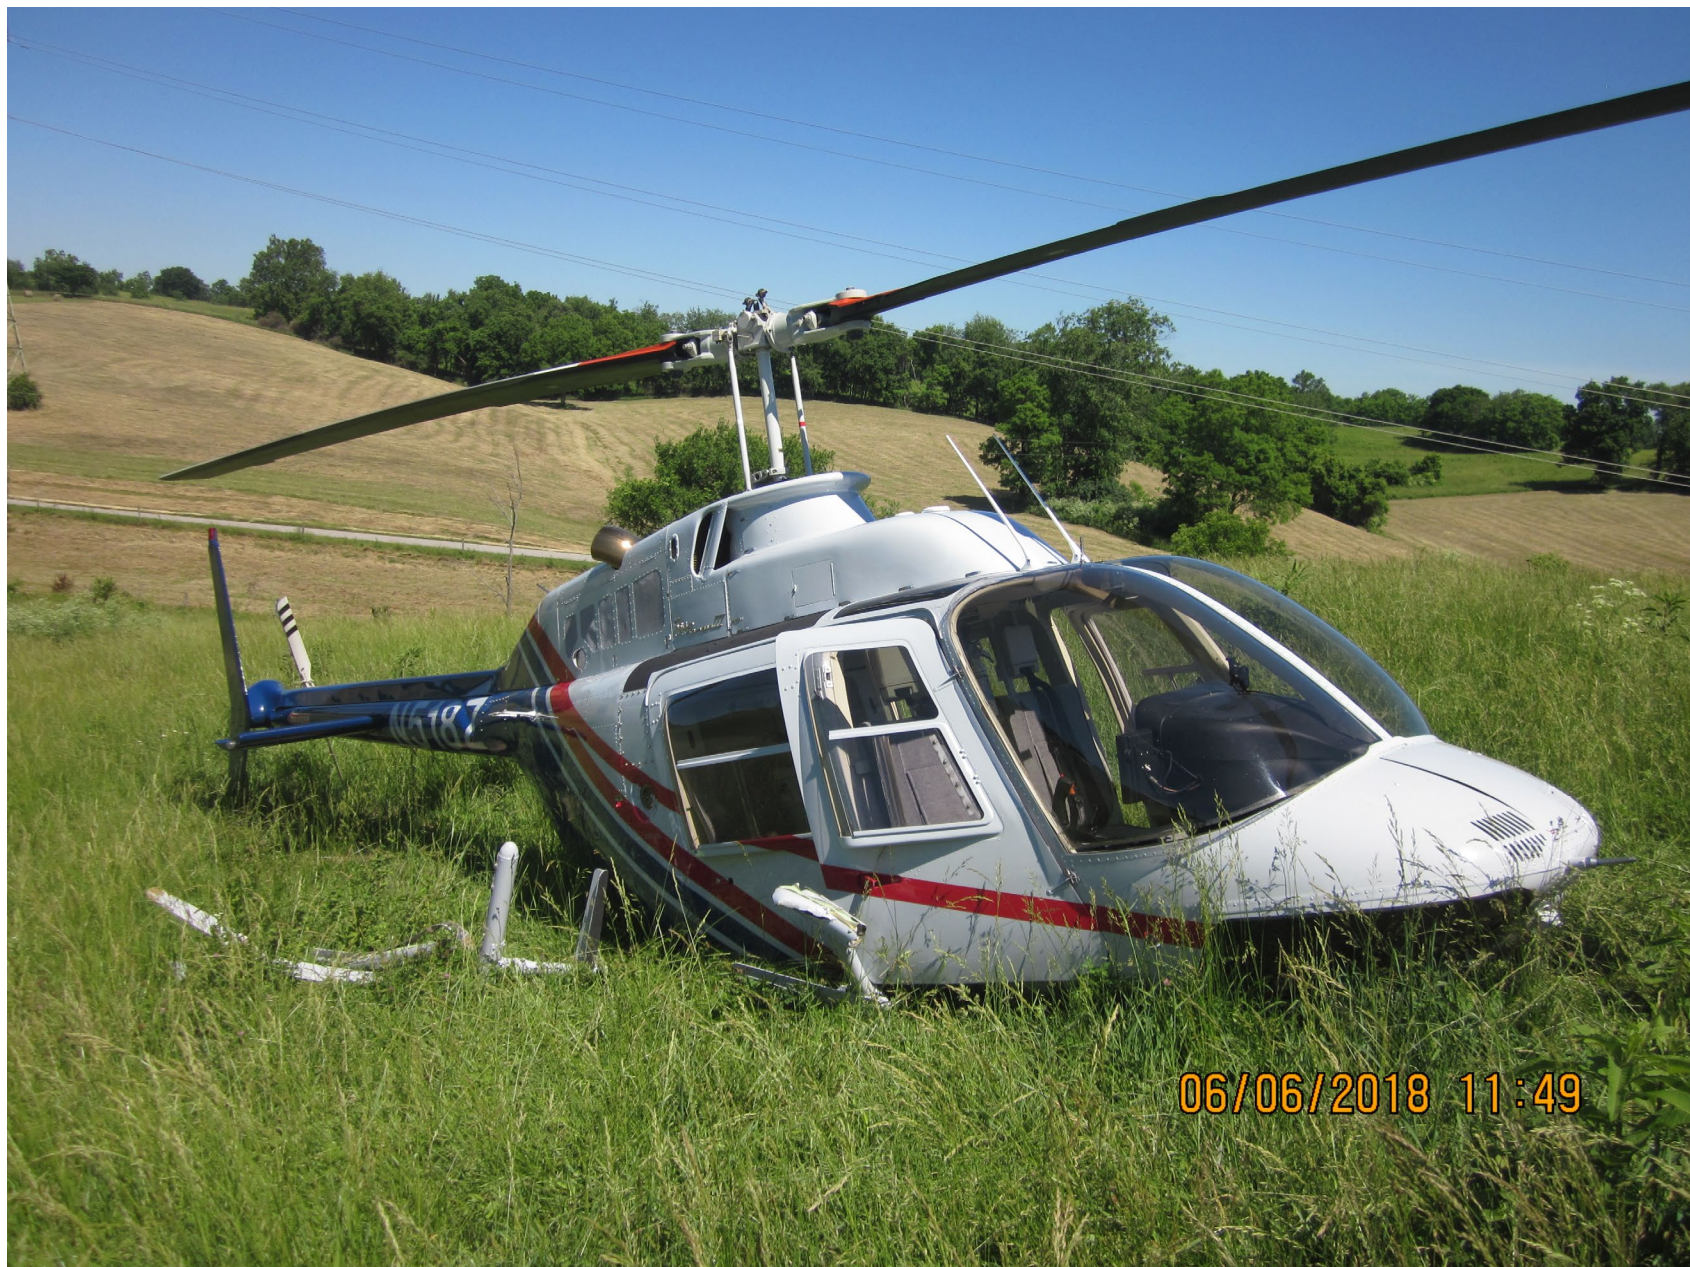
**Photo 4 – Right-front view, showing N518Z at the accident site. Photo courtesy of the FAA.**

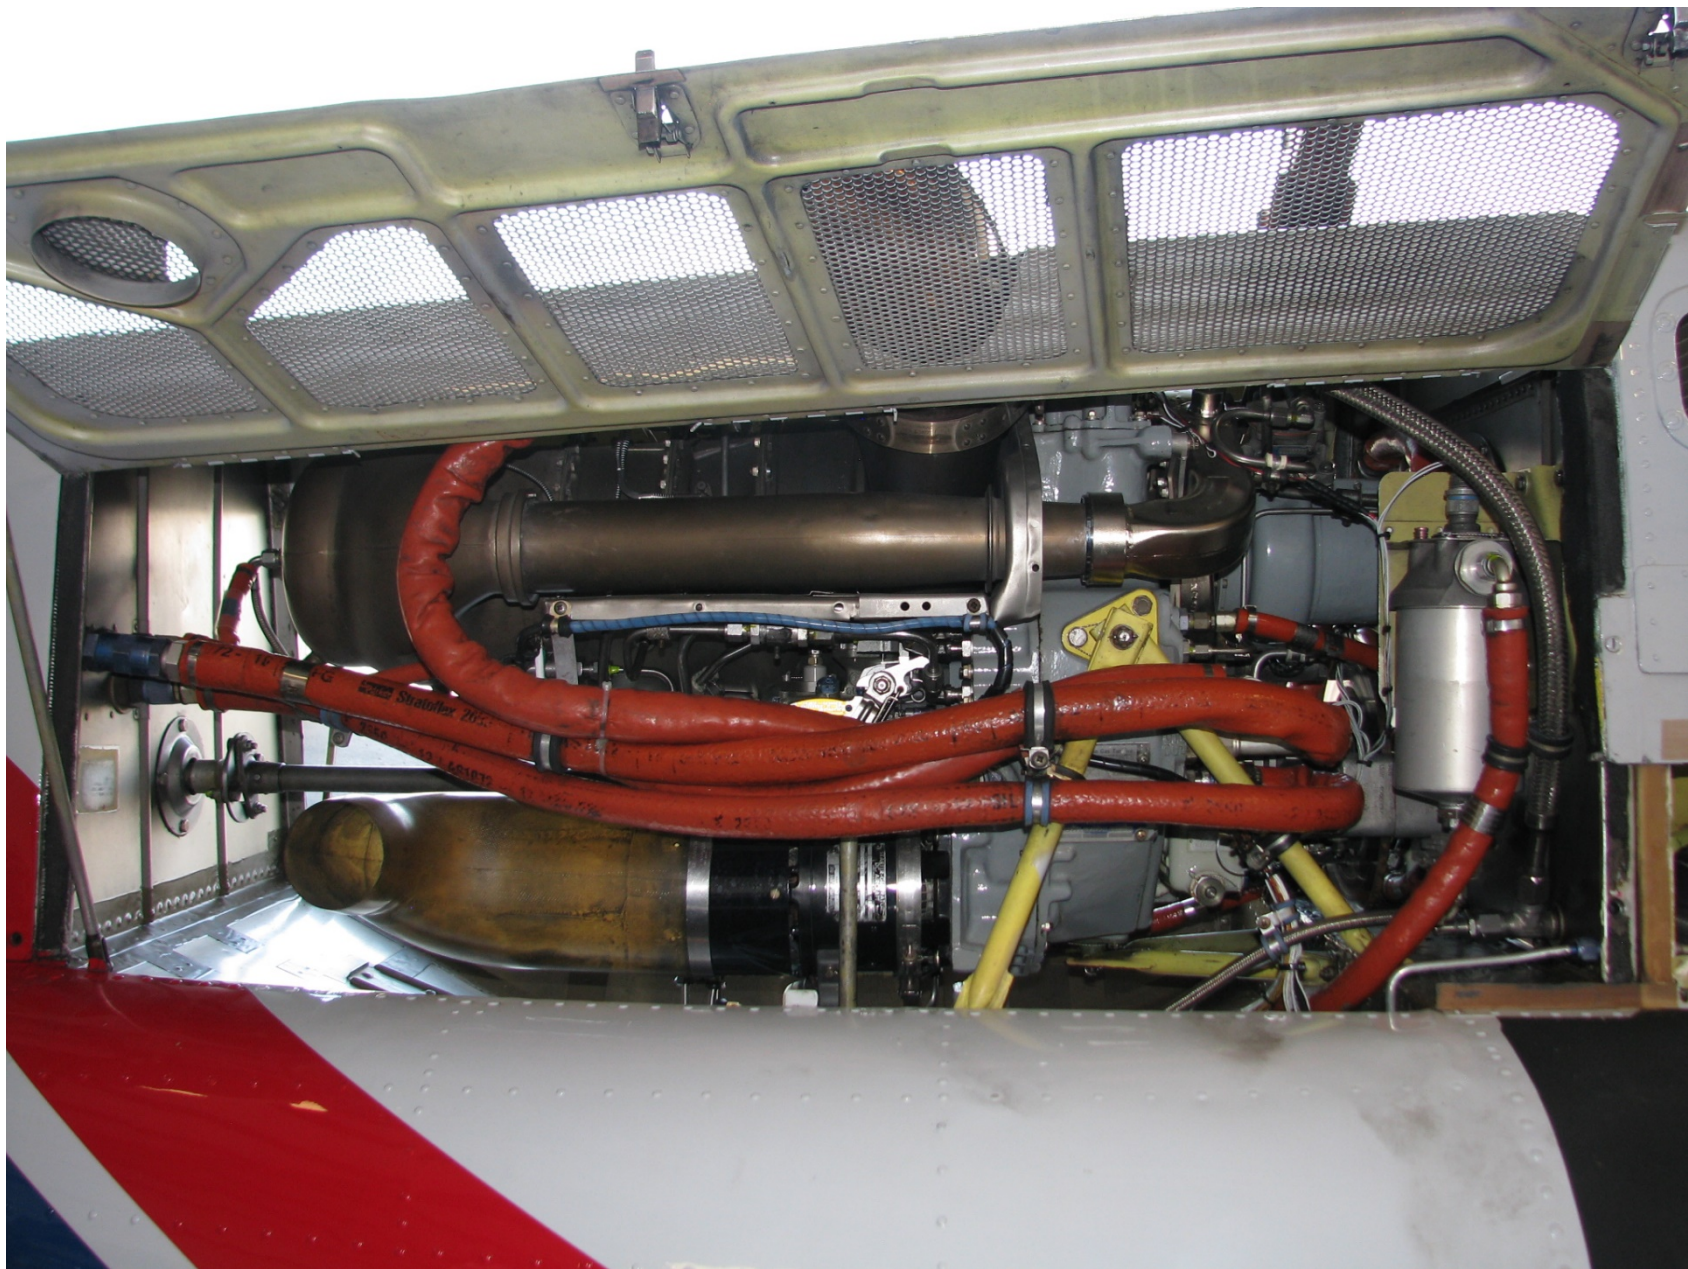
**Photo 5 -Right-side view of the engine bay, showing the airframe-mounted fuel filter. Photo courtesy of the FAA.**
