## **NATIONAL TRANSPORTATION SAFETY BOARD**

# **AIRFRAME EXAMINATION**

**WPR18LA170**

Location: Las Vegas, NV  
Date: June 13, 2018  
Aircraft: Schweizer 269C Helicopter, Registration Number: N557DC  
NTSB IIC: Albert Nixon

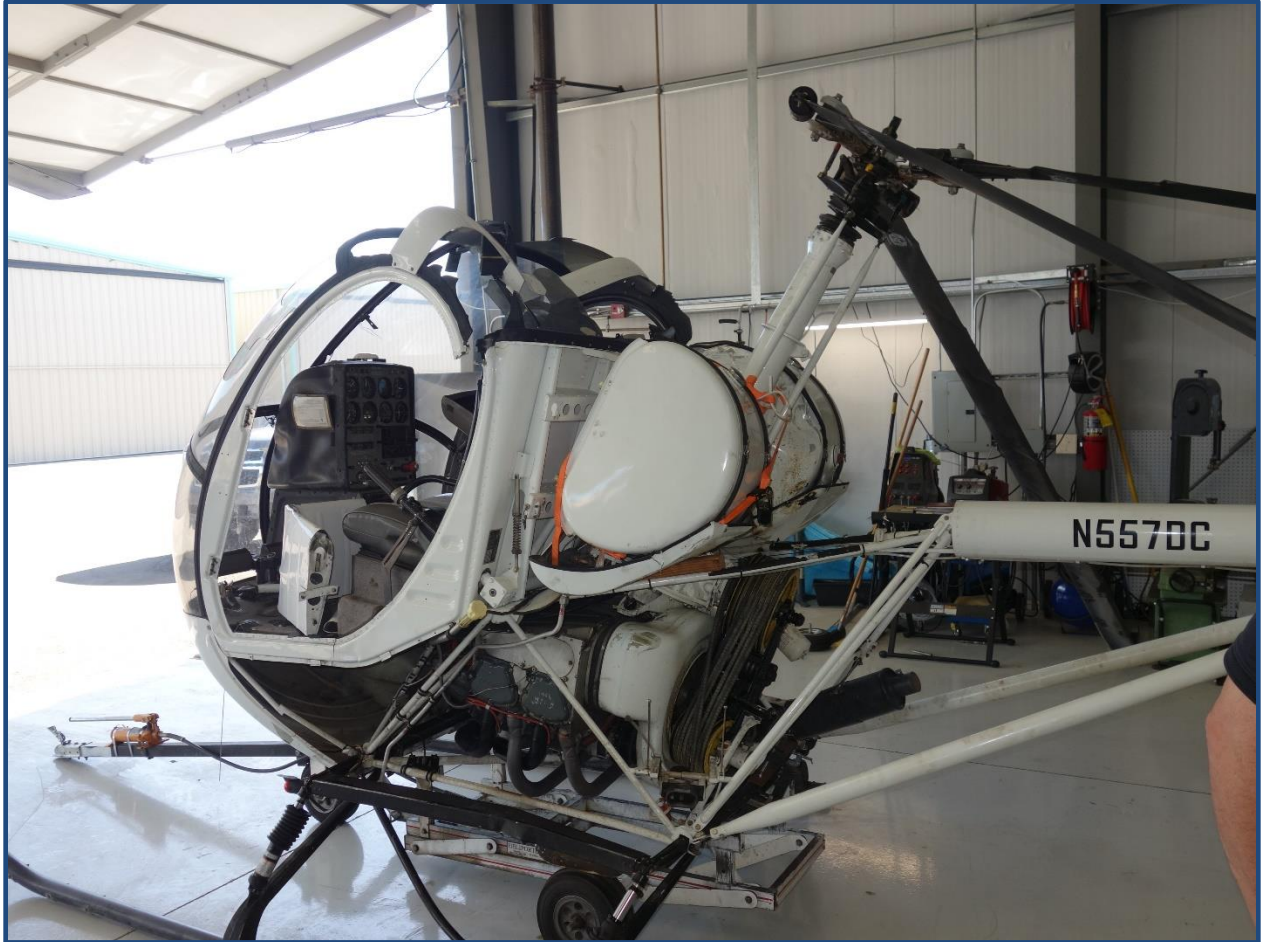
Examination of the helicopter revealed that the skids remained attached to the main fuselage. A crossbar on the rear section of the skid was installed to help stabilize the helicopter during the examination. Damage sustained during the accident rendered the helicopter unstable. The main rotor blades exhibited wrinkling and were positioned within 110° of each other. The mast was tilted to the right. Flight continuity was established to tail rotor and main rotor blades.

The cockpit cabin area and instrument panel were intact. The top section of the cockpit area was separated. The Hobbs meter (Datcon) indicated 2158.2 hours.

The tail and tail rotor were intact.

Figure 1: Helicopter as viewed from the left side.
