# Continental Motors

## ENGINE EXAMINATION REPORT

| ENGINE MODEL | IO-550-N50B conv. to turbo-normalized TAT STC |
| FILE NUMBER | 17-630 |

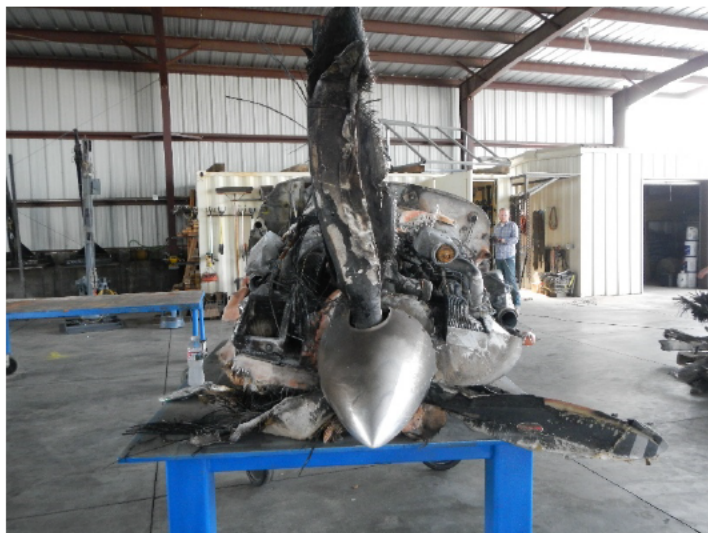
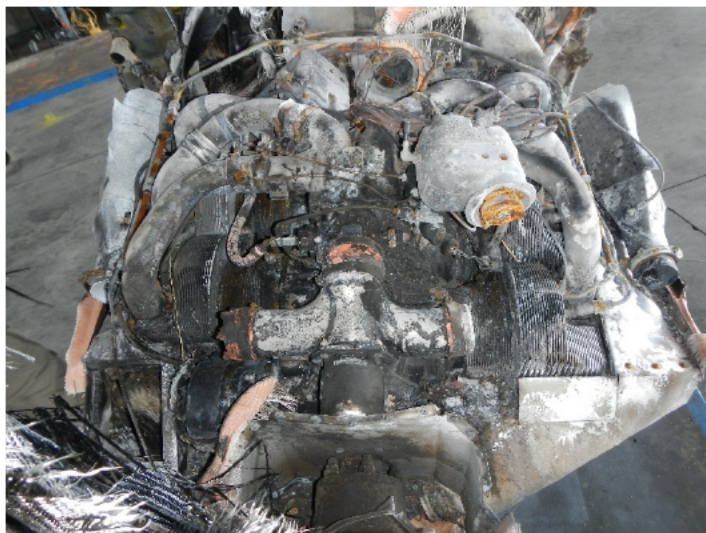
The engine sustained significant thermal damage that destroyed many of the engine-related systems. The engine remained attached to the firewall and the engine mount. The throttle, mixture, and propeller control cables remained intact and attached to their respective control levers; however, the cockpit controls were destroyed. The left magneto was separated from its mounting pad and remained attached to the engine via the burnt remains of the ignition harness. The crankcase in the vicinity of the #2 cylinder displayed a large hole. The rusted crankshaft and fractured #2 connecting rod pieces were visible through the hole.

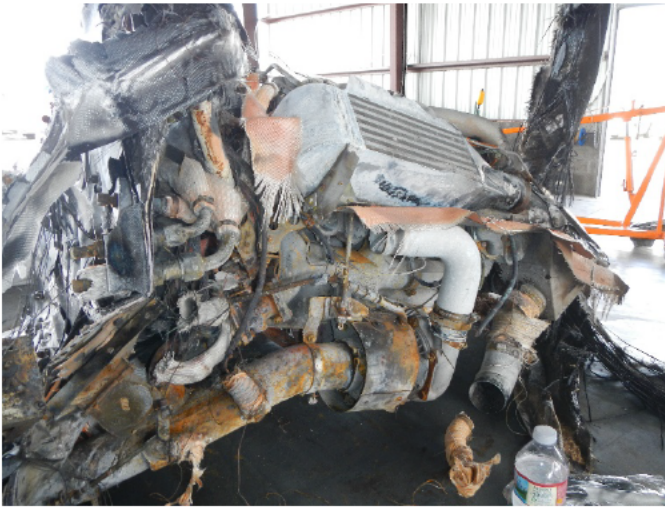
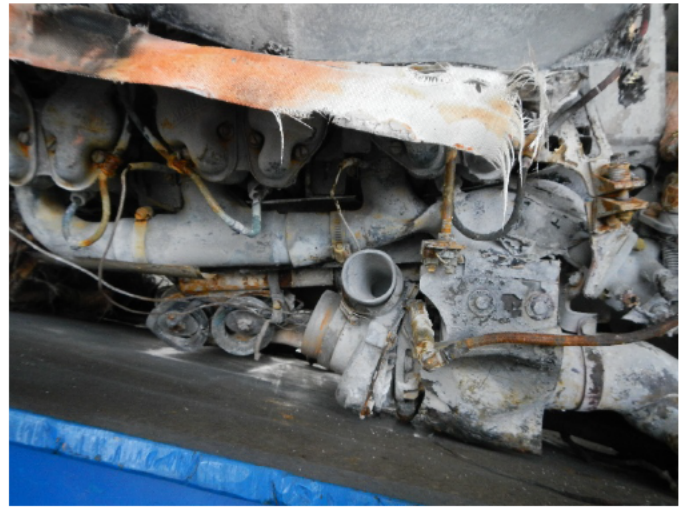
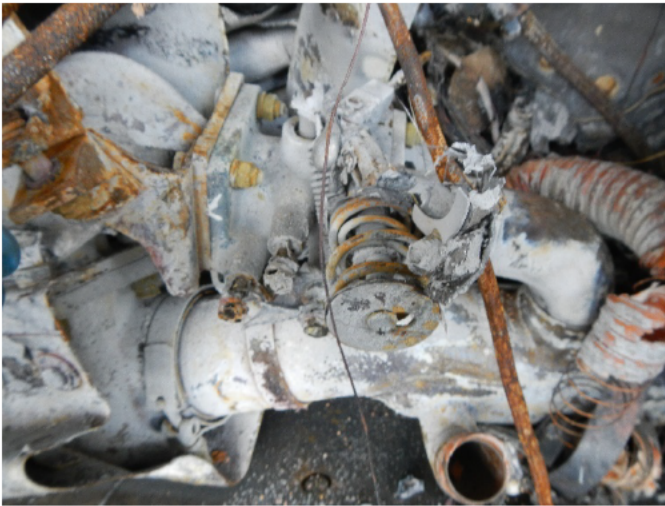
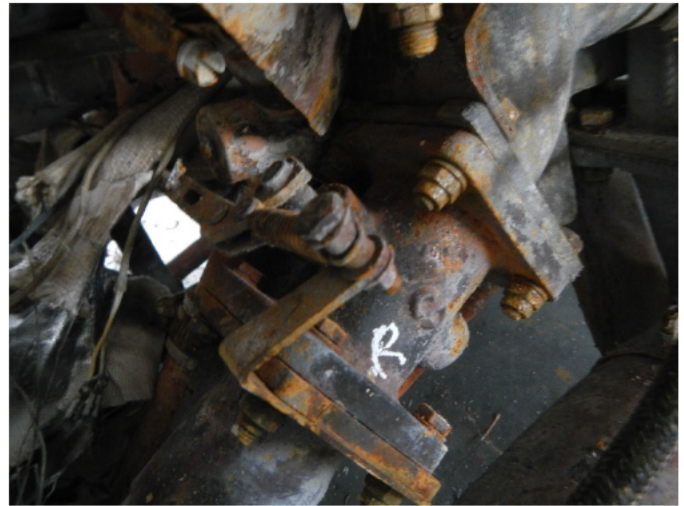
#### EXHAUST SYSTEM

The exhaust system remained intact and attached to the engine. It was cut away to facilitate examination of the engine/turbochargers. Both exhaust manifolds displayed re-solidified beads of molten metal, with the largest cluster noted in the low point of the right exhaust manifold. The wastegate controller was thermally damaged.

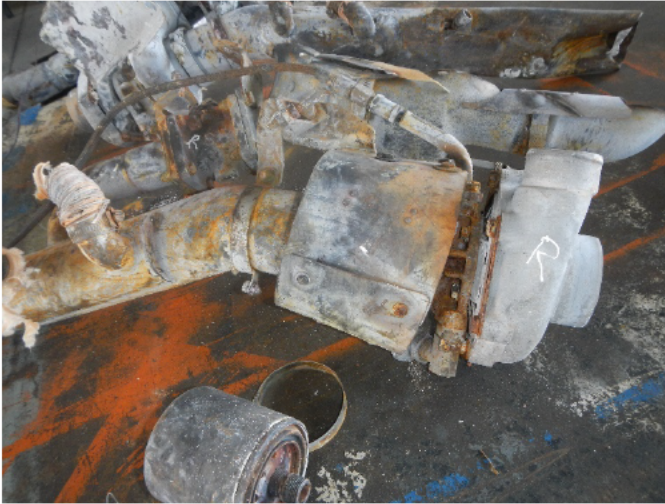
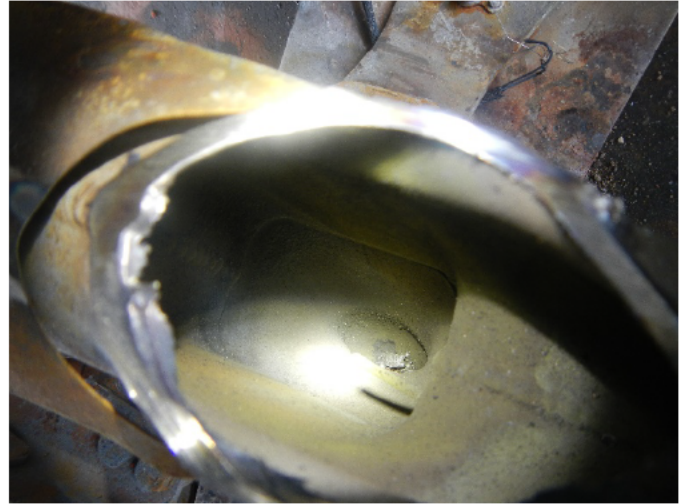
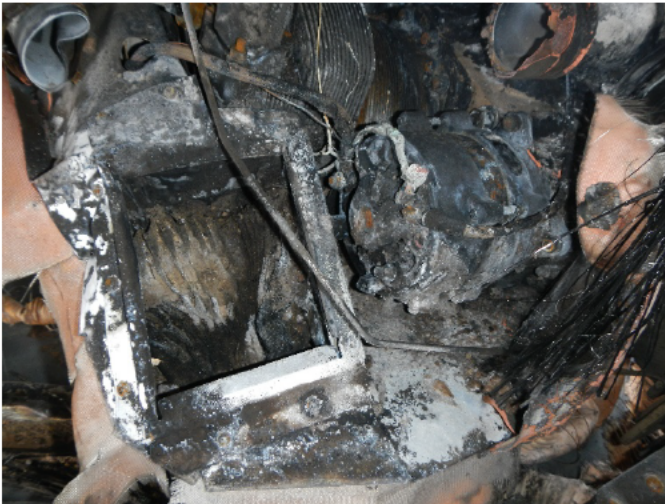
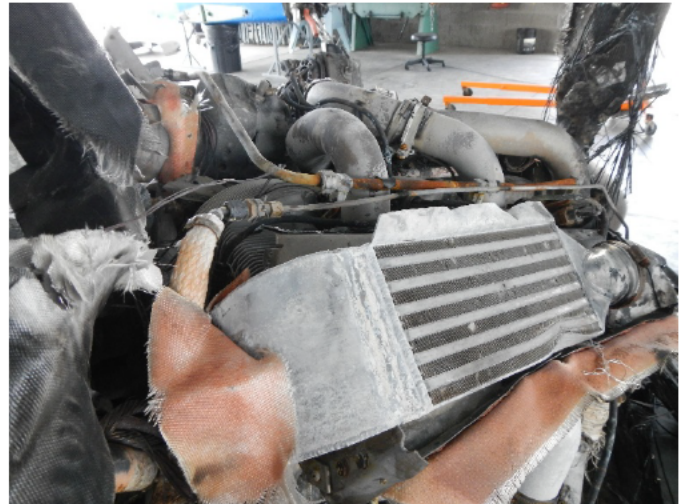
### INDUCTION SYSTEM

The thermally damaged remains of the induction system remained intact. The left turbocharger's impeller was damaged with the blades bent opposite the direction of rotation. The impeller housing was deformed and thermally damaged. Otherwise, the induction system was unremarkable.

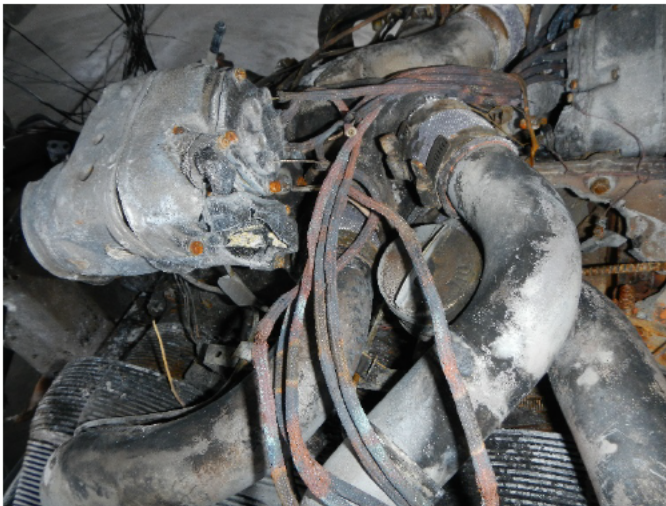
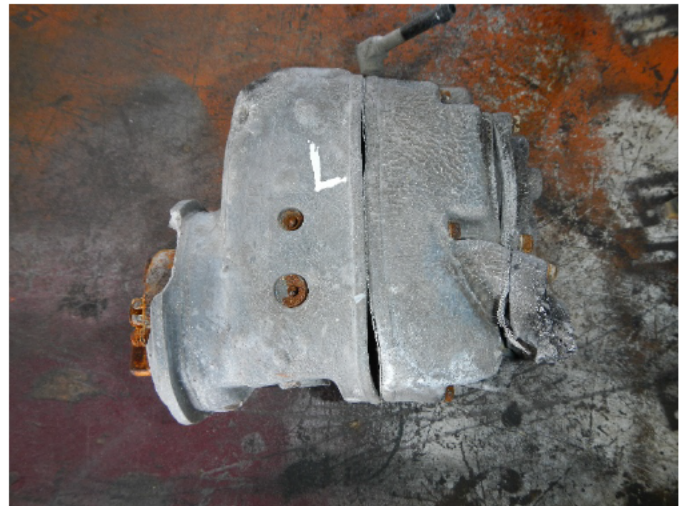
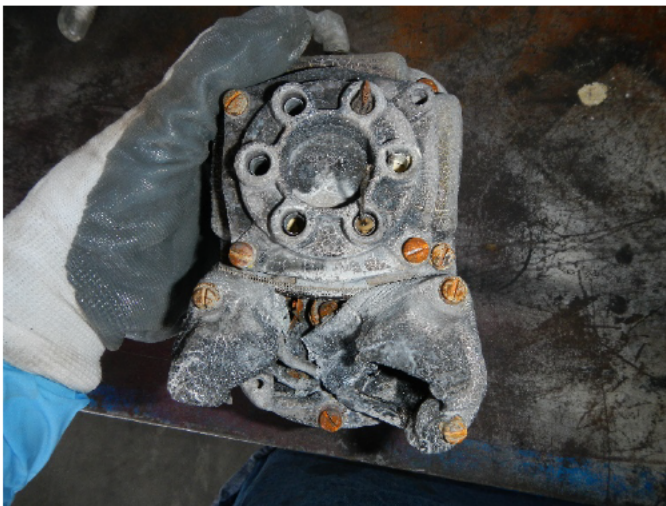
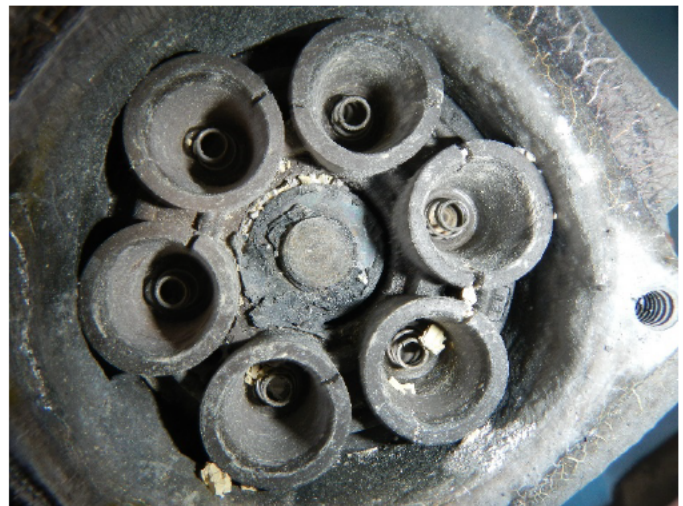
#### LEFT MAGNETO

**Condition:** The left magneto was separated from its mounting pad and remained attached to the engine via the ignition harness. The mounting flange was fractured and the housing sustained thermal deformation damage that partially melted the capacitor and point cover. Disassembly of the magneto revealed that internal components were destroyed. The distributor gear was melted away and the distributor finger was positioned between the #2 top and #5 bottom distributor poles.

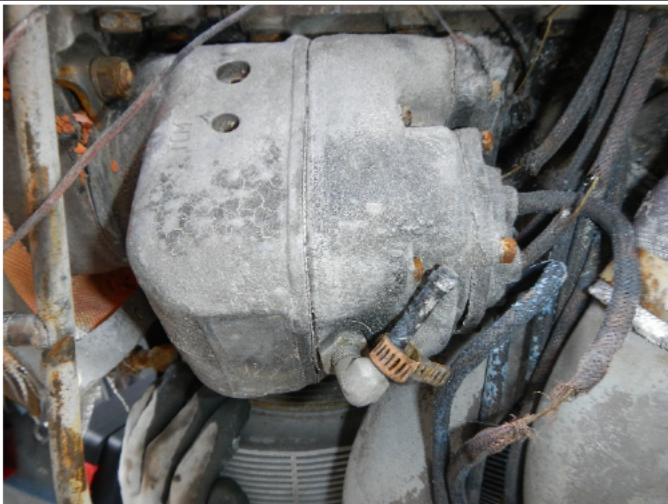
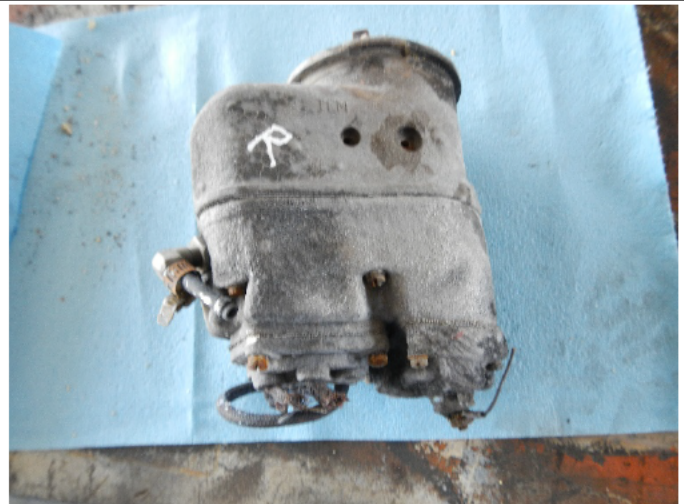
## RIGHT MAGNETO

The right magneto remained attached to the mounting pad and manual manipulation of the magneto did not result in any slipping or rotation of the magneto. The housing sustained thermal deformation damage that partially melted the capacitor and point cover. Disassembly of the magneto revealed that internal components were destroyed. The distributor gear was melted away and the distributor finger was positioned at the #3 top distributor pole.

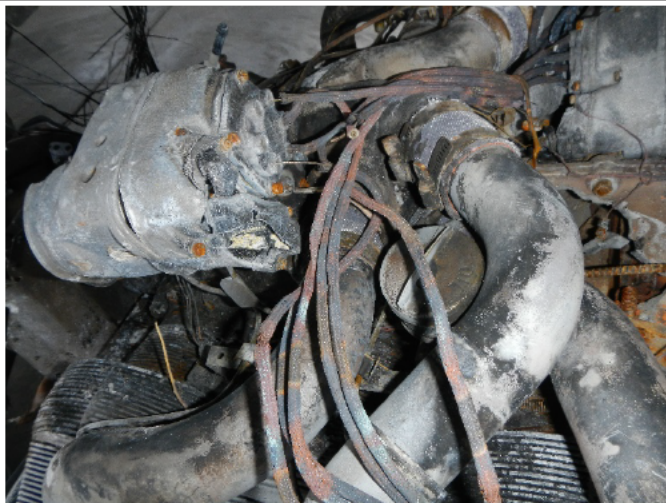
## IGNITION HARNESS

The ignition harness sustained thermal damage that destroyed the leads/terminals and precluded functional testing.

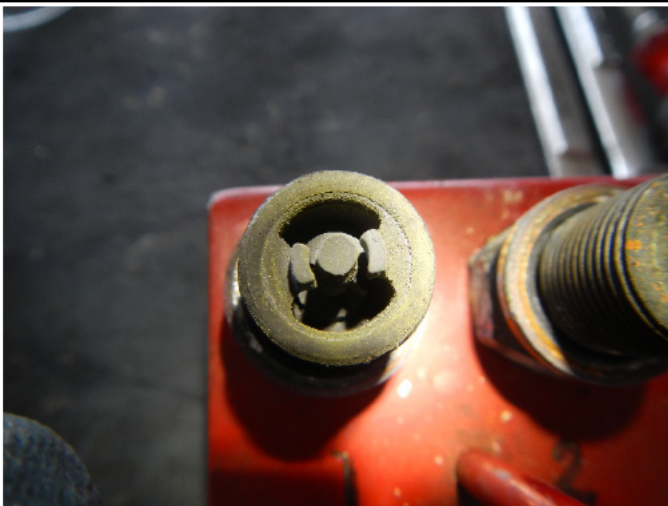
## SPARK PLUGS

All of the sparkplugs remained secured to their respective cylinders and their ignition terminals remained attached. Removal of the top sparkplugs revealed that their electrodes were significantly worn, the insulator core noses were fractured and missing material (consistent with detonation as per the Champion AV6-R Aviation Service Manual), and re-solidified molten metal beads were observed on the metallic surfaces. The bottom sparkplugs, which were observed via a lighted borescope, displayed similar signatures as the top. The #5 top sparkplug displayed a large clump of solid material on one side and the #6 sparkplugs were discolored green. Initial visual examination of the terminal end insulators in the top sparkplugs revealed they were intact.

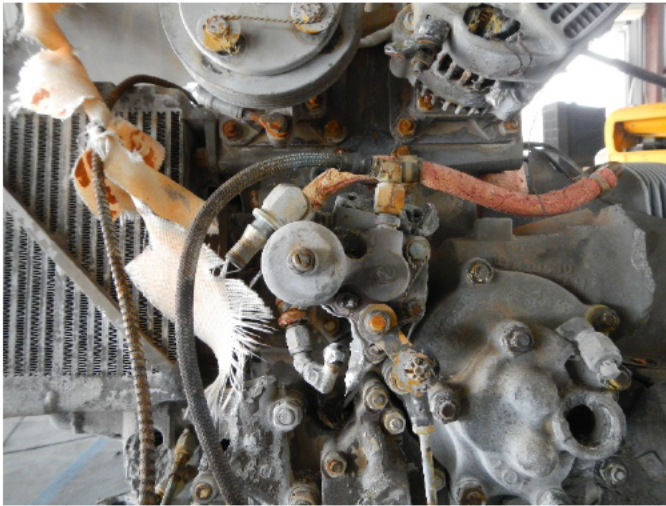
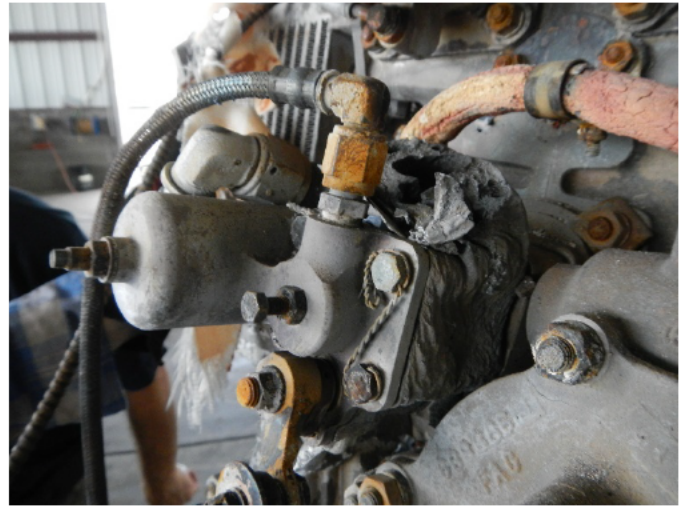
The fuel pump remained secured to the backside of the engine and the mixture lever was in place. The unit sustained significant thermal damage that distorted the fuel pump housing. It will be examined in more detail at a later date.

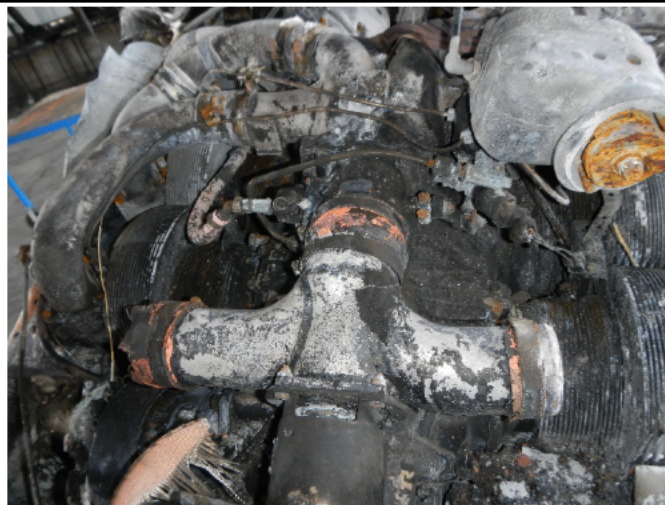
The throttle body remained attached to the topside of the engine with the throttle lever in place. The unit sustained thermal damage and was not examined in detail. The fuel lines to and from the metering unit were attached.

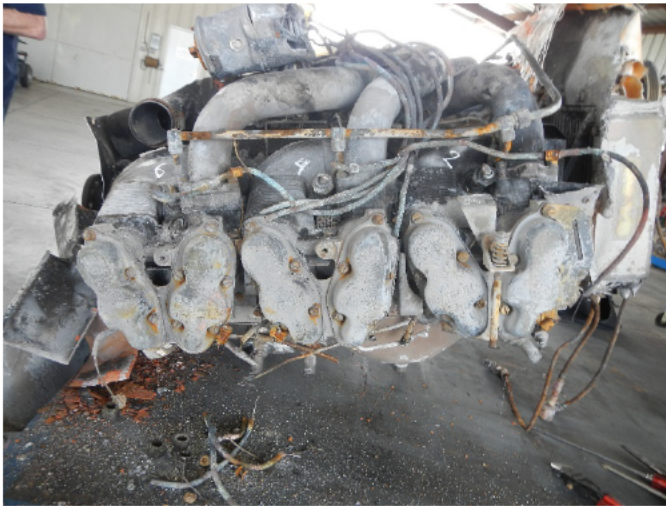
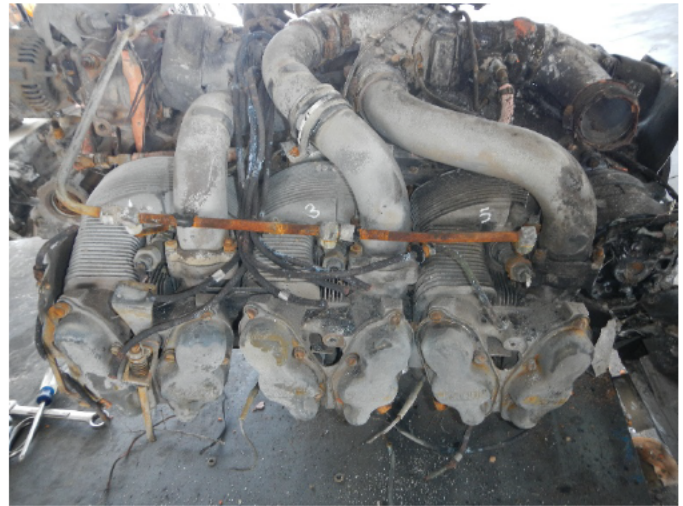
**FUEL NOZZLES  
AND LINES**

Condition: The upper deck reference lines remained attached to the nozzles and the fuel injector lines remained secured in place. The nozzles will be inspected at a later date.

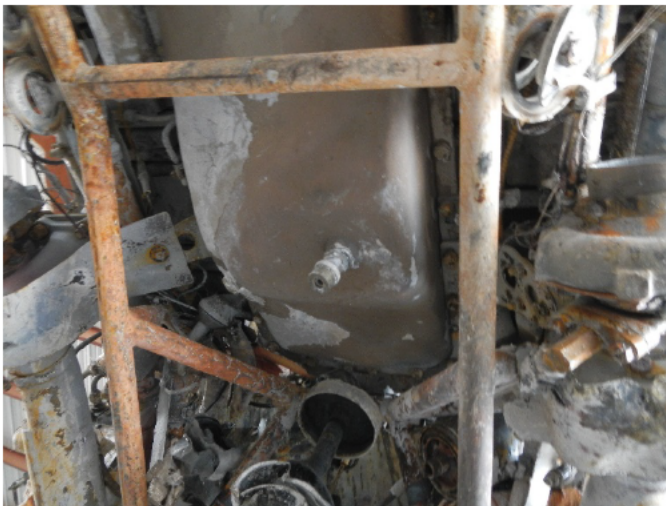
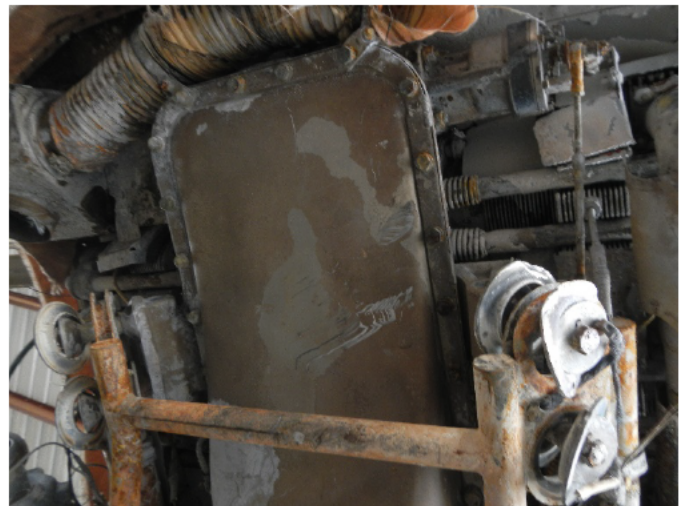
Condition: The oil sump remained secured to the bottom of the engine and it was intact with no punctures noted. No oil registered on the dipstick.

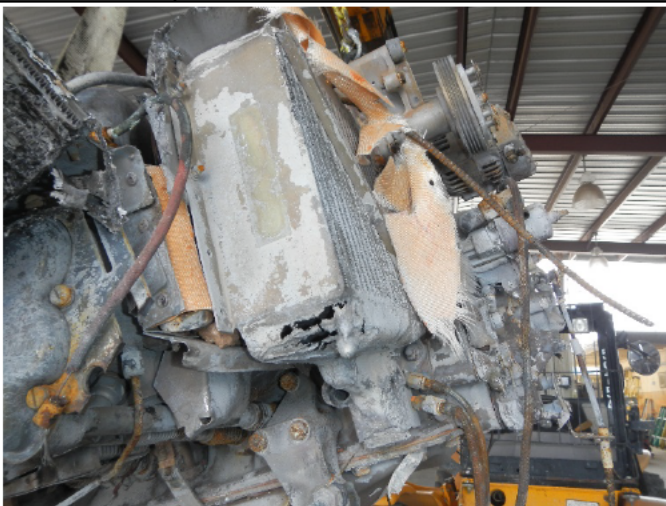
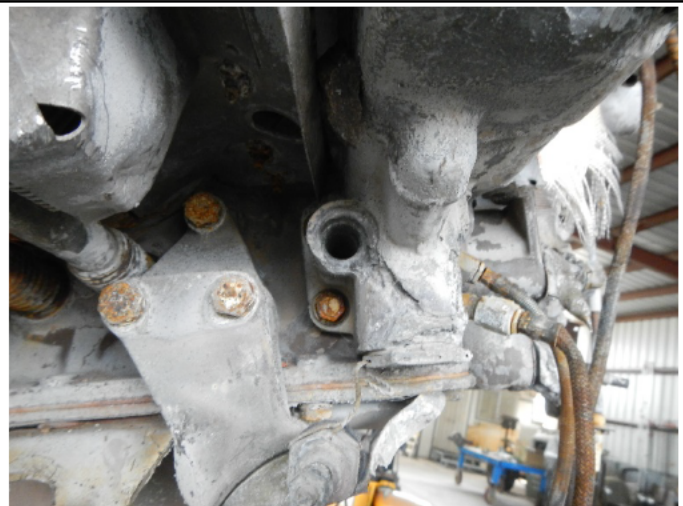
## OIL COOLER

Condition: The oil cooler remained attached to the aft left side of the engine. The bottom side sustained thermal damage that partially melted away portions of the cooler and deformed the fittings that remained attached.

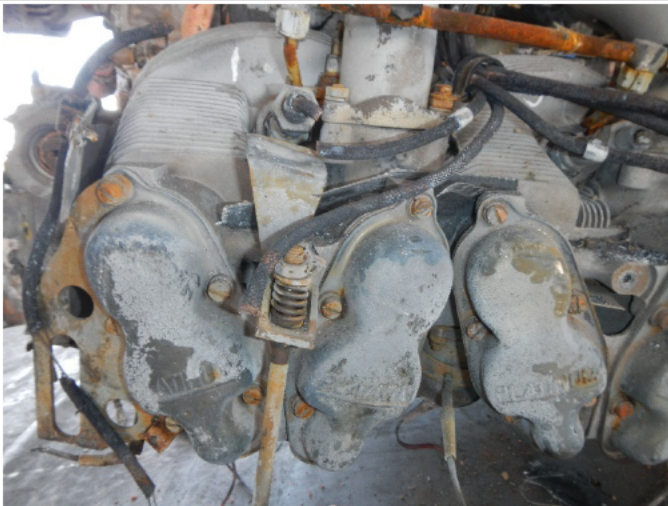
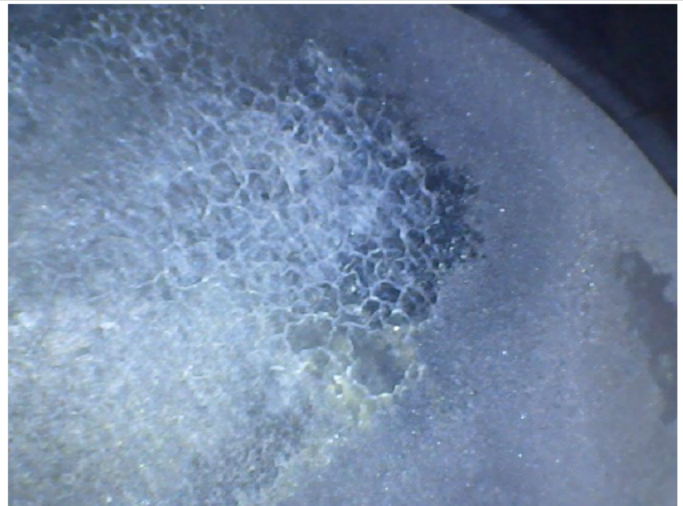
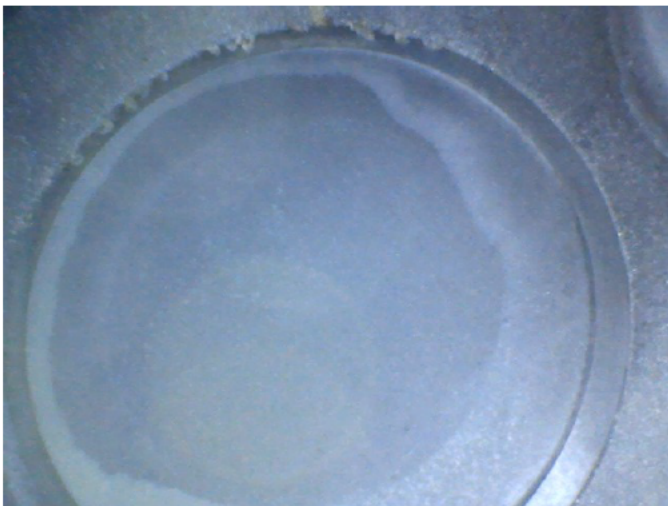
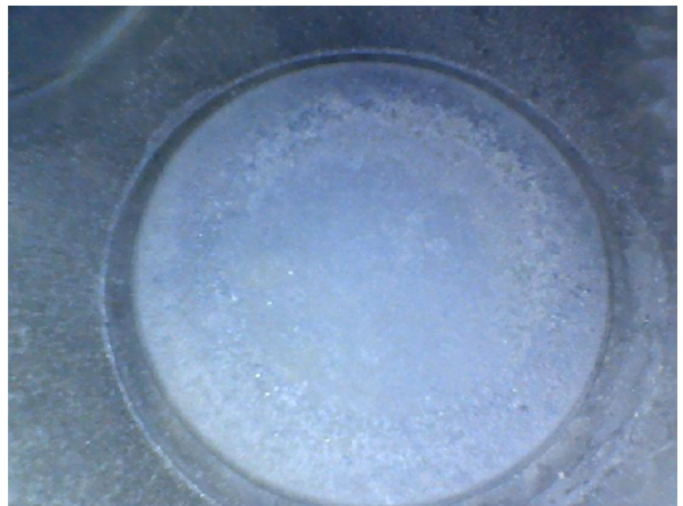
#### CYLINDER #1

**Condition:** The cylinder remained attached to the crankcase with no external anomalies noted with the exception of the post-crash fire damage. Examination of the internal components with the use of a lighted borescope revealed that the piston was almost devoid of its normal combustion deposits, the face displayed incipient piston erosion, and there were two patches that appeared to be re-solidified pools of molten metal. The valves and valve seats were intact and also appeared to be devoid of normal combustion deposits. The barrel showed linear scrape marks over the typical honing pattern.

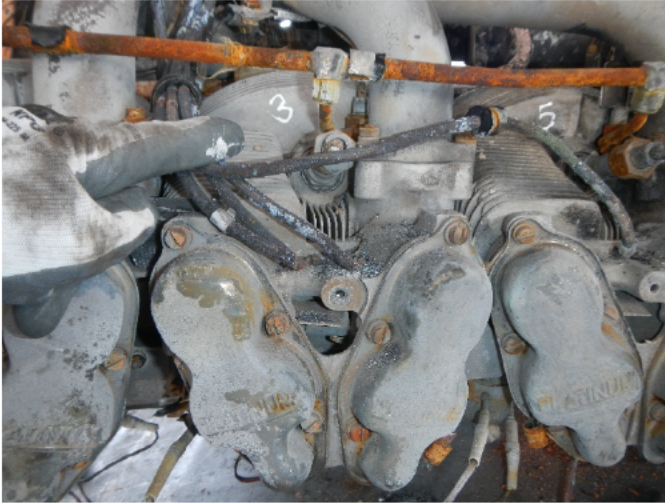
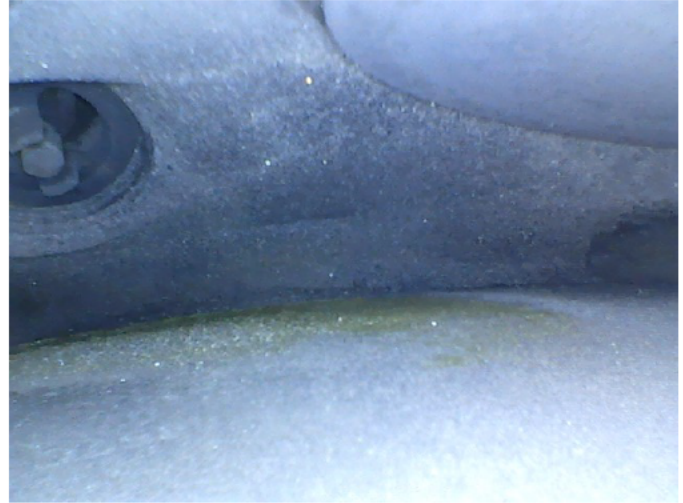
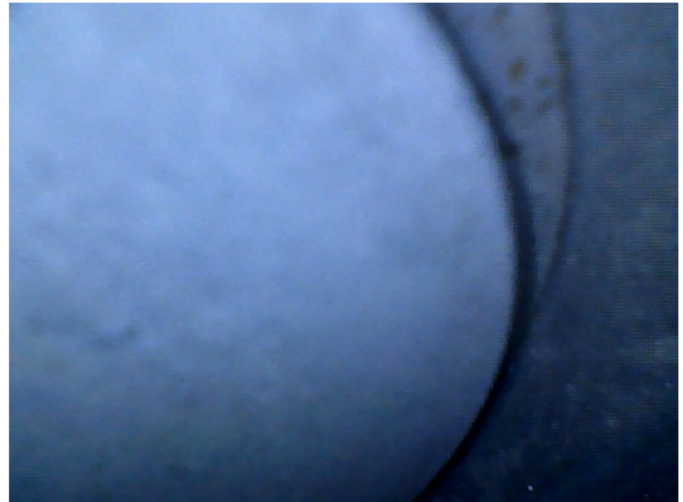
### CYLINDER #3

Condition: The cylinder remained attached to the crankcase with no external anomalies noted with the exception of the post-crash fire damage. Examination of the internal components with the use of a lighted borescope revealed that the piston was almost devoid of its normal combustion deposits and the face displayed incipient piston erosion. The valves and valve seats were intact and also appeared to be devoid of normal combustion deposits. The barrel could not be observed due to the position of the piston.

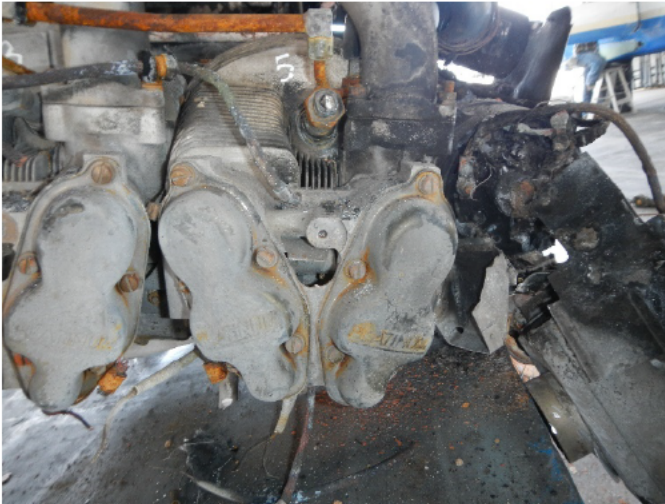
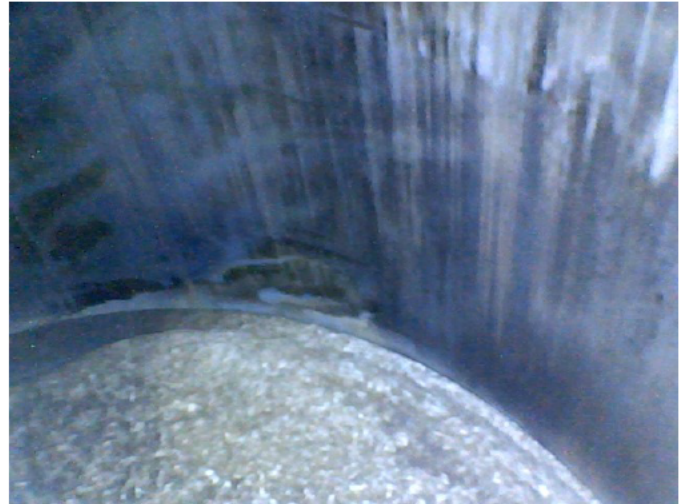
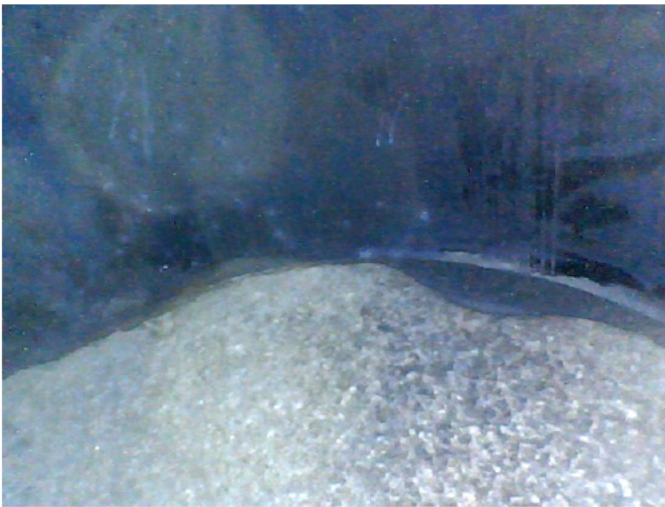
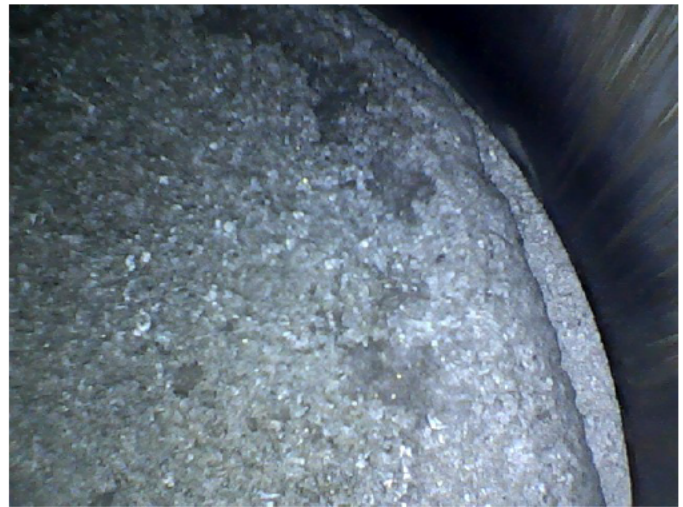
### CYLINDER #5

Condition: The cylinder remained attached to the crankcase with no external anomalies noted with the exception of the post-crash fire damage. Removal of the top sparkplug revealed re-solidified molten metal around the sparkplug hole. Examination of the internal components with the use of a lighted borescope revealed that the piston was heavily eroded. The outer circumference of a piston ring land was visible and the piston erosion extended inboard of the piston ring land in one area. Heavy scrapes were observed on the barrel walls. The valves and valve seats will be examined in more detail at a later date.

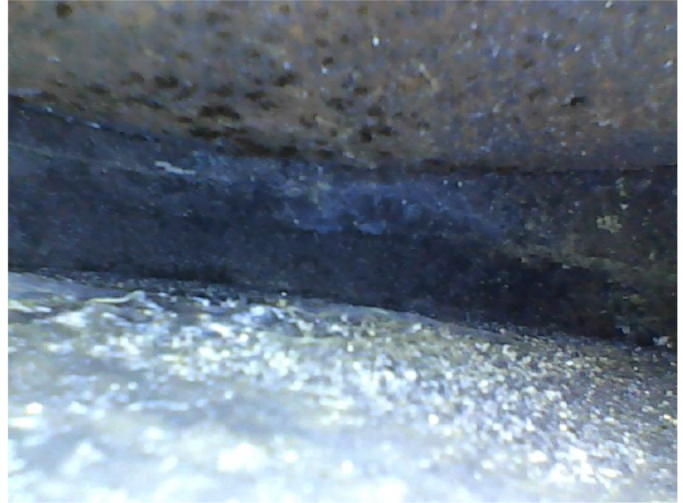
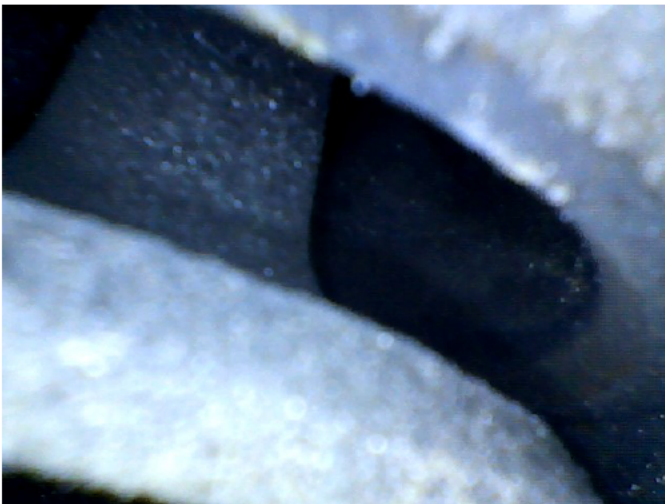
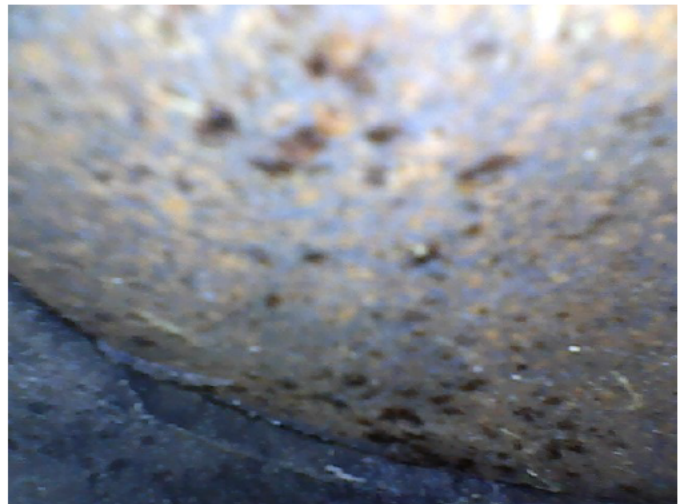
### CYLINDER #2

Condition: The cylinder remained attached to the crankcase with no external anomalies noted with the exception of the post-crash fire damage. Examination of the internal components with the use of a lighted borescope revealed that the piston was almost devoid of its normal combustion deposits and the face displayed incipient piston erosion. The valves and valve seats were intact and also appeared to be devoid of normal combustion deposits. The barrel could not be observed due to the position of the piston.

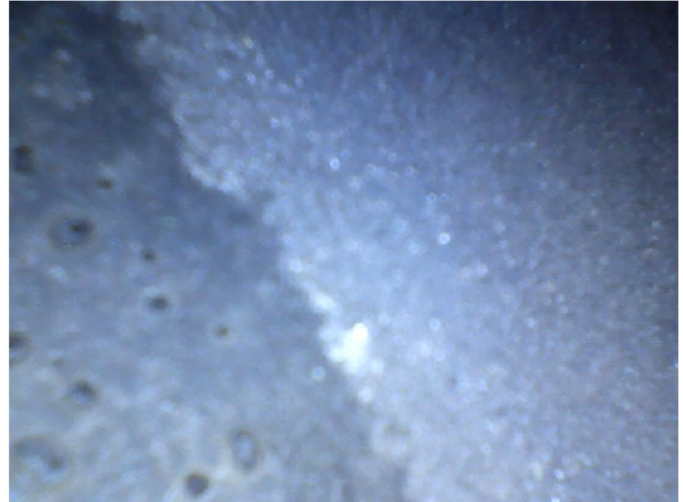
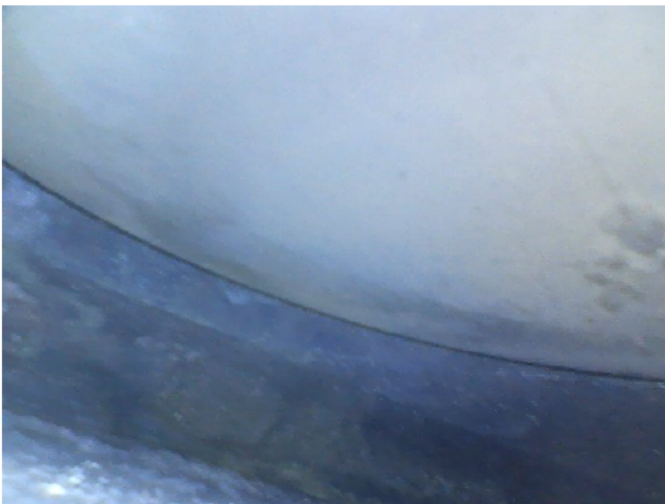
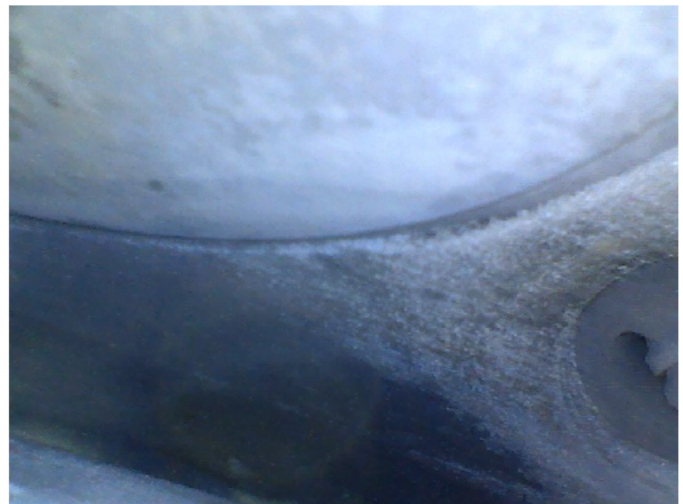
### CYLINDER #4

Condition: The cylinder remained attached to the crankcase with no external anomalies noted with the exception of the post-crash fire damage. Examination of the internal components with the use of a lighted borescope revealed that the piston was almost devoid of its normal combustion deposits and the face displayed incipient piston erosion. The valves and valve seats were intact and also appeared to be devoid of normal combustion deposits. The barrel could not be observed due to the position of the piston.

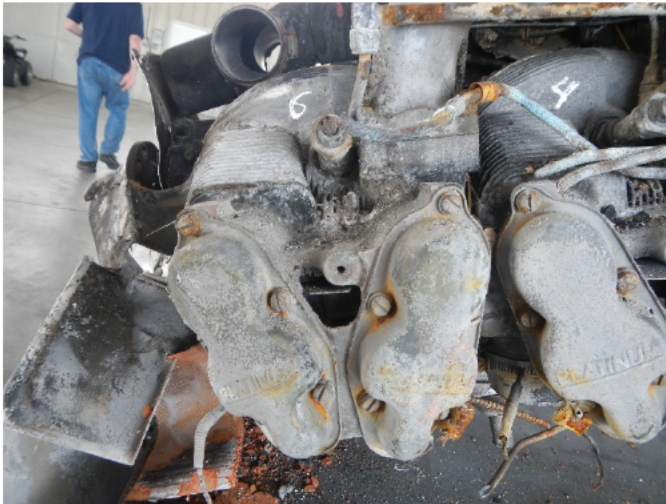
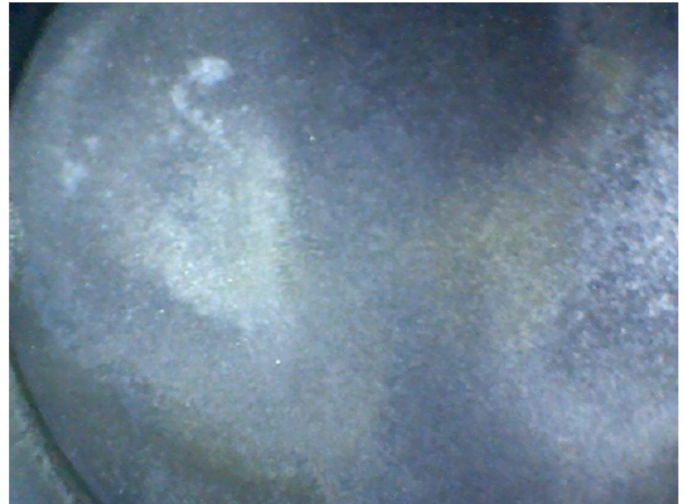
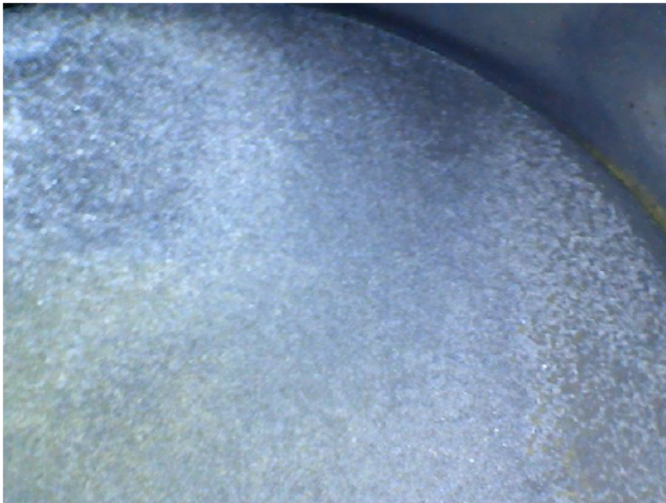
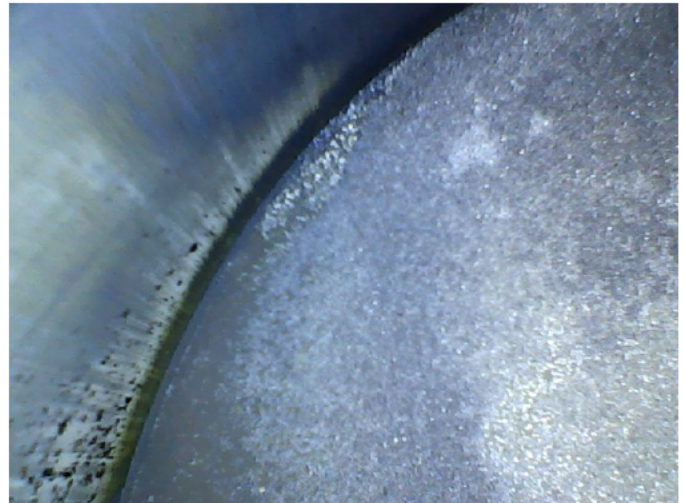
### CYLINDER #6

Condition: The cylinder remained attached to the crankcase with no external anomalies noted with the exception of the post-crash fire damage. Examination of the internal components with the use of a lighted borescope revealed that the piston was almost devoid of its normal combustion deposits, the face displayed piston erosion. The valves and valve seats were intact and also appeared to be devoid of normal combustion deposits. Portions of the valve and valve seats were green in color (as was the case with the sparkplugs). The barrel showed linear scrape marks over the typical honing pattern.

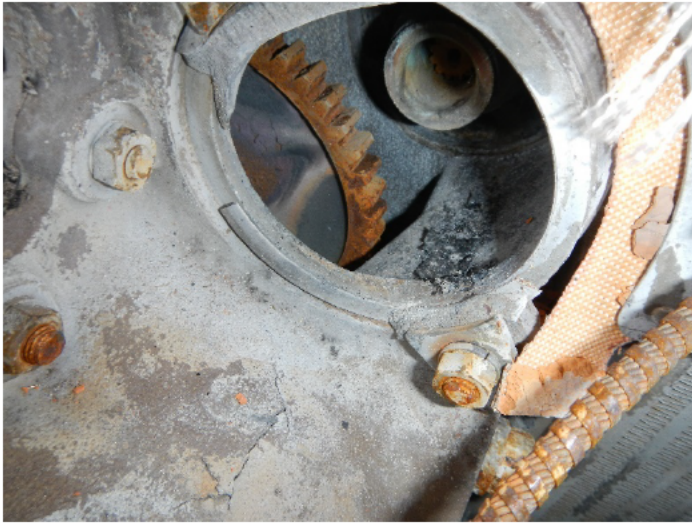
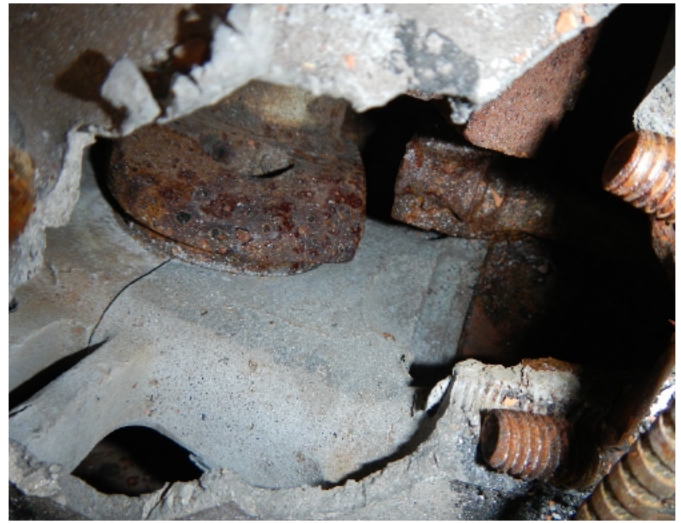
| <b>CRANKCASE</b> | Casting Number: | 1-3-5: Unknown | 2-4-6: Unknown | S/N: Unknown |
|---|---|---|---|---|
| Condition: | The crankcase halves remained attached to each other and the cylinders remained attached to the crankcase. The top left side of the crankcase displayed a large hole that permitted a view of the crankshaft and separated #2 connecting rod. Another crack was noted in the vicinity of the #1 connecting rod. | | | |

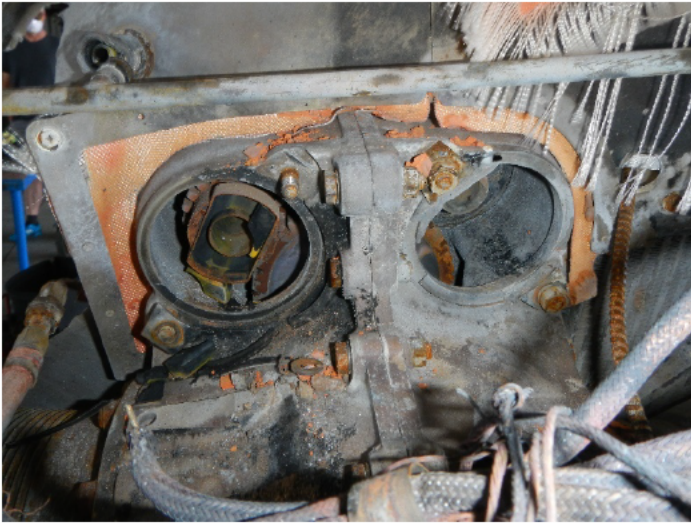
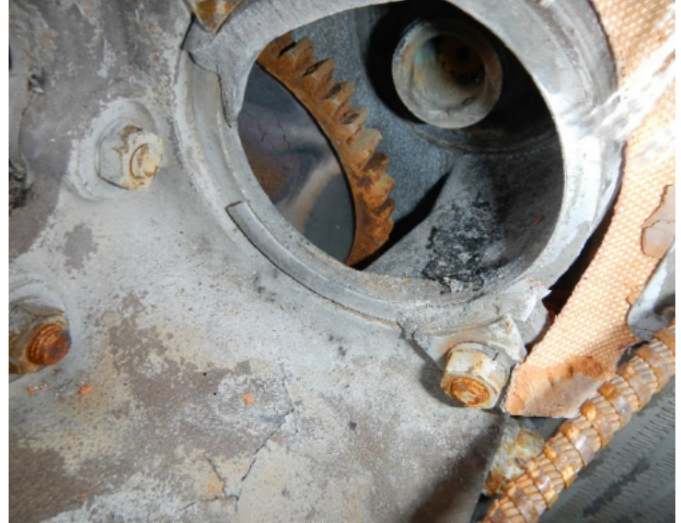
### ACCESSORY GEARS

**Condition:** A portion of the idler gear was observed through the magneto mounting pads. It was corroded and thermally discolored. There were no noted pre-accident anomalies with the gear teeth; however, it will be examined in more detail at a later date.

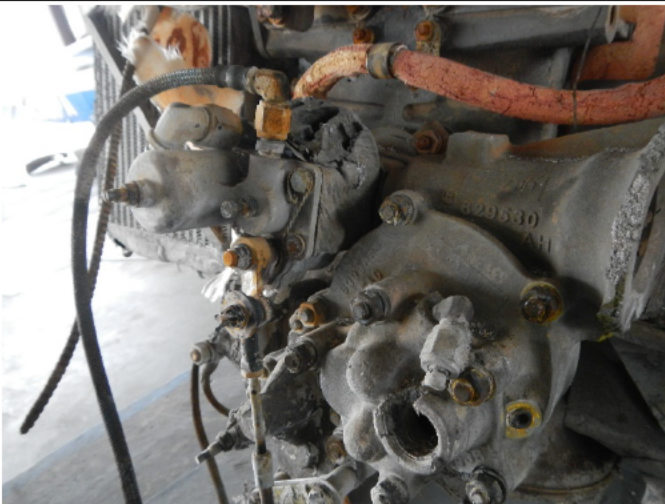
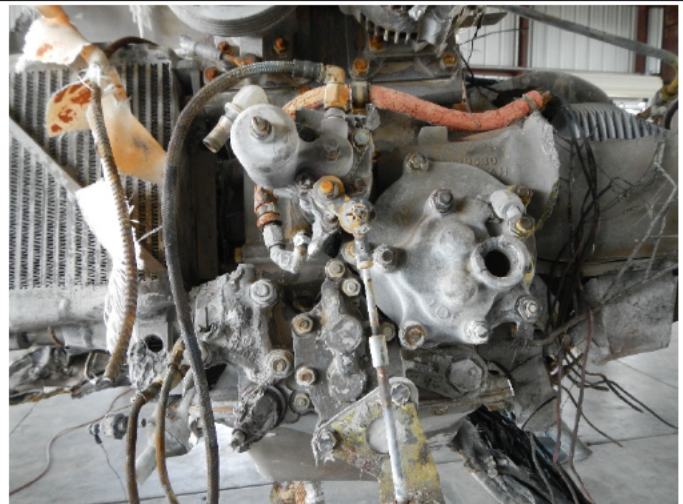
#### STARTER ADAPTER

**Condition:** The starter adapter was fractured and partially melted. It will be examined in more detail at a later date.

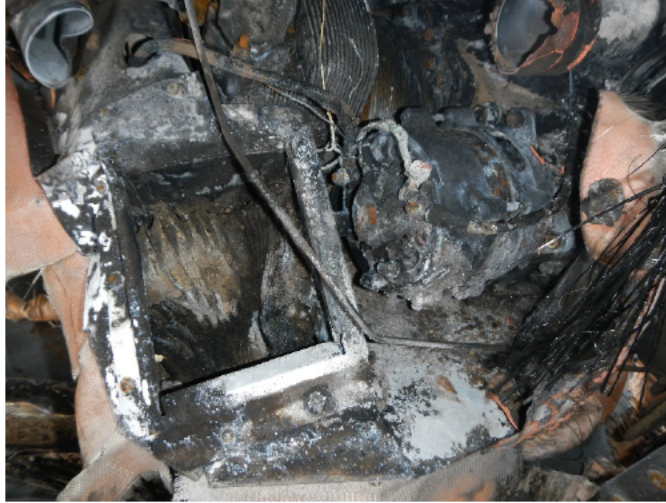
**ALT/GEN #1**

The alternator was attached to the front right side of the crankcase. It sustained thermal damage and was not a part of this examination.

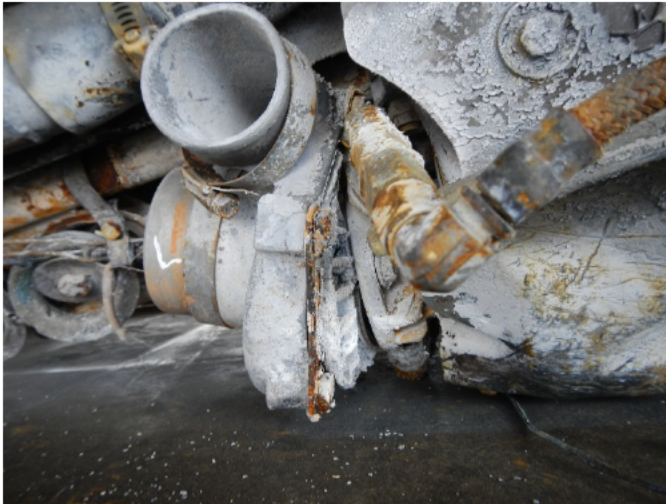
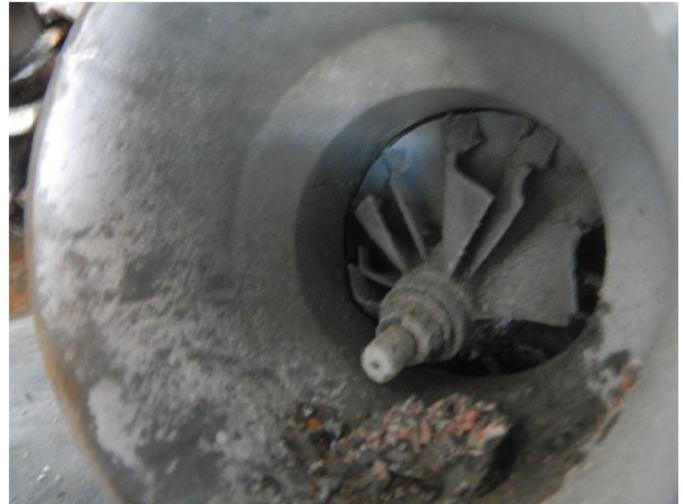
## L TURBO

The left turbocharger remained attached to the mounting bracket. The oil line to the bearing feed fitting remained in place as did the return oil line. The impeller housing sustained significant thermal damage that distorted the housing and impeller. Debris was found in the impeller inlet and appeared to be a result of the post-crash fire damage.

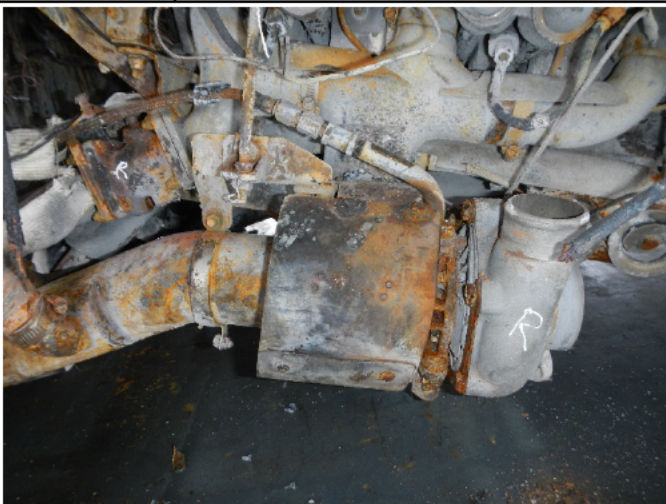
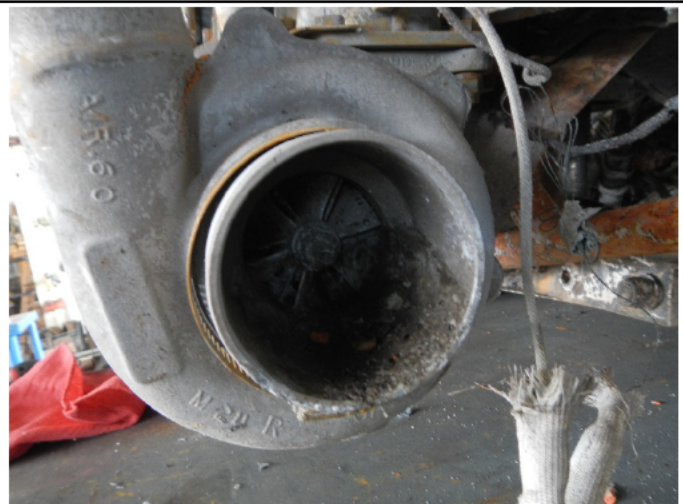
## R TURBO

The right turbocharger remained attached to the mounting bracket. The oil line to the bearing feed fitting remained in place as did the return oil line. Debris was found in the impeller inlet, but there was no sign of FOD on the impeller. The debris appeared to be a result of the post-crash fire damage.
