# Continental Motors

## ENGINE EXAMINATION REPORT

| ENGINE MODEL | IO-550-N50B conv. to turbo-normalized TAT STC |
| FILE NUMBER | 17-630 |

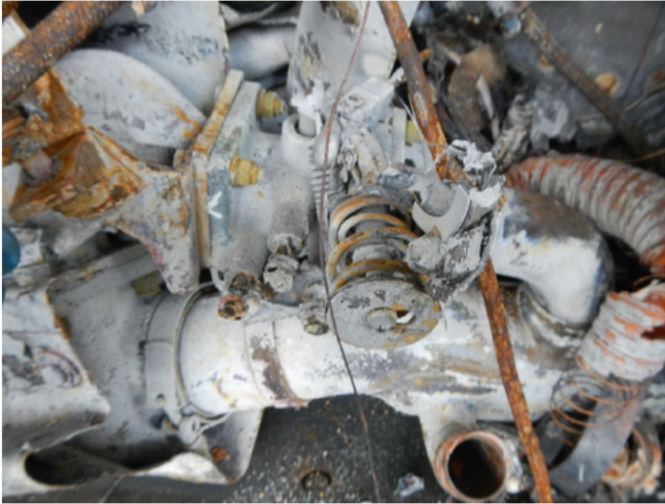
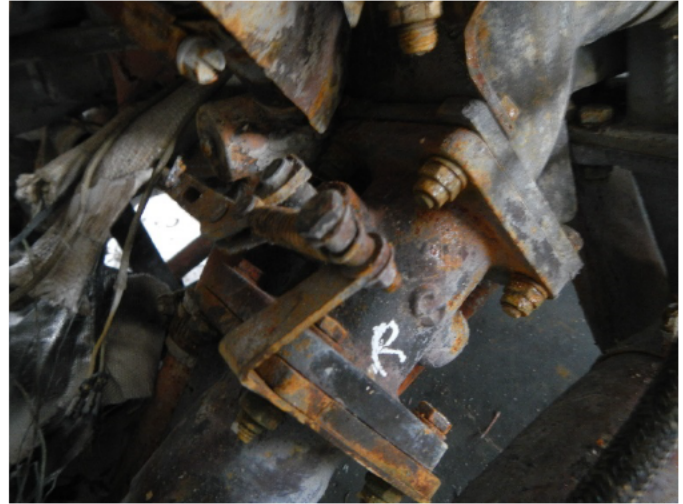
**WASTEGATE**

Condition: The wastegate actuator was destroyed and the internal springs were visible.

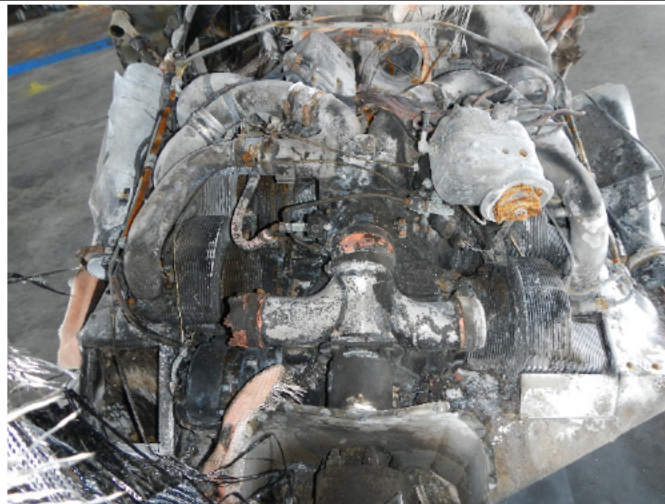
Condition: The overboost valve was attached to the intake wye between the intercoolers and before the throttle body. The overboost valve was thermally damaged.

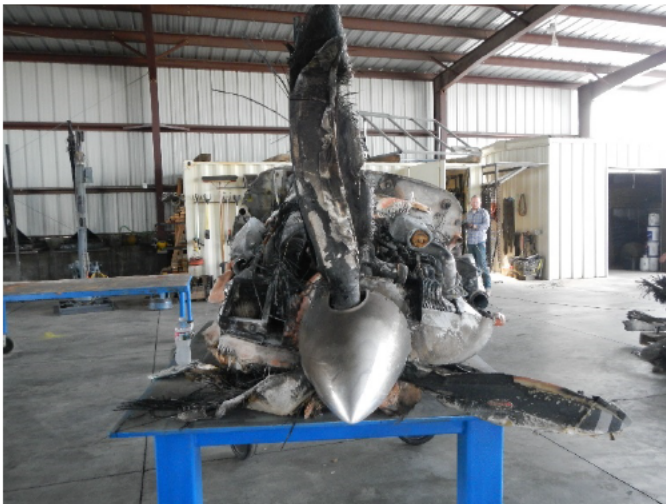
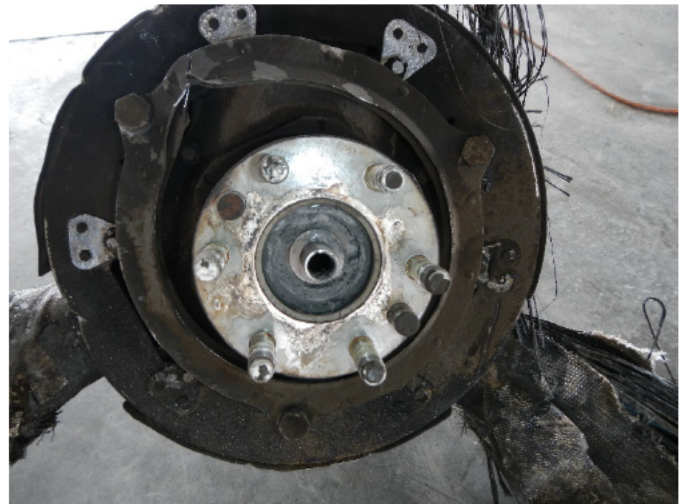
The propeller remained attached to the crankshaft's propeller flange. The three composite blades remained attached to the hub. The blades were thermally damaged. The propeller was removed to facilitate the examination of the engine and was not examined in detail.
