AmSafe Observations to WPR18LA174

11 July 2018

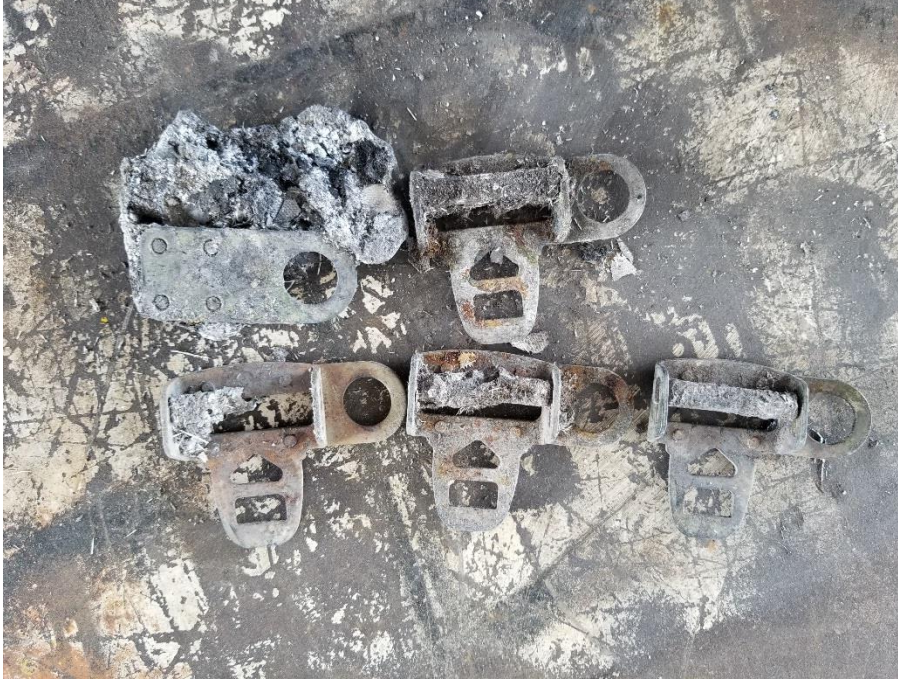
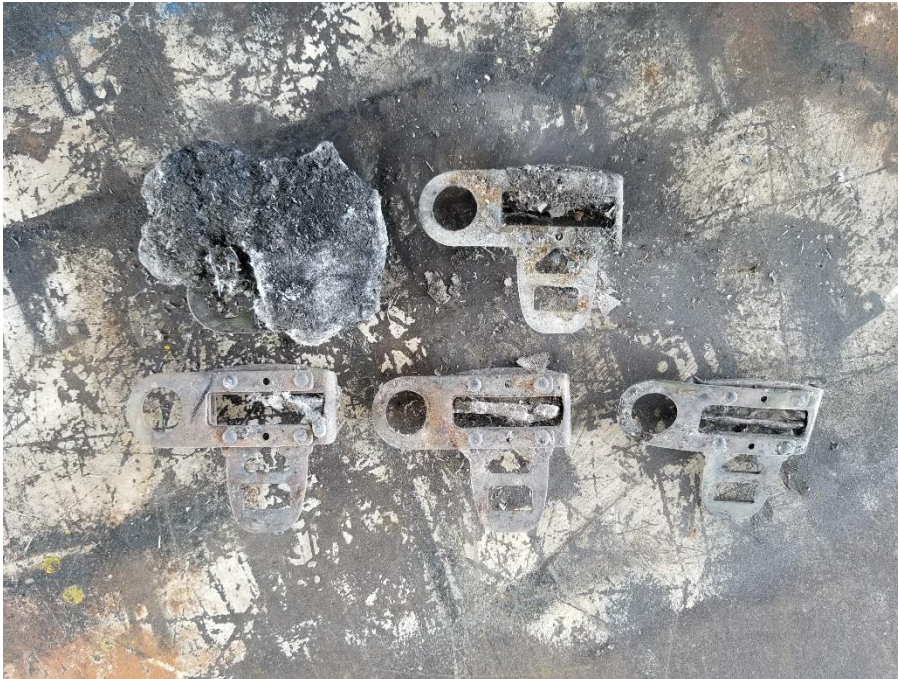
- Restraint Buckle/Connectors recovered:  
'Front Side' view

'Back Side' view

No detectable indications of malfunction.

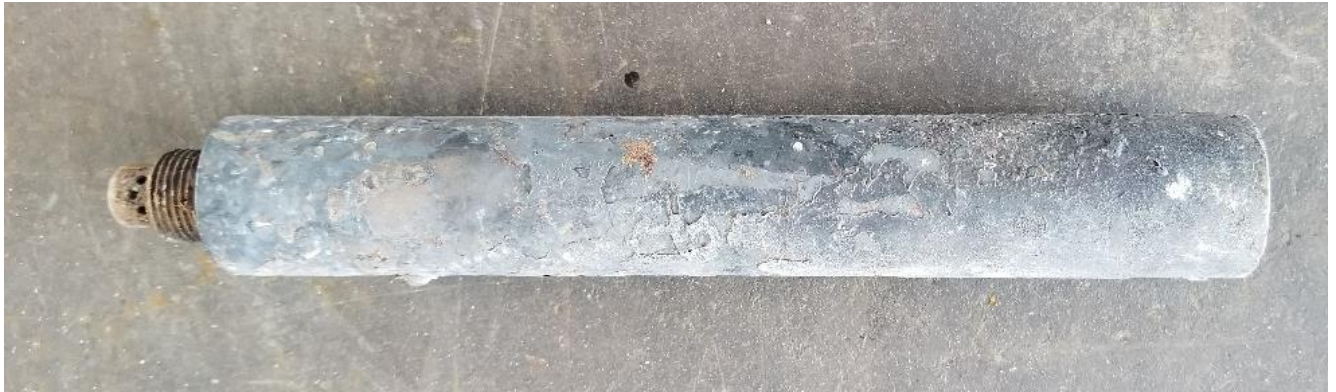
Figure 1 Inflator "1" Overview

- The Aluminum hose fitting (ref Fig 9) was completely absent from the threaded diffuser of the inflator, (ref Figs 1&2), completely melted off. No evidence of consumable restraint components surviving in the recovered debris.

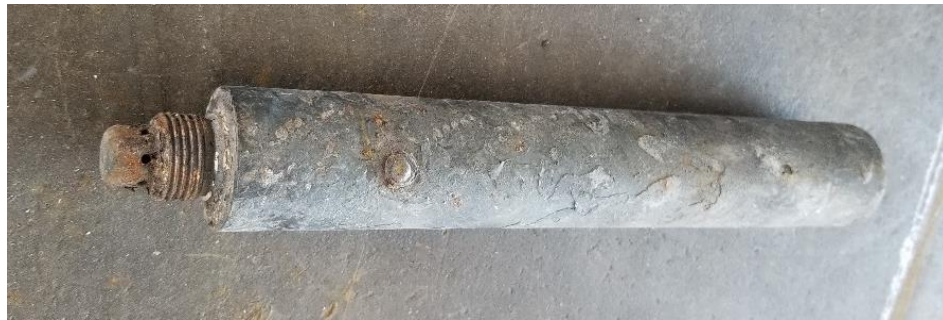
Figure 2 Inflator "1" Output End view (threaded diffuser, interface to Inflatable Restraint)

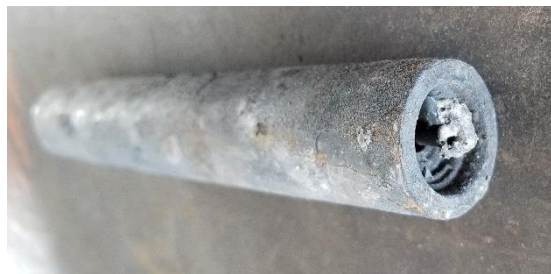
Figure 3 Inflator "1" Igniter-end view (reference-compare to Fig 8)

- The igniter end exhibited consumption and/or expulsion of the several igniter components (Fig 3 compared to Fig 8).
  - The igniter carrier housing (concentric feature in Figure 8 outboard of the igniter pins/plastic shorting insert) has been expelled from the inflator (Fig 3) – possibly weakened weld degraded by the fire, then overcome by internal back pressure of the ignited/overheated internal gas pressure venting thru the region.

- The pins of the igniter remain engaged in the residue of the electrical connector and residue of the plastic header of the igniter which has been burned/extruded from the inflator.

These characteristics collectively suggest that Inflator “1” had not deployed prior to the fire because of the expelled igniter housing (Figure 3). If the igniter housing element had remained on the unit (ref Fig 8) then the disposition would have been –inconclusive–.

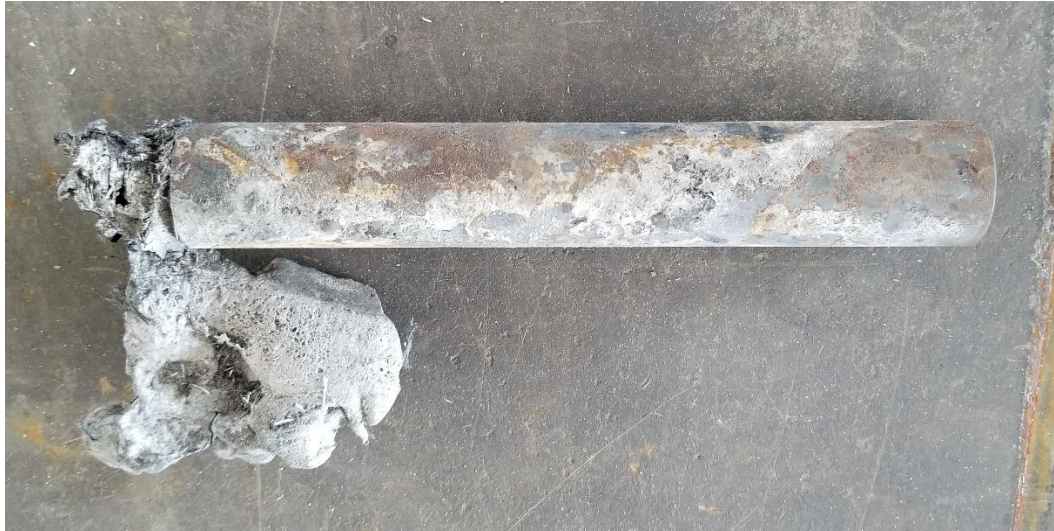
Figure 4 Inflator "2" Overview

- Residual, melted, Aluminum puddle attached to the inflator threaded diffuser (Figs 4 & 5) is likely the hose fitting (ref Fig 7 & 9). This melt likely occurred after discharge and was in a ‘cooler heat’ environment than Inflator “1” otherwise the residual debris around the diffuser (Figs 4 & 5) would have distinct jetting holes blasting thru the softened/molten Aluminum Fitting, or more material being absent. Also there is no evidence of consumable restraint components surviving.

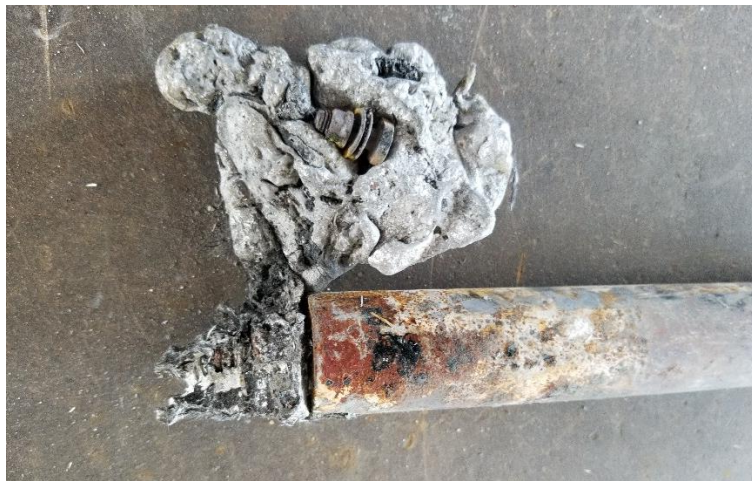
Figure 5 Inflator "2" Output End view (threaded diffuser, interface to Inflatable Restraint)

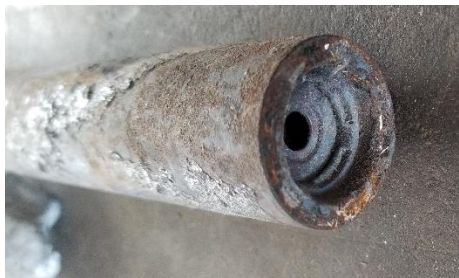
Figure 6 Inflator "2" Igniter-end view (reference-compare to Fig 8)

- The igniter end (Fig 6) exhibited complete expulsion of the igniter and its housing.
  - Again, likely weakened weld degraded by the fire on this end of the inflator, then being overcome by internal back pressure of the ignited/overheated internal gas pressure venting thru the region

These characteristics collectively suggest that Inflator “2” had not deployed prior to the fire because of the expelled igniter housing (Figure 6). If the igniter housing element had remained on the unit (ref Fig 8) then the disposition would have been –inconclusive–.

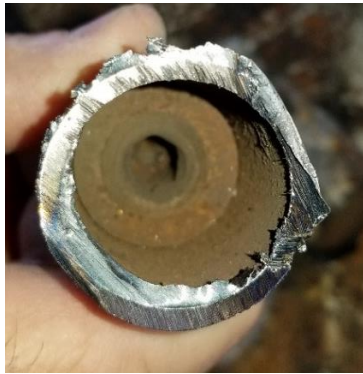
- The internal burst membrane exhibits petaling outward (toward downstream diffuser cavity) (Fig 10) – This characteristic is a typical functional response to rapid pressurized/rupture/blowdown, regardless of normal deployment or deployment due to heating. (If the Fig 10 petaling would have been inward, (pointing back inside the body) then the venting from the igniter end would have been the primary exhaust path instead of this apparent simultaneous venting.)

Figure 10 Inside inflator “1” body, looking at Burst Membrane exiting into Diffuser

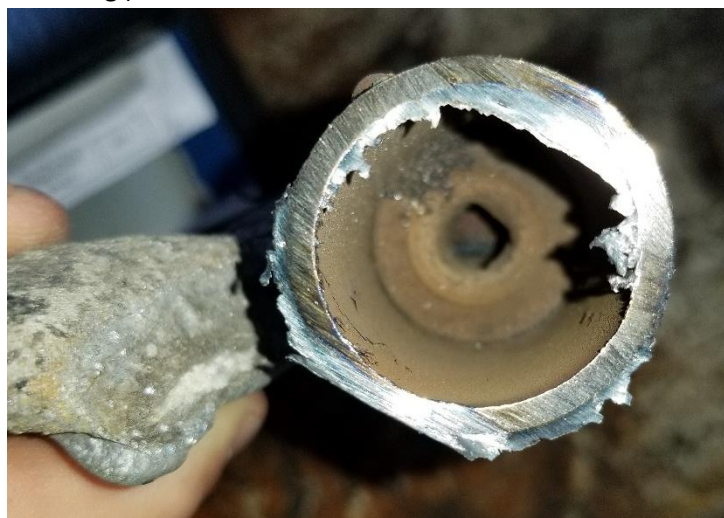
- The internal burst membrane also exhibits outward petaling (Fig 11) (toward downstream diffuser cavity), same as Inflator “1”. Again, this characteristic is a typical functional response to rapid pressurized/rupture/blowdown. (If the petaling would have been inward, (pointing back inside the body) then the venting from the igniter end would have been the primary exhaust path instead of this apparent simultaneous venting.)

Figure 11 Inside inflator “2” body, looking at Burst Disk exit into Diffuser
