# NATIONAL TRANSPORTATION SAFETY BOARD

MATERIALS LABORATORY FACTUAL REPORT

Report No. 19-001

Place : Richfield, Utah  
Date : June 21, 2018  
Vehicle : Shemp Herth Arcus M  
NTSB No. : WPR18LA177  
Investigator : Joshua Cawthra, AS-WPR

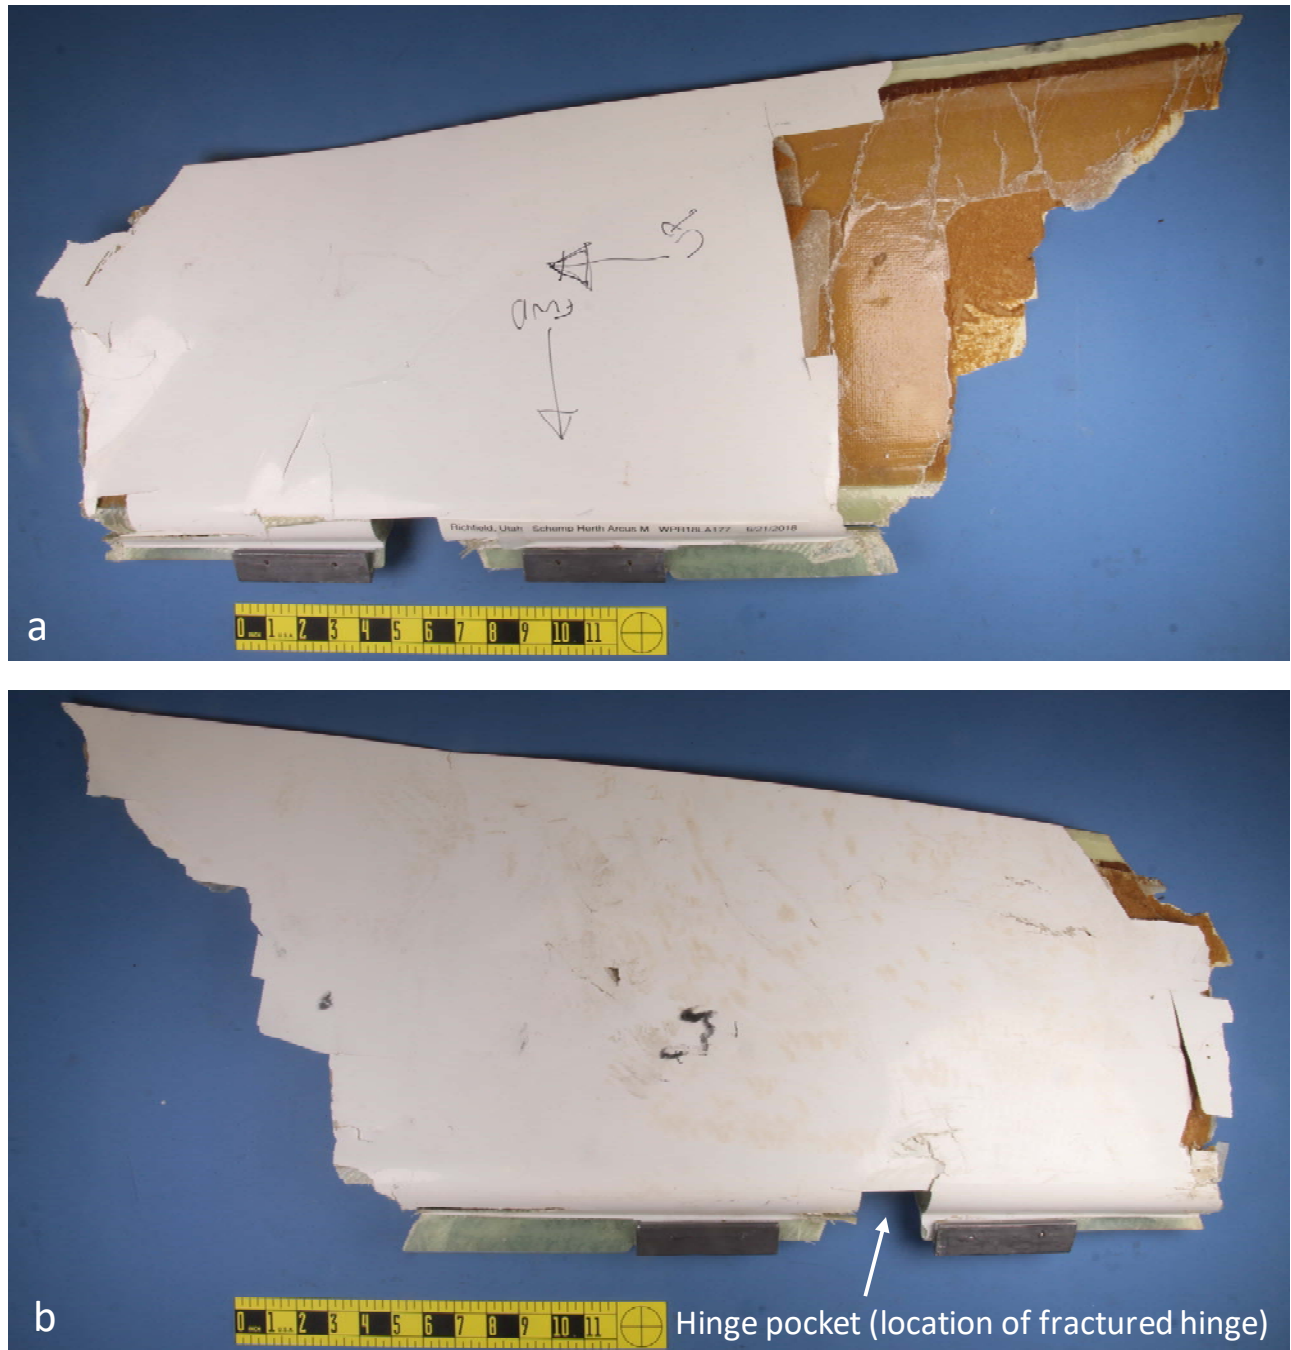
Figure 1 The as-received rudder piece.

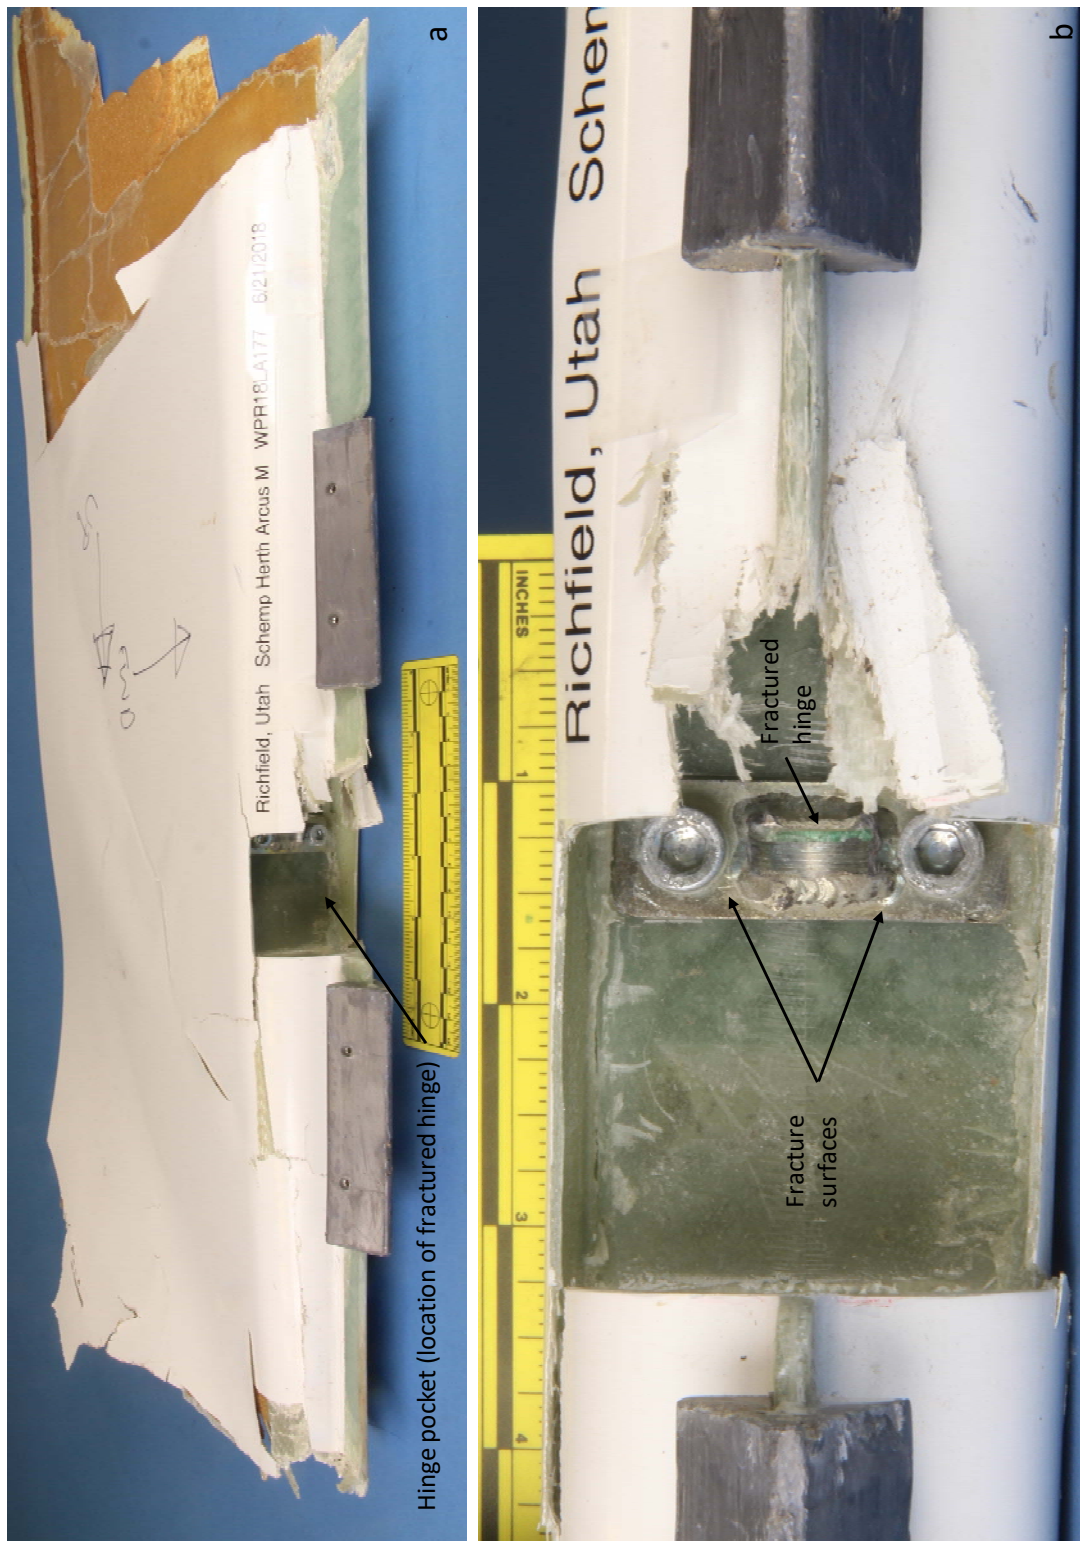
Figure 2 Close views of the fractured hinge knuckle.

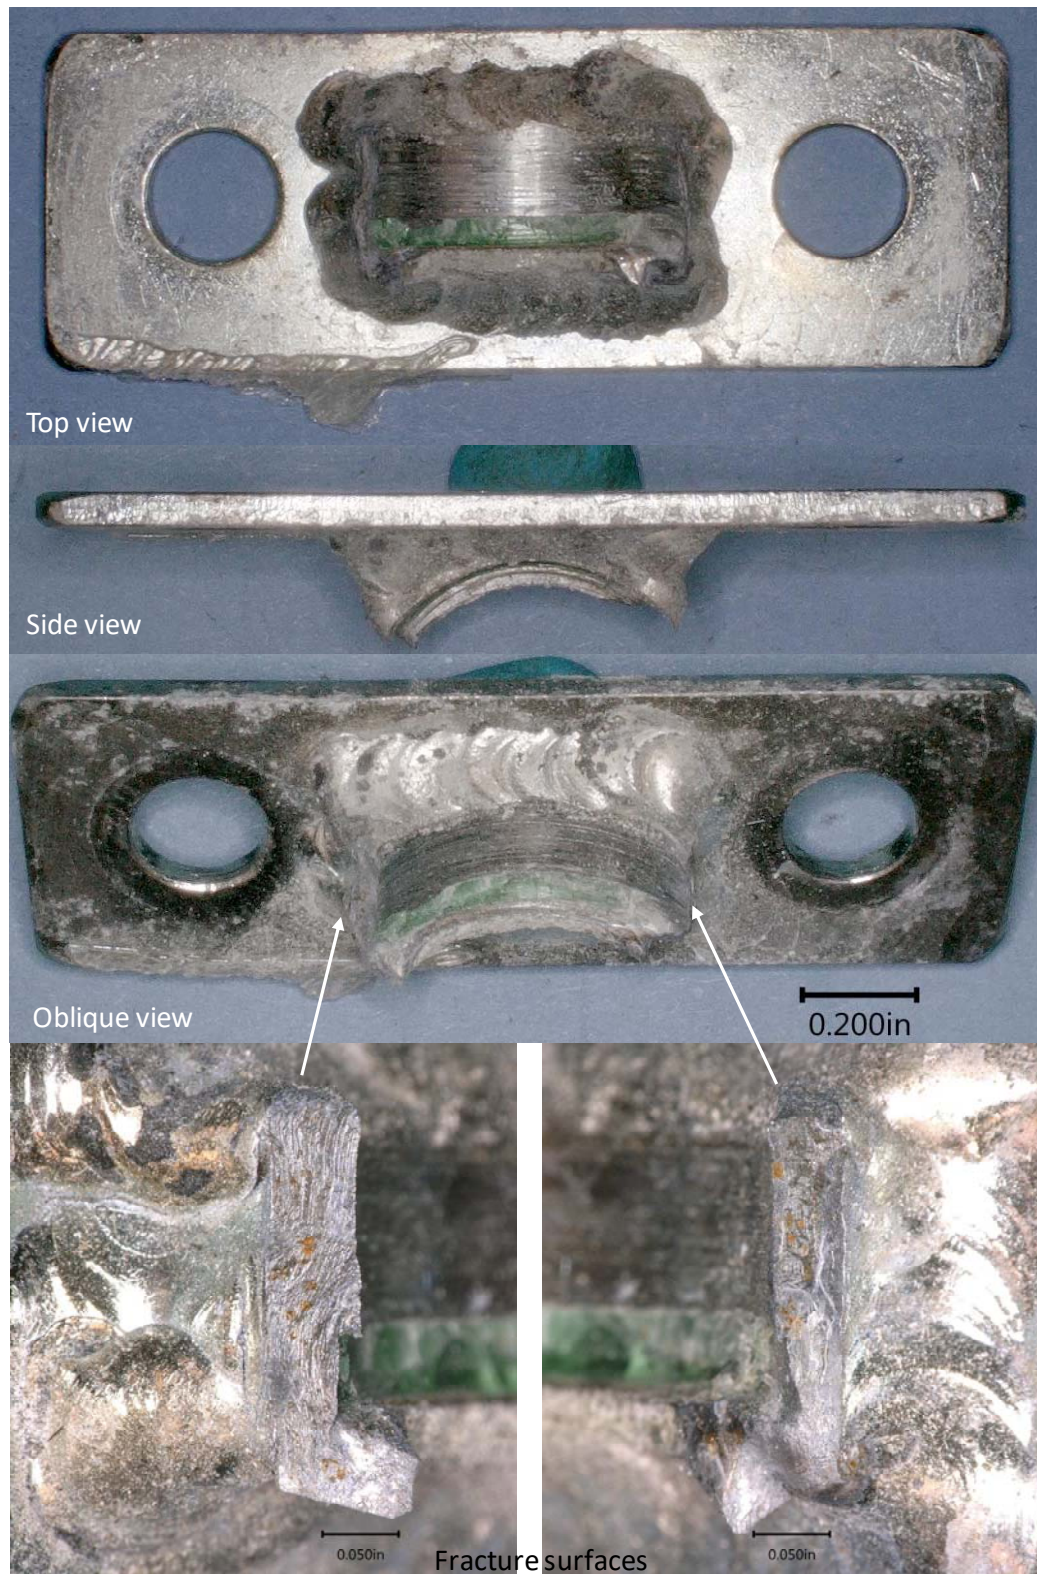
The purpose of this report is to document the upper bearing attach fracture. The balance of the bearing is missing and has not been recovered. The as-received rudder piece is shown in Figure 1. Close views of the fractured hinge knuckle are shown in Figure 2. Examination of the fractures (Figure 3) using a digital microscope revealed that the knuckle fractured in two locations due to overstress.

Figure 3 Digital microscope images of the fractured hinge knuckle.
