## **NATIONAL TRANSPORTATION SAFETY BOARD**

### **ENGINE EXAMINATION**

**WPR18LA181**

Location: Phoenix, Arizona  
Date: June 26, 2018  
Aircraft: Cessna 172S, Registration Number: N154ME, Serial #: 172S8534  
NTSB IIC: Andrew Swick

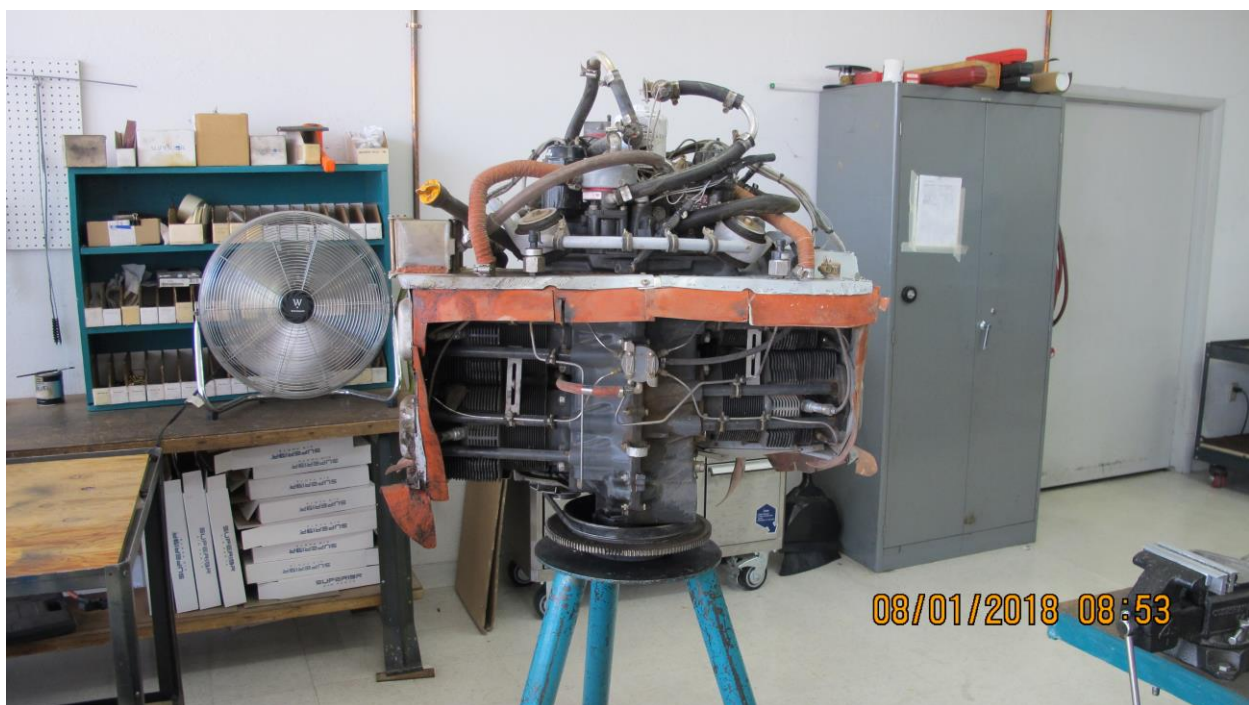
**Figure 1-Engine Examination, Vertical Stand**

The engine was relocated from its storage facility in Phoenix, Arizona to the facilities in Chandler, Arizona on August 1, 2018. The engine mounting assembly was cut from the airframe and the mounts remained attached to the engine. The engine was installed on a vertical engine stand and disassembled. About 1/2 a quart of dark oil dripped from the exhaust pipe. The crankshaft could not be rotated by hand. The exhaust assembly had impact damage to several stand pipes and the exhaust muffler. The induction assembly had a small dent on one elbow. The induction tube connections were undamaged and secured. The magneto ignition leads had impact damage near the magneto distributors. The left magneto p-lead was loose at the magneto connection.

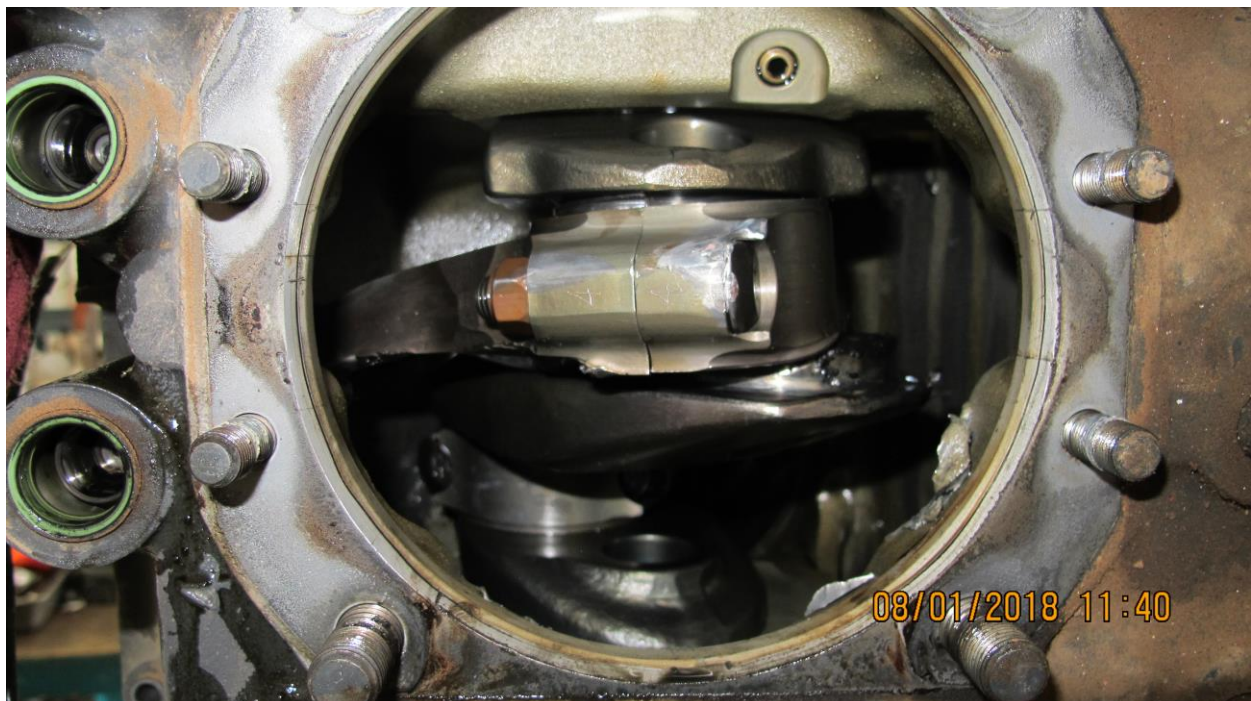
Figure 2-No. 4 Cylinder Bay, Crankshaft and Connecting Rod Separation

The no. 4 cylinder was removed from the crankcase. The no. 4 connecting rod was separated on the I-beam near the piston attachment. The rod had impact damage and could not be moved by hand.

The crankcase was disassembled revealing the crankshaft, camshaft and internal components. The camshaft was undamaged. The no. 3 and 4 cylinder bays had impact damage.

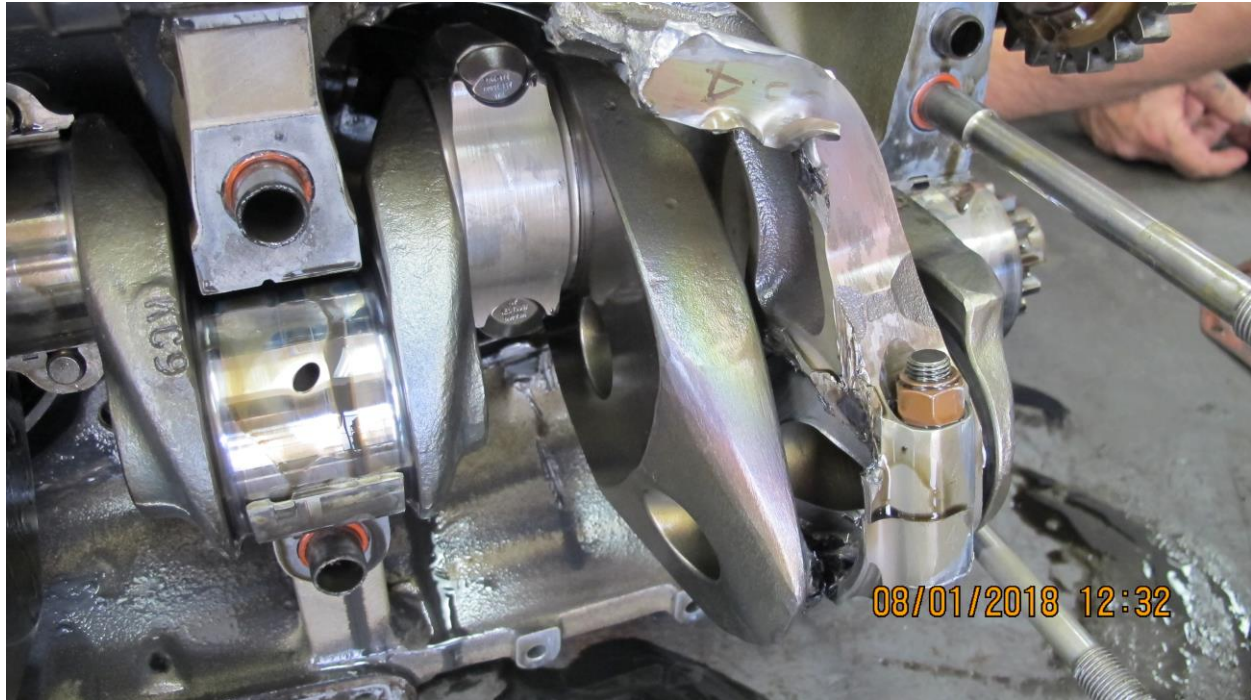
**Figure 3-Crankshaft, Aft End**

The crankshaft was separated at the no. 4 connecting rod journal. Material wear and deformation was visible between the crankshaft separation surfaces, cheek's outer circumference and the connecting rod yoke and cap end at the no. 4 journal. Thermal discoloration was noted on three of the crankshaft cheeks.

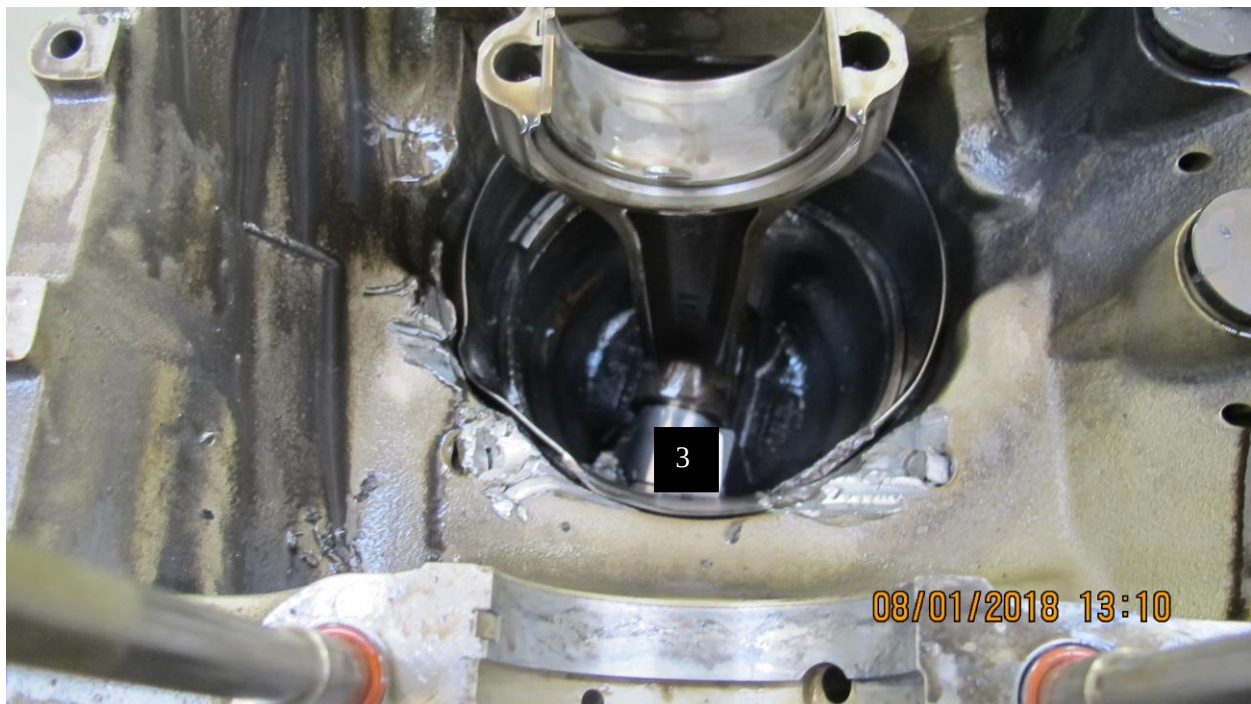
**Figure 6-No. 3 Connecting Rod and Cylinder Bay Area**

The number 3 connecting rod remained attached to the piston and had a slight lengthwise twist in the I-beam. The connecting rod was removed from the piston. The cylinder skirt and adjacent crankcase surfaces had impact damage.

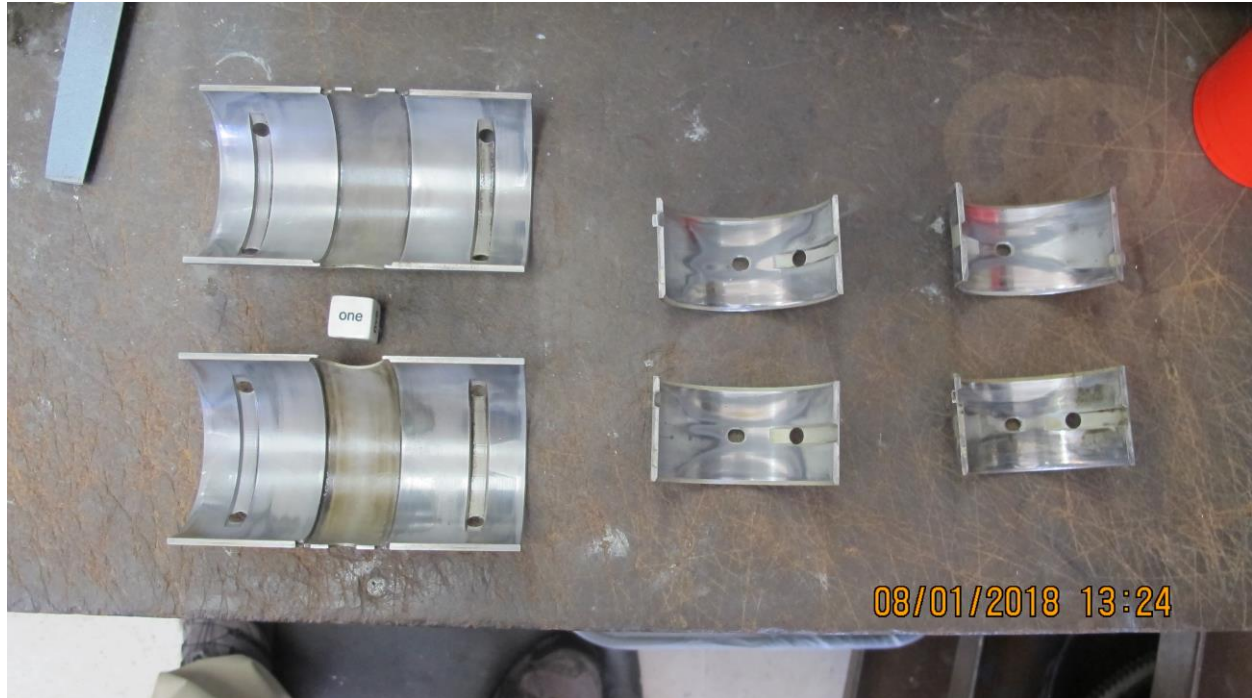
**Figure 7-Crankshaft Main Bearings**

The crankshaft main bearings revealed normal operational wear signatures.

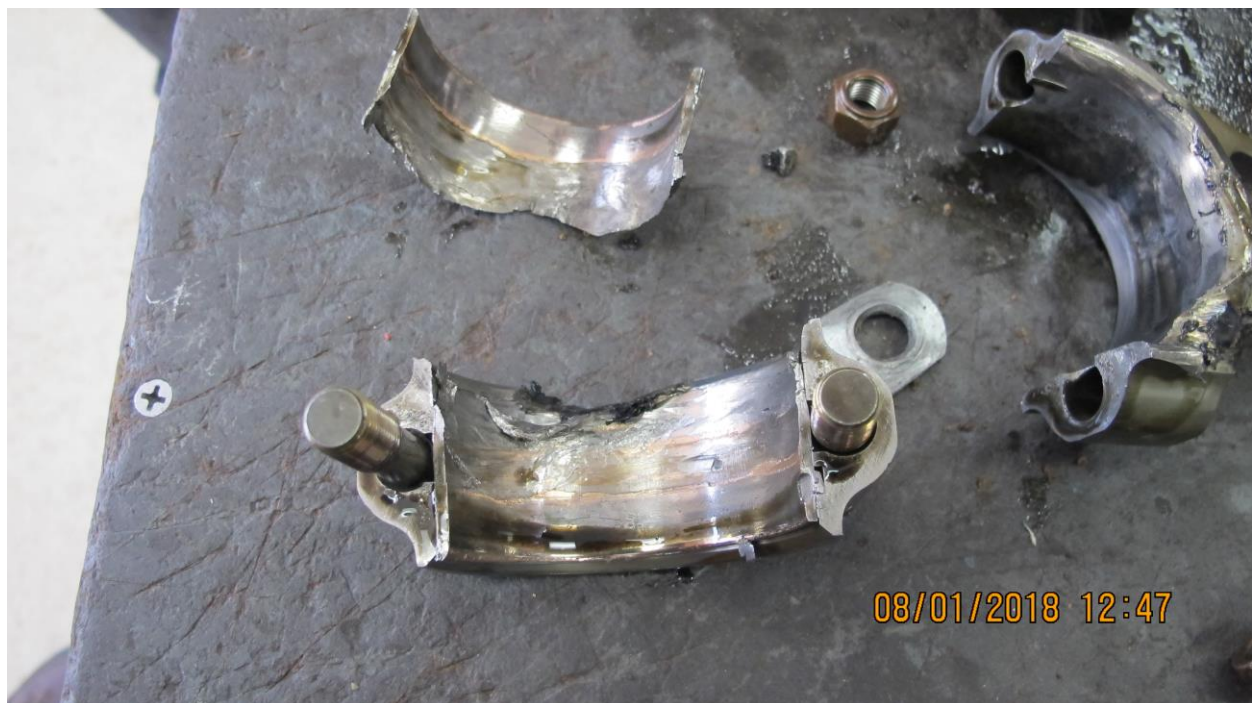
**Figure 8-No. 4 Connecting Rod Cap and Bearing**

The no. 4 connecting rod sections were removed from the piston and the crankshaft. Fretting was identified on the connecting rod and cap connection surfaces. The no. 4 connecting rod bearing was worn and had material loss and deformation.

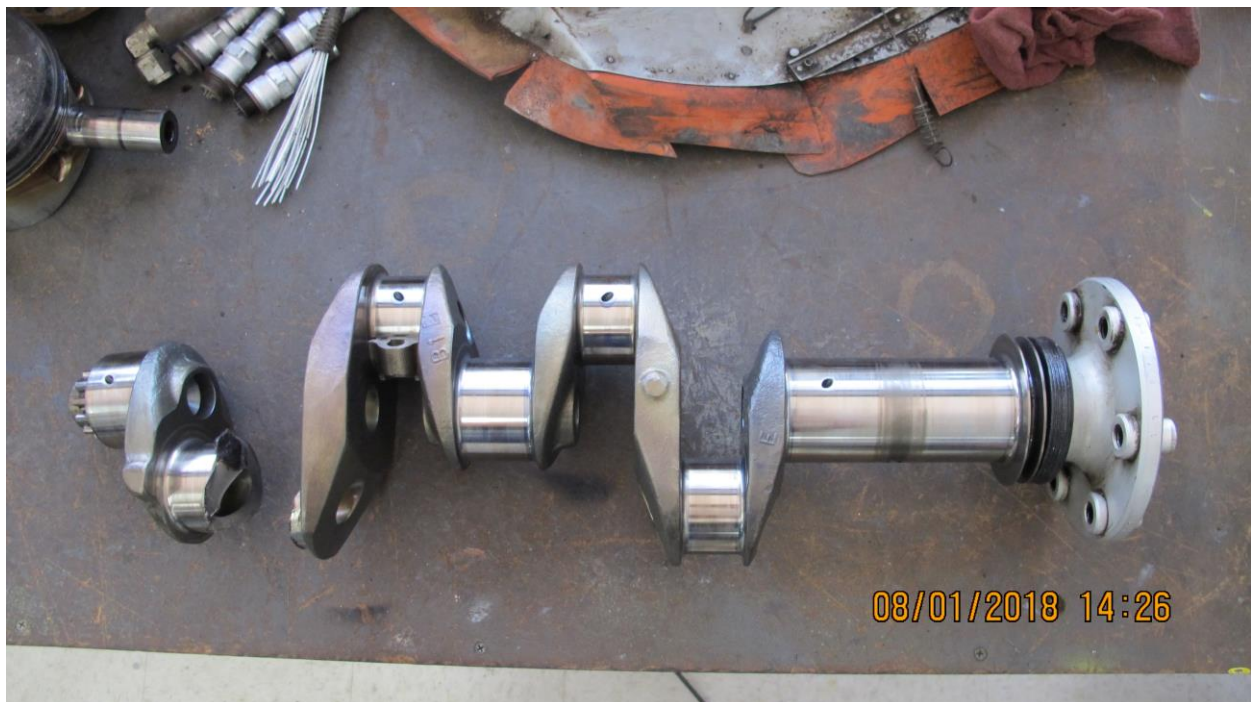
**Figure 10-Crankshaft**

The no. 3 connecting rod end cap could not be removed from the crankshaft. Thermal discoloration is noted on the crankshaft cheeks adjacent to the no. 3 and 4 connecting rod journals. The remaining crankshaft was unremarkable.

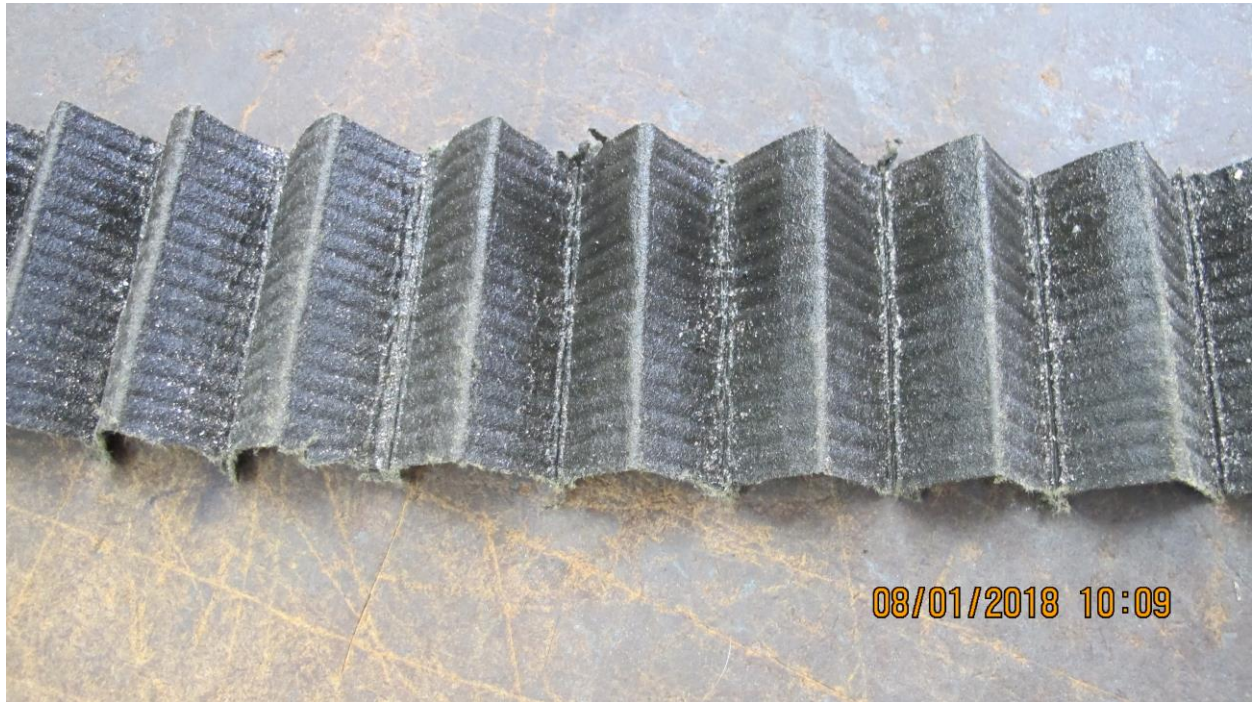
**Figure 11-Oil Filter Element**

The oil filter was removed and disassembled. Metallic debris was noted in the folds of the filter element.
