# NATIONAL TRANSPORTATION SAFETY BOARD

## MATERIALS LABORATORY STUDY REPORT

Report No. 19-048

Place : Phoenix, AZ  
Date : June 26, 2018  
Vehicle : Cessna 172SP (N154ME)  
NTSB No. : WPR18LA181  
Investigator : Andrew Swick (AS-WPR)

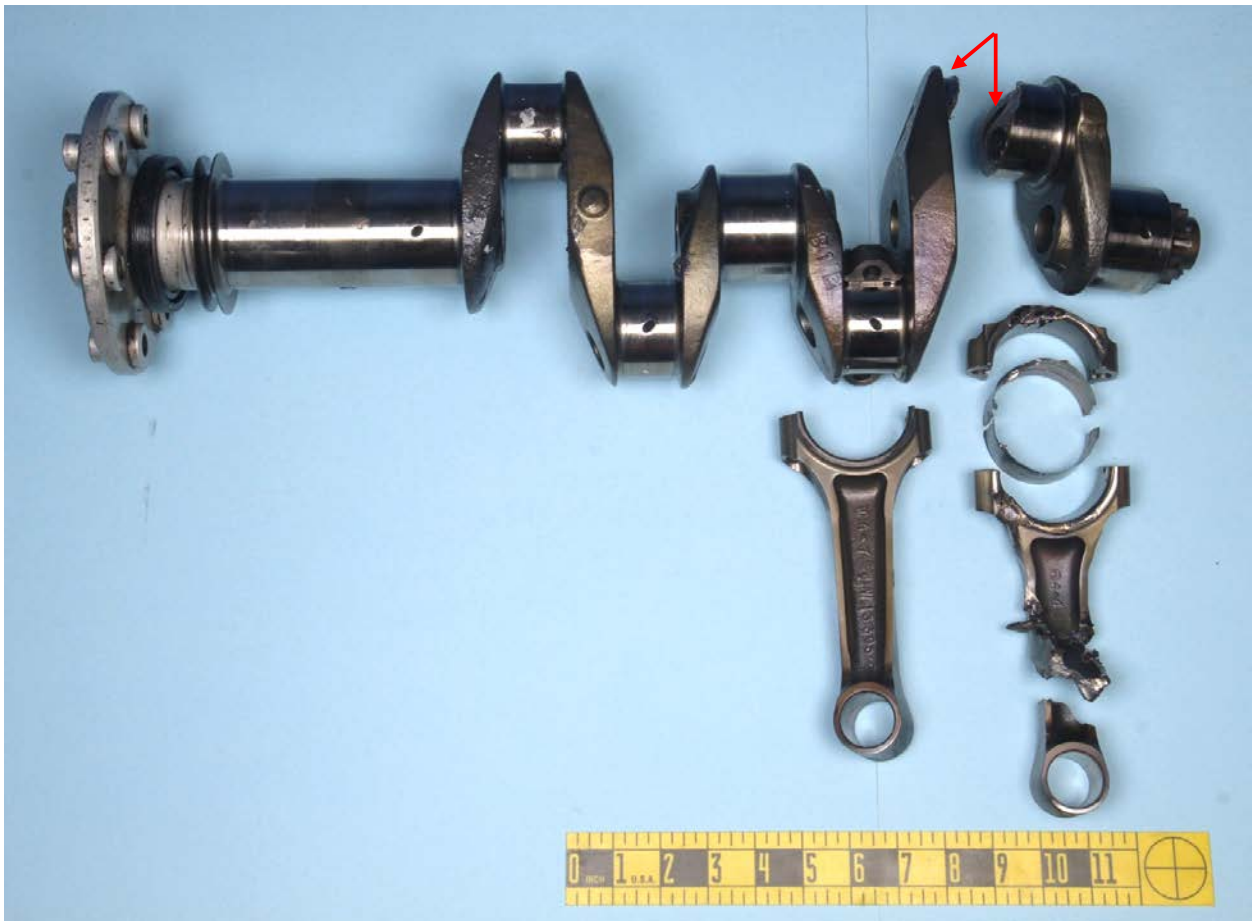
The crankshaft was submitted separated through the no. 4 bearing journal, as indicated by the red arrows in Figure 1. Figures 2 – 4 show images of the fracture surface on the crankshaft. The fracture surface was relatively flat, with crack arrest lines extending from close to the outer diameter of the journal on the web side. The crack arrest lines propagated from a subsurface location approximately 0.05 inches inboard of the outer diameter. The direction of crack propagation outward from the subsurface location is indicated by the white arrows in Figures 3 and 4. The flat fracture surface and crack arrest lines were consistent with fatigue fracture.

The separation through the stem of the no. 4 connecting rod was consistent with overstress.

Figure 1: Overall photo showing the crankshaft and mating no. 3 and no. 4 connecting rods. The crankshaft had separated through the no. 4 bearing journal.

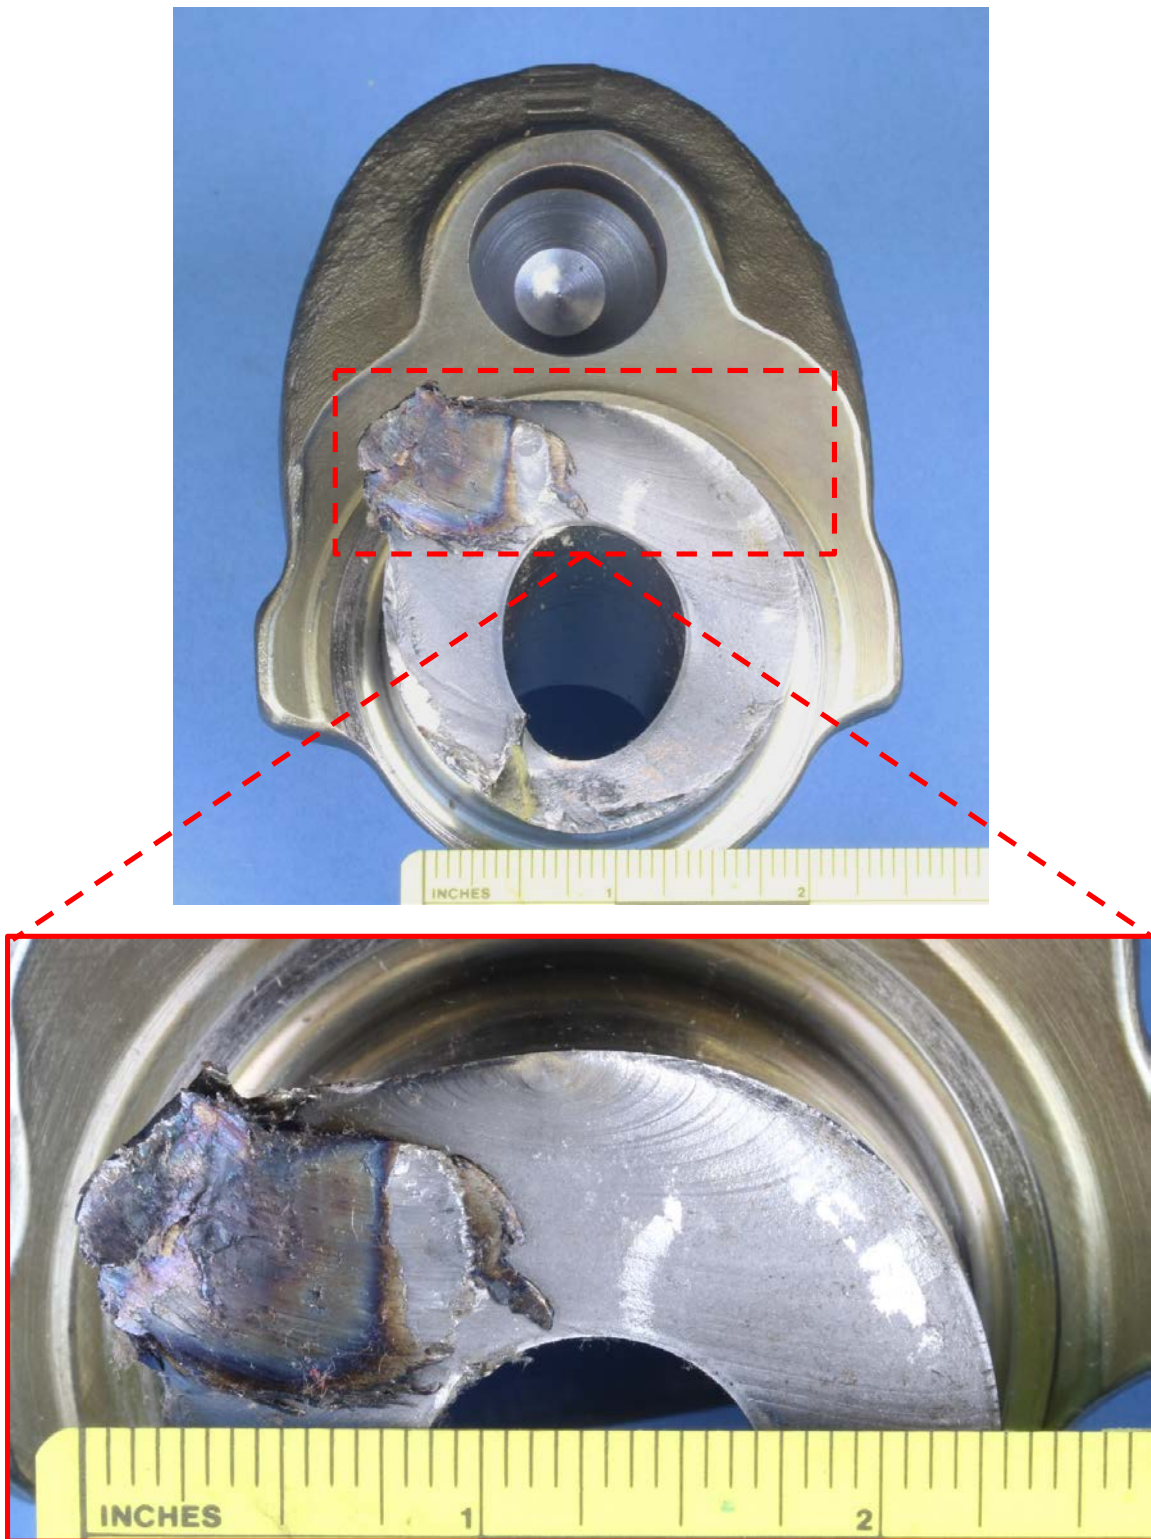
Figure 2: Overall (top) and close-up (bottom) photos of the crankshaft fracture surface.

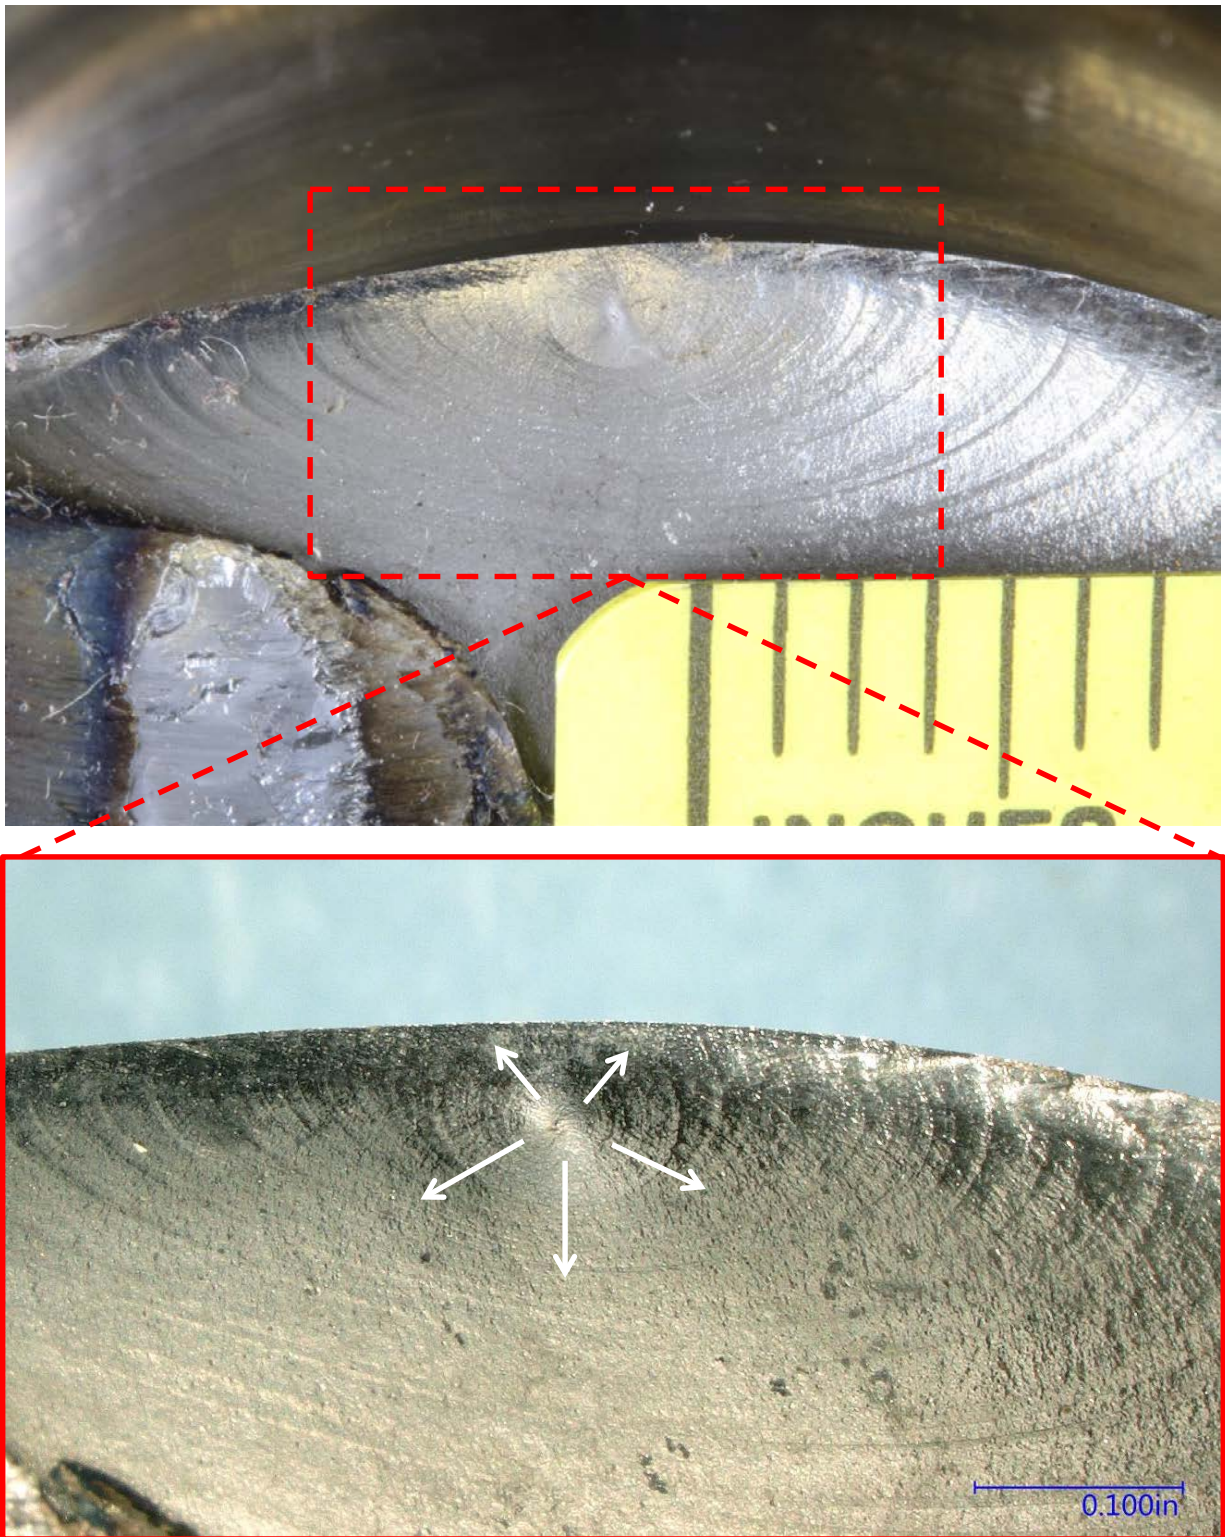
Figure 3: Close-up photo (top) and digital microscope image (bottom) of the crankshaft fracture surface. The white arrows indicate the direction of fatigue propagation from the subsurface fatigue initiation site.

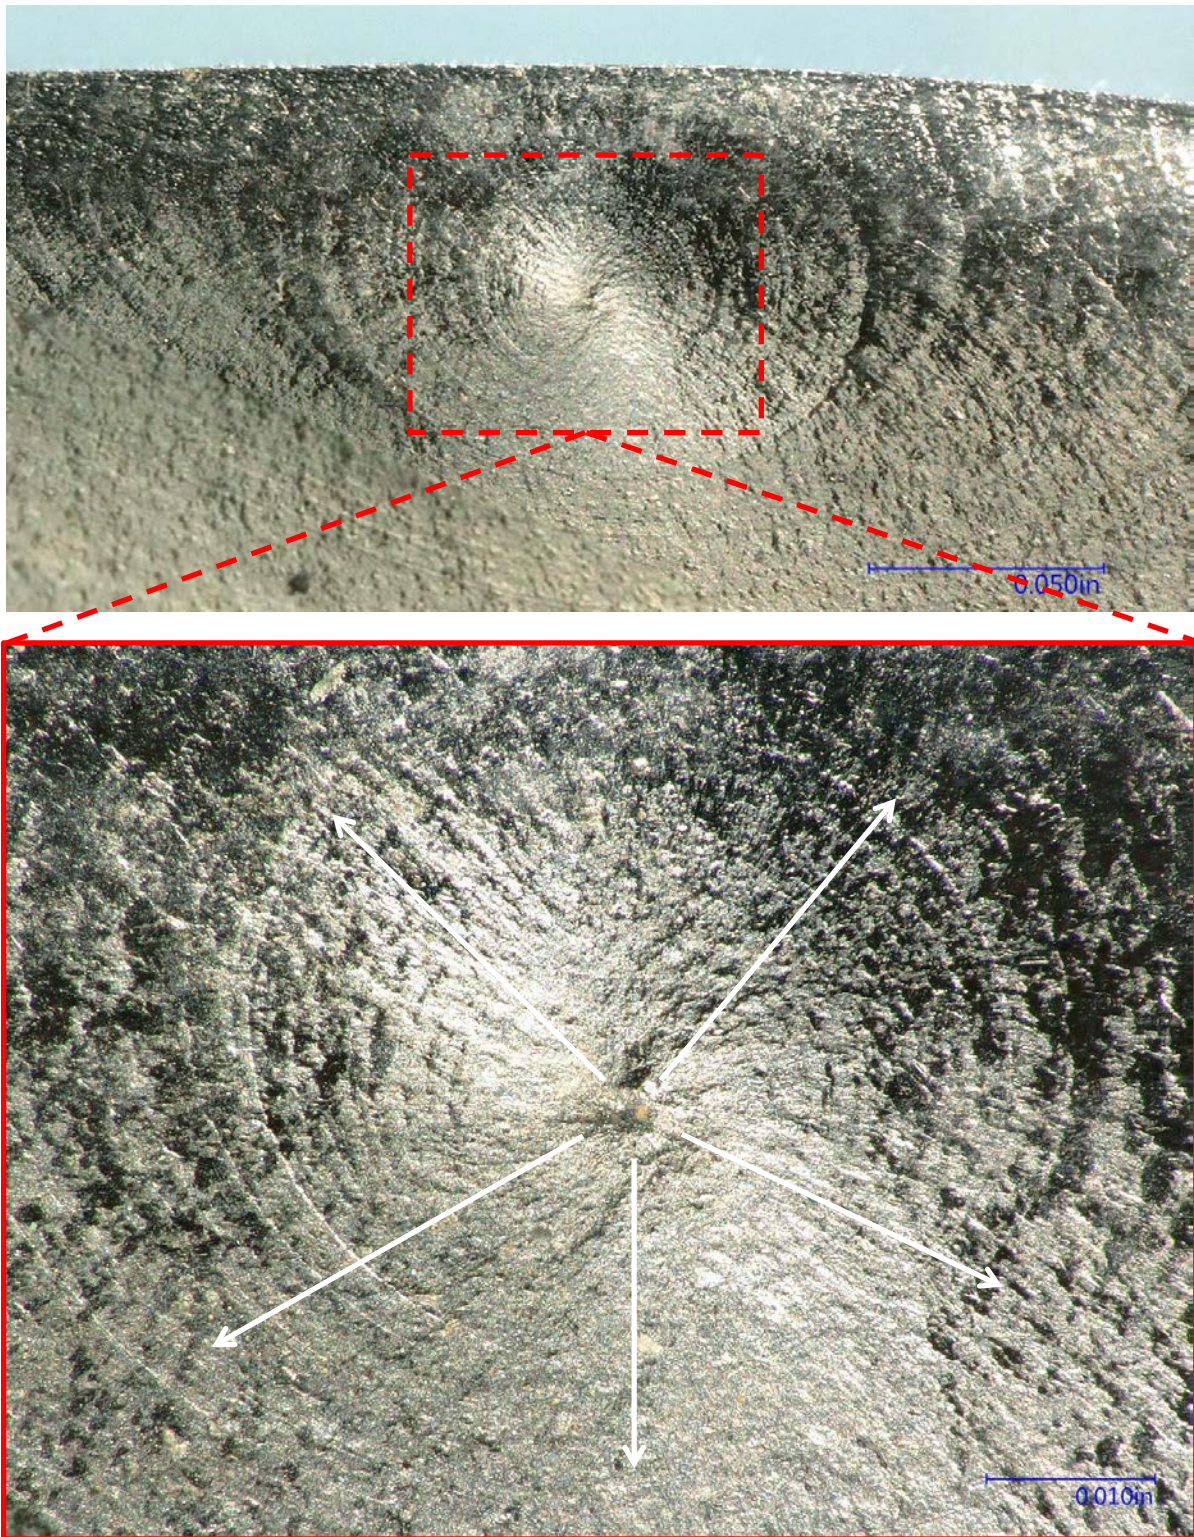
Figure 4: Digital microscope images of the crankshaft fracture surface. The white arrows indicate the direction of fatigue propagation from the subsurface fatigue initiation site.

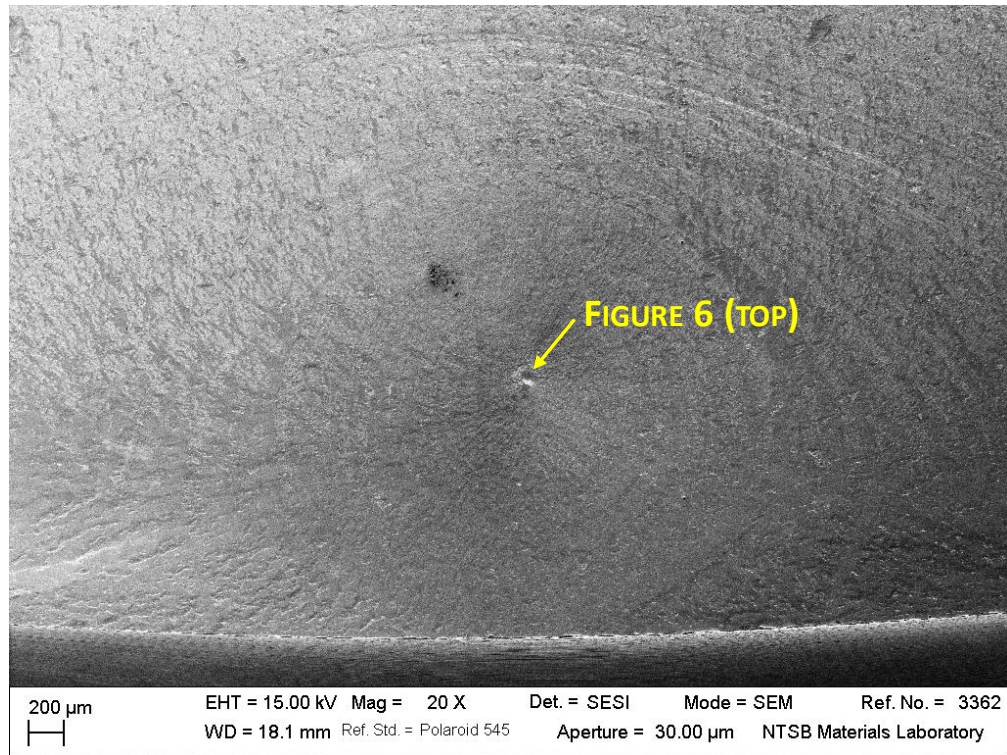
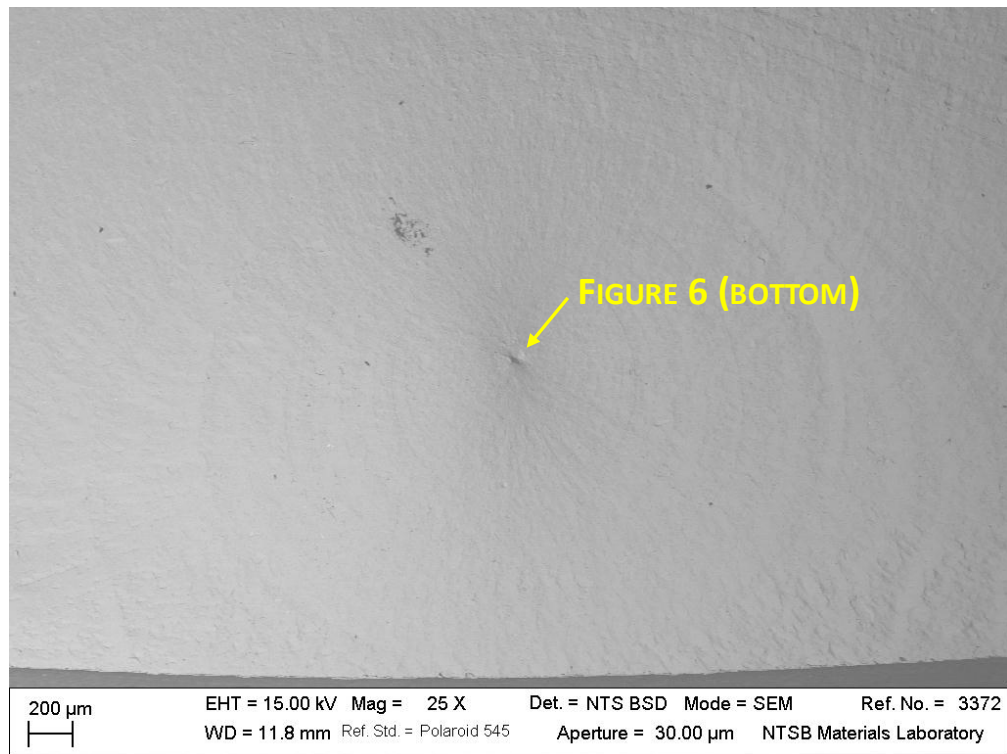
The fracture surface was examined using a Zeiss Auriga 40 field emission (FE) scanning electron microscope (SEM). SEM images of the fracture surface are shown in Figures 5 and 6. The fatigue initiation area was confirmed to be subsurface. No flaws or embedded particles were observed at the site of the fatigue initiation.

Figure 5: Secondary electron (top) and backscattered electron (bottom) SEM images of the crankshaft fracture surface.

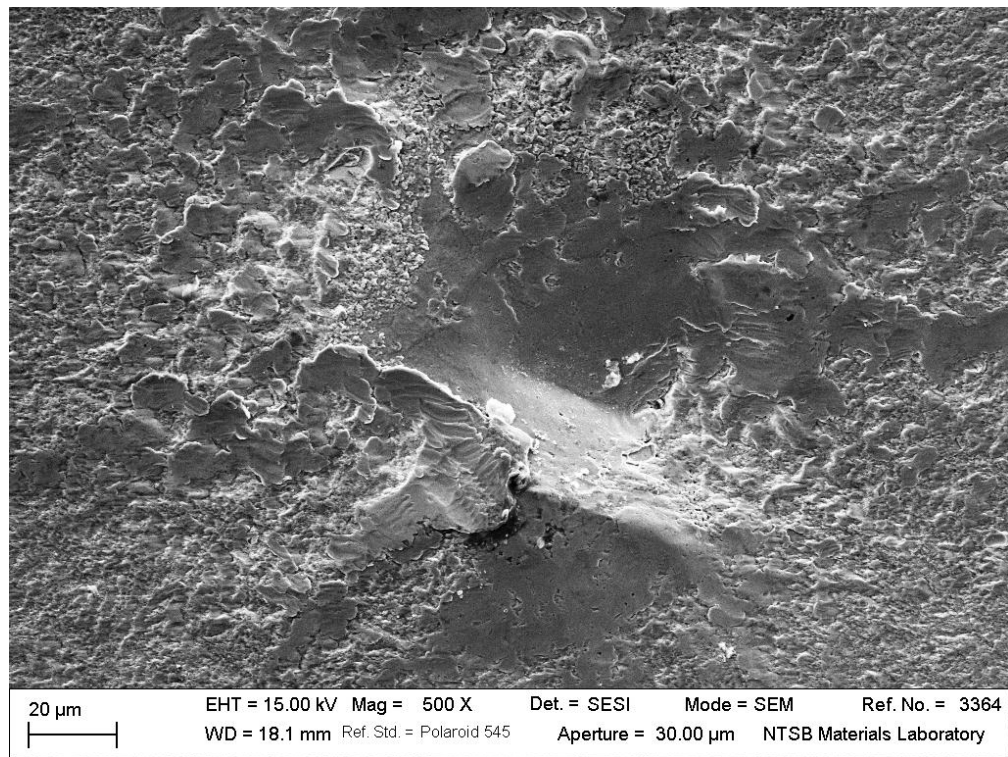
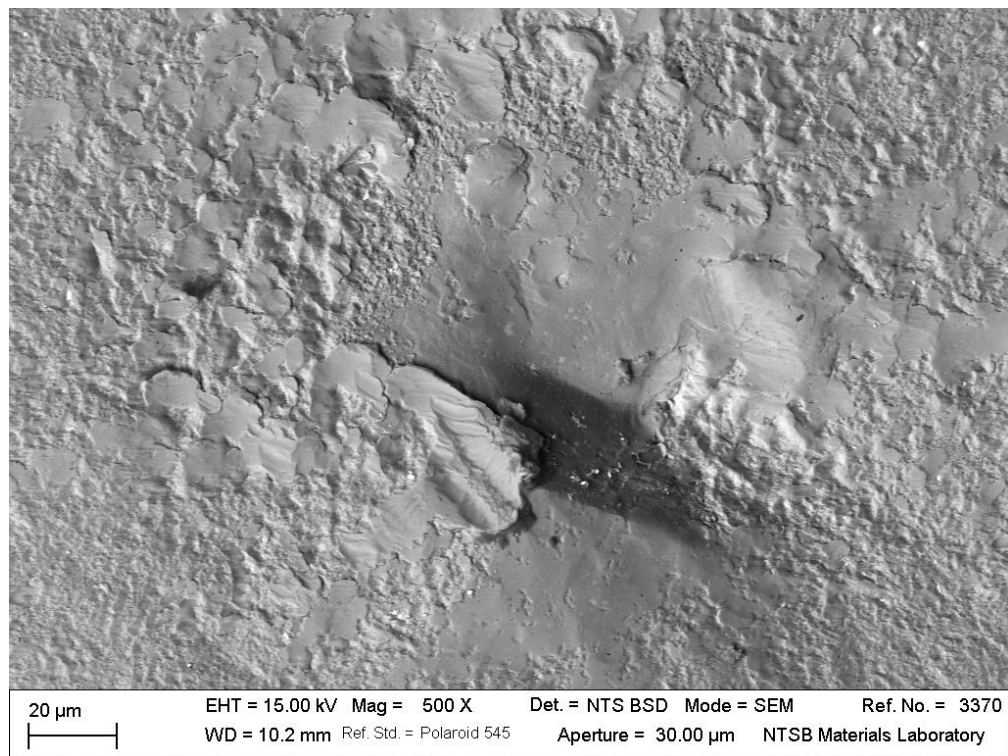
Figure 6: Secondary electron (top) and backscattered electron (bottom) SEM images of the fatigue initiation site on the crankshaft fracture surface.
