## **NATIONAL TRANSPORTATION SAFETY BOARD**

# **AIRFRAME AND ENGINE EXAMINATION**

**WPR18LA205**

Location: El Cajon, California  
Date: July 28, 2018  
Aircraft: Cessna 177, N3477T, Serial #: 17700777  
NTSB IIC: Albert Nixon

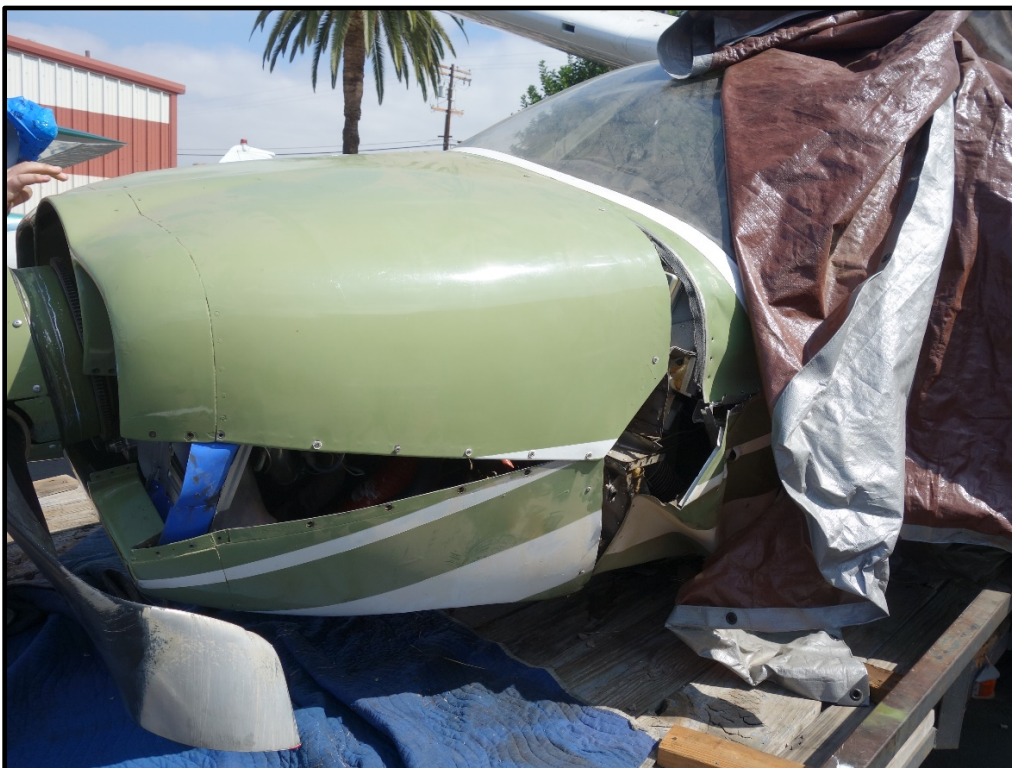
Examination of the airframe revealed the fuselage came to rest upright on the nose and the left wing. The left-wing sustained impact damage from the outboard half. The right wing was relatively intact. The flaps were extended about 10 degrees. The empennage section was relatively intact. All flight control surfaces remained attached at all their respective attachment points. The rudder trim was about 30 degrees right and the elevator trim was observed about ½ inch down. The aileron trim was about 3/8 inch up. Flight control continuity with the flight controls was established. However, the rudder only had partial movement due to impact damage caused by the nose gear assembly folding aft into the fuselage.

The left side of the fuselage sustained some impact damage. The flap handle corresponded to the flaps position.

**Figure 1: The recovered airplane wreckage as viewed from the left.**

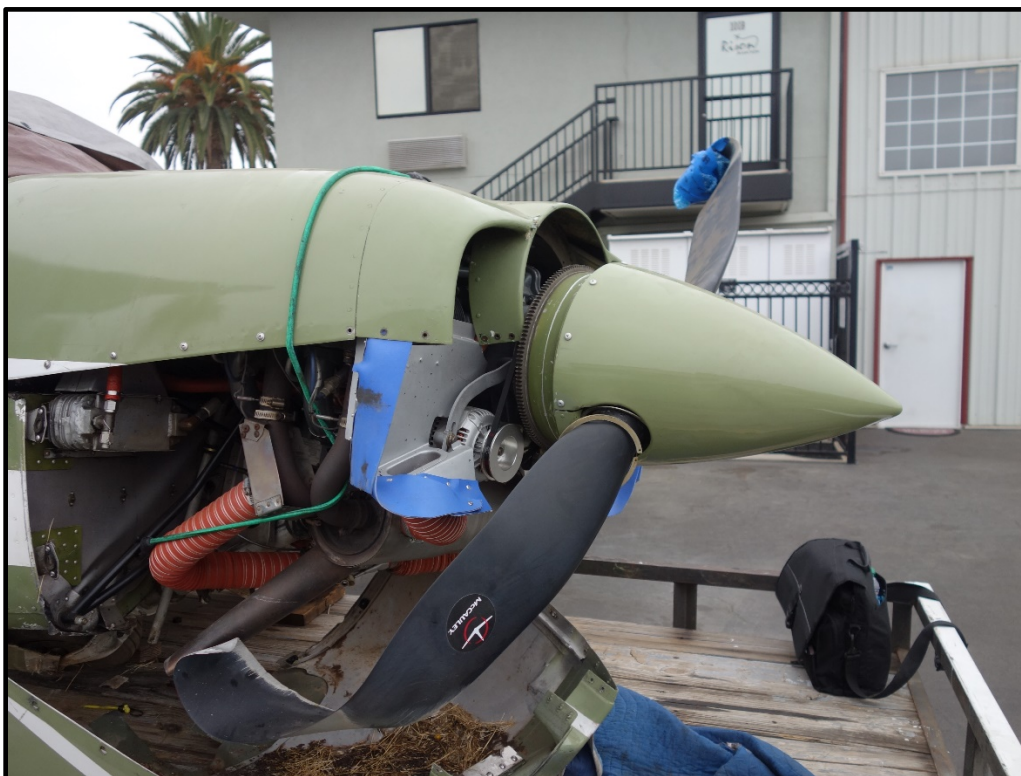
**Figure 2: Engine and propeller as viewed from the right side.**

Examination of the Lycoming O-360-A1F6D engine, serial number L-18178-36A revealed that it remained partially attached to the airframe by the engine mounts. The engine accessories remained attached to the engine via their respective mounts. All rocker covers were removed, and the cylinder overhead areas were lubricated and unremarkable. The crankshaft was rotated by hand utilizing the propeller and rotational continuity was established throughout the engine and valve train. During crankshaft rotation thumb compression and suction were attained on all cylinders.

The two-bladed propeller remained attached to the crankshaft flange. The blades were attached, with one blade tip was fractured and both blades were bent aft about one ft from the outboard portion. Chordwise scratches were observed on both blades. The spinner remained attached to the propeller. No impact marks and/or abrasions were observed on the spinner.

The examination of the engine revealed no evidence of mechanical malfunctions or failures that would have precluded normal operation.
