## **NATIONAL TRANSPORTATION SAFETY BOARD**

# **AIRFRAME AND ENGINE EXAMINATION**

**WPR18LA214**

Location: Basin City, WA  
Date: August 7, 2018  
Aircraft: Bell 206B, N607RA, Serial # 678

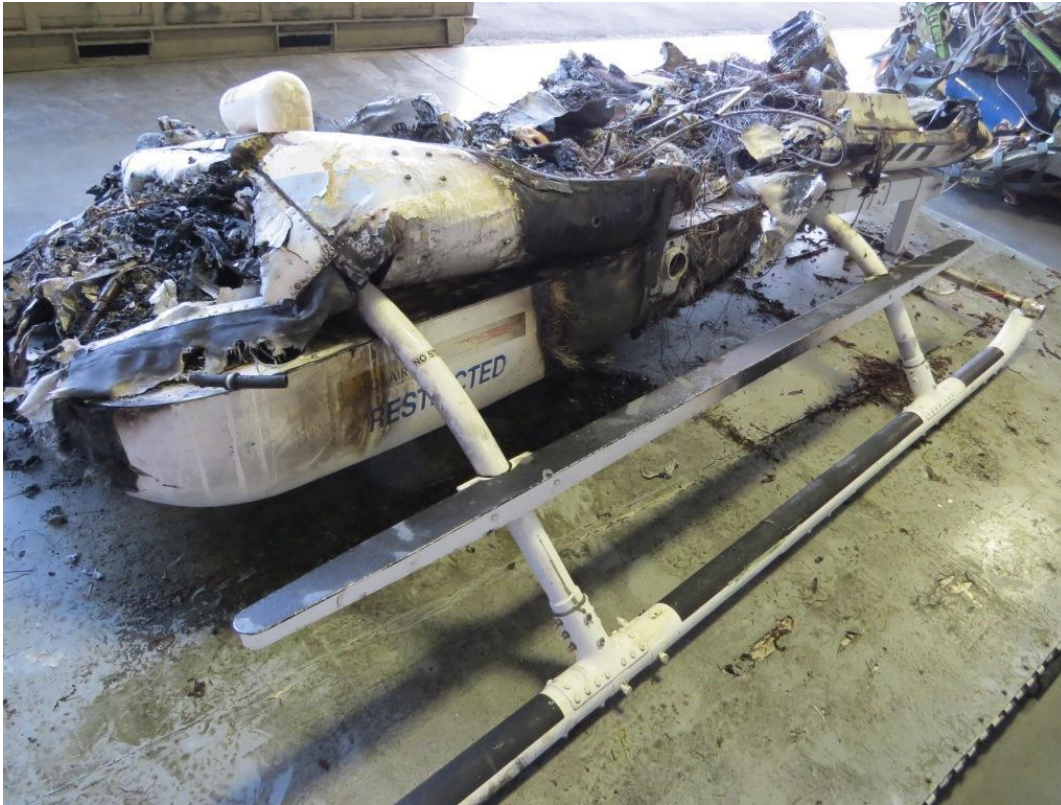
**Figure 2 - Fuselage & Left Skid**

- The majority of the forward and intermediate fuselage was consumed in the post crash fire, with the exception of most of the lower fuselage, which remained attached to the landing skid crosstubes.
- The tailboom detached from the intermediate fuselage, with indications of both possible blade strike and thermal damage
- Portions of the spray rig were observed in the wreckage
  - Some remained attached to the wreckage, other sections did not

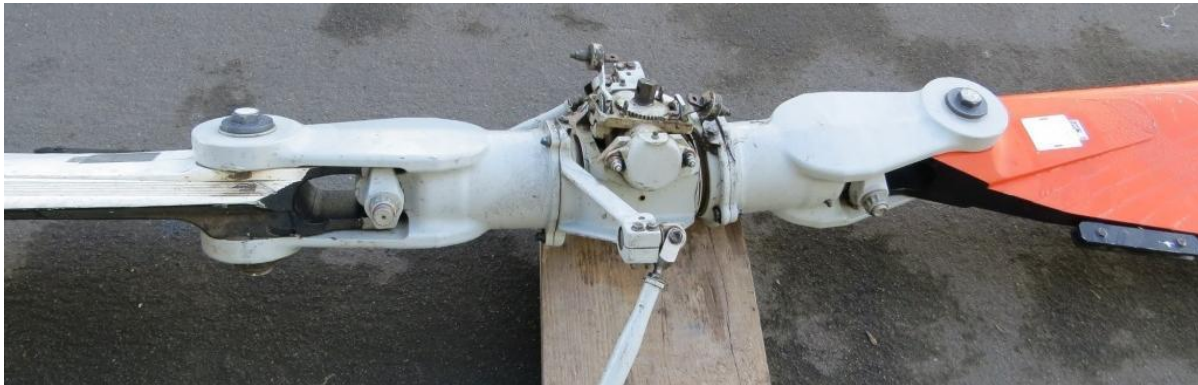
**Figure 5 – Main Rotor Blade Hub**

- The mast was fractured immediately below the hub
- Both main rotor blades remained attached to the MRB hub
- Main rotor blade s/n A-8101 was fractured at the outboard end of the blade doublers, with additional fracturing near the blade tip
  - Upward bending of the fractured portion of the blade was noted
  - This was consistent with ground contact
- Main rotor blade s/n A-7835 was missing the tip of the blade, and exhibited aft and upward bending.
- Both main rotor blades exhibited additional damage (scrapes, dents, and gouges)
- Main drive continuity was demonstrated by rotating the input drive quill by hand, and observing the rotation of the mast.

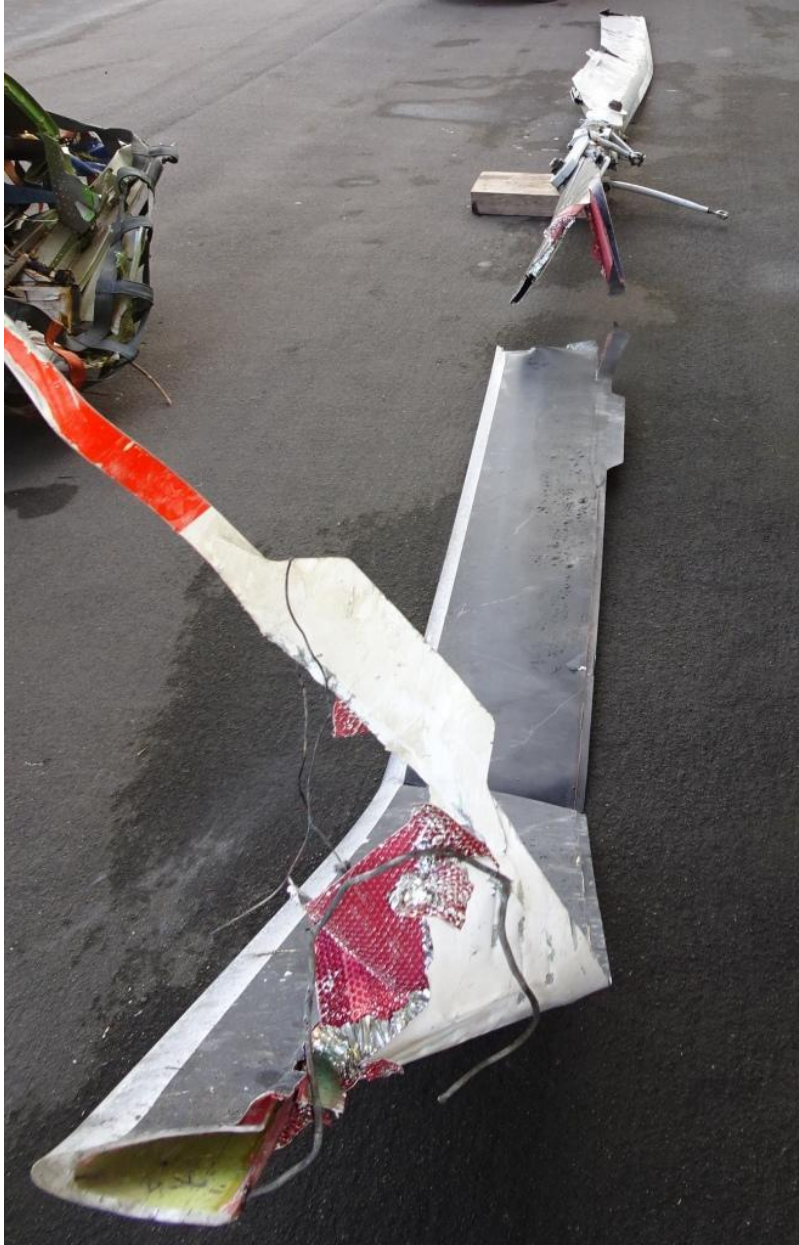
**Figure 7 - Damaged Main Rotor Blade**

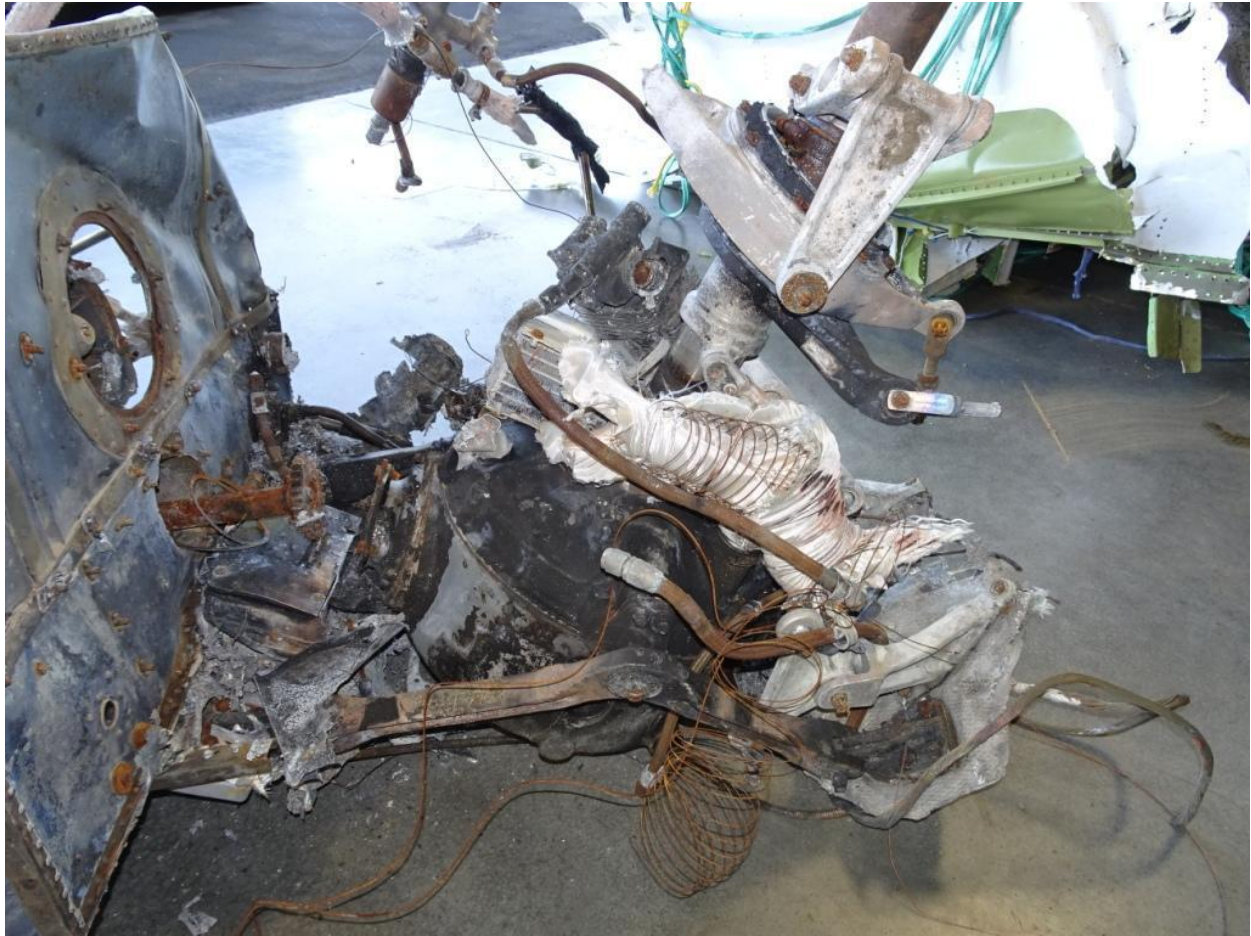
**Figure 8 - Transmission and Mast**

- The forward outer coupling of the engine-to-transmission driveshaft was not able to be located in the wreckage; presumed to be fragmented and/or consumed by fire
- Rotational scoring was observed on the transmission isolation mount
- The engine to transmission driveshaft remained attached to the aft outer coupling that remained attached to the engine
- No evidence of any non-impact or thermal exposure damage was observed on the transmission
- The transmission was visually inspected and suffered thermal damage
- No abnormal sounds were heard when the transmission was rotated by hand
- The two transmission chip detectors were removed and visually inspected, with no particulate matter observed. The mast chip detector was unable to be removed.

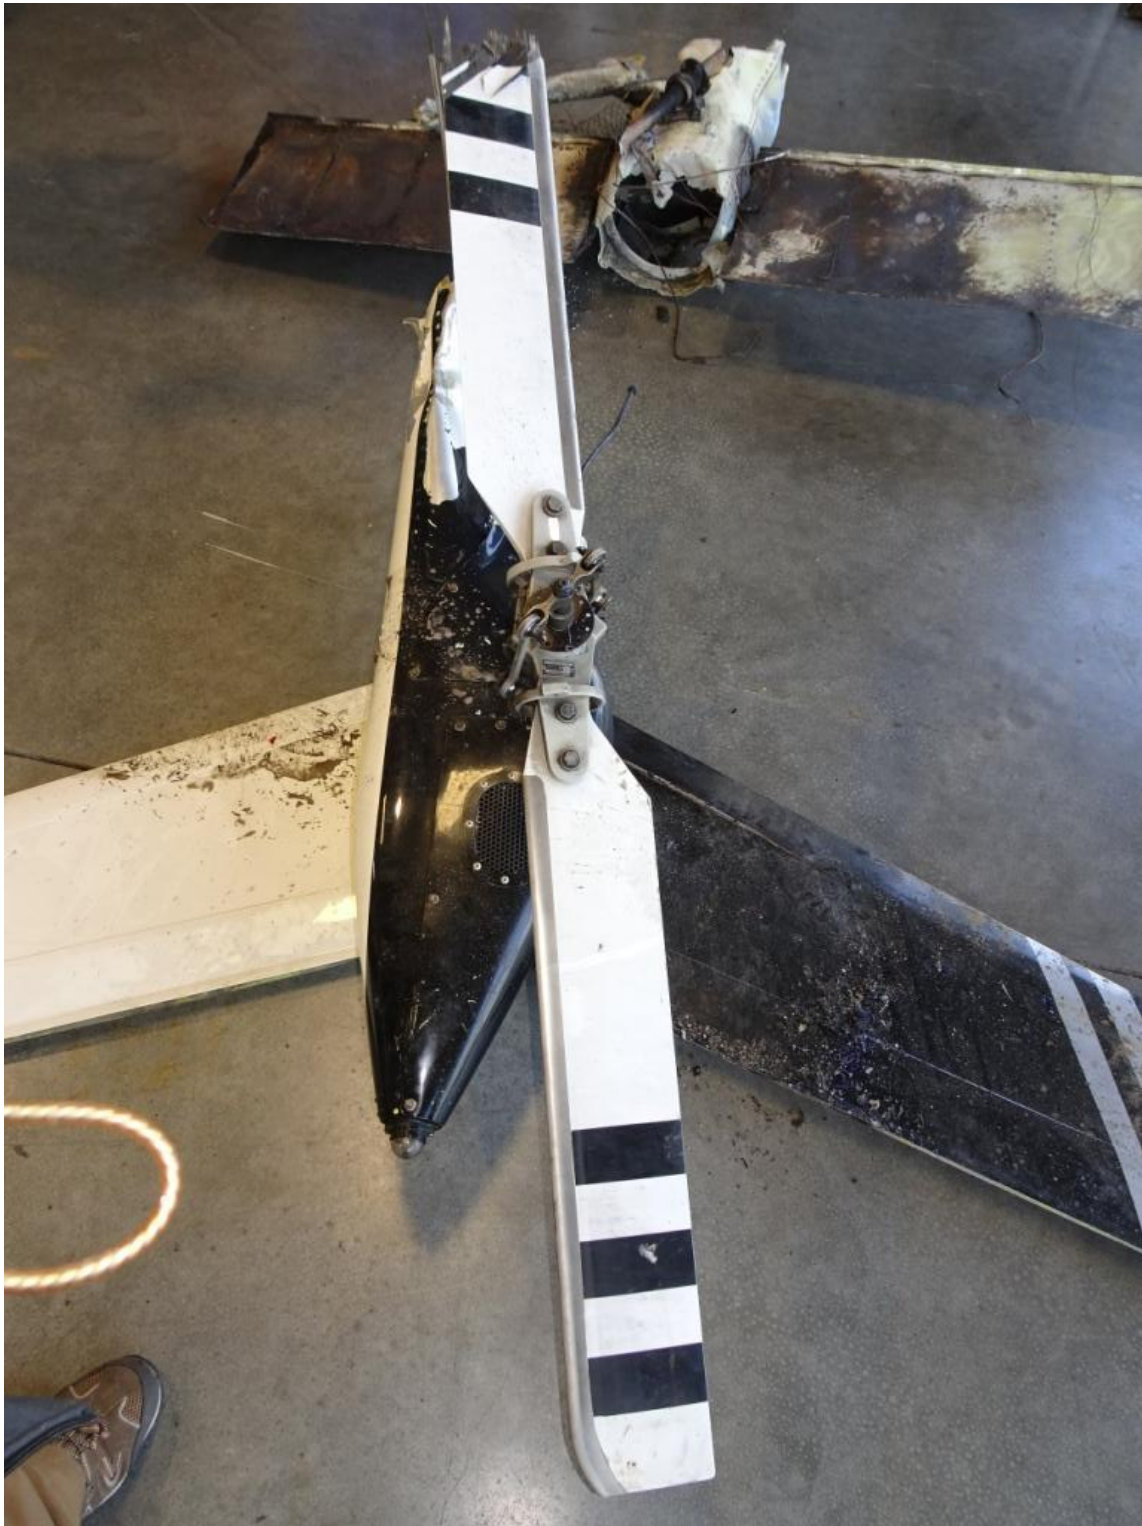
**Figure 9 - Tail Rotor Assembly**

- The helicopter was equipped with aftermarket composite tail rotor blades (TRBs)
- Both TRBs remained attached to the TRB hub
- Both tail rotor blades were unremarkable except for the tip of blade s/n A592 that appeared to have contacted the ground with the tip broken off
- The other TRB (s/n unable to be read) was undamaged
- The tail rotor hub was unremarkable
- Due to fragmentation and consumption by fire, tail rotor drive continuity could only be established from the tail rotor through the tail rotor gear box
- The majority of the tail rotor driveshaft segments were consumed by fire
- The forward short shaft (steel shaft) and the oil cooler blower shaft were identified in the wreckage
- Oil was present in the tail rotor gearbox; it appeared normal in color and no contaminants were present
- The chip detector was removed and visually inspected, with no chips observed

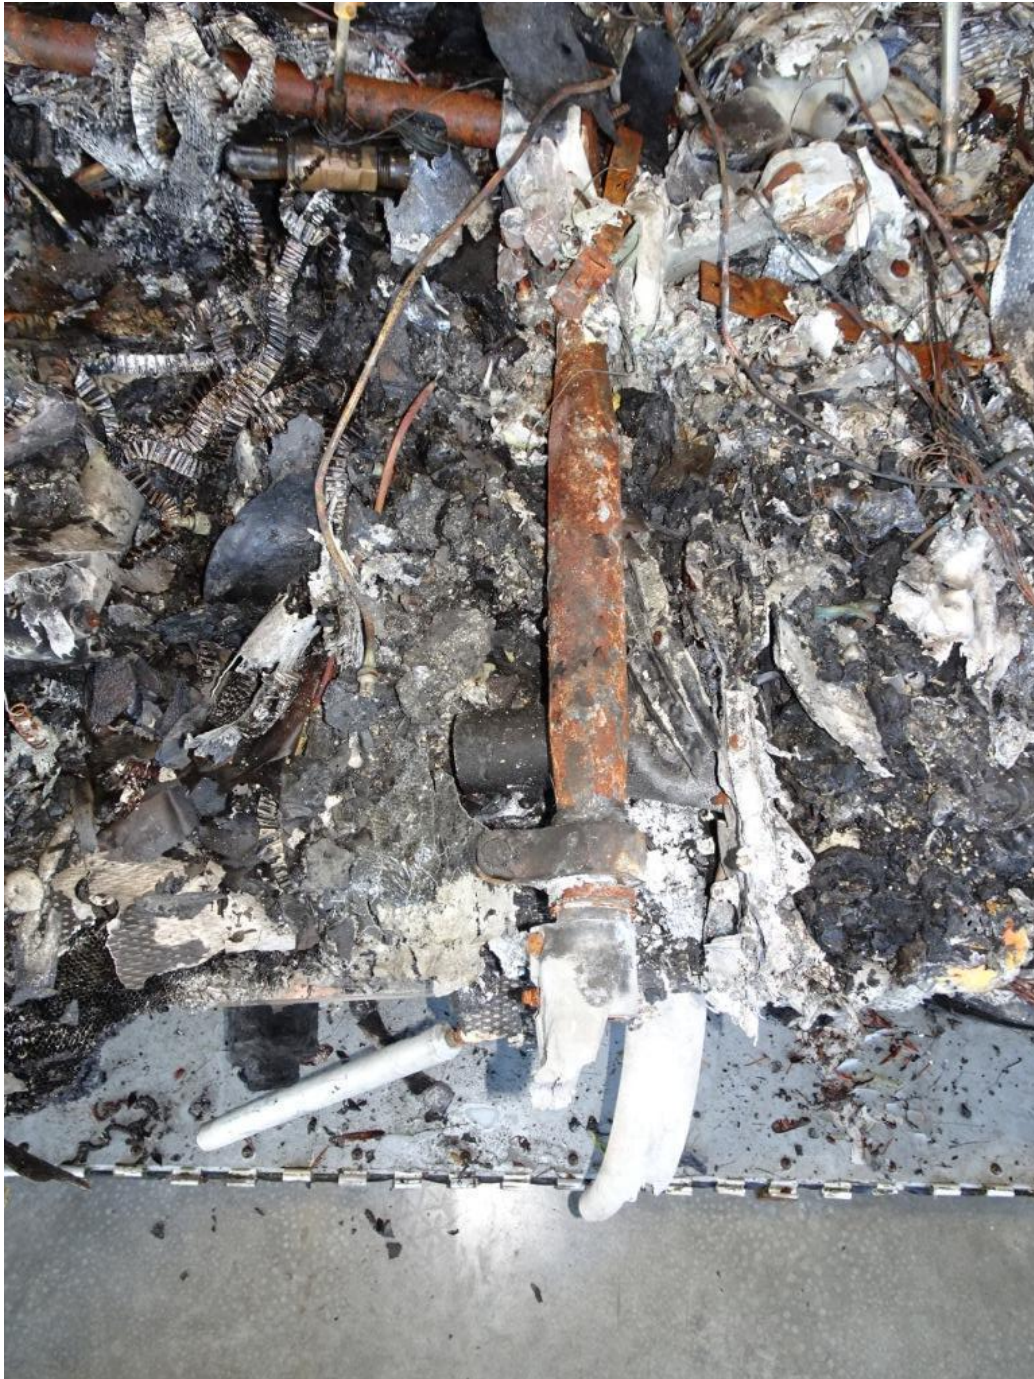
**Figure 13 – Collective Jackshaft (looking right)**

- Most of the flight controls were consumed in the post-crash fire
- The right collective stick was present, but the throttle twist grip was missing
- The left collective stick was missing
- Both cyclic sticks were missing
- The yoke that connects the right and left cyclic sticks was missing
  - The mixing lever was present, with significant thermal damage
- The left seat anti-torque pedals were missing
- The right seat inboard pedal remained, but the outboard pedal was not located
- Only one of the three servo actuators was identified, and it was thermally damaged
- No other flight control components were located; they were apparently consumed by fire

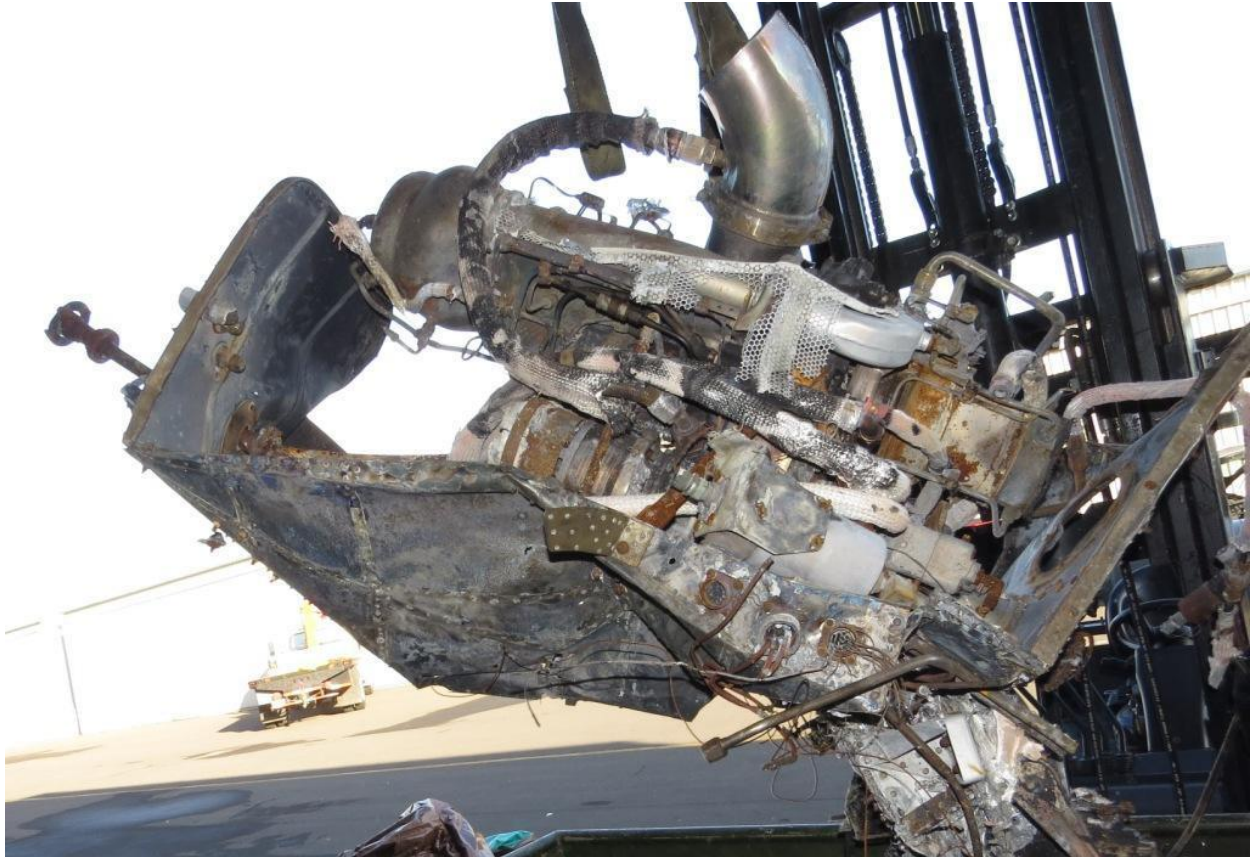
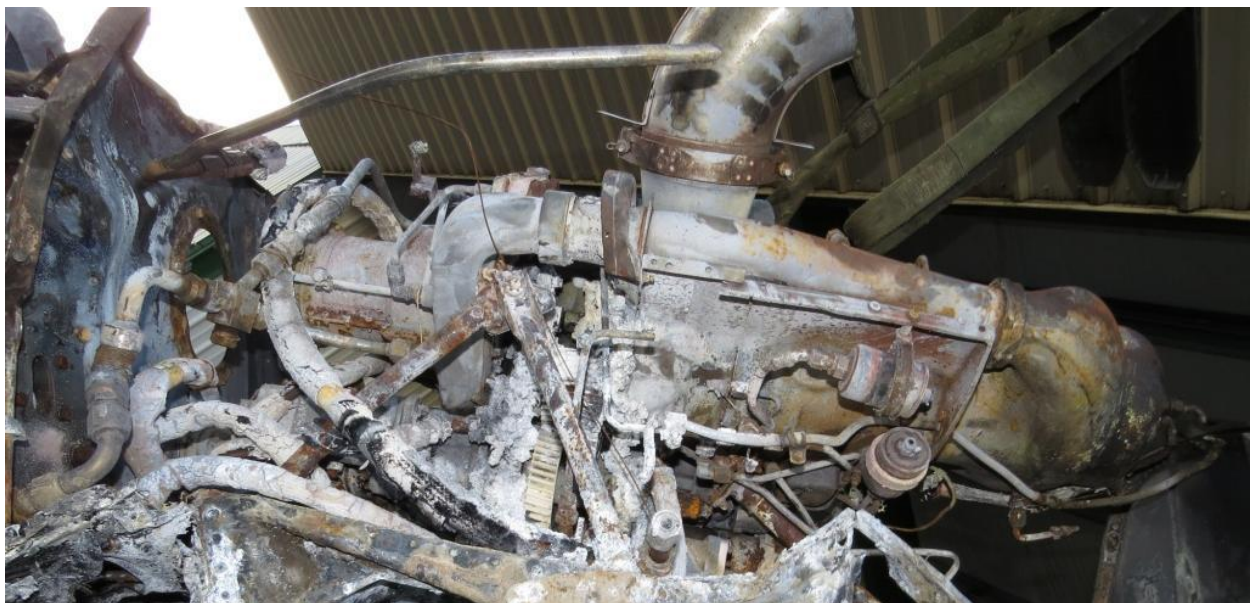
**Figure 16 - Engine**

- The magnesium accessory gearbox had mostly burned away, revealing the interior gears
  - The intensity of the magnesium fire also consumed or badly damaged the attached engine accessories.

- The engine exhibited significant corrosion; this was attributed to the post accident exposure to firefighting and accident site irrigation water
- All available/accessible engine B-nuts and fittings were checked by hand for proper torque

- All were found to be at least hand tight.
- The Power Turbine Governor (PTG) was completely consumed by fire
- The Fuel Control Unit (FCU) was fire damaged, and the control arm could not be manipulated by hand.

- The bleed valve body was partially melted by the post-crash fire.

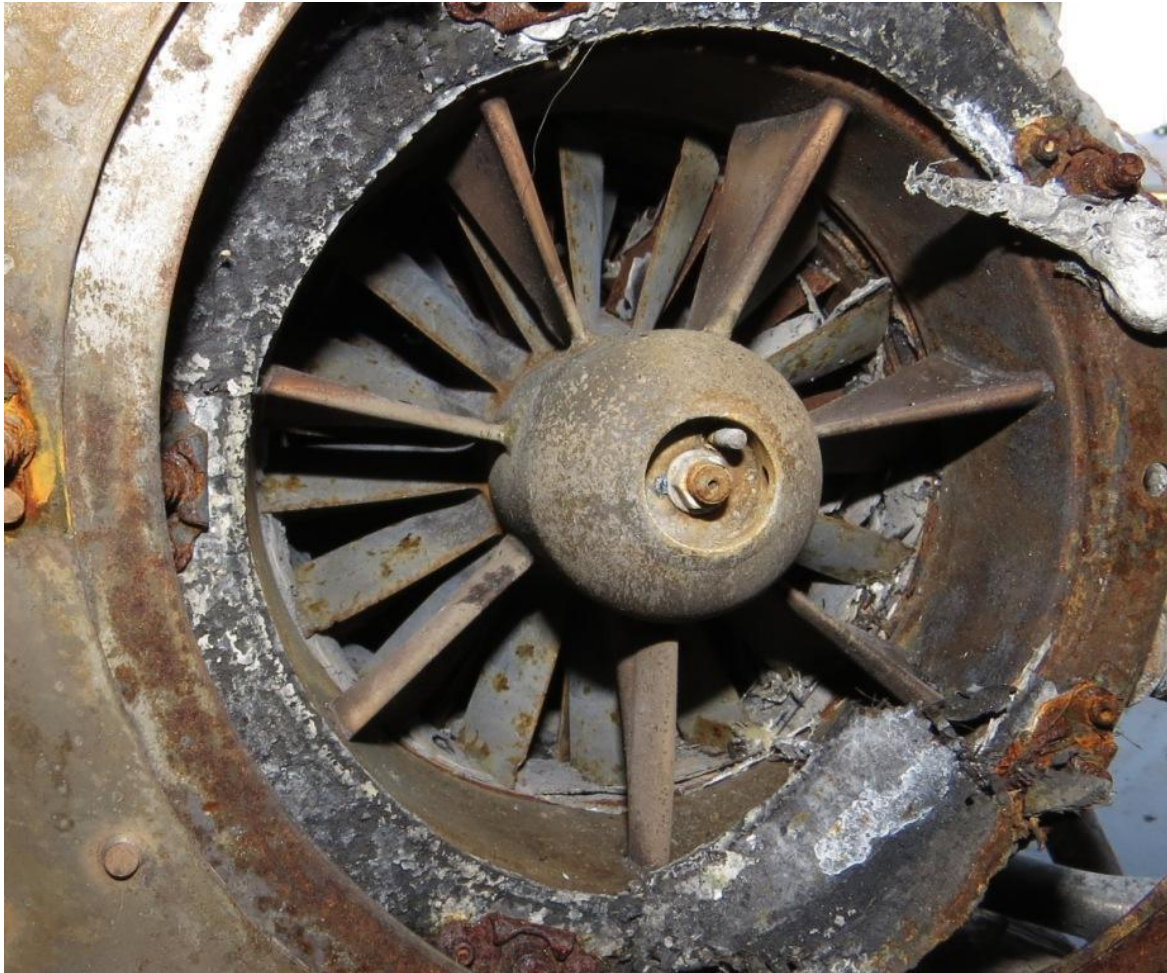
Figure 18 - Compressor Inlet Face

- The compressor, like the rest of the engine, had been exposed to the post-crash fire.
- The binder of the composite compressor liner had melted or burned away, and left ashen debris throughout the compressor
- Examination of the compressor revealed no evidence of mechanical failure
- The leading edges of numerous blades exhibited evidence of small hard-body impact marks.
- Neither the N1 nor N2 rotor systems could be rotated by hand.

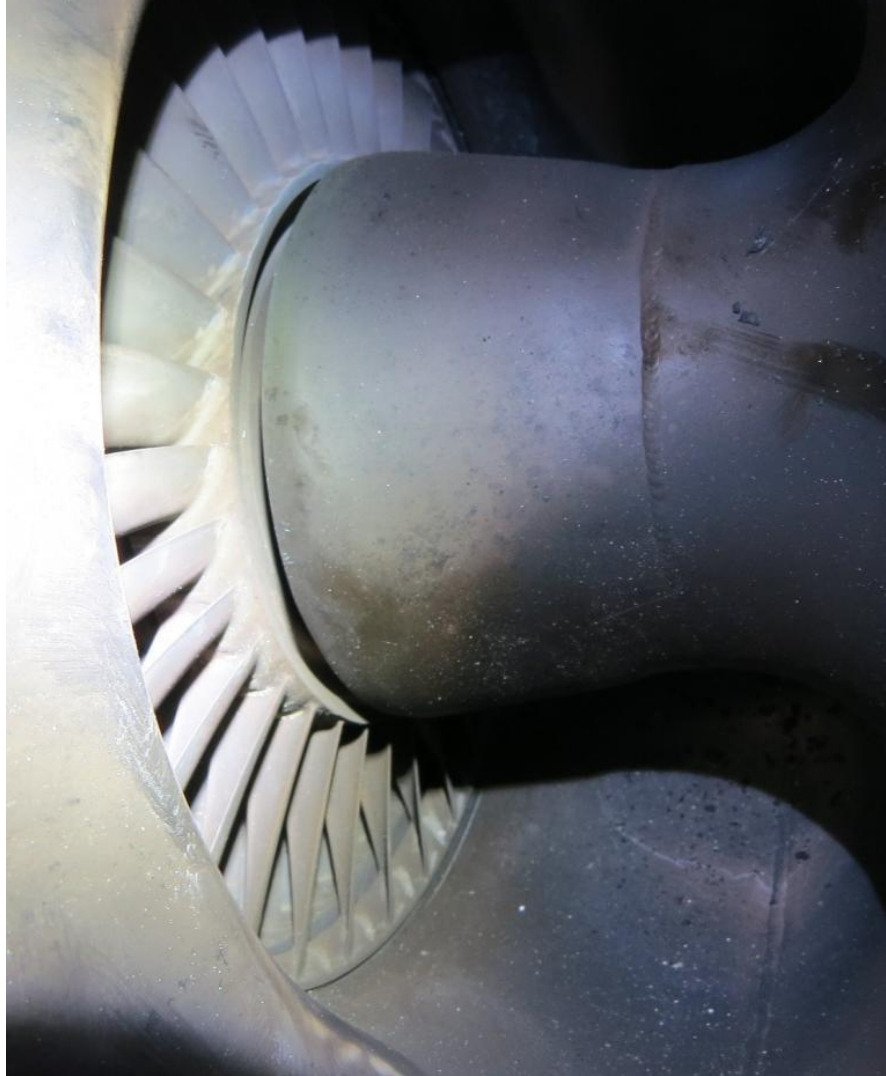
**Figure 19 - Turbine Outlet Blades**

- The turbine module exhibited no evidence of operational failure or malfunction
- Visual inspection of the 4<sup>th</sup> stage (power turbine) revealed no evidence of FOD, operational damage or thermal degradation

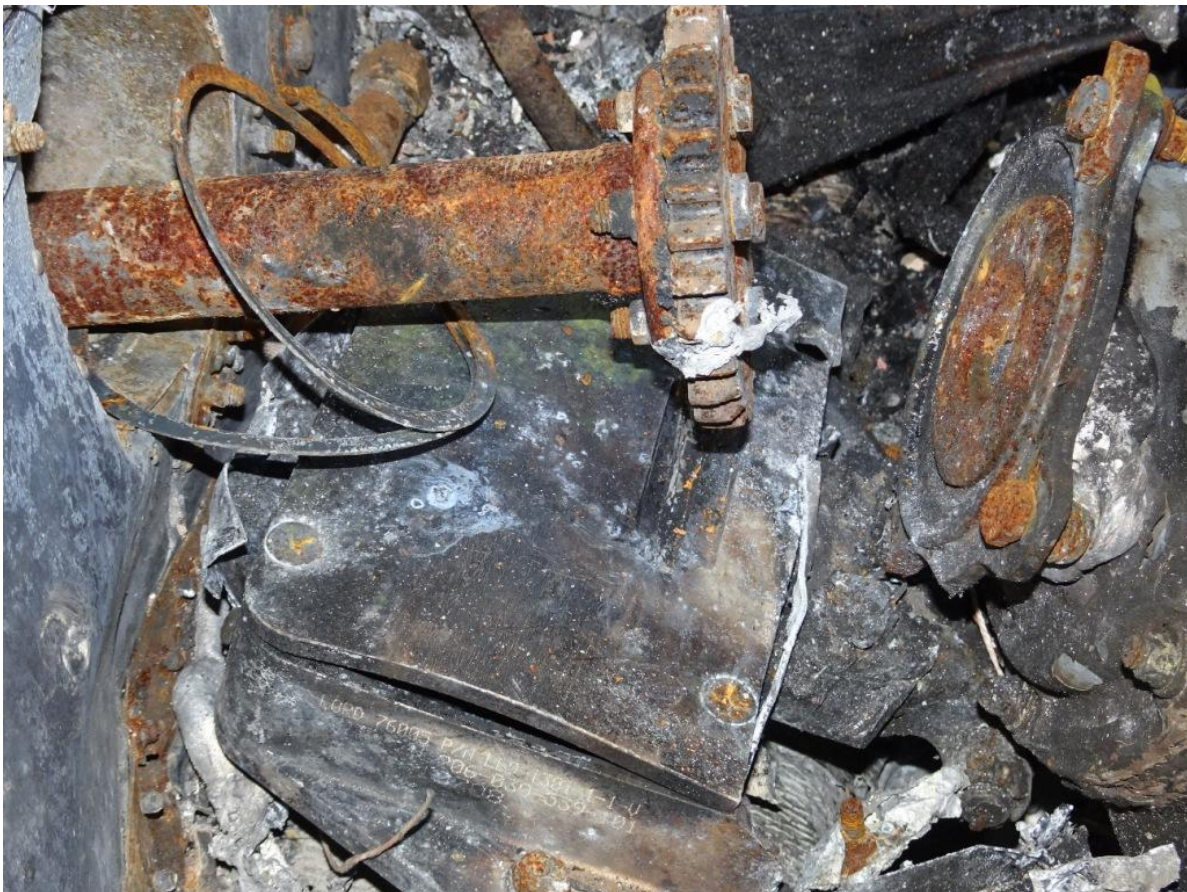
- The source of the metal slivers and chips was determined to be from the engine inlet plenum, inside which was located a splined shaft coupling that failed during impact

- An inner section, with external splines
- An outer section, with internal splines; this outer section sleeves over the inner section to form the coupling
- The isolation mount had a ground-out transverse (perpendicular to the shaft axis) channel that was not its design configuration
  - The damage is consistent with structural flexing during impact, which caused the outer splined section to contact the isolation mount and disintegrate.
  - Further flexing caused the still-rotating inner splined section to contact and grind into the mount
- The material liberated by the grinding of the isolation mount was ingested by the engine and deposited within the turbine section.
- It is presumed that this metal ingestion was also the cause of the minor FOD damage observed (and noted previously) on the compressor blades
- This evidence is indicative of continued engine operation during impact

**Figure 20 - Grinding-Damaged Isolation Mount**

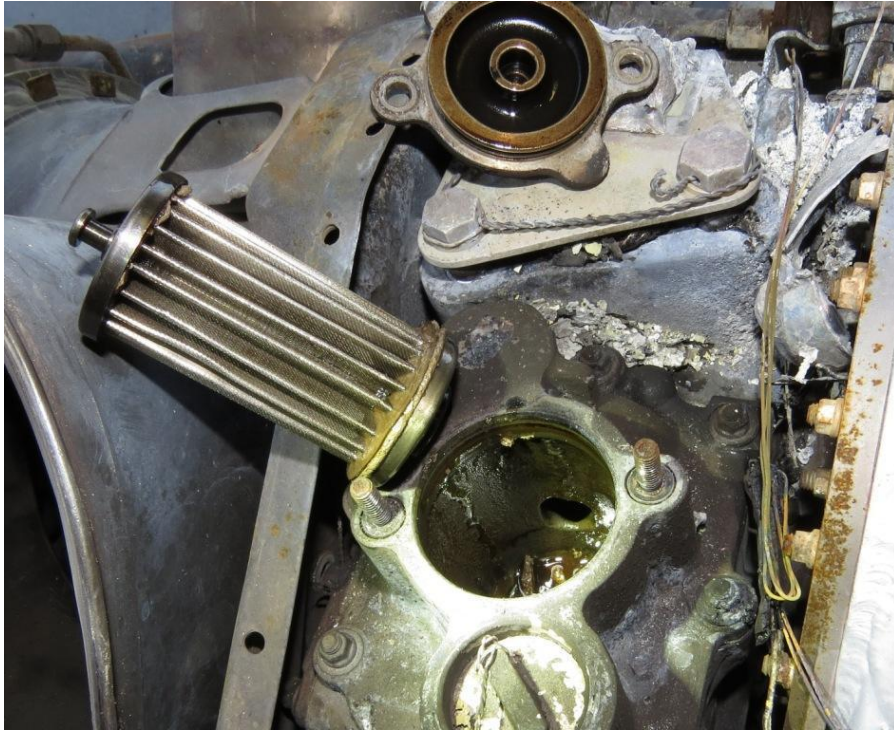
Figure 21 - Engine Oil Filter

- The lubrication system, including both magnetic chip detectors, was mostly consumed by fire
- The engine-mounted oil filter was essentially intact
  - It had been exposed to intense heat, and some of the filter's solder had melted and re-solidified within the filter housing and at the base of the filter itself.
  - Otherwise, the filter was free of debris.

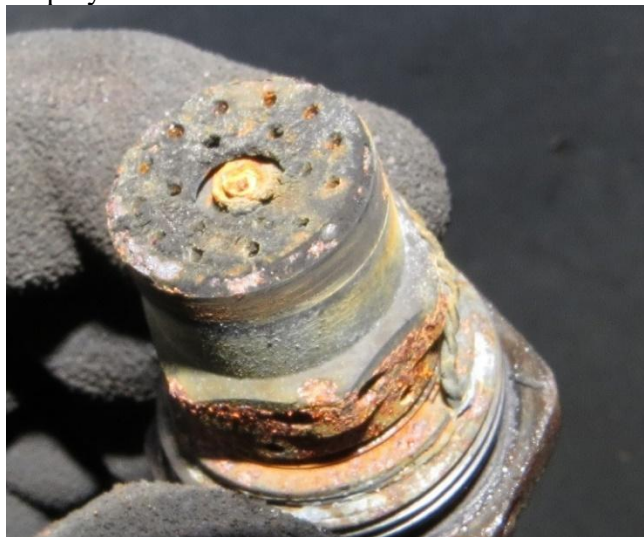
- The Fuel Spray Nozzle spray face was corroded but otherwise unremarkable

Figure 22 - Fuel Spray Nozzle Face
