## **Engine Investigation Report**

**Model 250-C20B  
Engine CAE 834648**

**Northwind Helicopter  
Basin City, Washington**

**Accident date: 7 August 2018  
Investigation date: 3 October 2018  
Report date: 3 October 2018**

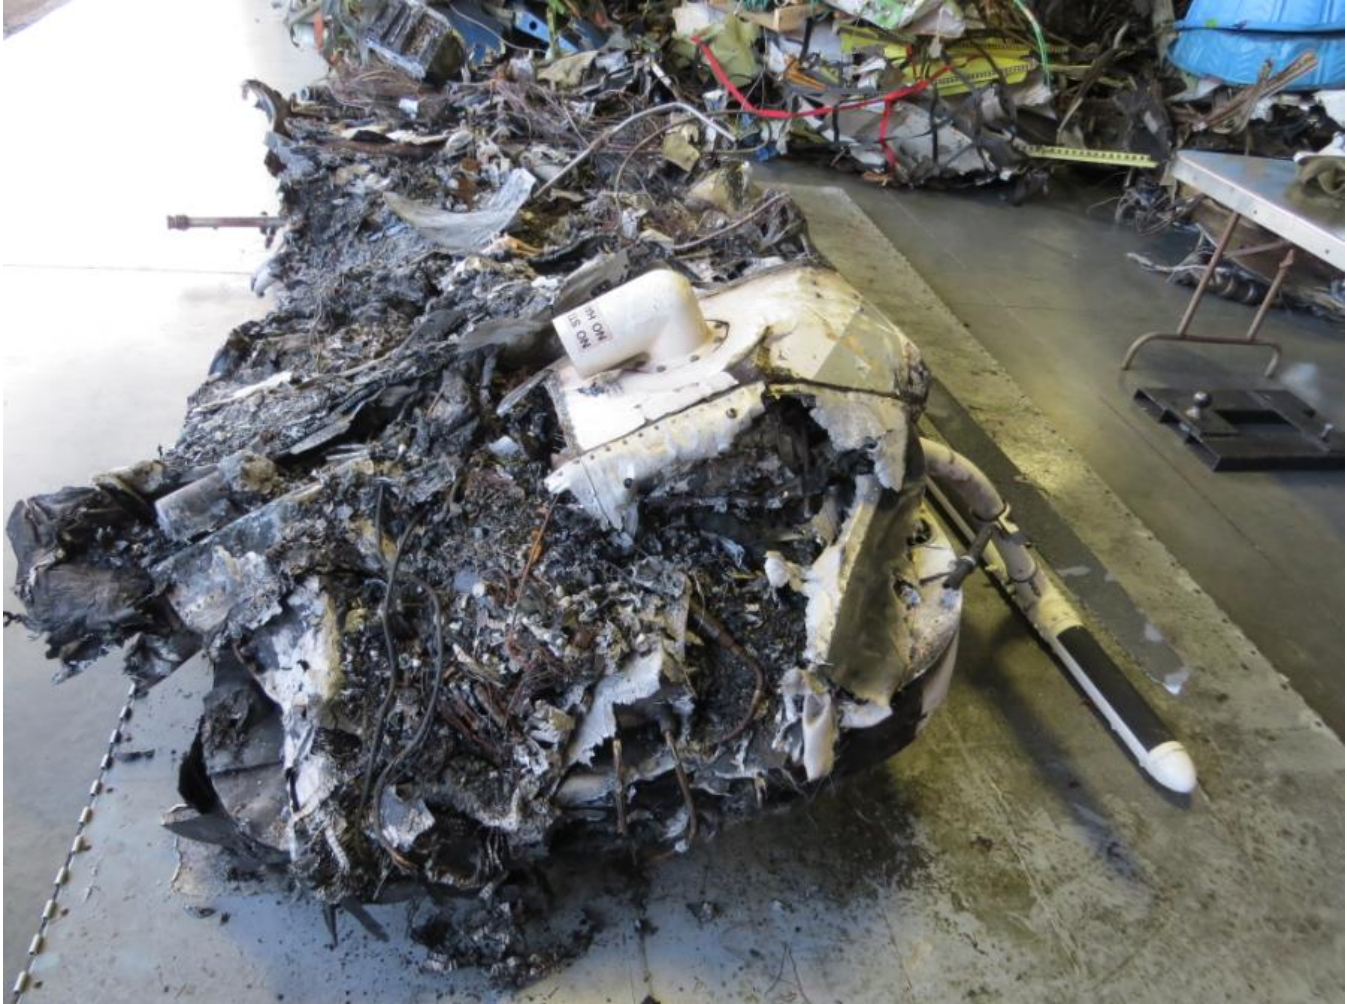
The aircraft was presented for examination in a secure hangar at Auburn Municipal Airport. The majority of the airframe and engine had been exposed to an intense post-accident fire.

The remains of the aircraft exhibited damage consistent with a main rotor strike of terrain. The main rotor assembly had fractured at the mast and separated from the airframe. One main rotor blade had fractured at the blade grip in apparent overload.

The tail boom was severed from apparent main rotor strike, and had also melted. The landing skids, while partially consumed by fire, did not appear to have been spread by a hard landing. The fuselage had been completely consumed by fire down to the floorboards.

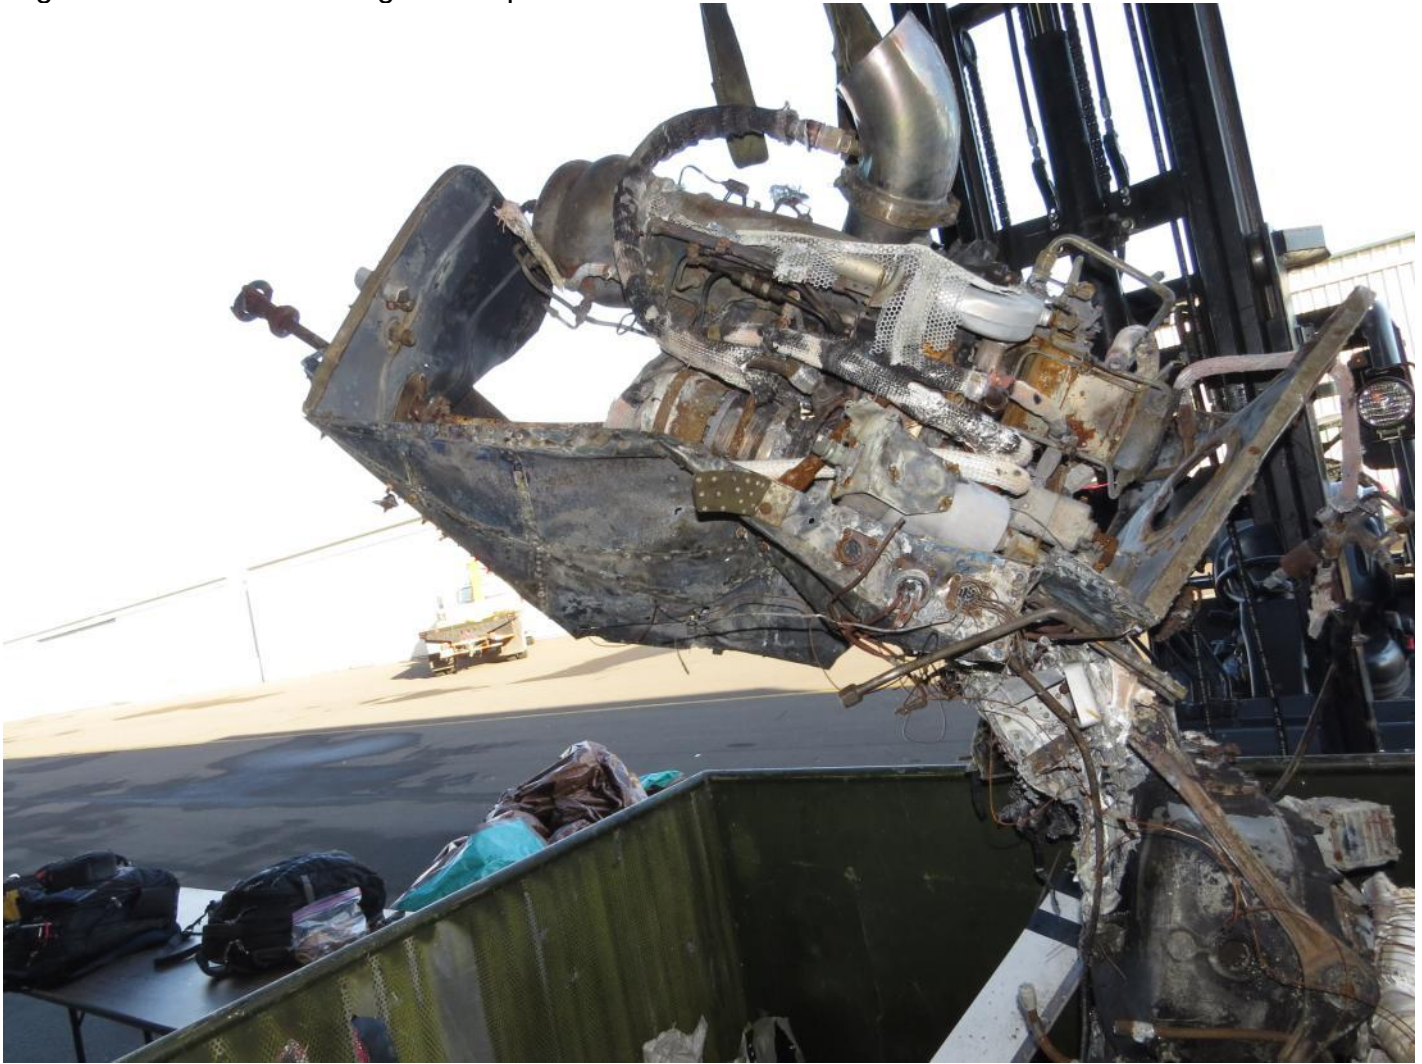
The engine was presented in a separate debris container from the fuselage. The engine was lifted from the container for examination. The engine was still partially attached to the horizontal and vertical firewalls, as well as loosely attached to the main transmission via various lines and cables. The magnesium accessory gearbox had mostly burned away, revealing the interior gear trains. The intensity of the magnesium fire also consumed or badly damaged the attached engine accessories. The engine had also been exposed to large amounts of water from firefighting efforts and the irrigation system of the field in which the aircraft had crashed. As such, significant corrosion had begun to set in on most engine components.

All available engine B-nuts and fittings were checked by hand for proper torque. All were found to be at least hand tight. The Power Turbine Governor was completely consumed by fire. The Fuel Control Unit was fire damaged and intact, but the control arm could not be manipulated by hand.

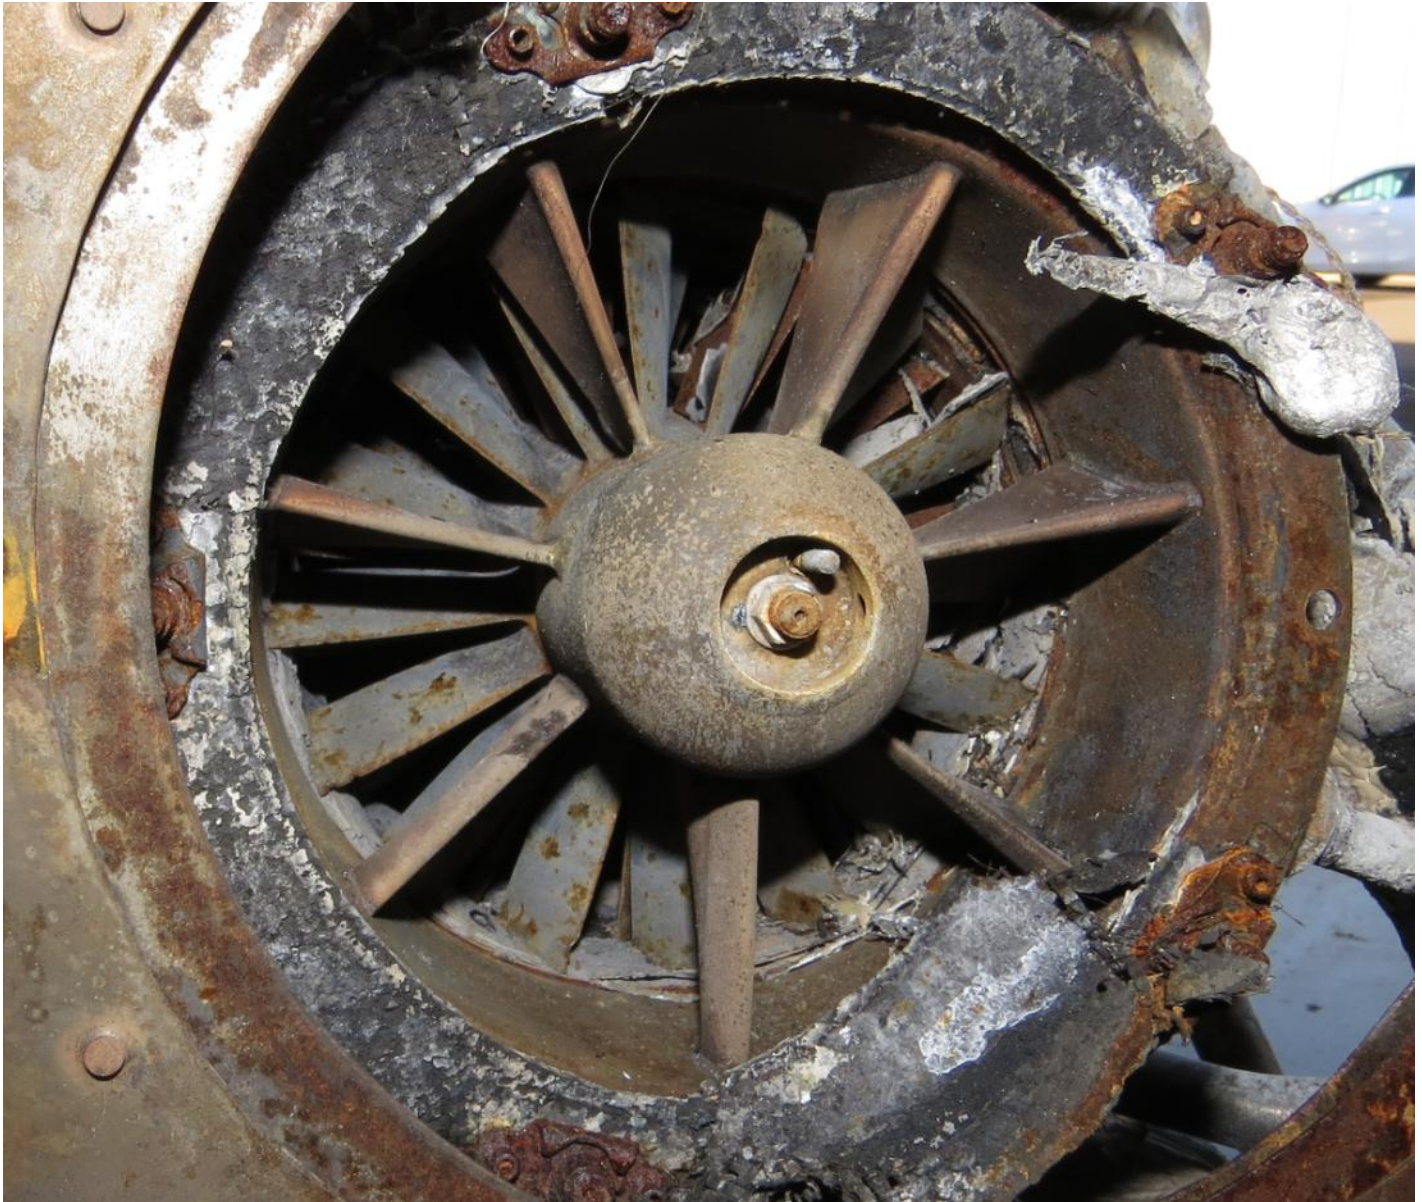
The compressor, like the rest of the engine, had been exposed to an intense post-crash fire. The composite compressor liner had melted and left ashen debris throughout the compressor. Examination of the compressor revealed no evidence of operational failure. The leading edges of numerous blades exhibited evidence of small hard-body impact marks.

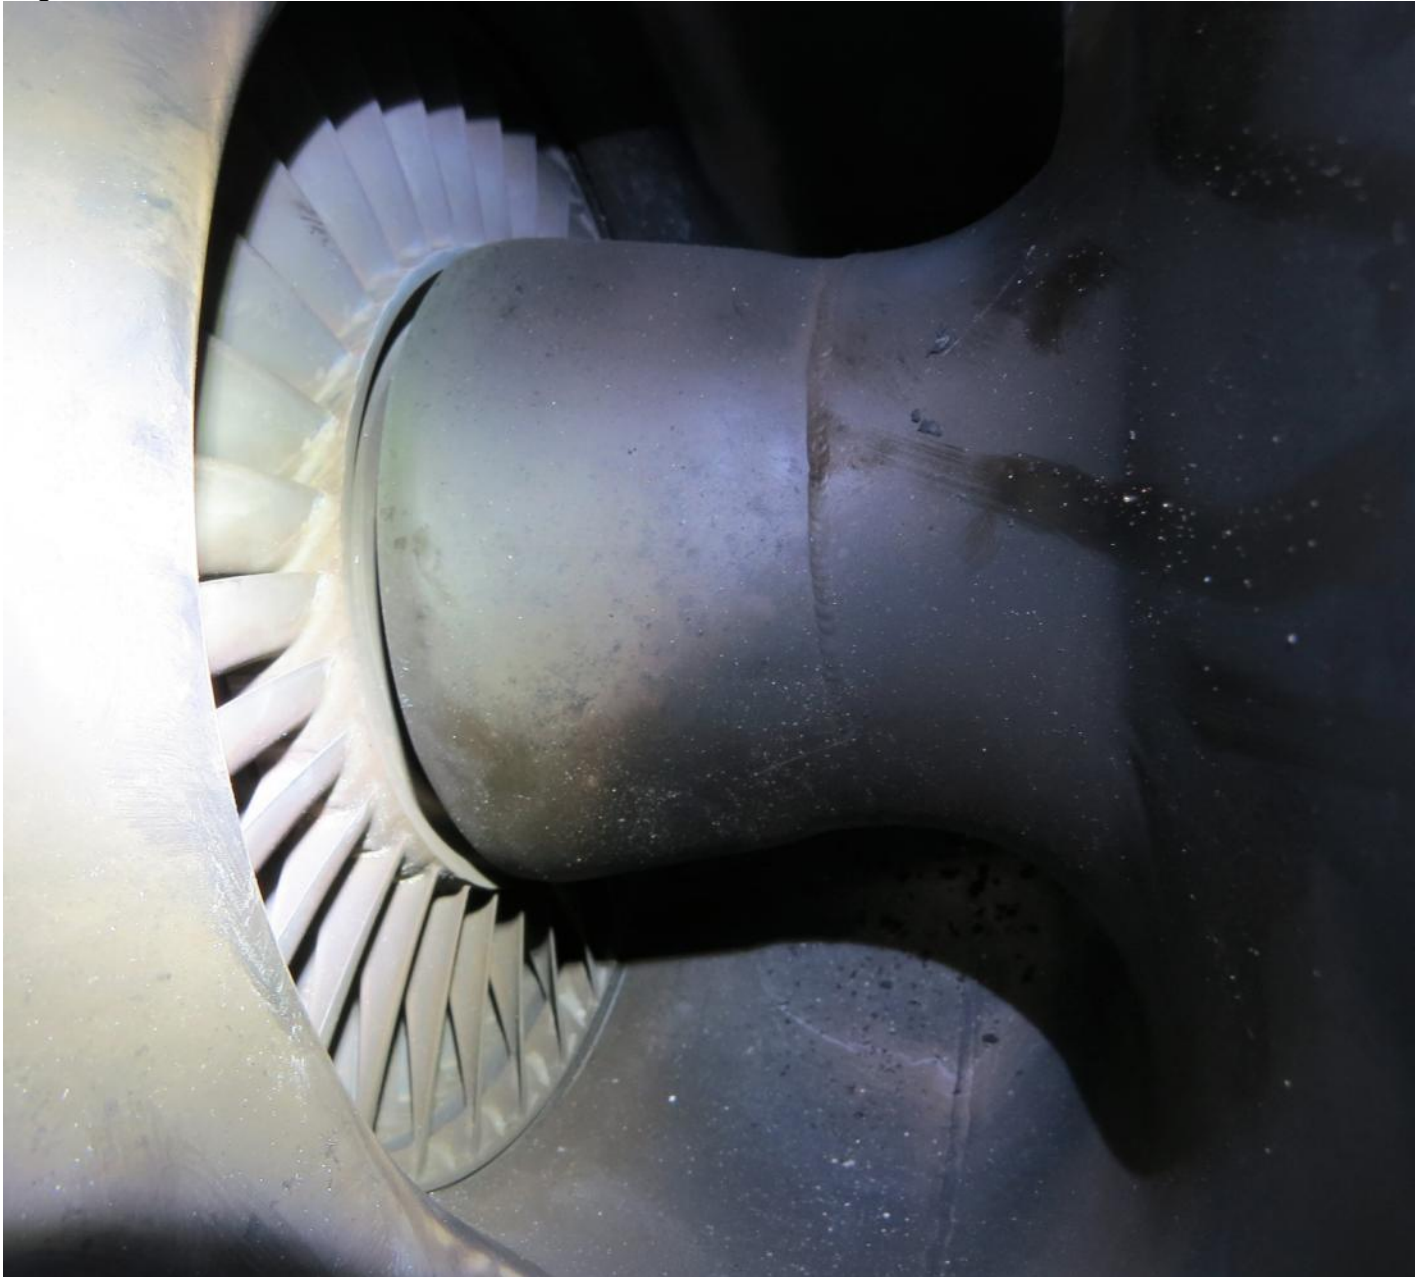
The turbine module exhibited no evidence of operational failure or malfunction. Visual inspection of the 4<sup>th</sup> stage (power turbine) revealed no evidence of FOD, operational damage or thermal degradation.

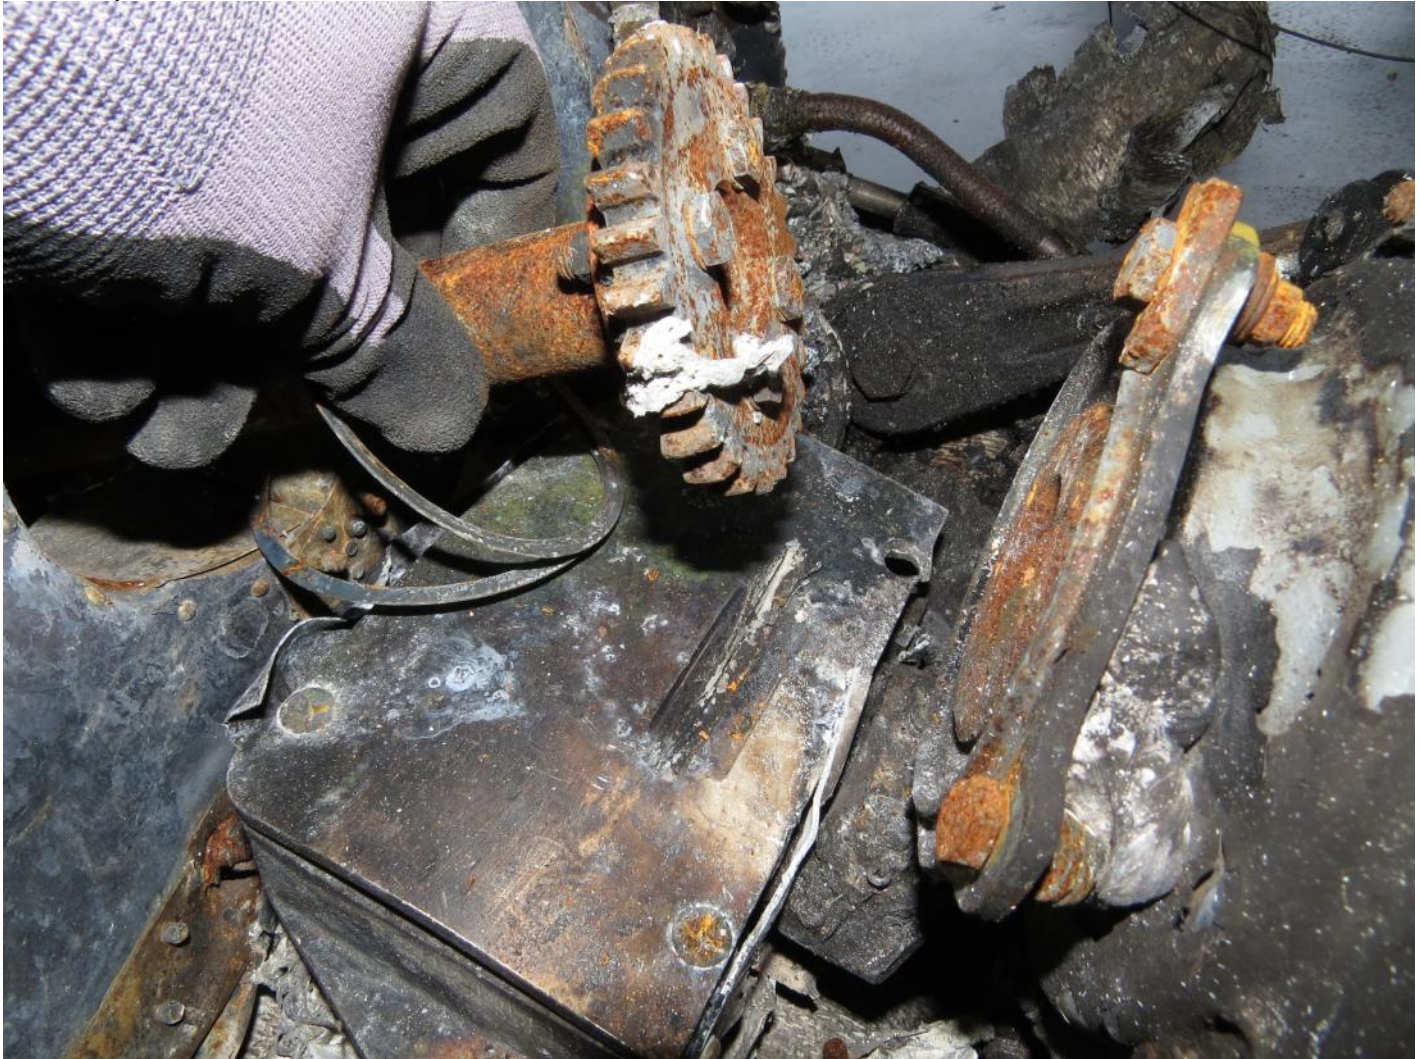
The igniter was removed to permit boroscope inspection of the 1<sup>st</sup> stage (gas generator turbine). Visual examination revealed no evidence of FOD or thermal degradation of the 1<sup>st</sup> stage nozzle or turbine blades. A significant quantity of metal slivers and chips were found adhered to the leading edges of the 1<sup>st</sup> stage turbine nozzle. Shiny metal splatter was also noted adhered to the turbine nozzle shield. The source of the metal slivers and chips was determined to be from the engine inlet plenum, where the airframe isolation mount was exposed to the rotating splined connector that disintegrated after the initial crash. The evidence observed is consistent with continued engine operation after impact, causing the splined connector to grind away material from the isolation mount which, in turn, was ingested by the engine and deposited within the turbine section. It is presumed that this metal ingestion was also the cause of the minor FOD damage noted earlier on the compressor blades.

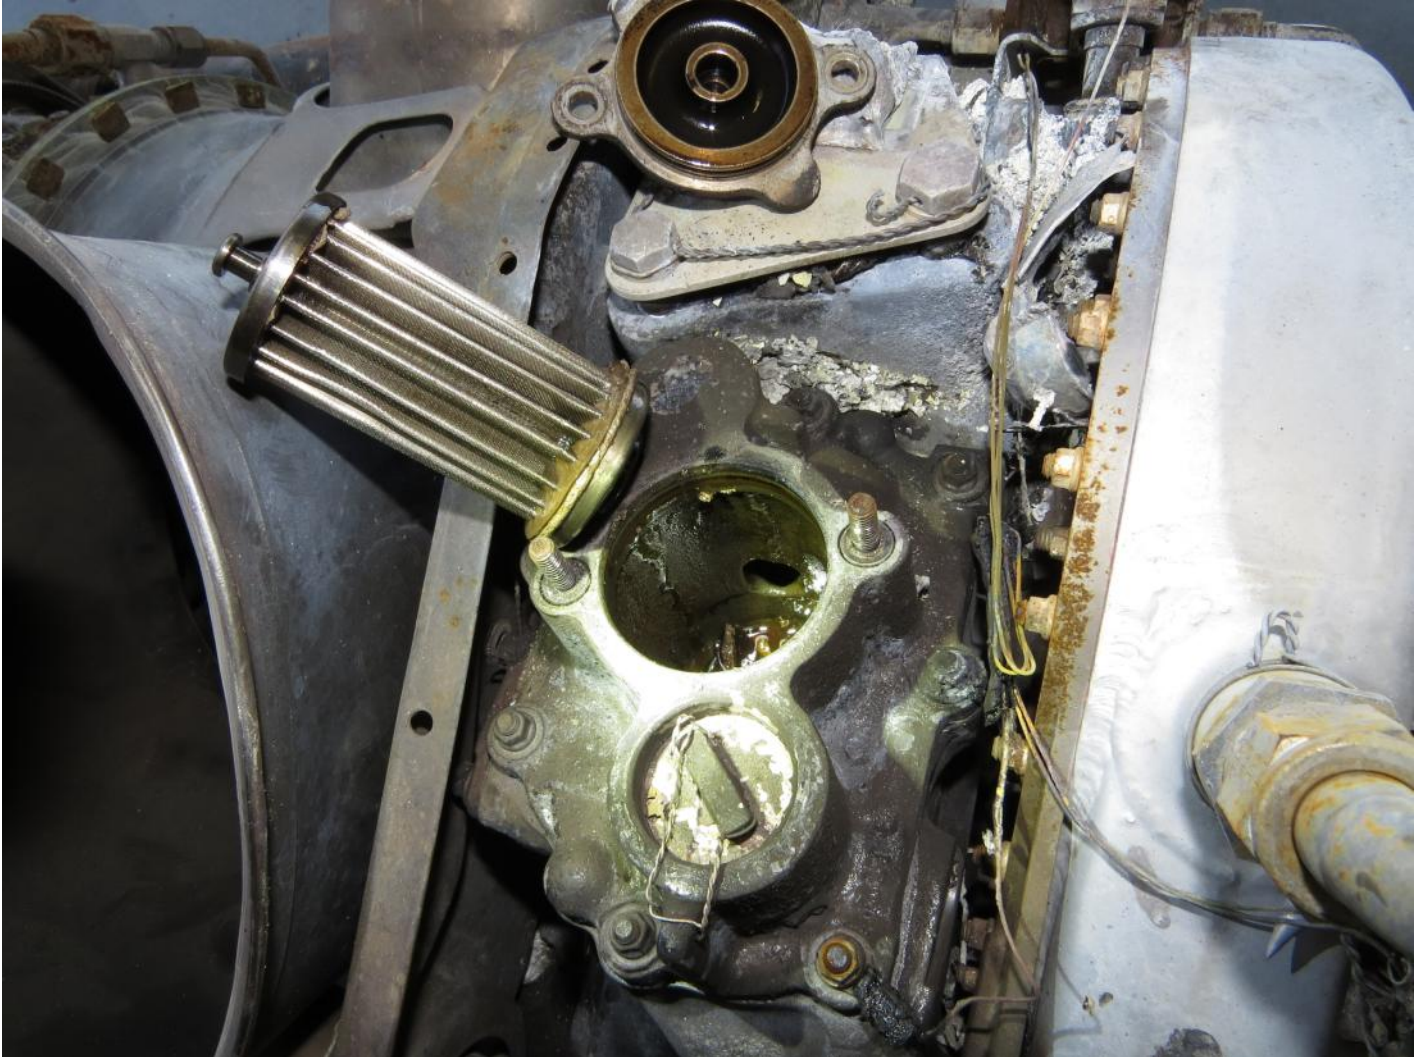
The engine's lubrication system, along with both magnetic chip detectors, was mostly consumed by fire. The engine-mounted oil filter was intact and examined. It had been exposed to intense heat, and some of the filter's solder had melted and re-solidified within the filter housing and at the base of the filter itself. Otherwise, the filter was free of any debris.

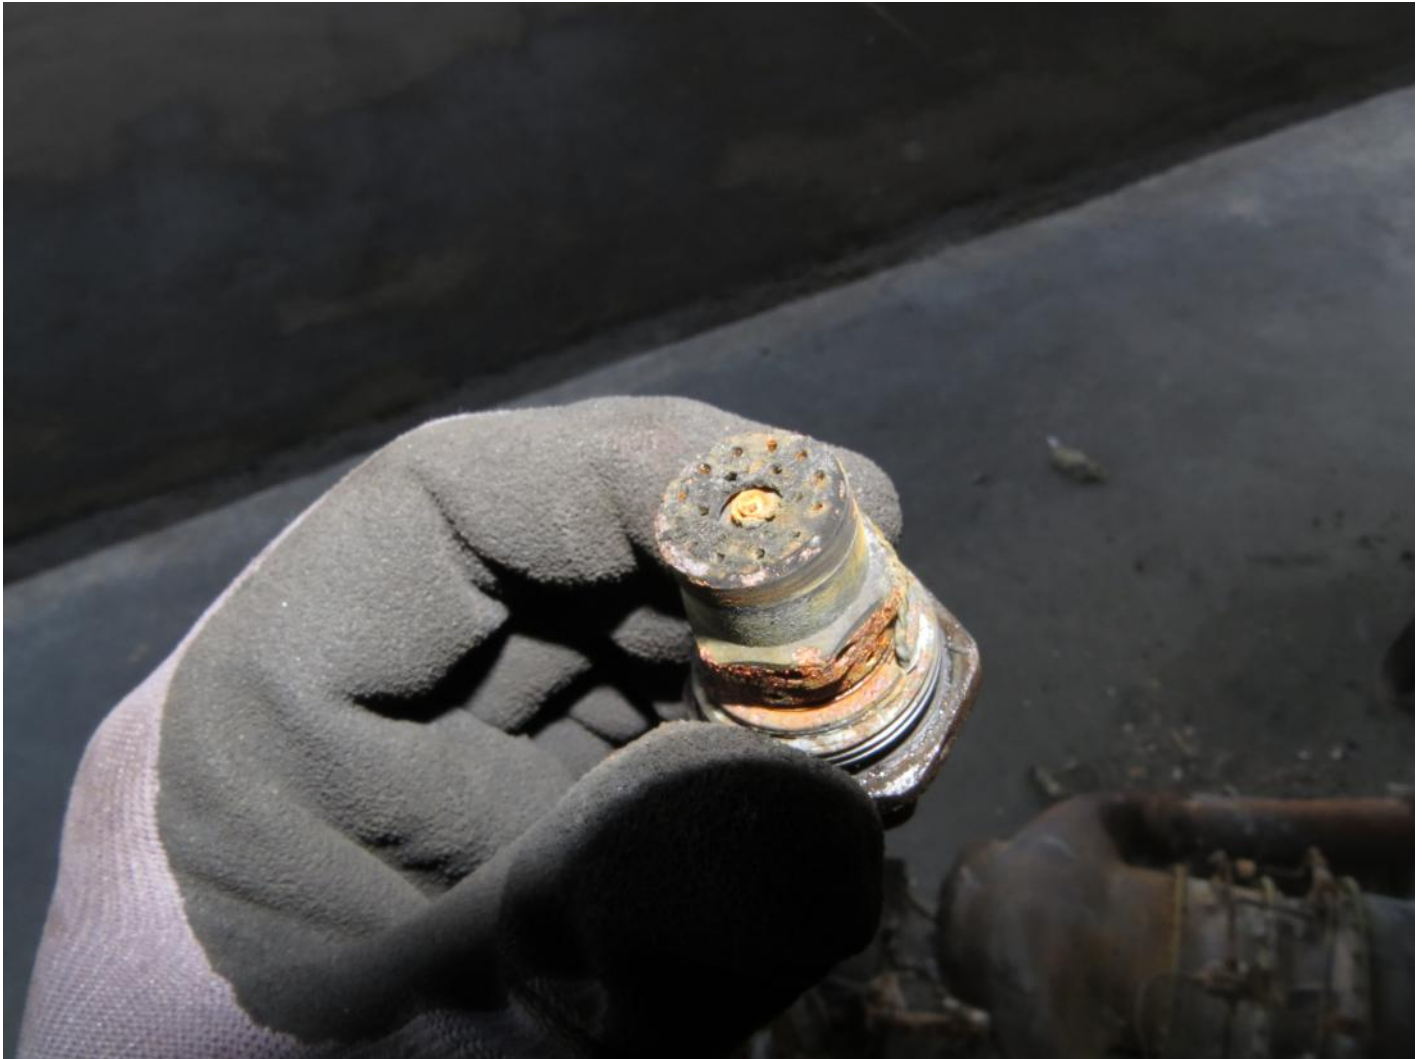
The Fuel Spray Nozzle was removed and examined. The spray face was corroded but otherwise unremarkable.
