**WPR18LA215**  
**Photos courtesy Northern Air Inc and USFS**

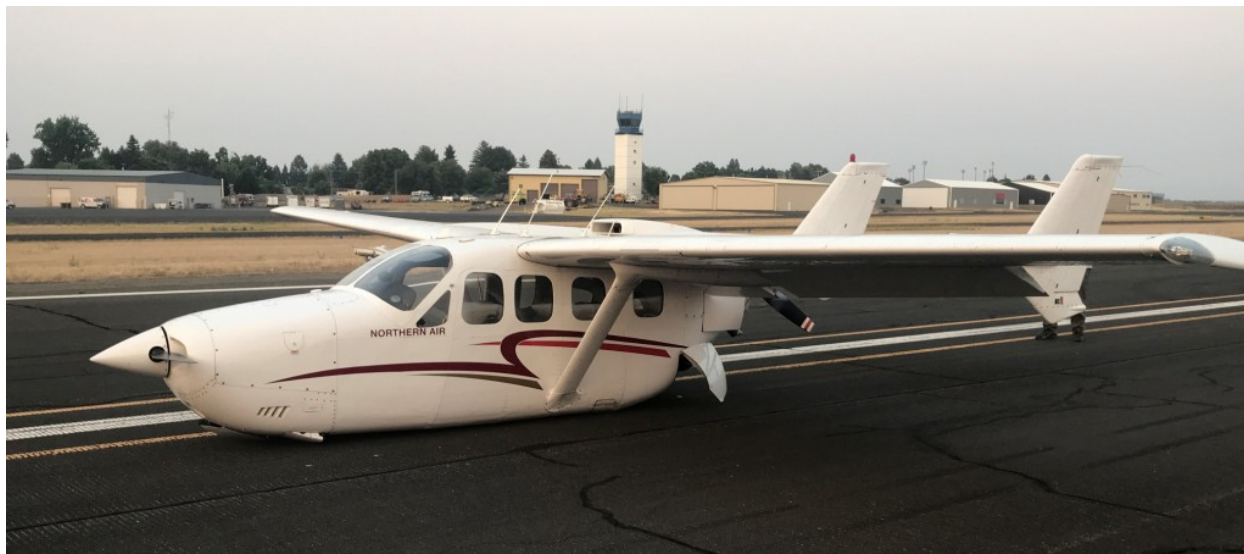
**Figure 1 - Airplane on Runway**

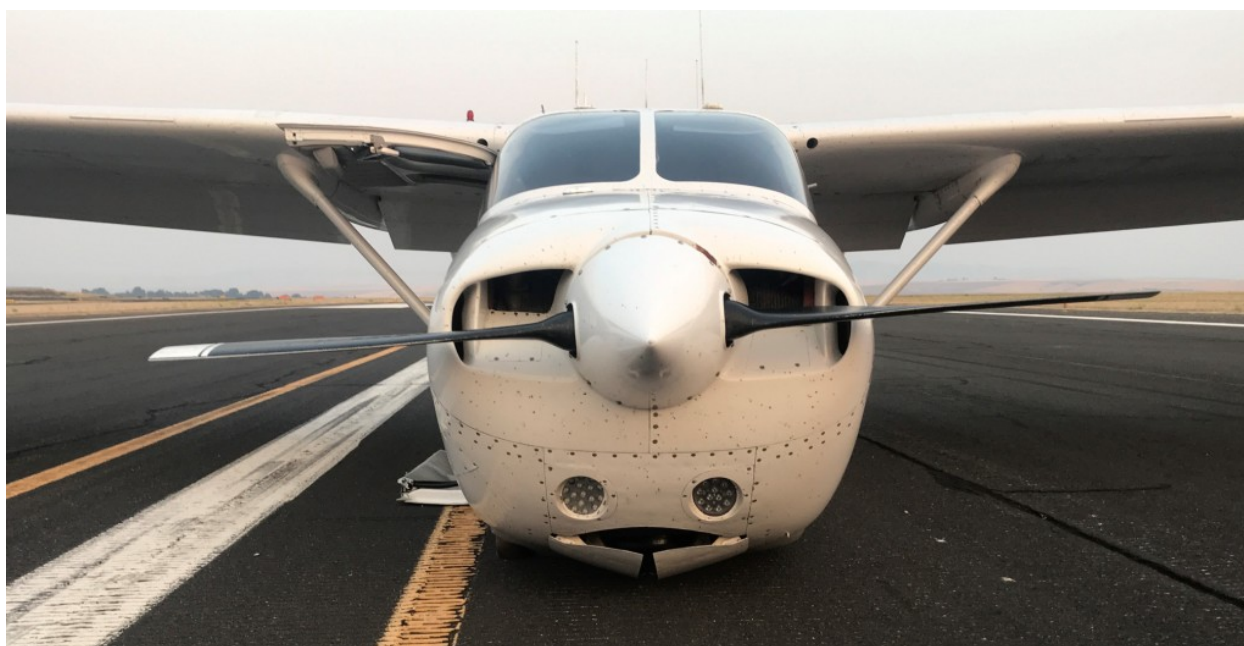
**Figure 2 - Airplane on Runway**

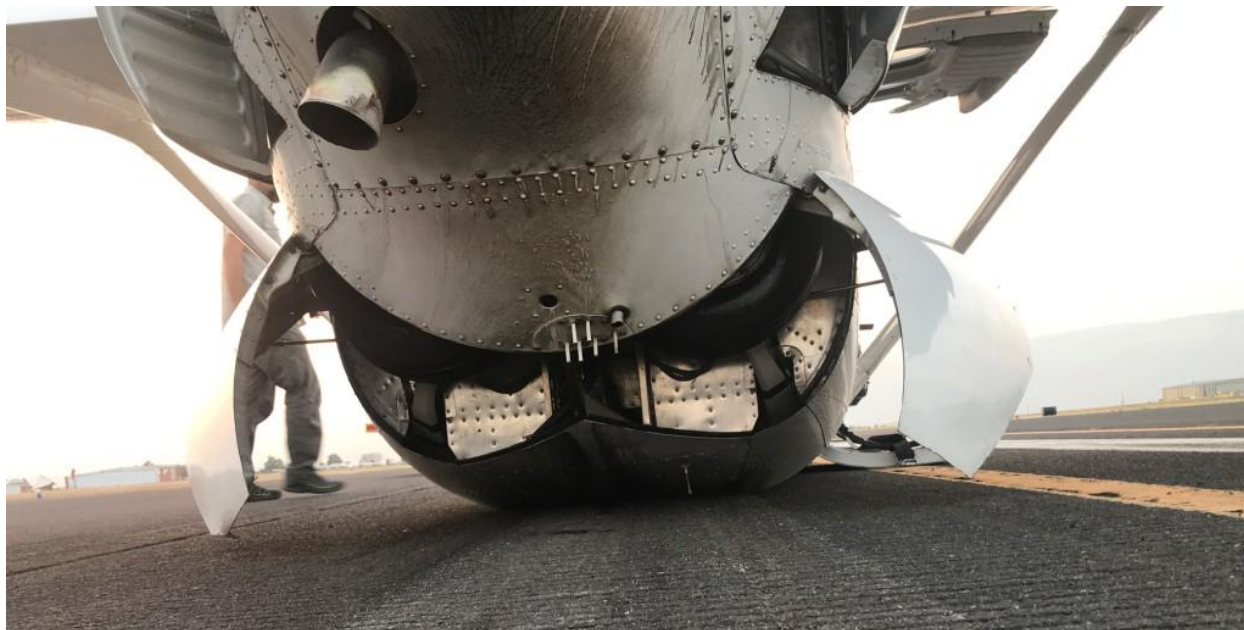
**Figure 3 - Aft View of MLG Wells**

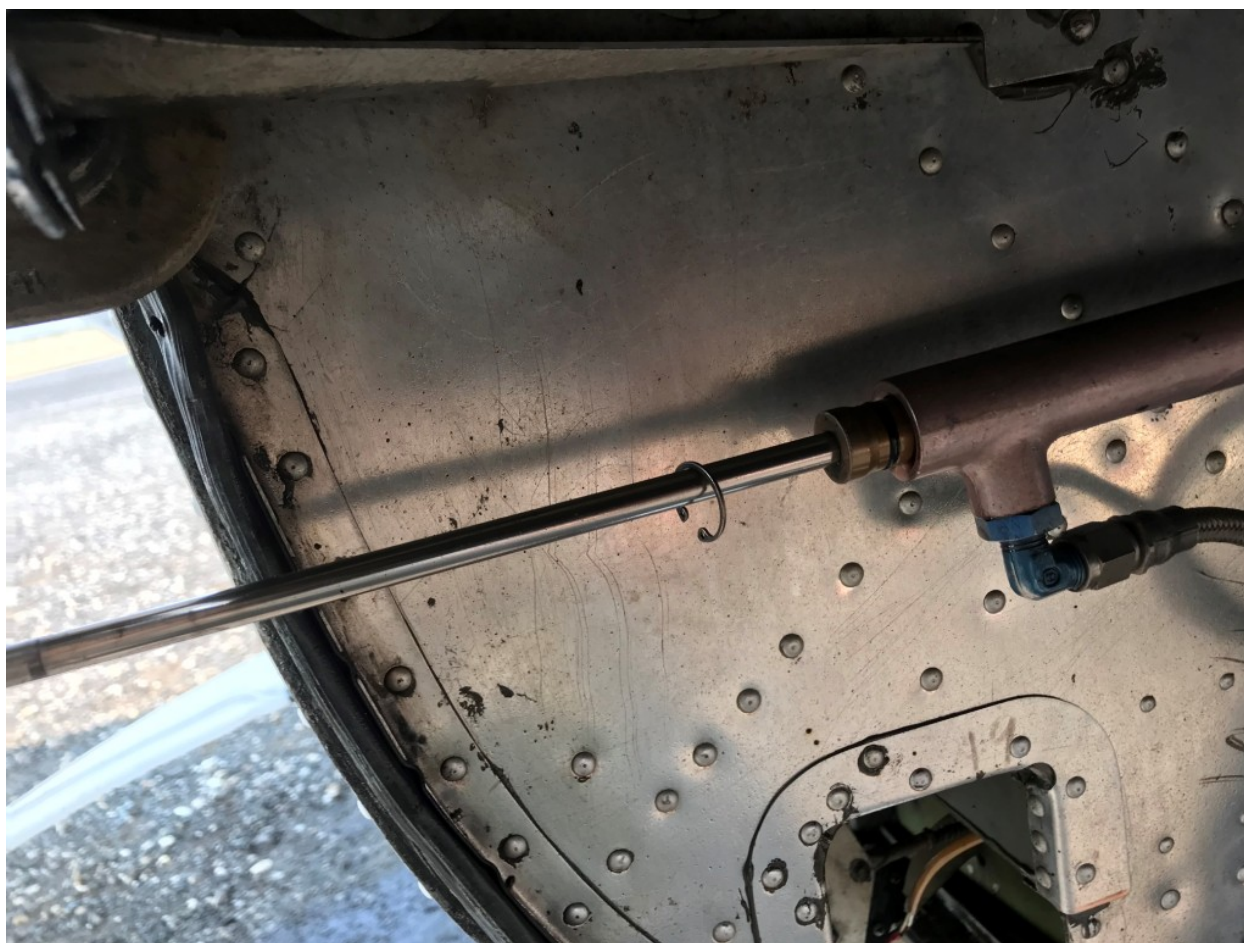
**Figure 4 - Left MLG Door Actuator w Circlip & Rod**

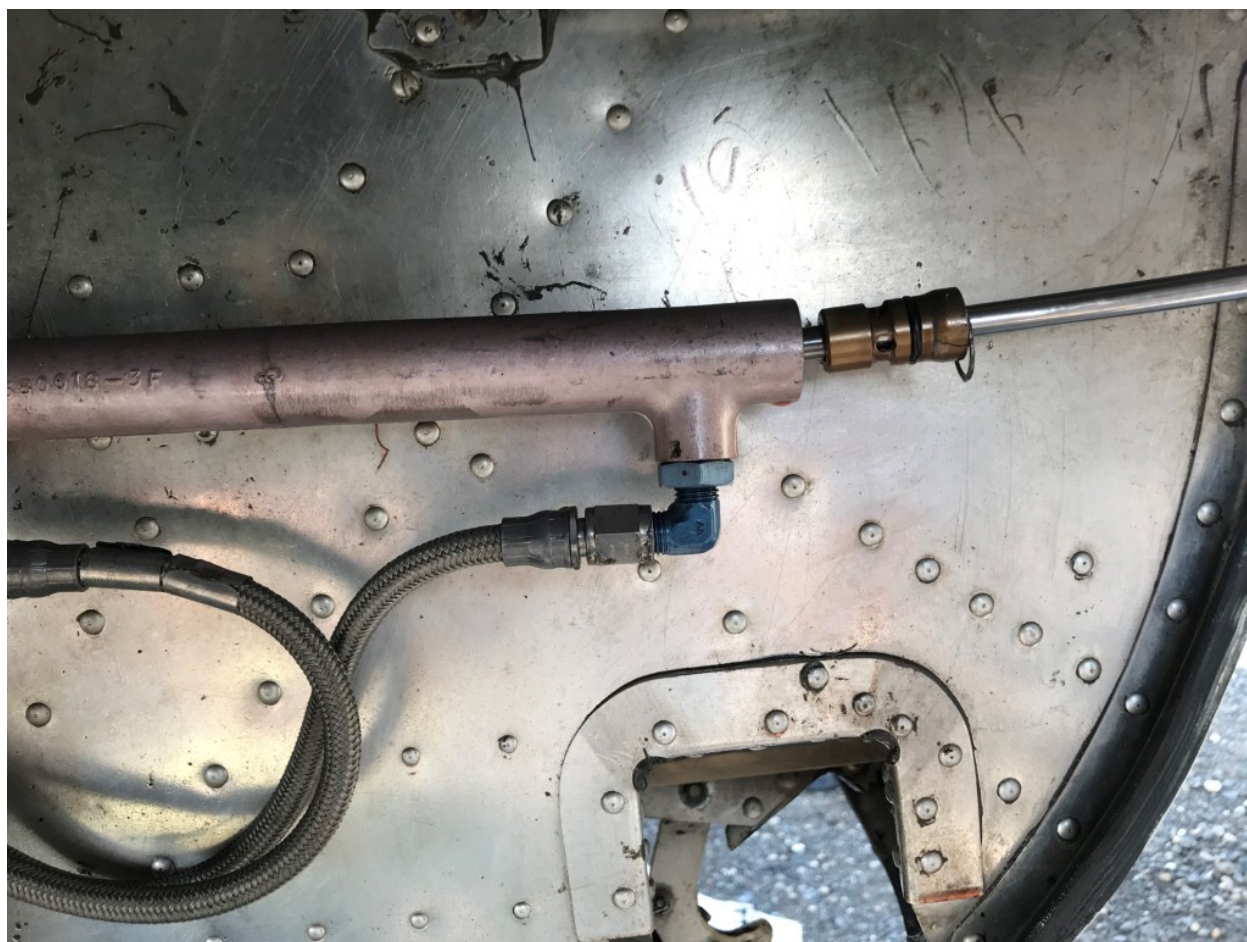
**Figure 5 - Right MLG Door Actuator w Circlip & Rod**

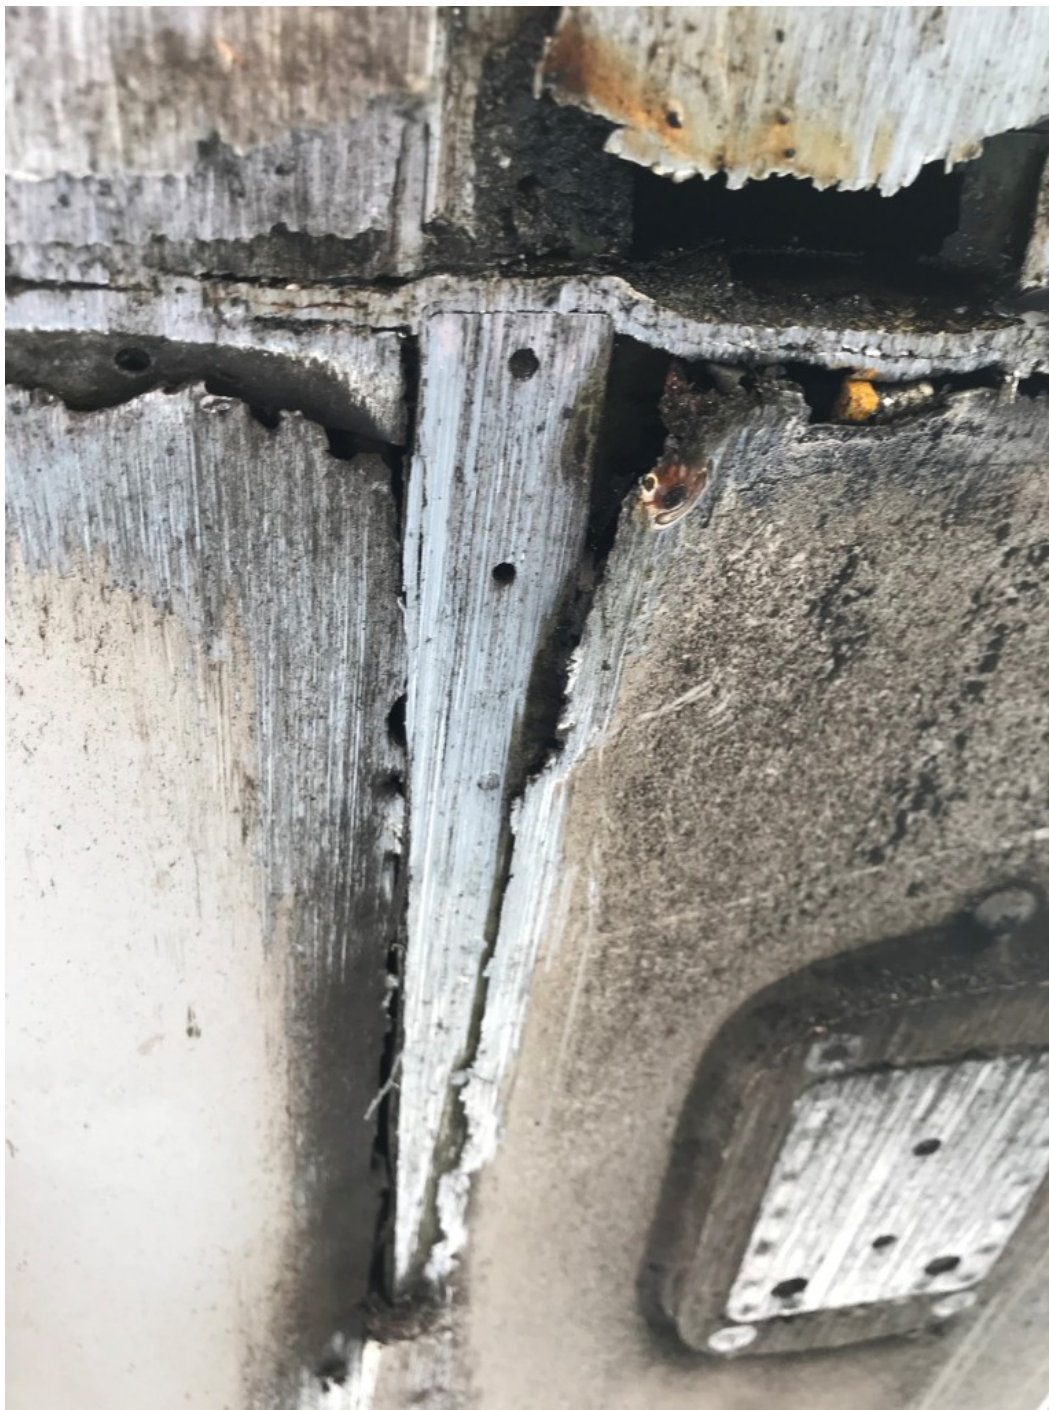
**Figure 6 - Fuselage Lower Skin Damage**

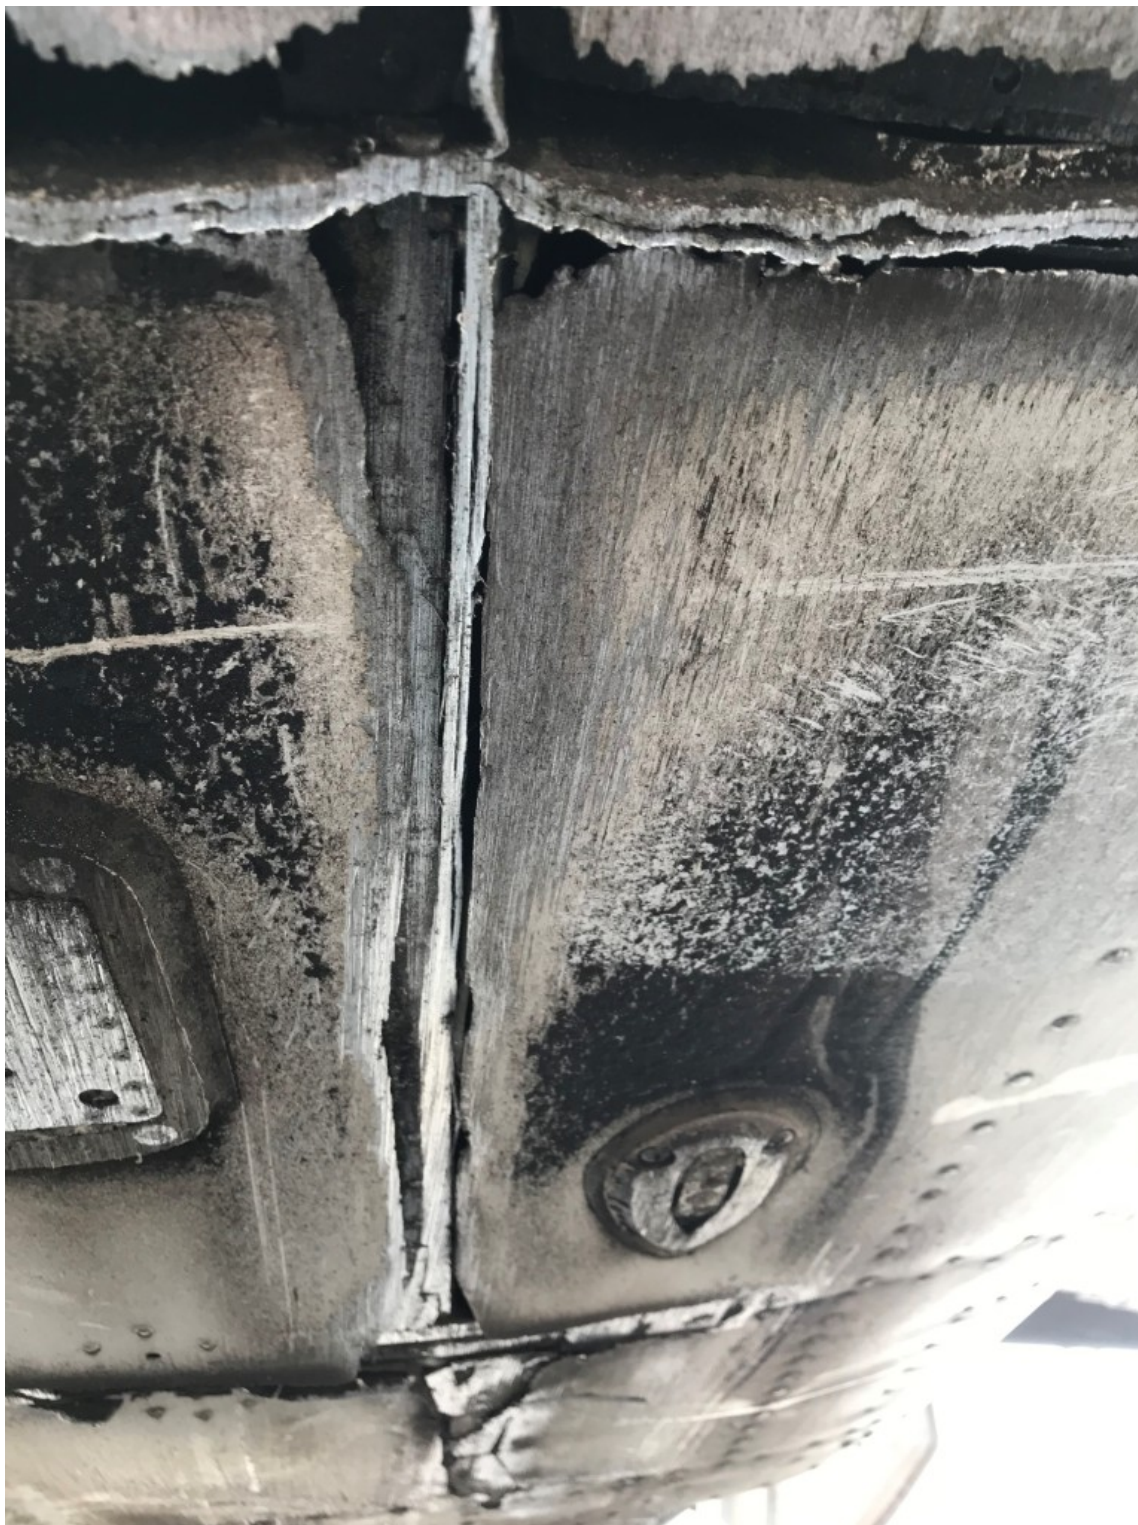
**Figure 7 - Fuselage Lower Skin Damage**

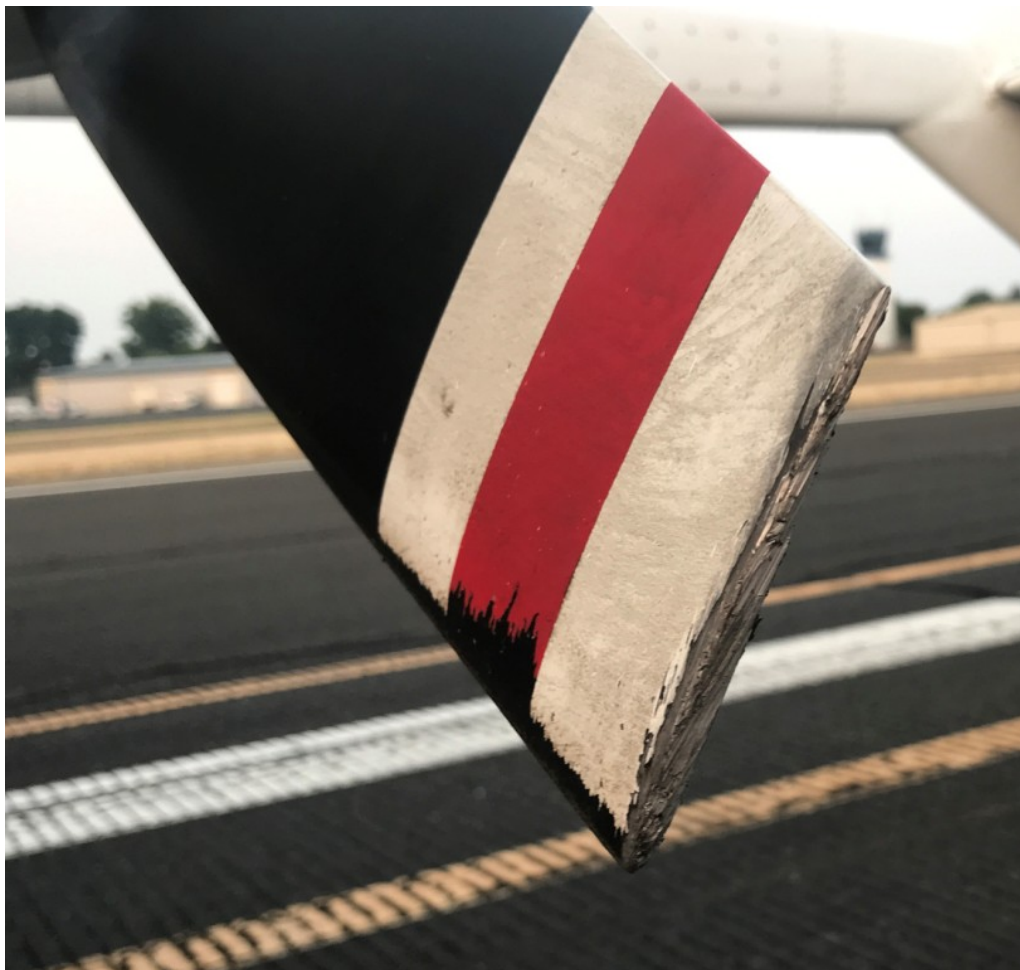
**Figure 8 - Rear Propeller Tip Damage**
