## RECORD OF CONVERSATION

**Date: August 14, 2018**  
**Person Contacted: Mr. Destin Hinton (Federal Aviation Administration Inspector)**  
**NTSB Accident Number: WPR18LA217**

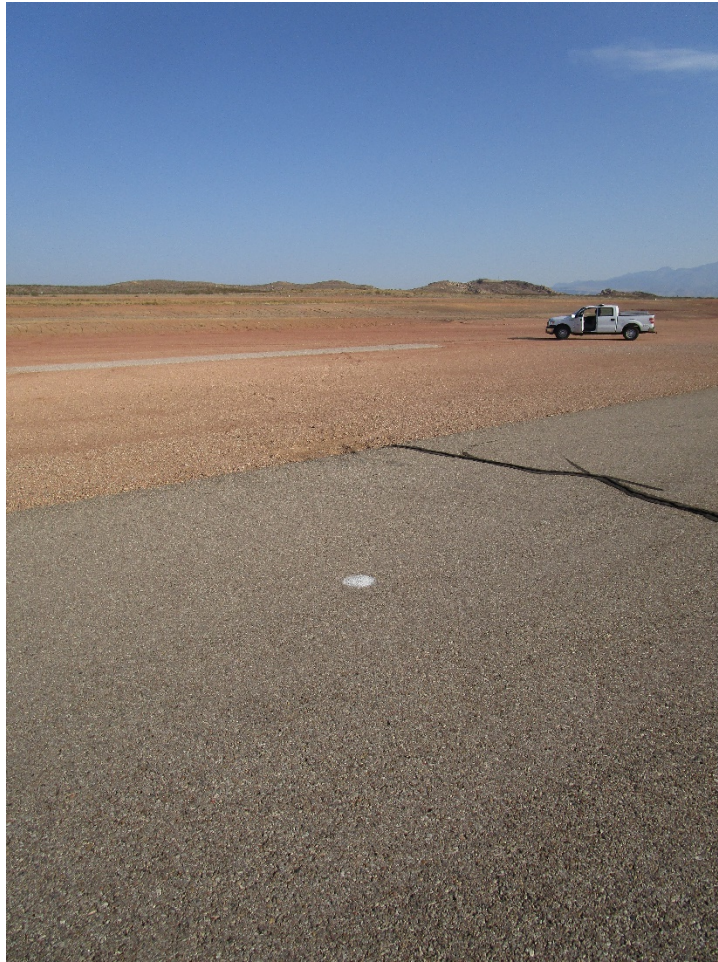
*Figure 1: Damage to Runway and Adjacent Dirt*

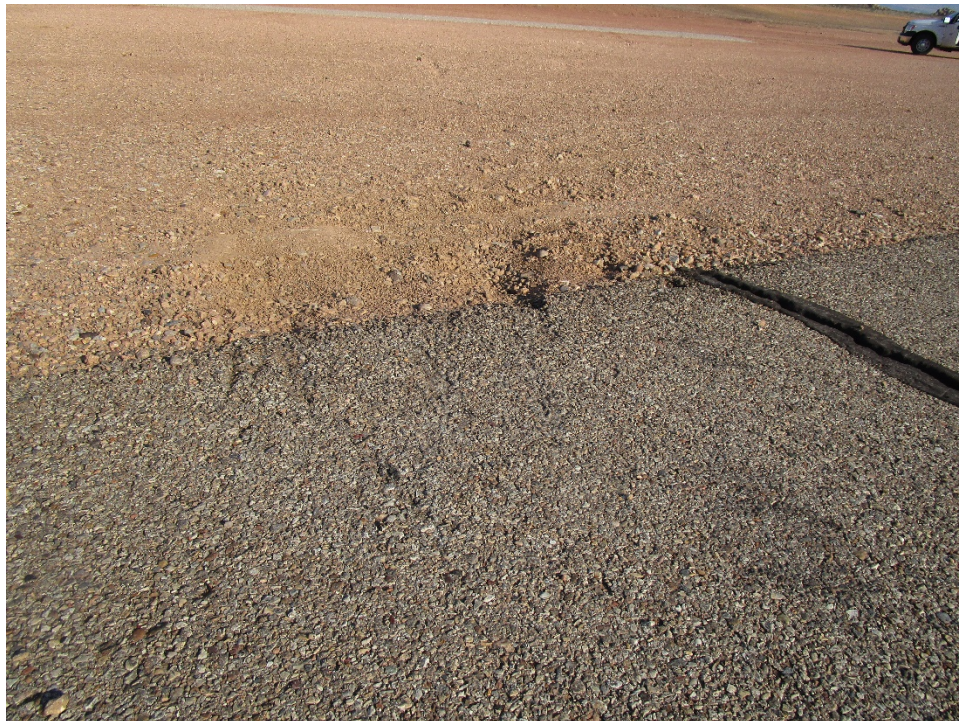
*Figure 2: Damage to Runway Edge*

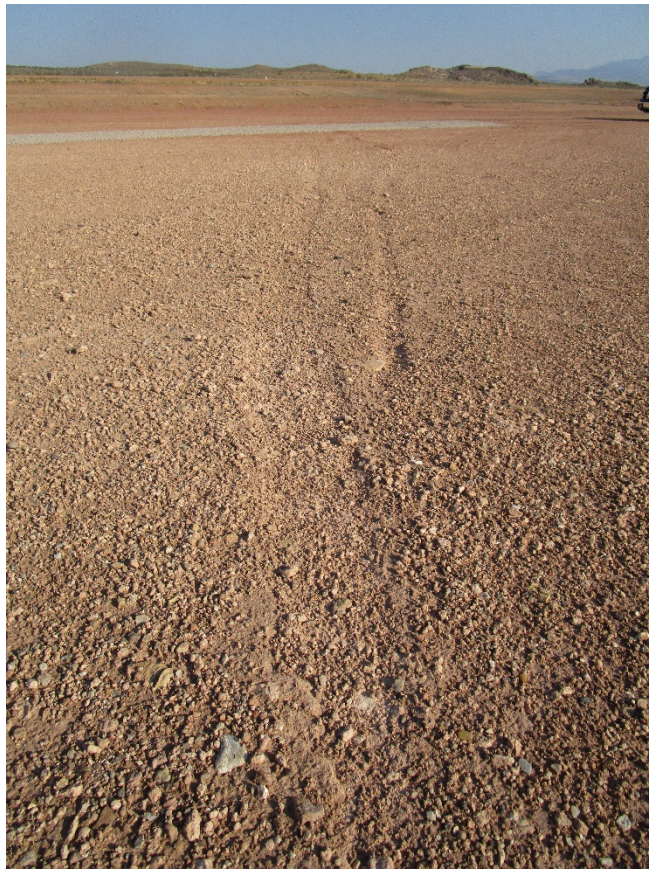
*Figure 3: Disturbed Dirt*

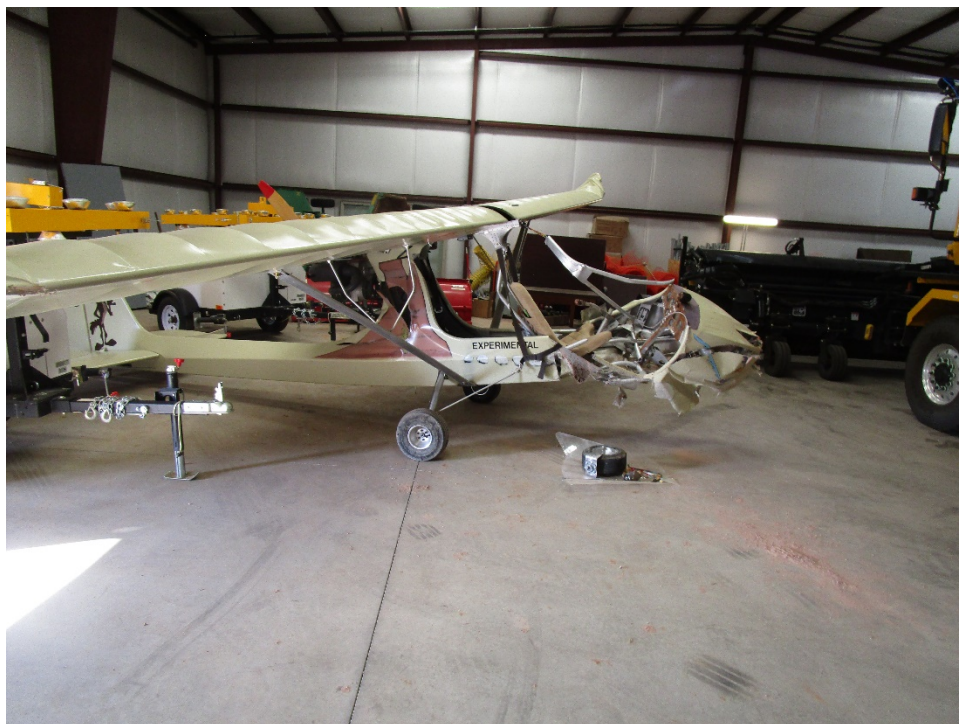
*Figure 4: Right Side of Airplane*

- Both the left and right wing exhibited upward crush damage to the wingtips
- The tail was mostly undamaged.
- The cabin and fuselage structure were twisted, and the fabric was ripped in various locations throughout.

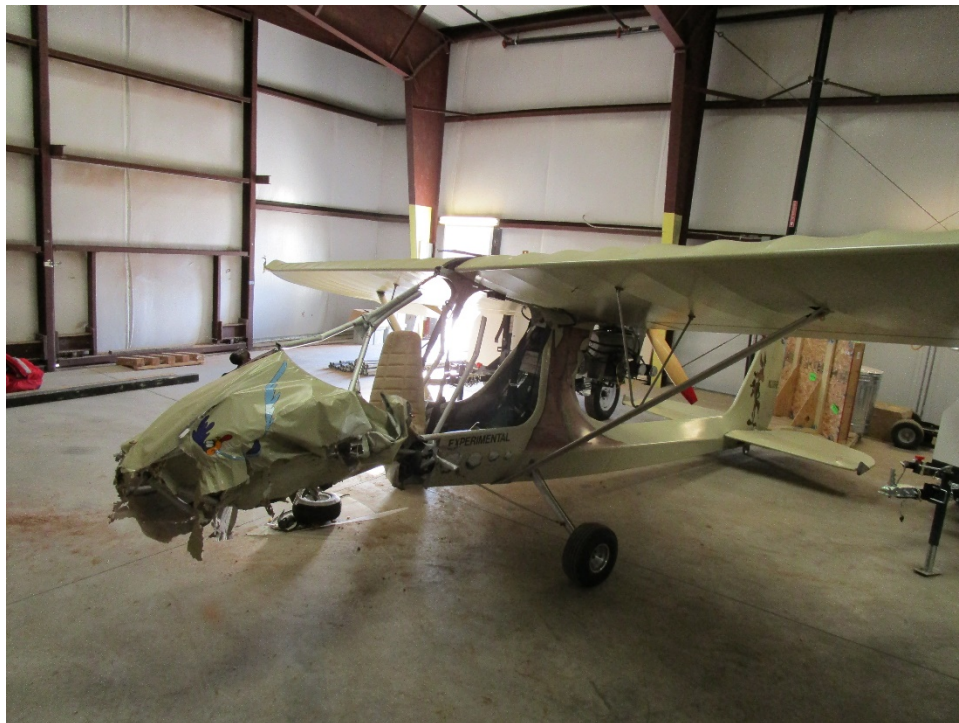
*Figure 6: Left Side Forward Fuselage*

- The nosewheel was fracture separated and the airplane came to rest in a nose down attitude.
- The forward fuselage was bent towards the left and the cabin area exhibited rotational damage.
