# NATIONAL TRANSPORTATION SAFETY BOARD

## MATERIALS LABORATORY FACTUAL REPORT

Report No. 19-030

Place : Honolulu, Hawaii  
Date : August 8, 2018  
Vehicle : MD Helicopters 369D, N369MH  
NTSB No. : WPR18LA221  
Investigator : Mike Huhn (AS-WPR) / Van McKenny (AS-40)

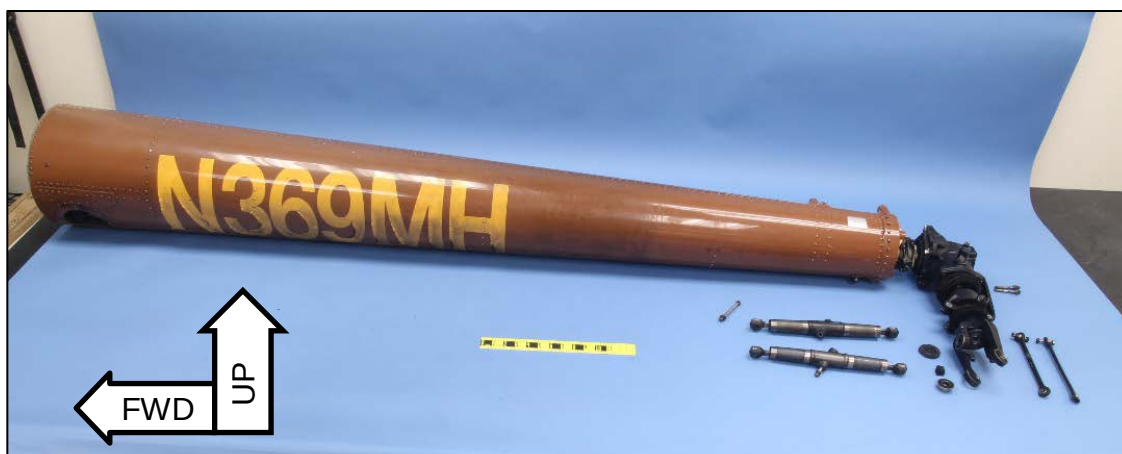
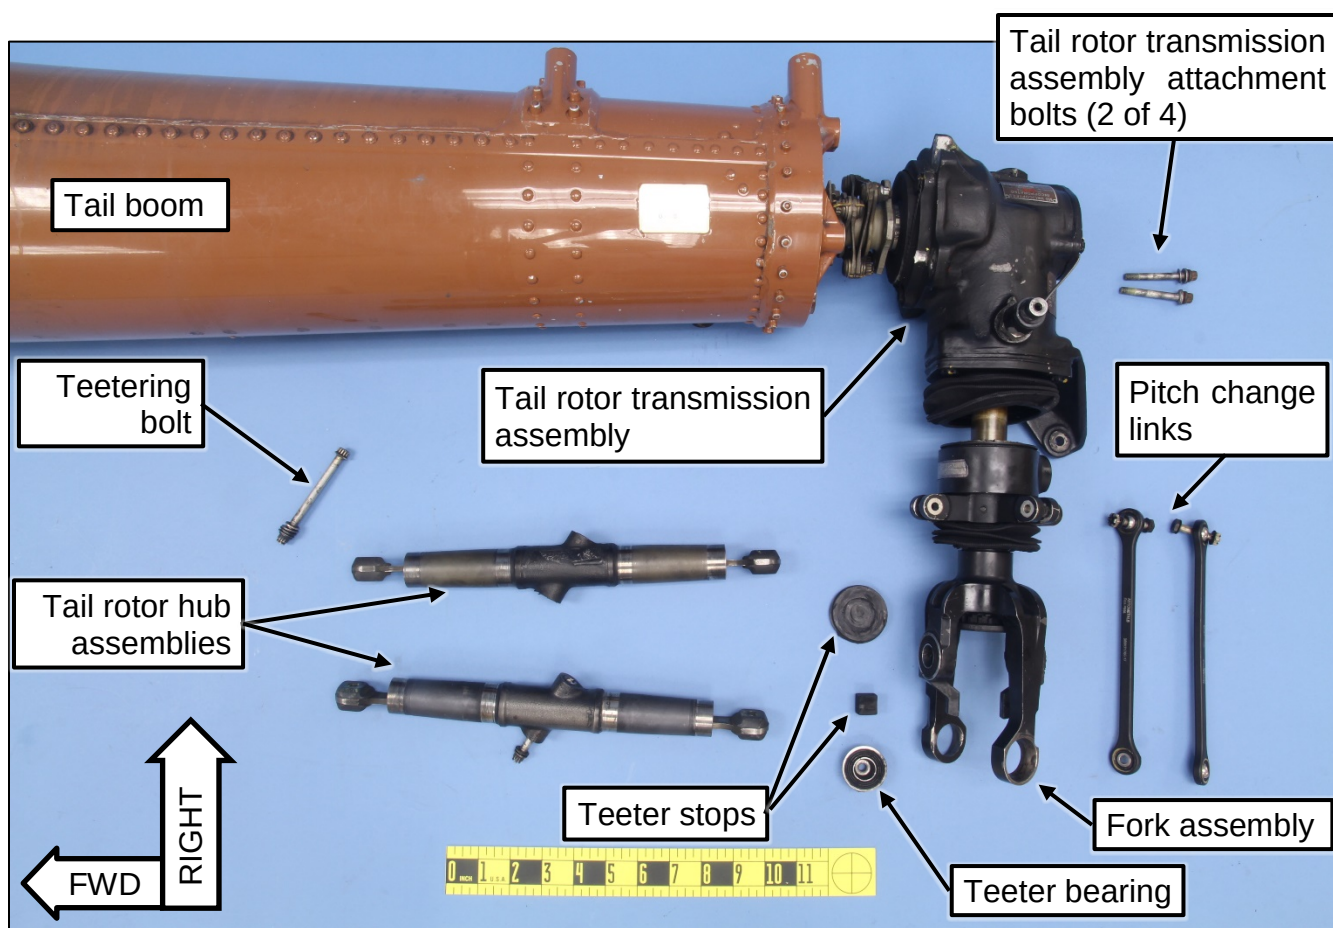
Overall views of the submitted components are shown in figure 1. The tail rotor transmission assembly had fractured from the aft end of the tail boom, and the outboard teetering bolt had fractured. Teeter bearings for the outboard tail rotor blades were fractured from the fork assembly, and one of the outboard teeter bearings was missing. One of the teeter stops for the outboard blades was also missing.

Figure 1. Overall view of the submitted components (upper image) with a closer view of the tail rotor assembly at the aft end of the tail boom (lower image).

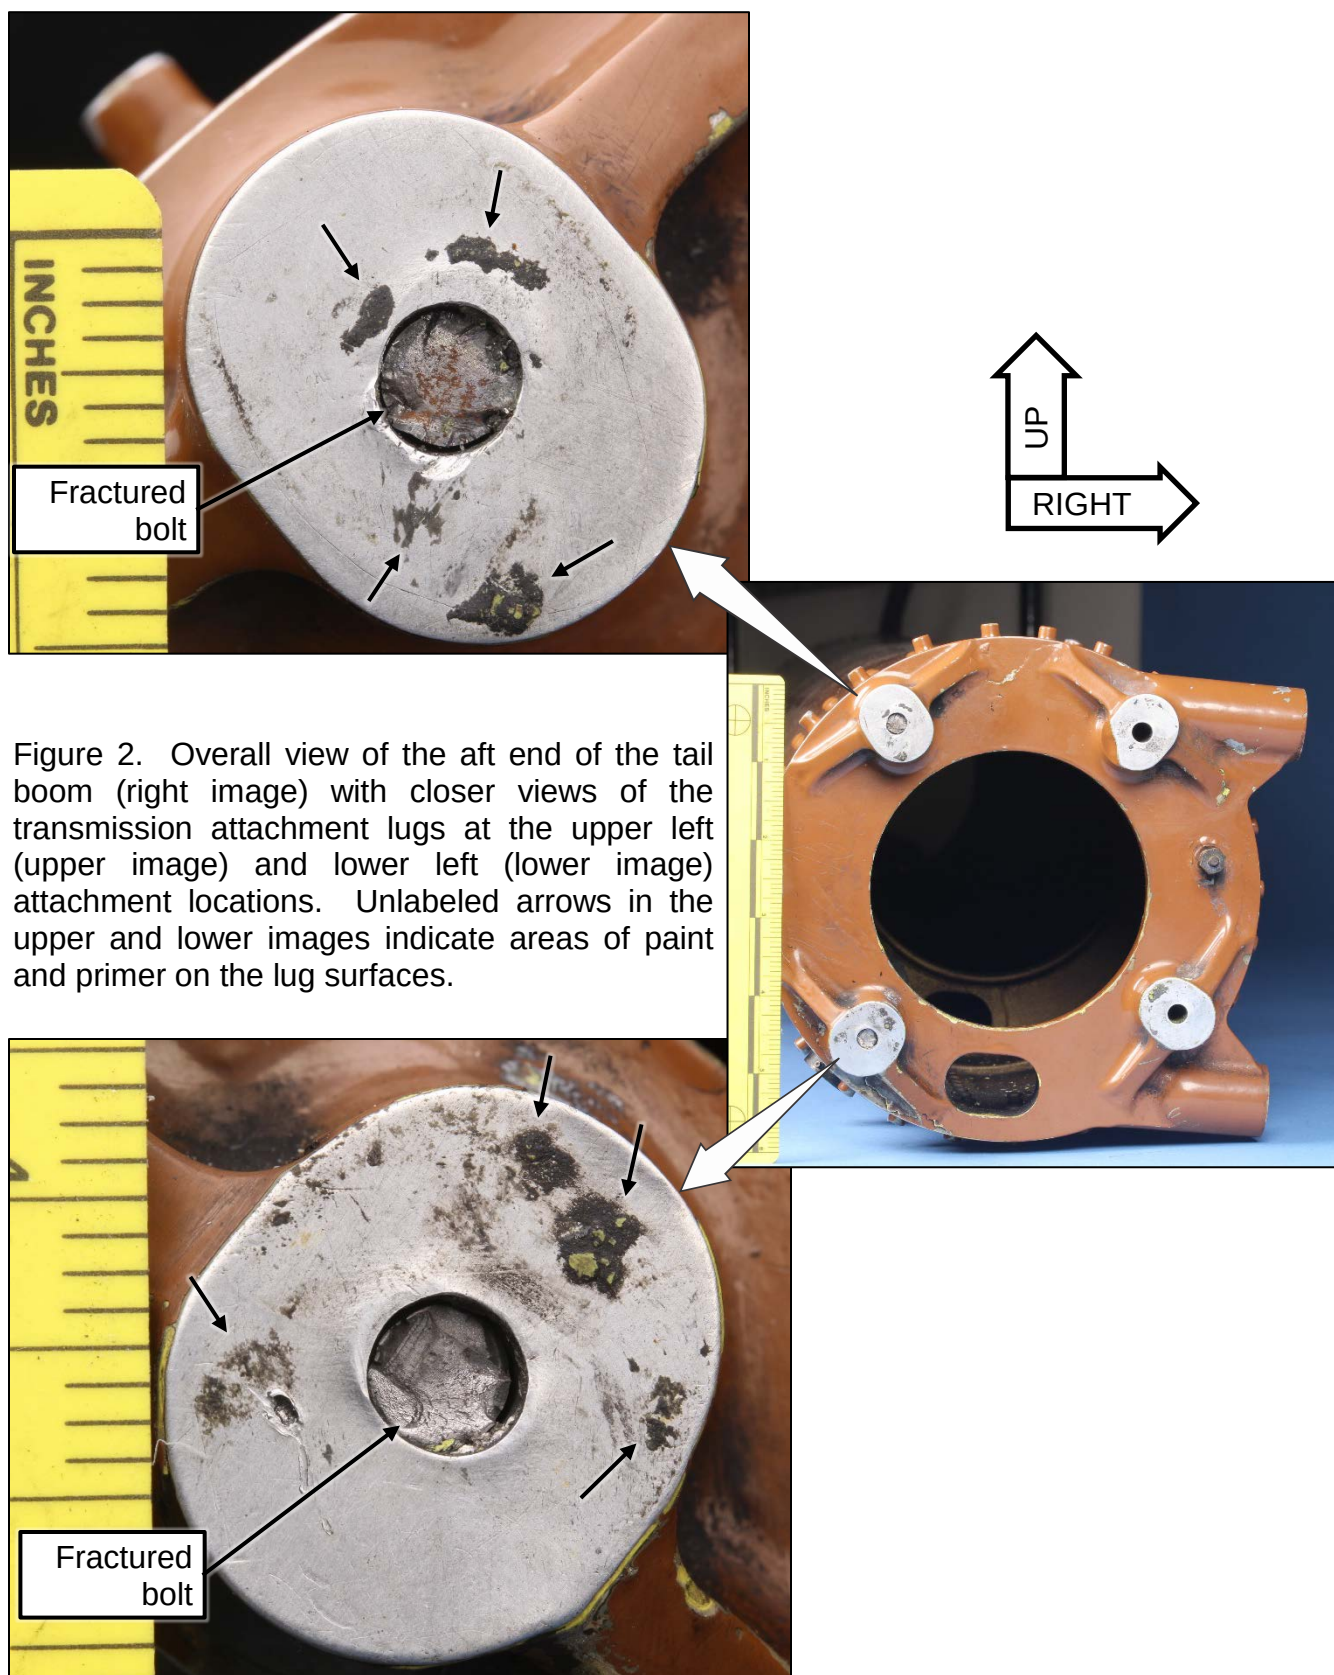
The aft end of the tail boom is shown in figure 2. The operator had reportedly cleaned the mounting lugs on the aft end of the tail boom after the accident. The two tail rotor transmission assembly attachment bolts at the left side of the tail boom were fractured, and closer views of the tail boom lugs with the fractured attachment bolts are

shown in the upper and lower images in figure 2. On the right side of the tail rotor transmission housing, the lugs on the attachment flange were fractured as shown in figure 3. The assembly attachment bolts from the right side were intact and were received disassembled from the tail boom as shown in figure 1.

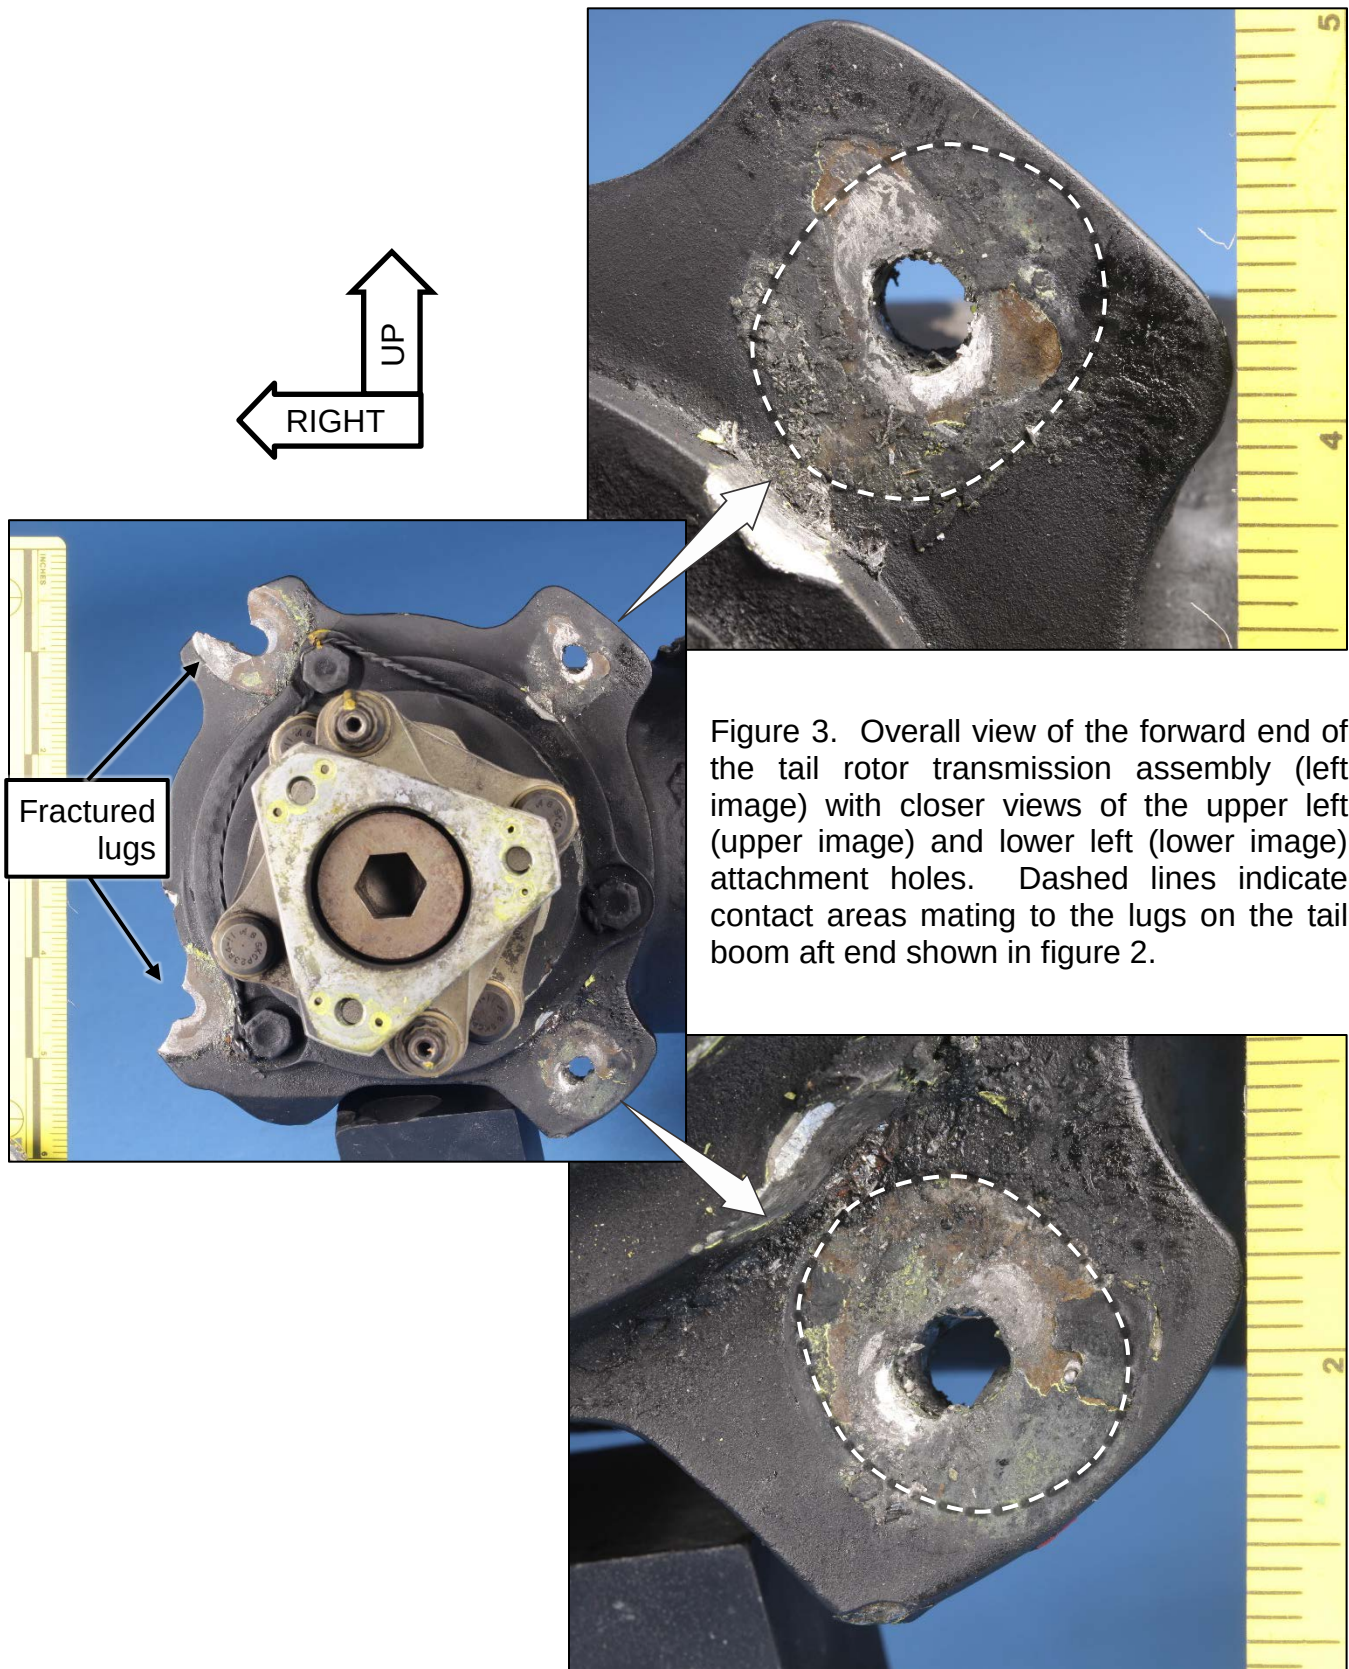
The tail rotor transmission housing was painted black and had a yellow-green layer under the black paint consistent with primer. Primer and paint were observed on the contact areas where the tail rotor transmission housing lugs mated to the tail boom lugs. Dashed lines in figure 3 indicate the areas on the left side of the tail rotor transmission housing flange that mated to the tail boom lugs. A piece of the paint and primer was flaked from the surface of the transmission housing flange with a scalpel, and the thickness measured 0.0058 inch. In figure 2, unlabeled arrows indicate black and yellow-green deposits that were observed on the mating surfaces of the tail boom lugs consistent with paint and primer transfer from the transmission housing to the mating tail boom lug surfaces. According to the OEM component overhaul manual, instructions for preparing the tail rotor transmission assembly for painting include a requirement to “mask all exposed gearshafts, input and output seals, mounting surfaces, holes, and pads.” The OEM maintenance manual notes in the tail rotor transmission installation instructions, “Ensure all paint and sealant is removed from mating surfaces.”

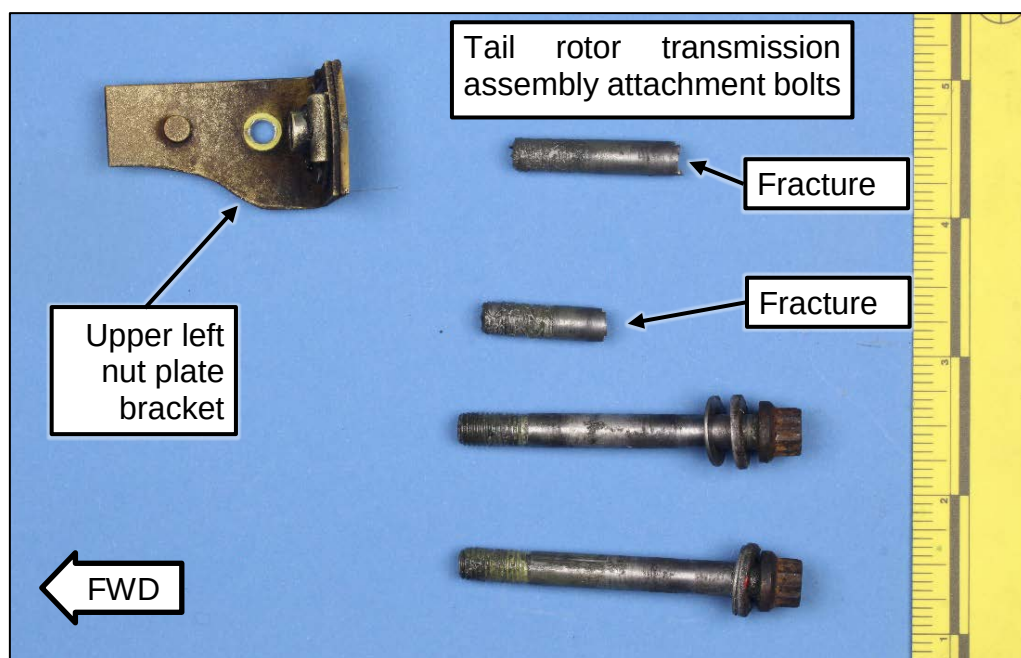
An overall view of the four assembly attachment bolts and the removed upper left nut plate bracket is shown in figure 4. The threads and portions of the grip areas of the attachment bolts appeared to be covered with black greasy deposits. A yellow-green coating consistent with primer was also noted on the threads. Slivers of fractured threads were observed intermixed with deposits on the threads of the lower left attachment bolt. According to the FAA-PMA tail boom maintenance practices in the Instructions for Continued Airworthiness, primer is applied to the assembly attachment bolts, and the assembly is installed while the primer is still wet.

Figure 4. Tail rotor transmission assembly attachment bolts and tail boom upper left nut plate bracket after disassembly from the tail boom.

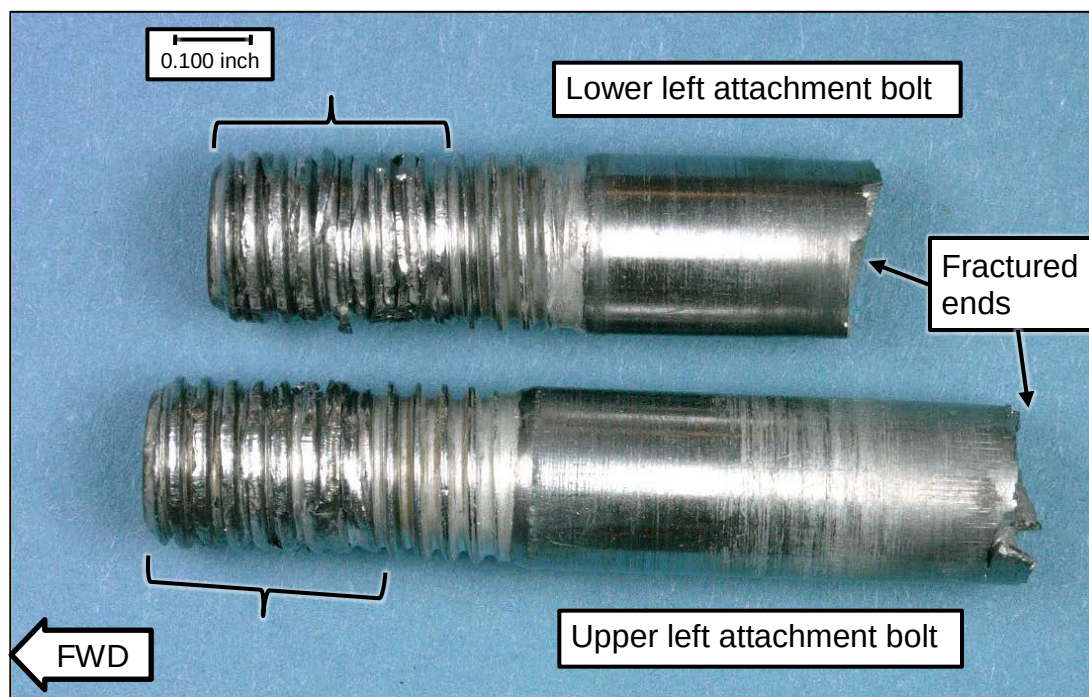
Brackets in figure 5 indicate areas of thread damage where thread peaks were sheared on each fractured attachment bolt. The outer diameter of the threads was measured in the damaged area and where the threads were intact for each fractured attachment bolt. On both fractured attachment bolts, the outer diameters of damaged threads measured 0.233 inch. Intact threads adjacent to the grip on both fractured attachment bolts had an outer diameter of 0.243 inch measured thread peak-to-peak. The specified major diameter of the threads of a MS21250-04026 bolt is 0.2475 inch to 0.2495 inch.

Approximately 9 threads showed evidence of engagement with mating threads on the contact flanks and 8 threads were sheared on each fractured attachment bolt. The MS MS21075L4 locking nut plates into which the bolts were installed had 5 threads along their axial length. According to Aerometals Service Bulletin SB-001, the forward ends of the attachment bolts should extend beyond the nut plate to an extent that 1 to 4 threads should be visible after installation.

Figure 5. Close view of the fractured tail rotor transmission assembly attachment bolts after cleaning. Brackets indicate threads with sheared thread peaks.

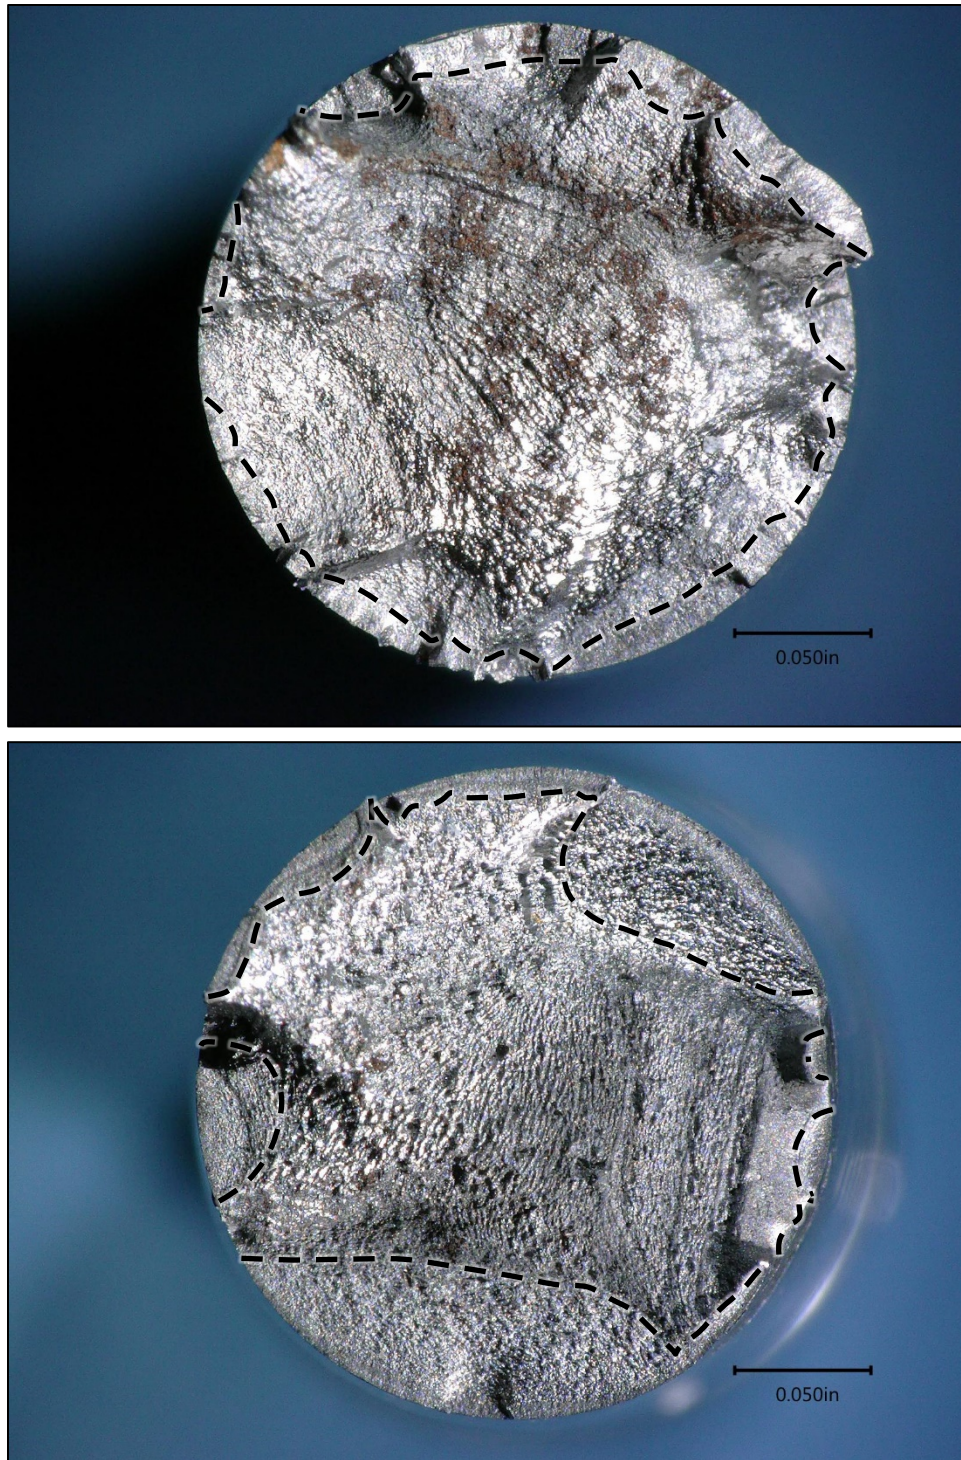
Optical images of the fracture surfaces for the fractured attachment bolts are shown in figure 6, and scanning electron microscope (SEM) images of the fracture surfaces are shown in figure 7. Portions of the fracture surfaces on each fractured attachment bolt had relatively flat fracture features with curving boundaries oriented in a plane perpendicular to the bolt axis, features consistent with fatigue. Dashed lines in figure 6 indicate these fatigue regions. The fatigue cracks initiated from multiple origins at the surface located around the circumference on each fractured attachment bolt and covered a relatively small portion of the total cross-sectional area, features consistent with low-cycle fatigue with relatively high stress levels. Dimple features consistent with ductile overstress fracture were observed in the central portion of each fractured attachment bolt during the SEM examination.

Figure 6. Optical images of the fracture surfaces on the tail rotor transmission assembly attachment bolt pieces from the upper left (upper image) and lower left (lower image) positions. Dashed lines indicate boundaries of relatively flat fatigue regions.

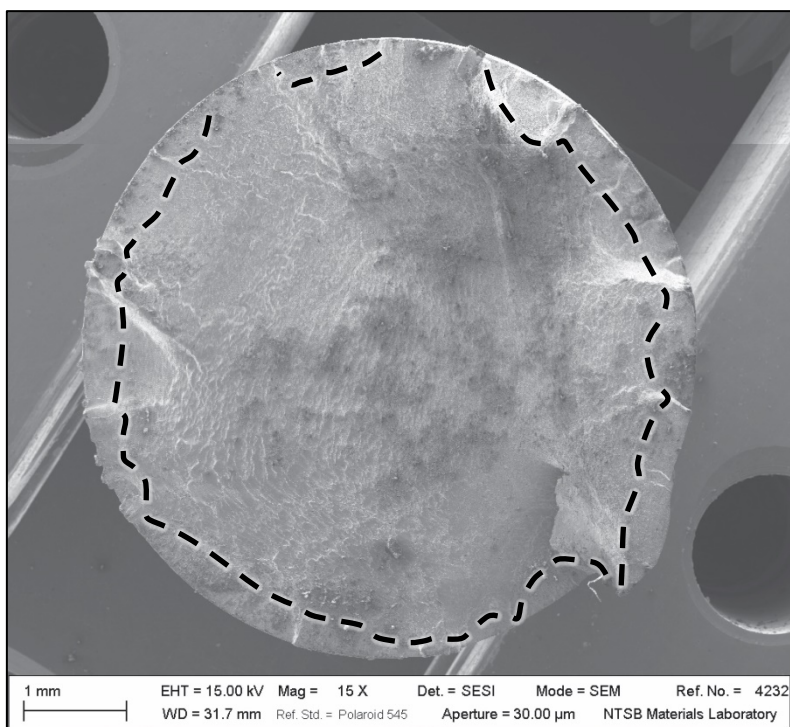
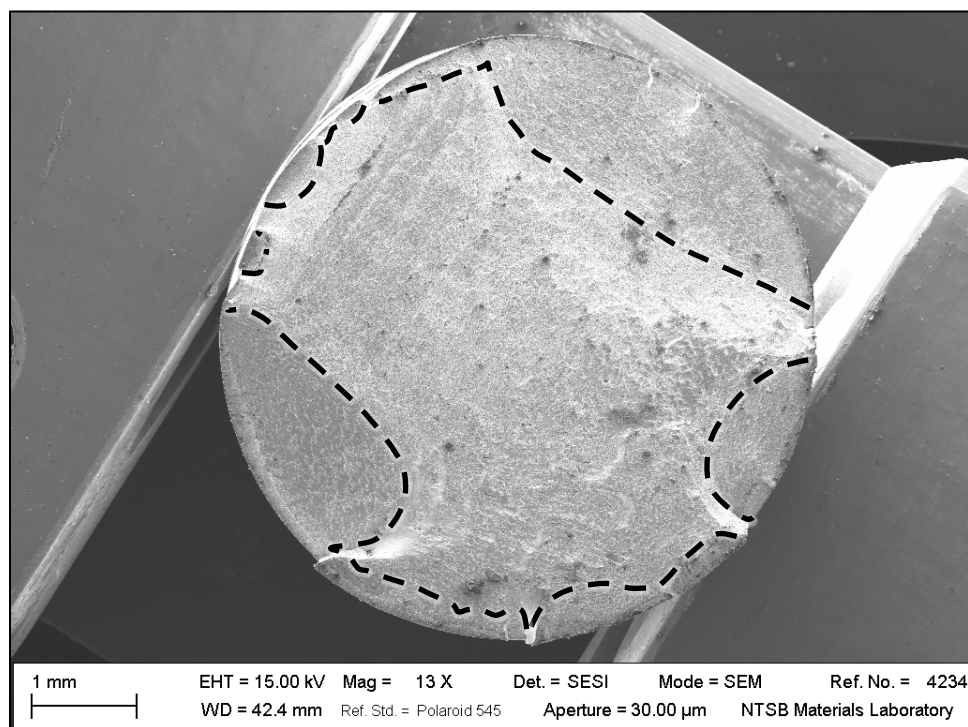
Figure 7. SEM images of the fracture surfaces on the tail rotor transmission assembly attachment bolt pieces from the upper left (upper image) and lower left (lower image) positions. Dashed lines indicate boundaries of relatively flat fatigue regions.

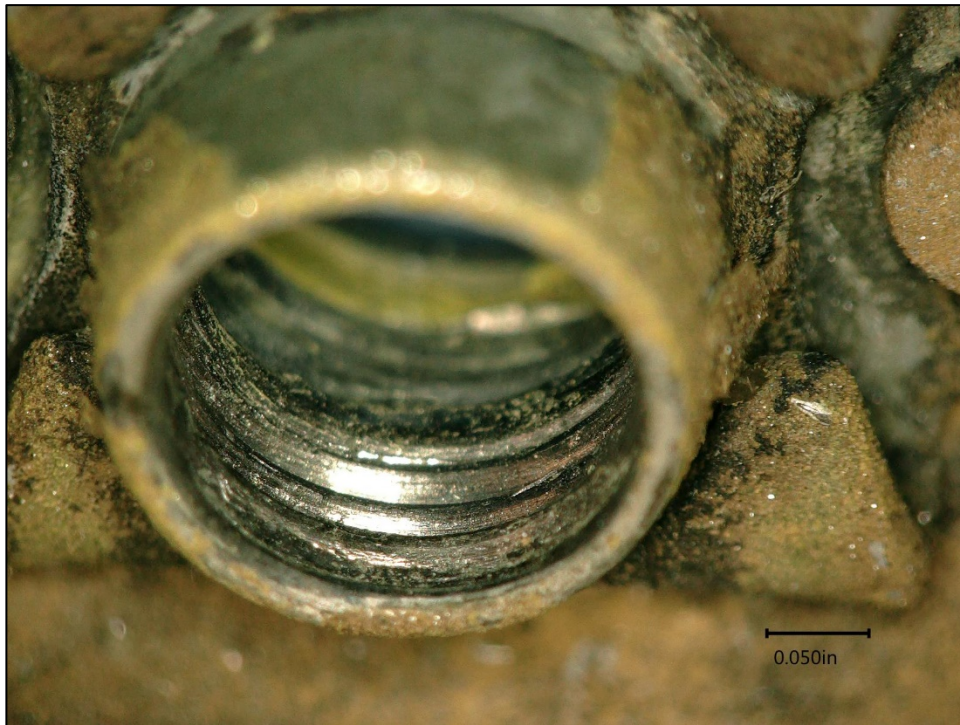
The upper left nut plate shown in figure 4 was cleaned using acetone and cotton swabs, and a view of the cleaned threads is shown in figure 8. Sheared thread peaks were observed on the interior of the nut plate. The inside diameter was measured perpendicular and parallel to the line defined by the nut plate attachment rivets, and the inside diameter measurements were 0.232 inch and 0.230 inch, respectively. According to the thread specification for a MS21075L4 locking nut plate, the minor diameter for the threads is specified as 0.2152 inch to 0.2229 inch before deformation is applied for the locking function.

Figure 8. Optical image of the upper left nut plate after disassembly from the tail boom and after cleaning showing damaged screw threads.

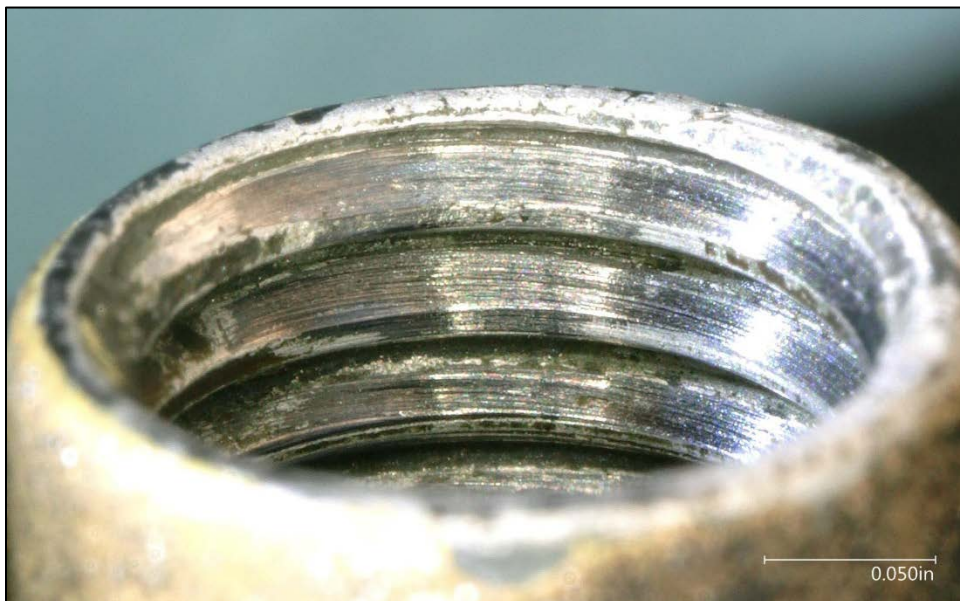
After the torque tests were completed, the lower right nut plate bracket was removed from the tail boom by drilling out the rivets attaching the bracket to the tail boom. The threads of the nut plate were then cleaned with a cotton swab and acetone. A view of the intact cleaned threads for the lower right nut plate is shown in figure 9. The inside diameter of the nut plate threads measured 0.217 inch and 0.220 inch for measurements obtained perpendicular and parallel to the nut plate attachment rivets, respectively.

Figure 9. Optical image of the lower right nut plate after disassembly from the tail boom and after cleaning showing intact screw threads.

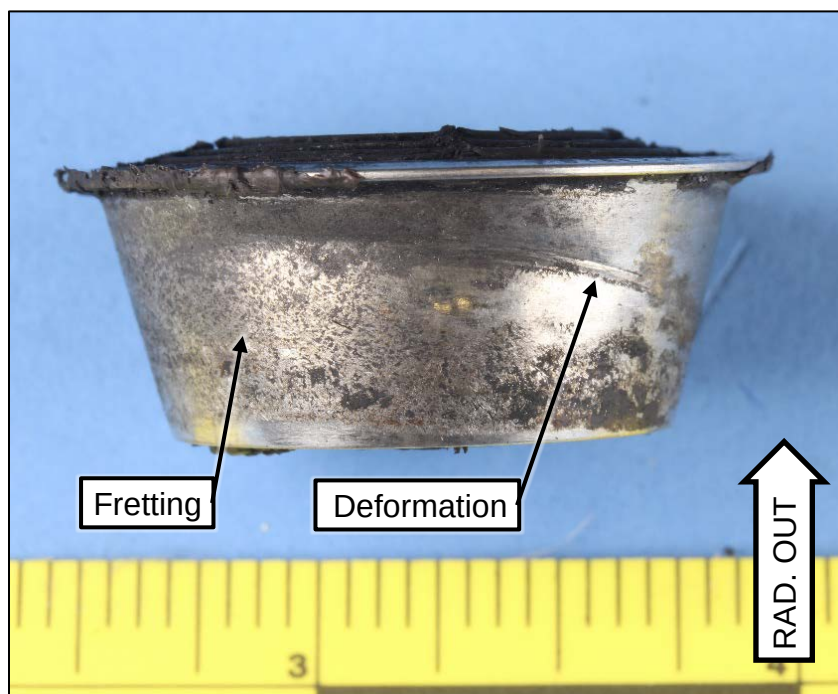
Close views of the recovered outboard teeter bearing are shown in figures 10 and 11. The teeter bearing consisted of concentric metal rings separated by layers of elastomer as shown in the view in figure 11. Cracks were noted in the elastomer, and small chunks of elastomer had accumulated on the radially outward surface in grooves between the concentric metal rings.

As installed, the teeter bearings are bonded to the fork assembly. Remnants of gray adhesive were observed in isolated areas of the mating surfaces of the recovered outboard teeter bearing and on the bearing seats in the fork arms. In some areas the apparent adhesive material appeared to be discolored yellow, brown, and black. Fretting damage was noted on the surface of the recovered outboard teeter bearing around approximately  $\frac{1}{4}$  the circumference as noted in figure 10, and corresponding fretting damage was noted on the fork assembly on one of the outboard bearing seats. The fretting damage on the fork arm was located on the inboard trailing quadrant on the bearing seat surface. An arc-shaped inward deformation was observed on the side of the recovered outboard teeter bearing as indicated in figure 10, consistent with off-axis contact with the edge of the bearing seat. The fretting damage appeared continuous across the deformation, consistent with the deformation occurring after the fretting damage.

Figure 10. Side view of the recovered outboard teeter bearing. Locations of fretting damage and off-axis contact deformation are indicated. The radially outward direction is also indicated for reference.

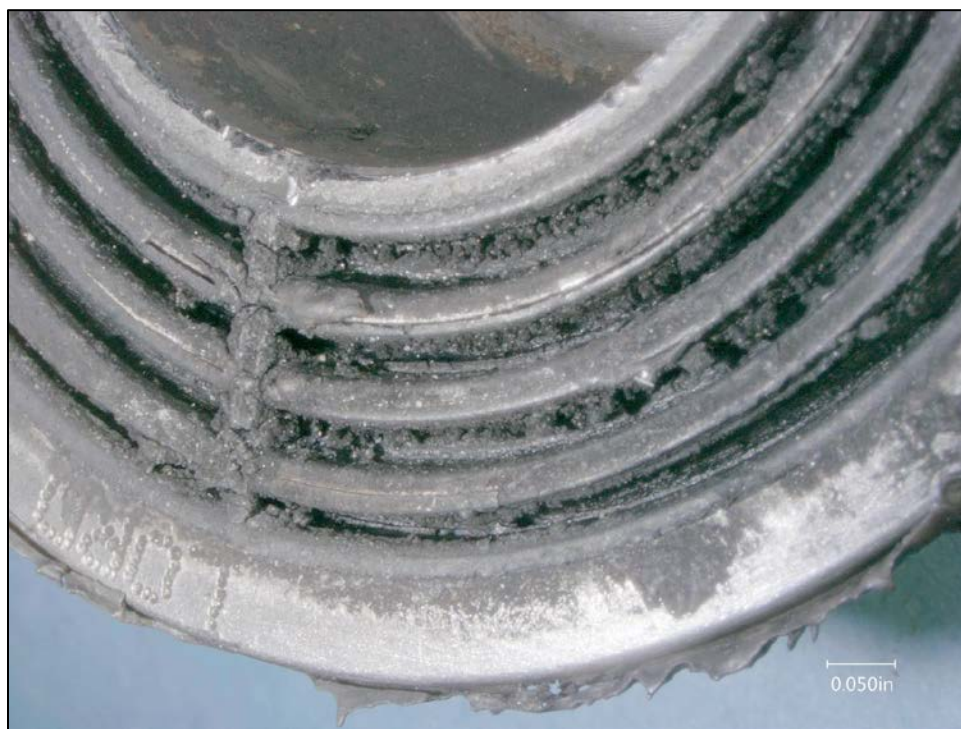
Figure 11. Close view of the radially outward side of the recovered outboard teeter bearing.

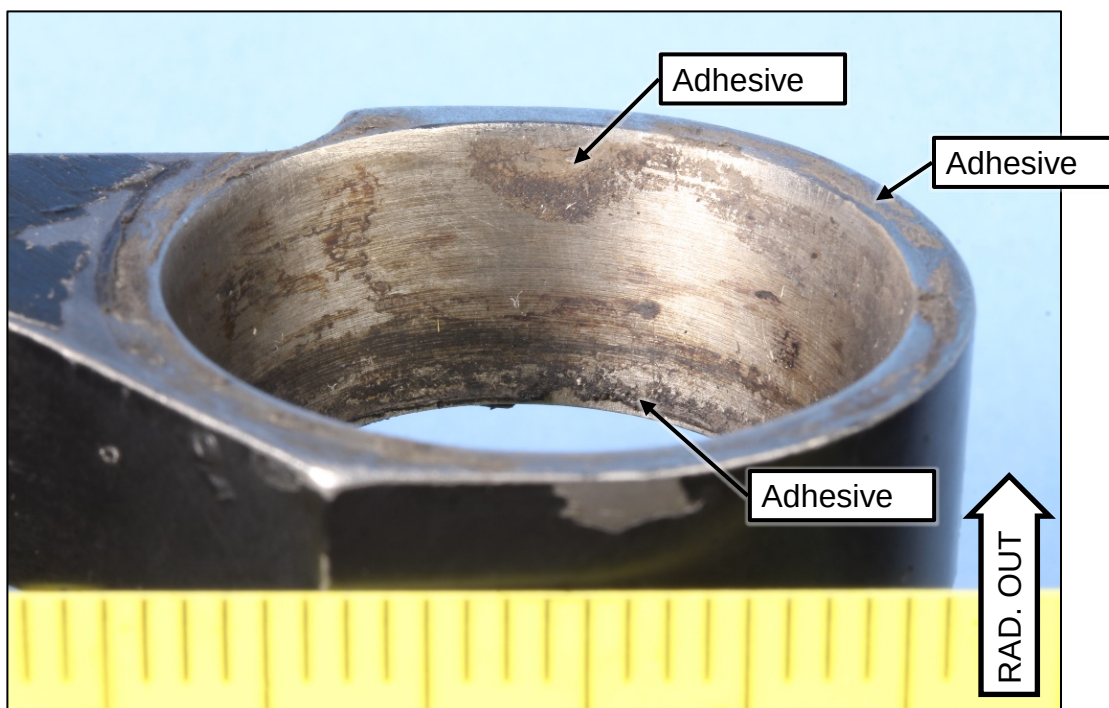
The bearing seat in the fork arm that held the missing outboard teeter bearing is shown in figure 12. Isolated areas of gray adhesive were noted on the surface on the radially outward face of the fork arm. On the bearing seat surface, isolated areas appearing consistent with discolored adhesive in shades of yellow, brown, and black were observed as indicated in figure 12. No evidence of fretting damage was observed on the bearing seat surface for the missing outboard teeter bearing.

No evidence of primer was observed on the exposed surfaces of the recovered outboard teeter bearing or in the exposed outboard bearing seats of the fork assembly. Additionally, no evidence of a glass-fiber scrim cloth was noted in the adhesive remnants of the outboard bearing seats, recovered outboard teeter bearing, or in the fractured adhesive from the removed inboard teeter bearing. According to a representative for the OEM participating as an investigative party member, the scrim cloth is used in the joint to ensure proper spacing is maintained in the adhesive joint during the bonding process.

Figure 12. Fork assembly showing the seat for the missing outboard teeter bearing. Remnants of adhesive on the mating surfaces are indicated.

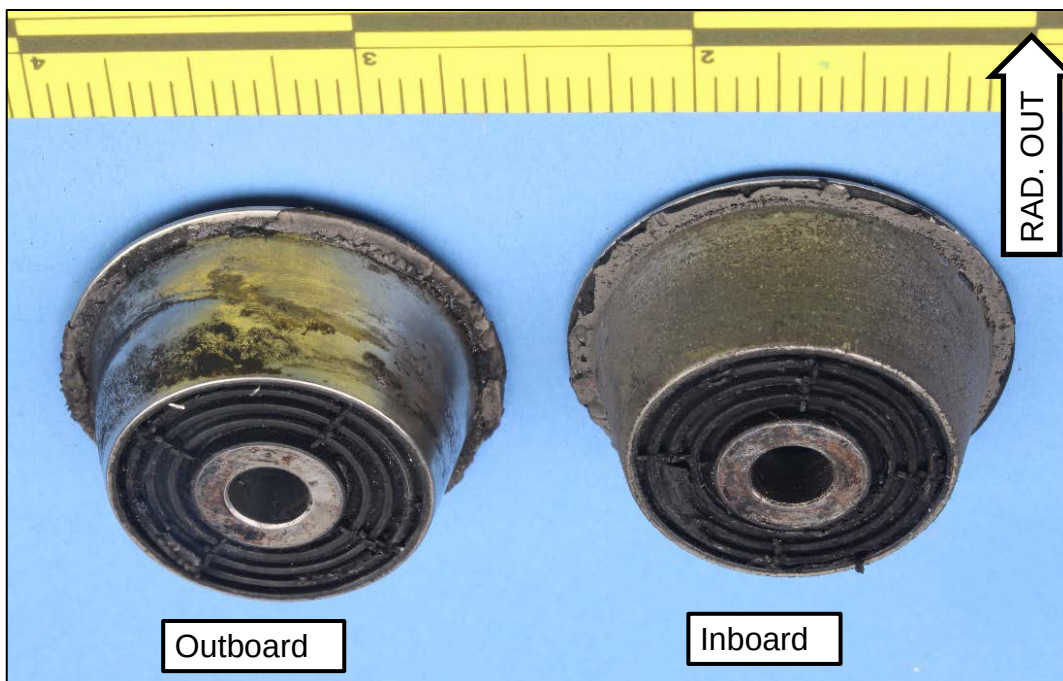
After the adhesion tests were completed, one of the inboard teeter bearings was selected for disassembly from the fork arm. To complete the disassembly, the fork arm was heated with a heat gun while applying pressure to press the bearing out of the bearing seat, resulting in a cohesive fracture in the adhesive. Views of the separated inboard teeter bearing and the mating bearing seat in the fork assembly are shown in figures 13 and 14, respectively. Gray adhesive material remained attached to both the bearing surfaces and the mating seat surfaces with uniform coverage. Isolated areas of the adhesive appeared discolored to a yellow and brown color. The recovered outboard teeter bearing is shown for comparison at the left in figure 13.

Figure 13. Views of the recovered outboard teeter bearing and one of the inboard teeter bearings after the inboard teeter bearing was pressed out of its seat in the fork assembly.

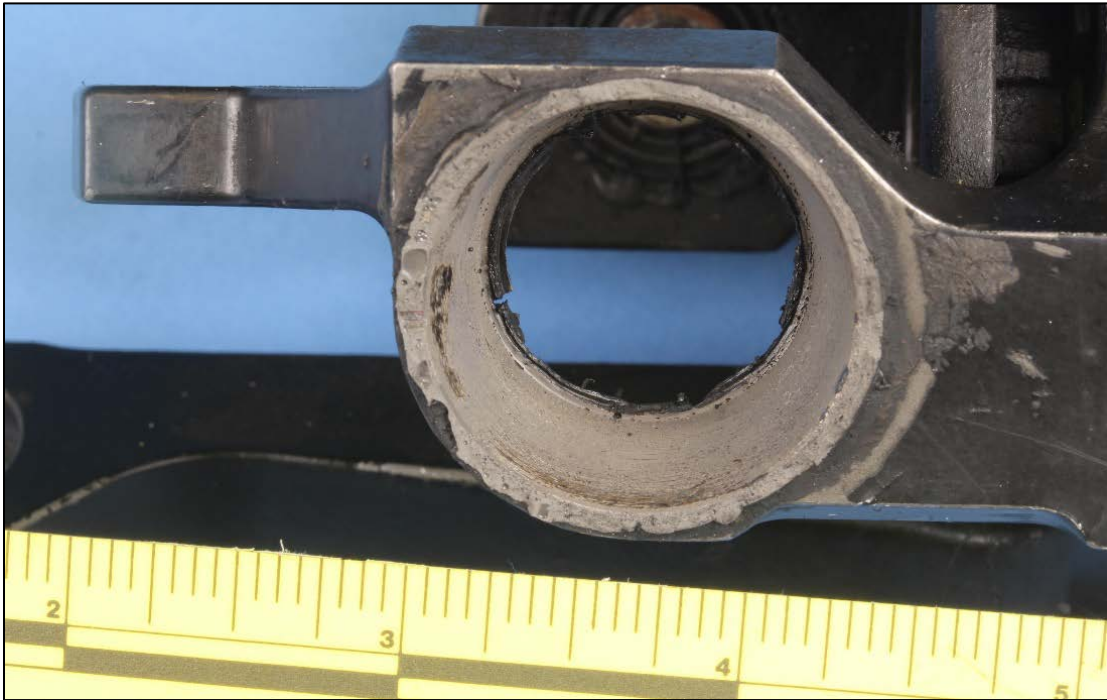
Figure 14. Inboard teeter bearing seat after the teeter bearing was removed. Gray adhesive covered the seat surface.

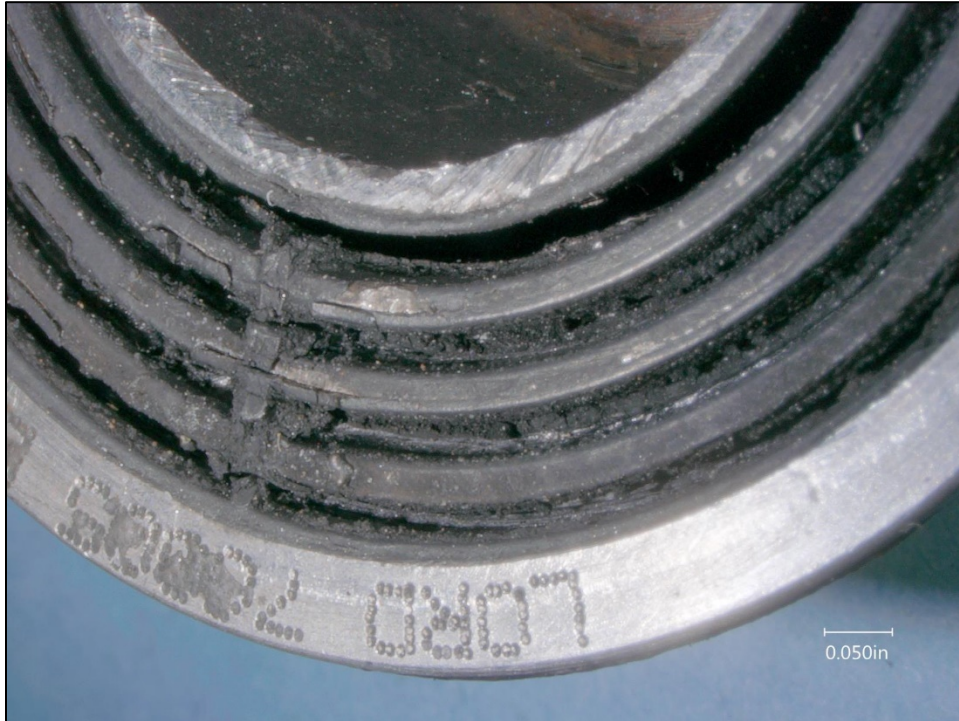
The radially outward face of the removed inboard teeter bearing is shown in figure 15. Cracks were noted in the elastomer, and small chunks of elastomer had accumulated on the radially outward surface in grooves between the concentric metal rings.

Figure 15. Close view of the radially outward side of the removed inboard teeter bearing.

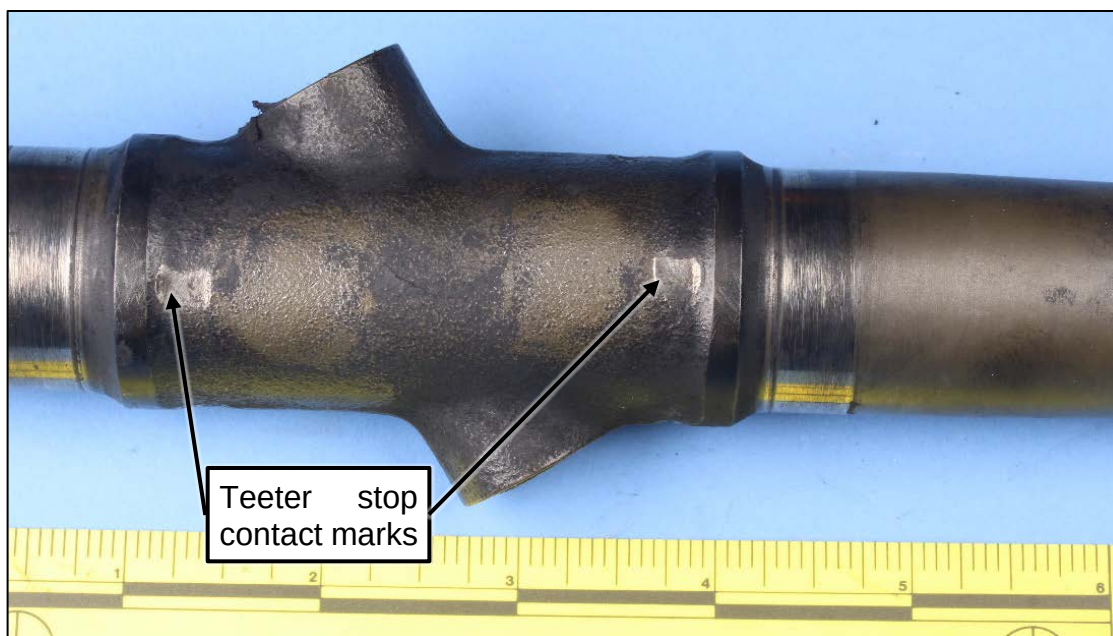
Close views of the inboard faces of the tail rotor hubs are shown in figures 16 and 17. Marks corresponding to contact with teeter stops were observed on both hubs as noted in figures 16 and 17. The inboard teeter bolt was intact and is shown disassembled from the inboard tail rotor hub in figure 1. The outboard teeter bolt was fractured in its

Figure 16. Inboard face of the inboard tail rotor hub showing contact marks corresponding to contact with the teeter stop.

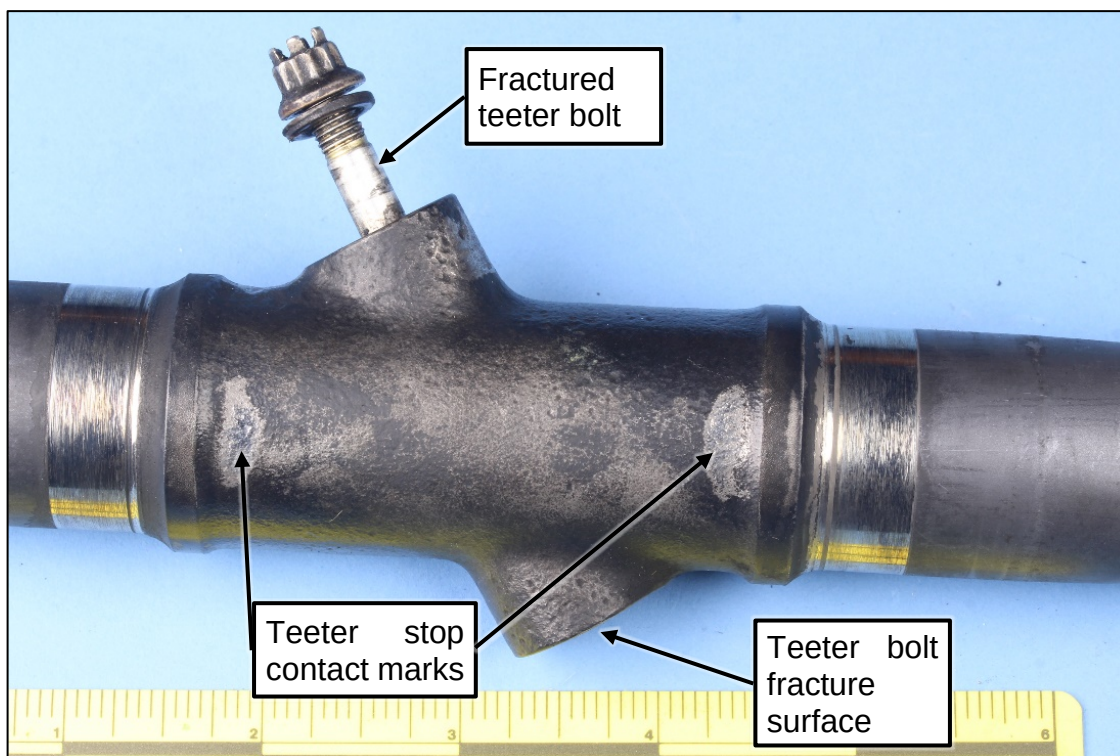
Figure 17. Inboard face of the outboard tail rotor hub showing contact marks corresponding to contact with the teeter stop.

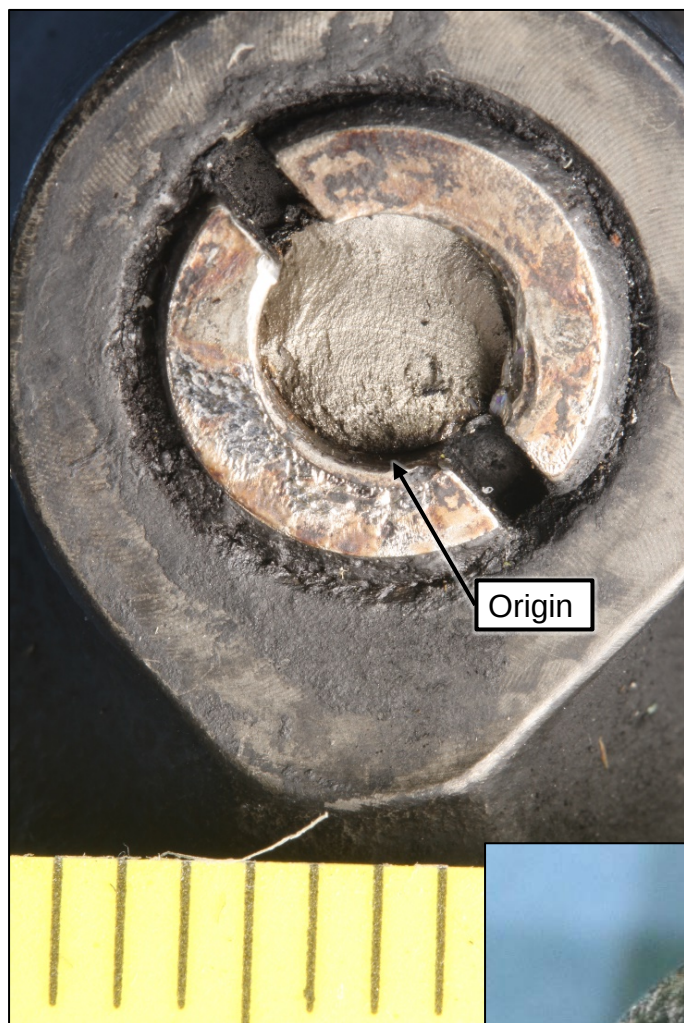
shank and remained within the outboard tail rotor hub as shown in figures 17 and 18. According to the OEM engineering drawing for the teeter bolt, the bolt material is specified as nickel alloy 718.

Figure 18. Outboard teeter bolt fracture surface before removal from the hub.

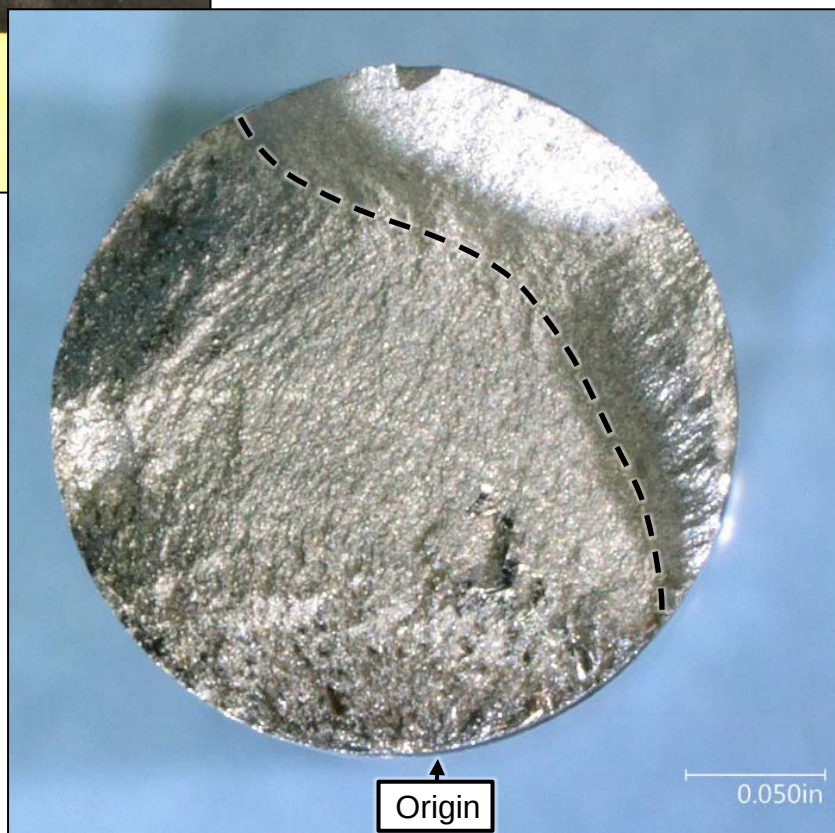
The fractured outboard teeter bolt was removed from the outboard tail rotor hub and was cleaned using an ultrasonic cleaner while submerged in a solution of Alconox detergent and water. A close view of the cleaned fracture surface is shown in figure 19. Curving crack arrest lines consistent with fatigue were observed extending across approximately 75 percent of the fracture surface to the curving boundary indicated by a dashed line in figure 19. The fatigue features emanated from an origin at the location indicated in figure 19. Relatively rough faceted features were observed on a plane perpendicular to the bolt axis near the origin up to a depth of 0.061 inch. Then the fracture transitioned to relatively smoother features on a plane at a slight angle relative to the bolt axis to the fatigue boundary. Beyond the fatigue boundary, fracture occurred at approximately 45 degrees to the axis consistent with ductile overstress fracture of the remaining ligament.

Figure 19. Outboard teeter bolt fracture surface after removal from the hub and cleaning with a brush using Alconox detergent and water. The fatigue origin is indicated, and a dashed line indicates the fatigue boundary.
