# NATIONAL TRANSPORTATION SAFETY BOARD

## MATERIALS LABORATORY FACTUAL REPORT

Report No. 19-030

Place : Honolulu, Hawaii  
Date : August 8, 2018  
Vehicle : MD Helicopters 369D, N369MH  
NTSB No. : WPR18LA221  
Investigator : Mike Huhn (AS-WPR) / Van McKenny (AS-40)

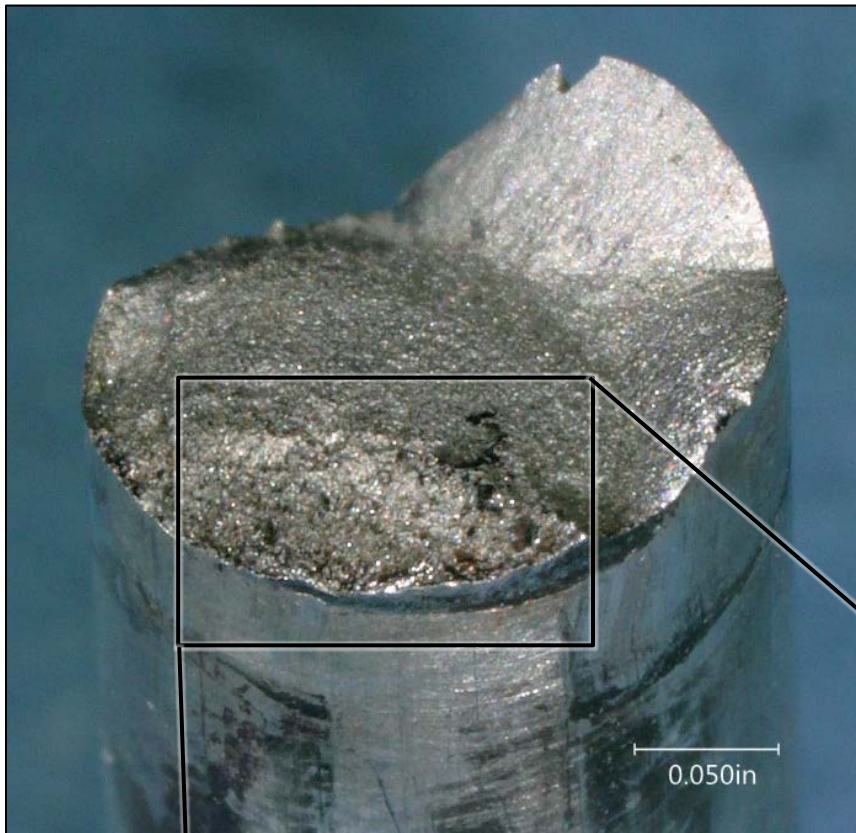
An oblique view of the outboard teeter bolt is shown in figure 20. A relatively smooth rubbed area consistent with contact damage associated with movement between the bolt and the mating surface was observed adjacent to the fracture surface as indicated in figure 20. The fatigue origin was located at the surface near the edge of the rubbed area.

Figure 20. Oblique view of the outboard teeter bolt fracture surface shown in the previous figure. The origin was located at an area of contact damage on the outer surface.

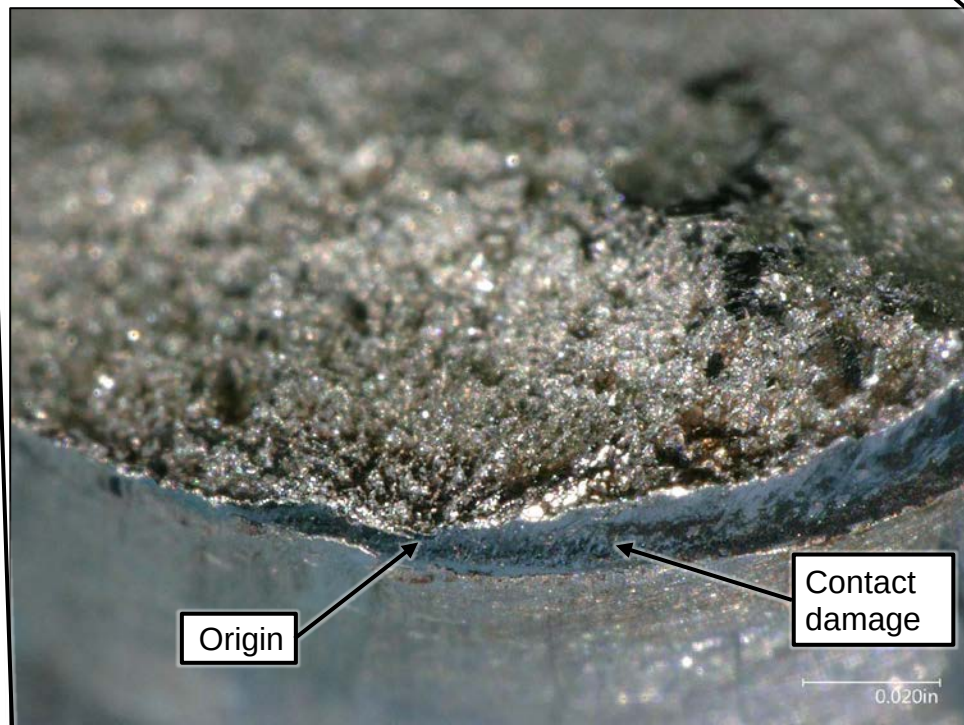
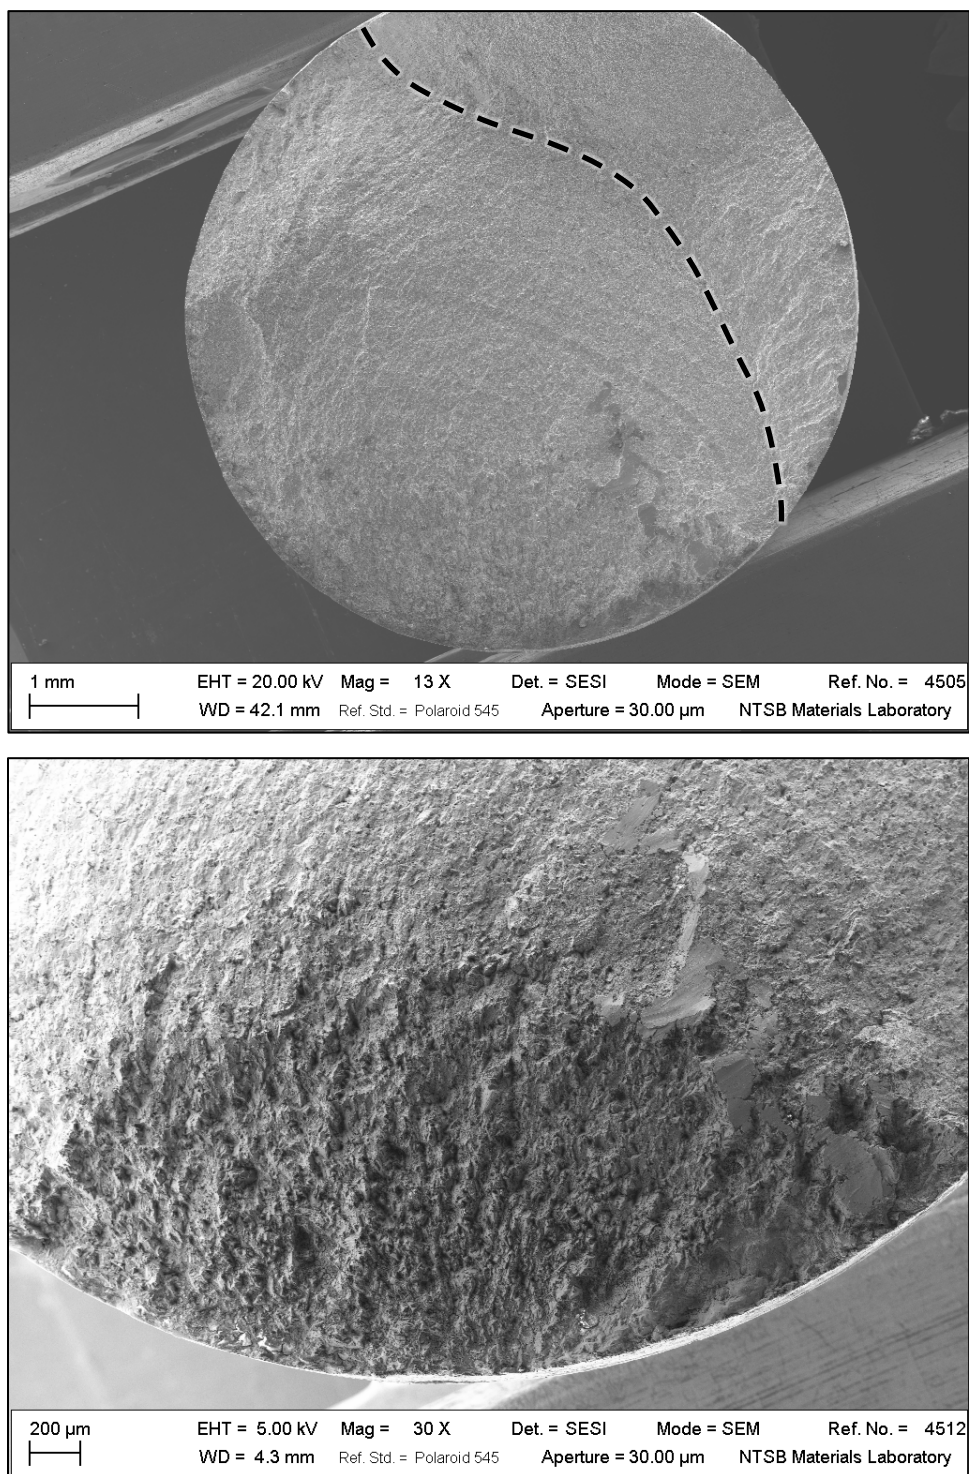
An overall view of the fatigue region as imaged using the SEM is shown in the upper image in figure 21, and a closer view of the relatively rough faceted region extending to a crack depth of 0.061 inch is shown in the lower image in figure 21. In the lower image in figure 21, the relatively rough faceted region appears darker due to the difference in angle relative to the electron detector.

Figure 21. SEM images of the outboard teeter bolt fracture surface after cleaning with Evapo-Rust and a soft-bristle brush showing the entire fatigue region (upper image) with a closer view of the relatively rough region near the origin (lower image). A dashed line in the upper image indicates the fatigue boundary.

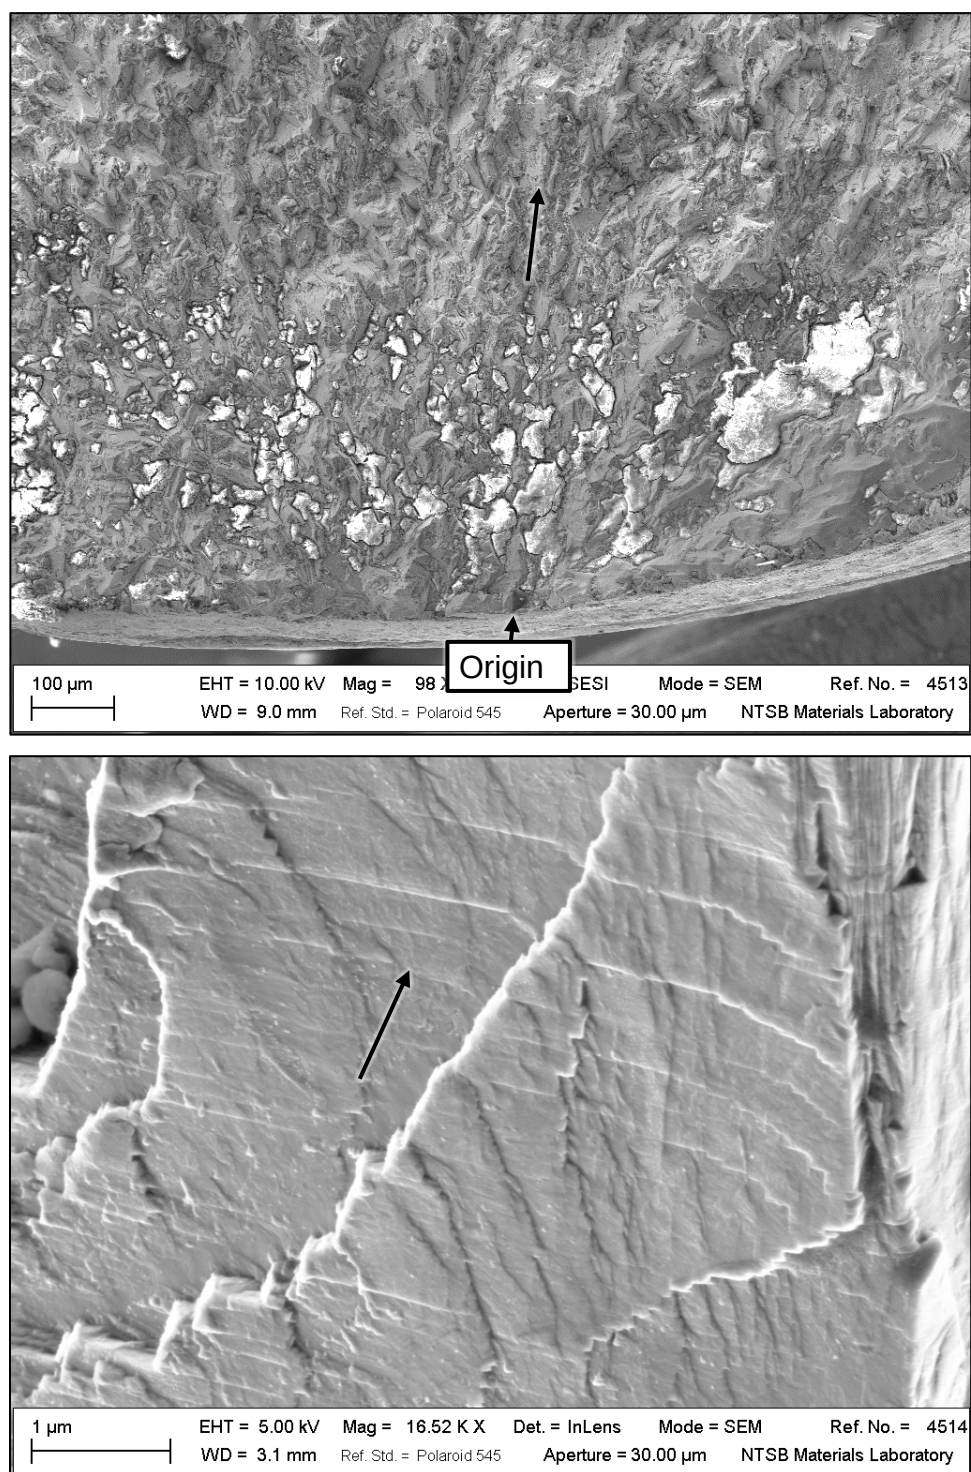
Figures 22 through 24 show typical features progressing from the origin to the fatigue boundary and into the overstress region of the remaining ligament as viewed in the SEM. Unlabeled arrows in each figure point in the direction of local crack growth. Figure 22 shows typical fatigue features in the faceted region near the origin. The upper image in figure 22 shows an overall view near the origin area where remaining oxides on the surface appear brighter. Fatigue crack growth along faceted planes was observed

consistent with fatigue in nickel alloy 718. The lower image in figure 22 shows typical fatigue features in one of the facets, and crack arrest lines have a jagged appearance consistent with microstructural interaction with the advancing crack front.

Figure 22. SEM images of the fracture surface shown in figure 21 showing the origin area (upper image) with a closer view of typical fatigue features near the origin (lower image). The brighter areas in the upper image are nonconductive oxides that appear brighter due to charging. Unlabeled arrows indicate crack propagation directions.

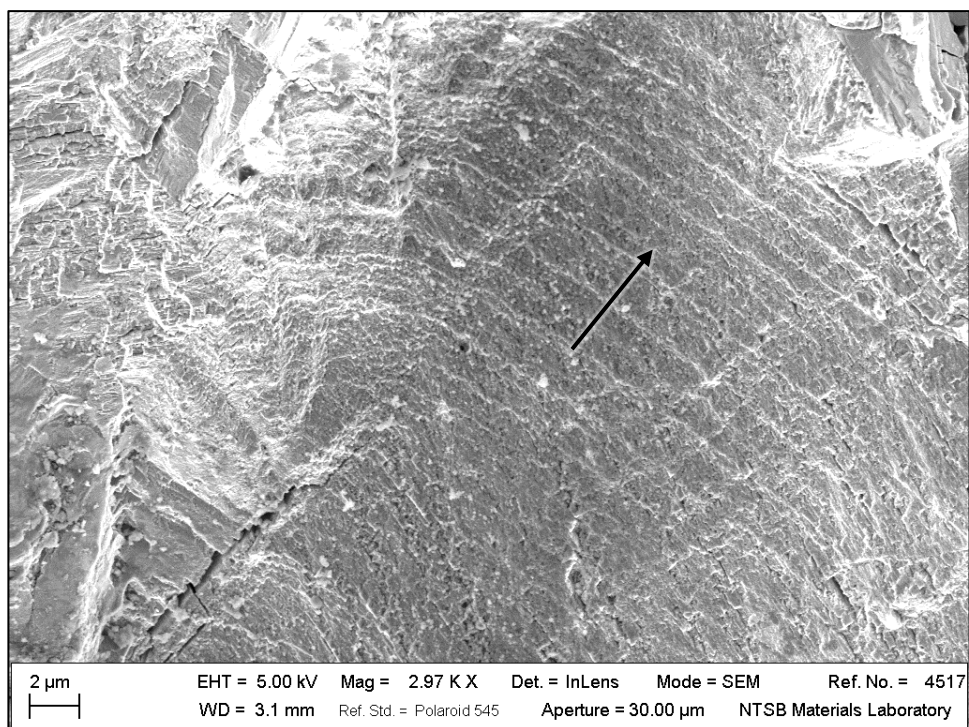
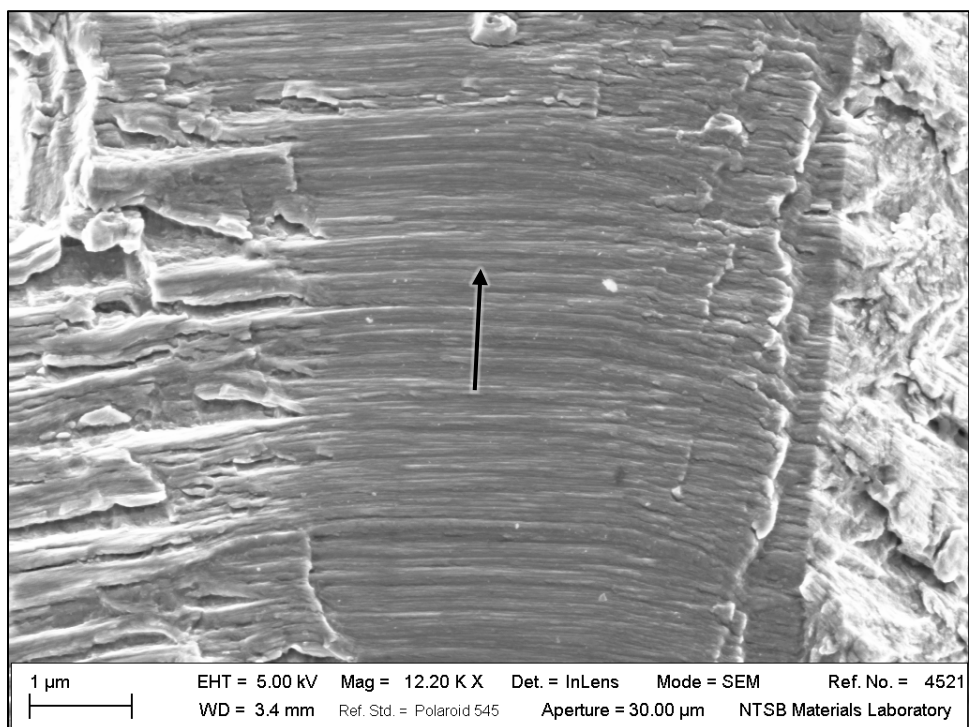
Figure 23 shows fatigue features farther from the origin near the edge of the faceted region (upper image) and in the smoother region at a location approximately 75 percent of the total fatigue crack depth (lower image). The upper image in figure 24 shows fatigue features near the fatigue boundary. Unlabeled arrows in figure 24 point to a striation associated with crack growth. Linear crystallographic features appearing as parallel light-gray and dark-gray lines oriented at approximately  $\pm 45$  degrees to the crack growth direction were also observed on this facet.

Figure 23. SEM images of the fracture surface shown in figure 21 showing fatigue features near the boundary of the rougher region (upper image) and at a location approximately 75 percent of the total crack depth (lower image). Unlabeled arrows indicate crack propagation directions.

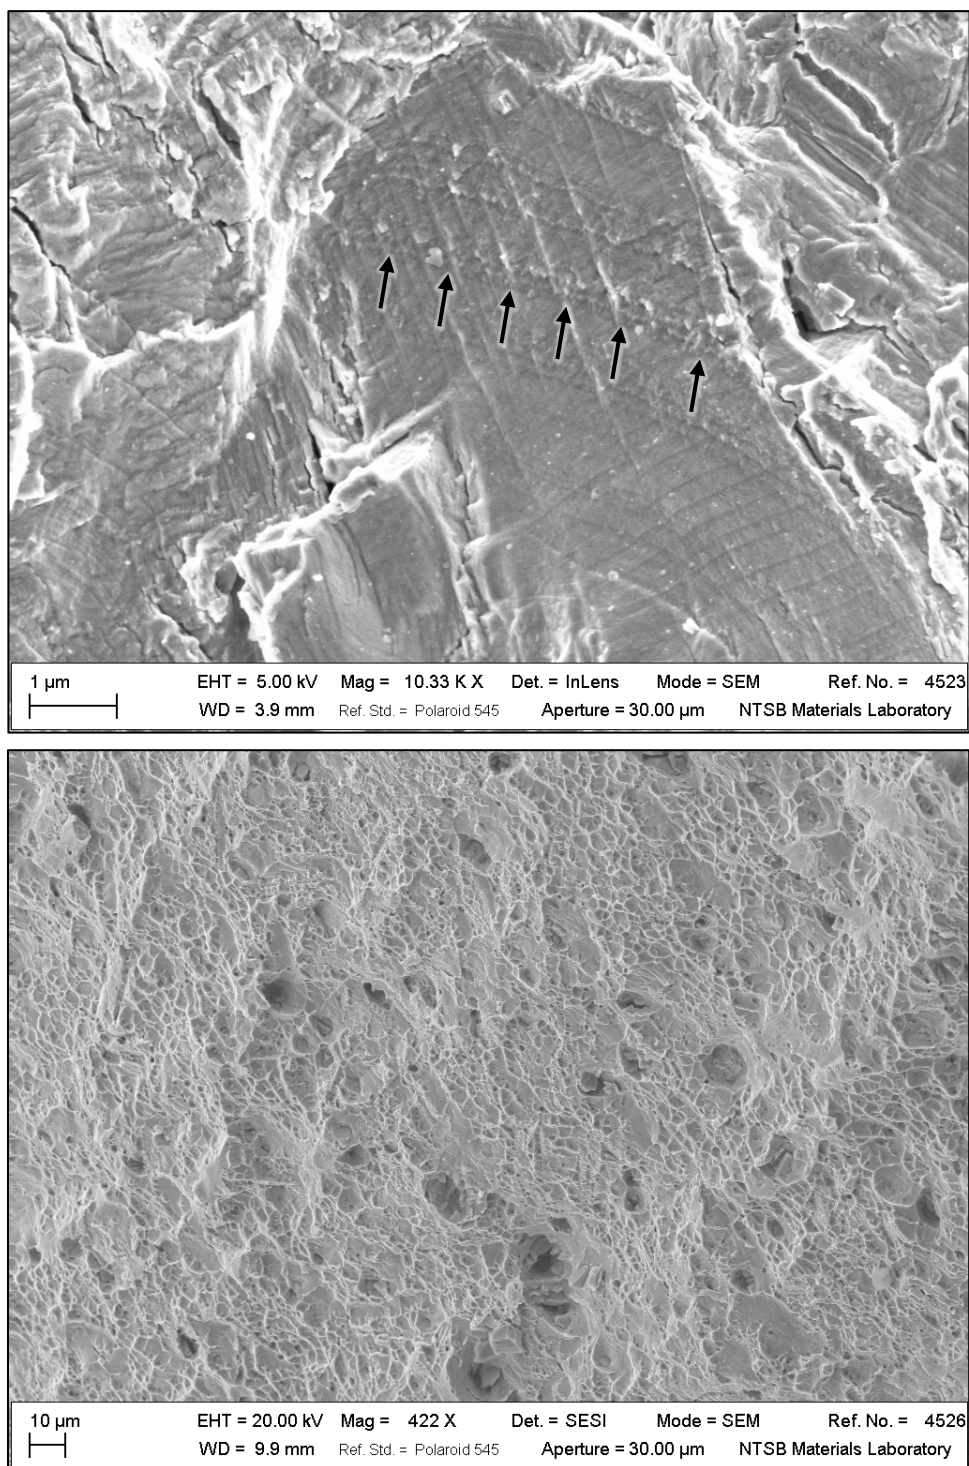
Dimple features consistent with ductile overstress were observed on the remaining 25 percent of the fracture surface beyond the fatigue boundary. The lower image in figure 24 is a representative sample of the observed overstress features beyond the fatigue boundary.

Figure 24. SEM images of the fracture surface shown in figure 21 showing fatigue features near the fatigue boundary (upper image) and ductile dimple features in the overstress region (lower image). Unlabeled arrows in the upper image indicate the crack propagation direction and point to a fatigue striation.
