# NATIONAL TRANSPORTATION SAFETY BOARD

MATERIALS LABORATORY FACTUAL ADDENDUM

Report No. 19-030B

Place : Honolulu, Hawaii  
Date : August 8, 2018  
Vehicle : MD Helicopters 369D, N369MH  
NTSB No. : WPR18LA221  
Investigator : Mike Huhn (AS-WPR) / Van McKenny (AS-40)

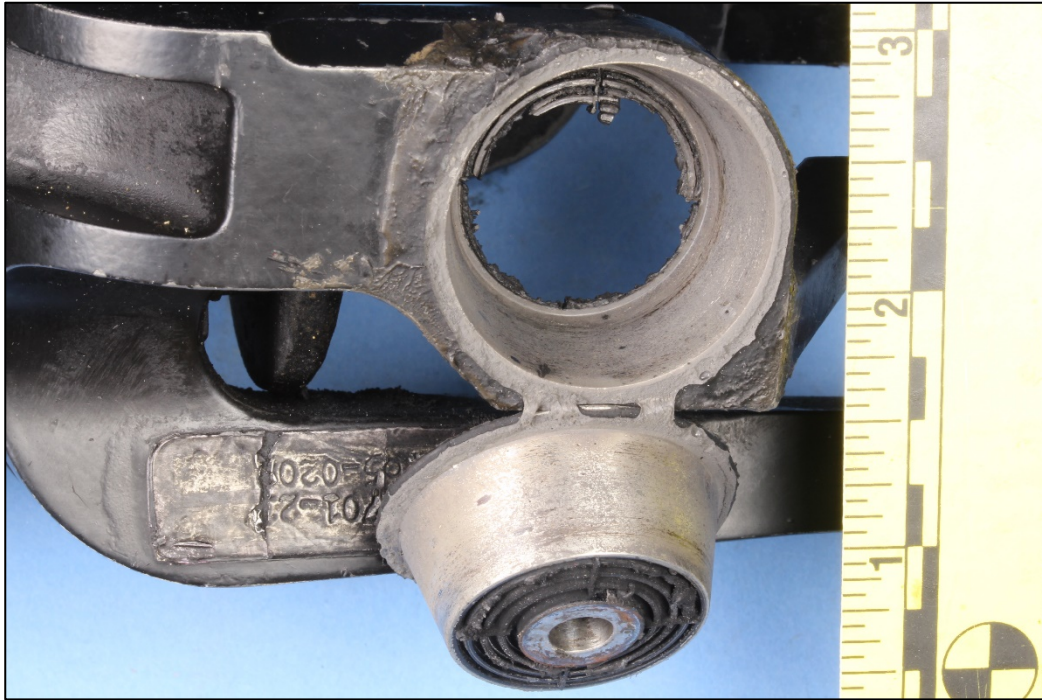
One of the inboard teeter bearings was removed from the accident fork assembly as described in Materials Laboratory Factual Report 19-030. This addendum to that report describes the removal of the other inboard teeter bearing from the accident fork assembly. To complete the disassembly of the remaining teeter bearing from the fork arm, the fork arm was heated with a heat gun while applying pressure to press the bearing out of the bearing seat, resulting in a separation of the bonded joint. A view of the separated inboard teeter bearing and the mating bearing seat in the fork assembly is shown in figure 1. A limited amount of gray adhesive material remained attached to both the bearing surfaces and the mating seat surfaces and appeared to have uneven coverage. Isolated areas of the adhesive appeared discolored to a yellow and brown color. No evidence of primer was observed on the bonded surfaces and no scrim cloth was present in the bonded joint.

Figure 1. Inboard teeter bearing seat after the teeter bearing was removed. Gray adhesive covered the seat surface.
