## **NATIONAL TRANSPORTATION SAFETY BOARD**

### **ON-SCENE EXAMINATION INFORMATION (Rev B)**

**NTSB Accident: WPR18LA221  
Accident Date: August 8, 2018**

| Aircraft: | MDHI 369D / N369MH |

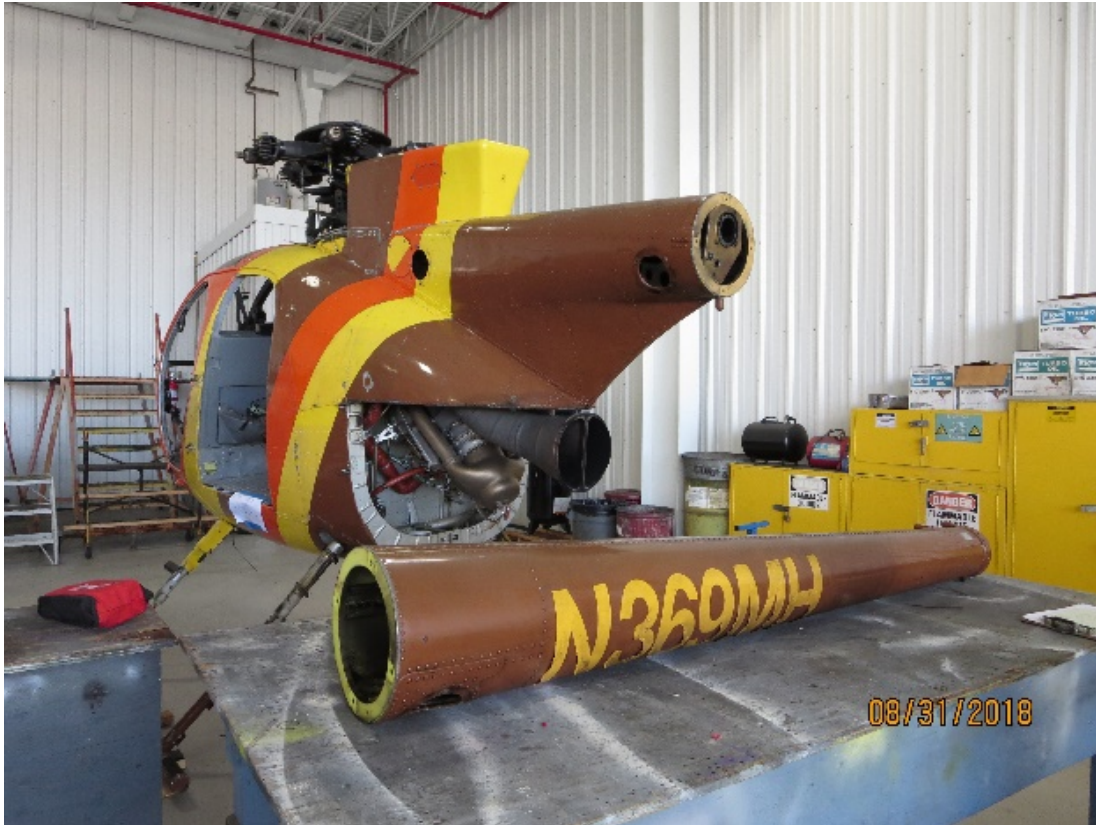
Figure 1 - Helicopter as Configured by Operator for Exam

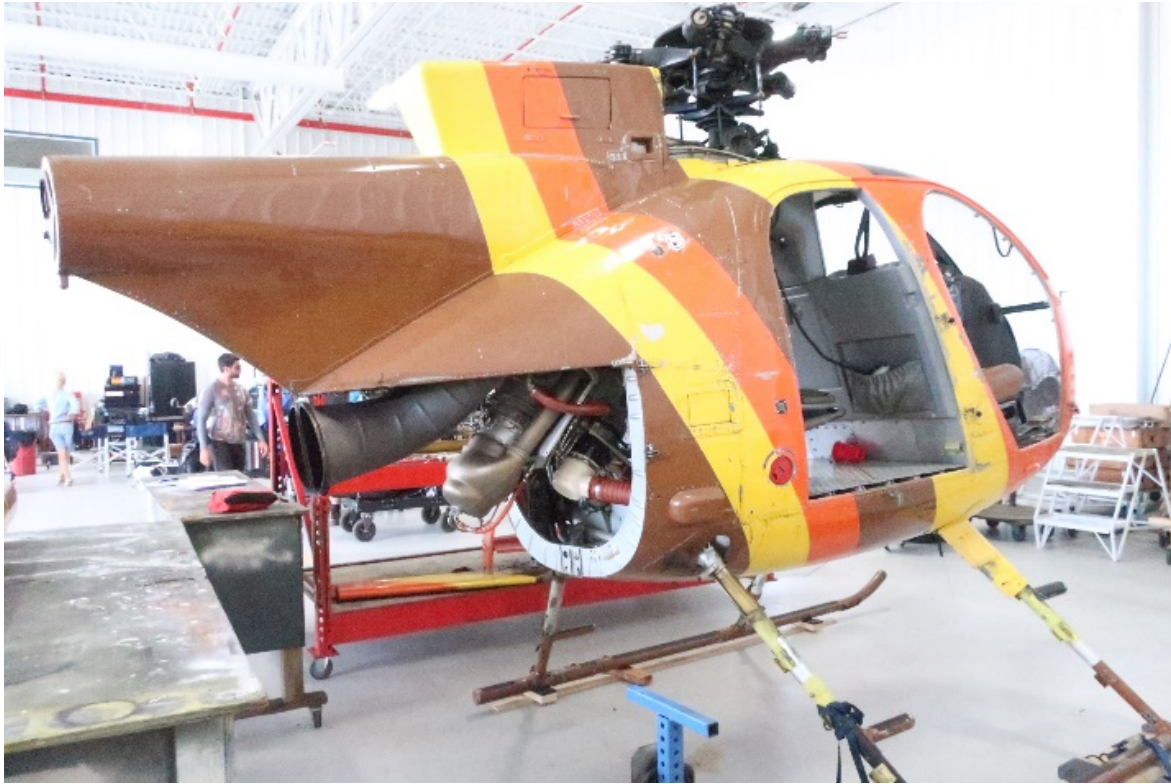
**Figure 2 - Helicopter as Configured by Operator for Exam**

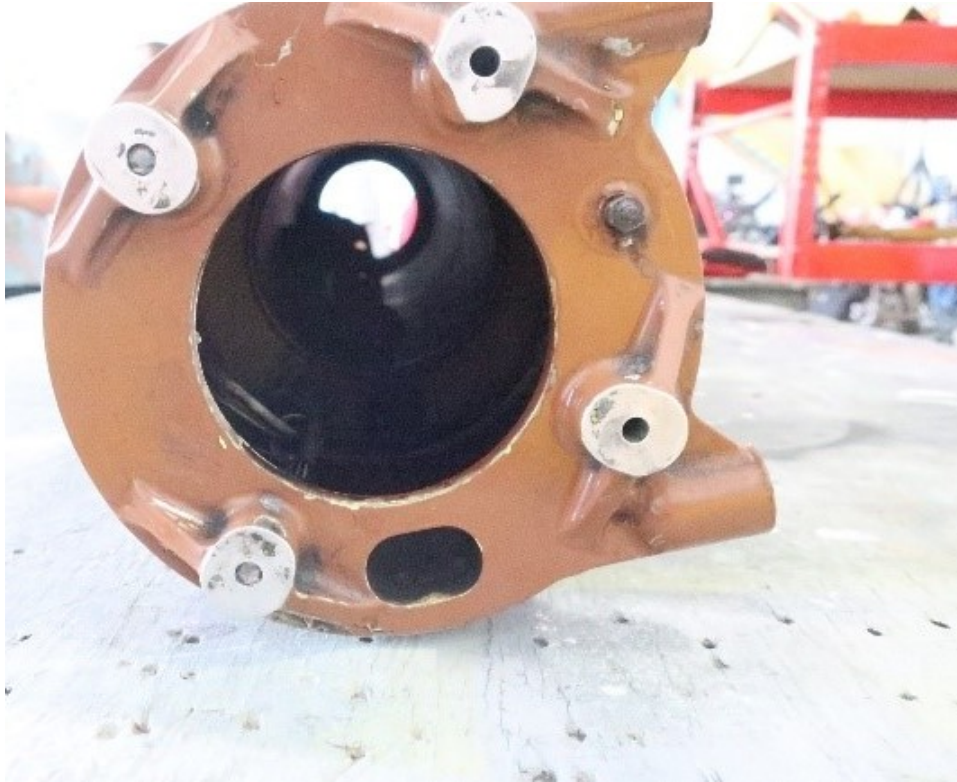
- Tail boom tail rotor gear box (TRGB) mounting fixture had TRGB mounting bolt fragment in the left upper and lower mounting bores. The right upper and lower mounting bores were unobstructed, and the mounting bolts/nuts had been retained within their tail boom mounting bores.
- The TRGB fixture bolt hole pads had been cleaned by the operator.

**Figure 3 - Tailboom Tail Rotor Gearbox Mounting Fixture**

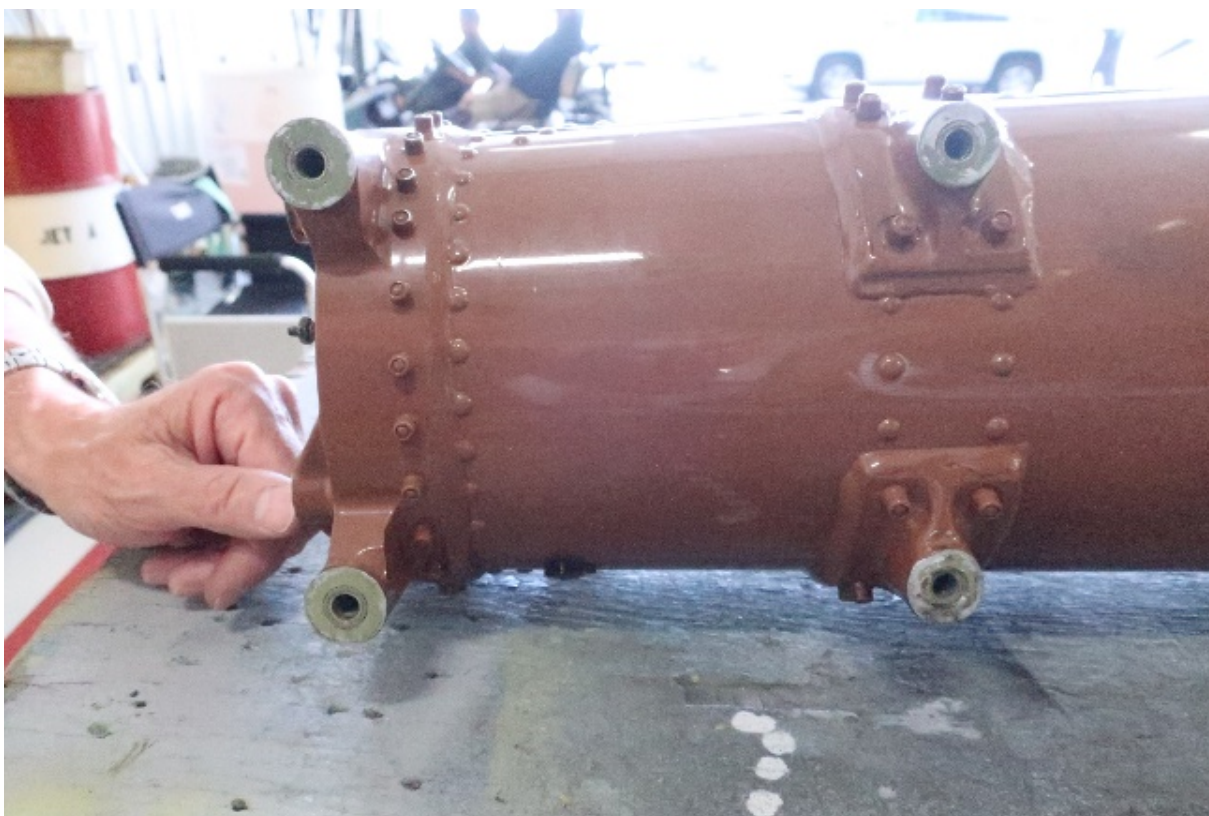
- Airframe was intact and landing gear in place
- Tail boom had been removed by the operator at the tail boom-fuselage attach point prior to the arrival of the investigation personnel .
- Right skid tube was fractured slightly forward of the aft foot.
- One of the four mounting lugs on the vertical stabilizer had fracture-separated from the stabilizer.
- No additional damage to the airframe was identified.
- Two Hobbs meters: Right side 3868.7, left side 8566.9

**Figure 4 - Tail Boom Vertical Fin Mounts**

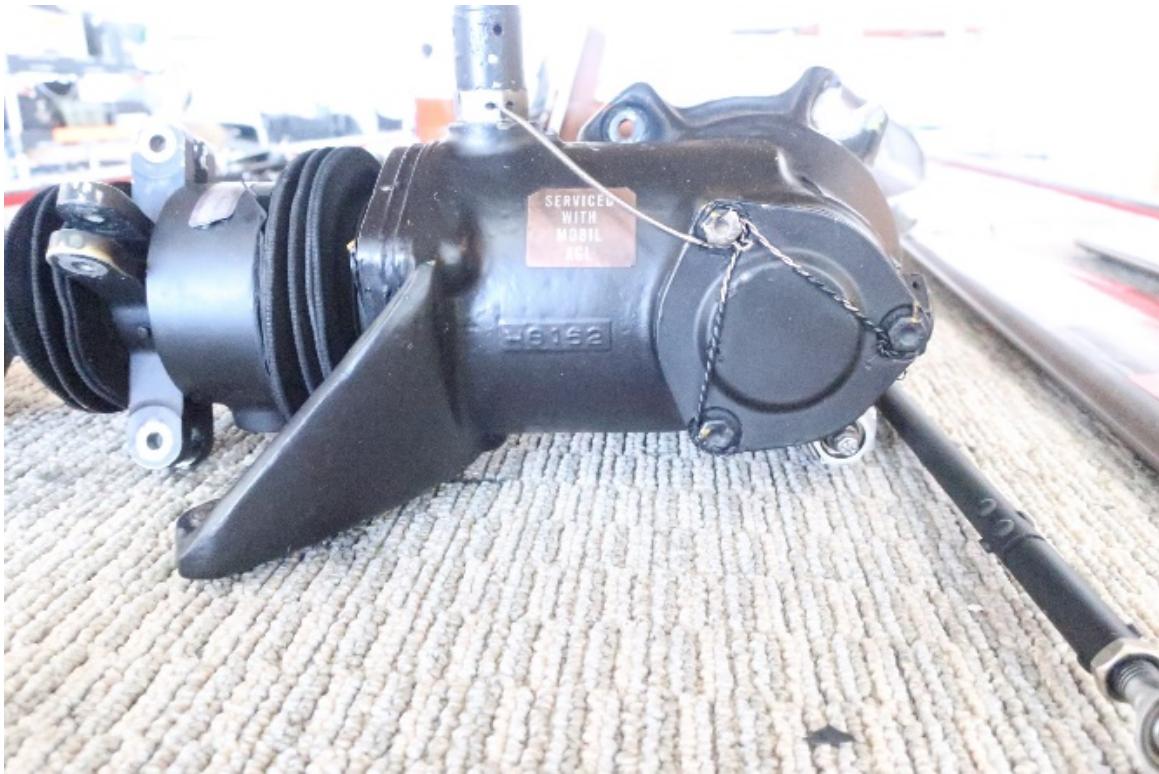
- The TRGB had been removed from the tail boom by the operator prior to the arrival of the investigation personnel
- Tail rotor drive shaft was still attached to the TRGB by the KA Flex coupling. The tail rotor drive shaft appeared undamaged. The KA Flex coupling appeared undamaged with all attachment hardware present and connected.
- The right upper and lower mounting lugs had fracture-separated from the TRGB.
- The left upper and lower mounting lug bolt holes exhibited some deformation
- The TRGB rotating components were able to be rotated freely by hand.
- The swashplate moved freely on the rotor shaft and rotated freely on the tail rotor shaft.
- The pitch links for both the inner and outer tail rotor hubs had been removed by the operator prior to the arrival of the investigation personnel.
- One outboard pitch link appeared bent.

Figure 5 - Tail Rotor Gear Box

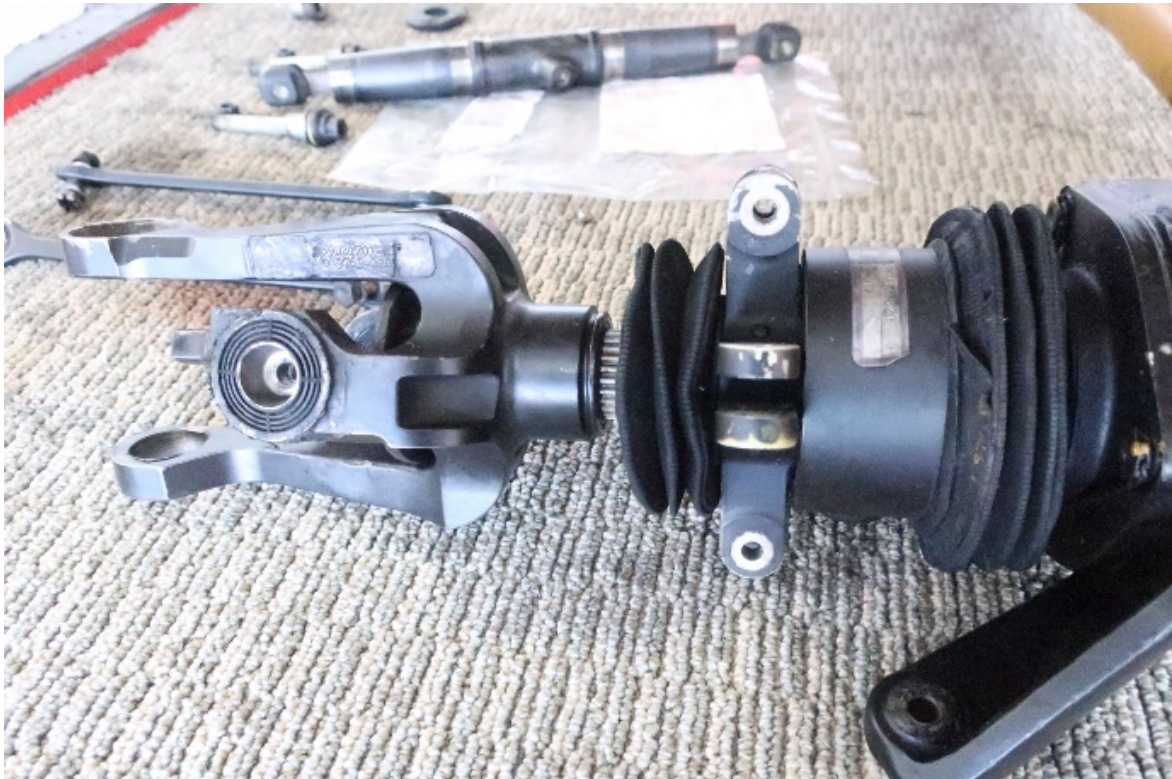
Figure 6 - Tail Rotor Fork

- Both tail rotor hubs had been removed from their respective forks by the operator prior to the arrival of the investigation personnel.
- The inner fork retained the elastomeric bearings.

- Outer fork: one elastomeric bearing had separated from the fork and was retained. It had a shallow dent on one side. The other bearing was absent and not recovered. No adhesive or scrim cloth was observed on the mating faces of the bearing or the fork.

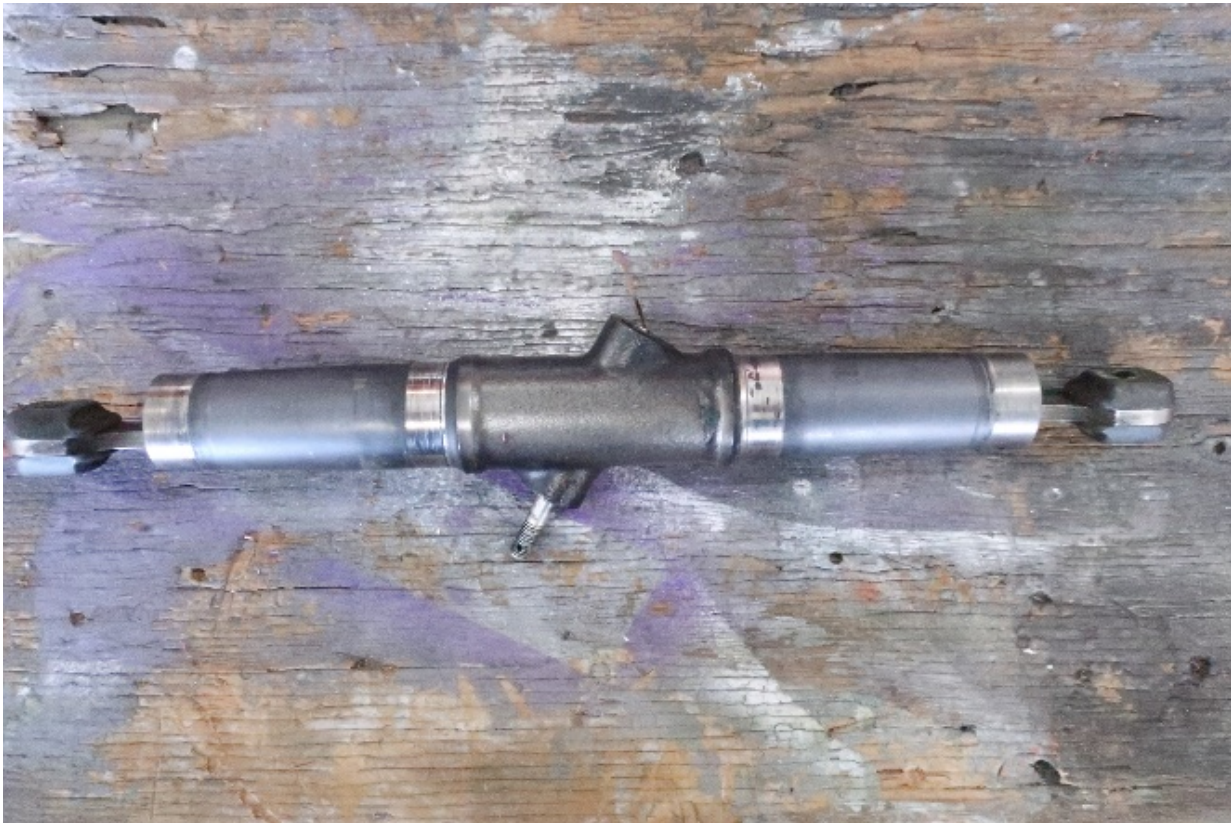
- The outer rotor hub had retained its strap pack and rotor blades. The blades had been removed by the operator prior to the arrival of the investigation personnel.

Figure 7 - Outer Tail Rotor Hub

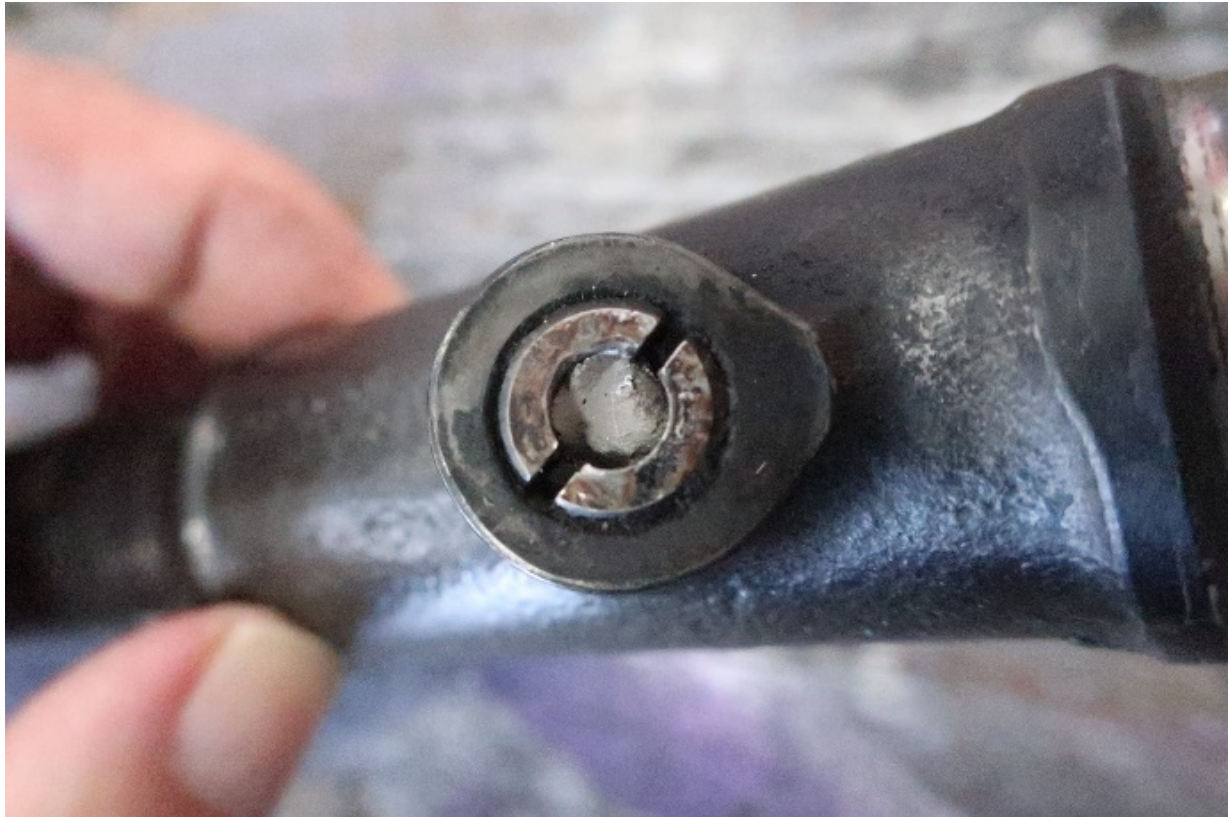
- The hinge bolt had fractured inside the rotor hub. The bolt head half of the hinge bolt was absent and had not been recovered.

**Figure 8 - Outer Tail Rotor Hinge Bolt (exhibiting fracture face)**
