## Chemical Analysis Report

**Engine Family** : PT6A-67F

**Air Line & Operator** : Air Spray Airtankers

**Sample Description** : Debris from hot section (4 locations)

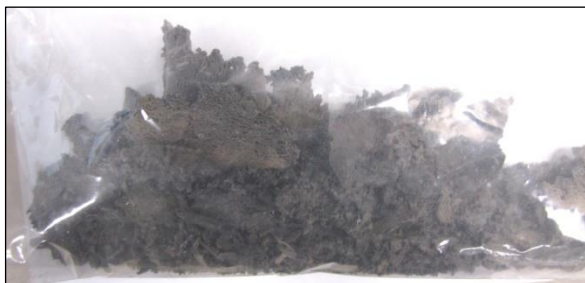
| Sample ID | Analysis |
|---|---|
| Debris from combustion chamber outer liner<br><b>S#1</b> | The debris were mainly composed of Silicon with some Aluminum in presence of Oxygen. Traces of Sodium, Potassium, Calcium, Titanium and Iron were also detected. |

The debris were similar to environmental debris (e.g. soil, sand). The shape of the debris could suggest that the debris have seen high temperature.

Picture 1: Debris from combustion chamber outer liner (S#1)

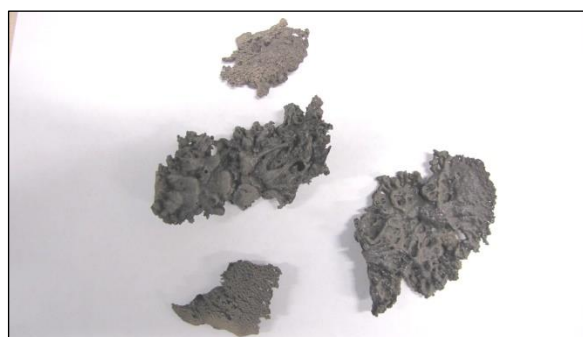
Picture 2: Separate debris from S#1

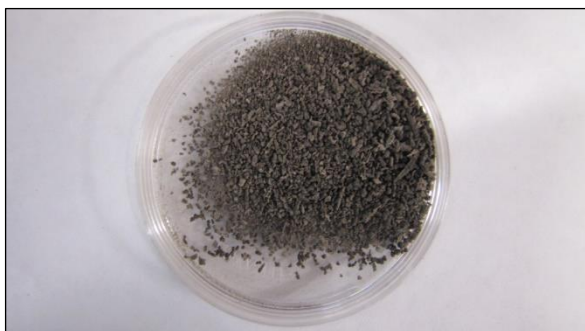
| Sample ID | Analysis |
|---|---|
| Debris from combustion chamber inner liner<br><b>S#2</b> | Idem to sample #1 |

Picture 3: Debris from combustion chamber inner liner (S#2)

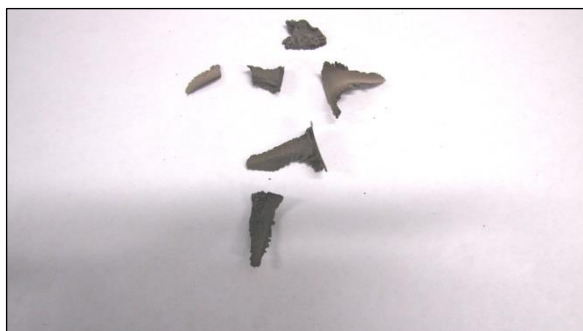
| Sample ID | Analysis |
|---|---|
| Debris from CT vane ring<br><b>S#3</b> | Idem to sample #1, but traces of Magnesium were also detected. |

Picture 4: Debris from CT vane ring

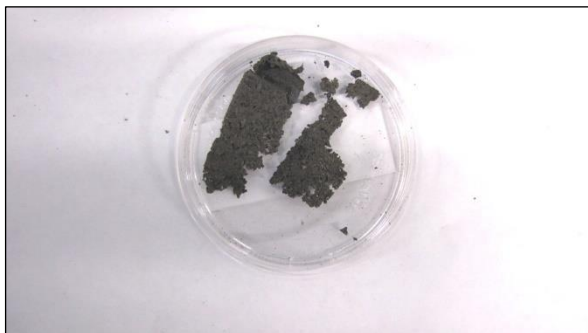
| Sample ID | Analysis |
|---|---|
| Debris from PT1 vane ring<br><b>S#4</b> | <p>The debris were mainly composed of Silicon with some Aluminum in presence of Oxygen. Traces of Sodium, Potassium, Calcium, Titanium, Chromium, Iron, Cobalt and Nickel were also detected.</p> <p>In some areas the Nickel is higher, suggesting traces of Nickel alloy; however the alloy identification cannot be determined.</p> |

Picture 5: Debris from PT1 vane ring
