## Accident / Incident Report

**Report No.: 18-124**

**AirSpray Airtankers  
Air Tractor AT-802F, N397AS  
Stevens County, Washington, USA  
14 August 2018  
PT6A-67F, RZ0138**

**Date of Issue: 20 November 2019**

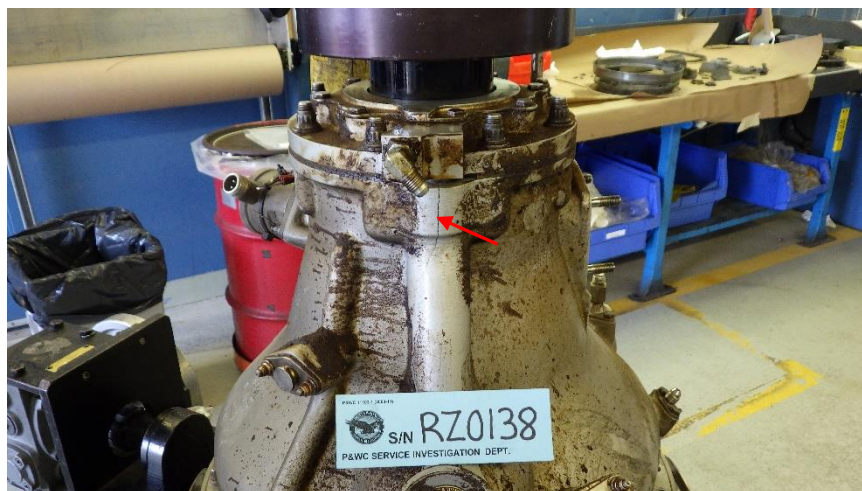
**Photo No. 4**

**Reduction Gearbox (RGB):** The lower portion of the reduction gearbox (RGB) was covered with a mixture of environmental debris and oil. The RGB was found cracked at the 6 O'clock position close to the propeller shaft flange (arrow, Photo No. 4).

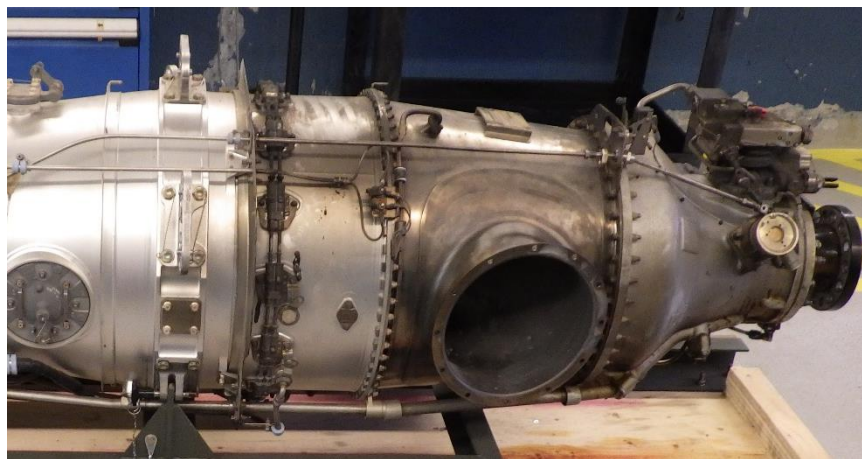
**Photo No. 5**

**Exhaust Duct:** The exhaust case upper external surfaces showed signs of PIF (Photo No. 5). The exhaust duct was cracked (arrow) from impact and showed dents from PT blades release (Photo No. 6).

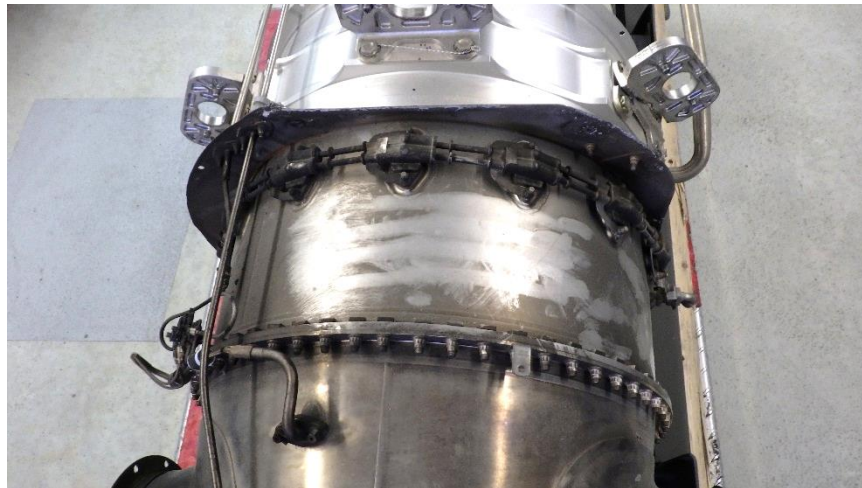
**Photo No. 7**

**Gas Generator Case (GGC):** The GGC upper external surfaces showed signs of PIF (Photo No. 7). The GGC was displayed impact damages. The fuel line and oil scavenge lines were mechanically deformed (circled, Photo No. 8). All fuel nozzle manifolds were still secured and tightened. Both igniter plugs were still secured and tightened.

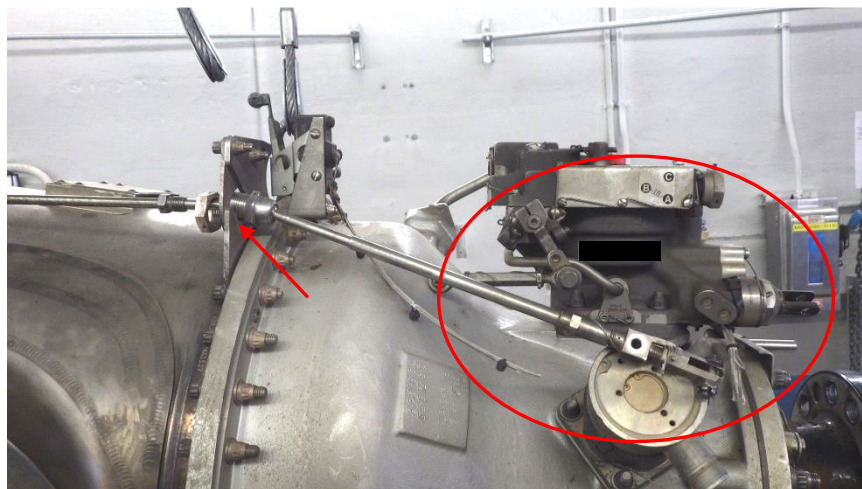
**Photo No. 10**

No damage was observed to the Power Control Linkage and it was continuous from the CAM box up to the Fuel Control Unit (FCU). The reversing cable was disconnected from the beta lever and propeller speed control lever (circled, Photo No. 10). The reversing cable was attached to the CAM box and secured. The reversing cable was found loose and not secured at the “A” flange (arrow, Photo No. 10).

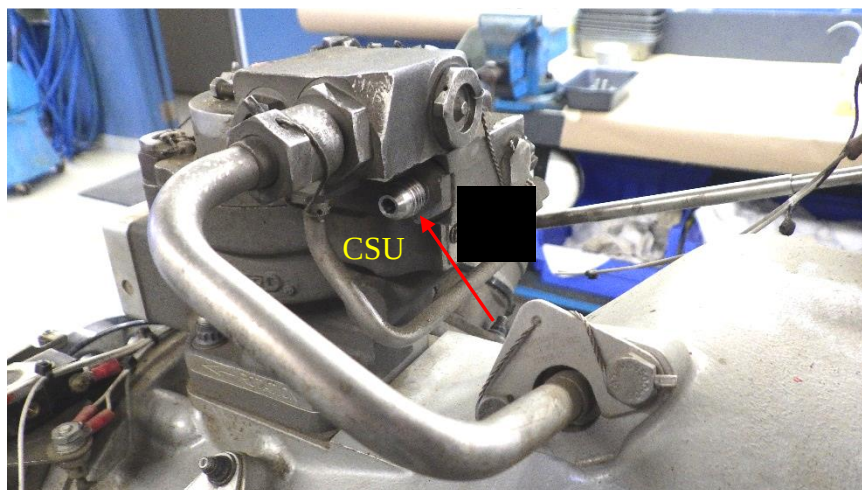
**Photo No. 11**

**Power Turbine Control (Py):** The Py pneumatic line was not received. Based on cleanliness of the FCU and propeller governor (CSU) fittings threads (arrows, Photo No. 11 and Photo No. 12), the Py line was likely removed post-accident during engine removal.

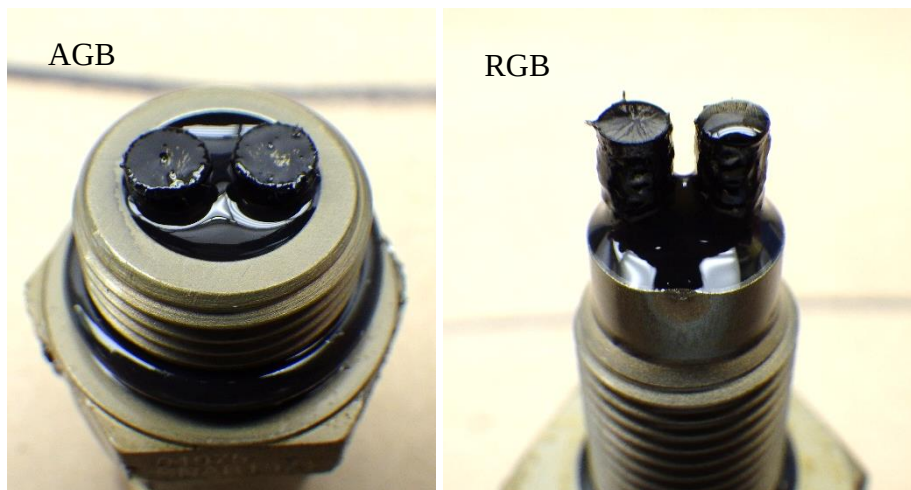
**Photo No. 13**

**Chip Detector(s):** The RGB and AGB magnetic chip detector (MCD) showed only some “Fuzz” (Photo No. 13).

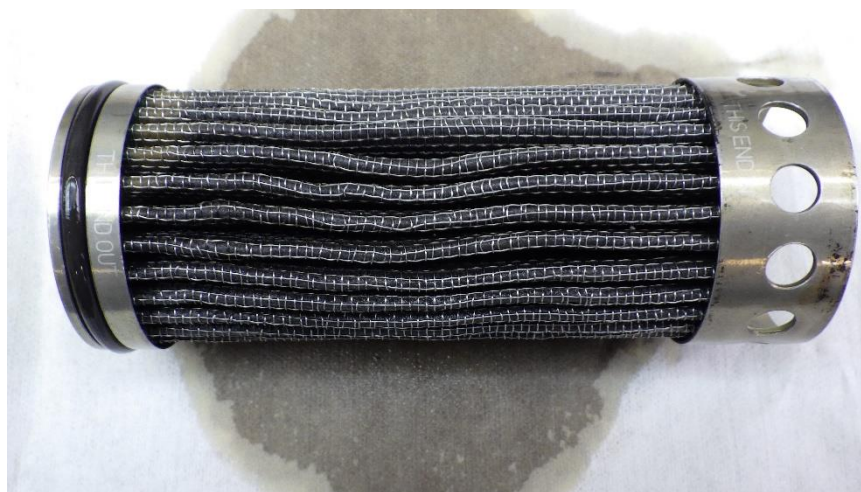
**Photo No. 14**

**Oil Filter:** The oil filter was dirty (Photo No. 14). The oil filter housing showed some metallic particles (circled, Photo No. 15). The oil filter was submitted to the P&WC Chemical Laboratory for further analysis (see section 5.0).

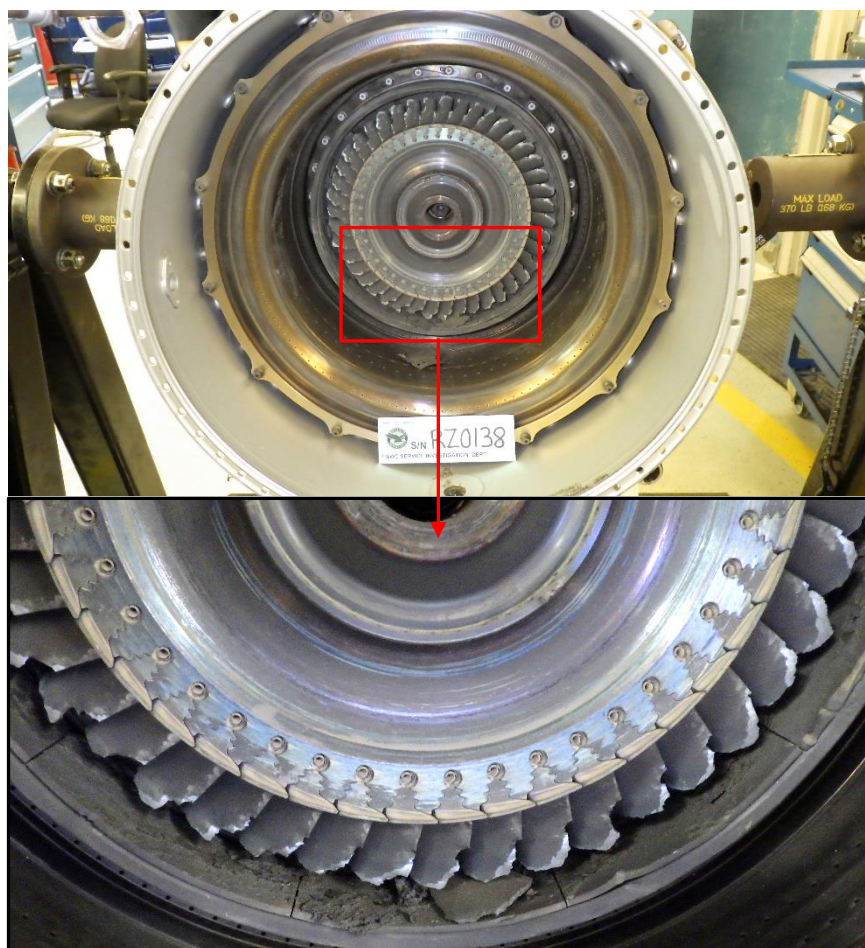
**Photo No. 16**

The engine was split at “C” flange to access the hot section components. The compressor turbine (CT) blades were all fractured near the tip (Photo No. 16). All CT blades were coated with foreign melted debris, dark grey in appearance (Photo No. 17). The CT disk downstream side exhibited heat discoloration and severe circumferential rubbing (Photo No. 17). The CT shroud segments presented rub, material transfer and fused debris accumulation (Photo No. 18). The CT vane ring showed normal operational wear, but displayed foreign melted debris build-up (Photo No. 19). The CT blades were sent to the P&WC Materials Laboratory for further analysis (see section 4.0). Sample of the foreign melted debris was collected from the CT vane ring and was submitted to the P&WC Chemical Laboratory for further analysis (see section 5.0).

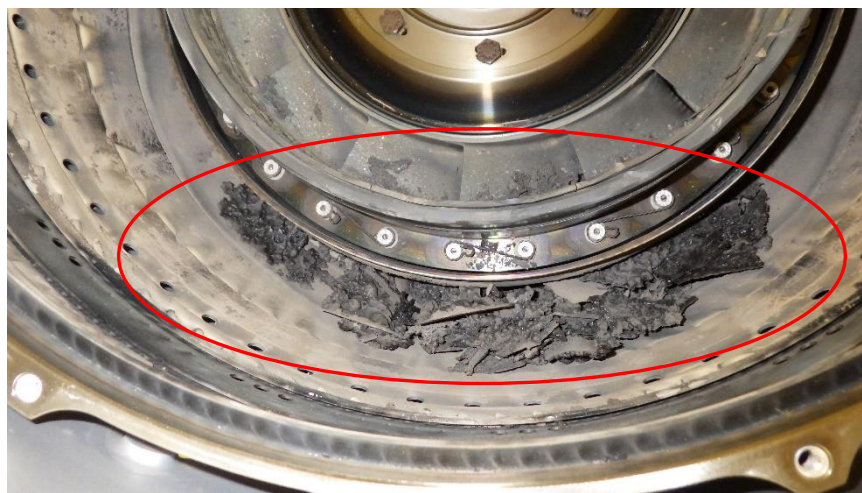
**Photo No. 20**

The combustion chamber displayed a significant accumulation of dislodged foreign melted debris, dark grey and tan in appearance (Photo No. 20 to Photo No. 22). The combustion chamber inner and outer liners did not show evidence of overtemperature exposure. The small exit duct showed normal operational wear, but also displayed foreign melted debris build-up. Samples of the foreign melted debris was collected from the combustion liners and were submitted to the P&WC Chemical Laboratory for further analysis (see section 5.0).

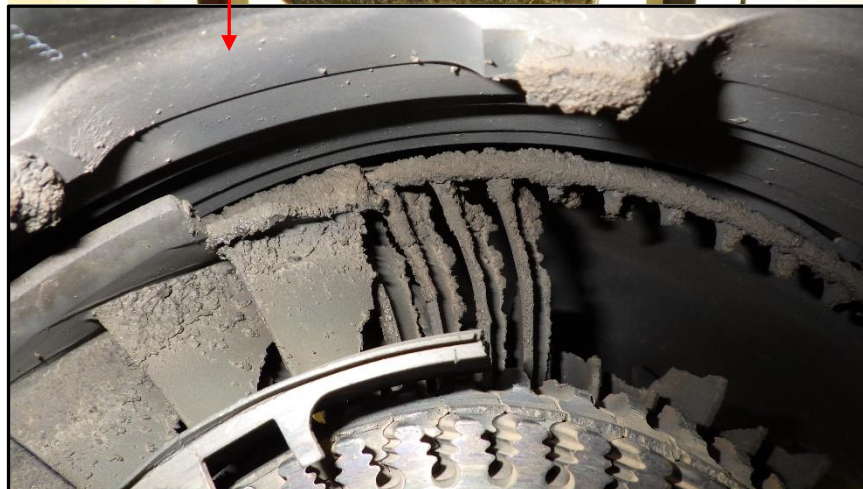
**Photo No. 24**

The PT section components were coated with foreign melted debris, dark grey in appearance (inset, Photo No. 24). All Inter Turbine Temperature (ITT) probes had fractured (Photo No. 23). The PT vane ring was fractured and some fragments were not retrieved (Photo No. 25). The interstage baffle was severely deformed, battered and showed severe circumferential rubbing marks due to contact with the CT disk assembly on the upstream side and the PT1 disk assembly on the downstream side (Photo No. 24 and Photo No. 26). The PT shroud was deformed and fractured (red arrow, Photo No. 27). The PT1 and PT2 blades were all fractured. All PT1 blades were pushed backward and were fractured at about the same airfoil heights, close to the base (yellow arrow, Photo No. 27). The PT interstage vane ring was fractured and displayed foreign melted debris build-up (Photo No. 28). Some PT2 blades were pushed backward and were fractured at various airfoil heights (Photo No. 29). The PT2 disk downstream and upstream sides showed circumferential rubbing. The No. 3 roller bearing showed normal operational wear. The PT1 and PT2 blades were sent to the P&WC Materials Laboratory for further analysis (see section 4.0). Sample of the foreign melted debris was collected from PT1 vane ring and was submitted to the P&WC Chemical Laboratory for further analysis (see section 5.0).

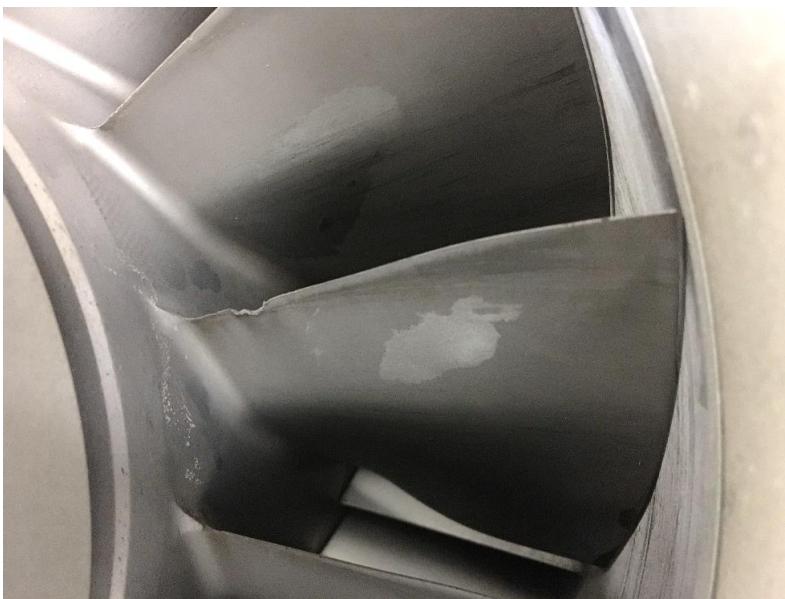
**Photo No. 30**

Some compressor 1<sup>st</sup>, 2<sup>nd</sup>, 3<sup>rd</sup>, 4<sup>th</sup> stages airfoils presented evidence of pre-impact foreign object damage (FOD) and displayed light erosion (Photo No. 30). The 1<sup>st</sup>, 2<sup>nd</sup>, 3<sup>rd</sup>, 4<sup>th</sup> stages stators showed environmental dust (light brown / tan) accumulation on the outer diameter (OD) (P2.5 area) (Photo No. 31). The 1<sup>st</sup> stage inner bore showed a significant amount of dust accumulation (inset, Photo No. 32). The centrifugal impeller presented evidence of pre-impact foreign object damage (FOD) and displayed light erosion (Photo No. 33). The back face of the impeller showed environmental dust (light brown / tan) accumulation (Photo No. 34). The No. 1 ball bearing and No. 2 roller bearing also showed normal operational wear. Samples of the dust collected in the cold section was submitted to the P&WC Chemical Laboratory for further analysis (see section 5.0).

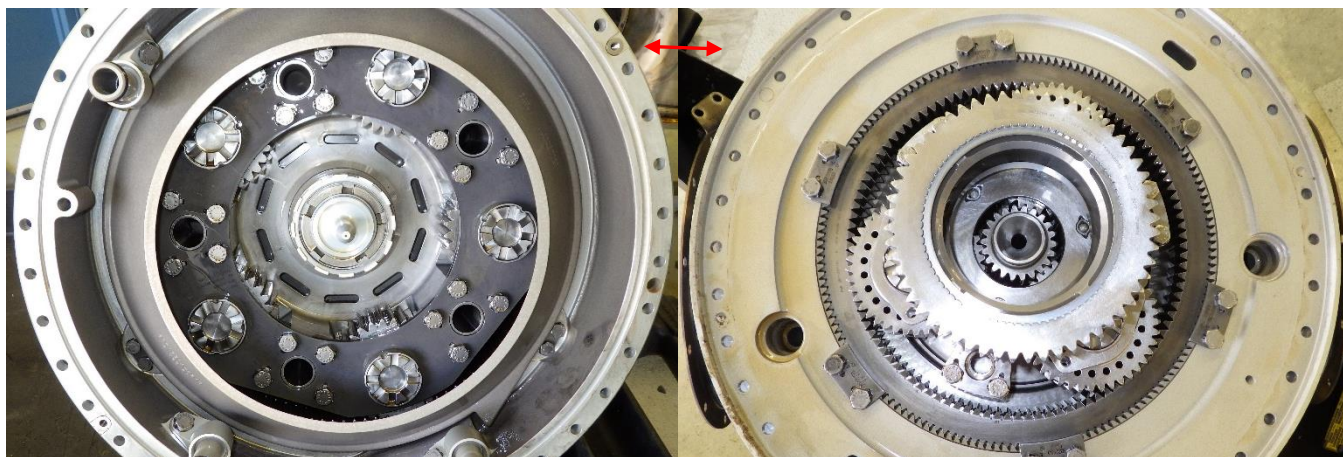
**Photo No. 35**

The RGB gears showed normal operational wear (Photo No. 35). The No. 4 roller bearing showed normal operational wear. The No. 4 bearing oil nozzle was intact. Nos. 5, 6 and 7 Bearings were not assessed.

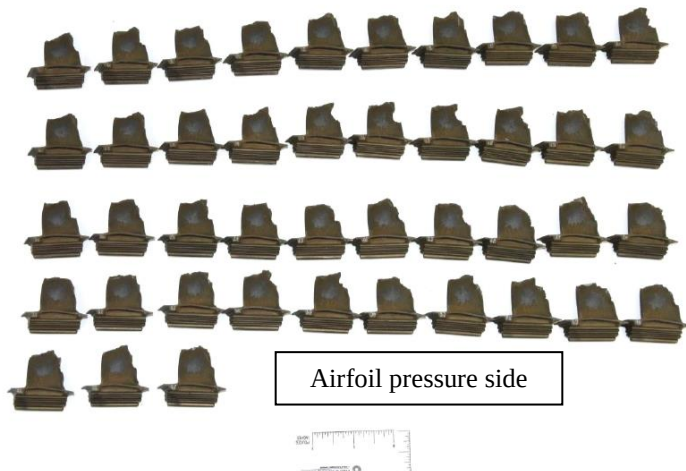
**Photo No. 36**

- 4.1 Examination of the CT blades showed that they exhibited overload fractures, likely corresponding to secondary damage (Photo No. 36 to Photo No. 38).

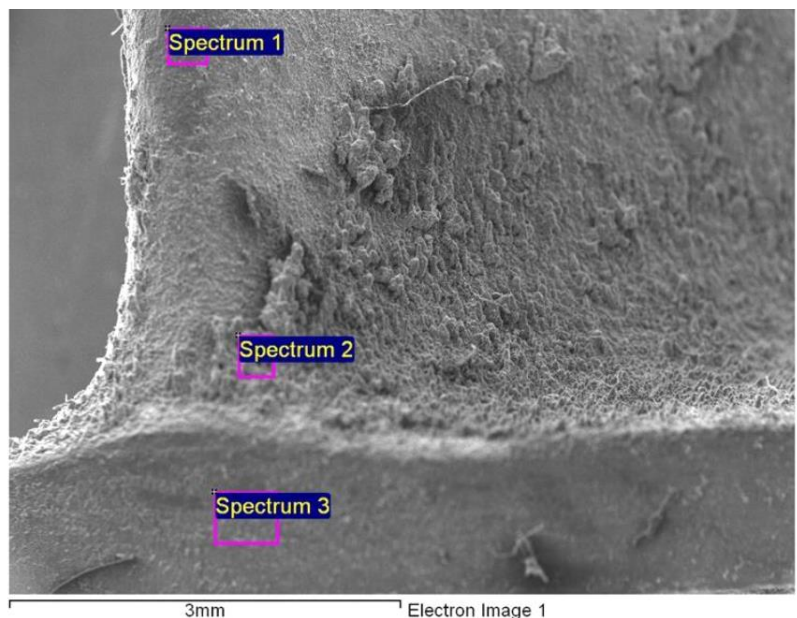
4.1.1 Energy Dispersive X-ray Spectroscopy (EDS) spot analyses of CT blade No. 11 leading edge area, semi-quantitative and standardless method, was used to determine the nature of the foreign melted debris build-up. The analyses showed aluminium and silicon rich mixed with a few other elements (Photo No. 39).

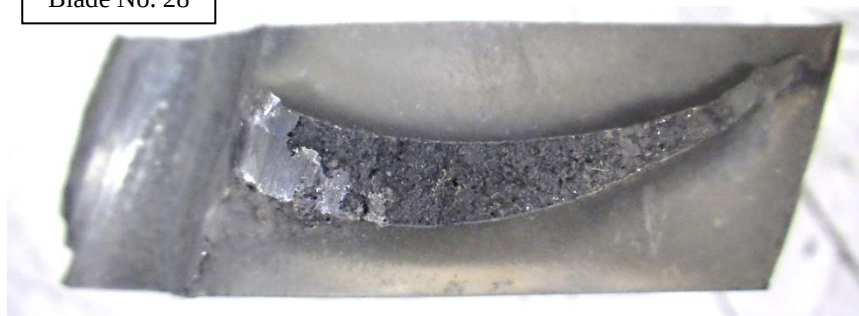
**Photo No. 42**

4.2 PT1 blades as received are shown in Photo No. 40 and Photo No. 41. Examination of the PT1 blades showed that they exhibited overload fractures (Photo No. 42), likely corresponding to secondary damage.

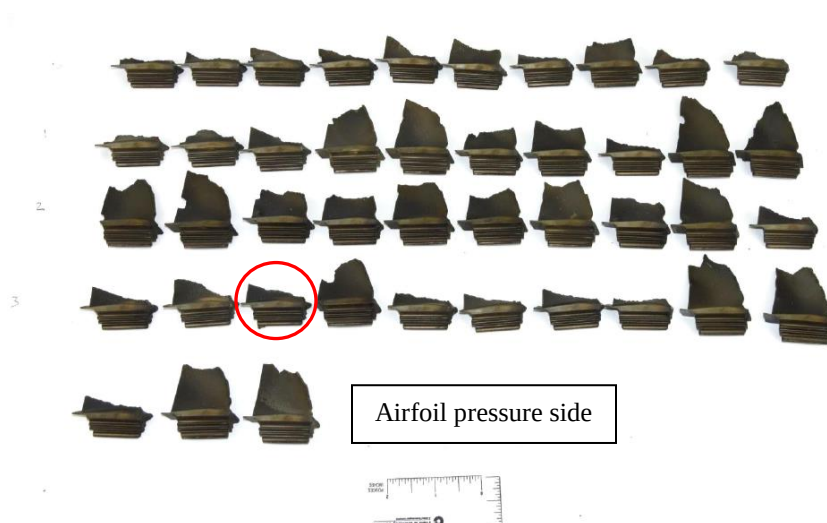
**Photo No. 43**

- 4.3 Examination of the PT2 blades showed that the blades with the longer airfoil remnants exhibited overload fractures and impact damage consistent with secondary damage. All of the other blades with airfoil fractures slightly above their platform also exhibited overload fractures (Photo No. 45) and

impact damage consistent with secondary damage, with the exception of blade No. 33 (circled, Photo No. 43 and Photo No. 44).

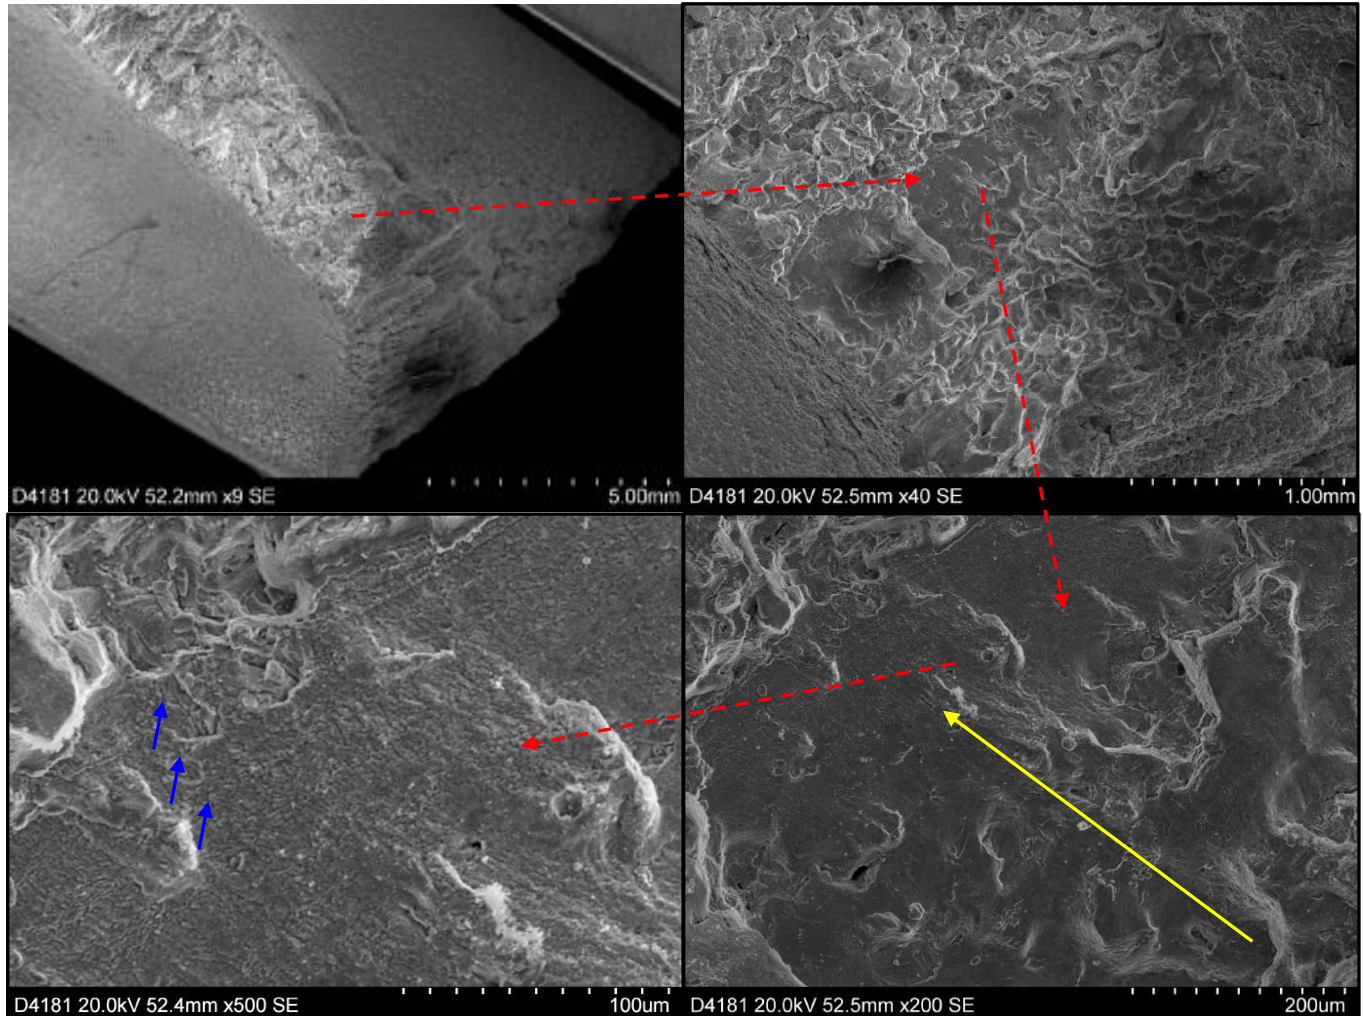
**Photo No. 52**

4.3.2 In general, the fatigue crack progression was chord wise, from the impacted area on leading edge area towards the trailing edge (yellow arrow, Photo No. 52), evidenced by the presence of crack progression marks (some were depicted by blue arrows, Photo No. 52).

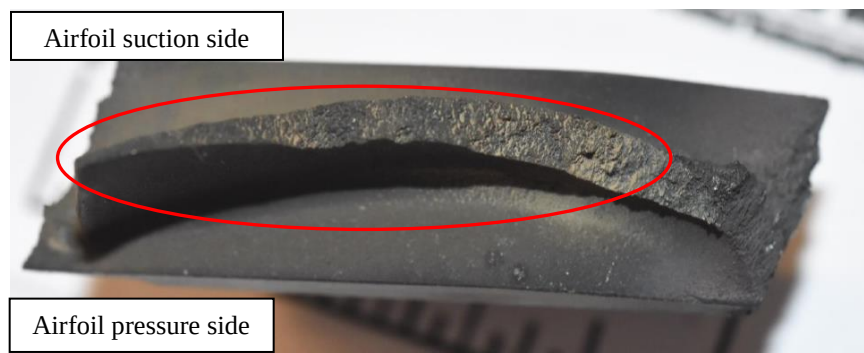
**Photo No. 53**

4.3.3 The remainder of the blade fracture exhibited evidence of ductile overload (circled, Photo No. 53).

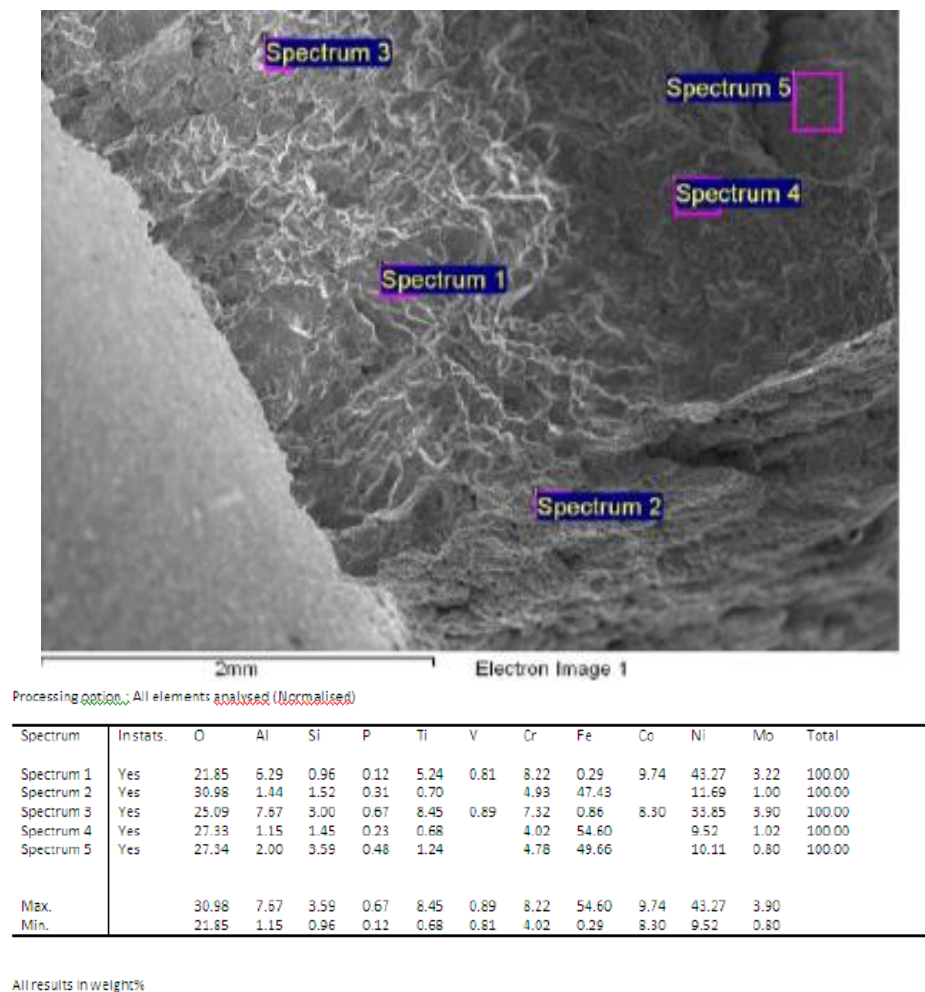
**Photo No. 54**

- 4.3.4 No metallurgical cross section was deemed necessary as the fatigue origin area could not be identified.
- 4.3.5 The secondary damage sustained by PT2 blade No. 33 platform prevented determining its S/N.
- 4.3.6 EDS spot analyses of PT2 blade No. 33 fracture surface slightly downstream from the leading edge impact area showed that the proportions of the elements detected, semi-quantitative and standardless method, were consistent with specifications (Photo No. 54). No evidence of foreign melted debris was found.

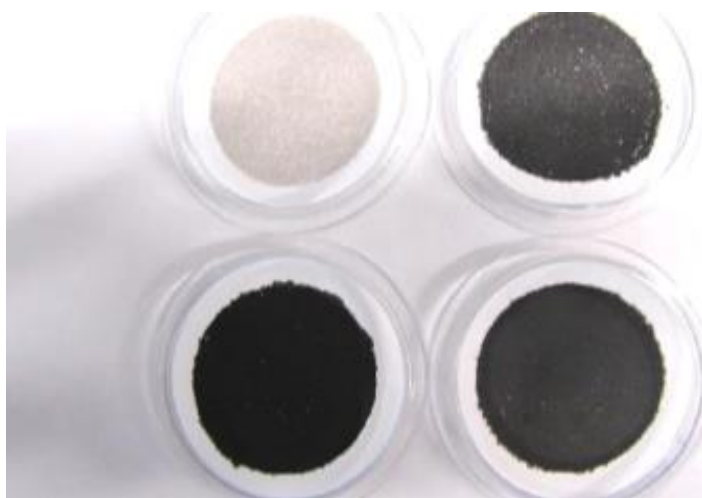
**Photo No. 55**

| Sample ID | Summary of Analysis |
|---|---|
| Oil filter<br><b>Sample No. 1</b> (Residue collected from the oil filter, Photo No. 55)<br>(Patch with presence of large metallic particles, Photo No. 56) | The particles analysed by APA were mainly composed of : <ul style="list-style-type: none"><li>• Iron base alloy, some particles were similar to low alloy steel and similar to 300 series SST. The low alloy steel particles included particles similar to UNS G93106 (AMS6260, 6265, 6267)</li><li>• An interaction between the low alloy steel UNS G93106 and the 300 series SST particles is observed.</li><li>• Traces of Cadmium particles and presence of Cadmium contamination on some Iron base particles</li><li>• Traces of Aluminum particles</li></ul> The large particles analysed by SEM-EDX were composed of Aluminum alloy. |

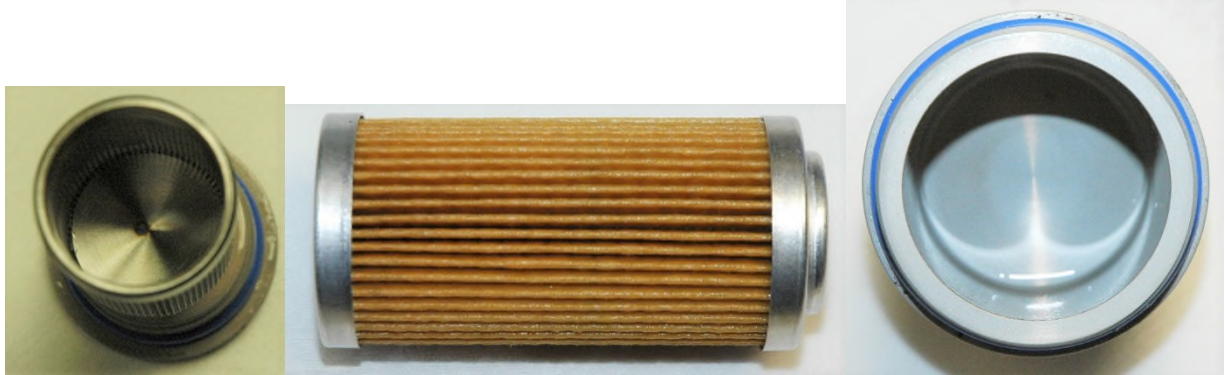
Figure 2

Prior to testing the fuel pump the outlet filter and inlet screen were removed for inspection and a small amount of fuel residue was collected. There was no significant debris in the outlet filter or inlet screen and no evidence of water or solid contamination in the fuel residue. A slave outlet filter was installed and the fuel pump was tested in accordance with [REDACTED]. The test was satisfactory.

Fuel pump inlet screen (left), outlet filter (centre) and outlet filter bowl (right) before testing

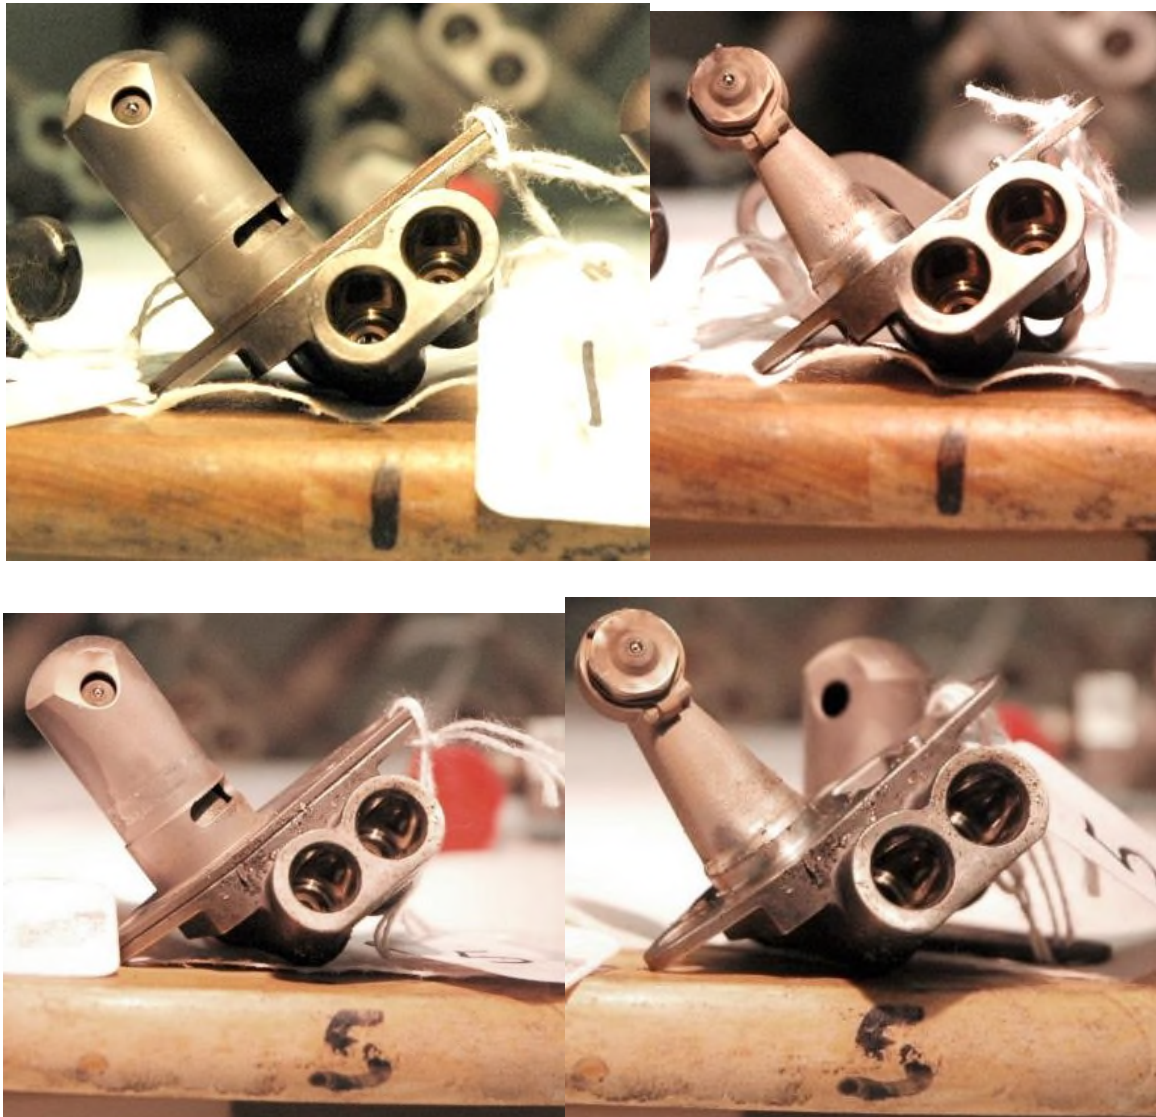
| Nozzle position | Observation |
|---|---|
| 1 | With the primary pressure [REDACTED] and the secondary pressure at [REDACTED] up to 30% streaks and voids were observed. |
| 5 | With the primary pressure at [REDACTED] up to 30% streaks and voids were observed. |

Figure 12  
No. 1 (upper photos) and 5 (lower photos) fuel nozzles before testing
