**FACTUAL NOTES, ENGINE TEARDOWN INVESTIGATION IN SUPPORT OF ACCIDENT INVESTIGATION OF AIR TRACTOR AT-802F REGISTERED N397AS PERFORMED FOR NATIONAL TRANSPORTATION SAFETY BOARD (NTSB)**

**NTSB Identification:** WPR18LA222

**P&WC Reference:** File No. 18-124

**Engine Model:** PT6A-67F, **Engine Serial No.:** RZ0138

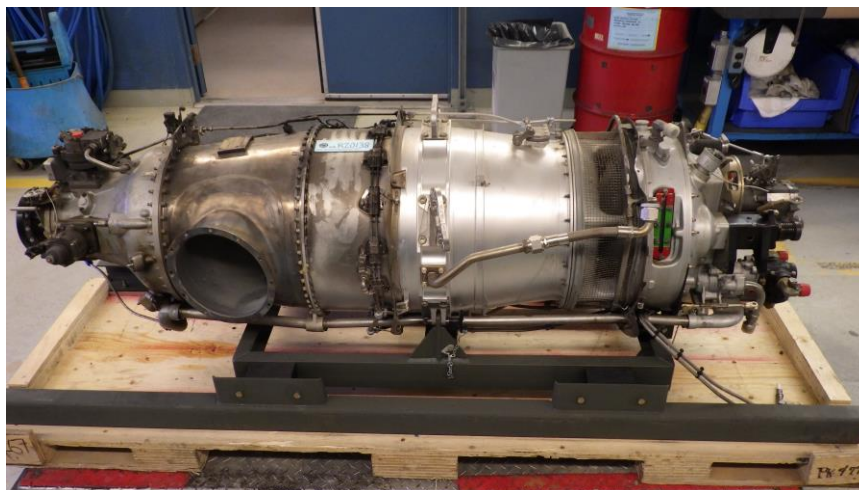
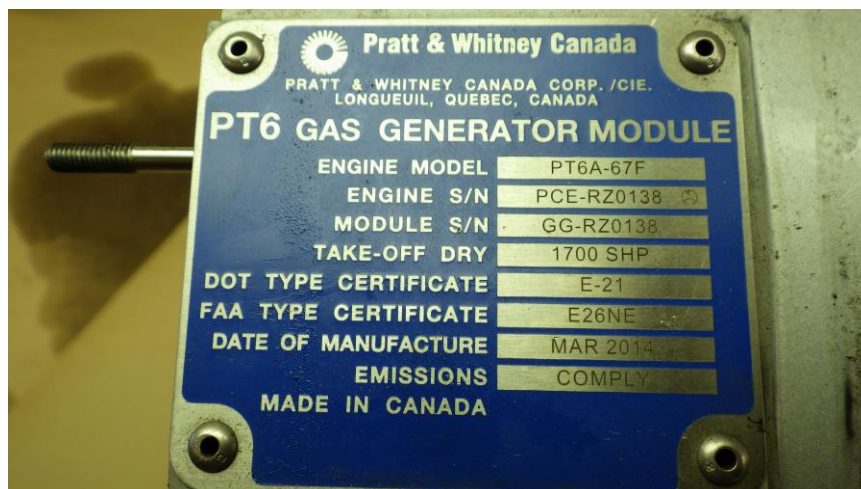
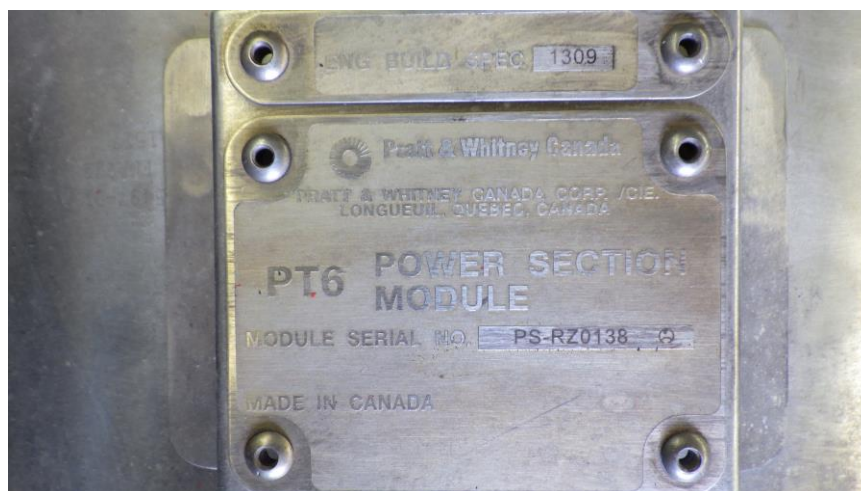
The shipping box was in good condition. Removal of the shipping box, revealed the engine with parts of the airframe mount, some airframe accessories, wiring harnesses, and firewall still attached. The gas generator case (GGC) and exhaust case upper external surfaces, mainly in the fuel nozzles area, showed signs of post-impact fire (PIF). The lower portion of the reduction gearbox (RGB) was covered with a mixture of environmental debris and oil. The RGB was found cracked at the 6 O'clock position close to the propeller shaft flange. The compressor rotor and the power turbine (PT) / propeller shaft rotor were both seized. The PT blades were examined on the downstream side through the exhaust duct ports. The first stage PT (PT1) and second stage PT (PT2) blades were all fractured. The exhaust duct was fractured from impact and showed mechanical damages from blade release. The GGC was displayed impact damages. The fuel line and oil scavenge lines were mechanically deformed. The inlet screen was not punctured, but was slightly soiled. A portion of the inlet screen and wash ring had been compressed inwards from impact. The internal gas path of the inlet case was generally clean. The gas generator module data plate confirmed the engine serial No. RZ0138.

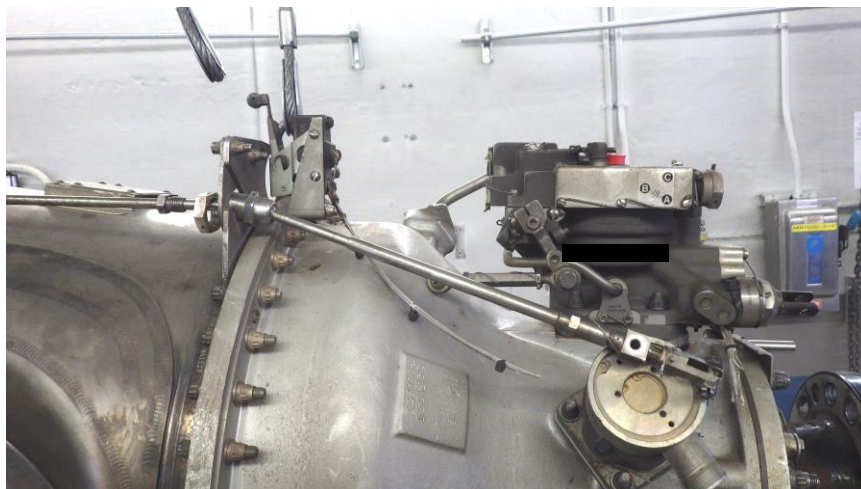
**Power Control Linkage:** No damage was observed and it was continuous from the CAM box up to the Fuel Control Unit (FCU).

**Reversing Linkage:** The reversing cable was disconnected from the beta lever and propeller speed control lever. The reversing cable was attached to the CAM box and secured to the reversing CAM.

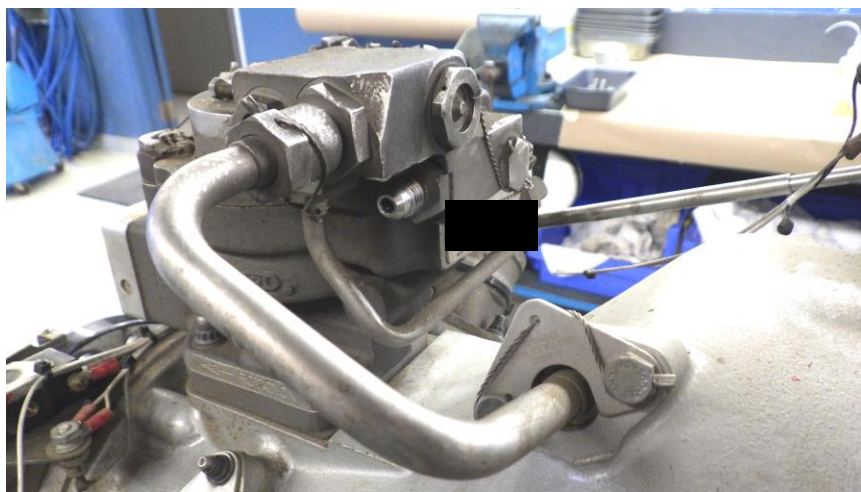
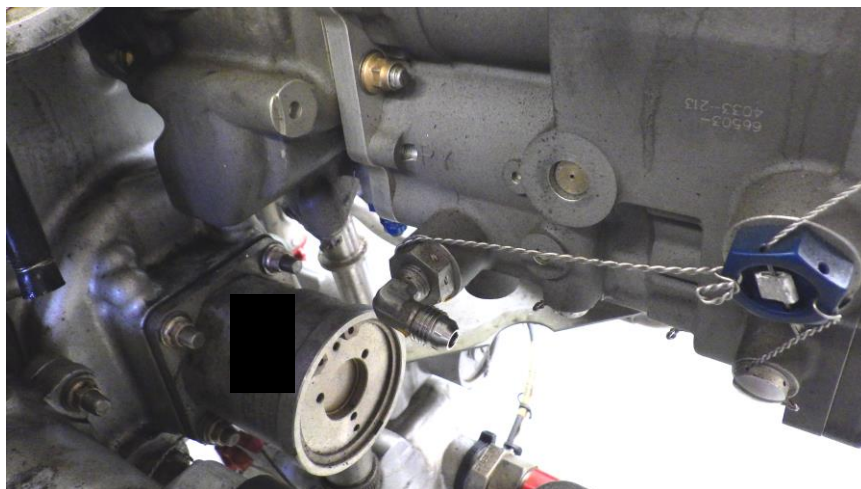
**Compressor Discharge Air (P3):** The P3 pneumatic line was continuous from the GGC to the FCU. All the "B" nuts were secured with lockwire and found tight. Leak check was performed on P3 line and no leak was found.

**Power Turbine Control (Py):** The Py pneumatic line was not received. Based on cleanliness of the FCU and propeller governor (CSU) fittings threads, the Py line was likely removed post-accident during engine removal

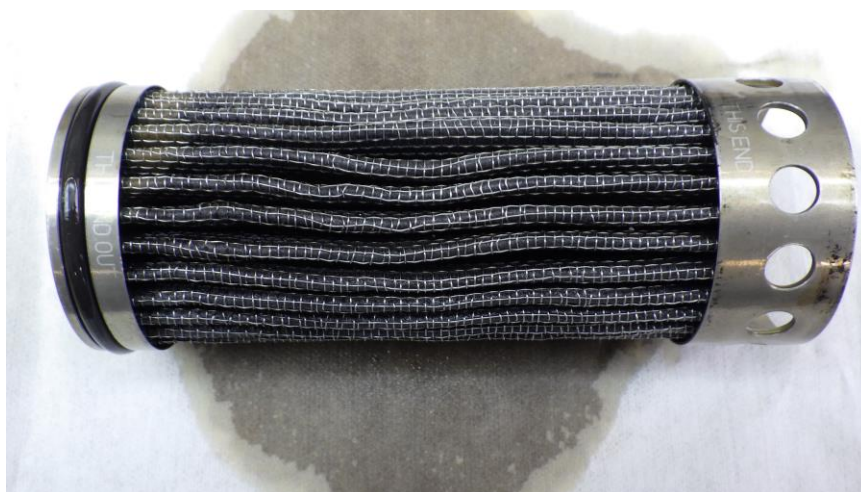
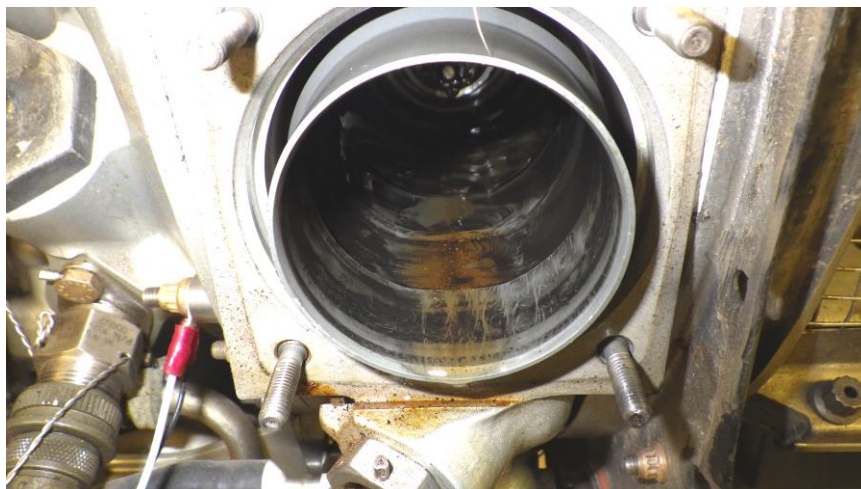
**Reduction Gearbox Chip Detector:** The magnetic chip detector (MCD) showed only some “Fuzz”.

**Accessories Gearbox Chip Detector:** The MCD showed only some “Fuzz”.

**Oil Filter:** The oil filter was dirty. The oil filter housing showed some metallic particles.

**P3 Air Filter:** The P3 air filter was dry and free of contaminants.

The accessories gearbox (AGB) and oil tank oil samples were clean and free of contaminants. The RGB oil sample displayed a darker discoloration, but was free of contaminants.

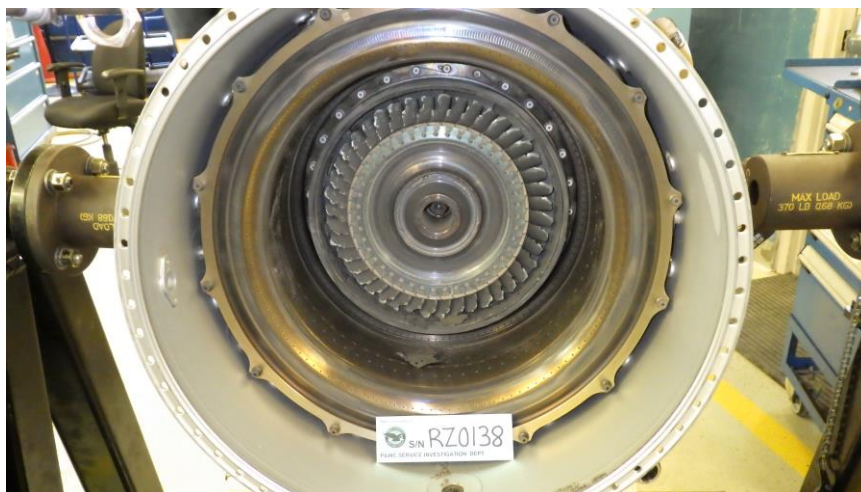
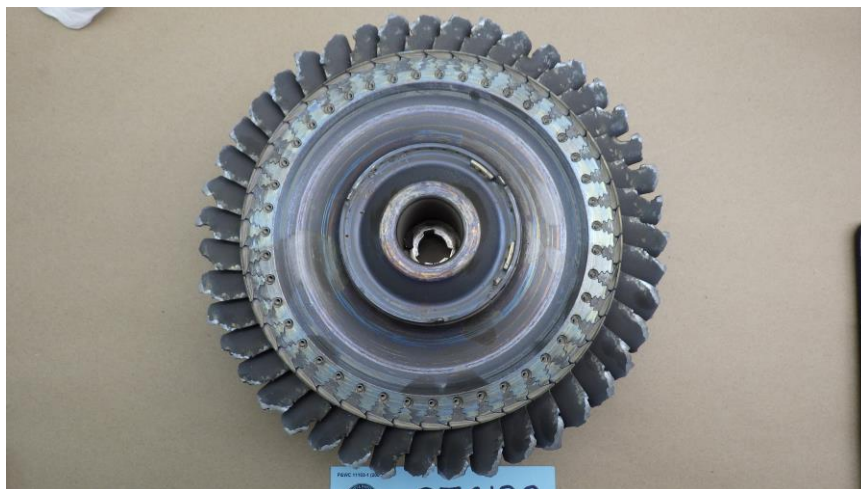
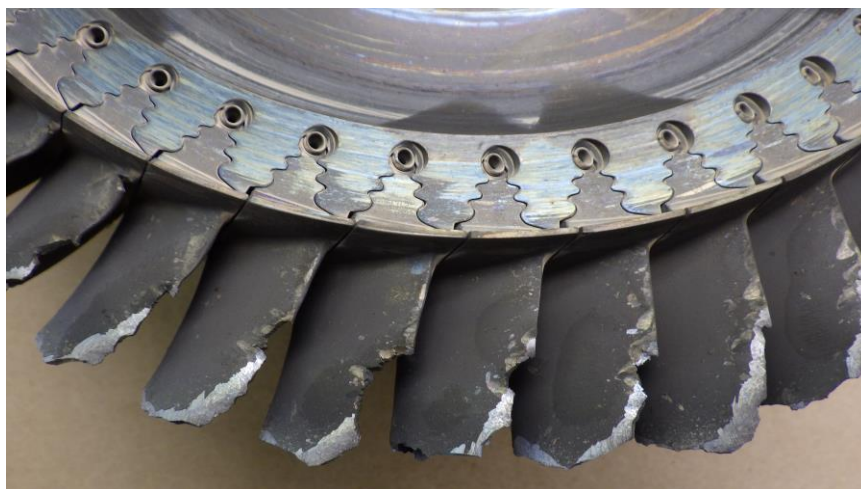
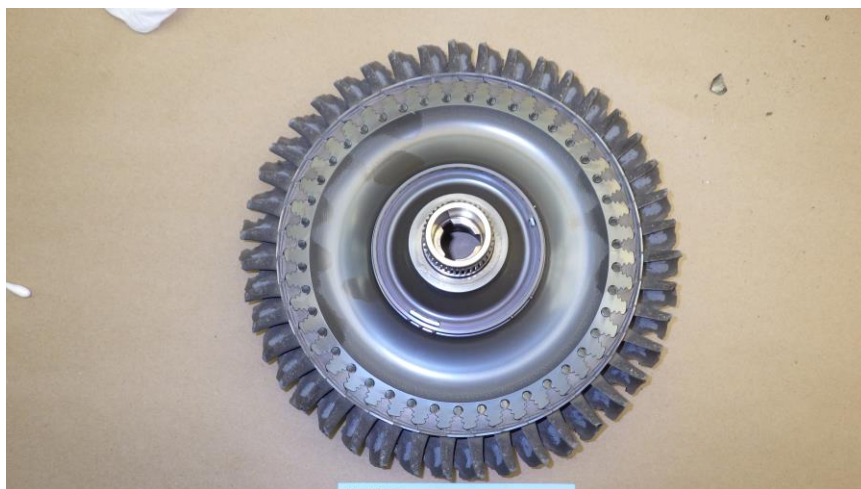
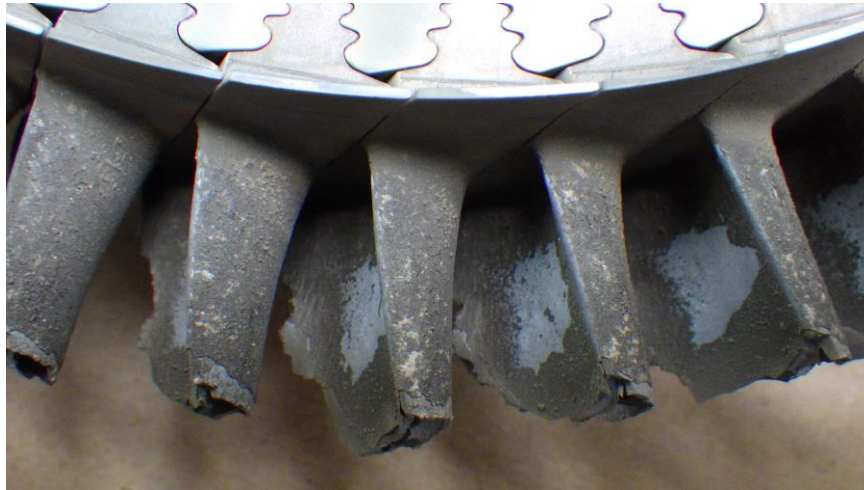
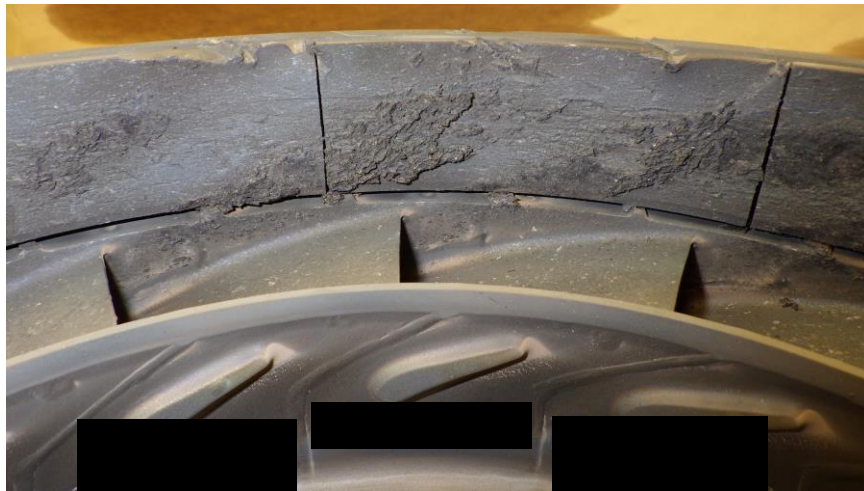
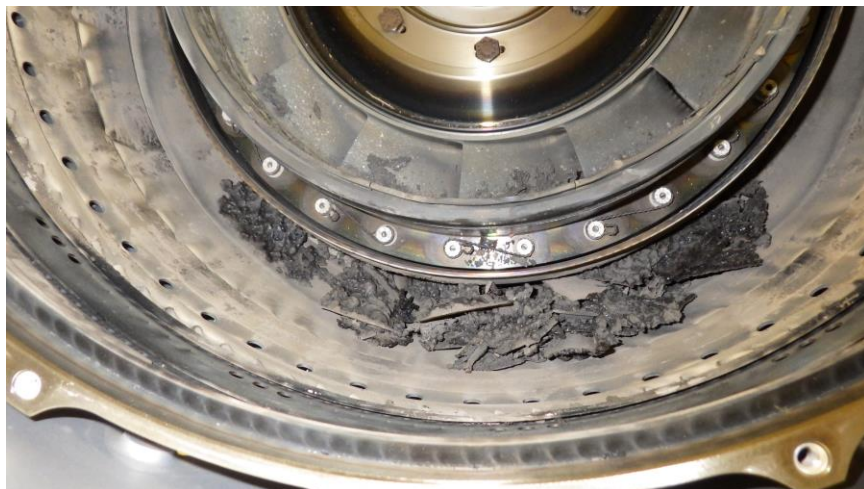
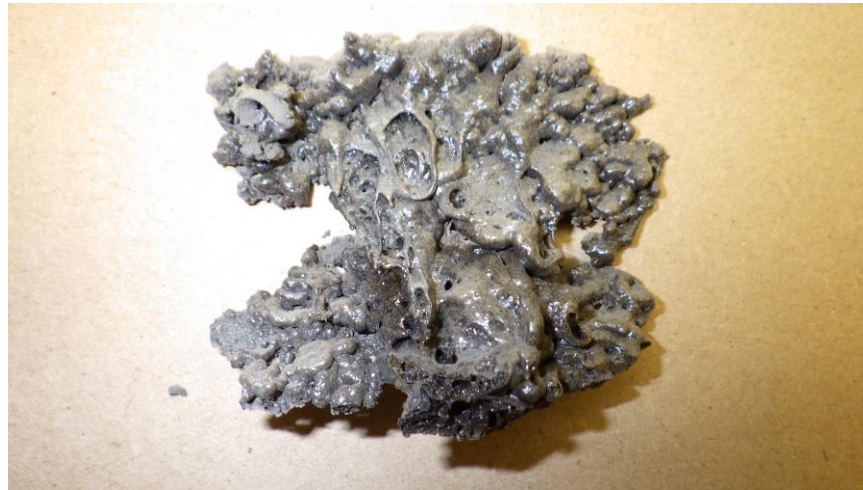
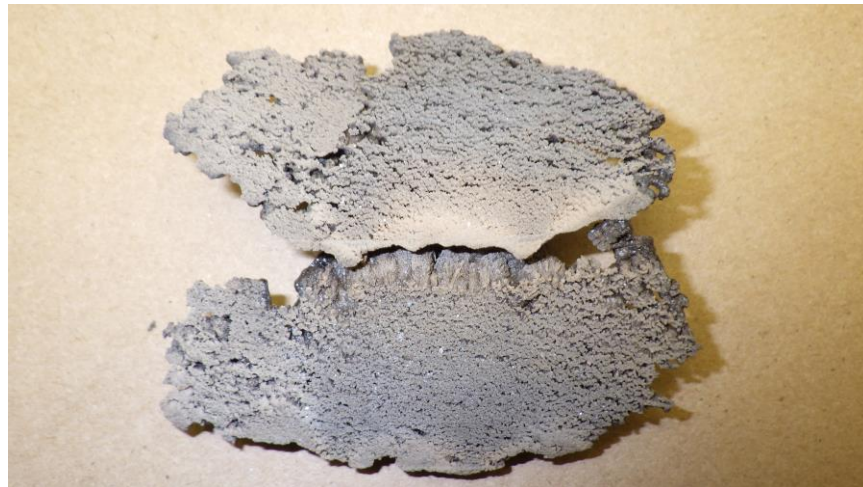
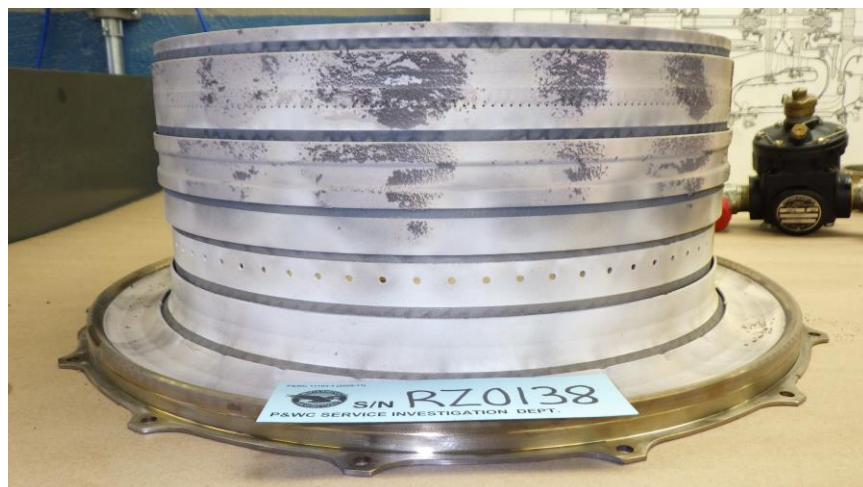
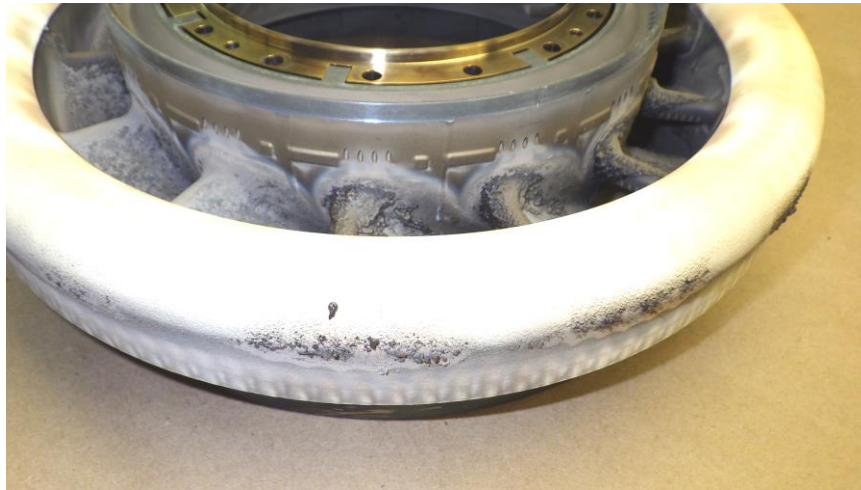
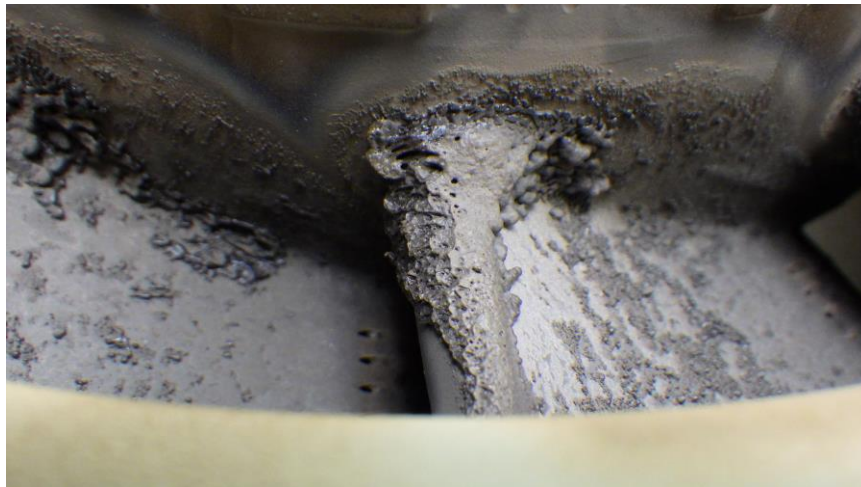
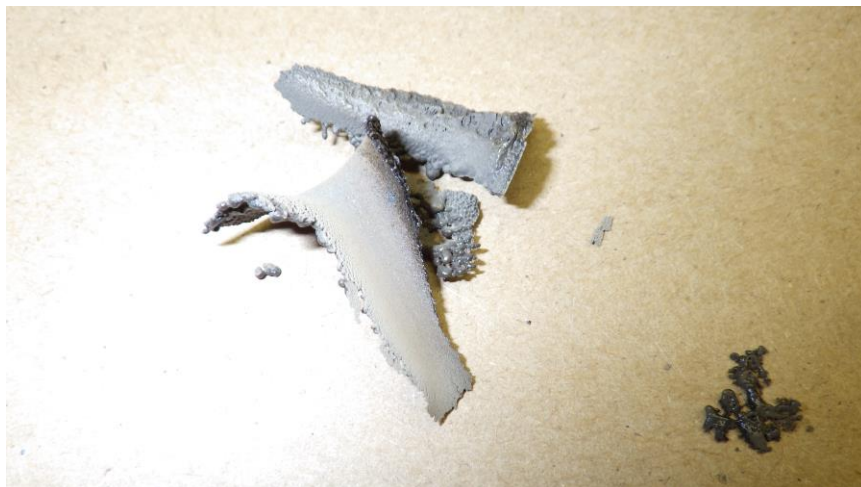
The compressor bleed valve (BOV) was removed and was found in the open position. The BOV was generally clean. Both igniter plugs and all fuel nozzle manifolds were still secured and tightened.

The engine was split at “C” flange to access the hot section components. The compressor turbine (CT) blades were all fractured. All CT blades were coated with fused/stuck debris, dark grey in appearance. The CT disk downstream side exhibited heat discoloration and severe circumferential rubbing. The CT shroud segments presented rub, material transfer and fused debris accumulation. The combustion chamber displayed a significant accumulation of dislodged “unknown” melted/molten debris, dark grey and tan in appearance. The combustion chamber did not show evidence of overtemperature exposure. The CT vane ring showed normal operational wear, but displayed fused debris build-up. The small exit duct showed normal operational wear, but also displayed stuck debris build-up.

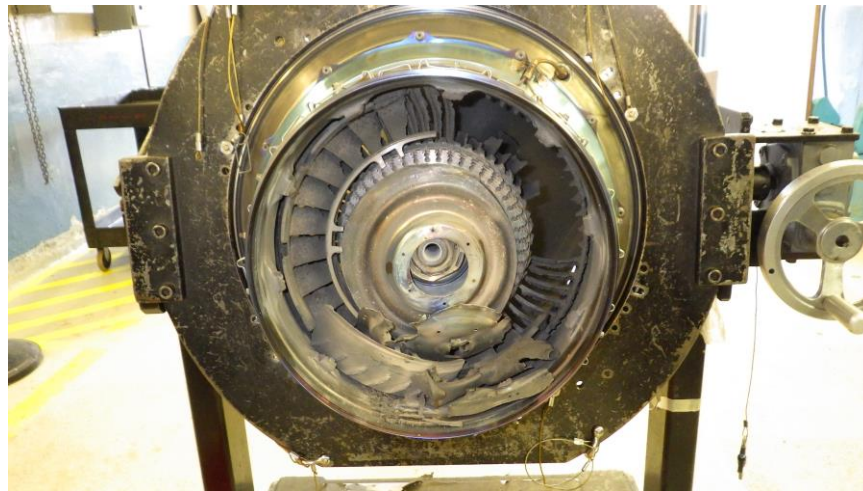
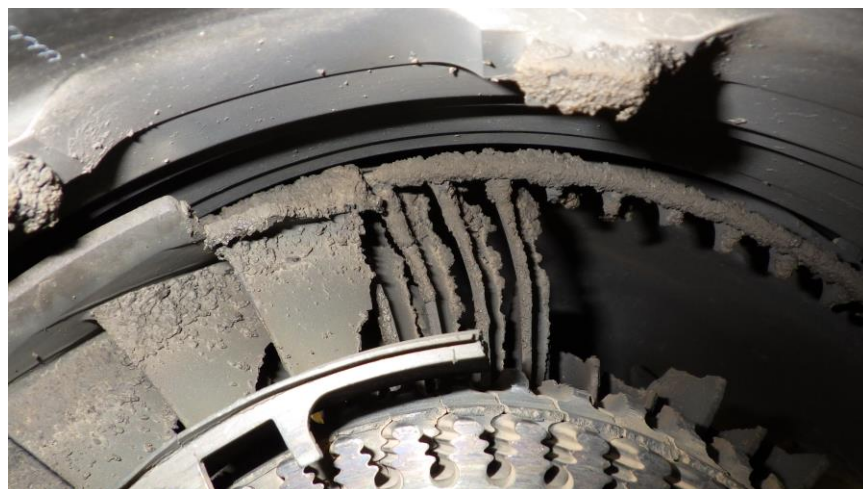
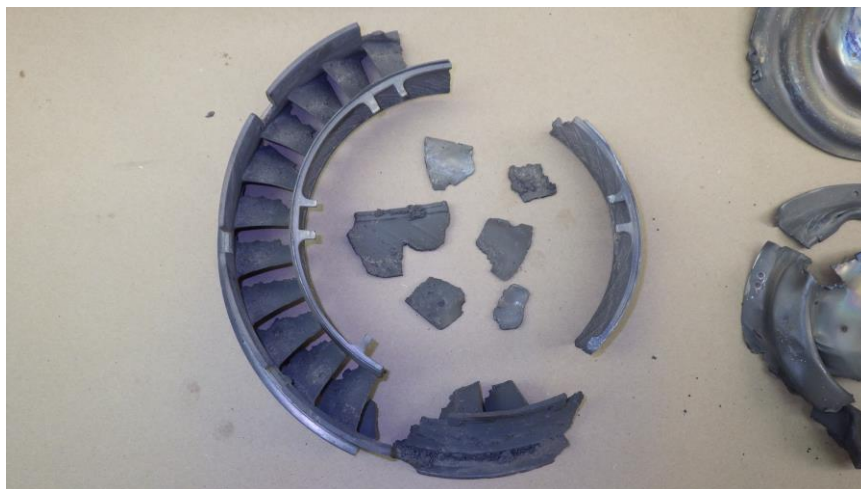
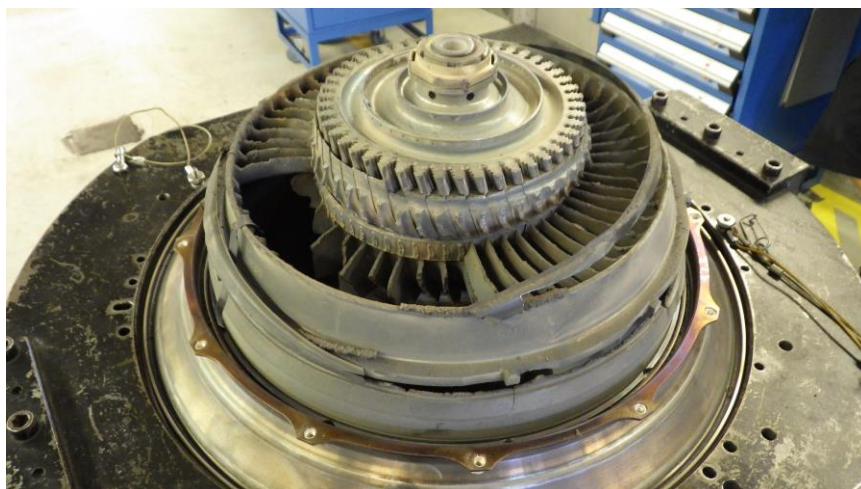
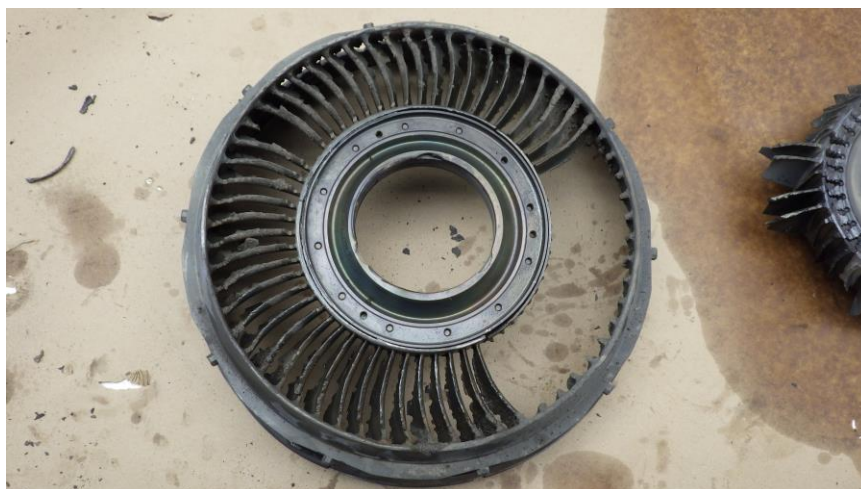
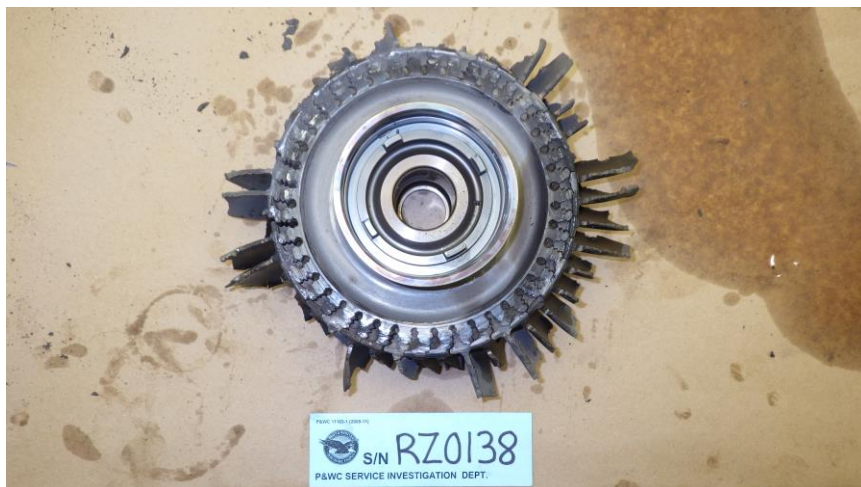
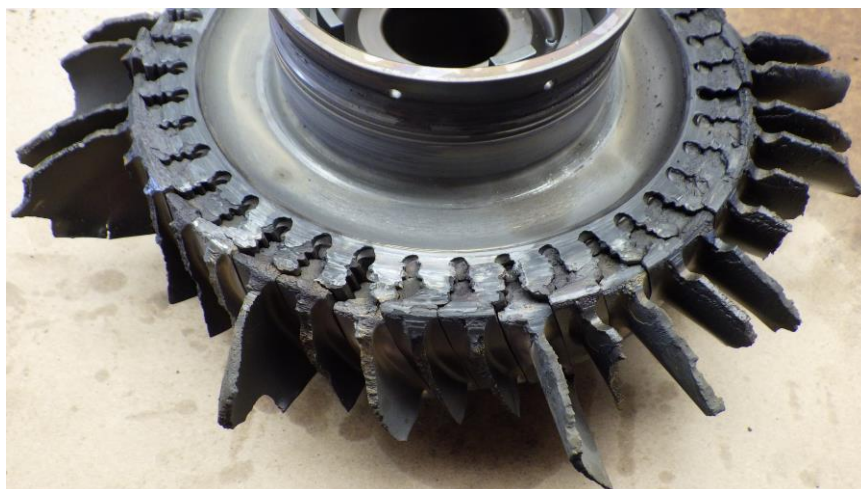
All T5 probes had fractured. The PT stator housing internal surface showed some scoring marks. The PT vane ring was fractured and some fragments were not retrieved. The interstage baffle was severely deformed, battered and showed severe circumferential rubbing marks due to contact with the CT disk assembly on the upstream side and the PT1 disk assembly on the downstream side. The PT shroud was deformed and fractured. The PT1 and PT2 blades were all fractured. All PT1 blades were pushed backward. The PT1 blades were fractured at about the same airfoil heights, close to the base. The PT1 disk downstream and upstream sides showed circumferential rubbing. The upstream side of the PT disk showed severe circumferential rubbing marks at the bore and serrations due to the contact with the interstage baffle downstream side. The balancing rim was deformed and fractured. Some PT2 blades were pushed backward. The PT2 blades were fractured at various airfoil heights. The PT2 disk downstream and upstream sides showed circumferential rubbing.

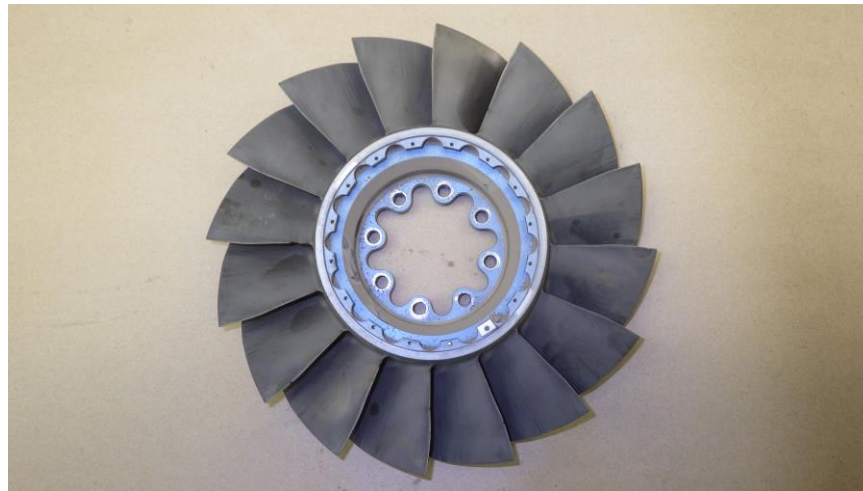
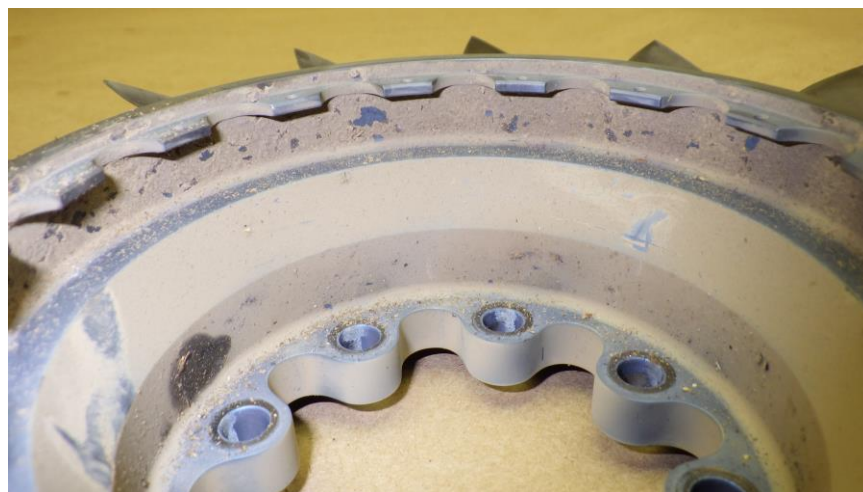
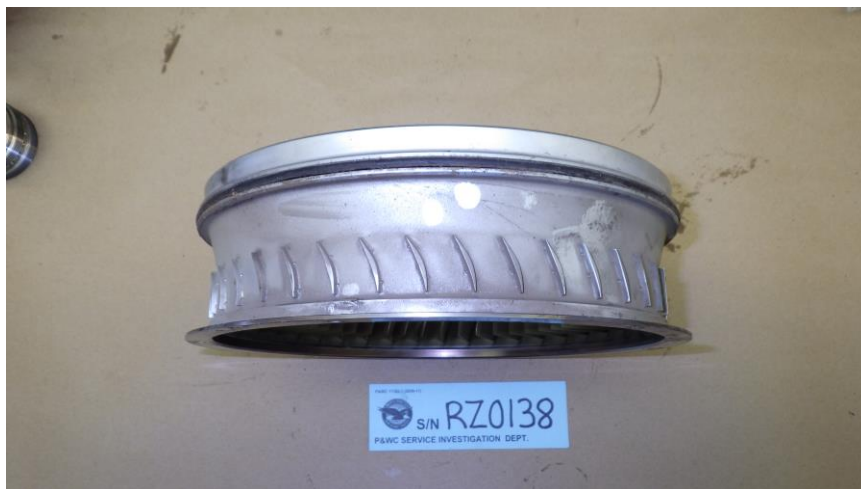
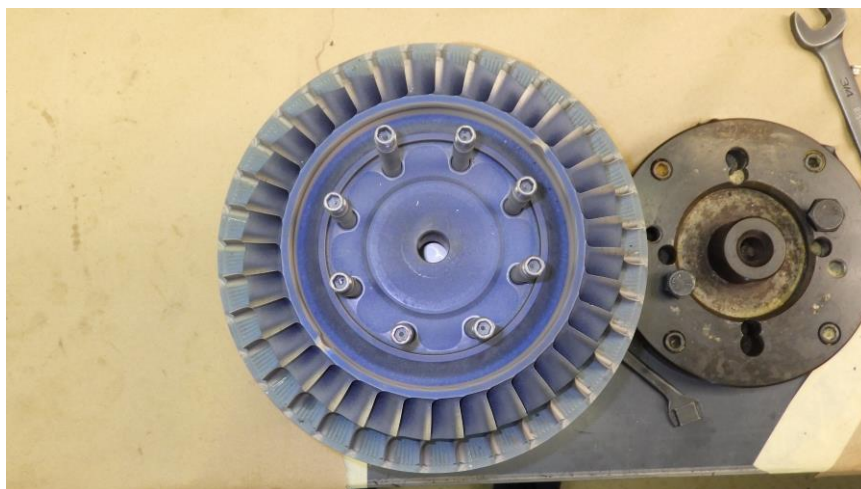
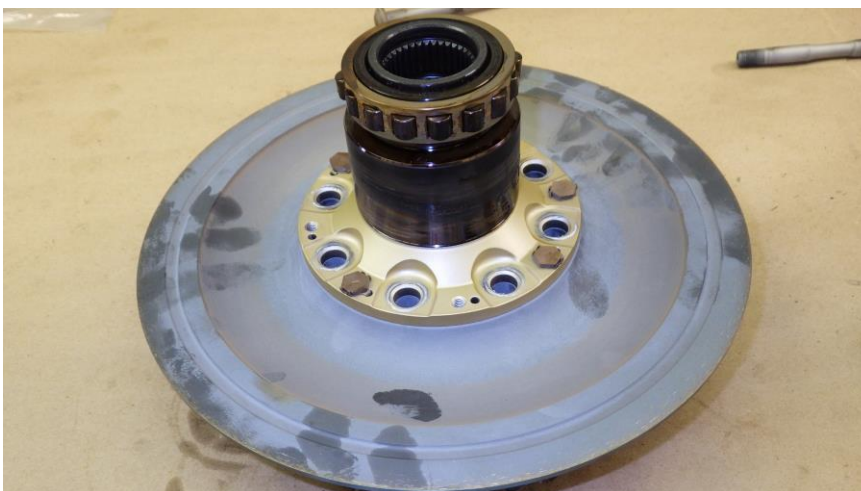
Some compressor 1st, 2nd, 3rd, 4th stages airfoils presented evidence of pre-impact foreign object damage (FOD) and displayed light erosion. The 1st, 2nd, 3rd, 4th stages stators showed environmental dust (light brown / tan) accumulation on the outer diameter (OD) (P2.5 area). The 1st stage inner bore showed a significant amount of dust accumulation. The impeller presented evidence of pre-impact foreign object damage (FOD) and displayed light erosion. The back face of the impeller showed environmental dust (light brown / tan) accumulation.
