## **NATIONAL TRANSPORTATION SAFETY BOARD**

### **SUMMARY OF AIRPLANE EXAMINATION**

**(WPR18LA227)**

| Aircraft: | N84CP, Cessna 182Q |

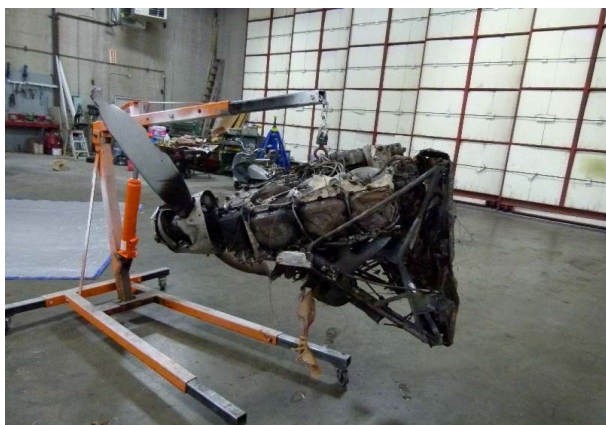
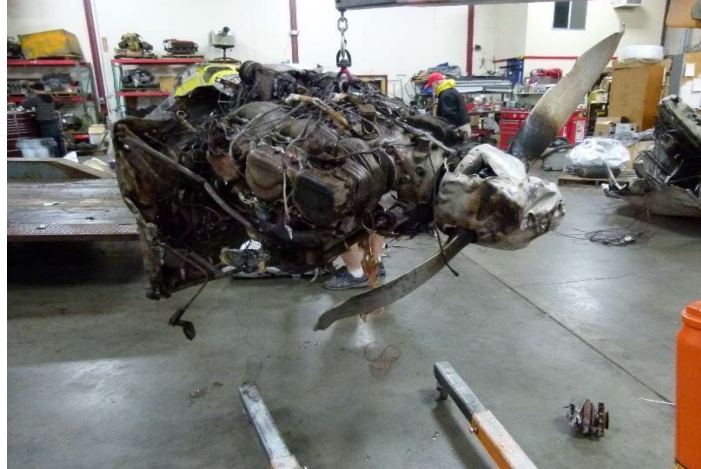
| <u>External inspection of engine</u> | The engine, engine mount and firewall had separated from the airframe, but remained together. The engine exhibited heavy thermal damage. Due to the thermal damage, the crankshaft would not rotate by hand. The firewall was then removed for the examination. |

Figure 1 - view 1 of engine as received

Figure 2 - view 2 of engine as received

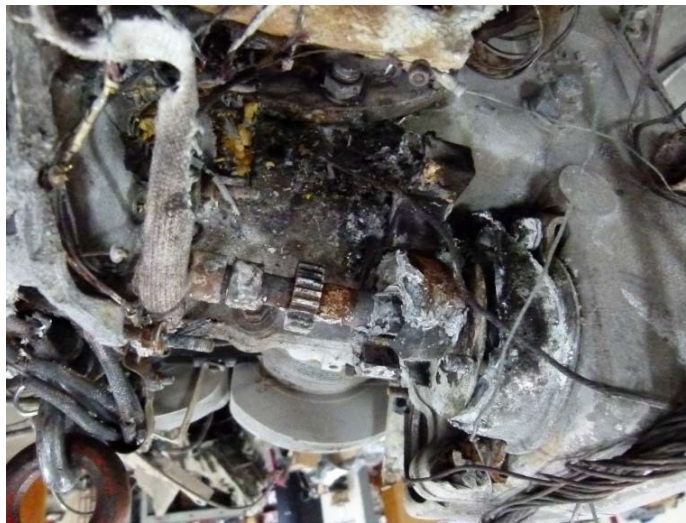
- Exhaust system: The exhaust system remained intact and exhibited impact damage.
- Inductions system: Th induction system was found to be mostly burned away by thermal activity.
- Ignition system: The left magneto was mostly burned away by thermal activity. Some of the magnetos internal parts remained mounted to the engine.

Figure 3 - photo of left magneto

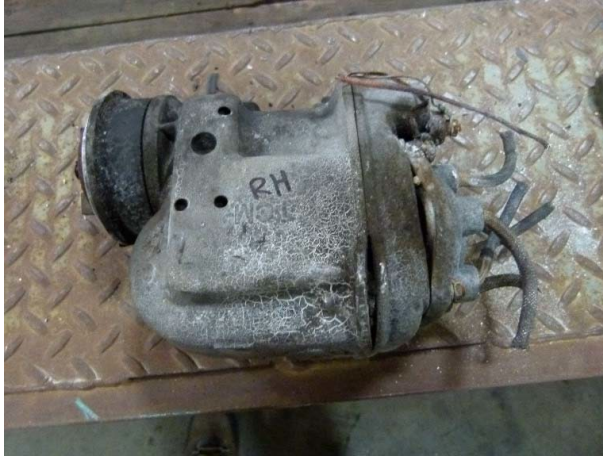
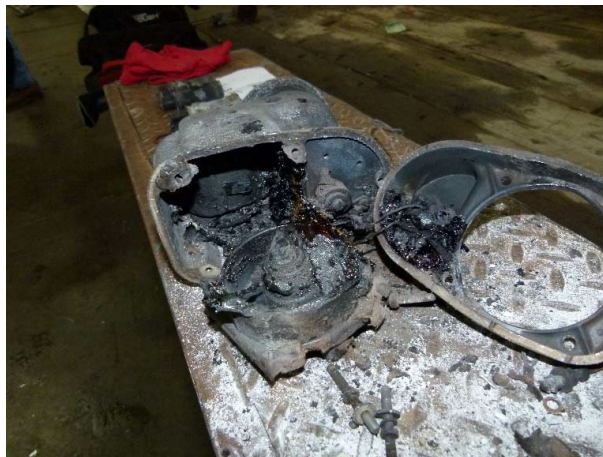
The right magneto remained attached to the engine and exhibited thermal damage. When magneto was removed, the drive would not rotate by hand. The magneto was disassembled and the internal components exhibited thermal distress.

Figure 4 - photo of right magneto

Figure 5 - photo of right magneto

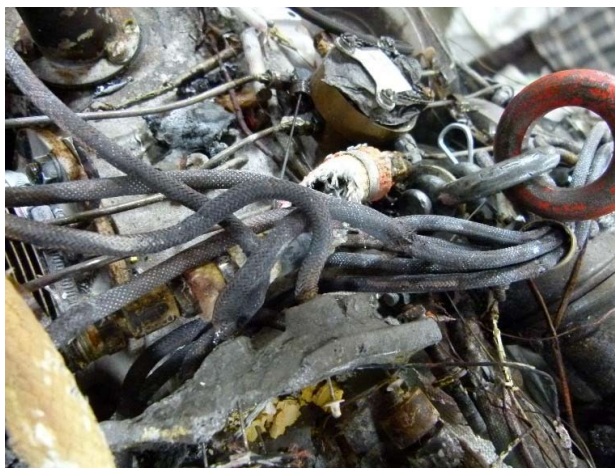
Ignition harness: The ignition harness exhibited thermal damage.

Figure 6 – photo of Ignition harness

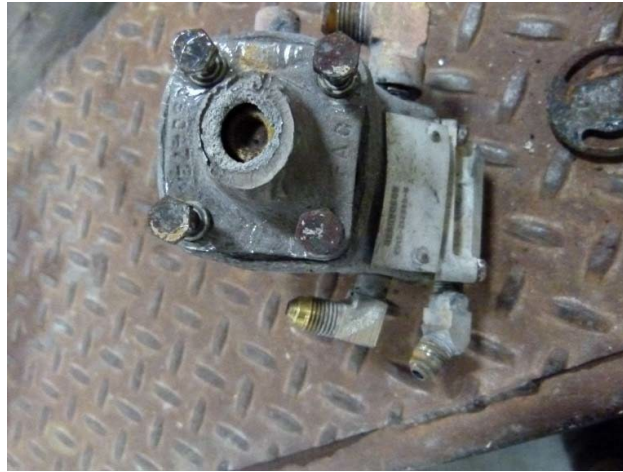
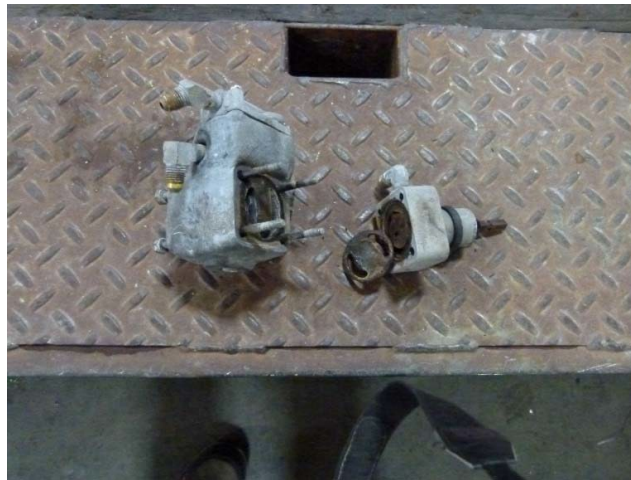
Fuel pump: The fuel pump remained attached to the engine and exhibited thermal damage. The fuel pump drive could not be rotated. The drive coupling was intact. The fuel pump was disassembled and no evidence of pre-impact anomalies was noted.

Figure 7 - photo of fuel pump

Figure 8 - photo of fuel pump

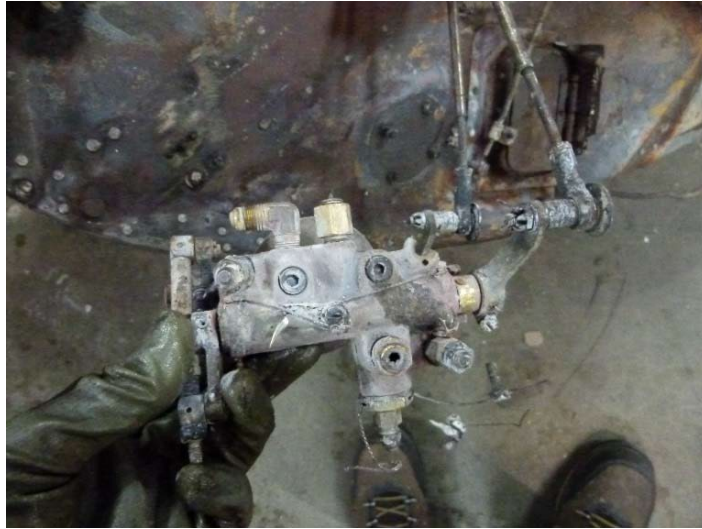
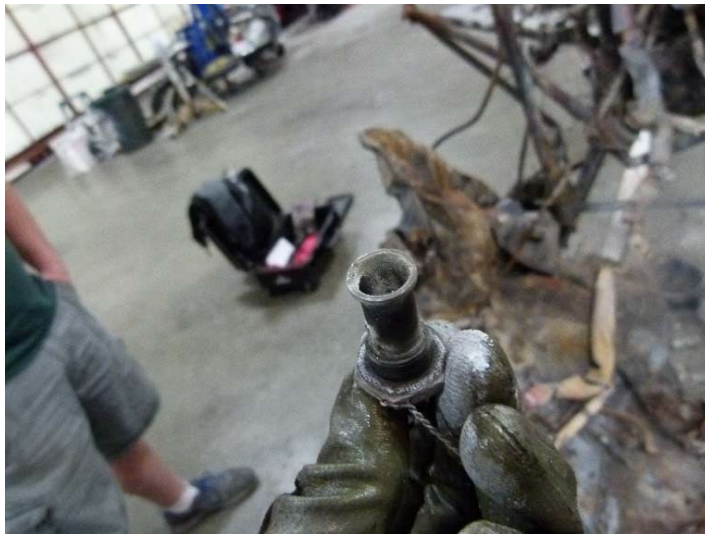
Throttle Body: The throttle body had been burned away with only the throttle plate and hardware left. The mixture control remained attached to the firewall by the throttle and mixture control arms and exhibited thermal damage. The throttle control arm was found in the full position. The exact position of the mixture control was not determined.

Figure 9 - throttle body and metering unit

Figure 10 - throttle body and metering unit

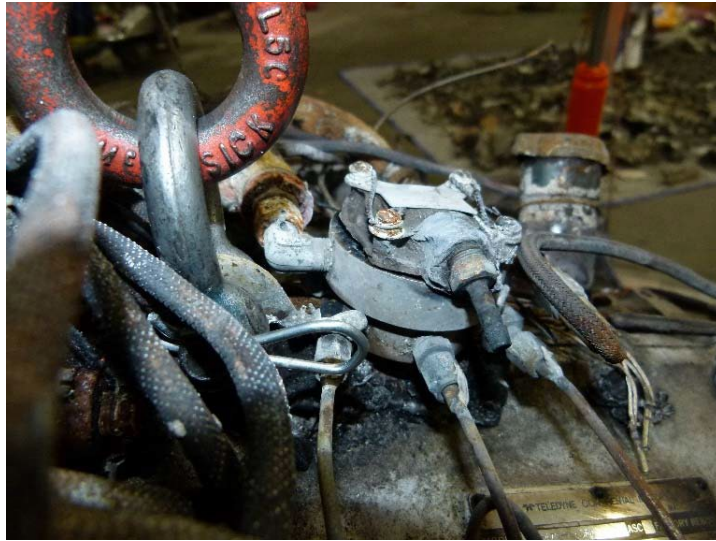
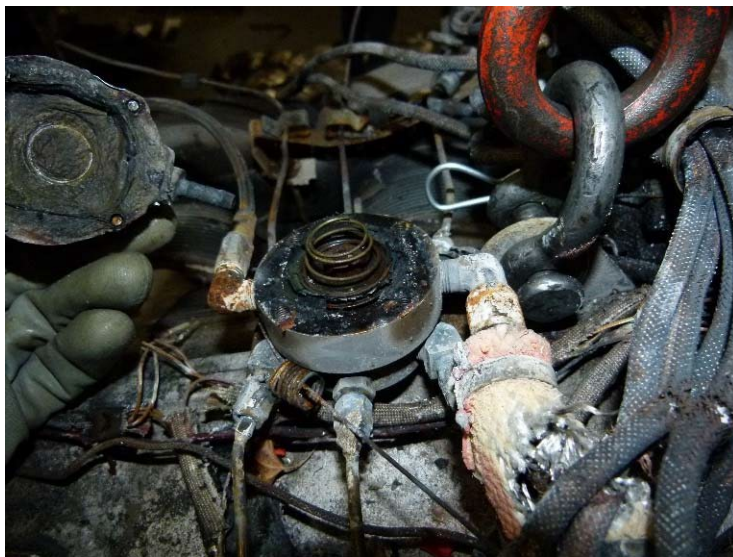
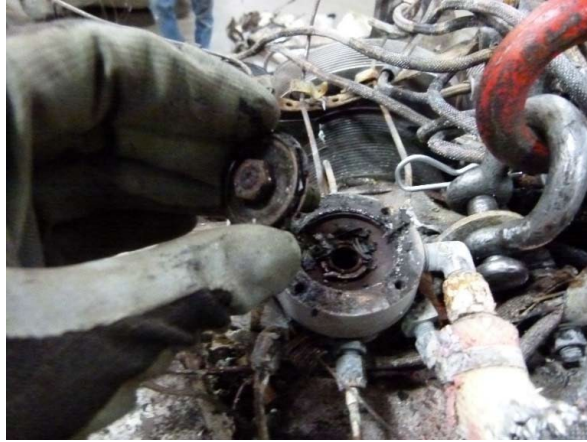
Fuel Manifold Valve: The fuel manifold valve remained attached to the engine and was thermally damaged. The cover was partially melted away exposing and burning the diaphragm. Pieces of the burnt diaphragm were noted on the manifold valves fuel screen, but the screen was not blocked.

Figure 11 - fuel manifold valve

Figure 12 - fuel manifold valve

Figure 13 - fuel manifold valve

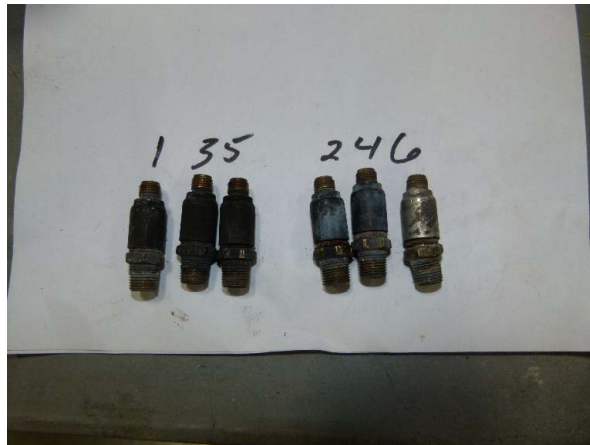
Fuel nozzles: The fuel nozzles were removed and unrestricted. The number 6 fuel nozzle was slightly bent.

Figure 14 - Fuel Nozzles

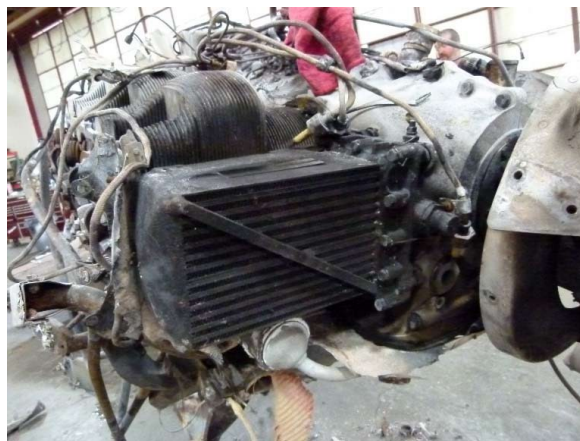
Oil Cooler: The oil cooler remained attached to the engine and was thermally damage.

Figure 15 - Oil Cooler

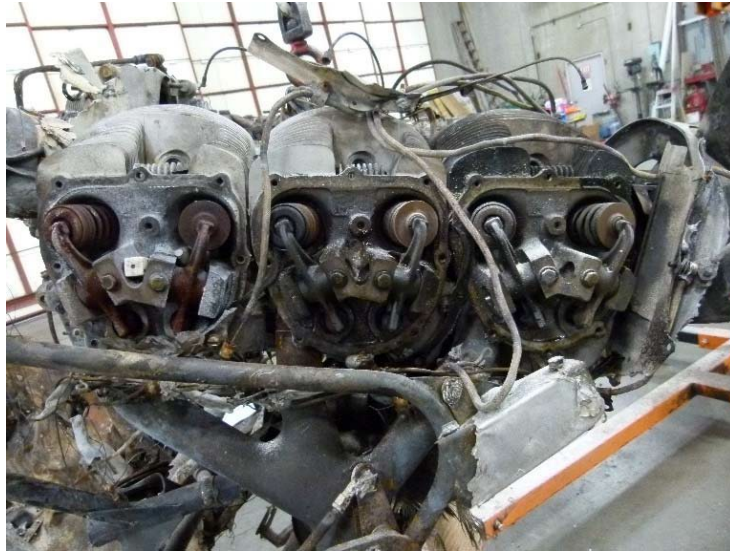
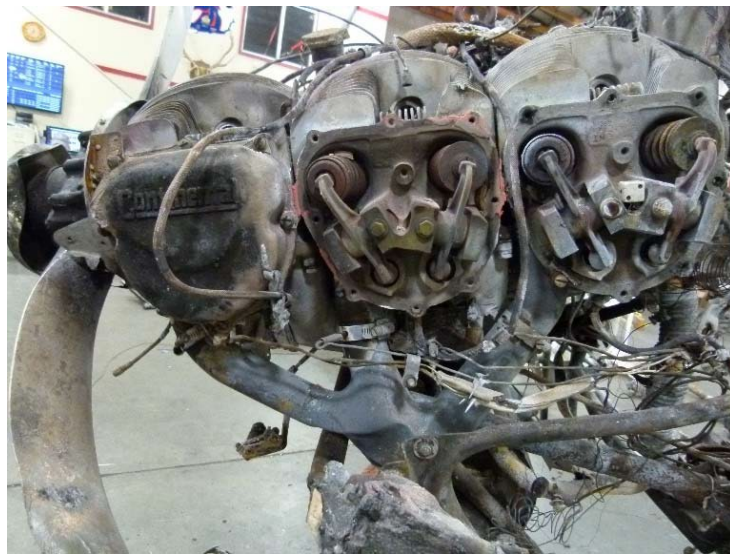
Cylinders: The cylinders remained attached to the engine. Thermal damage prevented removal of the number six valve cover. The top spark plugs were removed and the cylinder combustion chambers were examined with a lighted bore scope with no anomalies noted. The valves, valve springs and rocker arms were intact and thermally damaged. Bore scope pictures are of cylinder number 6.

Figure 16 - right side cylinders

Figure 17 - left side cylinders

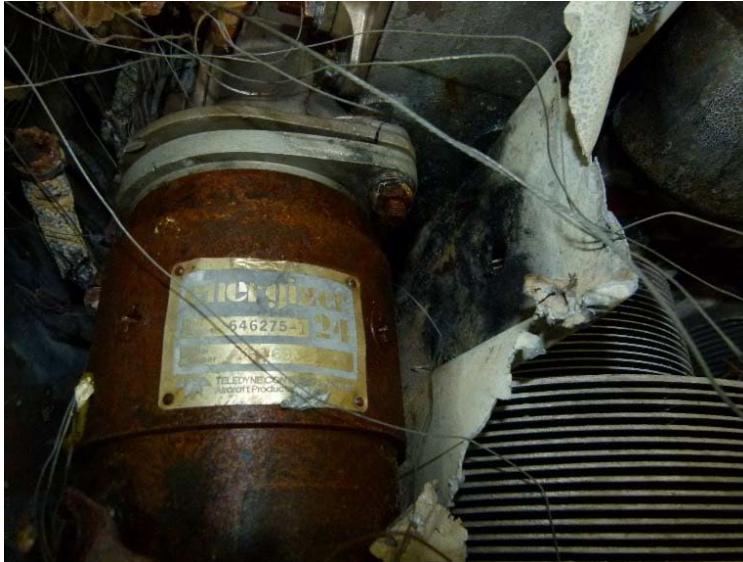
**Starter:** The starter remained attached to the starter adaptor and had been damaged by the post impact fire.

Figure 18 – Starter

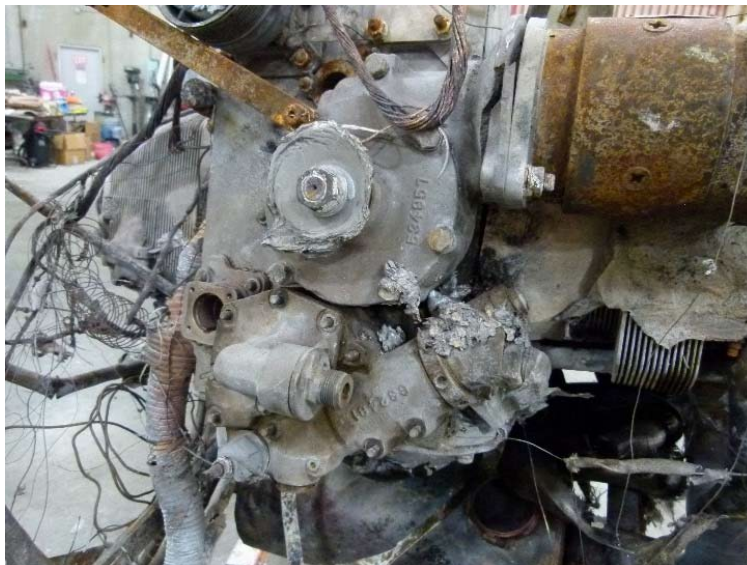
**Starter Adapter:** The starter adaptor remained attached to the engine. The alternator pulley was partially melted away and the starter mounting flange was fractured.

Figure 19 - Starter Adapter

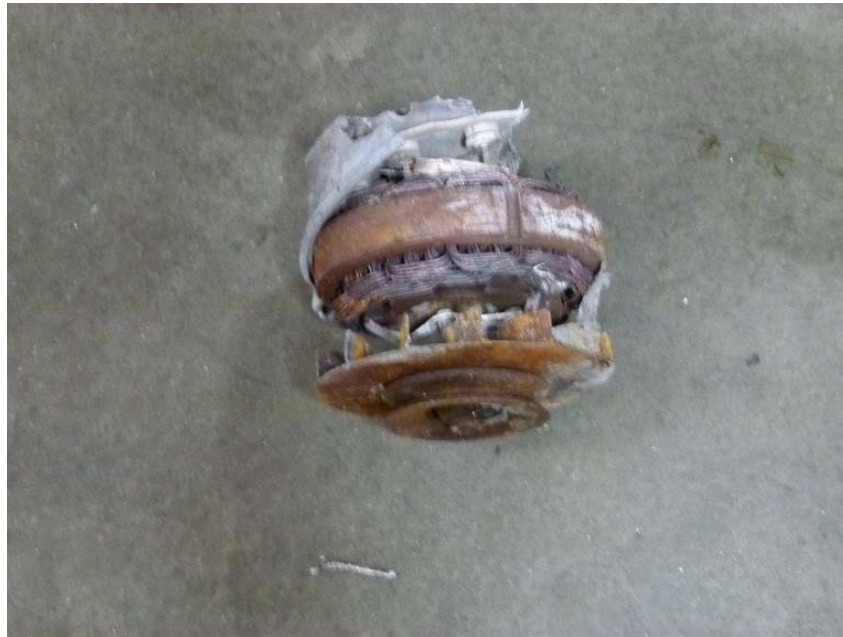
Alternator: The alternator had separated from the engine and was located with the airframe wreckage. The alternator was thermally damaged with most of the housing melted away.

Figure 20 – Alternator

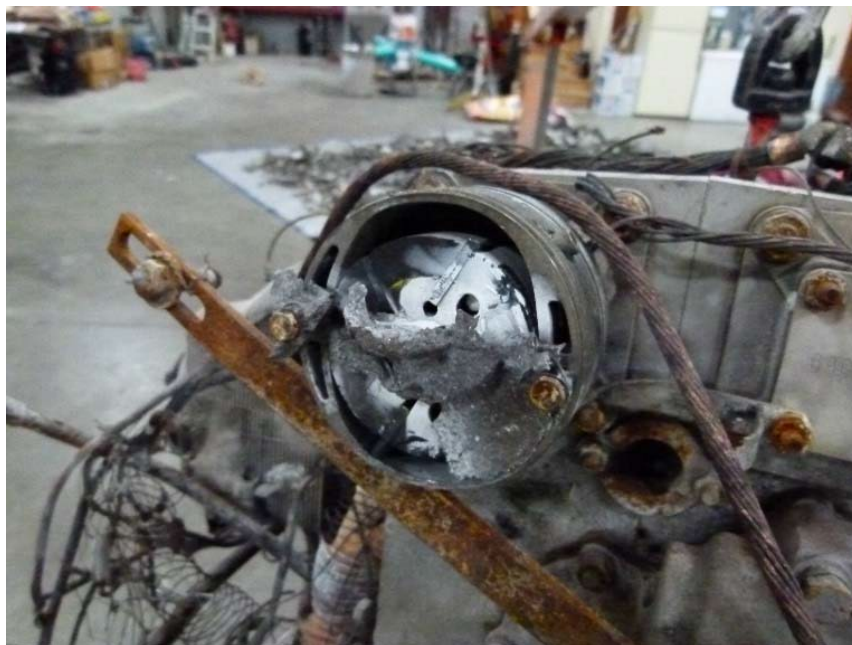
Vacuum Pump: The vacuum pump remained attached and the cover was mostly melted away. The rotor and vanes appeared intact.

Figure 21 - Vacuum Pump

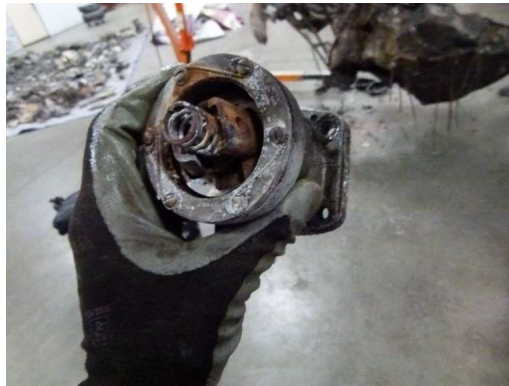
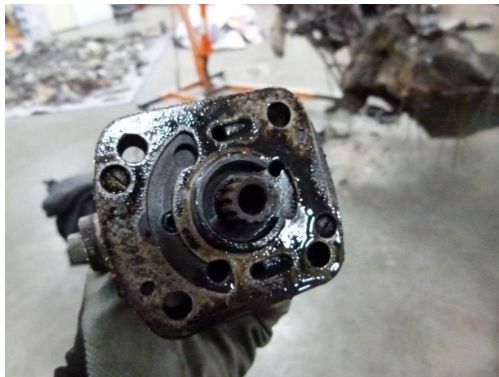
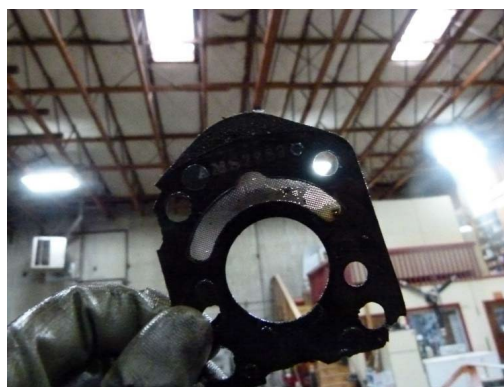
Condition: The propeller governor exhibited impact and thermal damage. The control arm was fractured away and not observed. The propeller governor drive did not rotate by hand. The gasket screen was free of obstruction.

Figure 22 - Propeller Governor

Figure 23 - Propeller Governor

Figure 24 - Propeller Governor

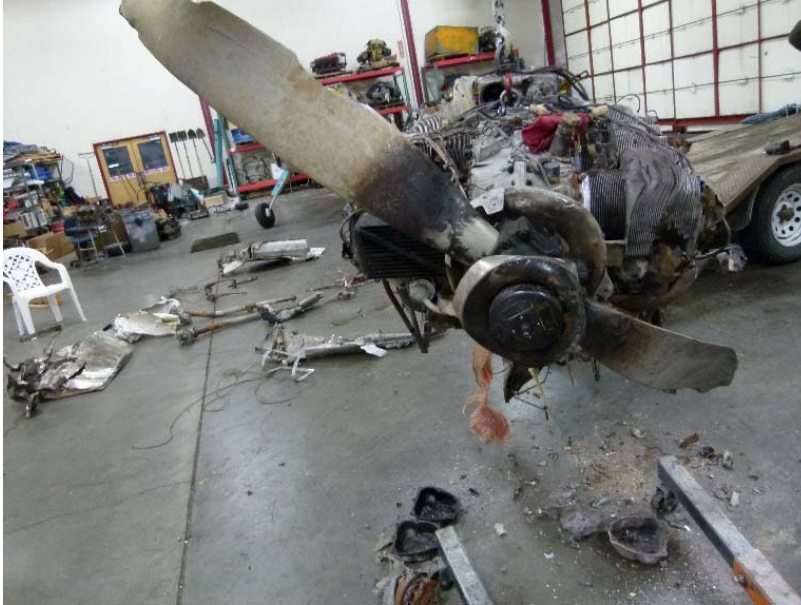
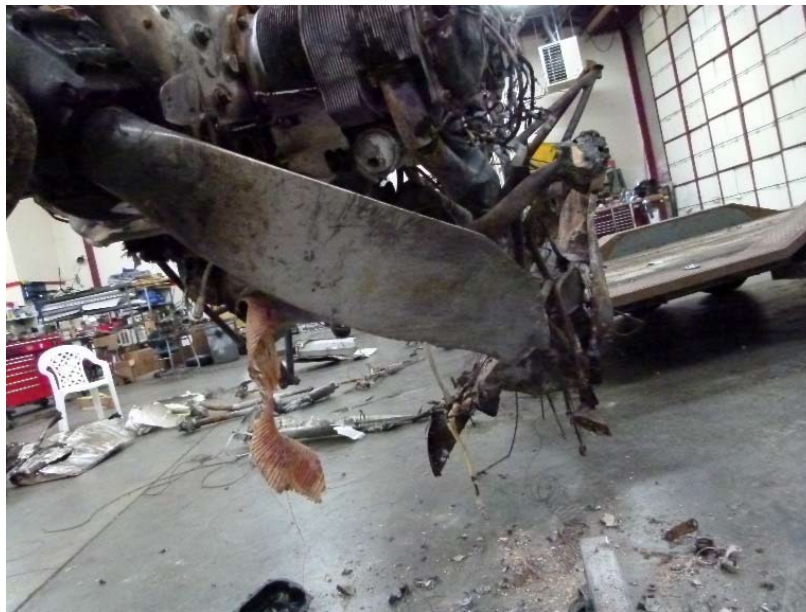
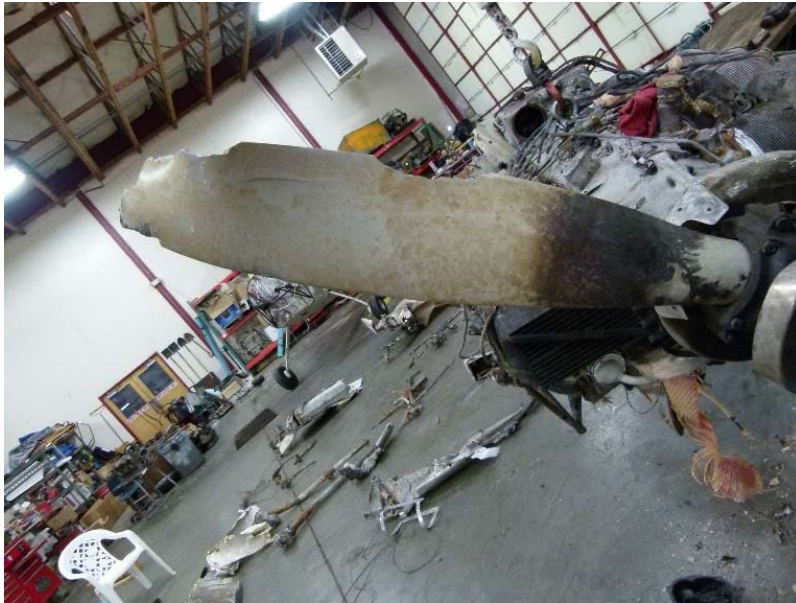
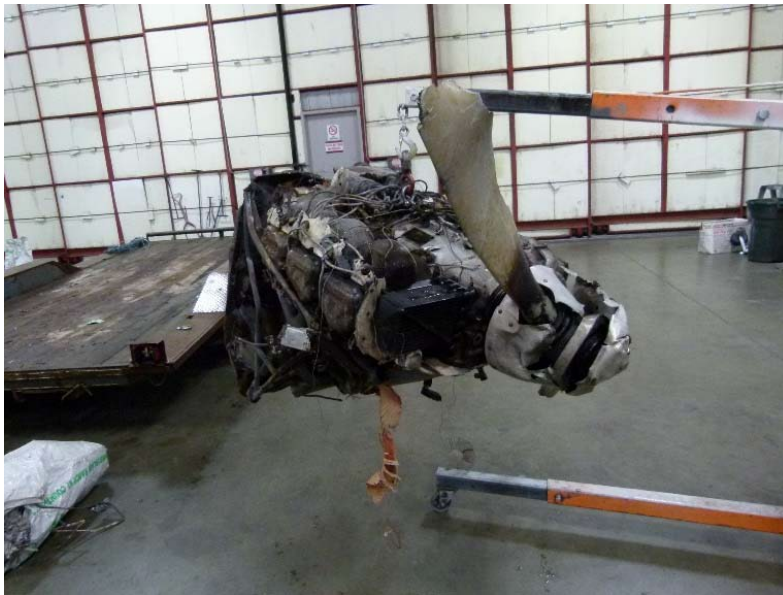
Propeller: The two-bladed propeller remained attached to the crankshaft propeller flange. One blade exhibited slight S shaped bend near the blade tip which was twisted aft slightly. The blade exhibited chordwise scratches and was missing material at the blade tip, leading edge and the trailing edge. The second blade exhibited chordwise and multi-directional scratches. From about the midspan of the blade to the tip was missing.

Figure 25 - view 1 of propeller

Figure 26 - view 2 of propeller

Figure 27 - view 3 of propeller

Figure 28 - view 4 of propeller
