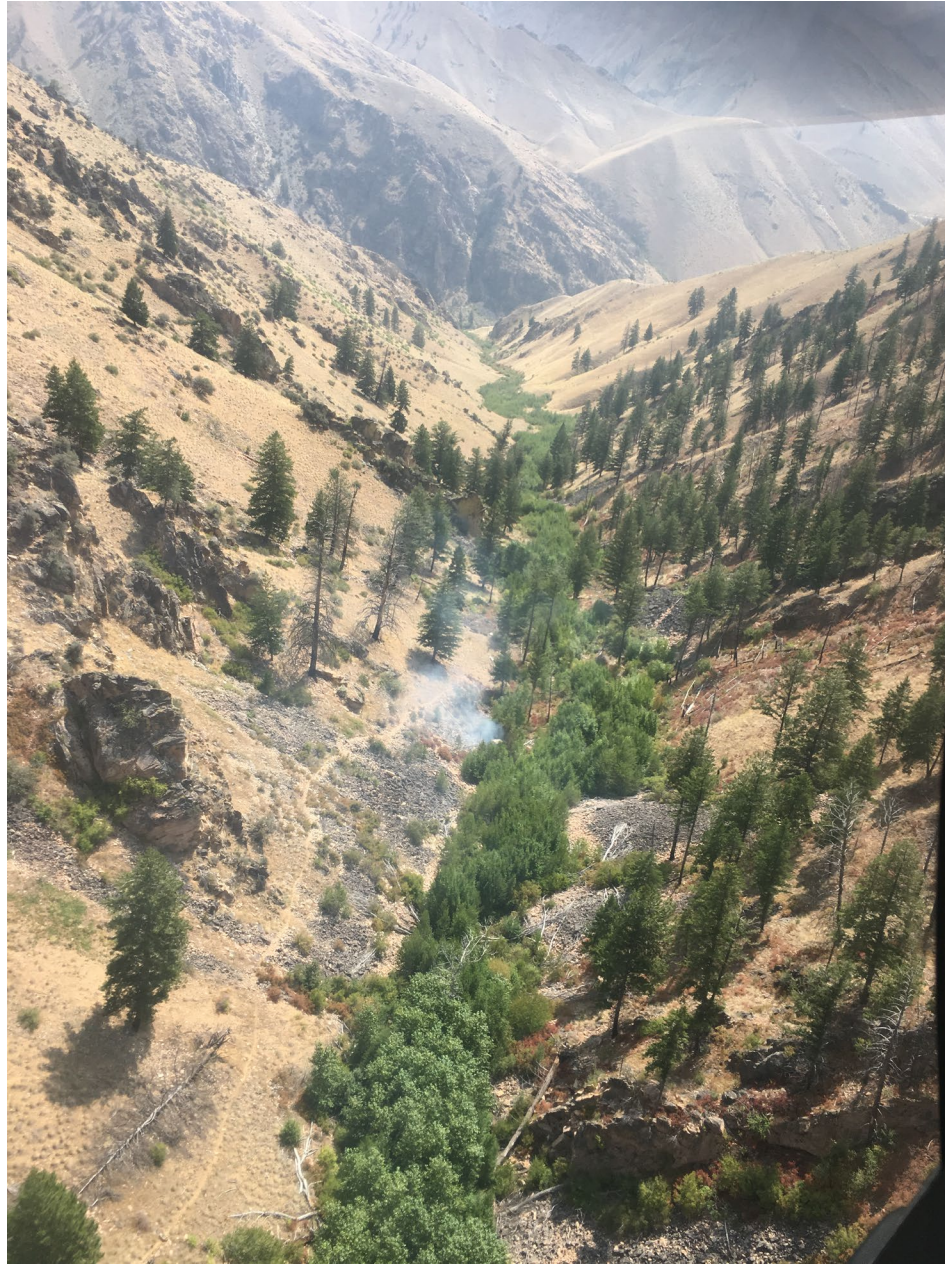
**Photo 1 – overhead view of accident site looking west up Short Creek (courtesy of Salmon-Challis Forest Service)**

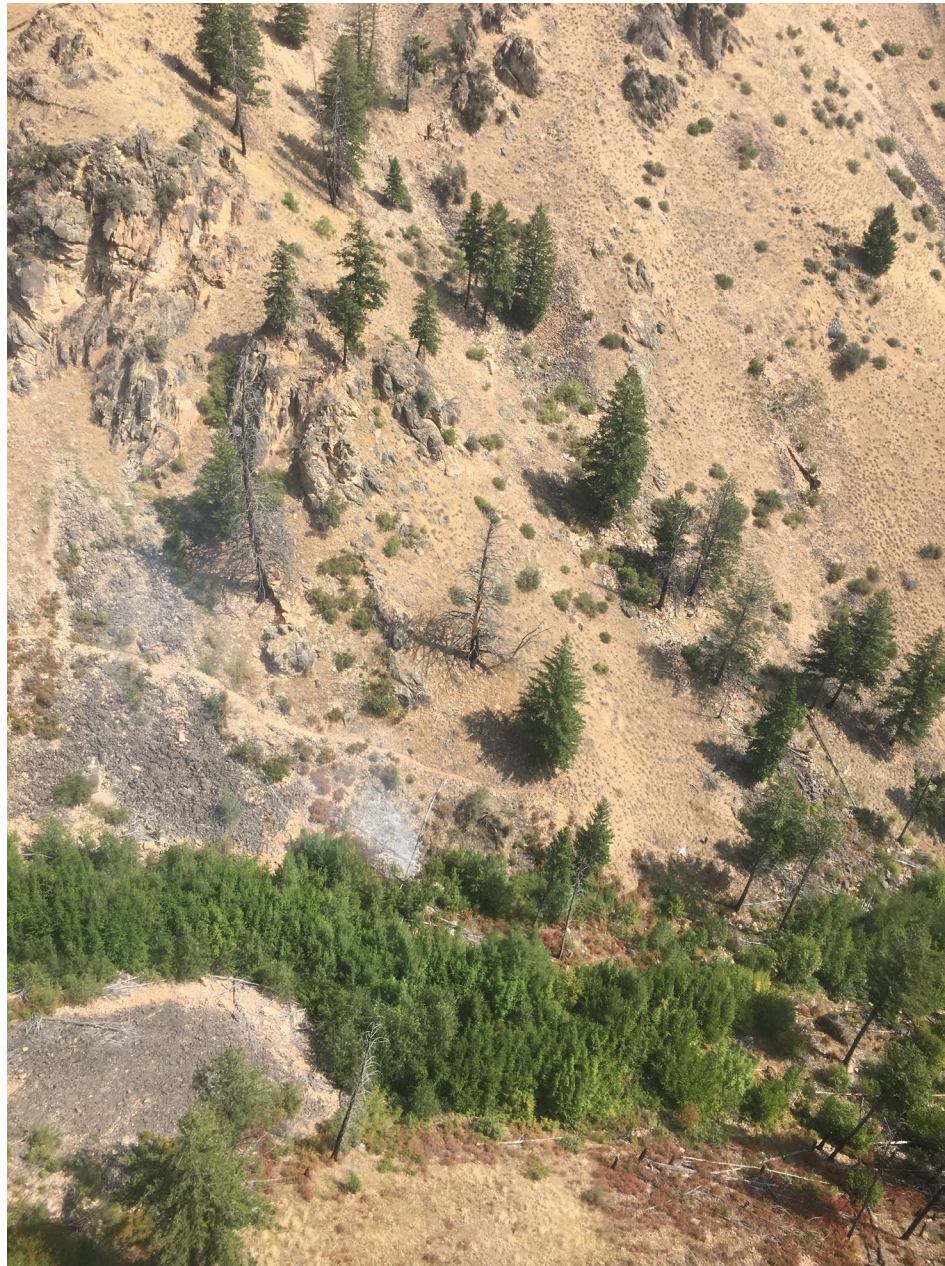
**Photo 2 – overhead view of accident looking vertically downward (courtesy of Salmon-Challis Forest Service)**

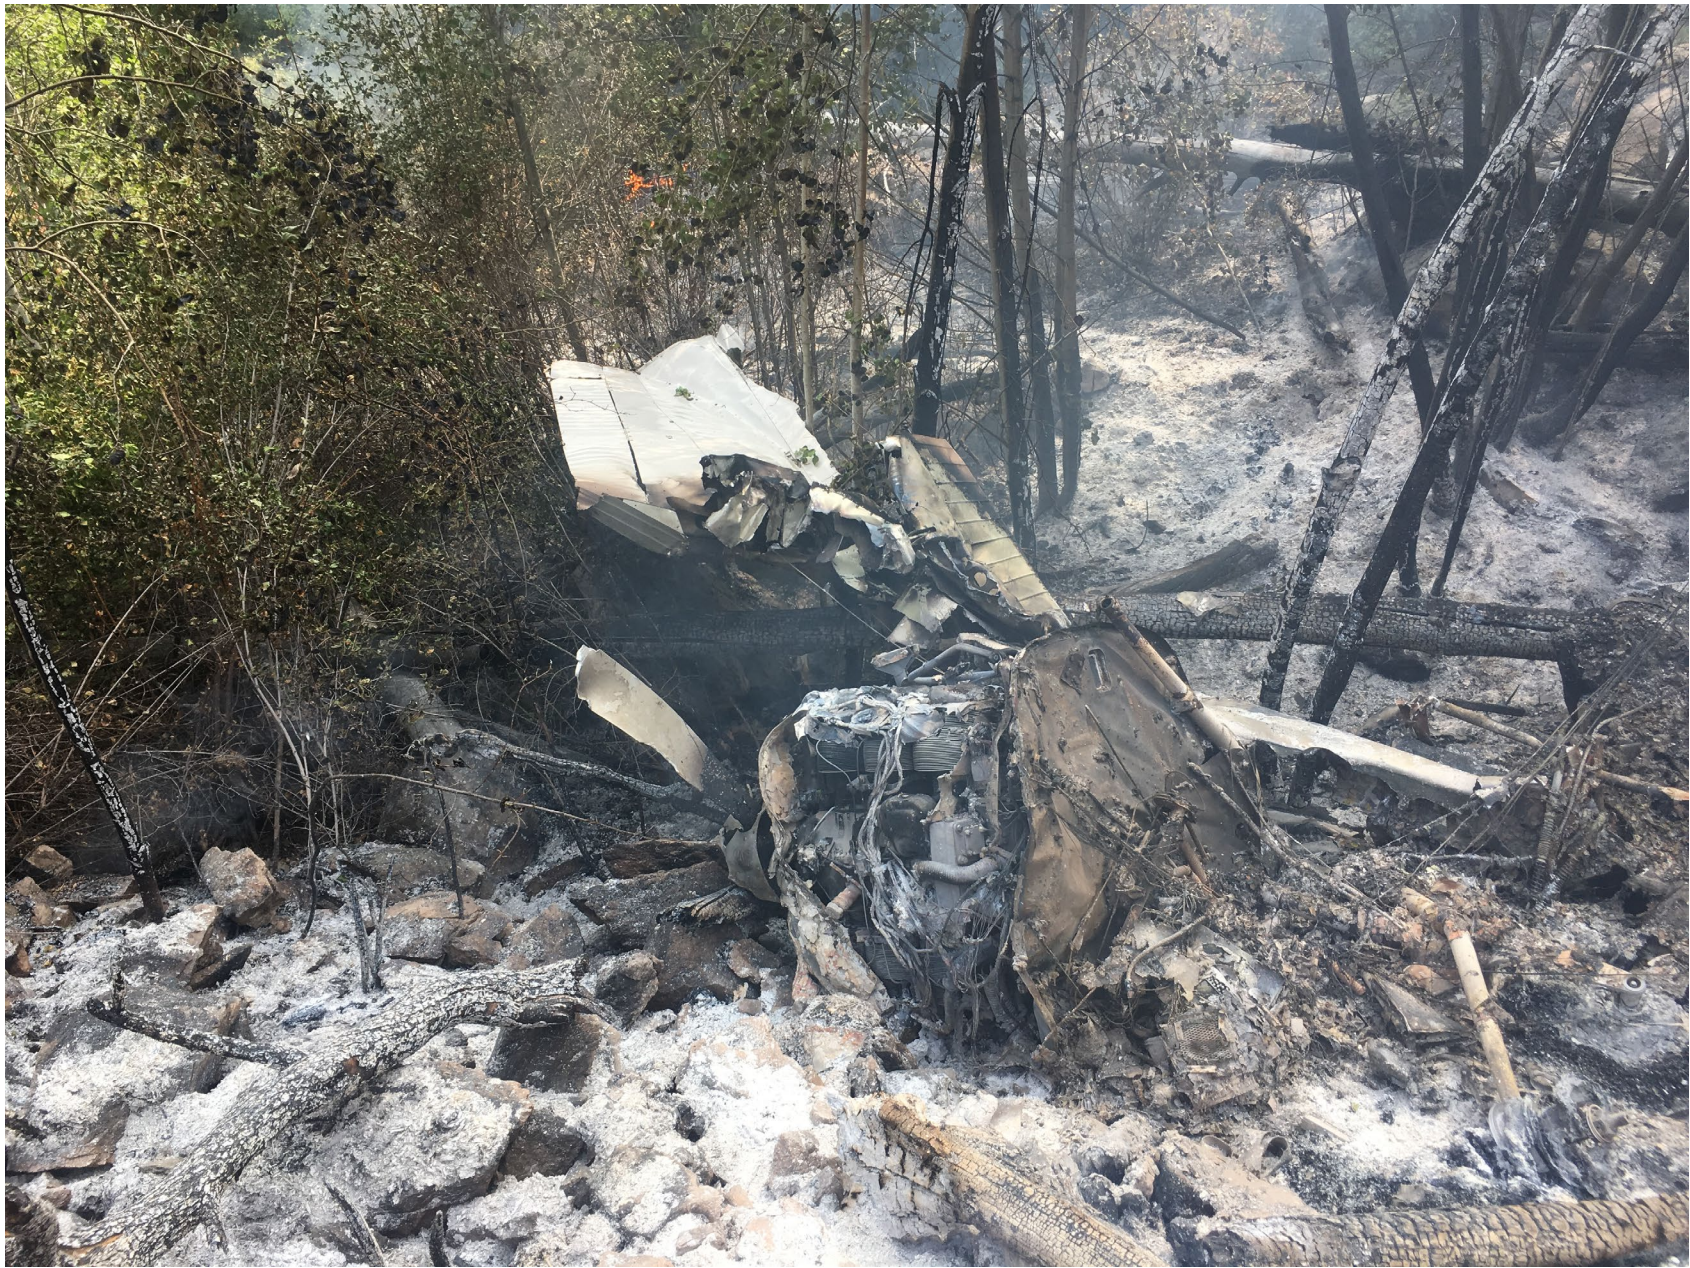
**Photo 3 – onsite view of wreckage, including cabin/cockpit area, firewall, engine, propeller, bottom of right wing and aileron (courtesy of Salmon-Challis Forest Service)**

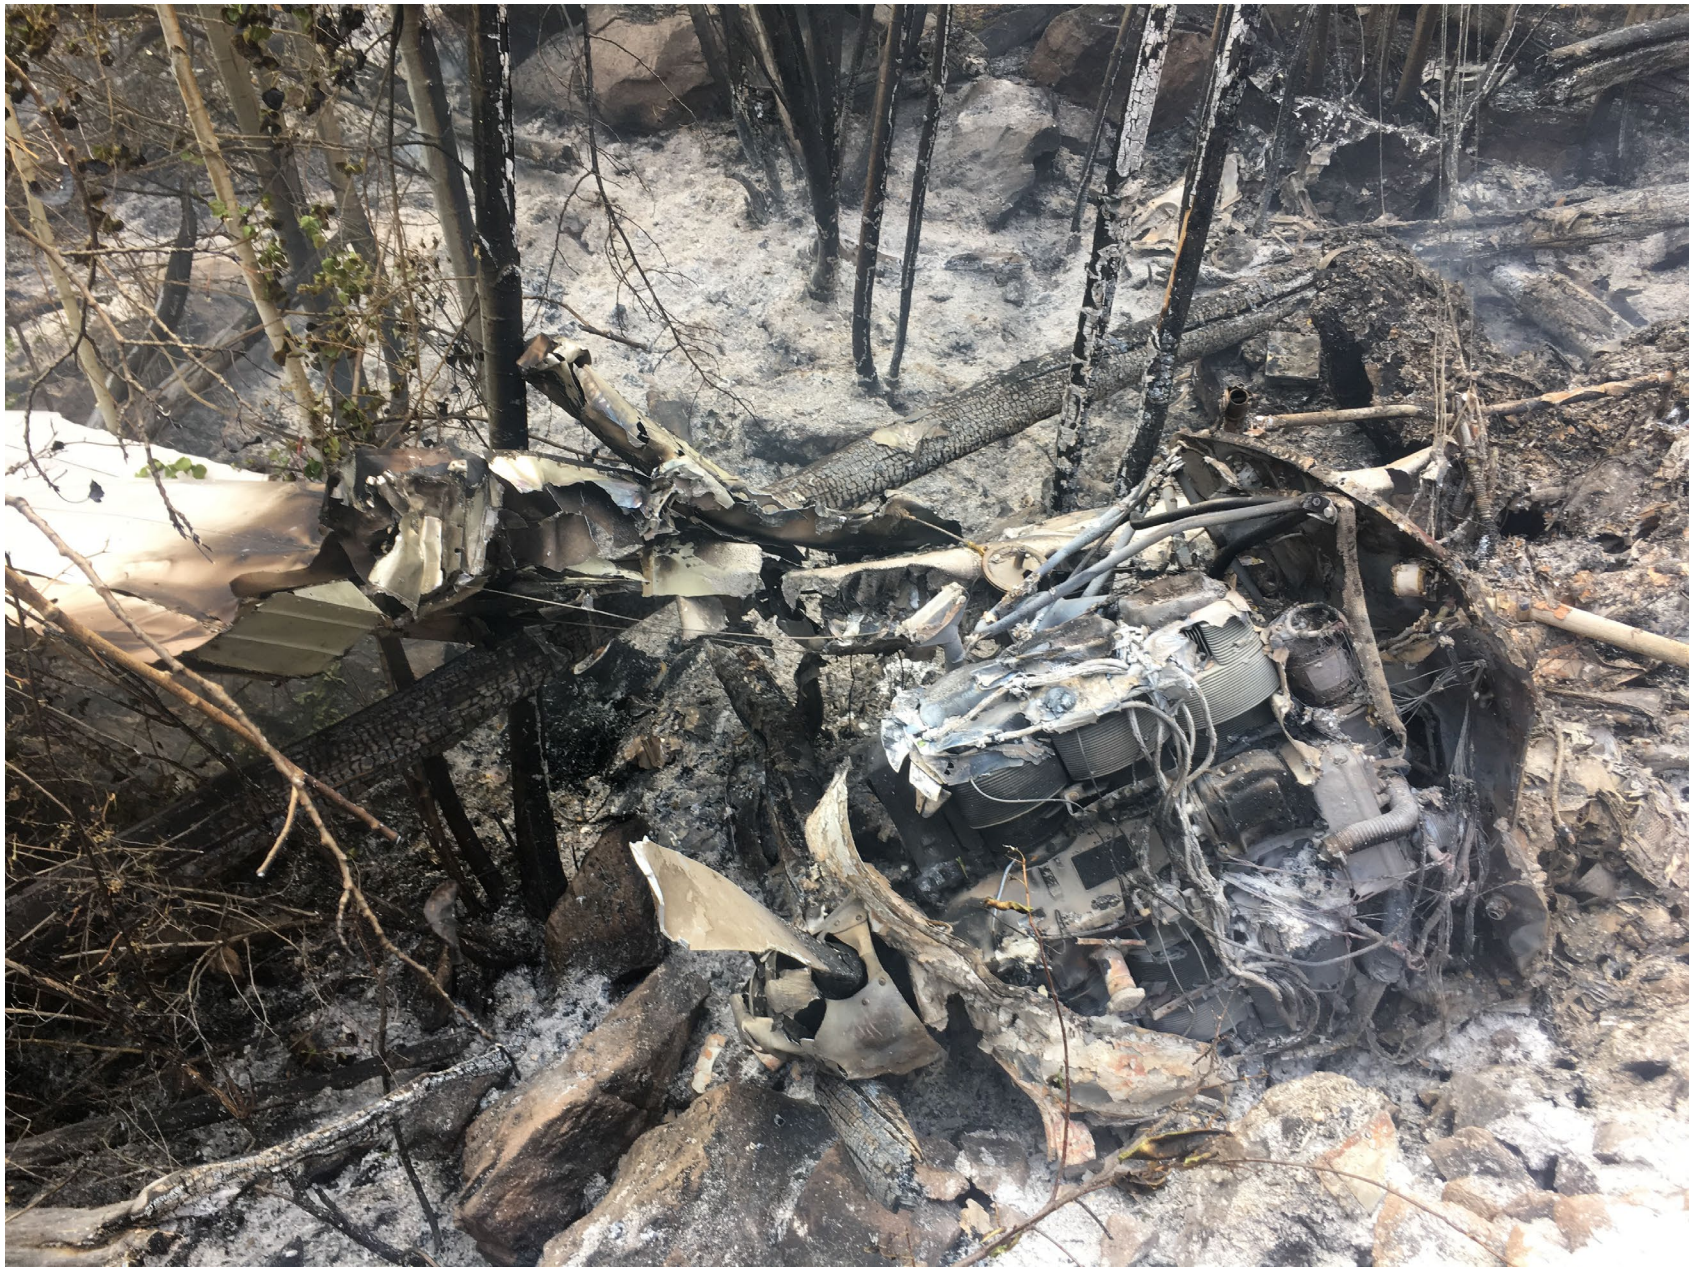
**Photo 4 – onsite view of engine, firewall and propeller (courtesy of Salmon-Challis Forest Service)**

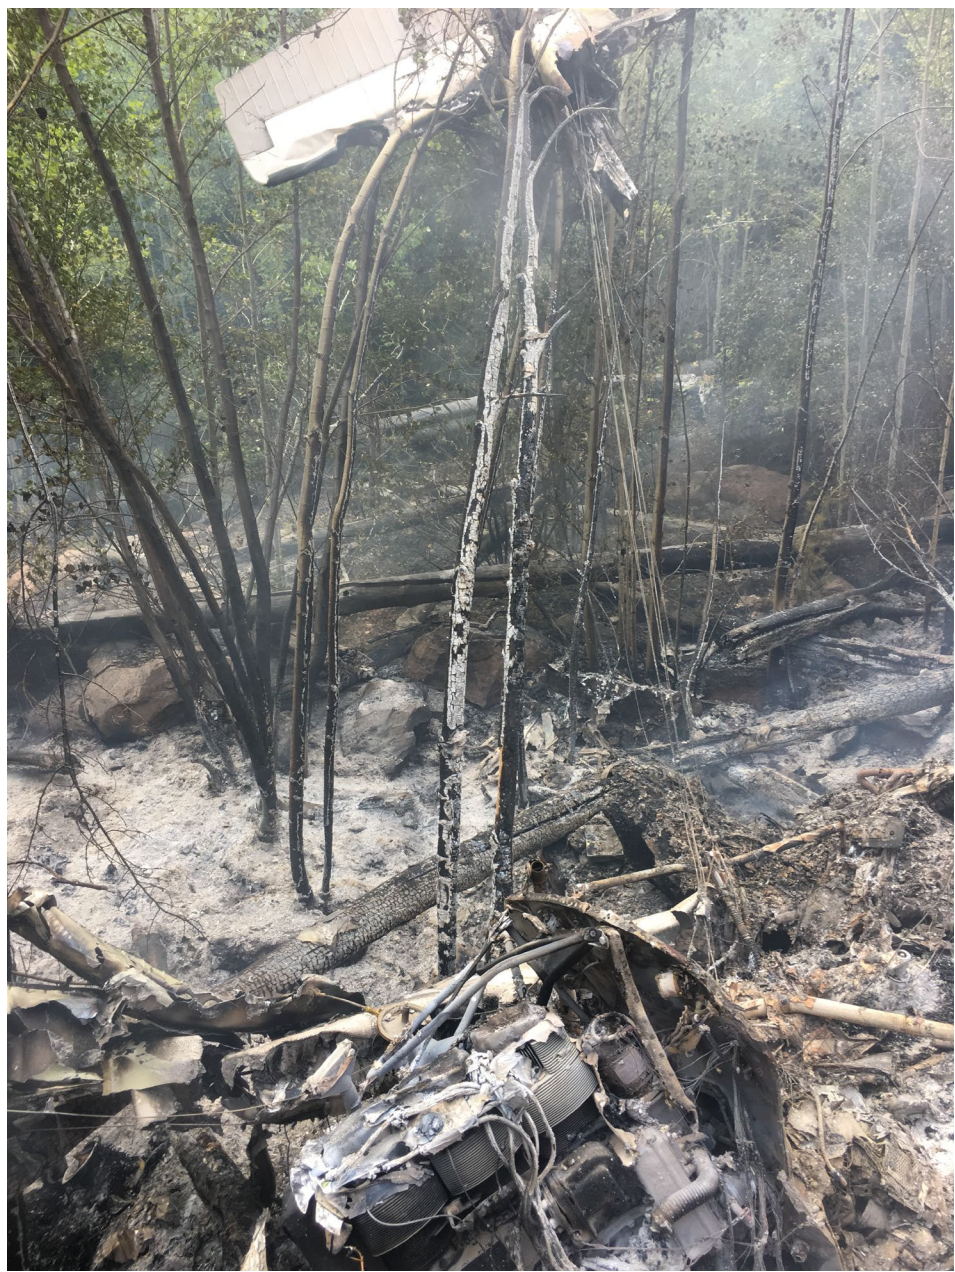
**Photo 5 – onsite view of engine and empennage wedged in tree (courtesy of Salmon-Challis Forest Service)**
