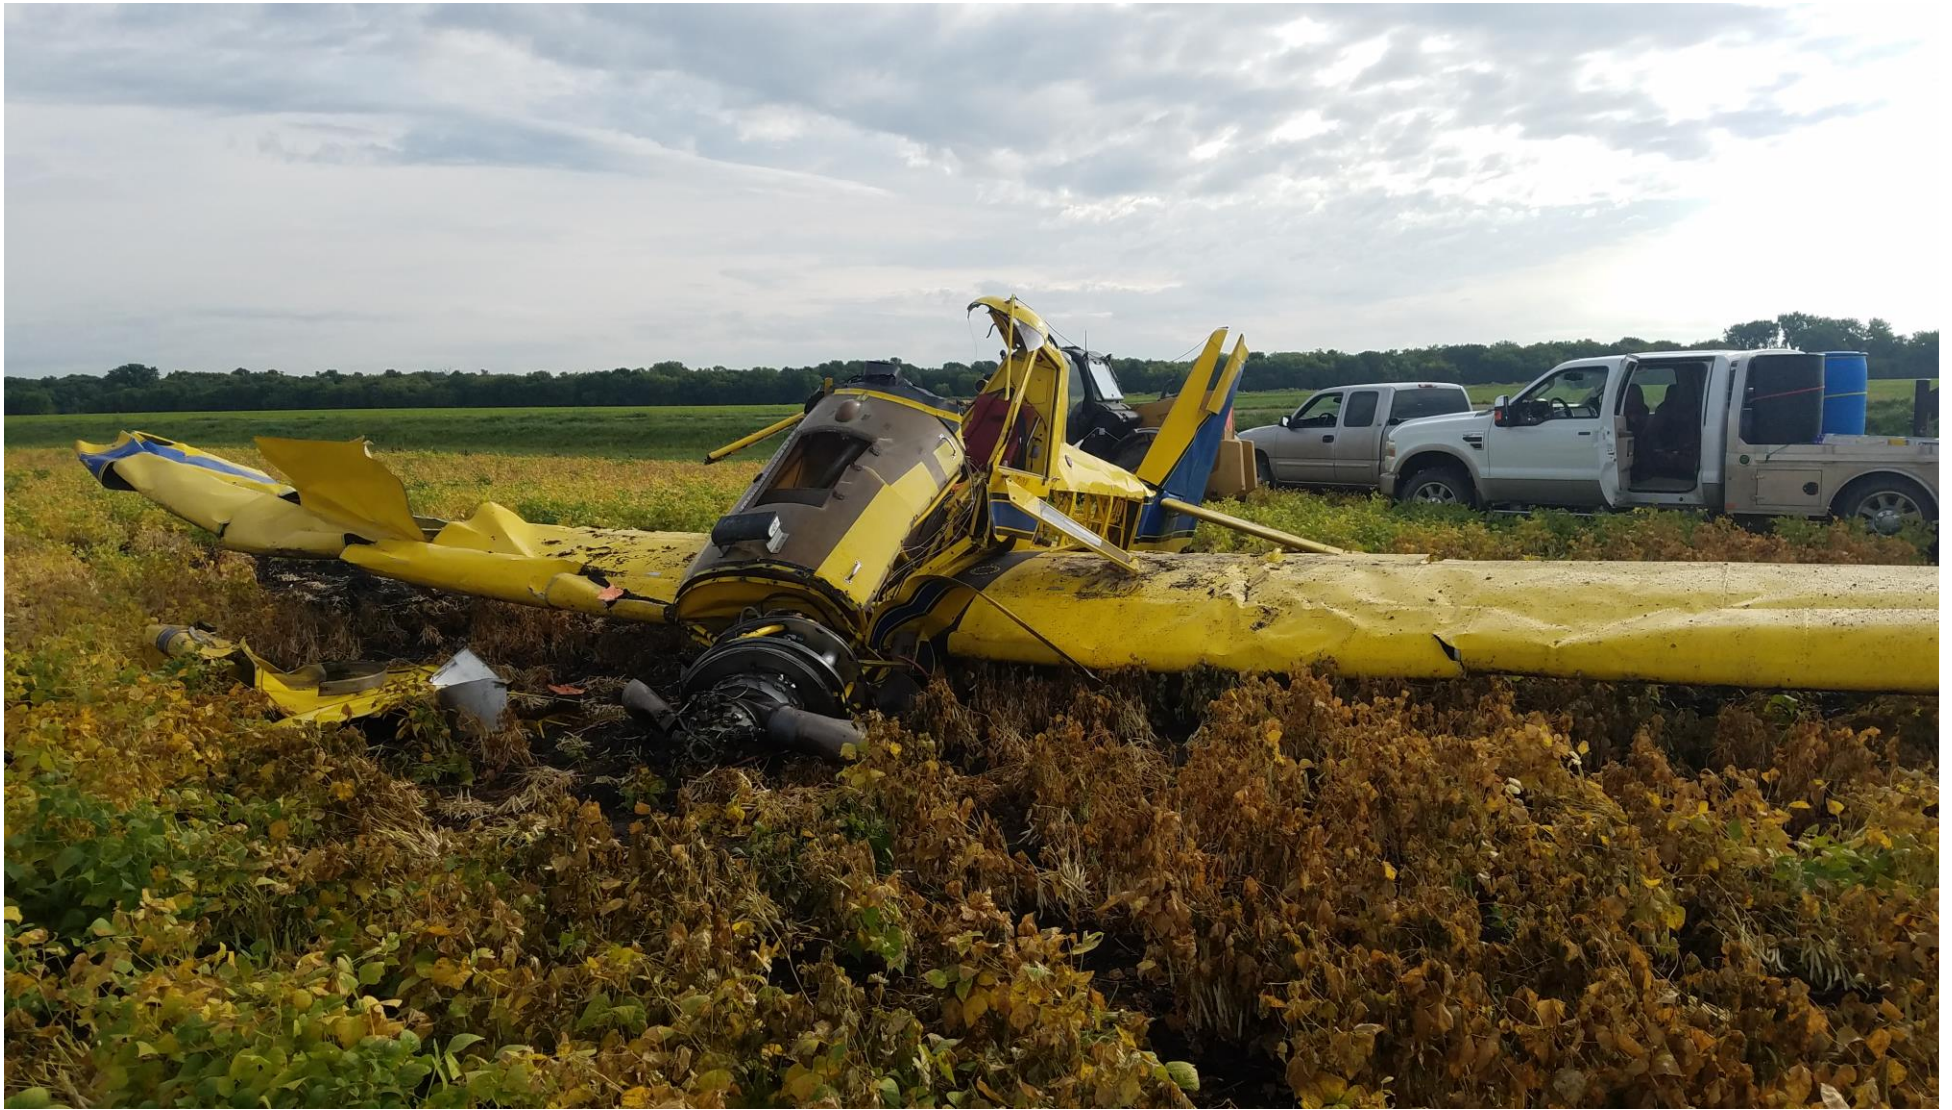
**Photo 1 – Accident site, forward view of the main wreckage. (Courtesy of first responders)**

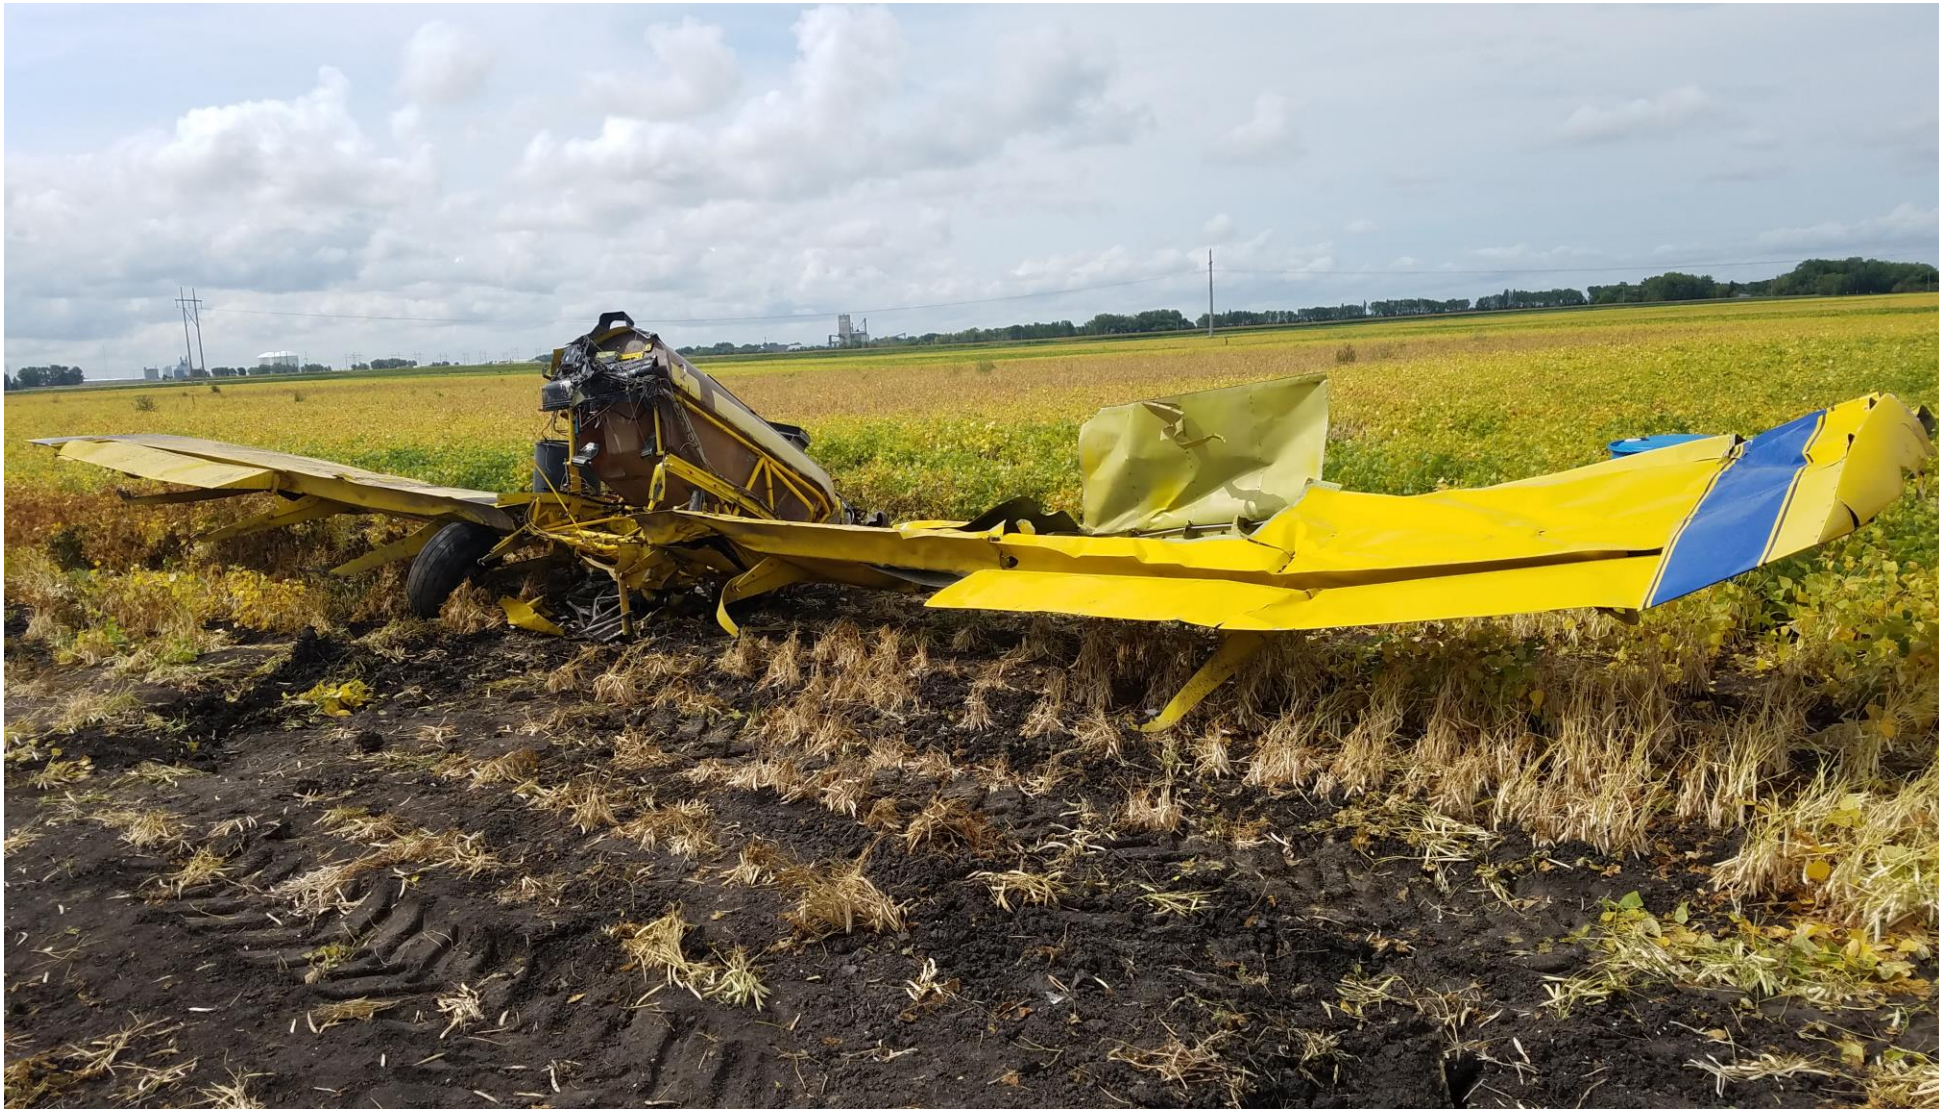
**Photo 2 - Accident site, view of the forward fuselage and wings during disassembly. (Courtesy of first responders)**

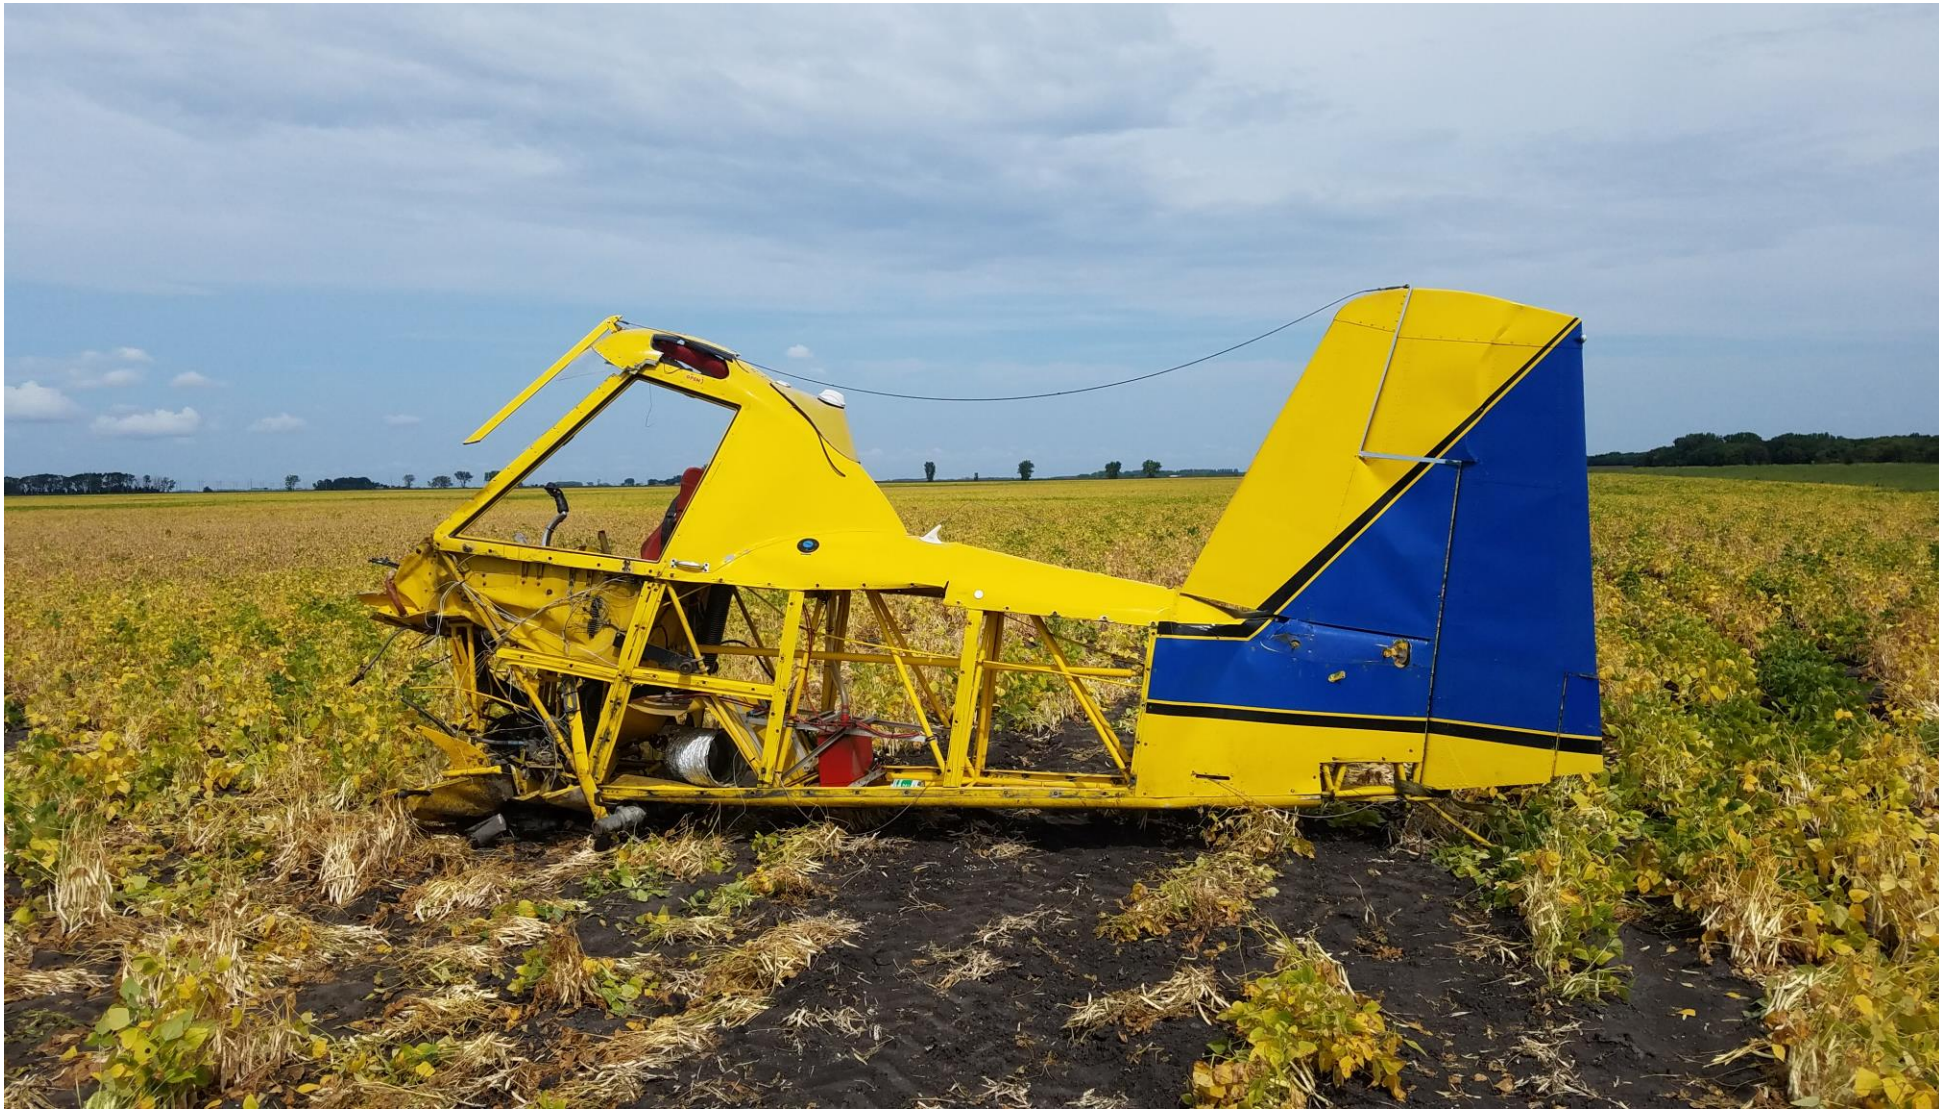
**Photo 3 - Accident site, left view of the main wreckage during disassembly. (Courtesy of first responders)**

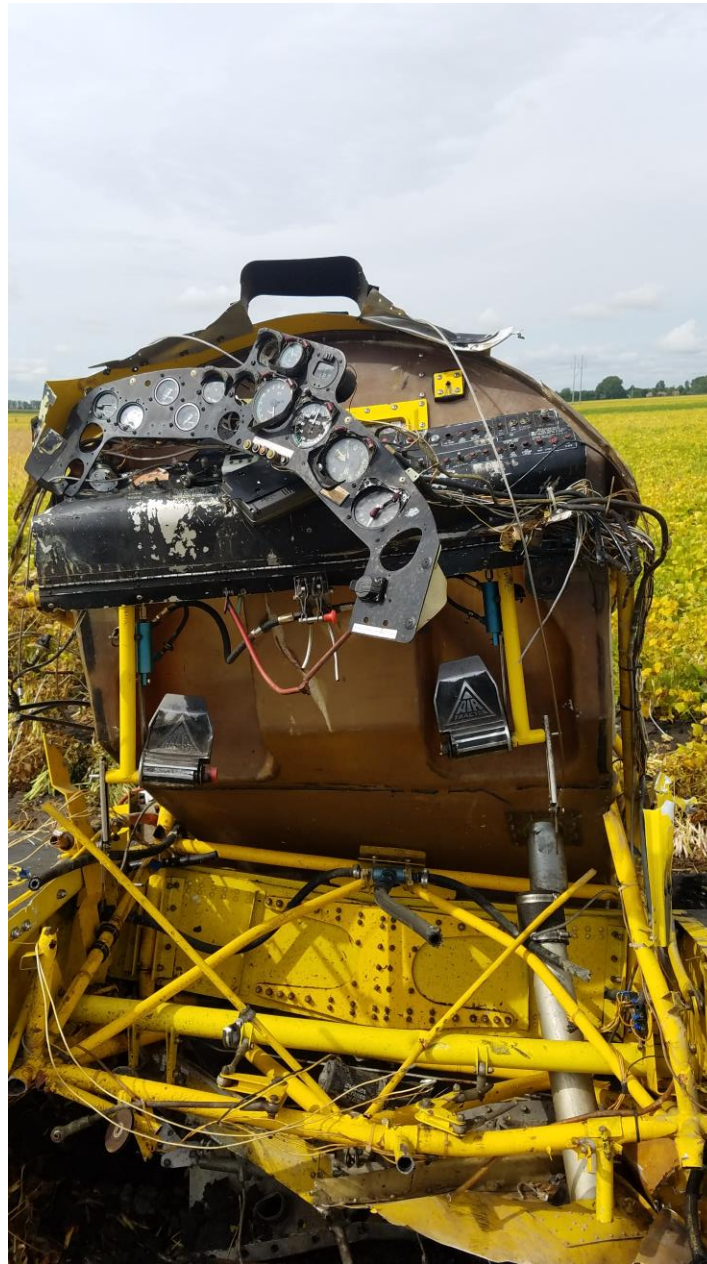
**Photo 4 - Accident site, view of the forward cabin area. (Courtesy of first responders)**

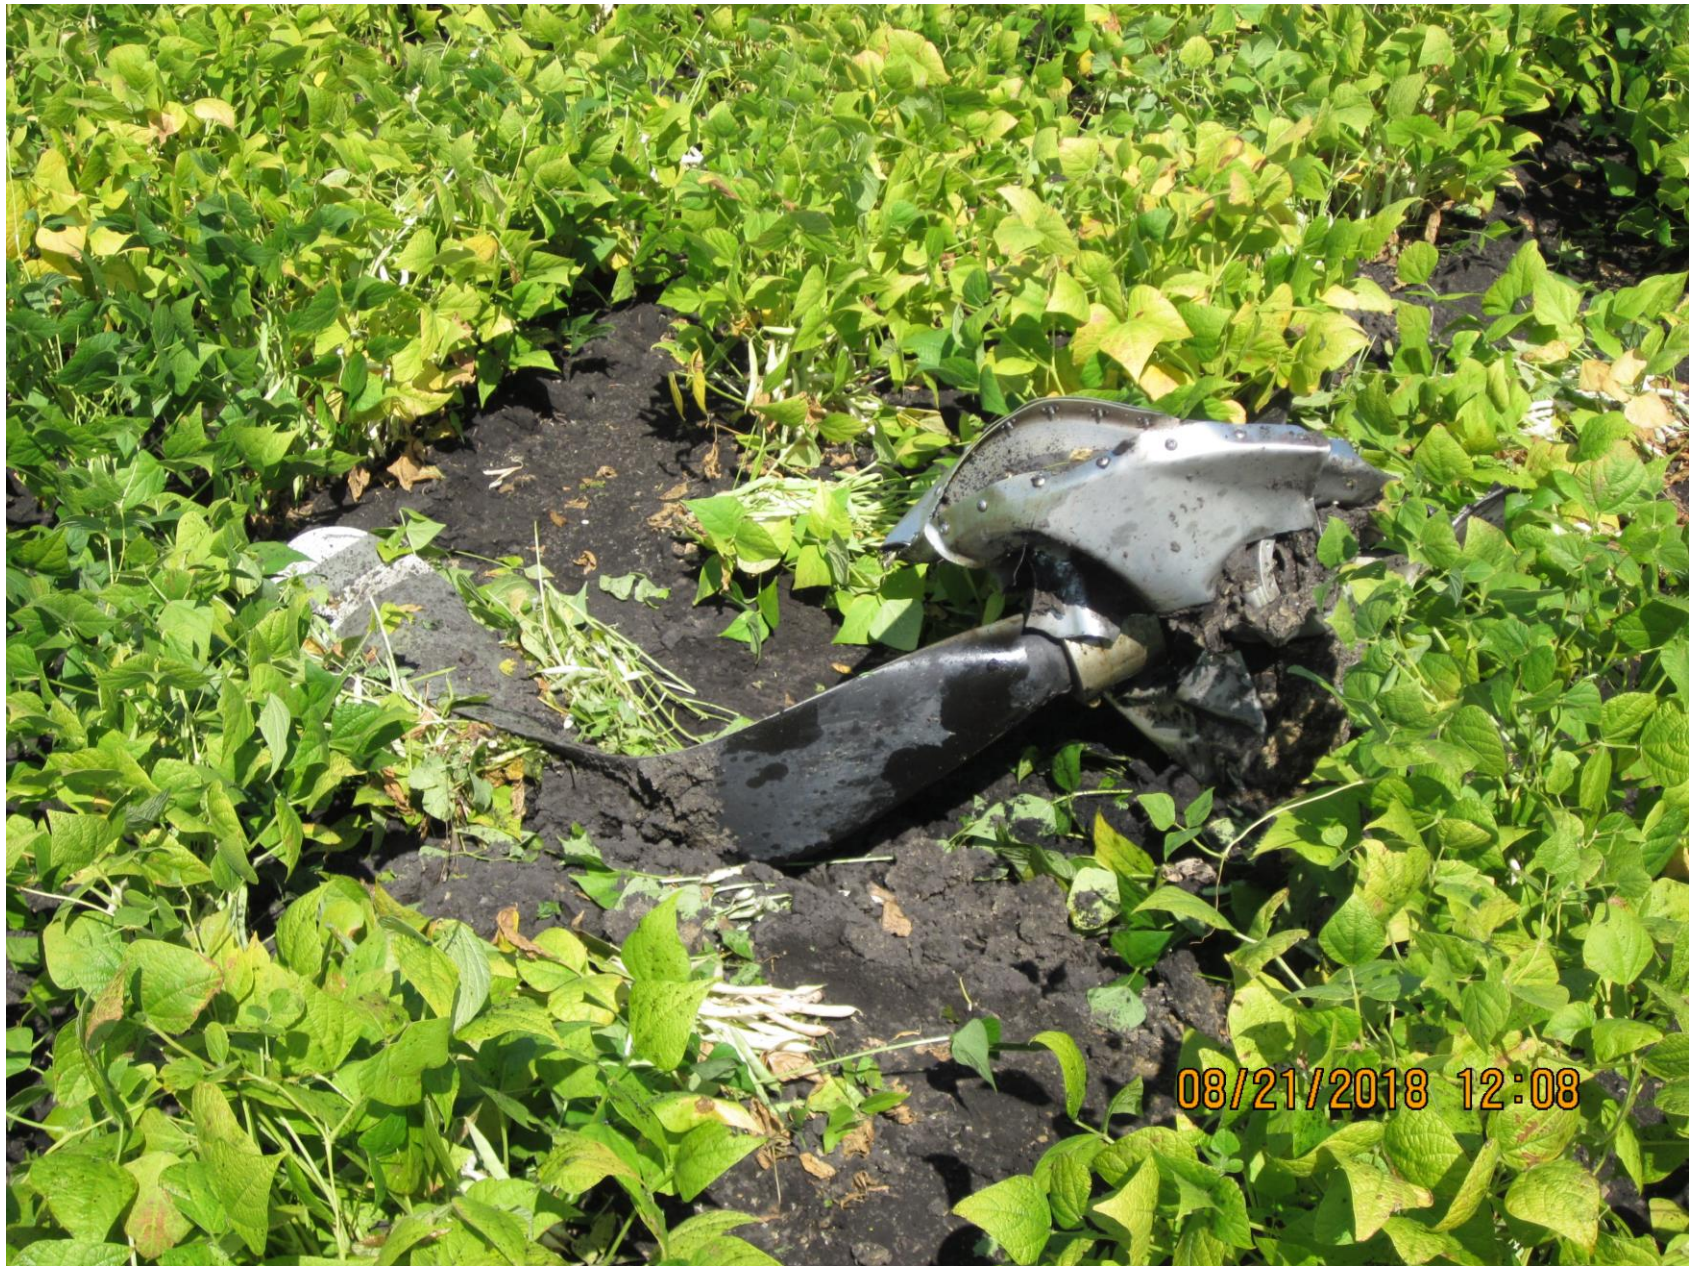
**Photo 5 - Accident site, separated propeller assembly. (Courtesy of first responders)**

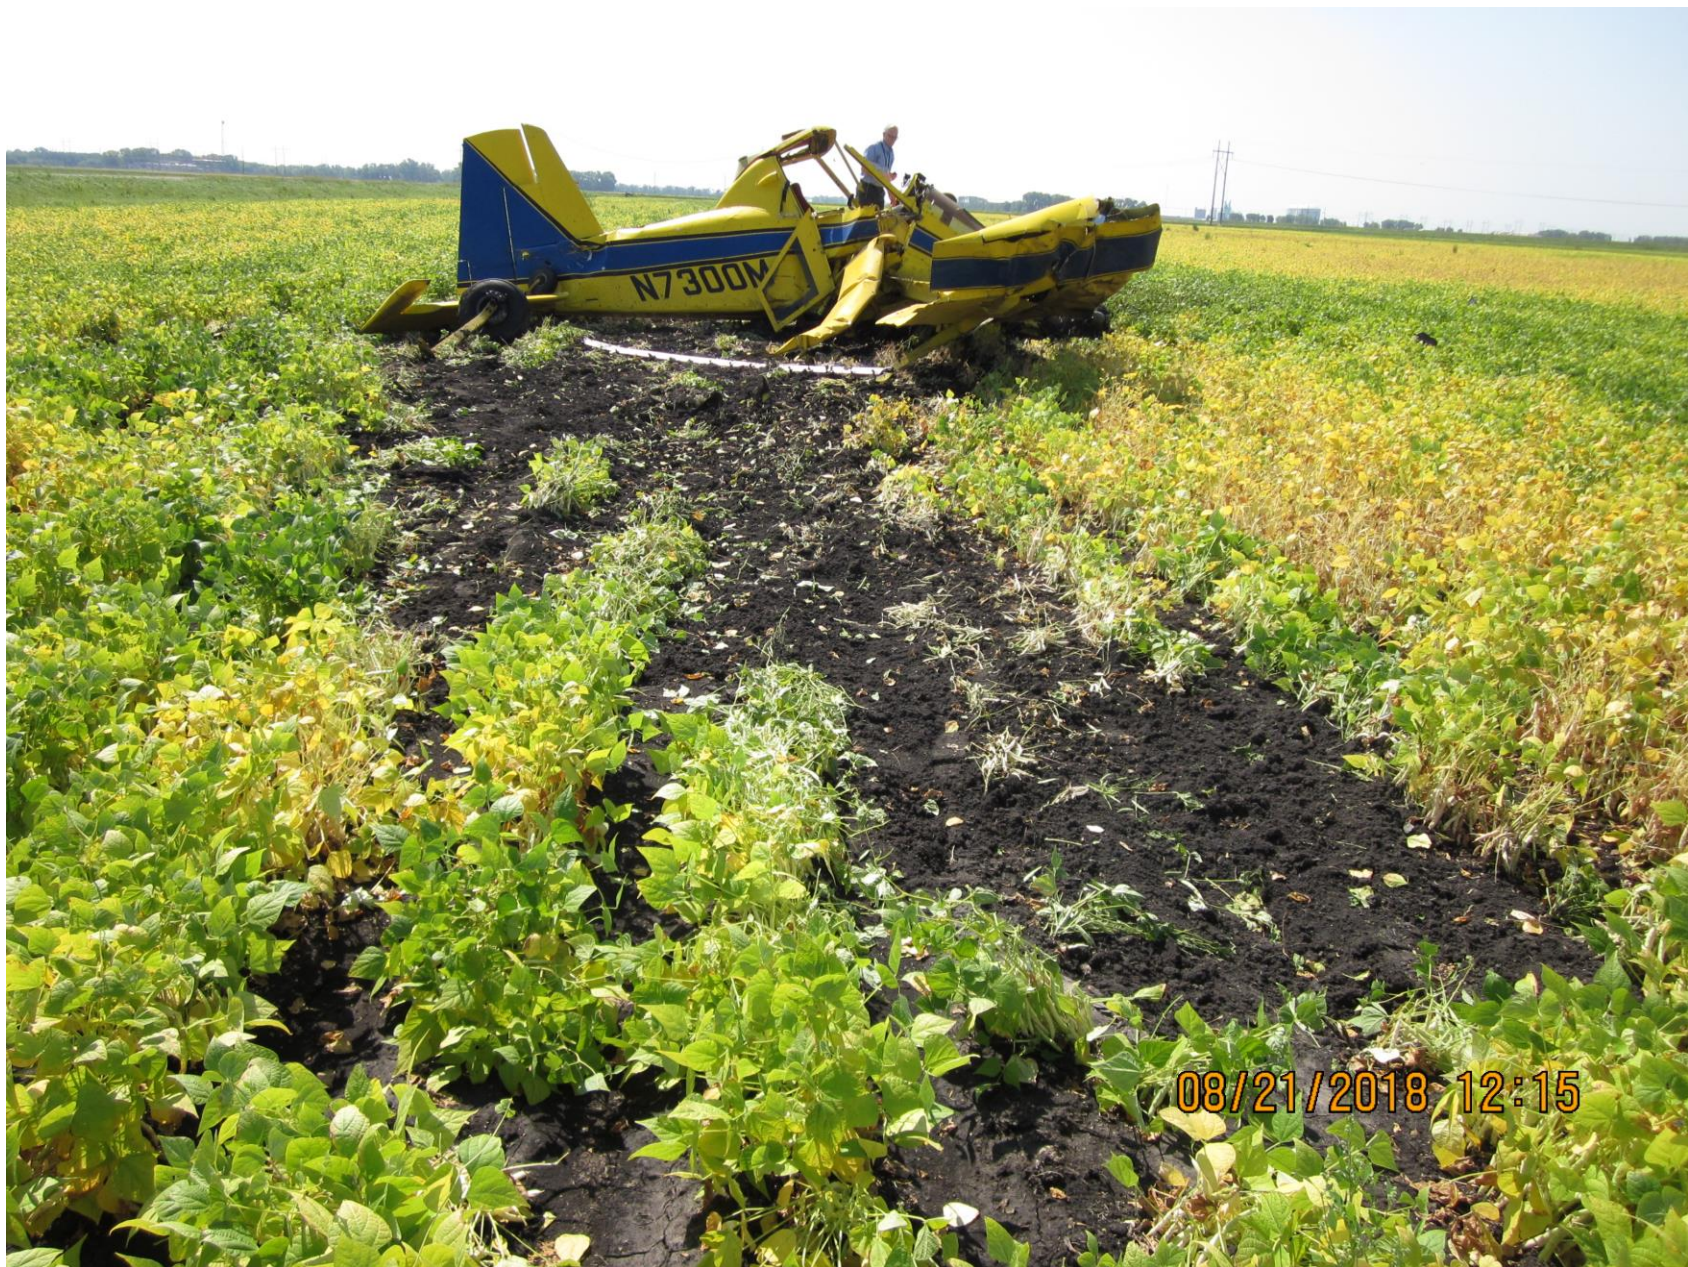
**Photo 6 - Accident site, right view of the main wreckage. (Courtesy of first responders)**

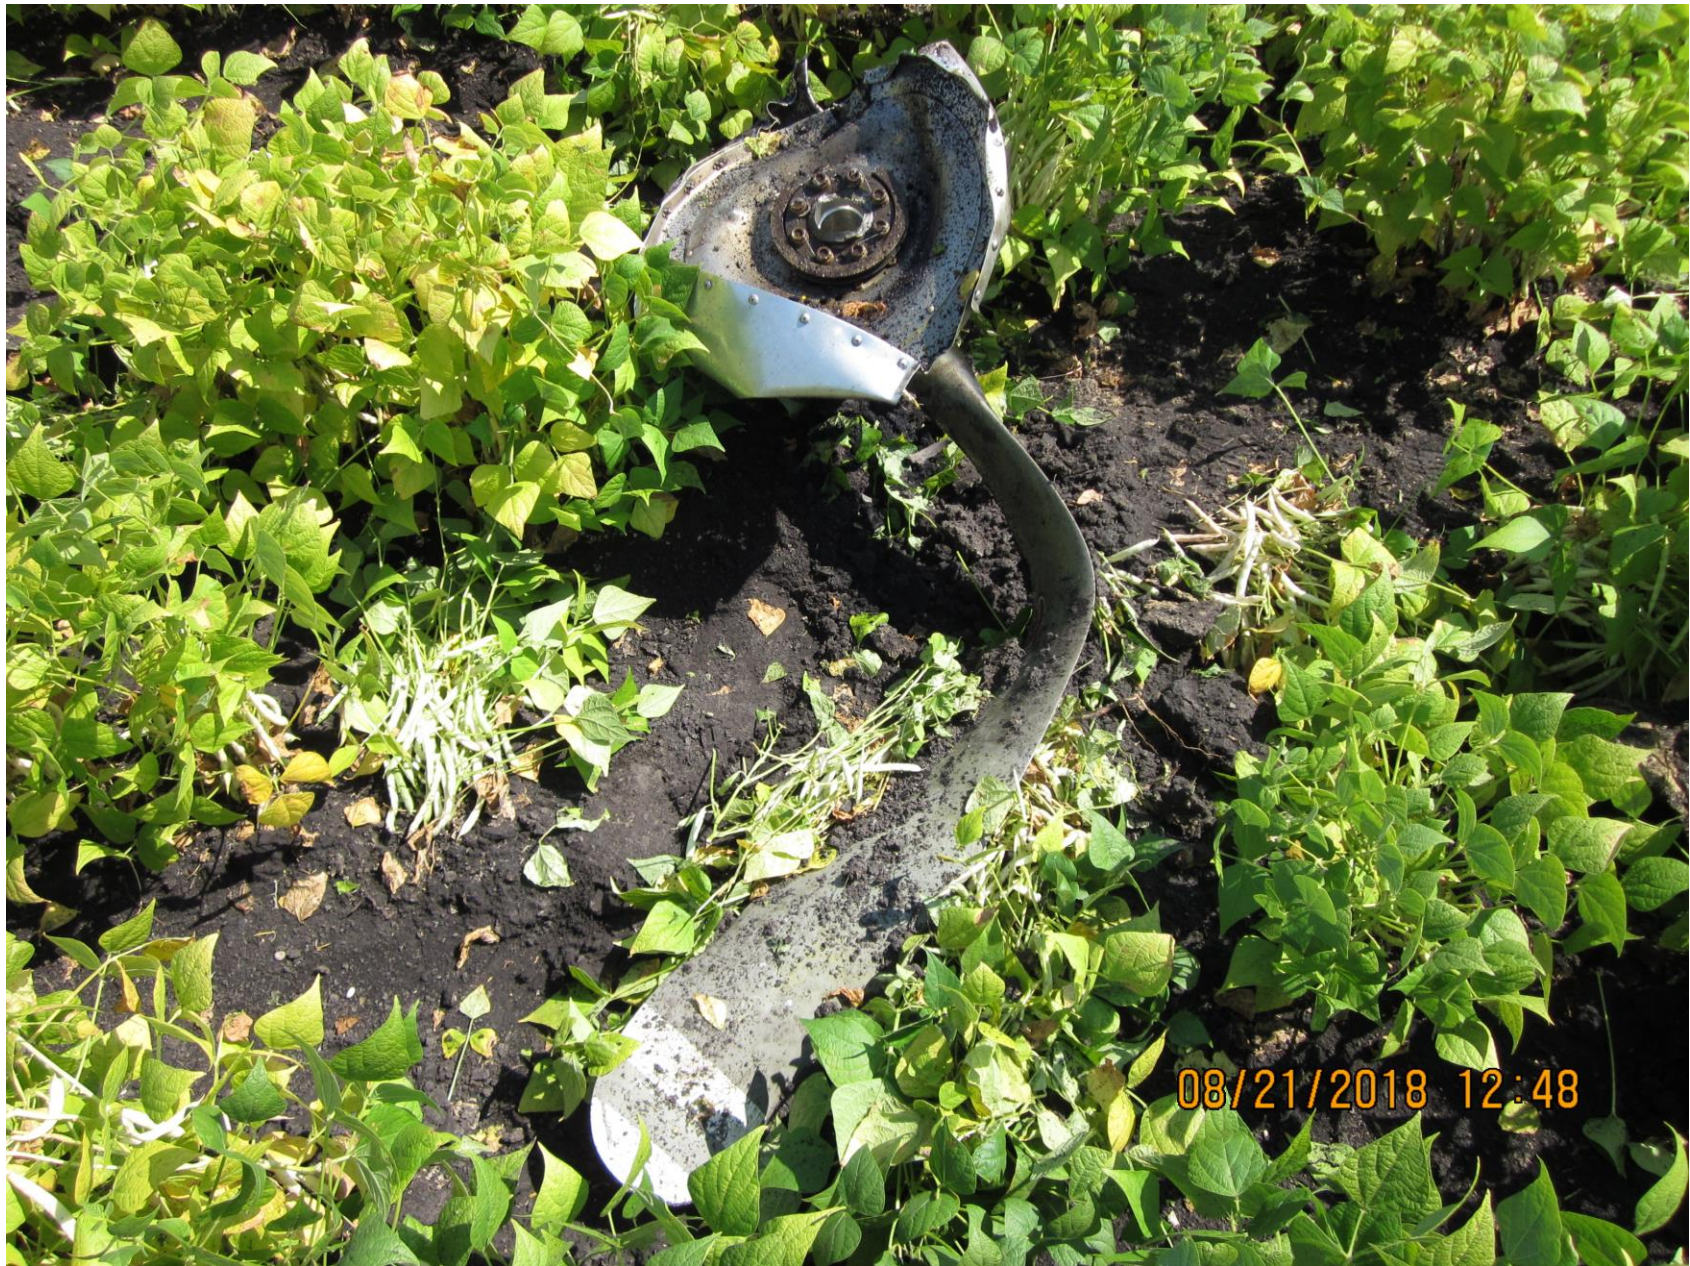
**Photo 7 - Accident site, separated propeller assembly. (Courtesy of first responders)**

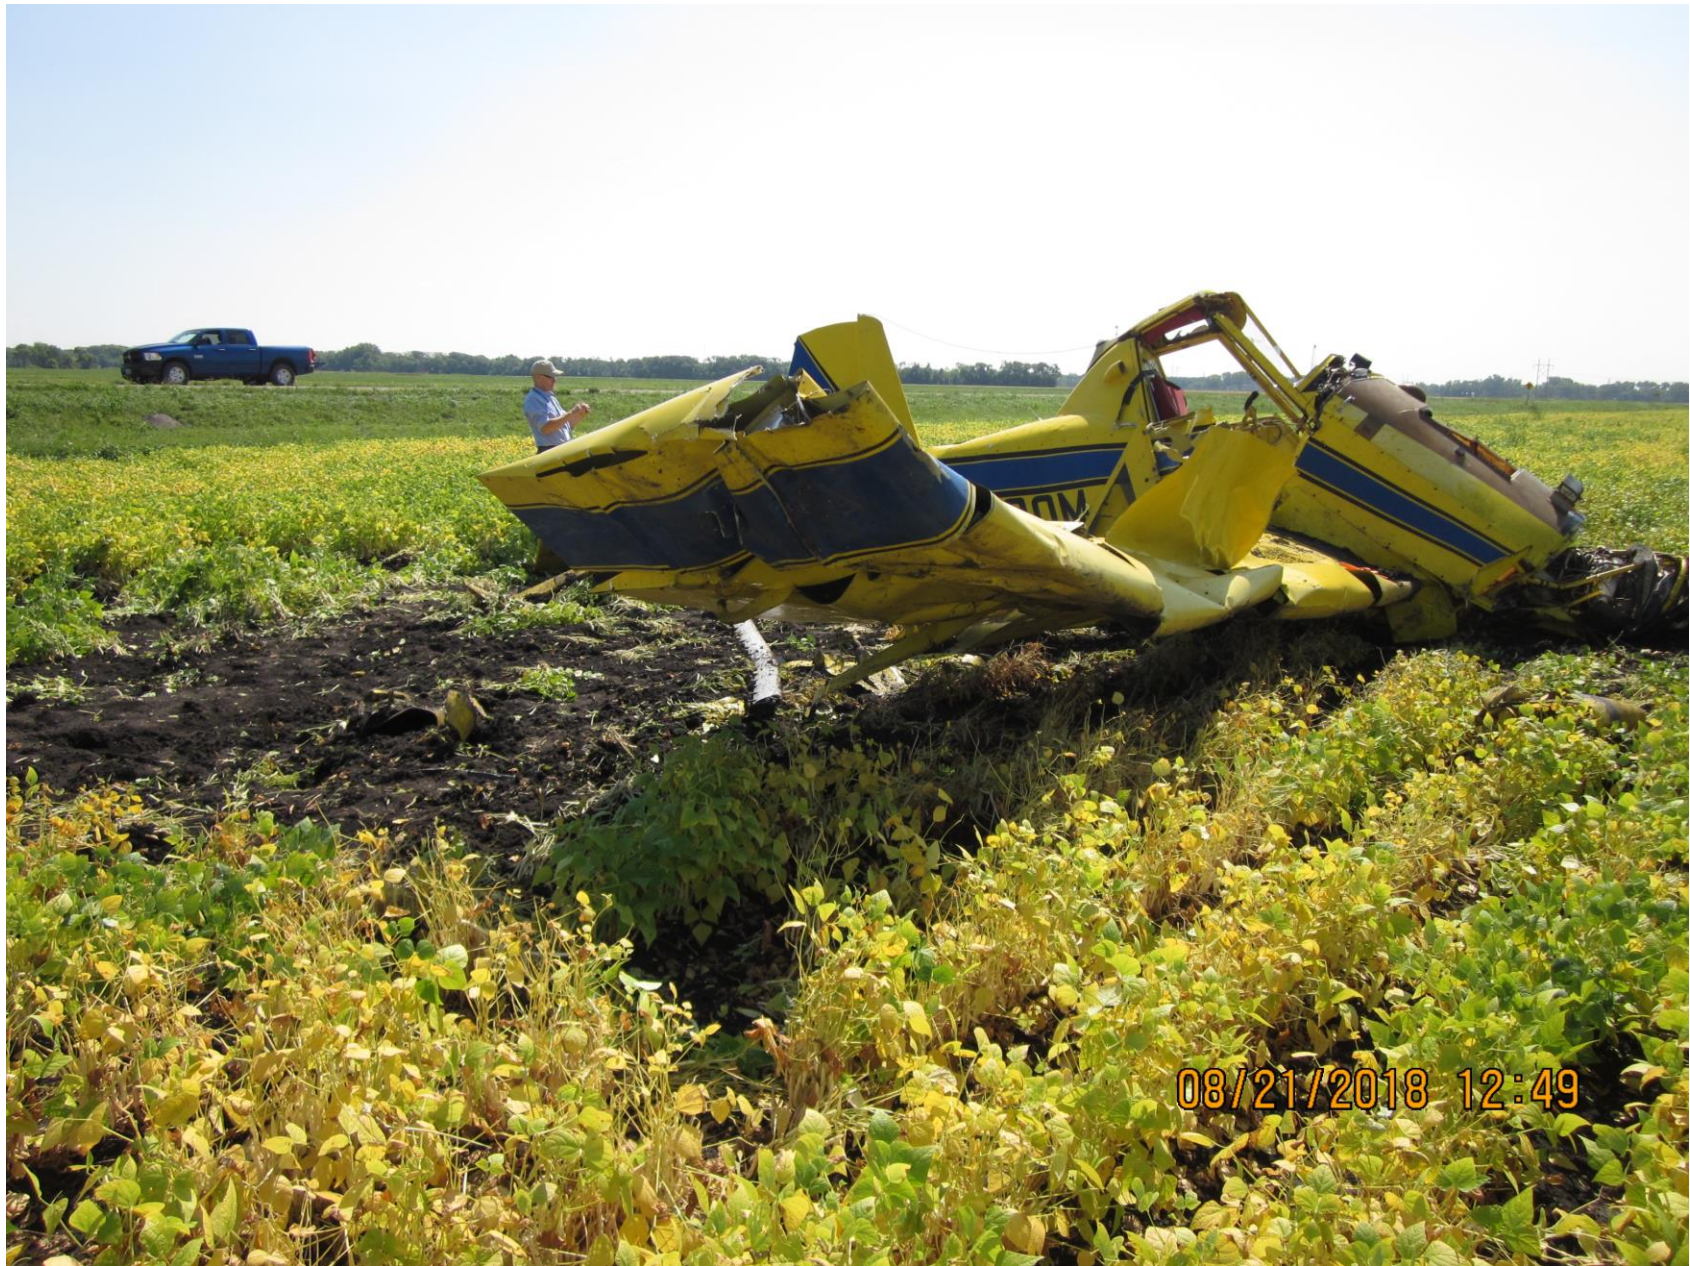
**Photo 8 - Accident site, right view of the main wreckage. (Courtesy of first responders)**

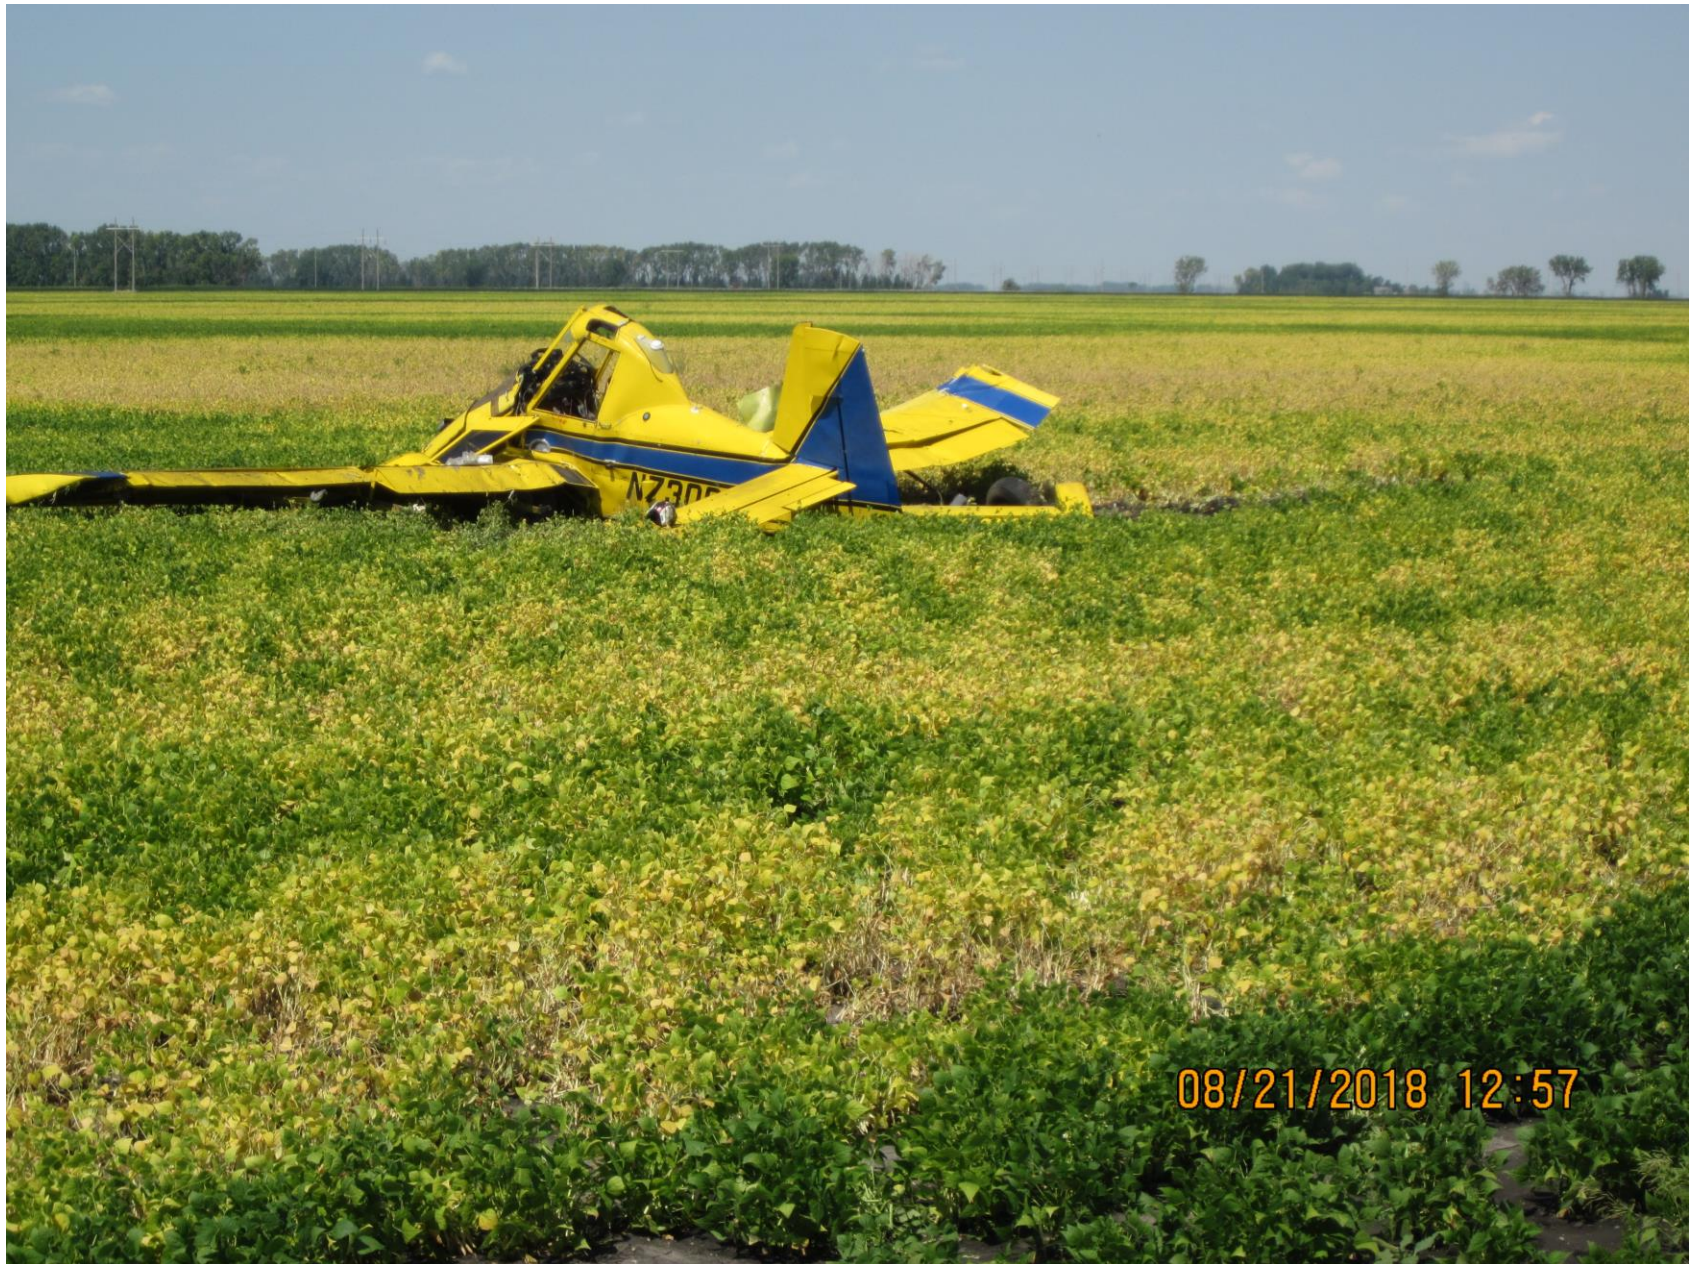
**Photo 9 - Accident site, left rear view of the main wreckage. (Courtesy of first responders)**

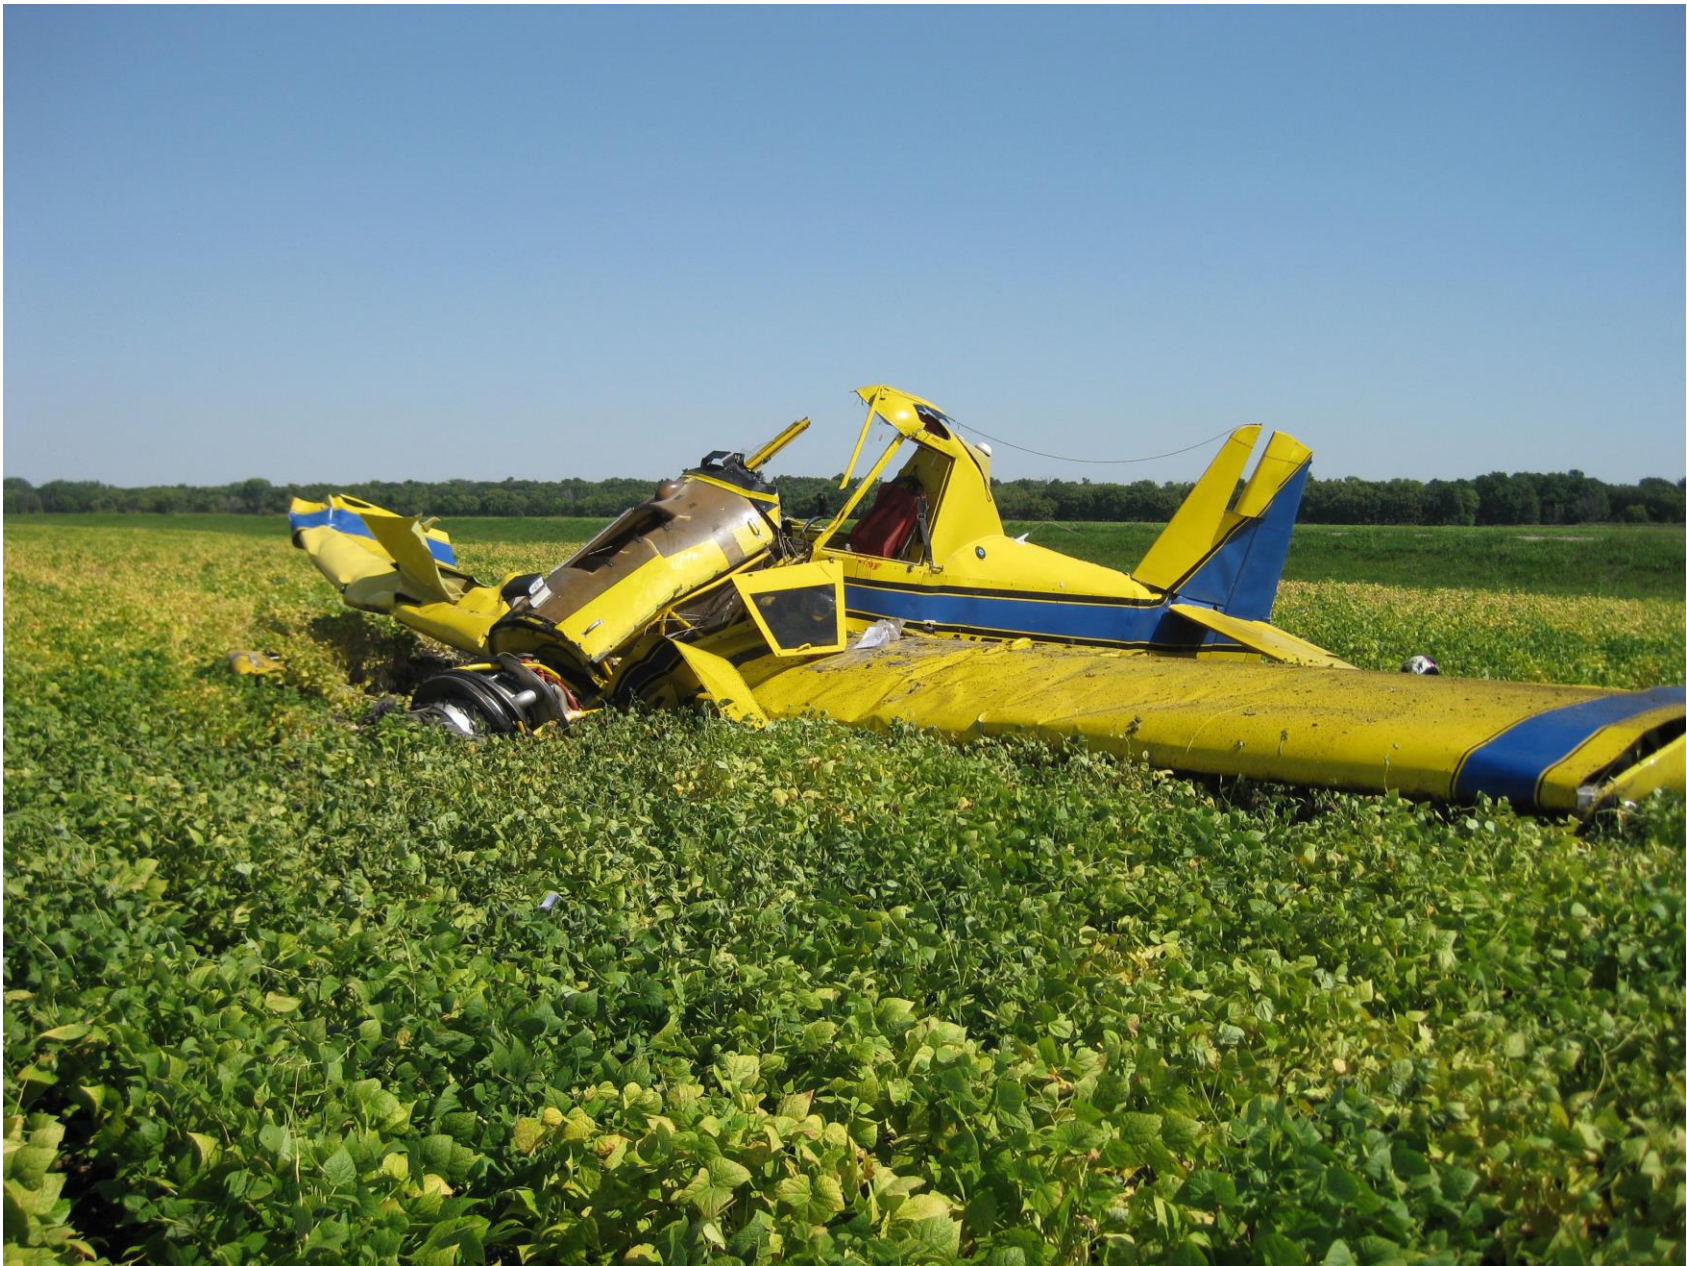
**Photo 10 - Accident site, left forward view of the main wreckage. (Courtesy of first responders)**

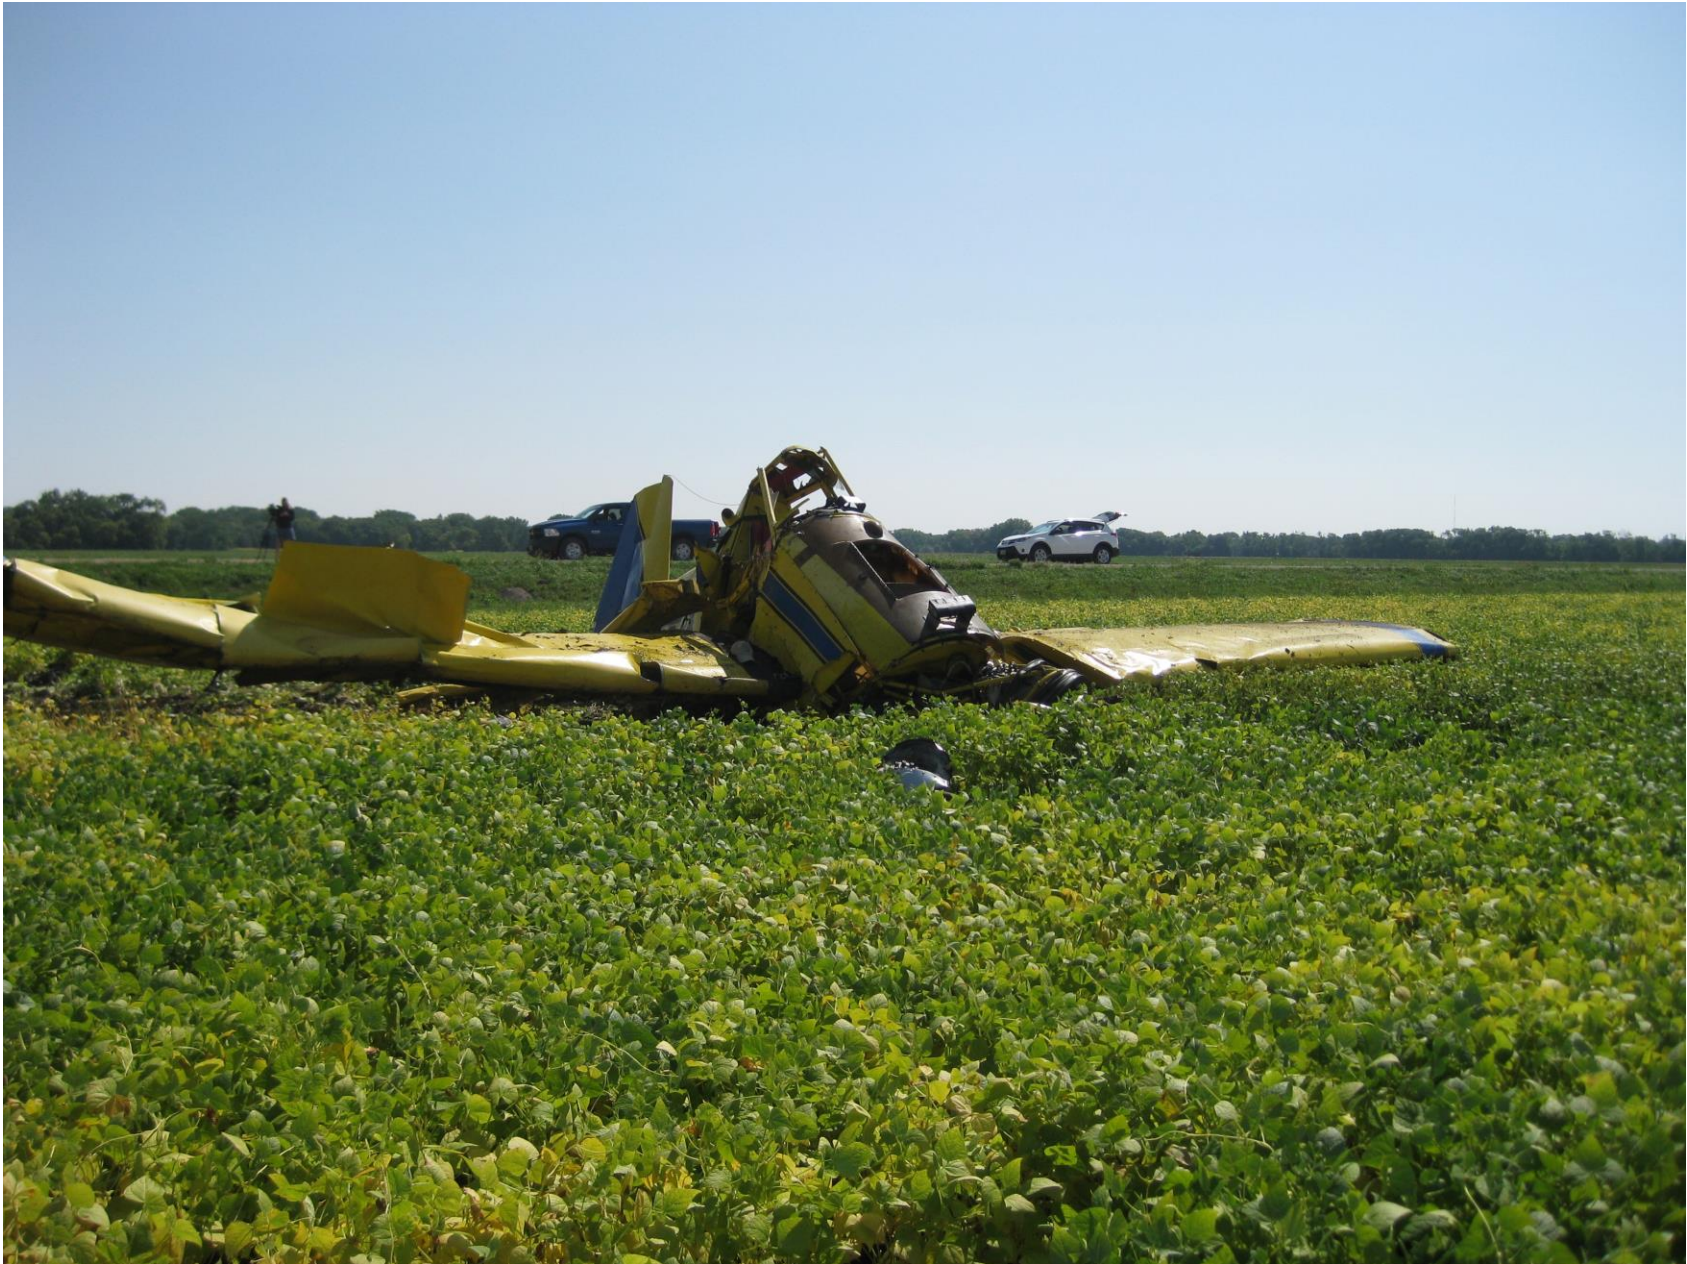
**Photo 11 - Accident site, forward view of the main wreckage. (Courtesy of first responders)**
