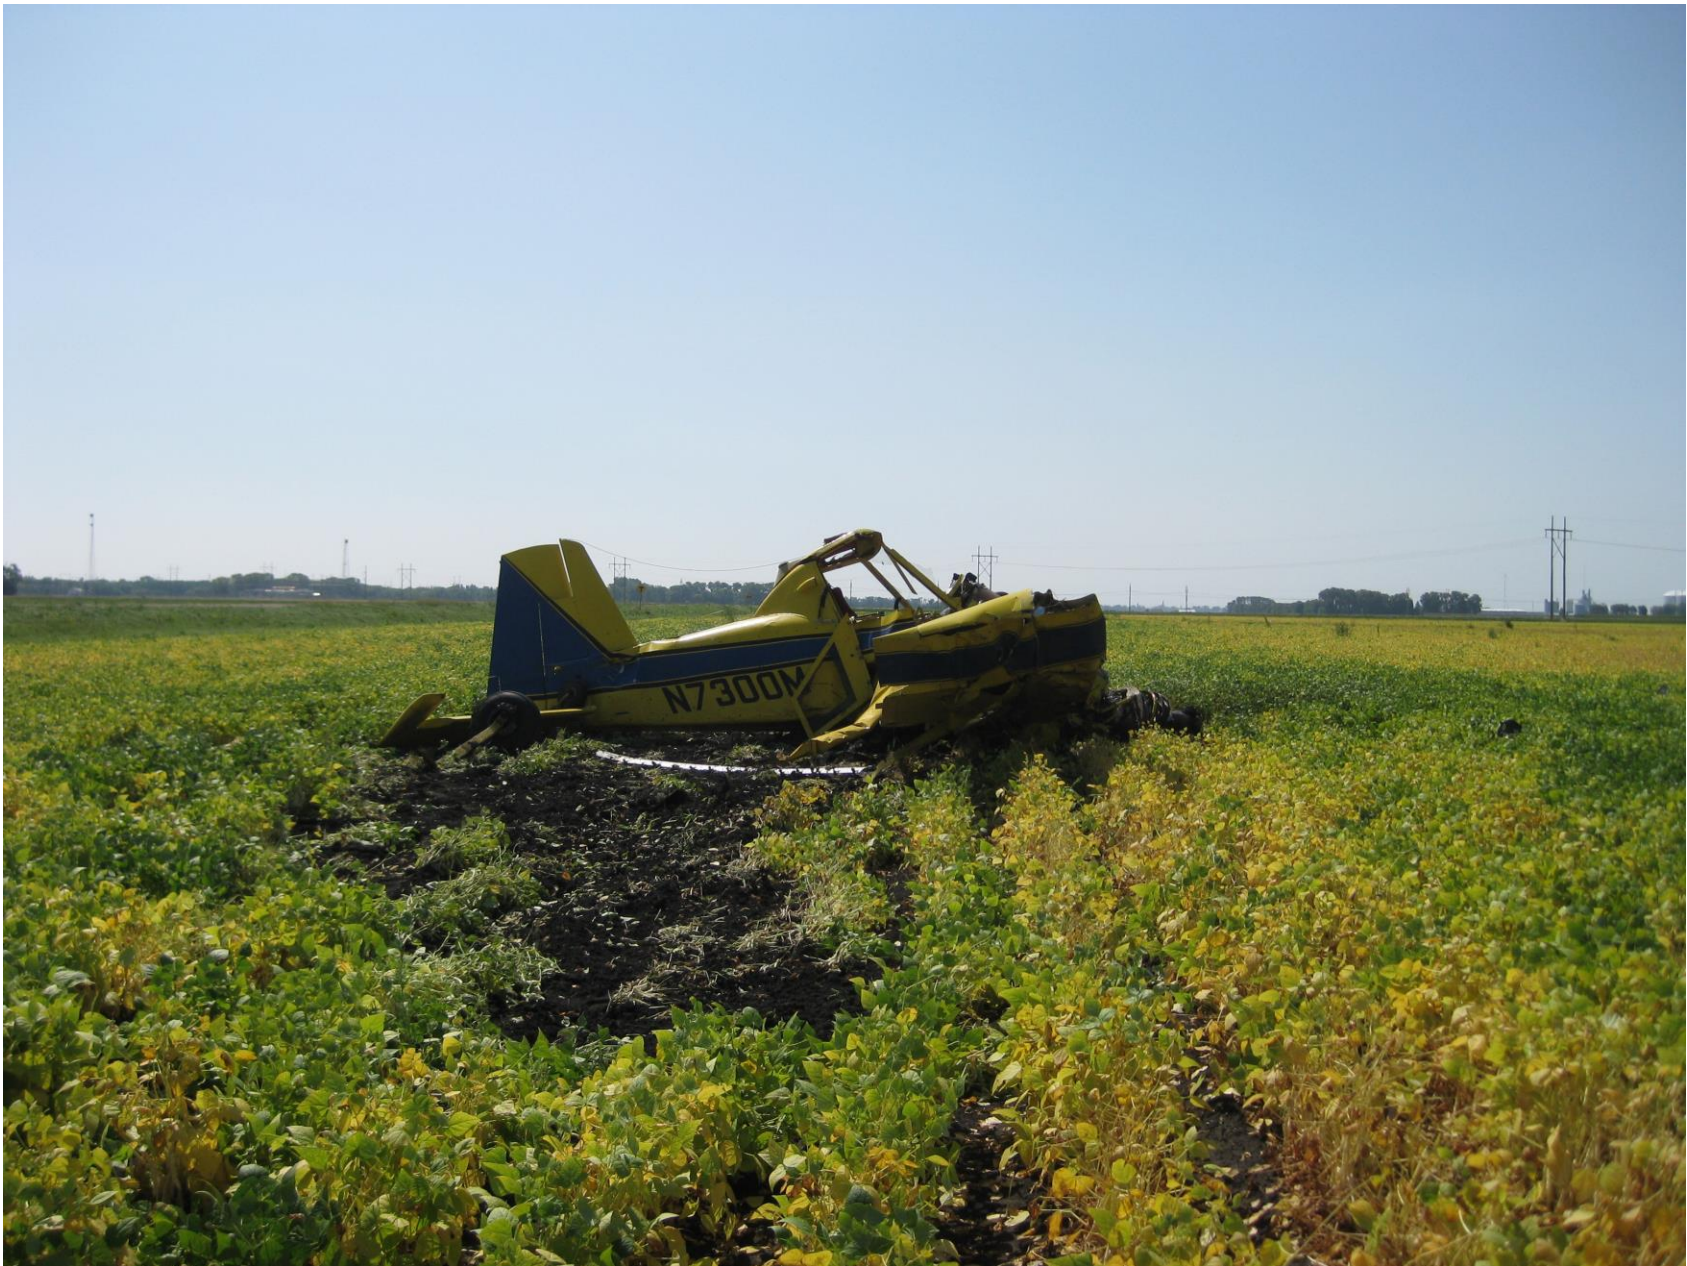
**Photo 12 - Accident site, right side view of the main wreckage. (Courtesy of first responders)**

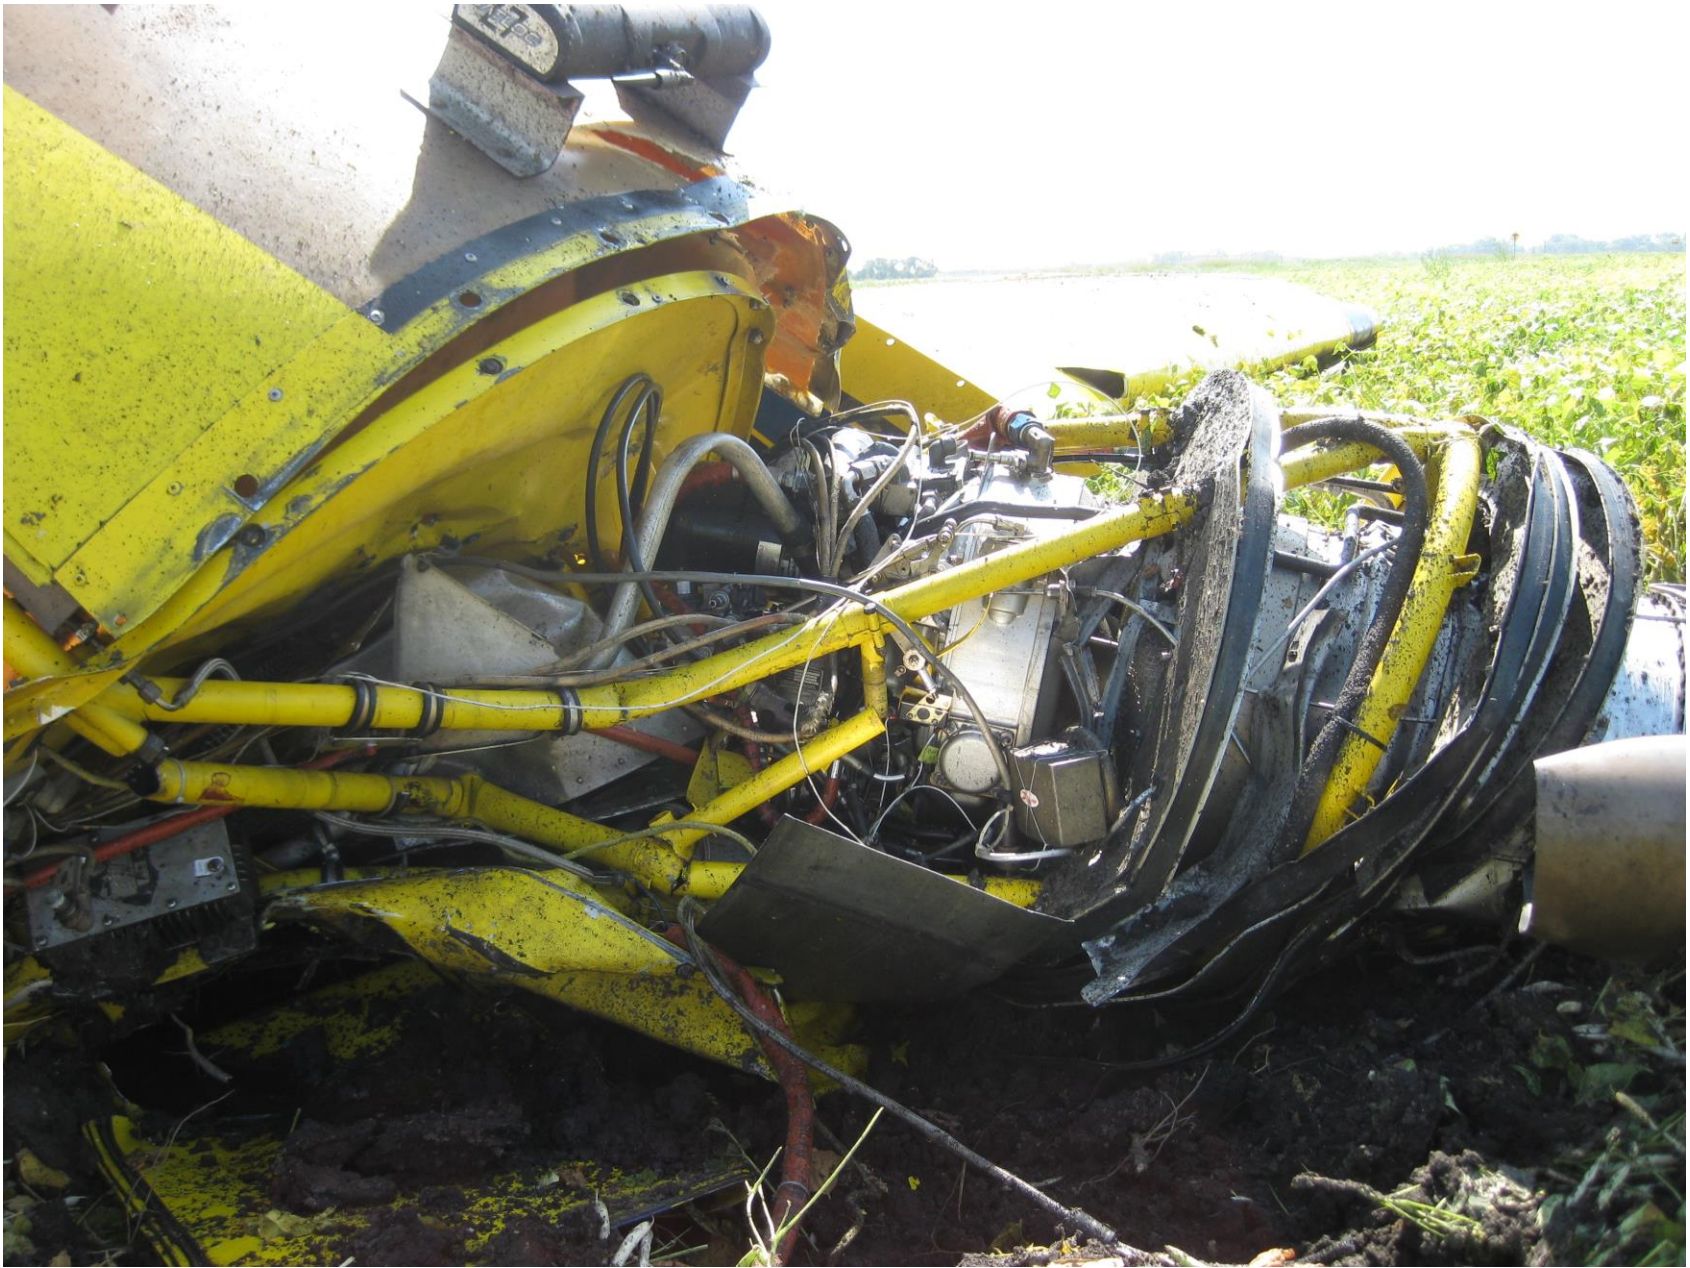
**Photo 13 - Accident site, right side of engine assembly. (Courtesy of first responders)**

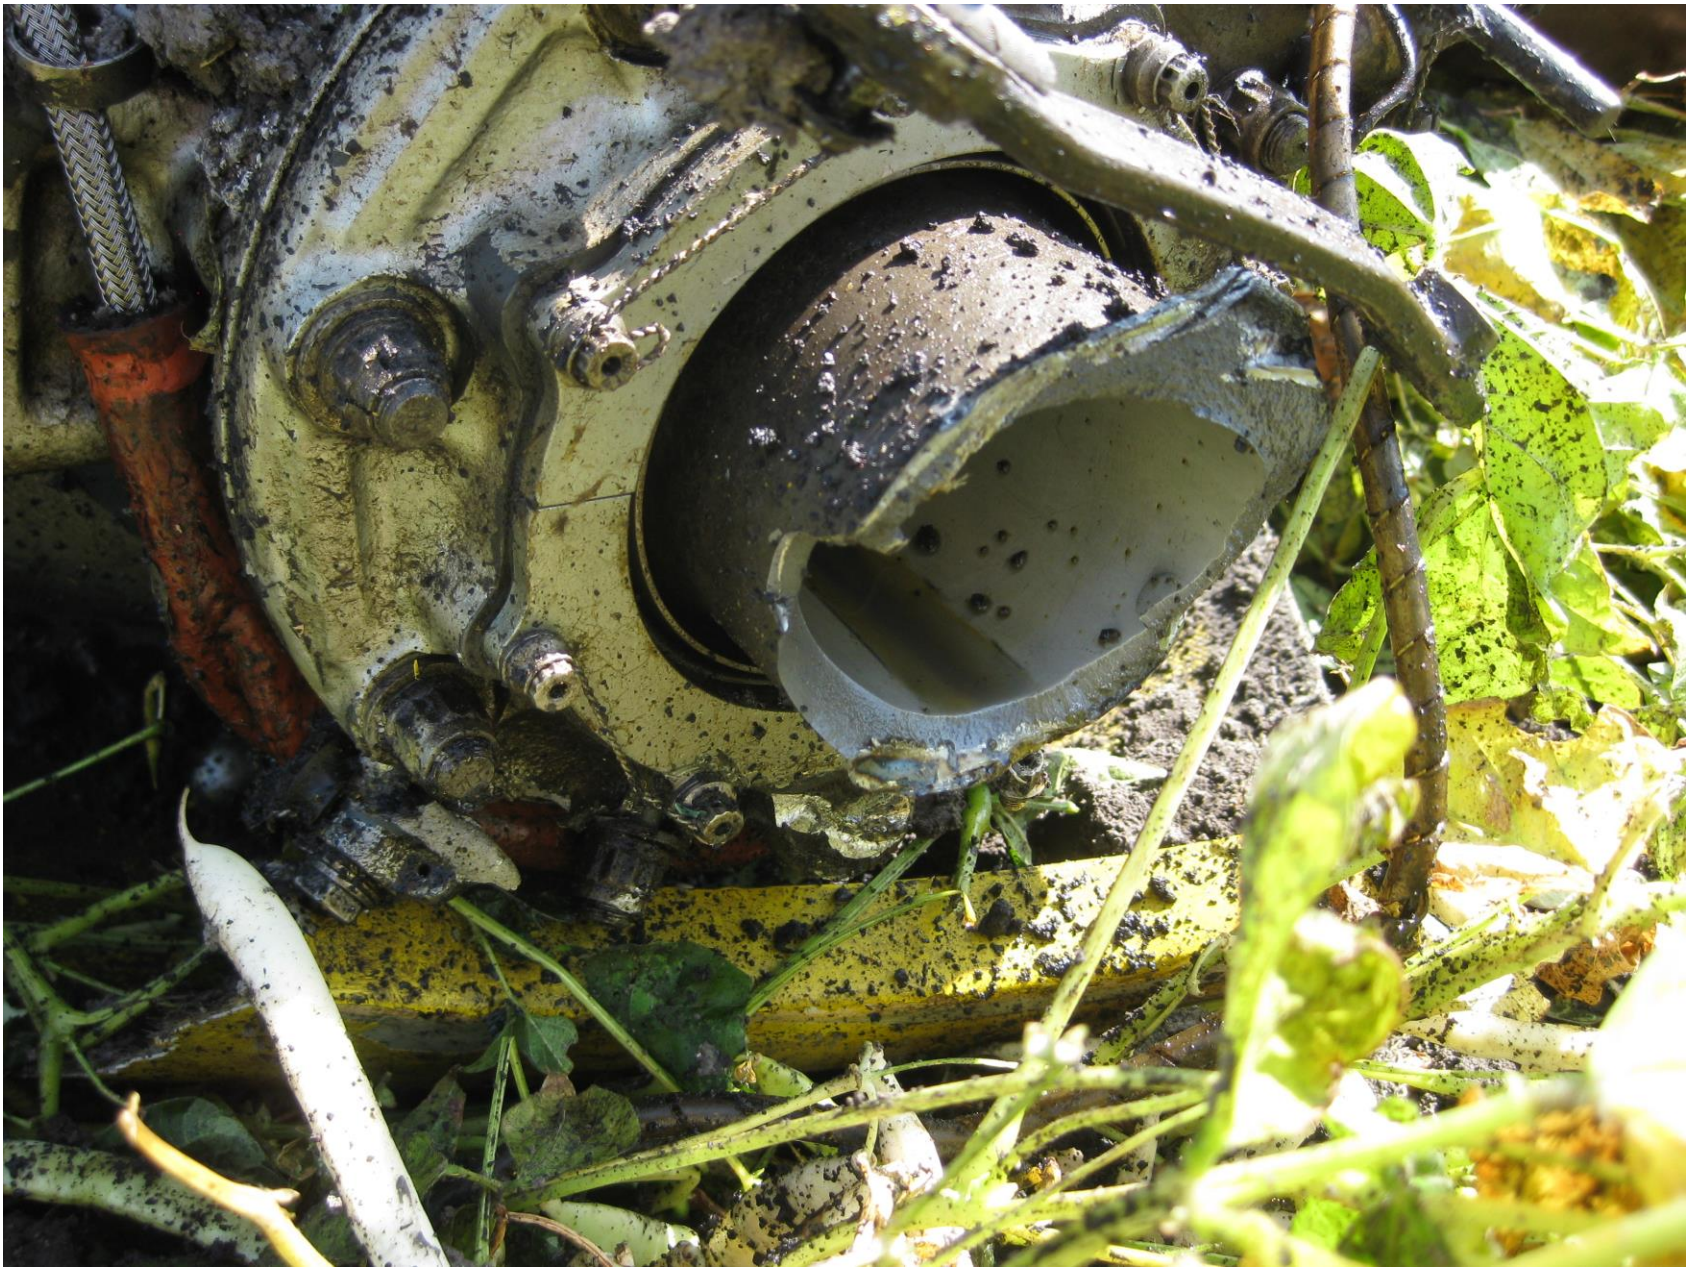
**Photo 14 - Accident site, drive shaft separation. (Courtesy of first responders)**

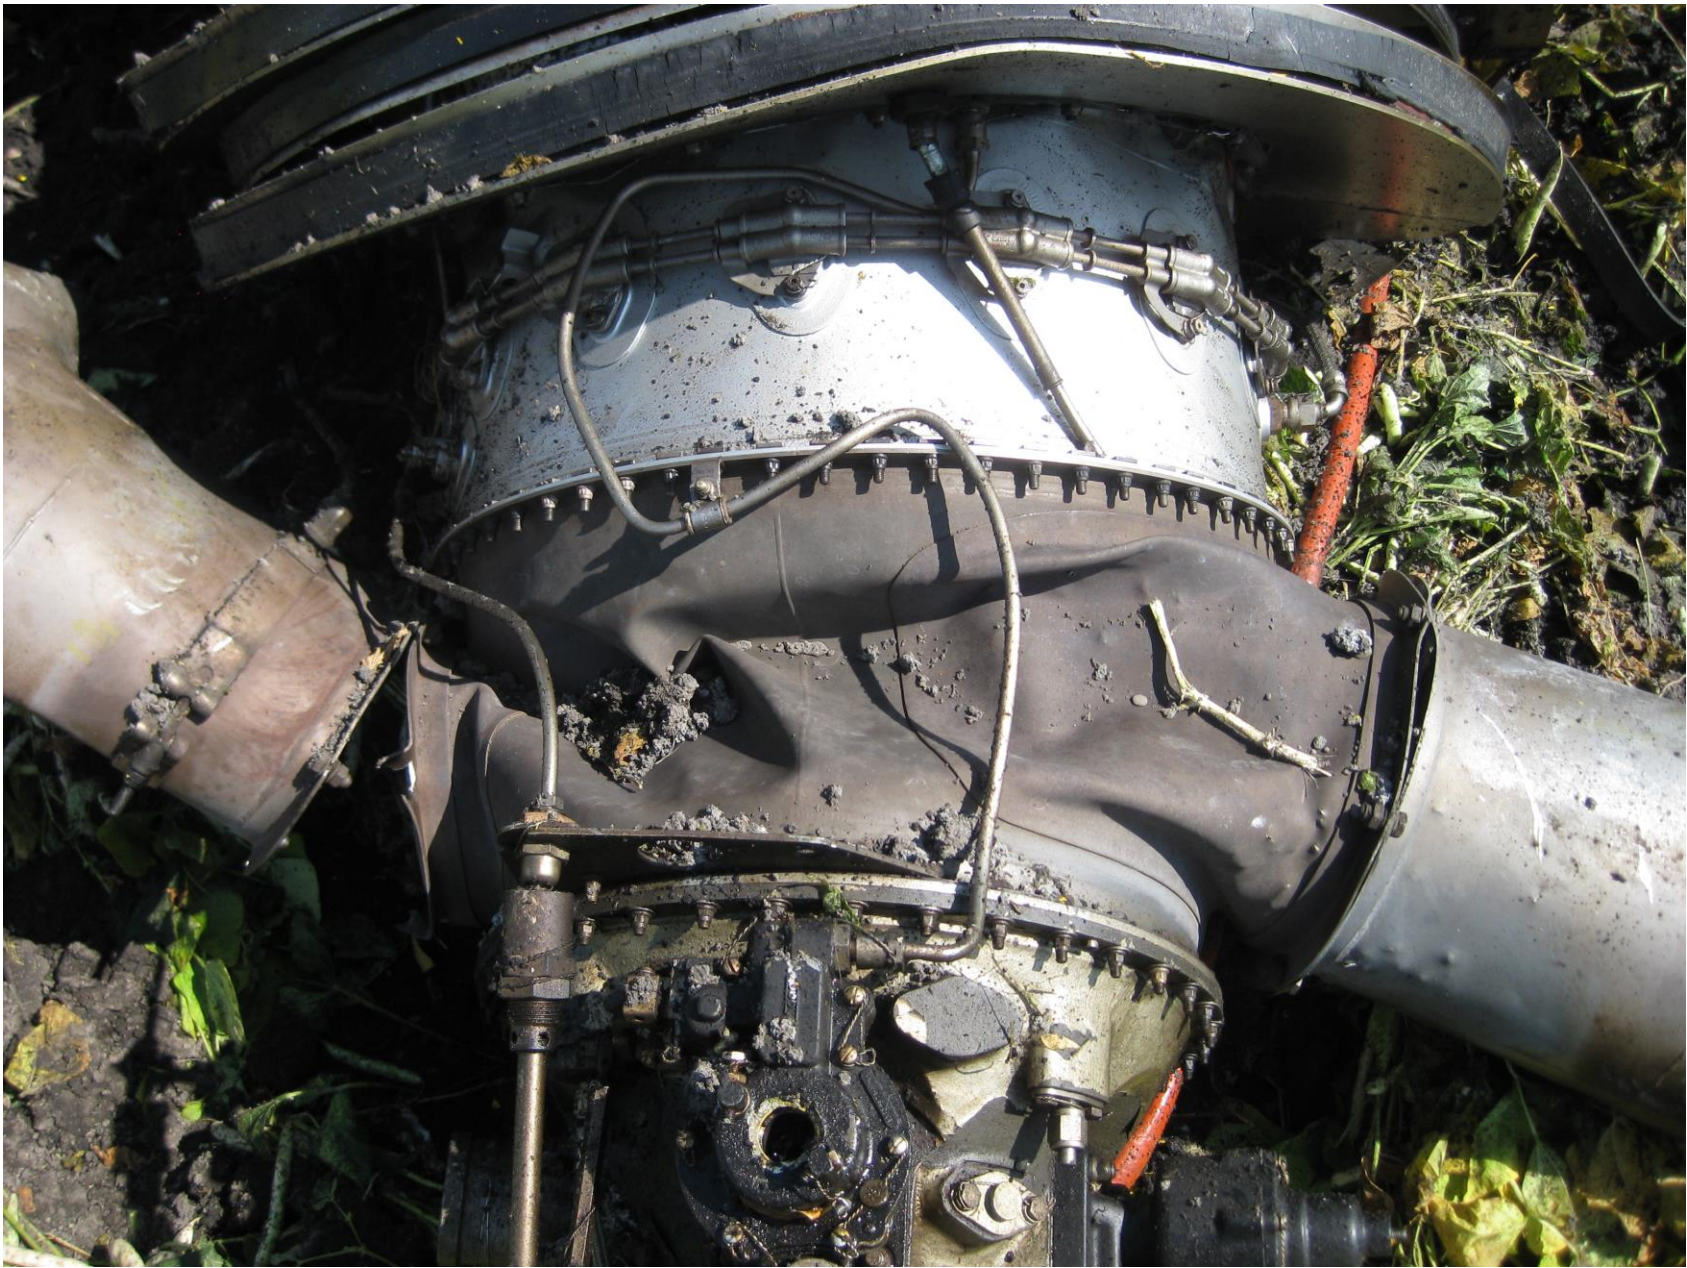
**Photo 15 - Accident site, engine power and exhaust sections. (Courtesy of first responders)**

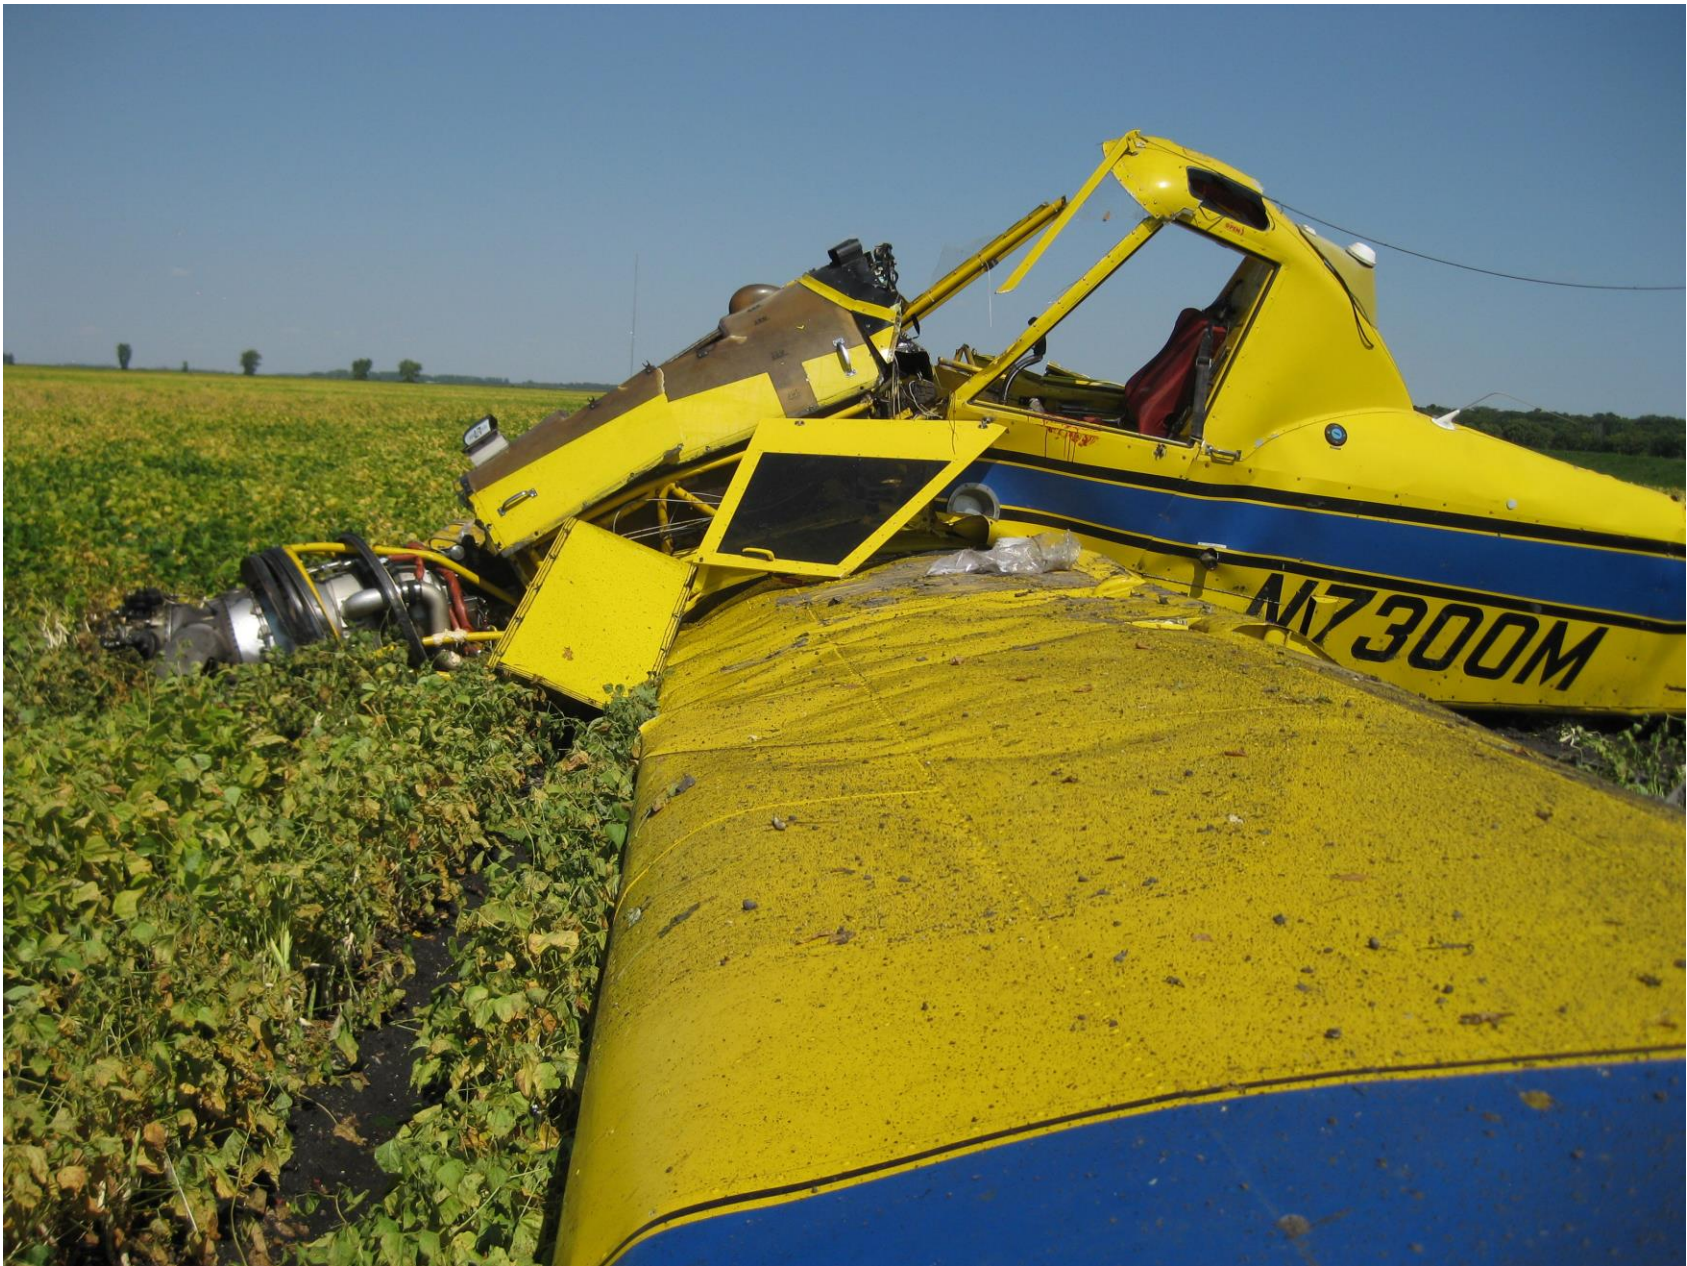
**Photo 16 – Accident site, left wing and side view of wreckage. (Courtesy of first responders)**
