# NATIONAL TRANSPORTATION SAFETY BOARD

## MATERIALS LABORATORY FACTUAL REPORT

Report No. 22-025

Place : Grand Forks, North Dakota  
Date : August 21, 2018  
Vehicle : Air Tractor AT-400, N7300M  
NTSB No. : WPR18LA234  
Investigator : Andrew Swick, AS-WPR

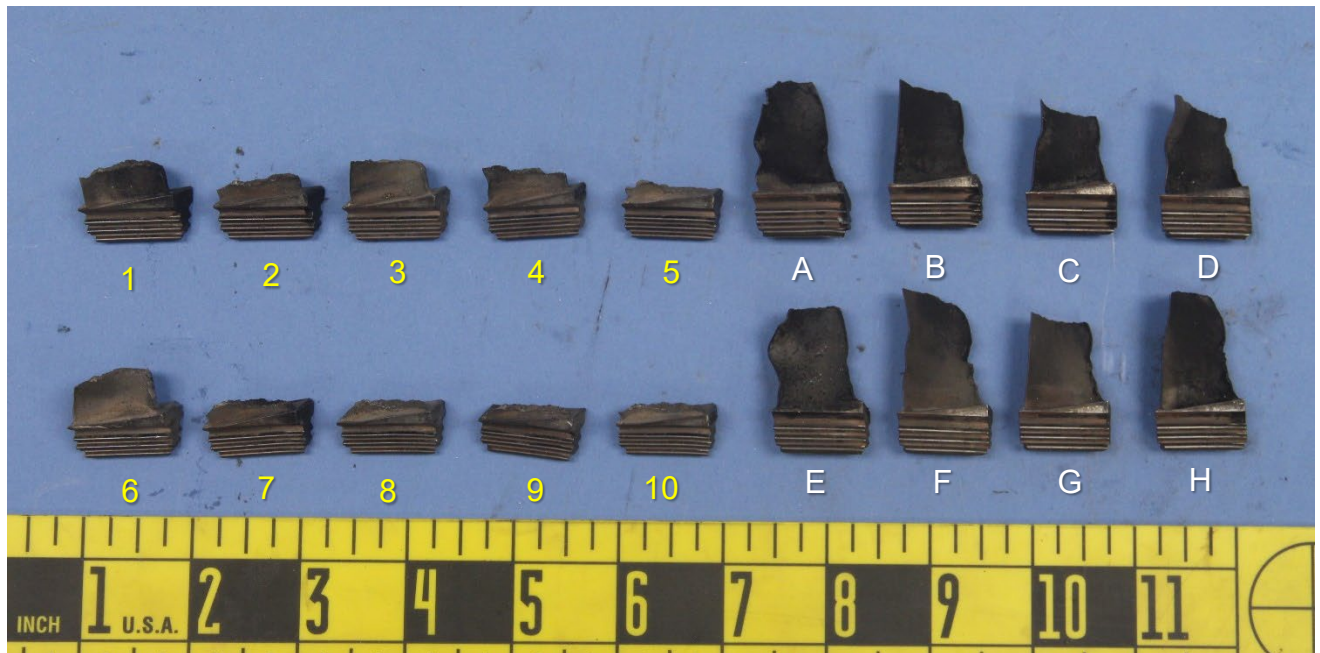
Figure 1 shows the turbine blades from the concave side, as received. For the purposes of this report, the blades were labeled 1 through 10 for the shortest blades, and A-H for the blades with larger remnants of blade material above the platform. As the initiating blades in turbine engine failures typically have little remaining material above the platform, the blades were divided based on remnant height—blades below 0.5 inches in remaining blade height were labeled 1 through 10, those above were labeled A through H. Using calipers, the heights of the blade material above the platform was measured, noting the highest and shortest lengths from the top of the platform, as displayed in Table I. In addition, the distance from the bottom of the dovetail to the top of the platform on the leading edge side was measured, as recorded in Table I.

Figure 1 – View of the turbine blade remnants, as received.

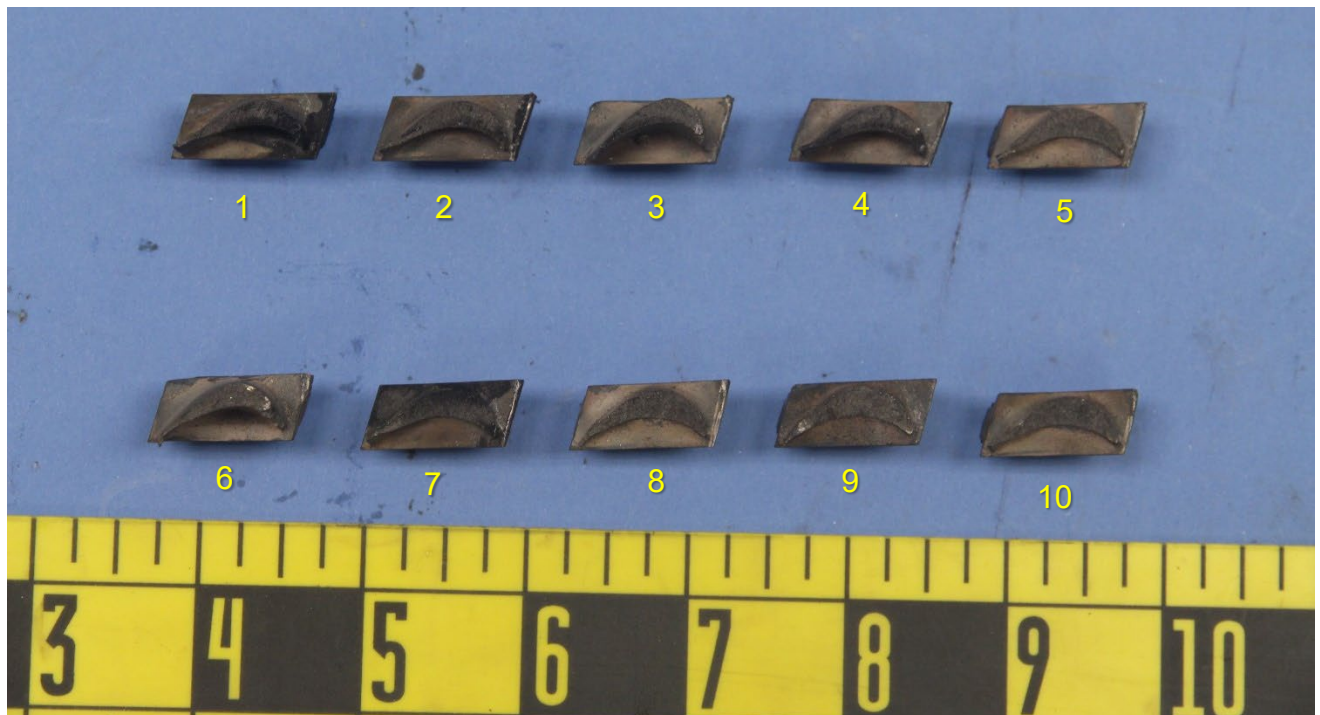
Figure 2 shows the fracture surfaces of the 10 shortest blade remnants. These fracture surfaces were all scrutinized using optical light microscopes to search for distinct areas of features on the fracture surfaces of Blades 1 through 10. While all the fracture surfaces were examined, the surfaces of Blades 7 through 10 are highlighted in this report from Figure 3 to Figure 11.

Figure 2 – Views of the fracture surfaces of the shortest blade remnants, on the left in Figure 1.

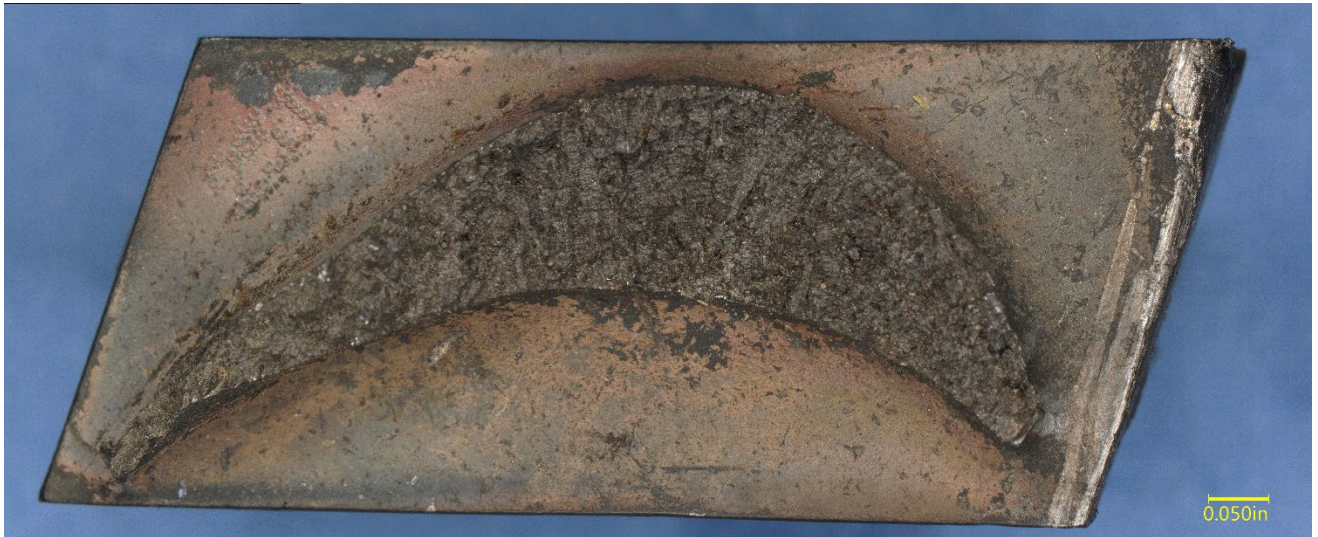
Figure 3 shows an overall montage of the fracture surface of Blade 8. As was typically found on all the blade remnants in this case, the surfaces exhibited areas of dark coloring, along with light gray to dark orange areas, consistent with surface oxidation and combustion deposits. These deposits were typical of exposure to high temperature environments. In addition, the fracture surfaces themselves exhibited a general rough and tortuous surface texture, with a dull and dark luster.

Figure 3 – The fracture surface of Blade 8.

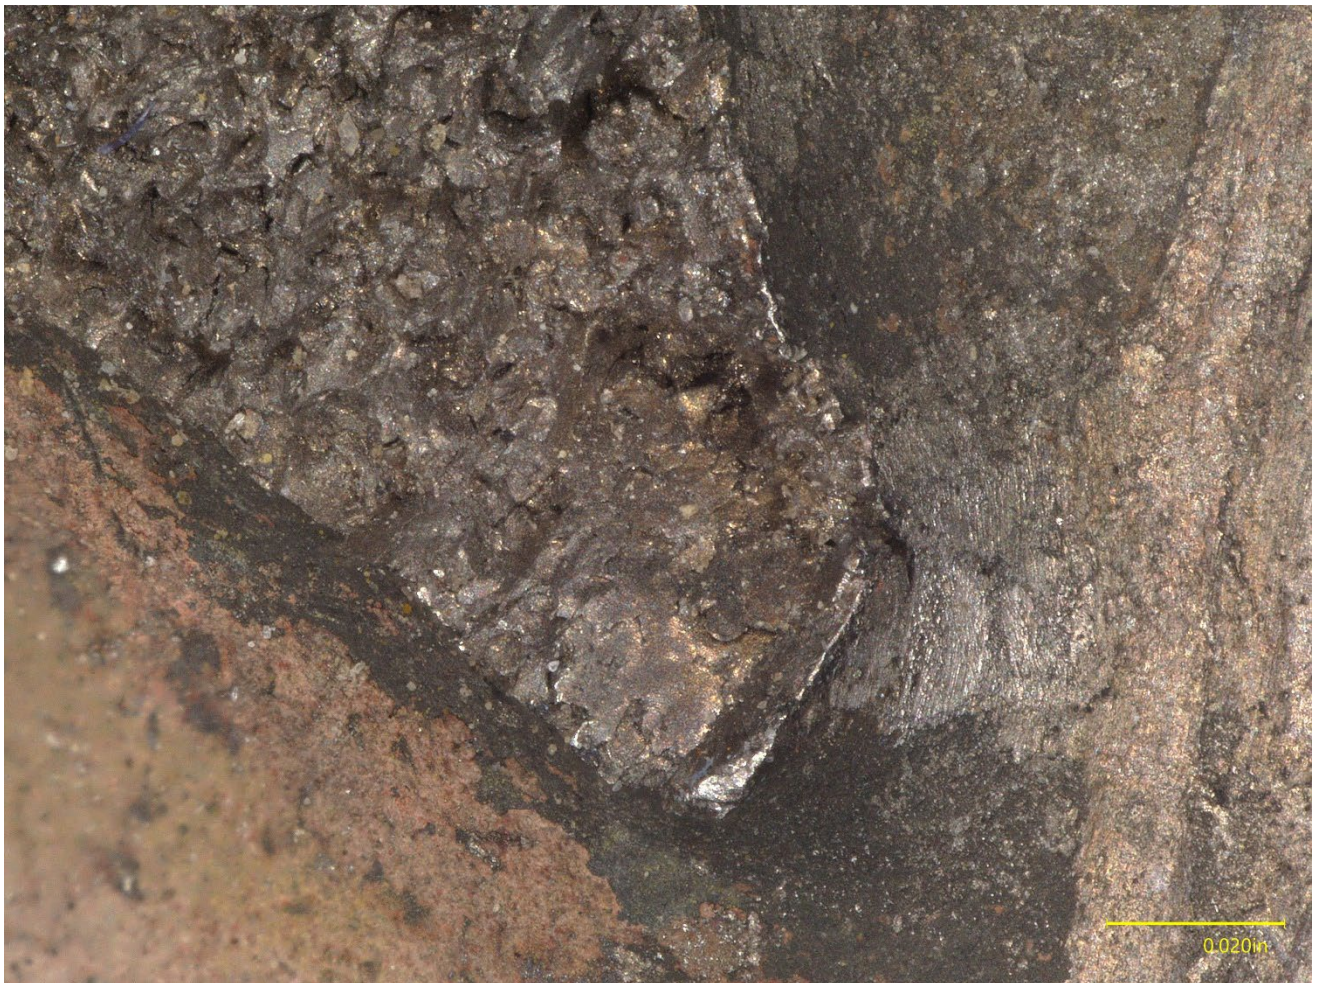
Figures 4 and 5 show closer views of the fracture surface from the leading and trailing edges, respectively. While at lower magnifications, these areas appeared flatter and lighter in color than the rest of the fracture surface, closer examination found mottled features with localized perpendicular material deformation, consistent with post-fracture smearing.

Figure 4 – Closer view of the leading edge of the Blade 8 fracture surface.

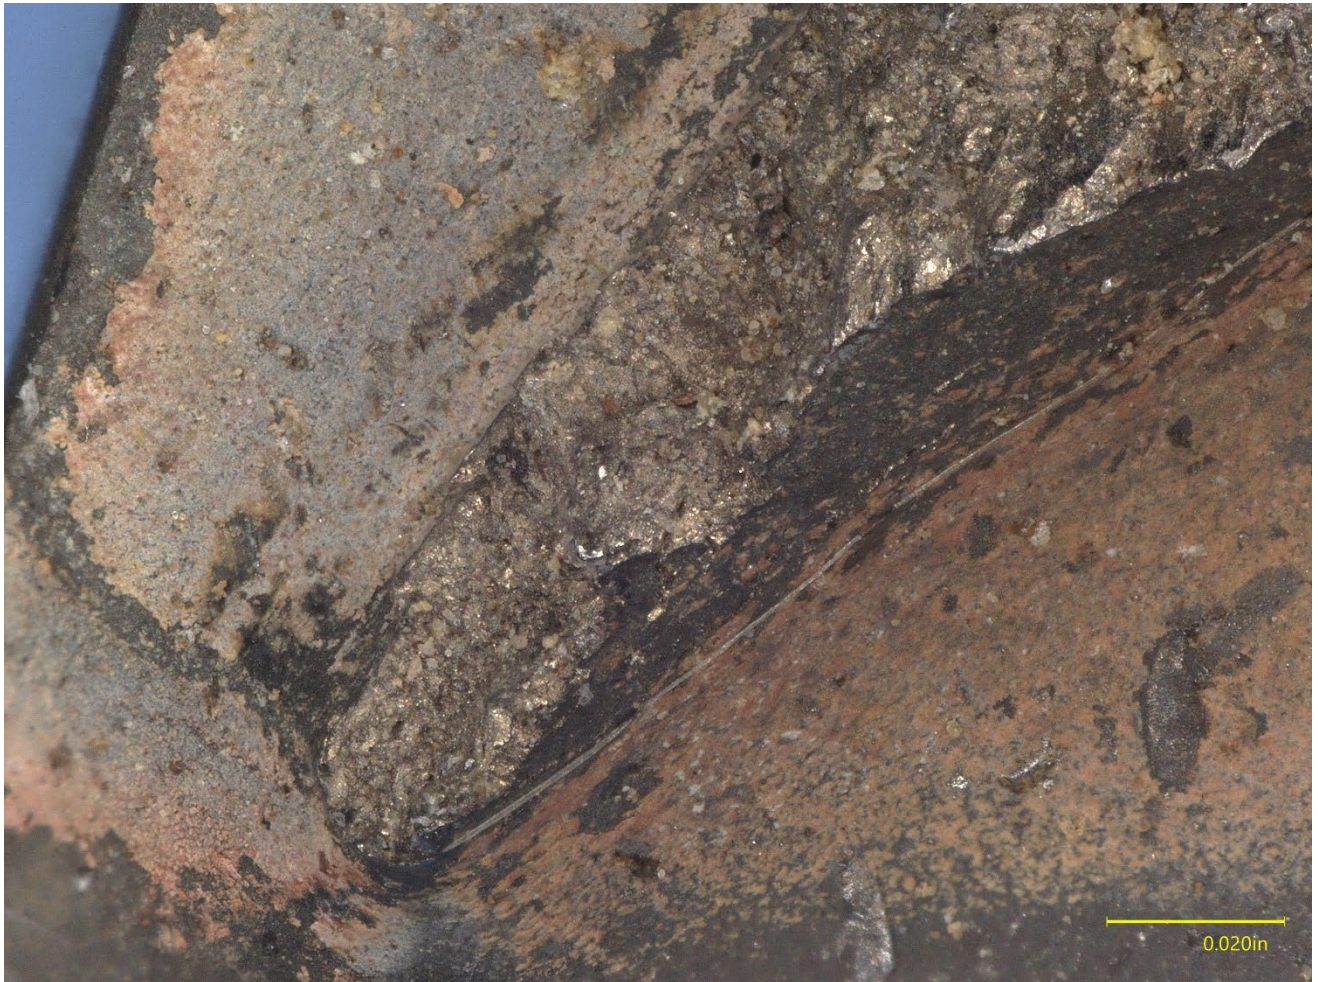
Figure 5 – Closer view of the trailing edge of the Blade 8 fracture surface.

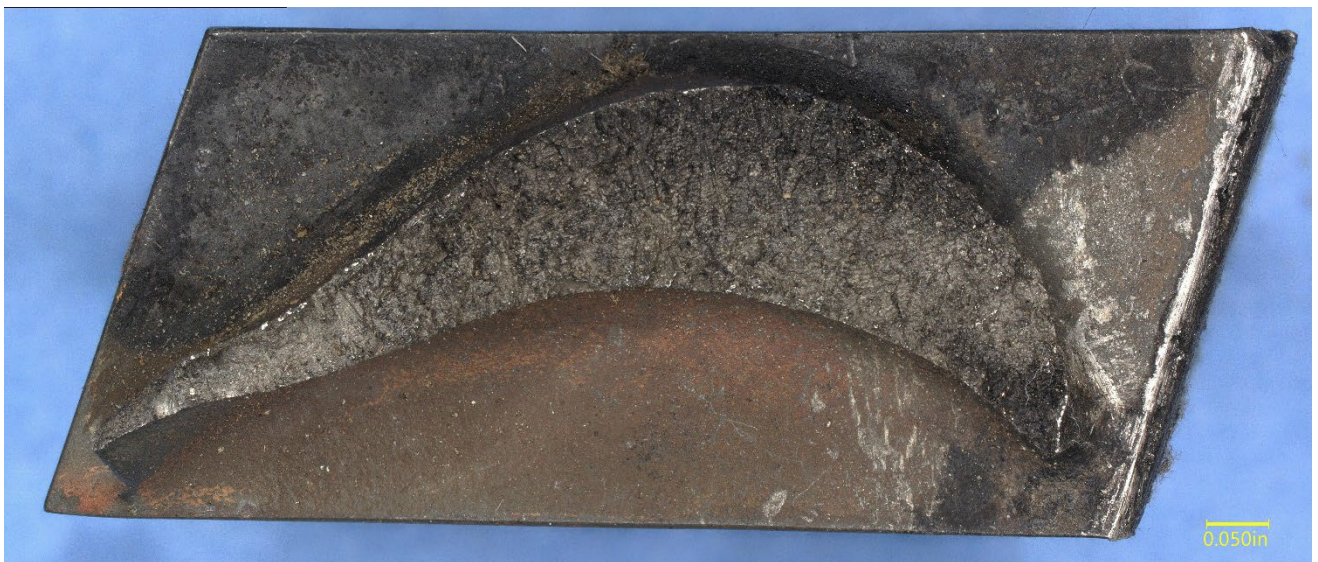
Figure 6 shows an overall montage of the Blade 7 fracture. This fracture exhibited darker deposits, primarily on the convex side of the fracture and platform, and the leading edge. While there were dark deposits on the leading edge portion of the fracture surface (see Figure 7), the fracture features in this area were consistent with those over the rest of the fracture surface.

Figure 6 – The fracture surface of Blade 7.

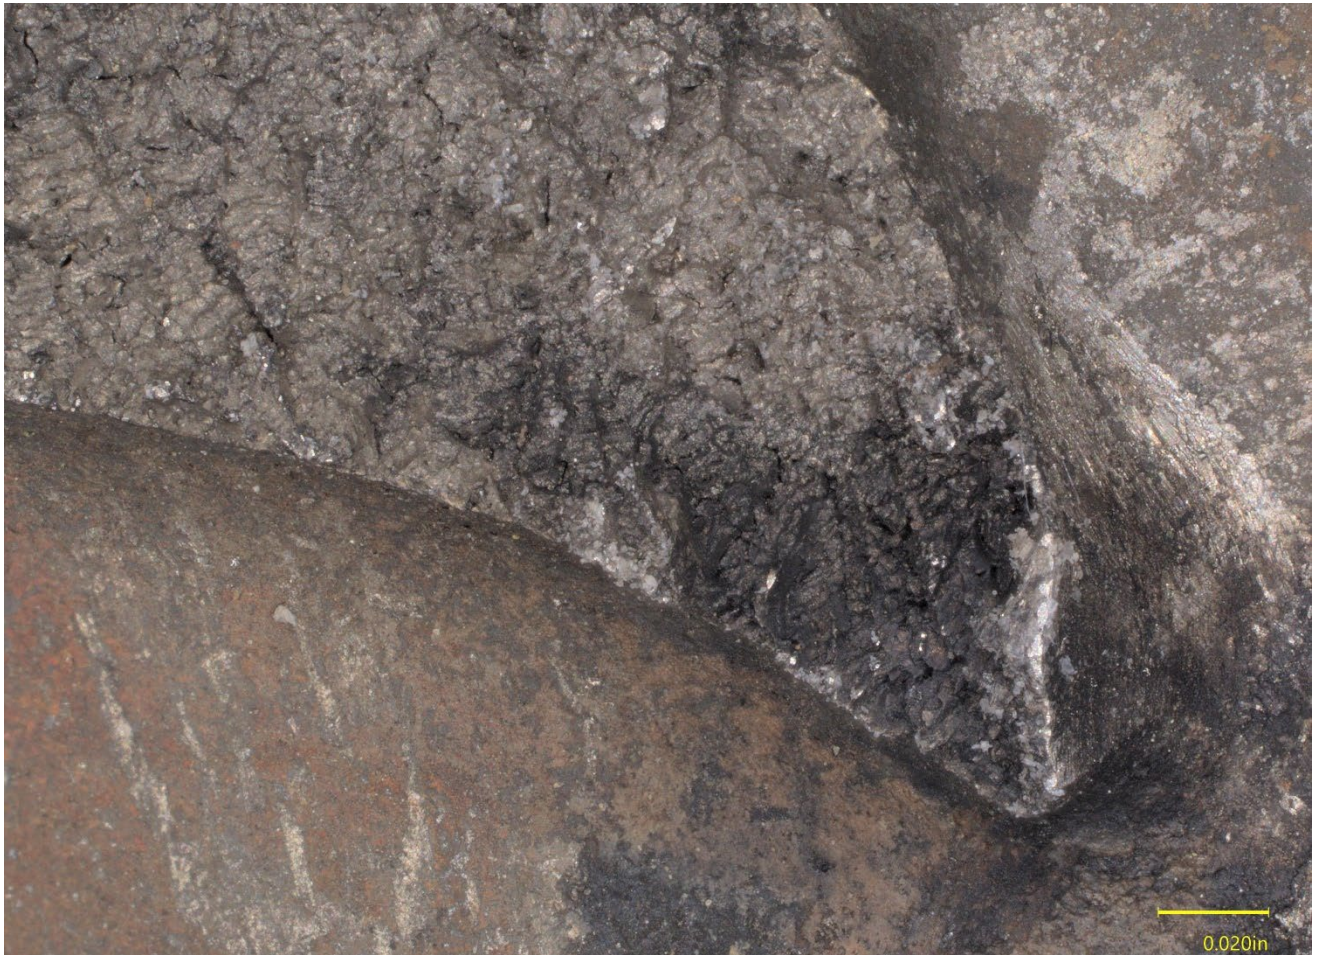
Figure 7 – Closer view of the leading edge of the Blade 7 fracture surface.

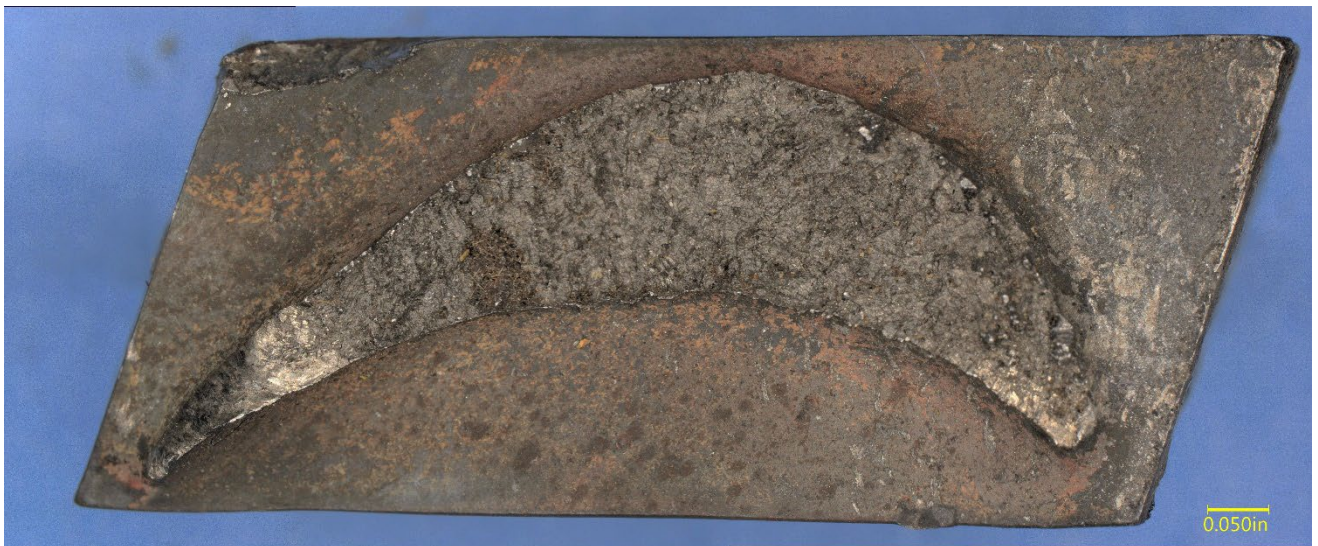
In addition, the trailing edge of the Blade 7 fracture exhibited a higher elevation relative to the platform, along with a local area of flatter, but angled fracture profile. This was similar to that seen on the trailing edge of Blade 9, shown in Figure 8. However, closer examination of the trailing edge areas found fracture features consistent with the rest of the fracture surfaces of Blades 7 and 9. In addition, the leading edge of Blade 9 exhibited smearing outward along and towards the concave side of the blade, highlighted in Figure 9.

Figure 8 – The fracture surface of Blade 9.

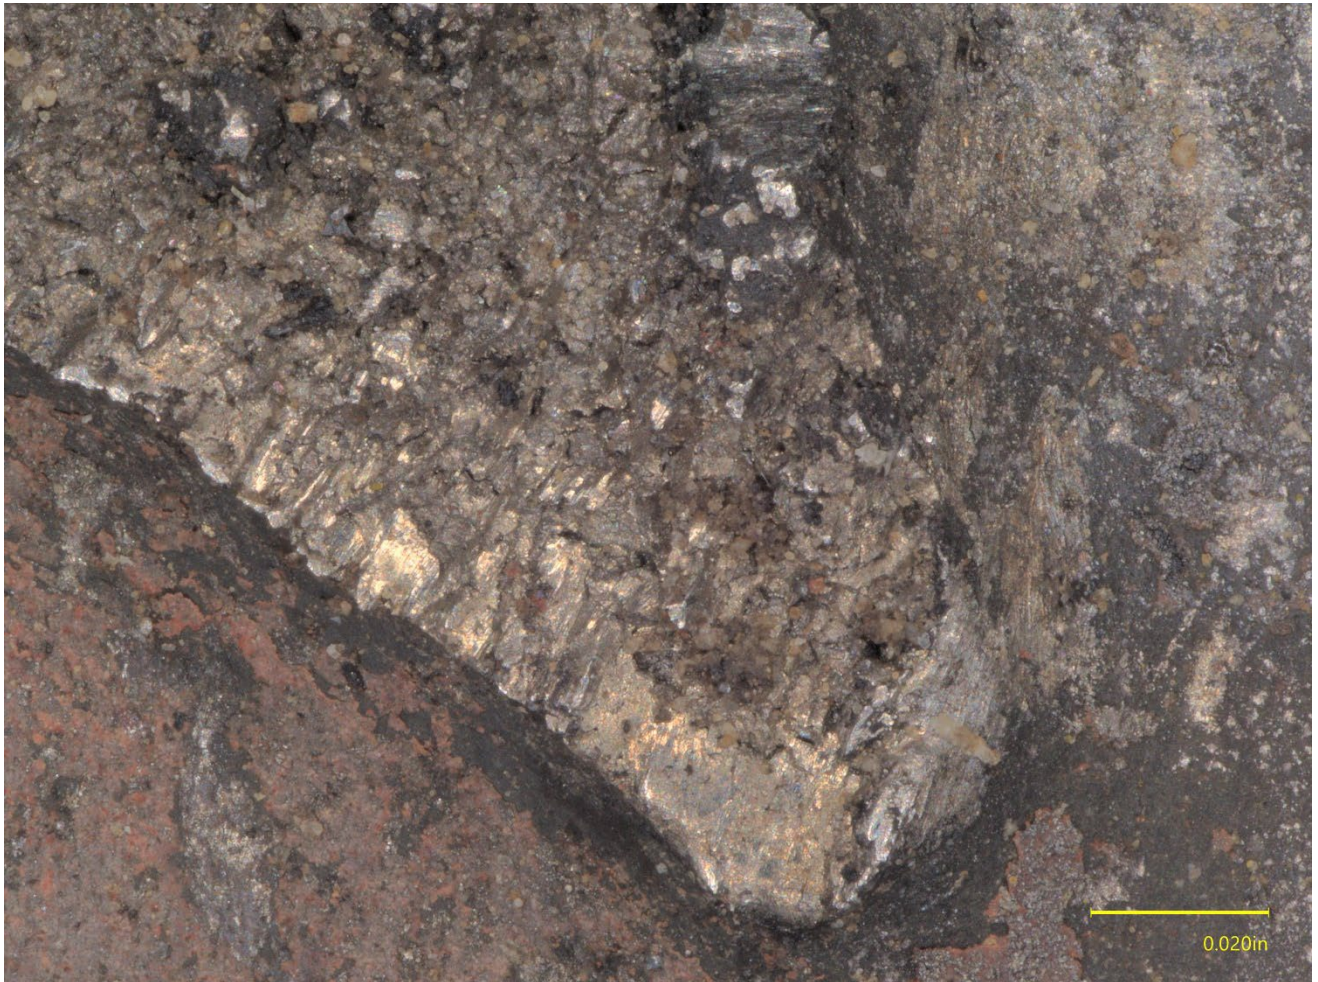
Figure 9 – Closer view of the leading edge of the Blade 9 fracture surface.

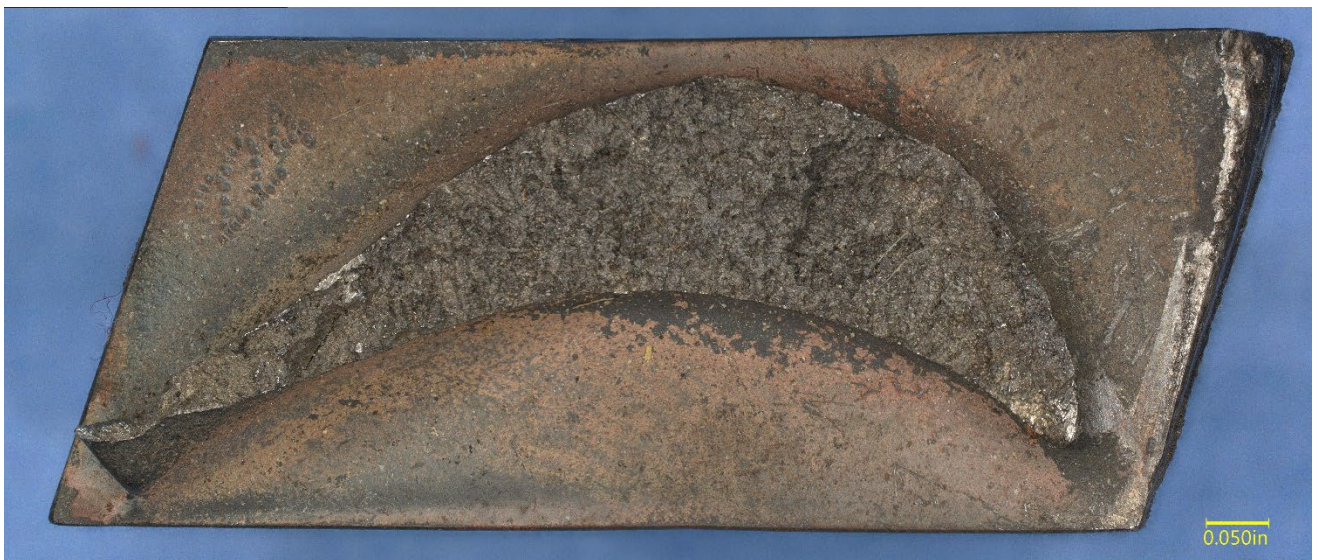
Figure 10 shows the fracture surface of Blade 10, which also had a different trailing edge profile than the rest of the surface, albeit more angled and faceted. The leading edge of Blade 10's fracture surface also appeared more reflective and flatter—this area exhibited deformation and flattening consistent with post-fracture smearing (Figure 11).

Figure 10 – The fracture surface of Blade 10.

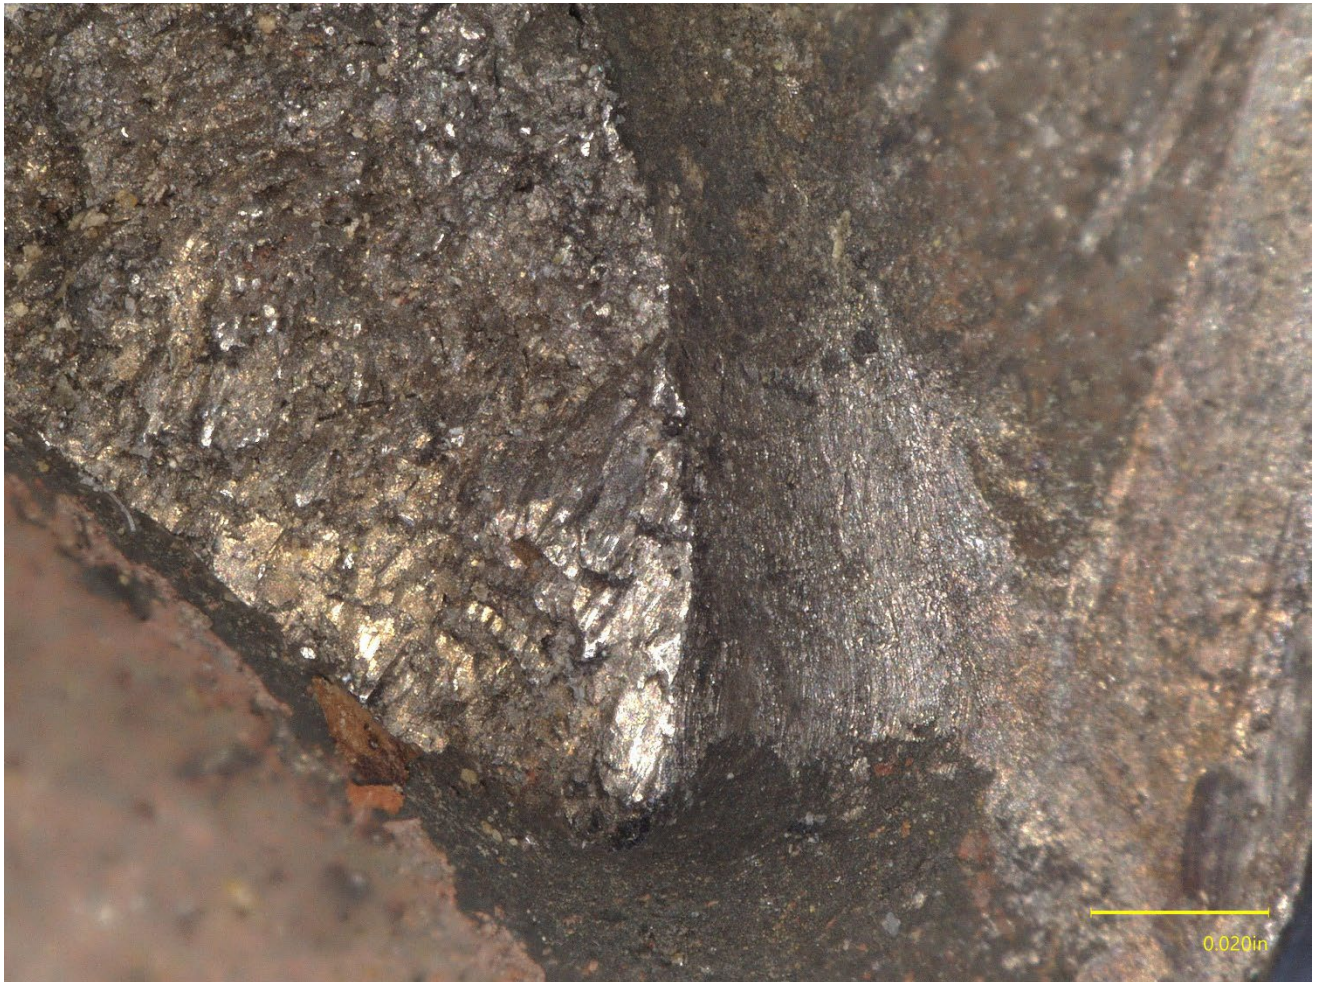
Figure 11 – Closer view of the leading edge of the Blade 10 fracture surface.

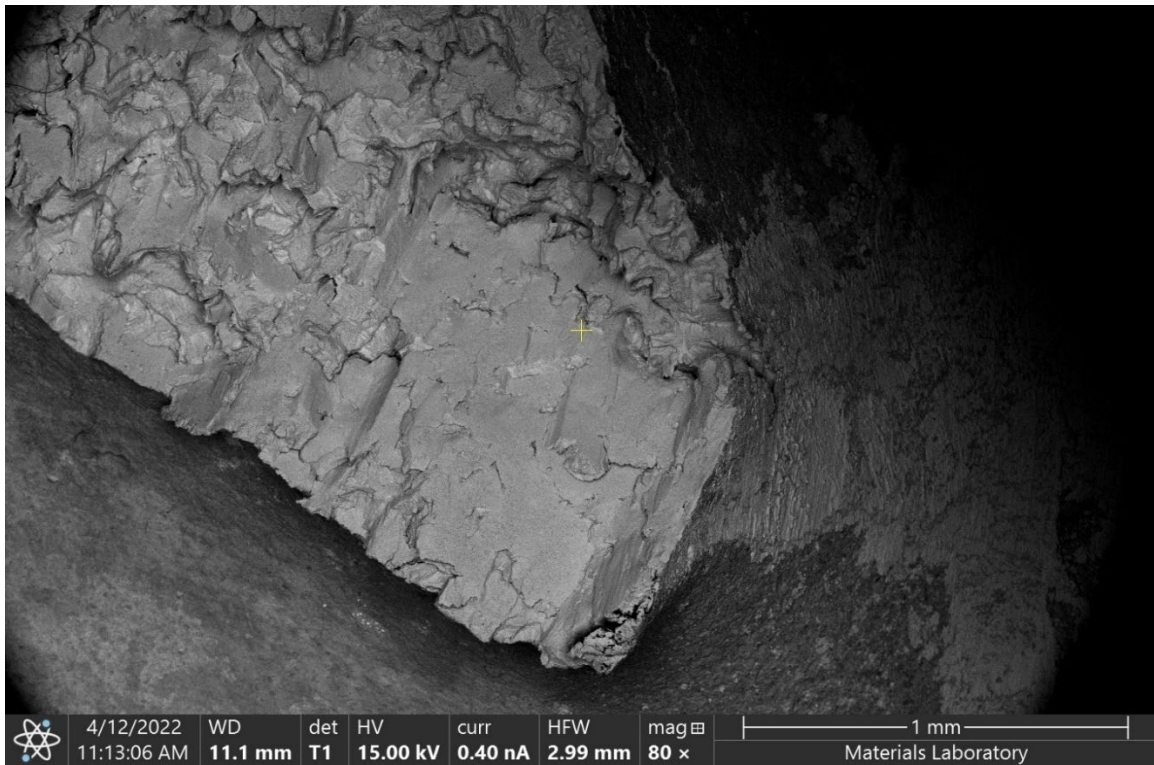
Several of the blades were examined using a field emission scanning electron microscope (FESEM) after sequential ultrasonic cleaning using acetone and an aqueous solution with Alconox detergent.<sup>2</sup> Figure 12 shows an overall view of the leading edge of the Blade 7 fracture surface, whereas Figure 13 shows a closer view. From the backscattered imaging, no large areas of dissimilar material were observed.<sup>3</sup> The secondary image showed areas that had not been obliterated by post-fracture smearing, which appeared rougher. As typified in Figure 14, these areas exhibited dimpled rupture, consistent with overstress fracture in tension.

Figure 12 – Backscattered electron (BE) micrograph of the leading edge of the Blade 7 fracture surface.

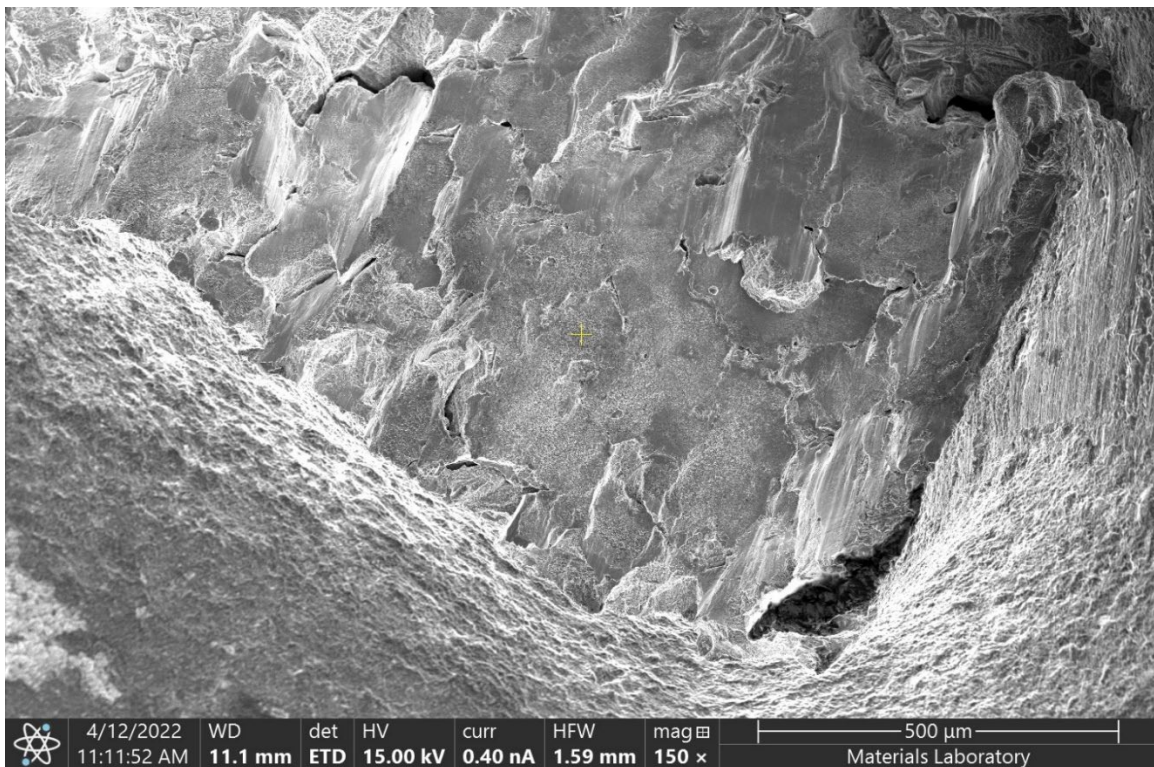
Figure 13 – SE micrograph of a closer view of the Blade 7 leading edge fracture, showing rough dimpled rupture with smoother smeared regions.

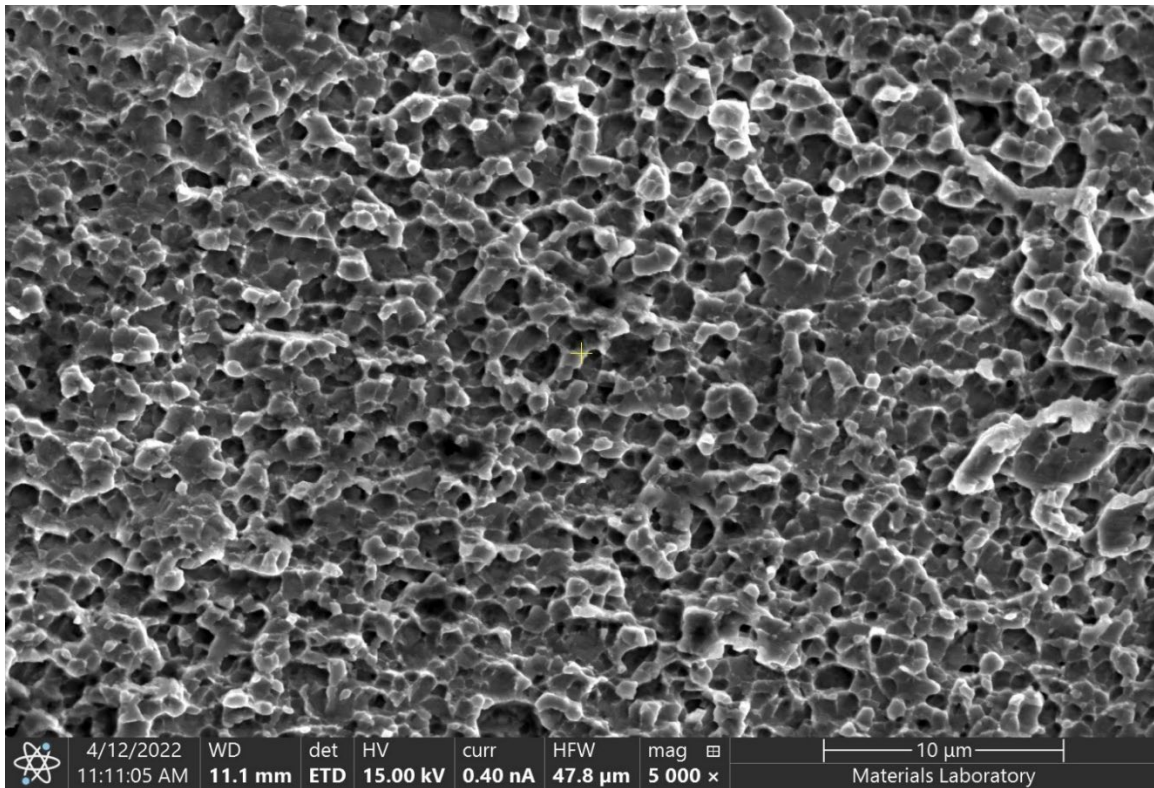
Figure 14 – SE micrograph of fine dimpled rupture in Figure 13.

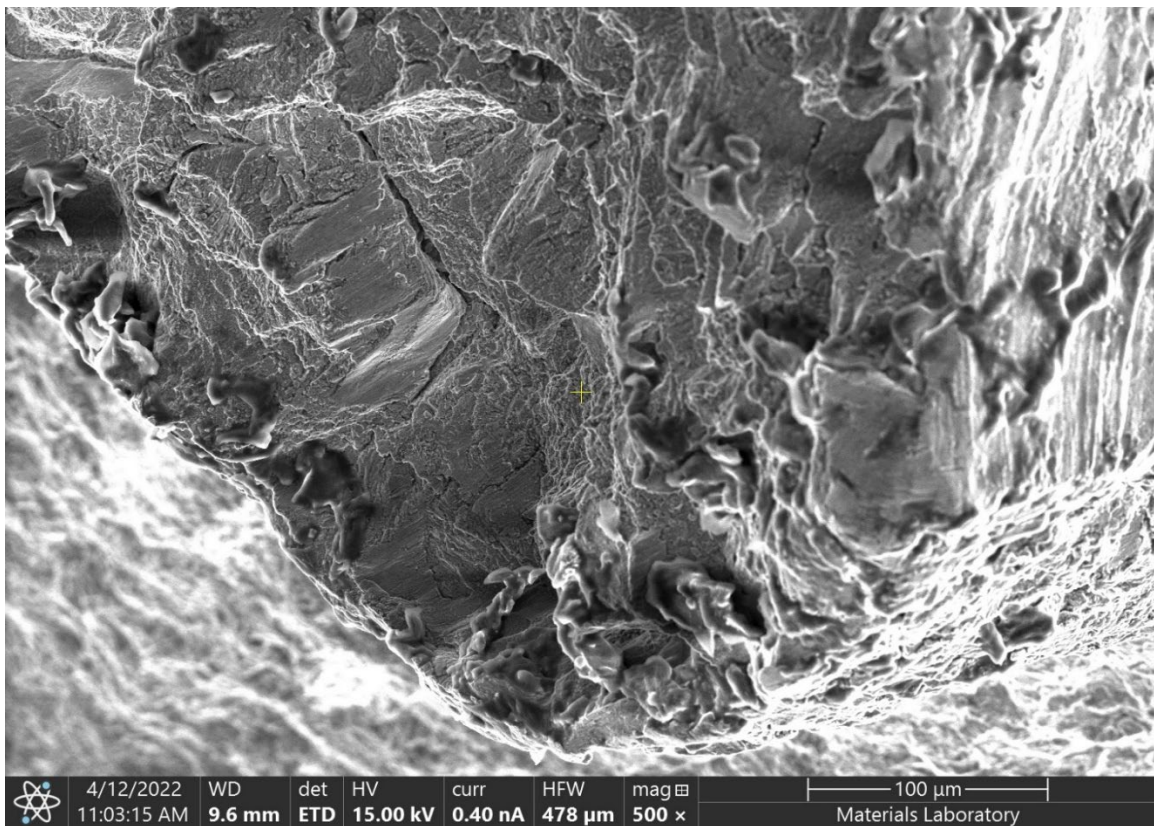
The leading edge of the Blade 8 fracture surface is shown in Figure 15. This fracture surface exhibited more pronounced peak and valley elevations, much of which had been damaged from impacts and smearing, consistent with post-fracture damage. Figure 16 shows a closer look at some of the damage. While the area in Figure 16 does show some parallel repeating lines, this region was surrounded by slanted dimpled rupture, consistent with overstress in shear.

Figure 15 – SE micrograph of the fracture surface at the leading edge of Blade 8.

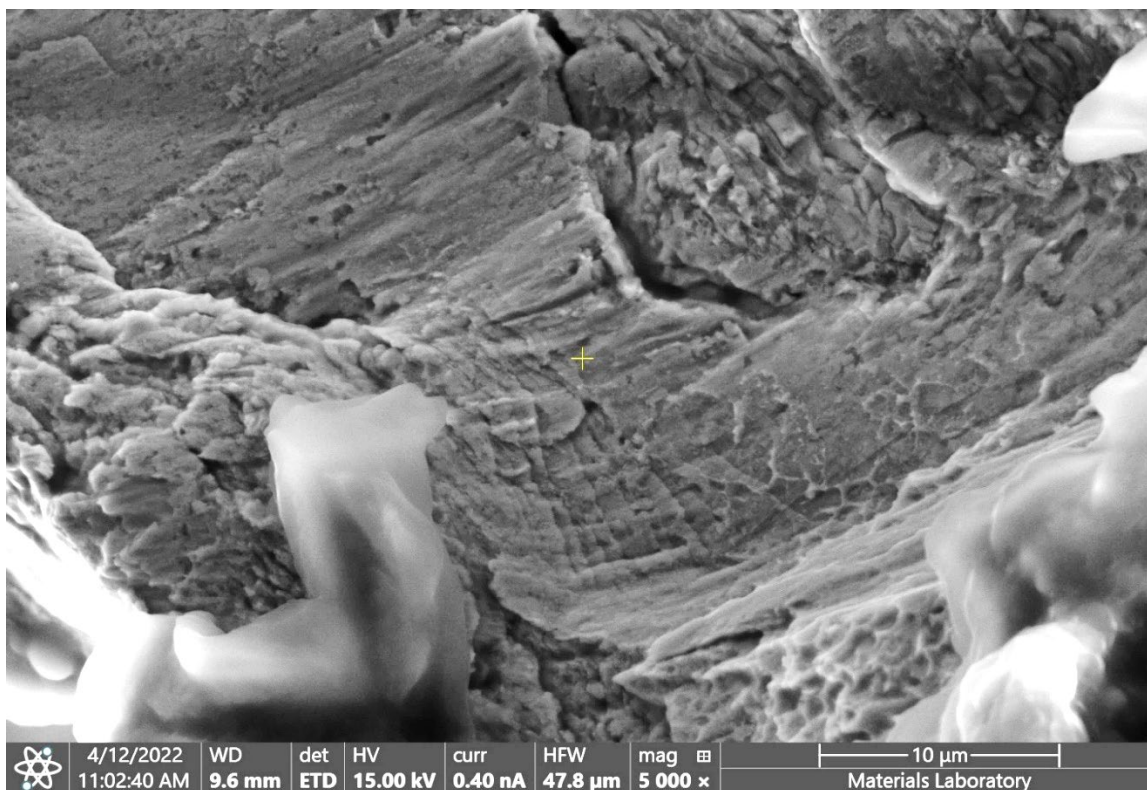
Figure 16 – SE micrograph of dimpled rupture and smearing streaks in Figure 15.

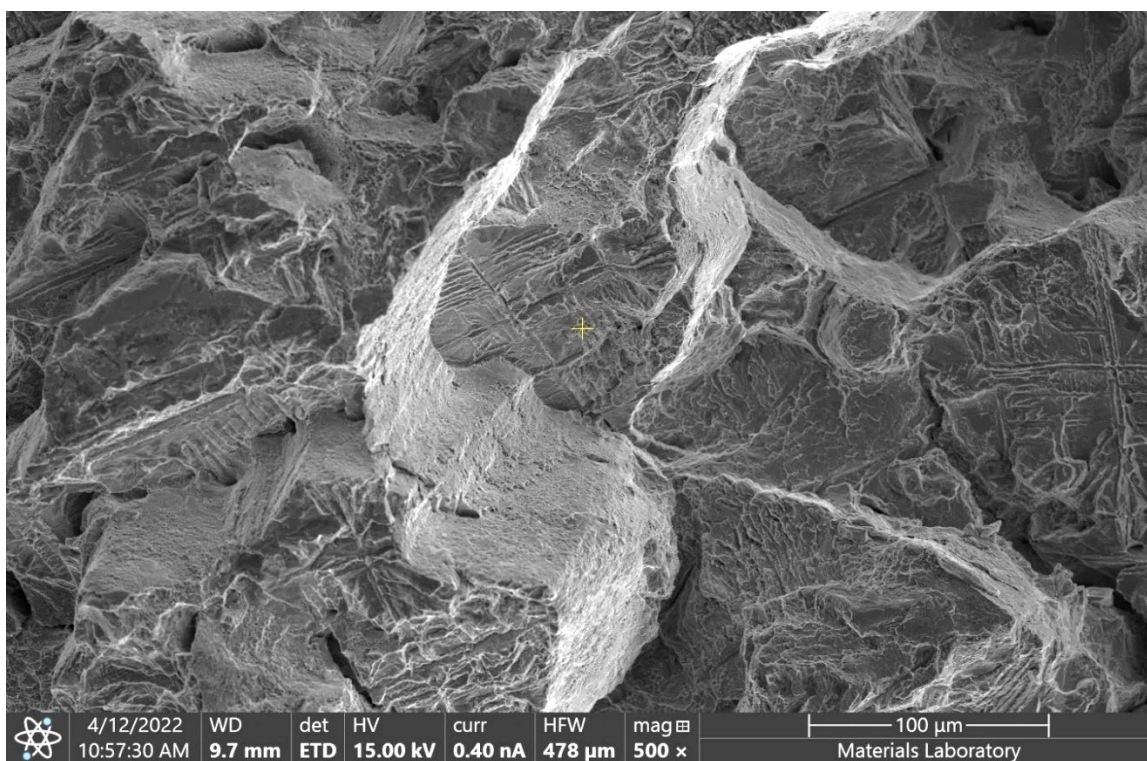
Overall, the fracture surfaces of the blades presented faceted features, as exemplified by the Blade 8 area shown in Figure 17. This fracture consisted of random plateaus and facets, along with cross-shaped features—these were consistent with fracture along the dendritic constituents and equiaxed grains boundaries typical of conventionally-cast turbine blades. As shown in Figures 18 and 19, the fracture features along the dendrites were relatively flat in morphology, whereas the fractures in the interdendritic regions exhibited more pronounced dimpled rupture.

Figure 17 – SE micrograph of a typical area of the Blade 8 fracture surface, showing ridges and planes consistent with the dendritic microstructure and grain orientation.

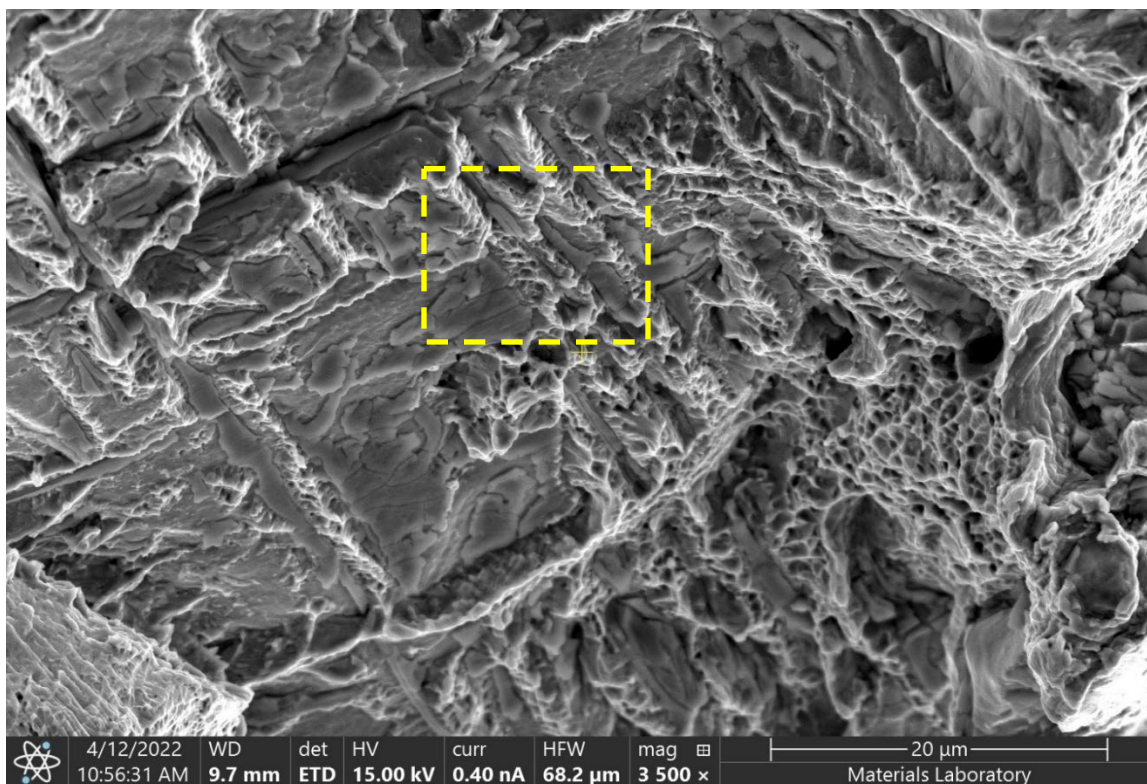
Figure 18 – SE micrograph of dimpled rupture in the interdendritic regions of the Blade 8 fracture surface. The boxed area is highlighted in Figure 19.

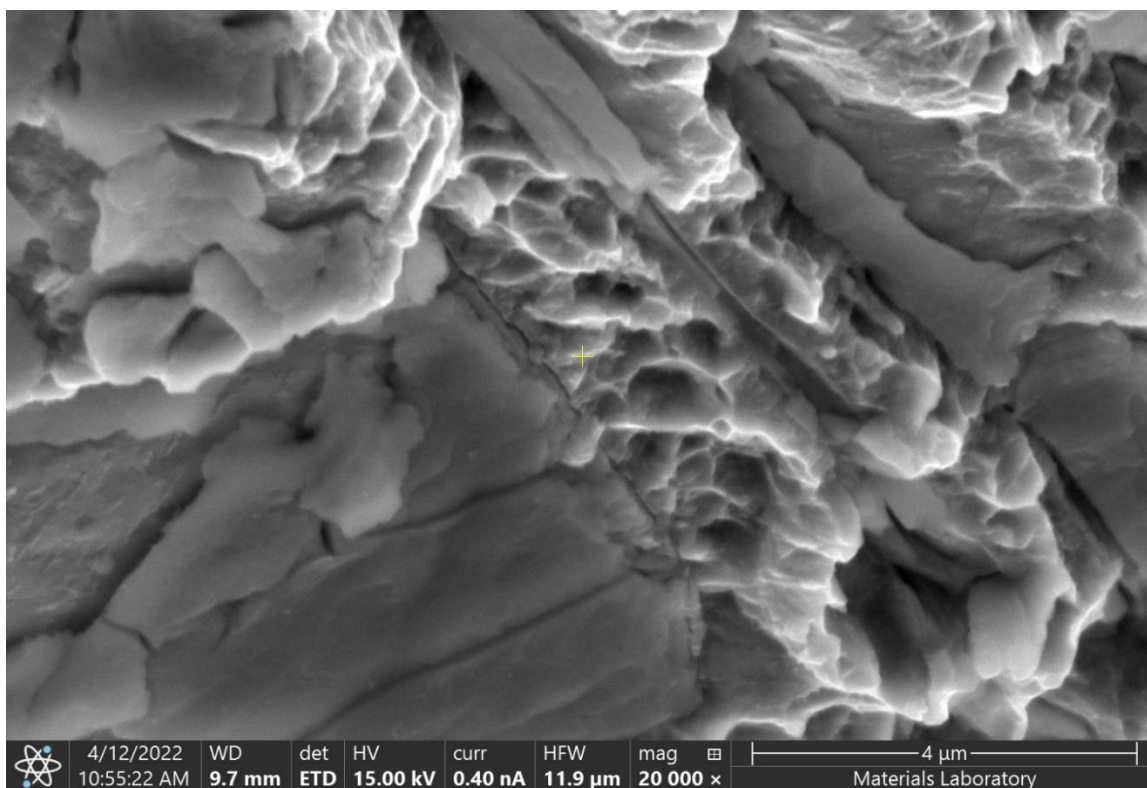
Figure 19 – SE micrograph of a closer view of the dimpled rupture in Figure 18.

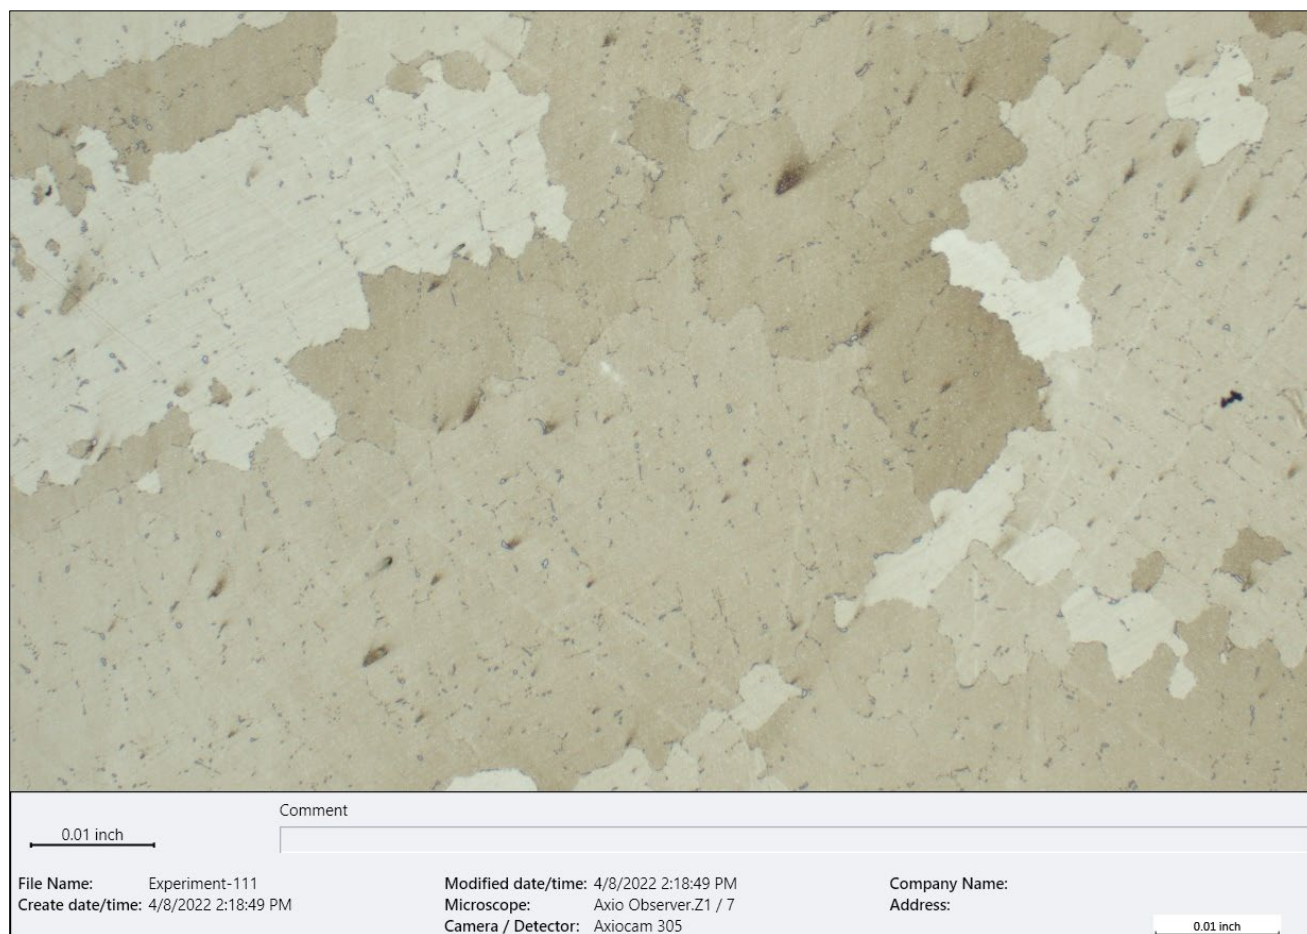
Blade D was sectioned vertically, mounted, polished, and etched with Kalling's Reagent #2.<sup>4</sup> A typical area of the dovetail below the platform is illustrated in Figure 20, revealing the equiaxed grain microstructure, along with the dendritic nature of the casting. The primary dendrites and grains were oriented randomly, consistent with conventional casting of the blade.

Figure 20 – Bright-field (BF) optical micrograph of a typical cross section of the Blade D dovetail (~50X, etched Kallings Reagent #2).

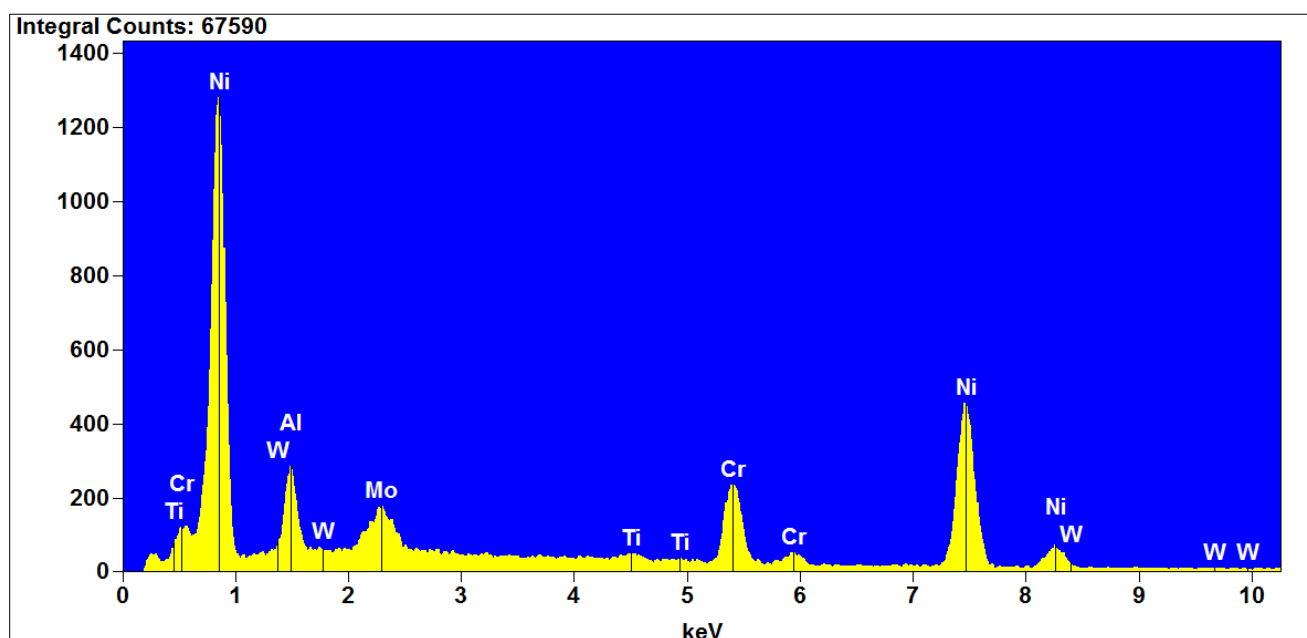
Figure 21 shows a typical spectrum from an energy dispersive x-ray spectroscopy (EDS) examination of the dovetail region of Blade D. As demonstrated by the peaks of nickel, chromium, aluminum, and titanium, among other elements, the composition was consistent with a nickel-based superalloy casting, such as IN 713C. Figure 22 shows a closer view of the microstructure in the dovetail. This micrograph demonstrates the smaller semi-cuboidal  $\gamma'$  phase, along with larger primary carbides. Not shown in this micrograph

Figure 21 – EDS spectrum of a typical area of the dovetail cross-section of turbine blade D.
