# NATIONAL TRANSPORTATION SAFETY BOARD

## MATERIALS LABORATORY FACTUAL REPORT

Report No. 22-025

Place : Grand Forks, North Dakota  
Date : August 21, 2018  
Vehicle : Air Tractor AT-400, N7300M  
NTSB No. : WPR18LA234  
Investigator : Andrew Swick, AS-WPR

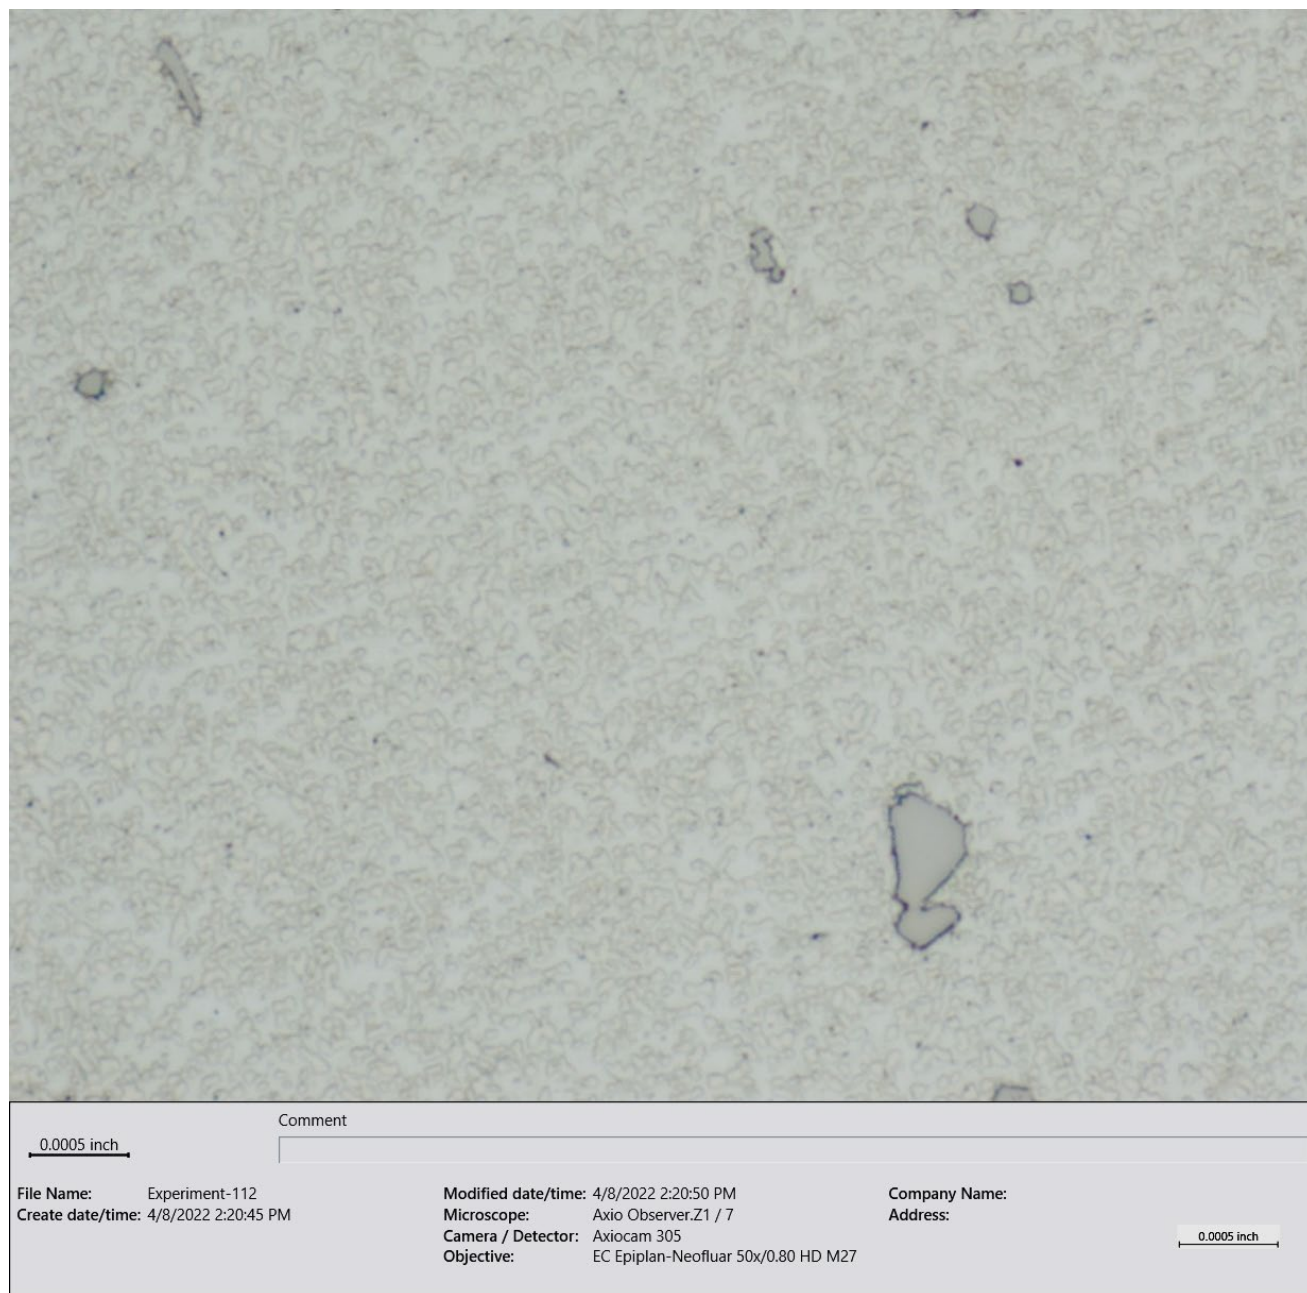
were also areas of eutectic  $\gamma'$  and secondary carbides between grains. This microstructure was typical of a heat-treated Ni-based superalloy casting.

Figure 22 – BF optical micrograph showing a typical view of the dovetail microstructure in Blade D, showing primary carbides and the small, semi-cuboidal  $\gamma'$  phases (~1000X, etched Kallings Reagent #2).

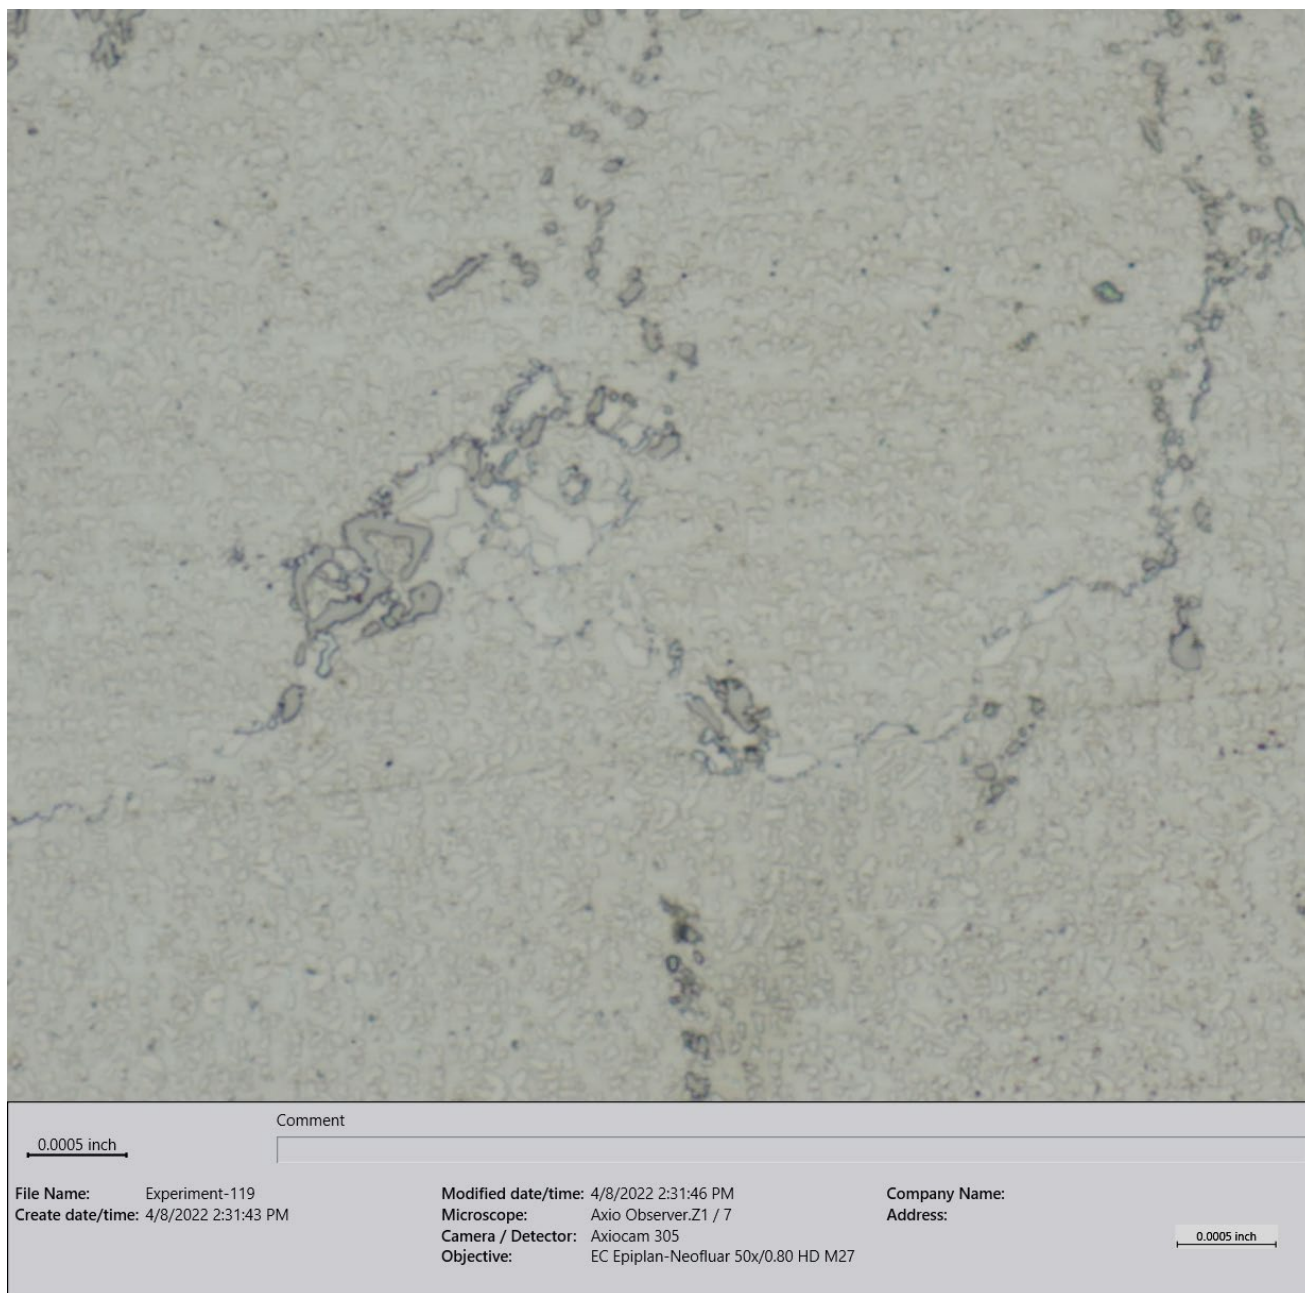
The microstructure was contrasted with that in the upper part of the blade remnant, near the fracture surface. As demonstrated by Figure 23, there were more carbides along the grain boundaries, along with some coarsening of the eutectic  $\gamma'$ . Some of the small  $\gamma'$  had spheroidized and/or elongated, but there were no indications of widespread coarsening or re-solutioning of these constituents.

Figure 23 – BF optical micrograph of a typical area of the microstructure near the Blade D fracture surface, showing some rafting and coalescing of the  $\gamma'$  phase (~1000X, etched Kallings Reagent #2).

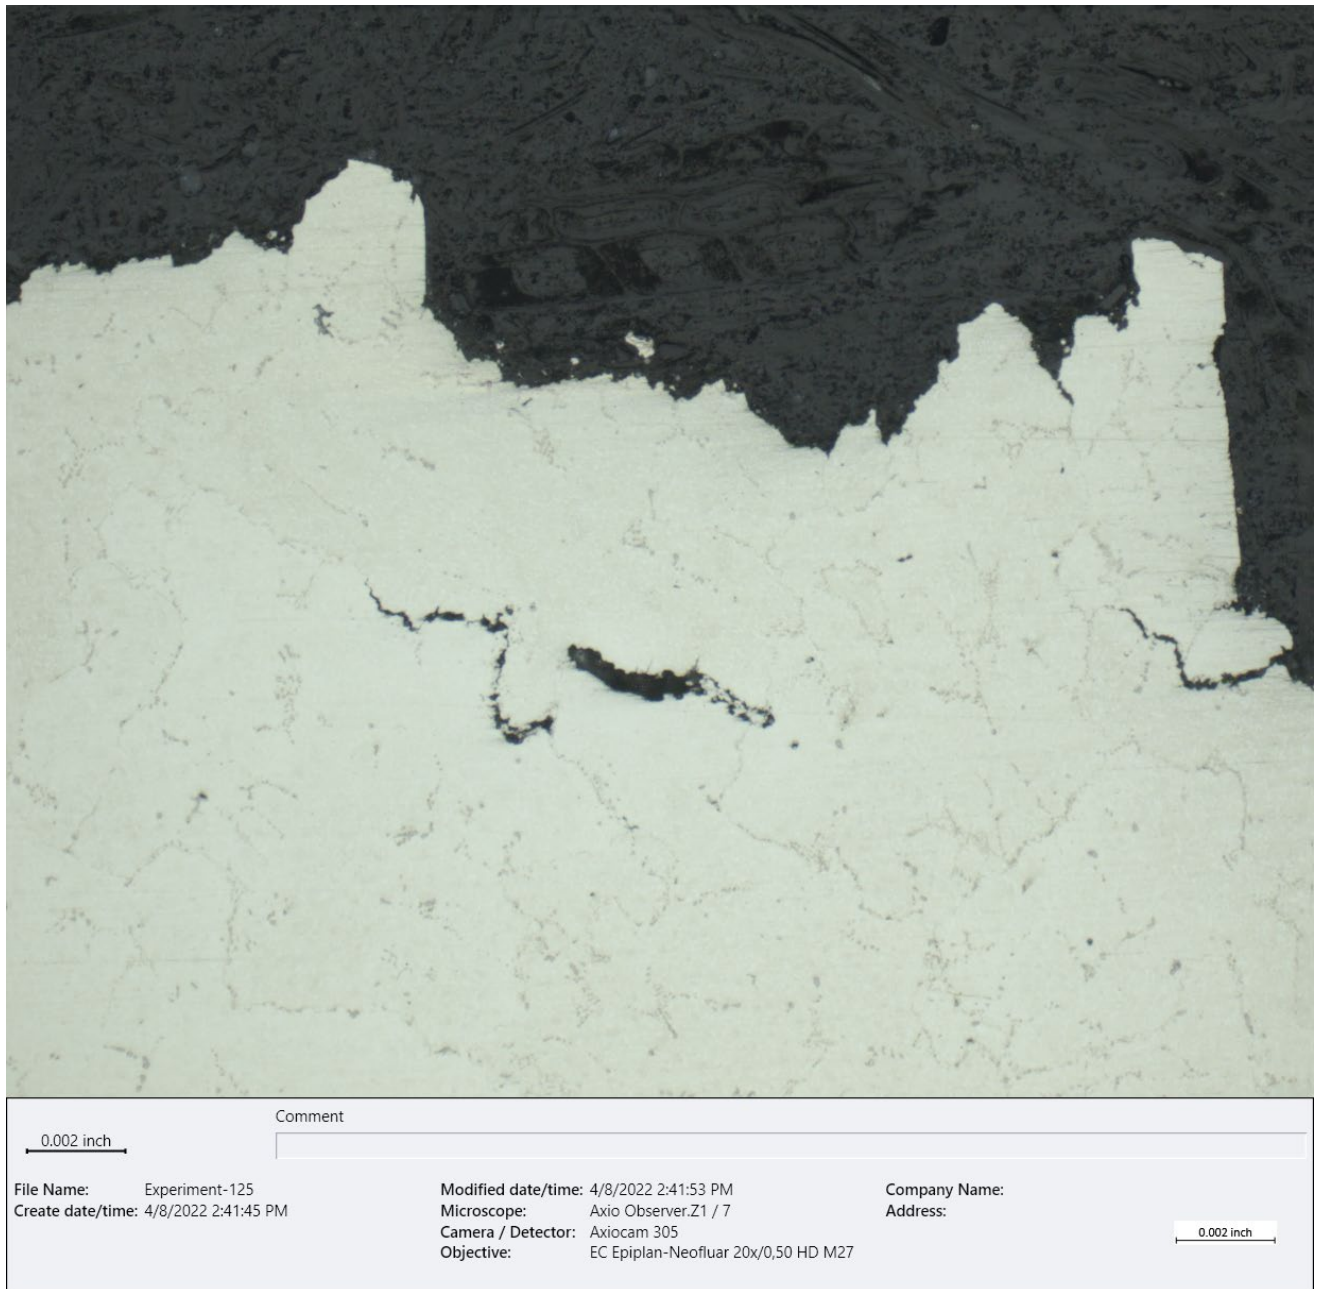
Figure 24 shows a cross section through the Blade D fracture surface, showing a rough, undulating surface, along with sub-surface cracking. This cracking, and the fracture surface path, were located along the interdendritic areas of the microstructure, consistent with the features observed on the fracture surface. Also of note was sub-surface damage on the convex side, as illustrated in Figure 25. This showed internal erosion and cracking within the 0.010 inches below the blade surface.

Figure 24 – BF optical micrograph of sub-surface intergranular cracks below the Blade D fracture surface (~200X, etched Kallings Reagent #2).

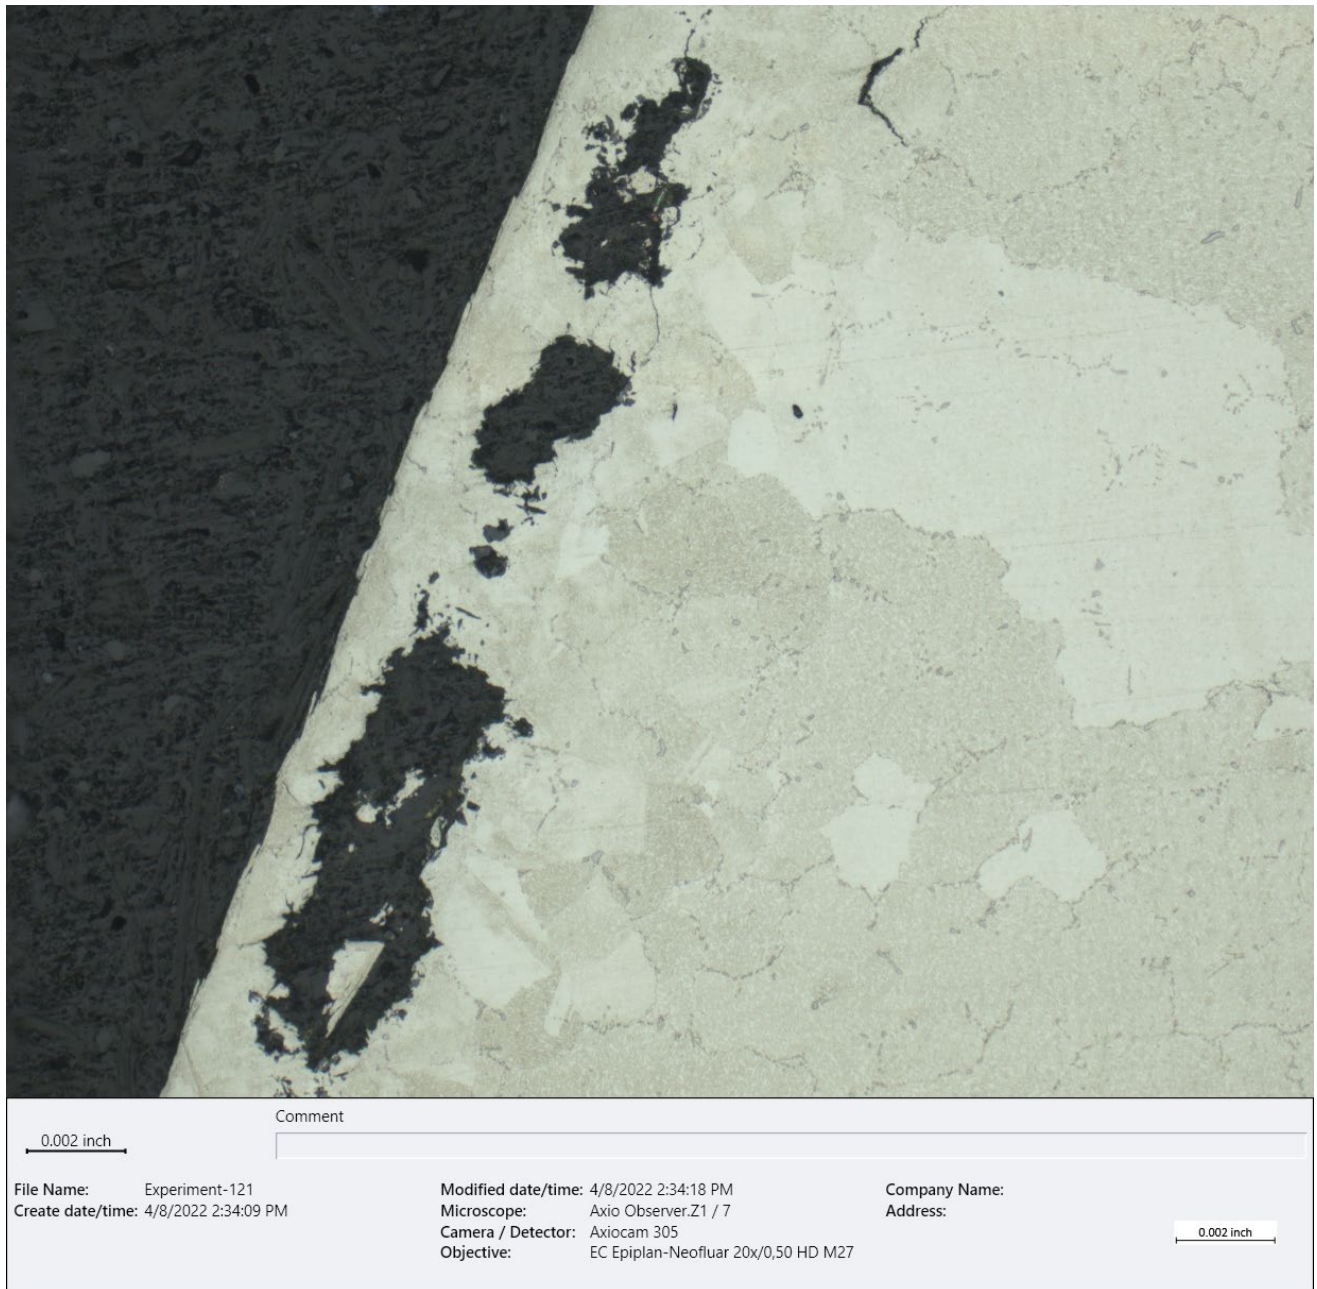
Figure 25 – BF optical micrograph of sub surface damage and cracks on the concave side of Blade D (~200X, etched Kallings Reagent #2).

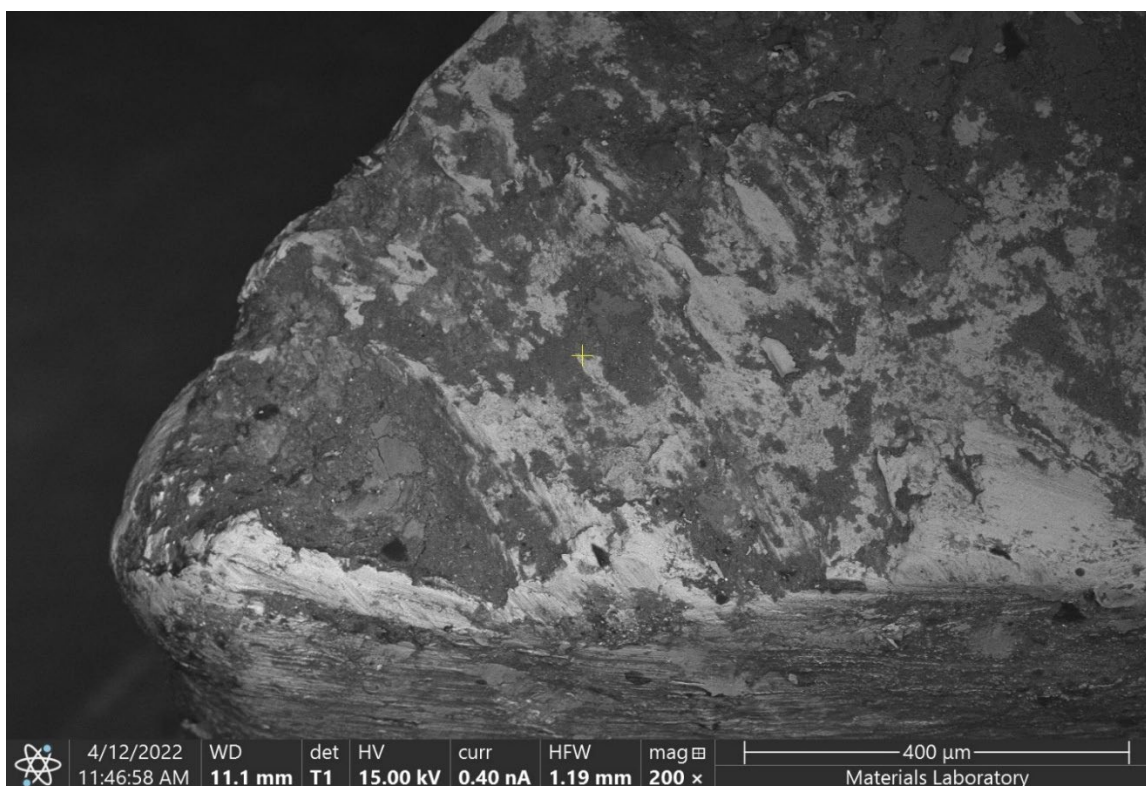
Due to the sub-surface damage found in Blade D, the fracture surface was also examined using a FESEM. Figure 26 shows an overall view of the Blade D leading edge fracture surface—this surface exhibited widespread surface contamination, which manifested as darker contrast areas in the BE image. The lighter colored areas were consistent with uncontaminated areas of the fracture surface, as typified in Figure 27. While there was some smearing damage on the fracture, slanted dimpled rupture features were apparent. Some of the edges of the dimples themselves had been damaged, as exemplified by the smearing in Figure 28. This was the only type of fracture features observed on the Blade D fracture surface, which did not exhibit features consistent with progressive cracking, corrosion, or high temperature stress rupture.

Figure 26 – BE micrograph of the leading edge of Blade D fracture surface.

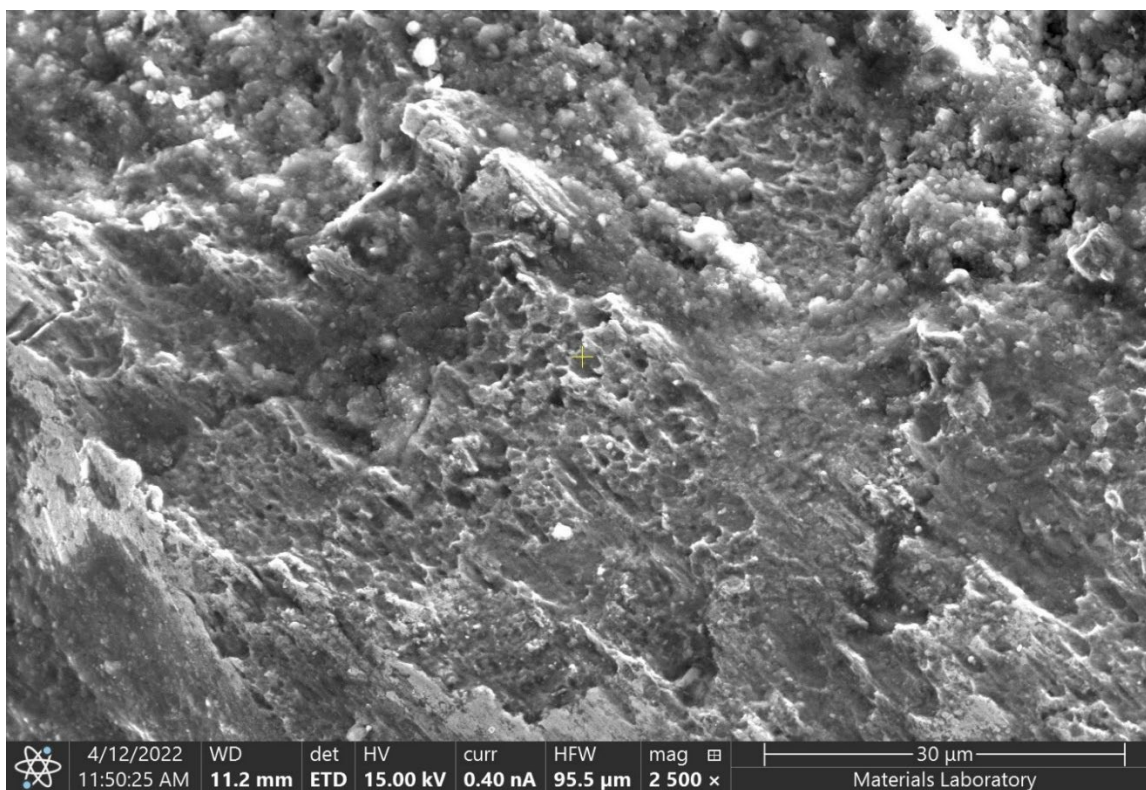
Figure 27 – SE micrograph of dimpled rupture in the less damaged areas in Figure 26.

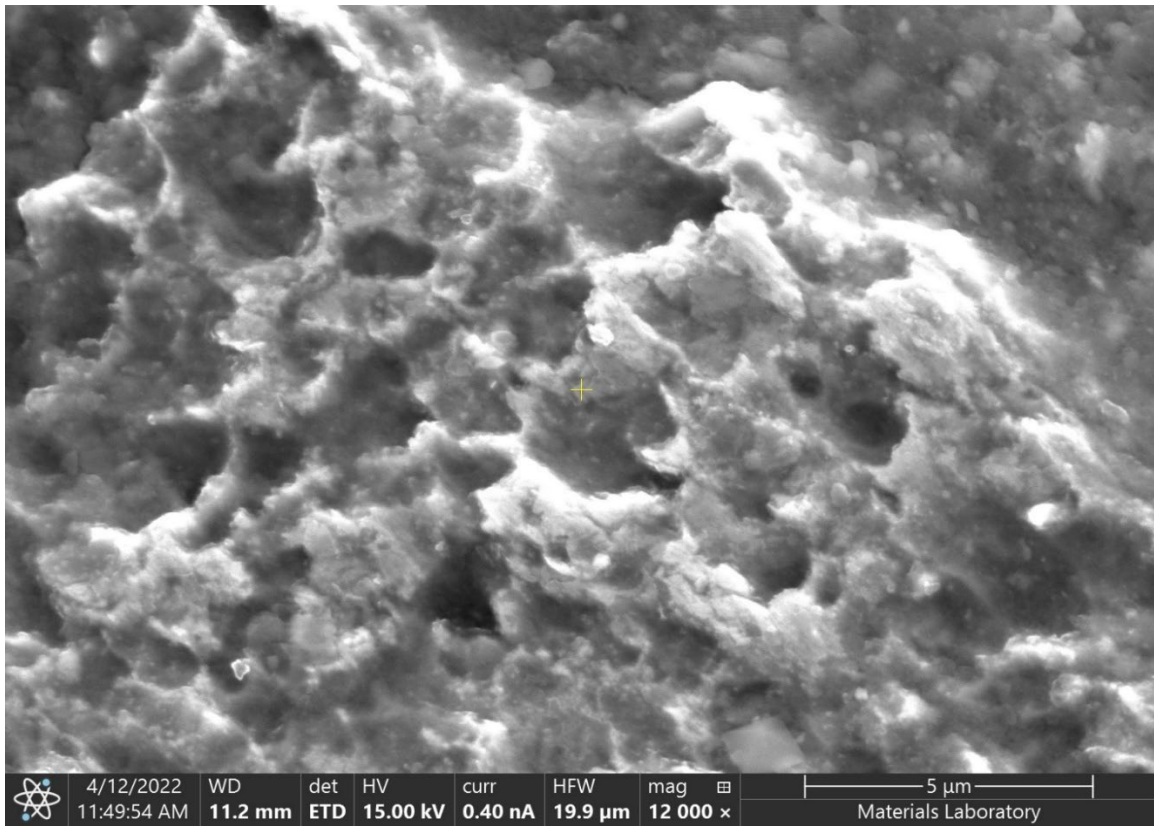
Figure 28 – SE micrograph of the smoothed and rounded dimple crests on Blade D.
