# NATIONAL TRANSPORTATION SAFETY BOARD

MATERIALS LABORATORY FACTUAL REPORT

Report No. 22-047

Place : Dardanelle, California  
Date : August 25, 2018  
Vehicle : Bell 212, N512TA  
NTSB No. : WPR18LA242  
Investigator : Fabian Salazar, ASI – WPR

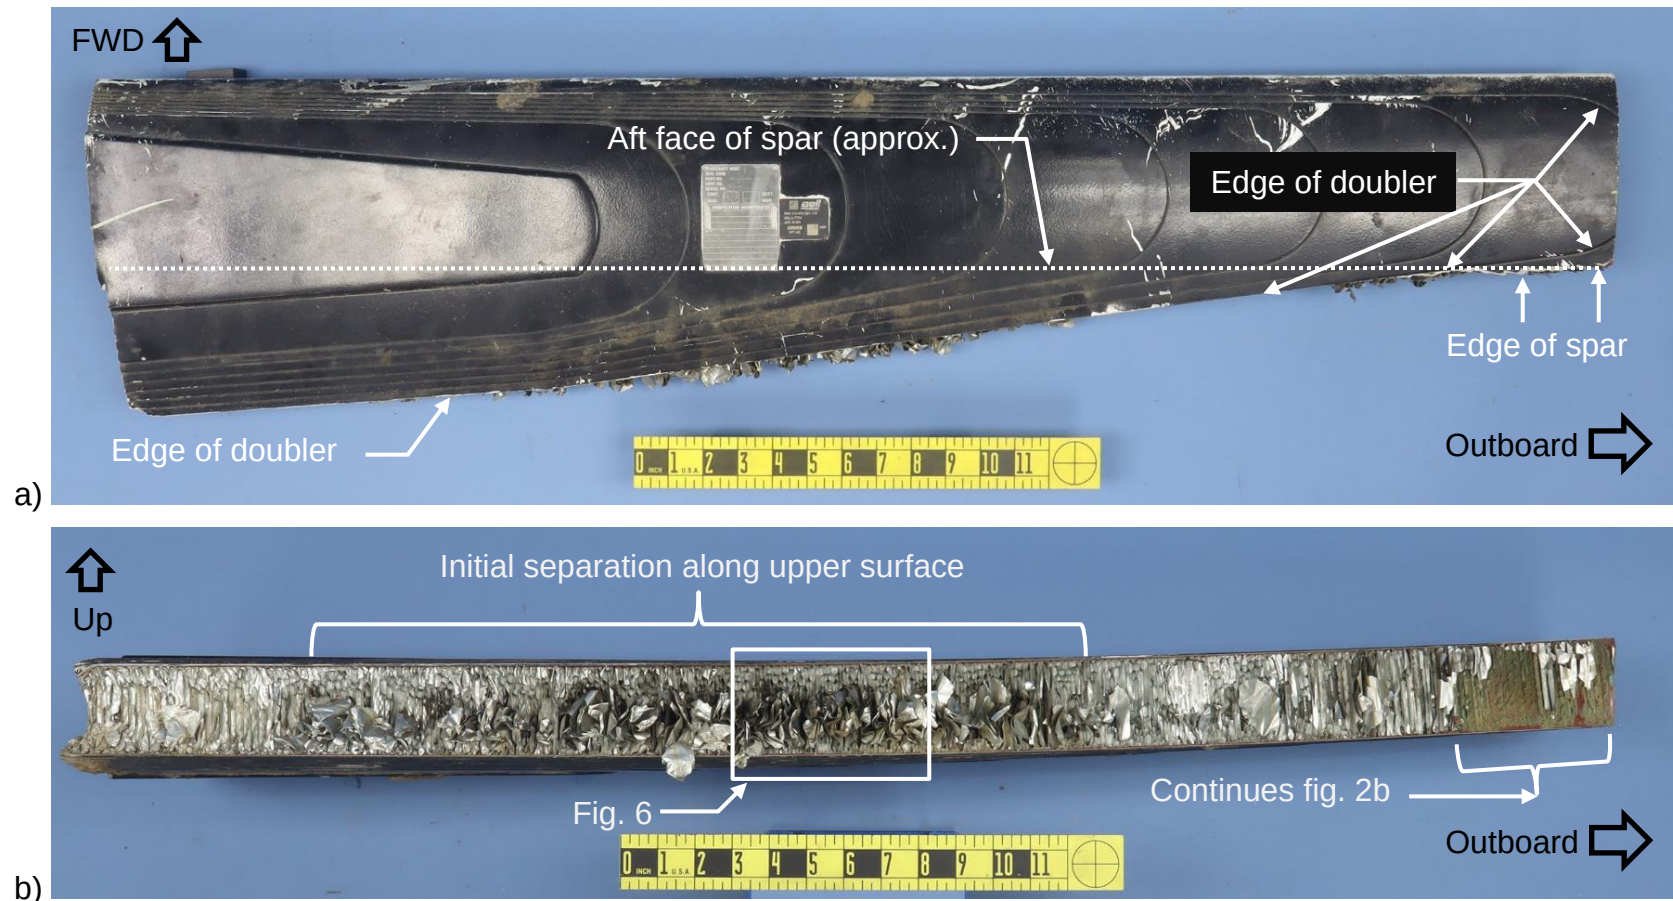
The spar exhibited an upward bend, as shown in figures 1b, 2b, 3b, and 4, and an aft bend, as shown in figure 3a. On-scene images of the trailing edge and afterbody are shown in figures 6a and 6b. The upper surface, shown in figure 6a did not exhibit any apparent large-scale skin wrinkling or bend buckling. The trailing edge exhibited a severe localized bend near the root, as seen in figure 6b, but the remainder of the trailing edge appeared to exhibit comparatively minimal bending and/or deformation elsewhere.

Near the root end of the blade, the afterbody had separated along the edges of skin doublers that extended past the aft face of the spar on the upper and lower surfaces, as indicated in figure 1a. Moving outboard along the blade, the width of the doublers gradually decreased until they intersected the aft face of the spar, at which point the afterbody separation ran along or adjacent to the aft face of the spar instead. Examination of the on-scene photo shown in figure 6b indicated that inboard of the root end piece, the afterbody separation continued to follow the edges of the doublers. As a result, the separation turned in the aft direction as it approached the root of the blade and then turned outboard again as it approached the trailing edge before finally arresting, as indicated by the red arrows in the figure. A branching fracture, indicated by the blue arrows in figure 6b, ran across the doublers, through the afterbody along a curved path, and ended when it reached the root end of the blade.

**Figure 1:** Piece of blade spar at root end: a) view from top looking down and b) view from aft looking forward.

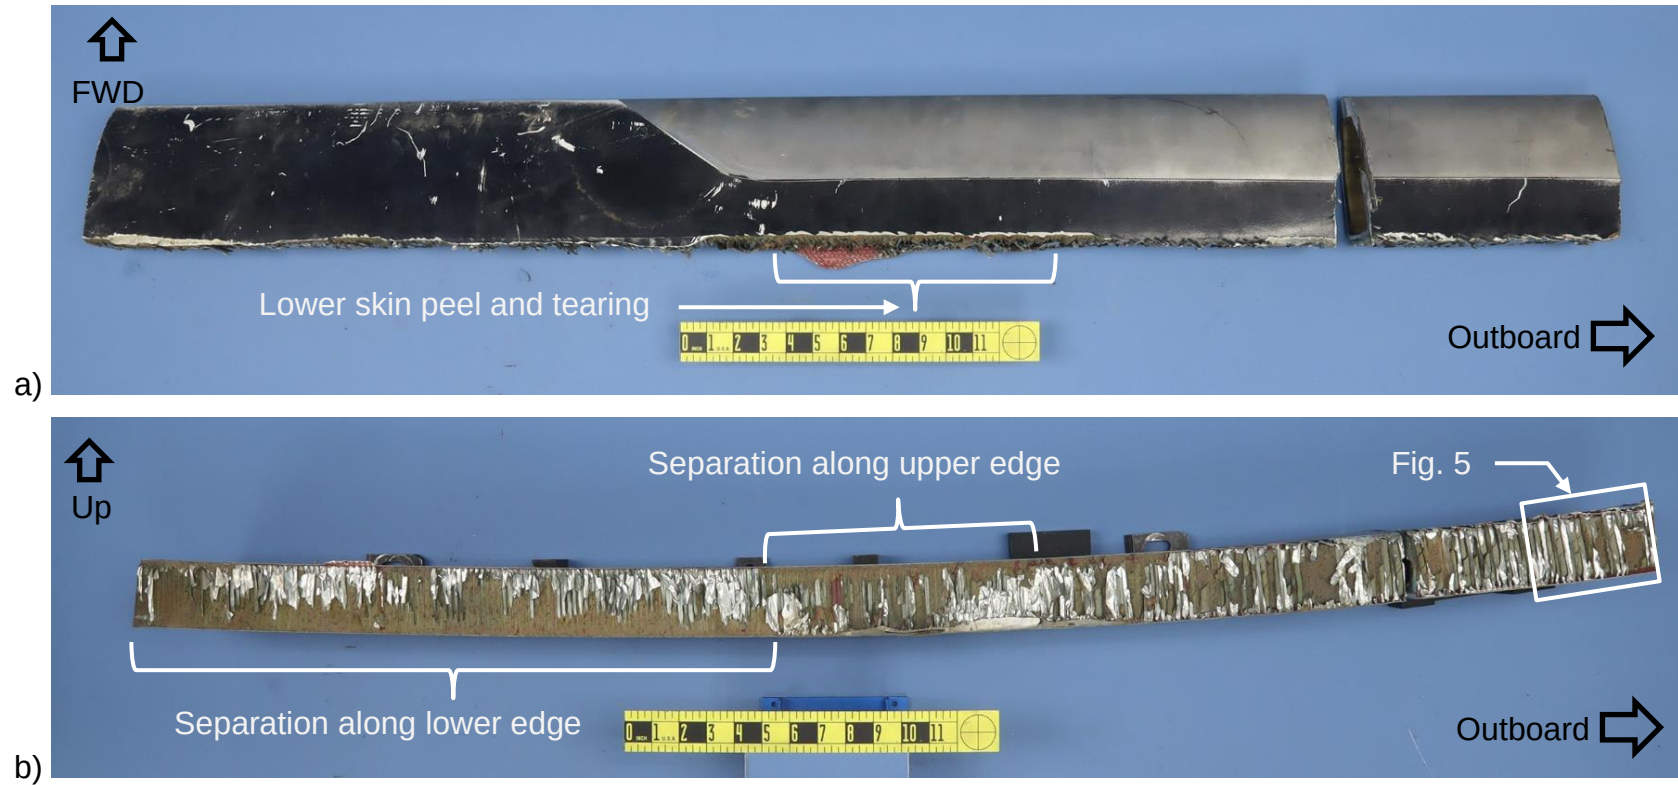
The upper and lower skin fractures and afterbody separations were examined by eye and with the aid of a stereomicroscope. On the root end piece there was a region spanning from approximately 6.5 inch to 27.2 inch<sup>1</sup> where the honeycomb core had fractured across the cell walls at approximately 45° angles starting near the upper surface, as shown in figure 7 and indicated in figure 1b. The honeycomb separation then progressed downward toward the lower surface before arresting. A second separation through the honeycomb was observed starting at the lower surface that progressed upward until it intersected the separation that had started from the upper surface. Further outboard, there was a region spanning from approximately 38.4 inch to 66.2 inch that exhibited cohesive fractures of the foam adhesive along the lower spar edge, as indicated in figures 1b and 2b. As the fracture progressed toward the upper surface the separation switched to tearing of the honeycomb core cell walls. A region with similar features but starting from the upper spar edge, also indicated in figure 2b, was observed from approximately 66.2 inch to 80.5 inch.

**Figure 2:** Middle blade spar pieces: a) view from top looking down and b) view from aft looking forward.

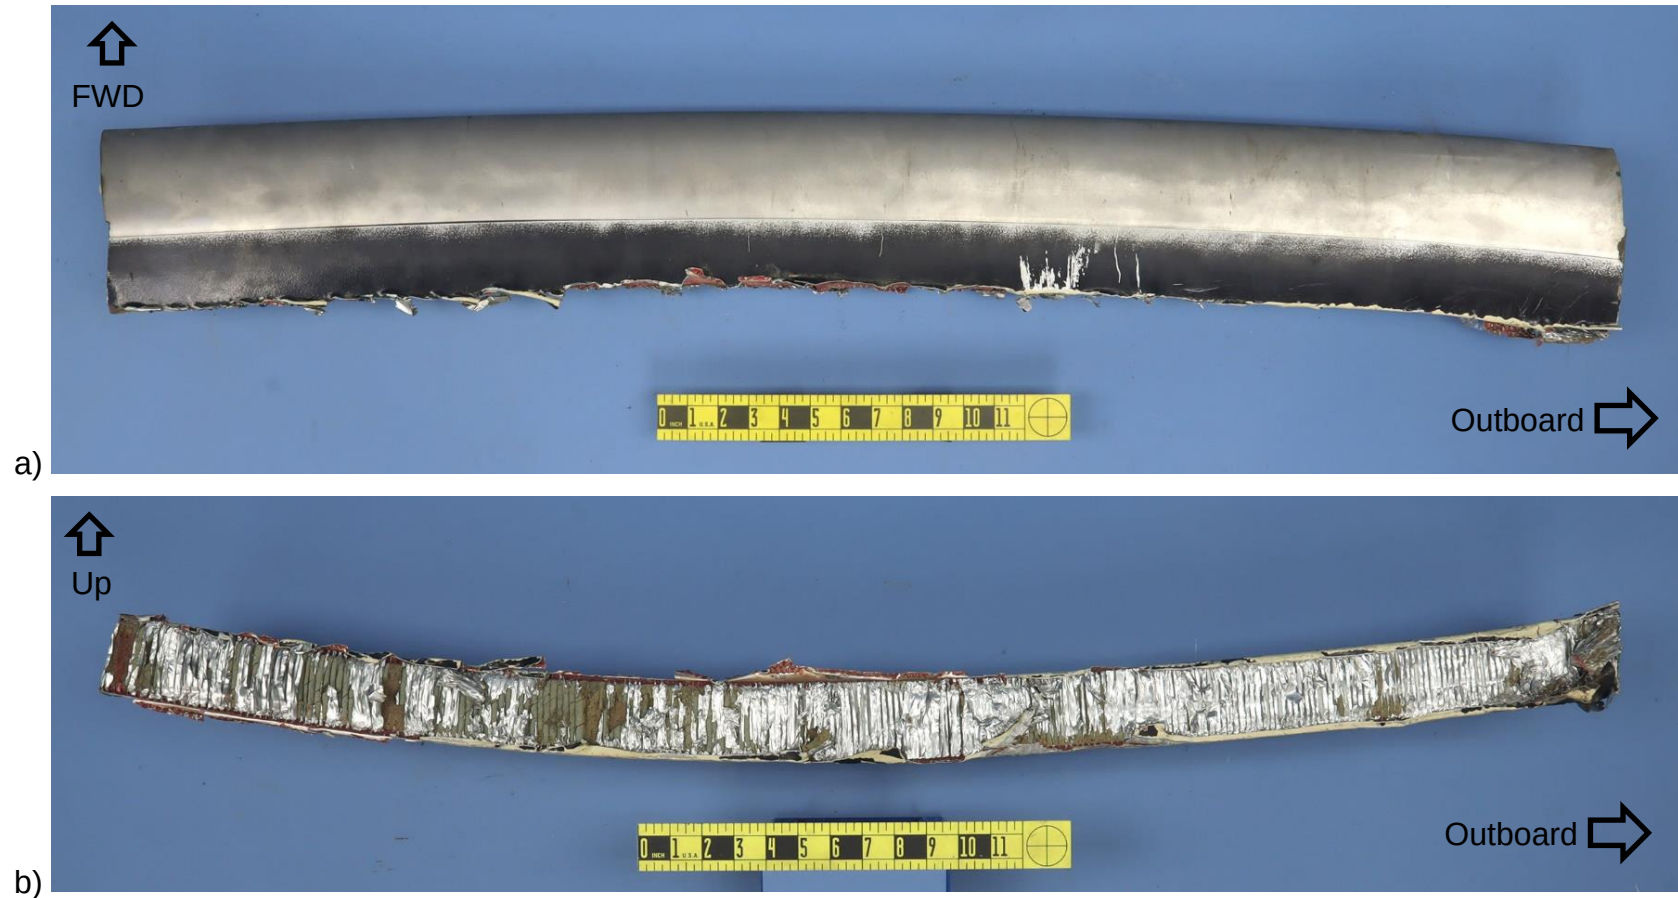
**Figure 3:** Outer blade spar piece: a) view from top looking down and b) view from aft looking forward.

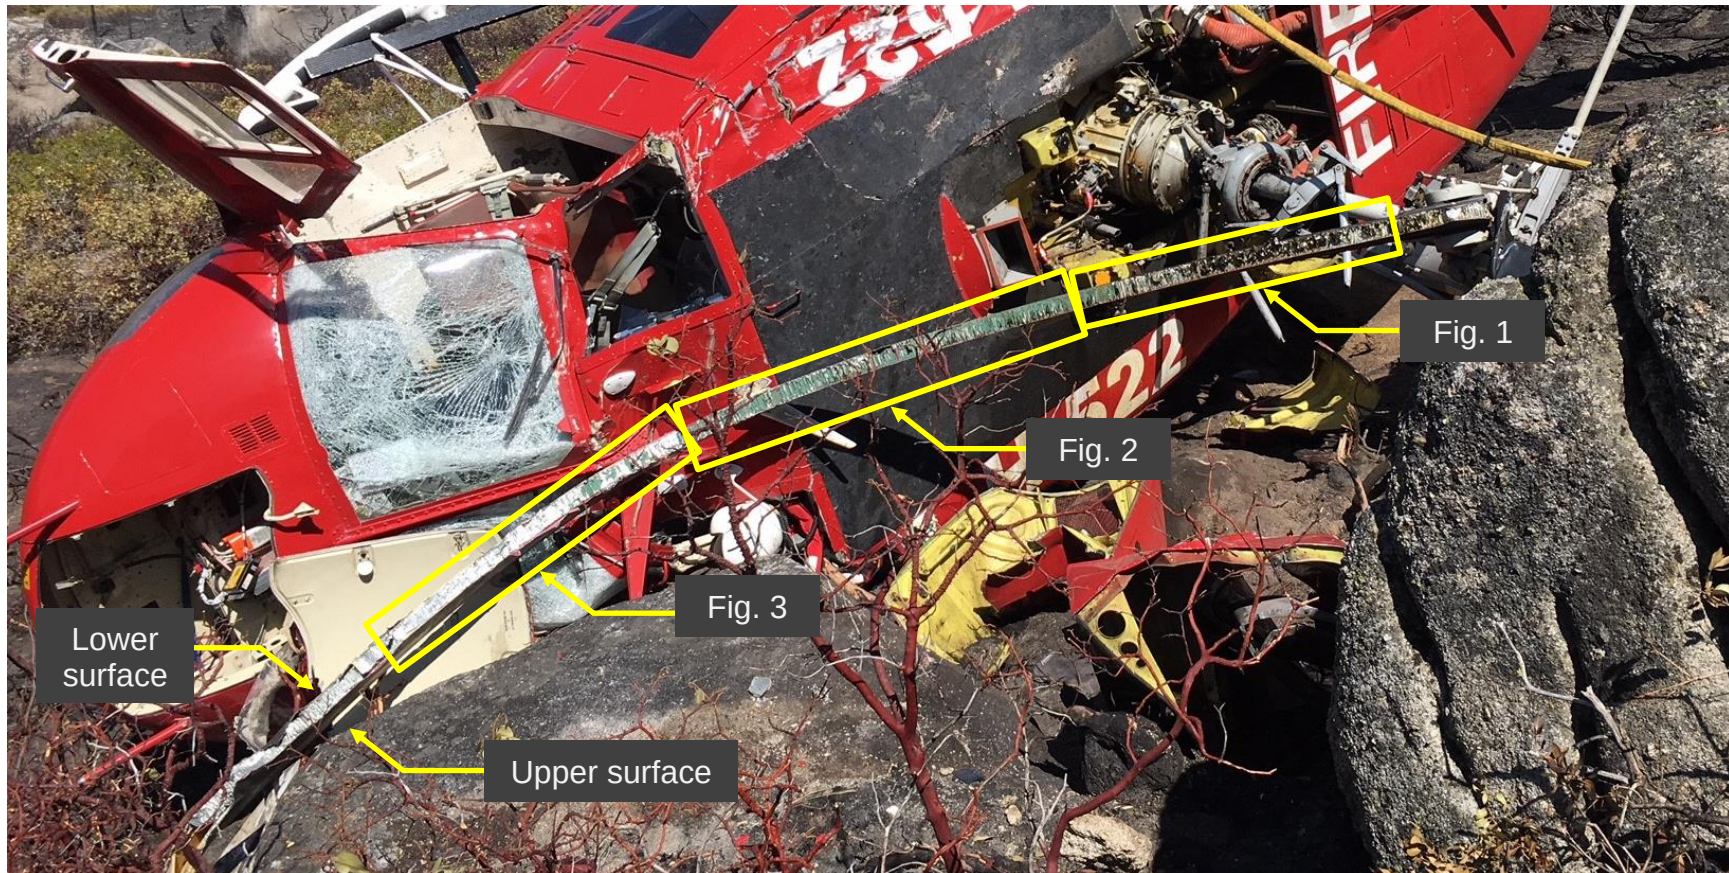
Pieces of a Bell 212 main rotor blade spar were submitted to the NTSB Materials Laboratory for examination as shown in figures 1 – 3. The pieces had been cut chordwise prior to shipping. The approximate origin of each piece is indicated on the photo shown in figure 4, which was taken at the crash site. The piece shown in figure 1 was closest to the root end of the blade. The adjoining pieces are shown in figures 2 (2 pieces) and 3 (1 piece), respectively. The lengths of the pieces, starting at the root end and as measured by a tape measure along the leading edge, were approximately 42.8 inch, 46.2 inch, 9.5 inch, and 47.2 inch, respectively. The blade kerf, measured on a dead-end cut, was approximately 0.1 inch (1/8 inch). Including the width of the cuts, the pieces spanned a length of approximately 146.0 inch (12.17 ft). For comparison, the rotor diameter is listed as approximately 48 ft. The trailing edge and much of the blade afterbody had separated from the D-spar as described below.

The upper skin, starting at approximately 80.5 inch and continuing to approximately 112.8 inch, exhibited alternating plastic bending/buckling and chordwise tearing features, as seen in figures 5 and 9, along with peeling separation between the skin and the honeycomb core that increased in length as the separation proceeded outboard. A large impact to the spar was observed along the lower spar edge at approximately 129 inch, as indicated in figure 11. Outboard of this point both upper and lower skins had separated through the afterbody approximately 0.19 inch to 0.25 inch from the aft face of the spar and both upper and lower skins were bent inward, lying flat against the spar's aft face. Further outboard, as seen in figure 4, the fracture moved further into the afterbody and toward final separation.

**Figure 4:** Photo taken at the crash site, with the rotor blade piece locations indicated by the yellow rectangles.

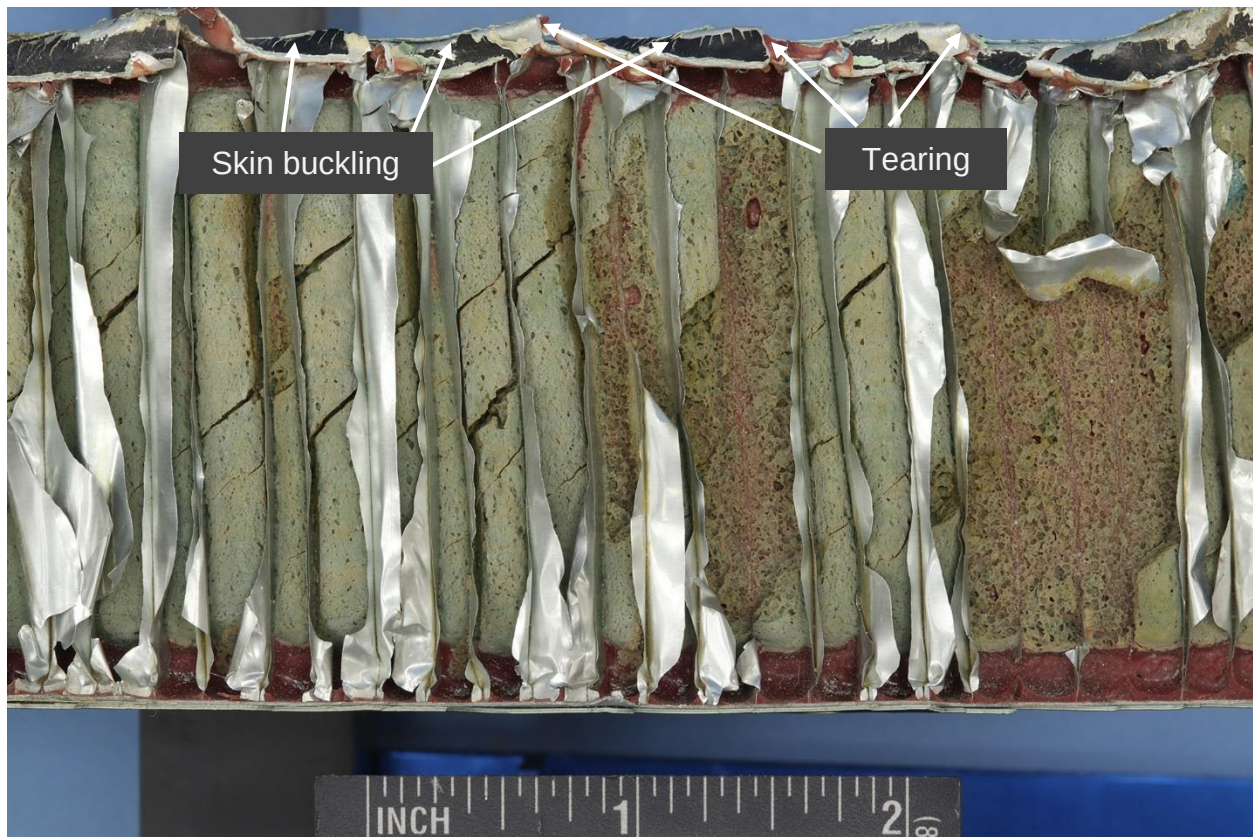
The construction of the spar to afterbody transition can be seen in figure 5. Upper and lower aluminum skins lapped and were bonded to the upper and lower surfaces of the spar. The skins extended aft forming the upper and lower surfaces of the afterbody. The interior of the afterbody was filled with a hexagonal aluminum honeycomb core. The skins and core were bonded using a film adhesive (red color in figure 5) and a layer of the adhesive also appeared to have been applied to the aft face of the spar. A yellow-green foaming adhesive was applied at the interface between the core and the spar aft face. As seen in figure 5 the foam formed elongated structures that conformed to the structure of the honeycomb core. The foam structures were cracked along 45° angles relative to the spanwise direction and in some regions the foam exhibited cohesive separations near the interface with the underlying red adhesive layer.

Continuing outboard, from approximately 80.5 inch to 100.0 inch, the lower aluminum skin continued to fracture in line with the lower edge of the spar and exhibited features consistent with tensile overstress, as previously described and as seen in figures 5 and 9. Outboard of that point, the lower skin fracture transitioned slightly aft, approximately 0.19 inch to 0.25 inch into the afterbody, and began to exhibit peeling, bending, and tearing features. Starting in this region and continuing outboard, the attached remnants of the honeycomb were flattened against the aft face of the spar, folding over in the outboard direction. From approximately 99.0 inch to 108.0 inch (the first 9 inches of the outboard piece in figure 3) red adhesive was observed smeared on the honeycomb walls, as shown in figure 10a. Several of the honeycomb walls were lifted with tweezers to see if adhesive was present beneath any of the folds, but no such indications were found, as shown for two locations shown in figure 10b.

**Figure 5:** Image of the main rotor blade spar aft face shown the construction of the spar to afterbody transition as well as skin bending/buckling and tearing features along the upper skin.  
See figure 2b for location information.

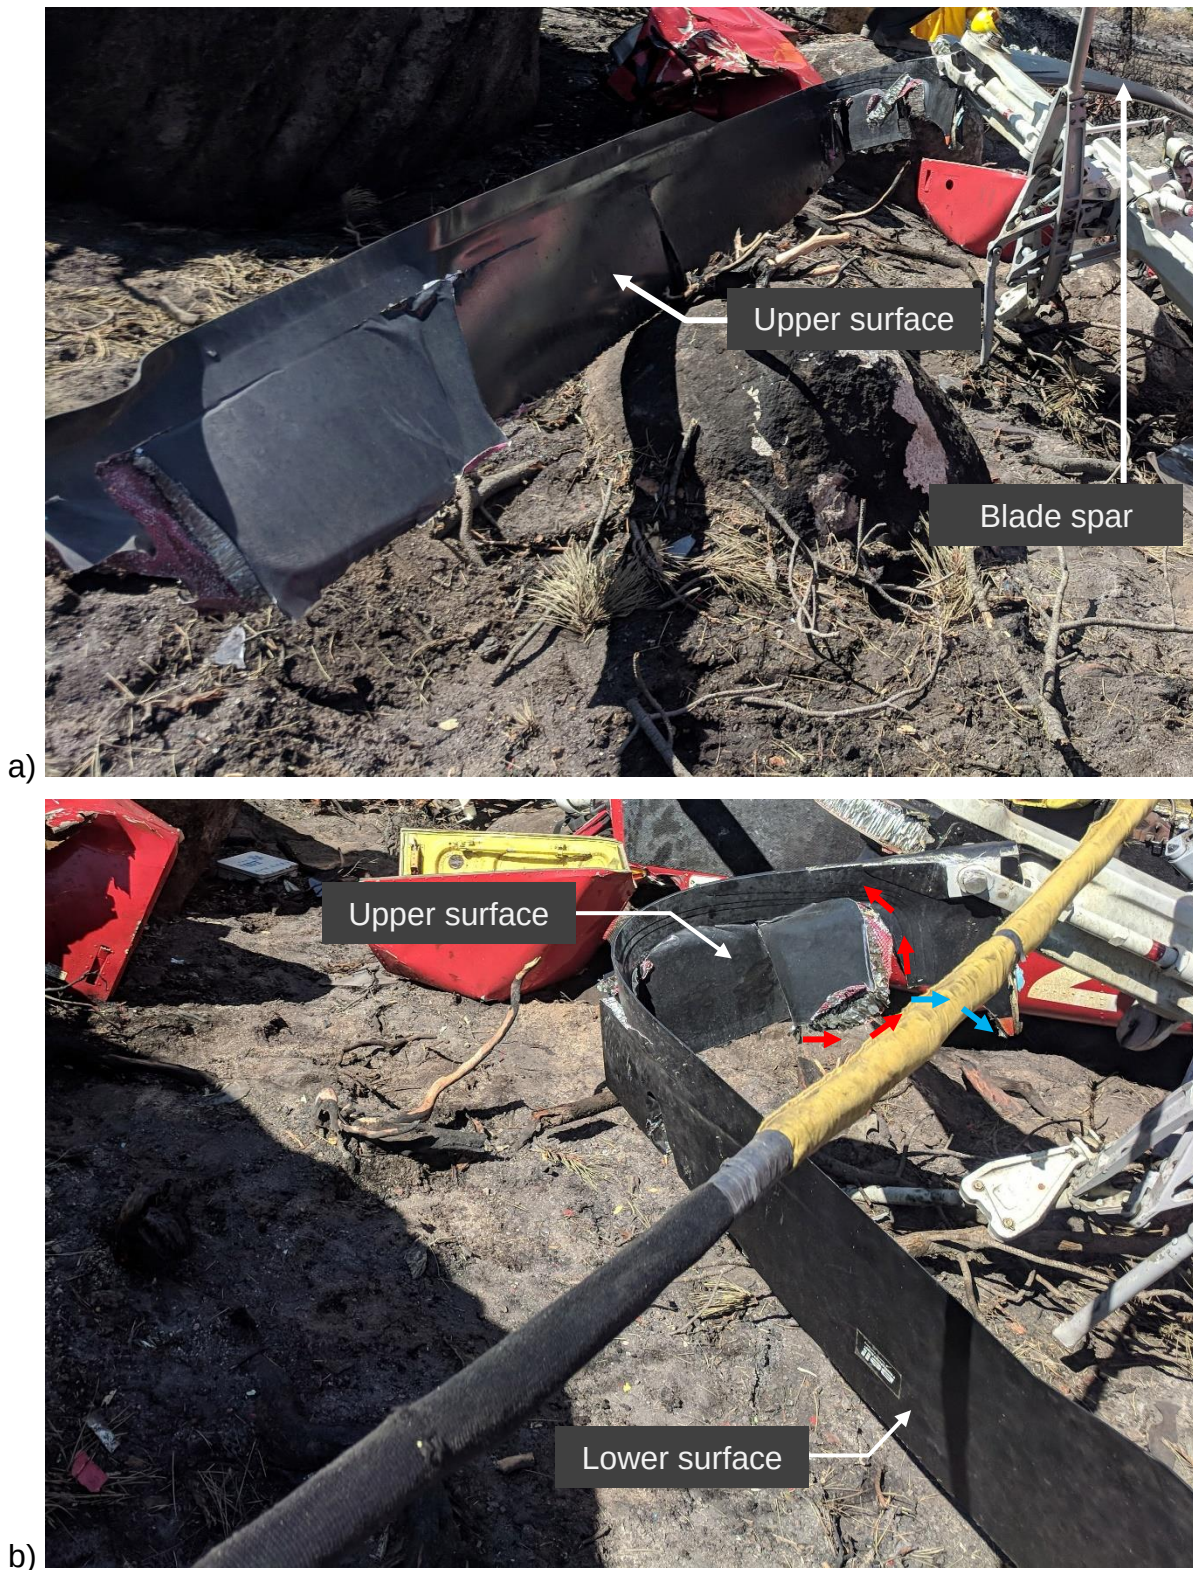
**Figure 6:** Images of the main rotor blade afterbody at the crash site: a) image showing the afterbody upper surface and b) image showing the root end of the blade with the upper surface visible in the background and lower surface visible in the foreground. The afterbody did not appear to exhibit the same upward bending as the spar.

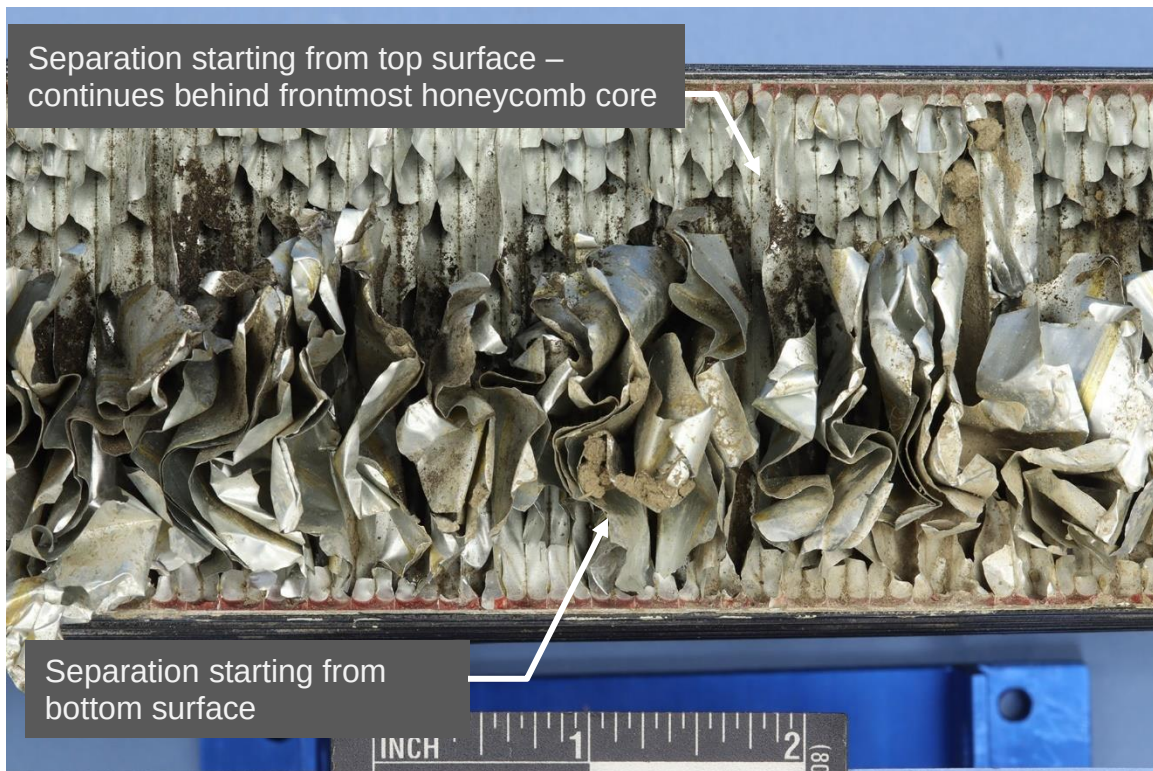
**Figure 7:** Image of the skin and honeycomb separation in the root end section. The skin fractures followed the edge of upper and lower skin doublers. See figure 1b for location information.

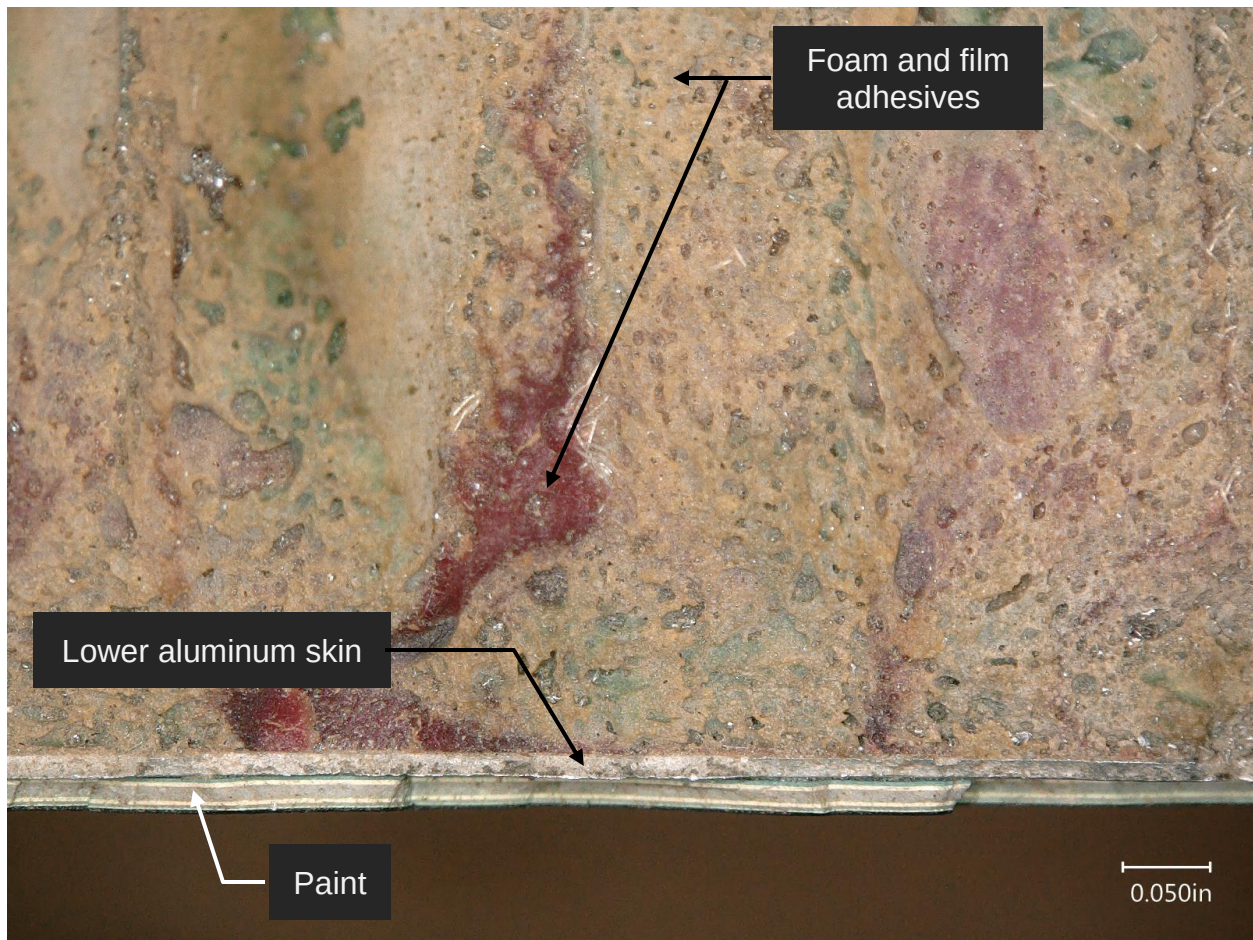
The upper and lower skin fractures from the root end section to the 80-inch mark were examined with the aid of a stereomicroscope. Most of the fractures were similar to that shown in figure 8 which was taken along the lower skin approximately 40.0 inch from the root end section. The fracture surfaces were inclined at 45° angles to the skin surface and had comparatively coarse features that were consistent with overstress fractures. One minor variation was a region of lower skin fracture from approximately 66.2 inch to 80.5 inch (see figure 2b) that, while still consistent with overstress fracture, had progressed aft into the afterbody and exhibited additional features of tearing, bending deformation, and peel separation.

**Figure 8:** Image showing typical tensile overstress fracture of the lower skin.

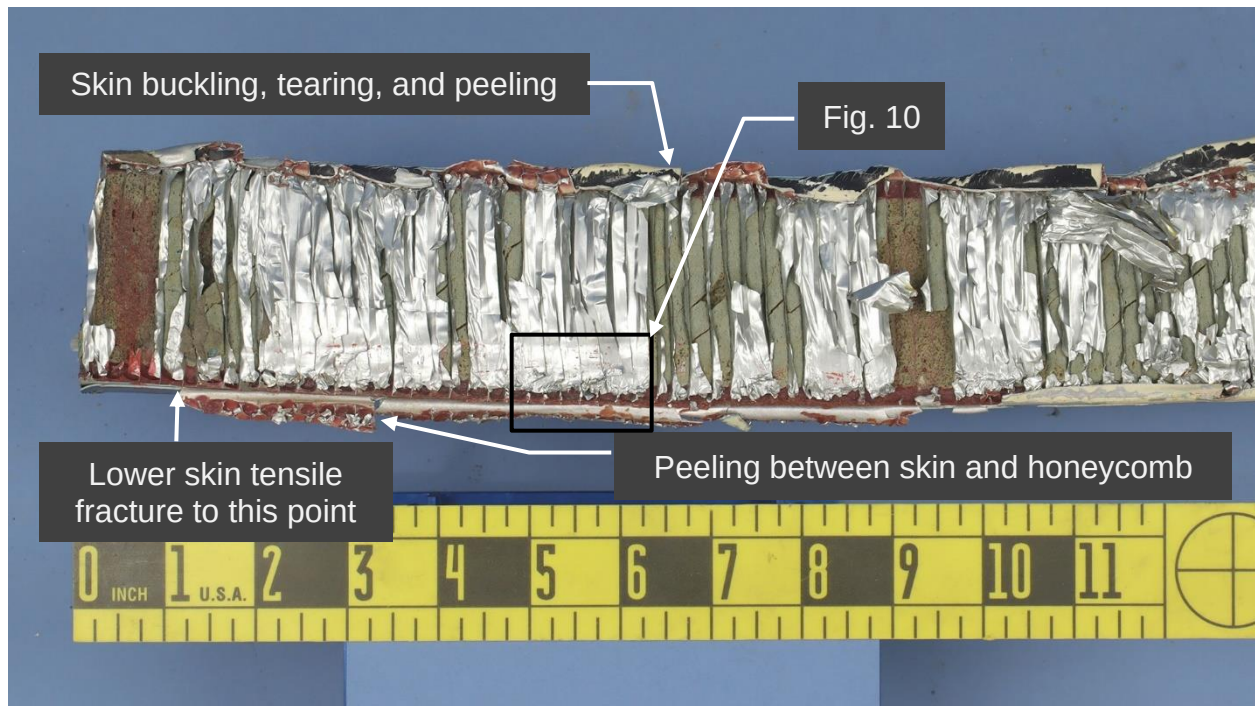
**Figure 9:** Image showing flattening of honeycomb, tearing, and peeling of upper and lower skins. The image is taken at the inboard end of the outer section, shown in figure 3b.

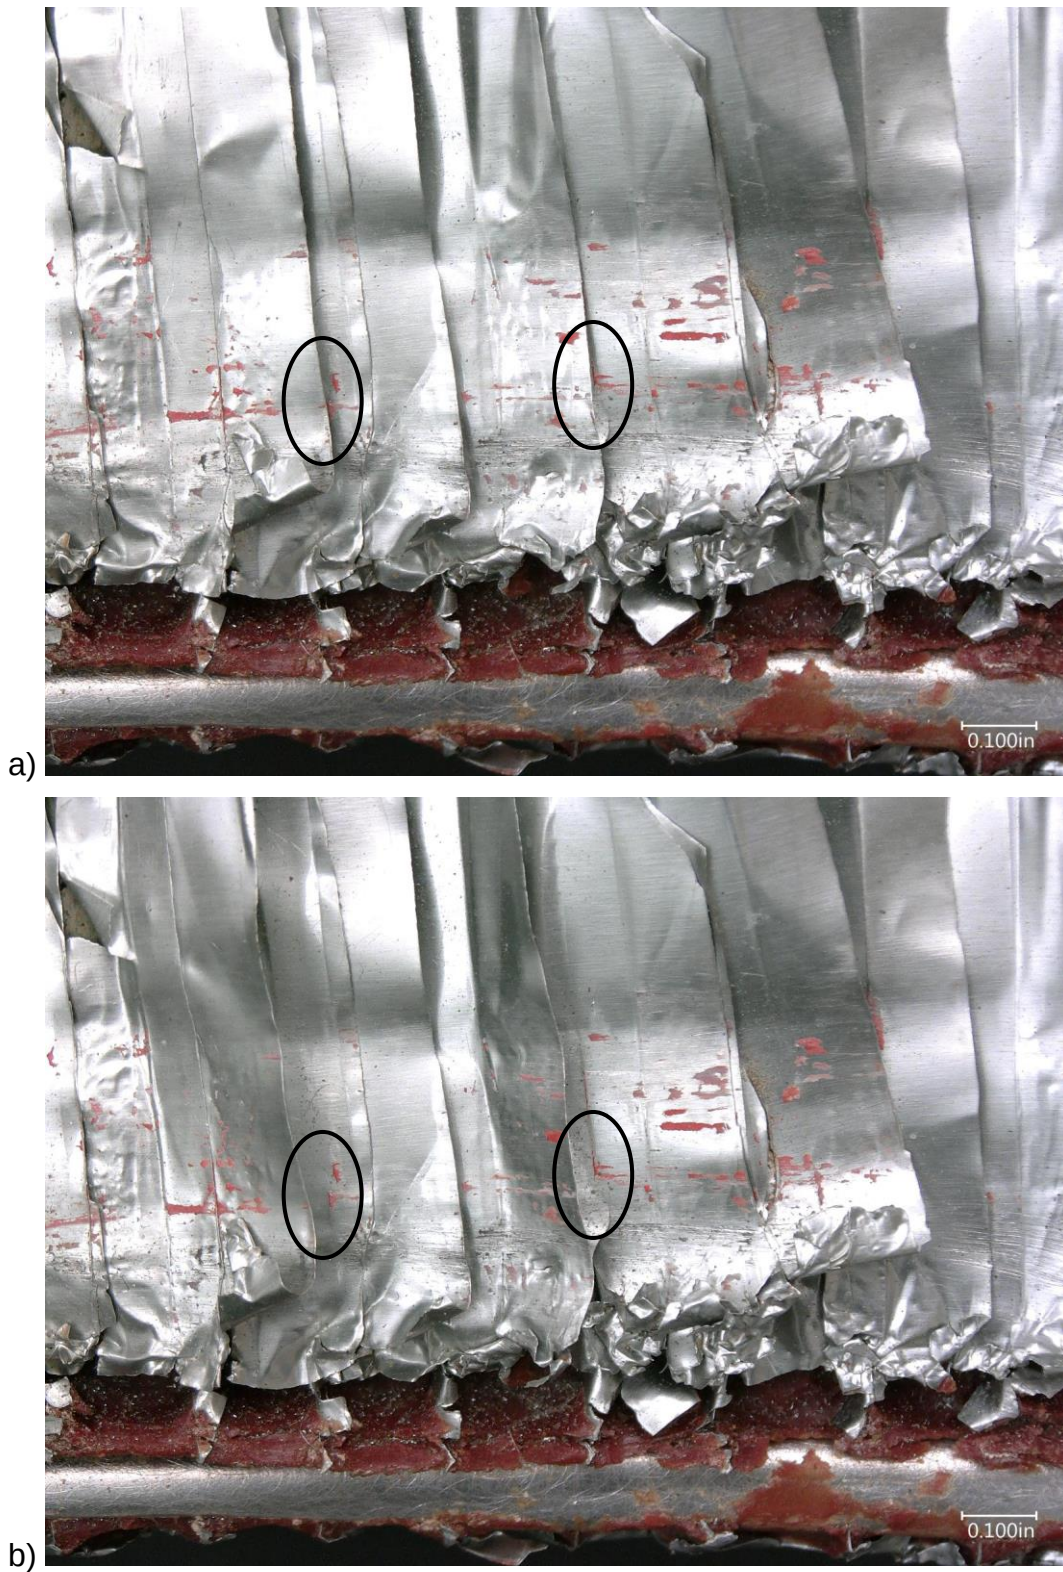
**Figure 10:** Images of the flattened honeycomb core : a) image showing smeared red adhesive on the cell walls and b) two of the cell wall lifted showing no adhesive under the folds.

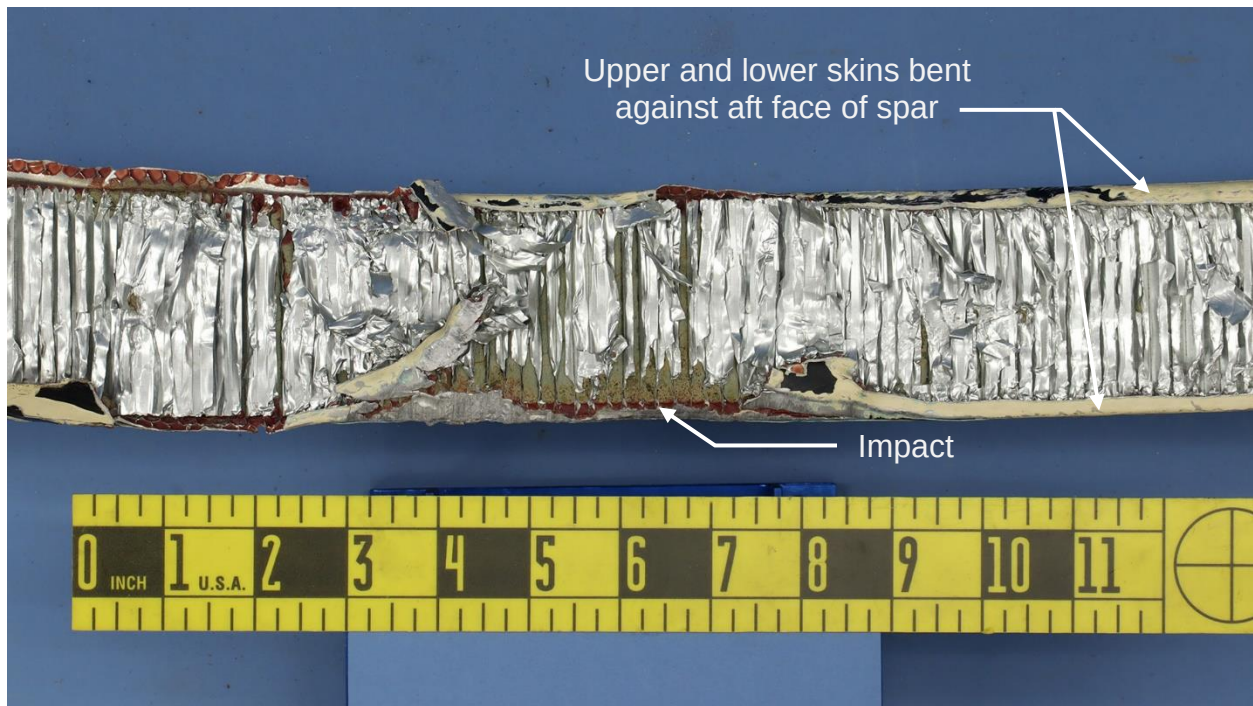
**Figure 11:** Image of outer spar pieces showing impact to the lower surface and the bending and folding of the upper and lower skins against the aft face of the spar.
