**NATIONAL TRANSPORTATION SAFETY BOARD**

**AIRFRAME & ENGINE EXAMINATION REPORT**

**WPR18LA242**

## **Roberts Aircraft Company (Bell) 212 – N512TA**

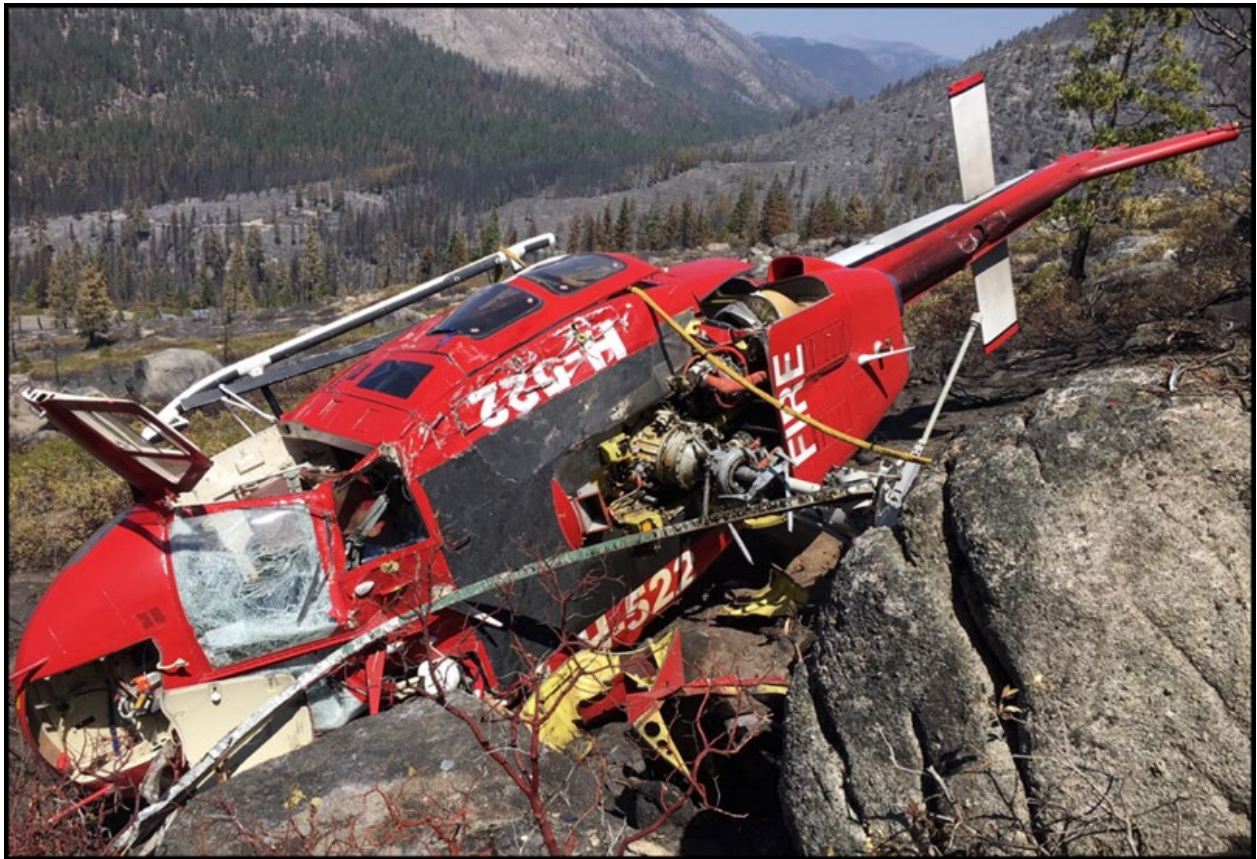
The helicopter came to rest on its left side, on a steep mountain side that had previously burned from a wildfire. All major components were found in a debris area of about 100 ft by 100 ft. The long line holding a water bucket, remained attached to the helicopter cargo hook. The line looped over the top of the fuselage and ran uphill to the water bucket.

Figure 1. Photo showing the helicopter at rest at the accident site. Photo US Forest Service.

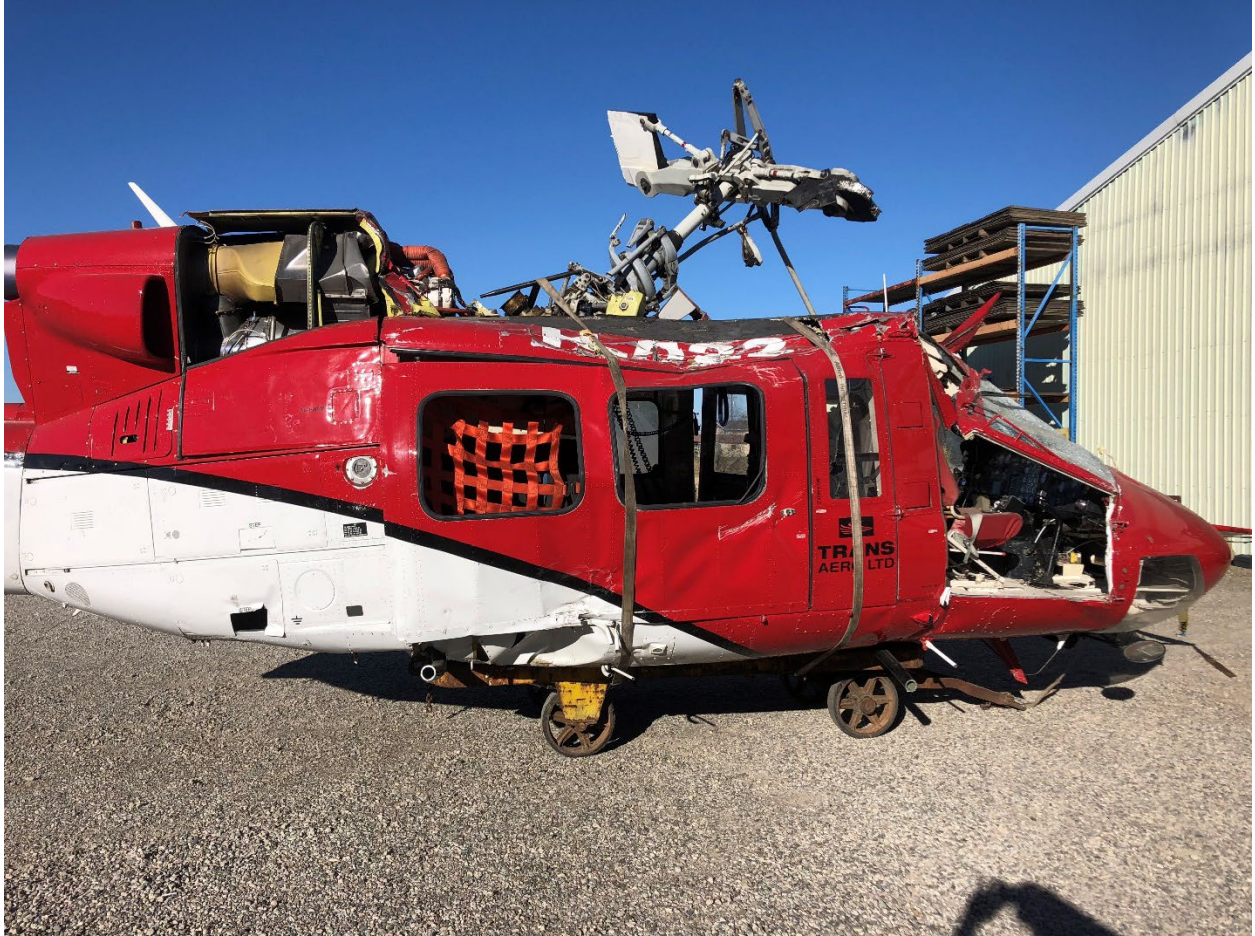
The helicopter was reported to have rolled once and then came to rest on its left side. The fuselage exhibited downward crushing to the upper area above the right-side pilot’s door and the right-side sliding cabin door. The forward fuselage including the windshields and the top of the fuselage extending to the aft part of the overhead windscreens exhibited downward crushing, which shattered both windshields. The two overhead windscreens (greenhouse) were both absent. The nose access panel remained partially attached to the nose. The right-side chin bubble remained attached to the lower fuselage and was missing the upper section.

The right pilot door remained attached to the fuselage, however, the downward crushing of the top of the fuselage also crushed the upper portion of the right-side doorway. The right-side jump-door remained secured and had some downward crushing at the top. The right-side sliding cabin door exhibited downward crushing at the top, with dents and scrapes on the door. Both windows were absent. An area underneath the sliding door exhibited inward crushing. The area of fuselage aft of the sliding cabin door exhibited minor dents and scrapes.

Figure 2. Right-side view of the helicopter at the recovery site.

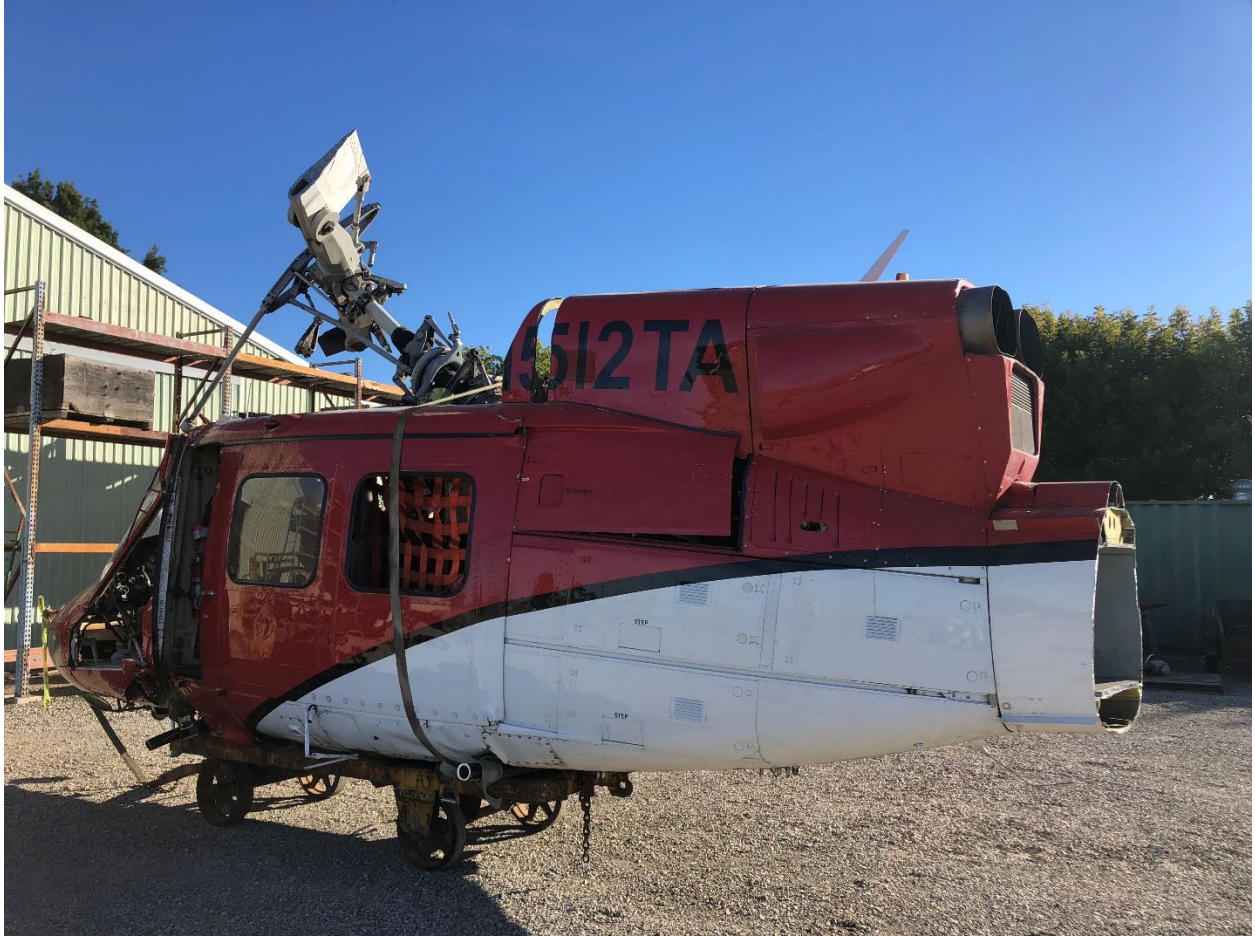
The left side of the fuselage forward of the tailboom exhibited minor damage. The left-side sliding cabin door exhibited minor damage. The aft window was absent. The forward window remained attached to the door. There was some evidence of upward crushing above the rear cross tube. The left-side jump door remained attached to the fuselage and was opened. The fuselage area between the left-side jump-door and the left-side pilot's door exhibited inward crushing. The left-side pilot's door was absent.

Figure 3. left-side view of the helicopter at the recovery site.

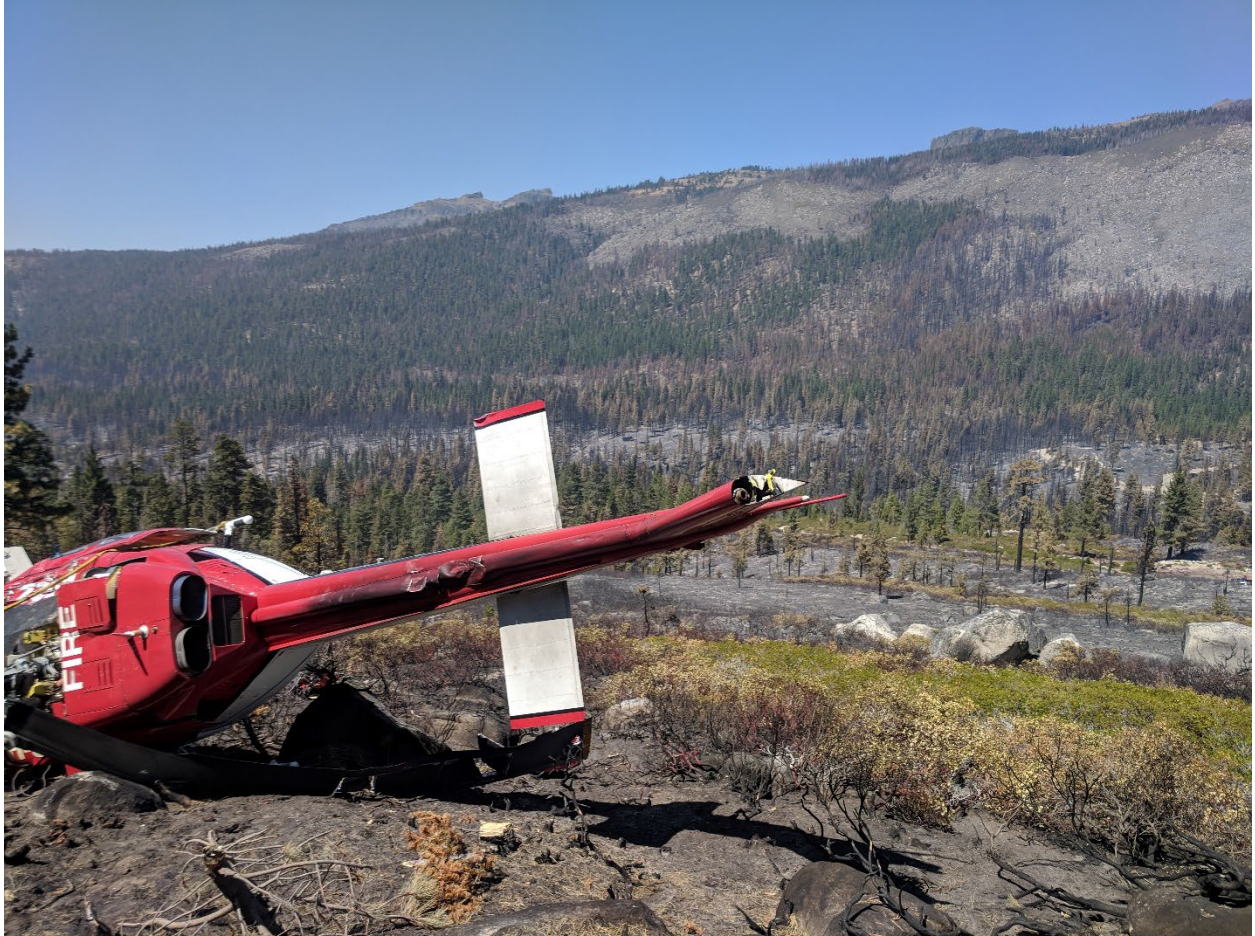
The left side of the vertical stabilizer exhibited minor damage. The left side of the tail boom exhibited minor damage. The left-side horizontal elevator exhibited minor damage. The top of the tail boom exhibited downward crushing at the tail rotor driveshaft cover, about mid-span. The top of the vertical stabilizer exhibited a fracture at the mounting pad for the 90° gearbox.

Figure 4. View of the tailboom while at the accident site. Photo US Forest Service

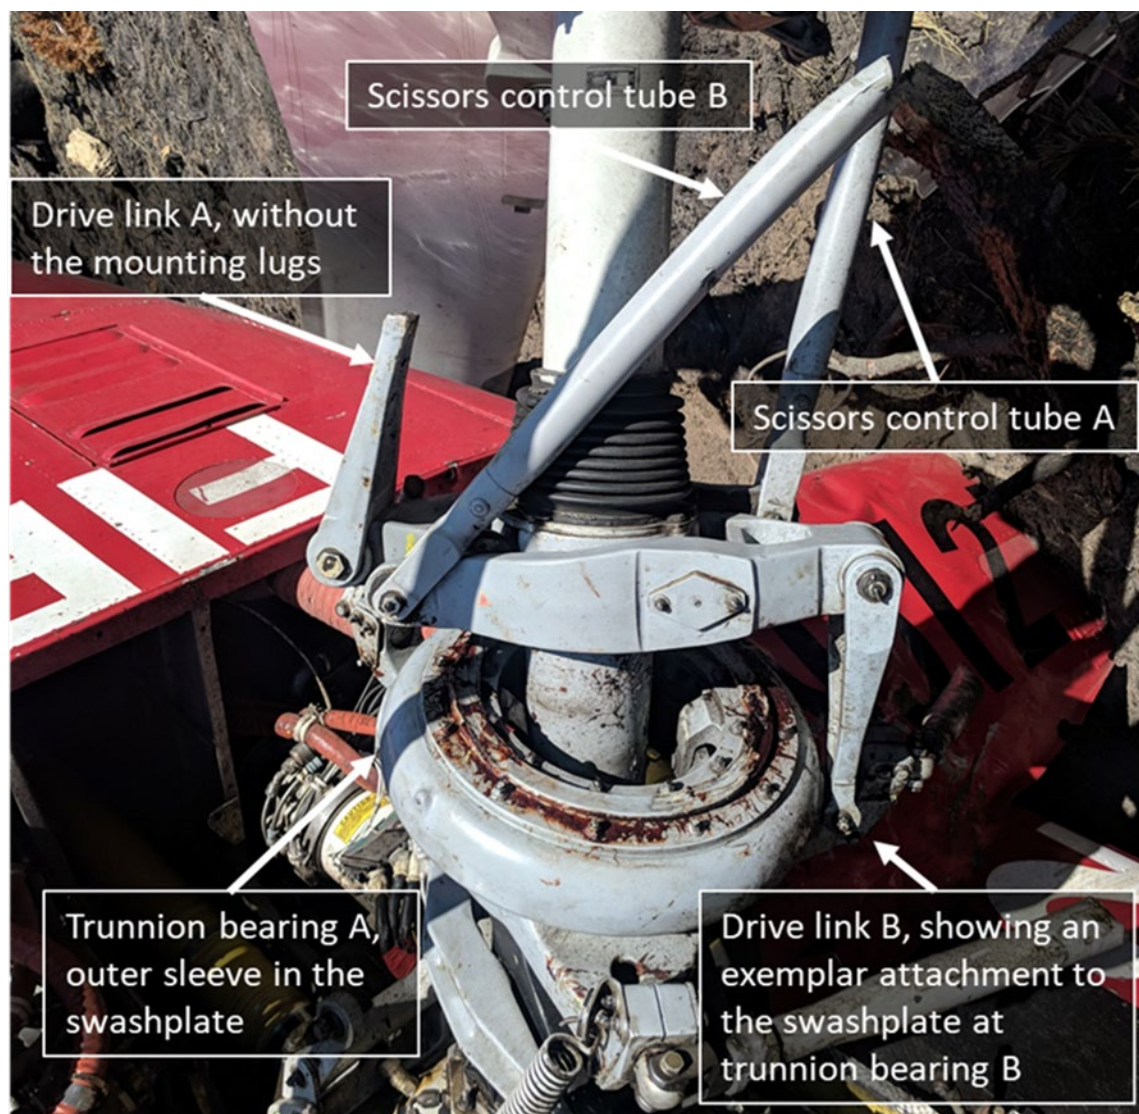
Examination of the main rotor control system from the rotating swashplate and above revealed that swashplate drive link A remained attached to the scissors assembly A. Drive link A was fractured at the two tangs used to attach it to the rotating swashplate via a two-piece trunnion bearing. The trunnion bearing outer sleeve remained attached inside the rotating swashplate. There were two distinct areas near the trunnion mount that had paint removed and appeared to have been struck by an object. The drive link A tangs and the inner race of the trunnion bearing separated from the swashplate and were not recovered. Scissors A connected at its opposite end to the scissors control tube, which exhibited no damage and remained attached at both ends. The upper end of the scissors control tube remained attached to the mixer attached to the stabilizer bar. The stabilizer bar remained attached to the stabilizer assembly and appeared to be partially buried in the terrain. From the stabilizer bar the A pitch change rod remained attached to the stabilizer bar and the A blade pitch horn. The A blade pitch horn separated from the A blade grip. The A blade grip secured the blade spar, and the A drag brace secured the A blade aluminum honeycomb after body. The A blade spar separated from the afterbody along the entire span of the blade. Numerous areas of sheet metal that made up the skin of the blade, were bent in a sharp 90° bend. Areas with these bends also had the black paint removed, exposing a tan colored paint. There was an area of darkened aluminum honeycomb near the root end of the blade.

The B swashplate drive link remained attached at the rotating swashplate and the B scissors. The B scissors remained secured to the rotating hub and attached to the B scissors control tube. The B scissors control tube fractured about mid-span. The upper section of the B scissors control tube remained attached to the stabilizer bar. The B stabilizer bar remained attached to the stabilizer bar assembly. The B pitch change rod remained attached to the stabilizer bar and the B blade pitch horn. The B pitch horn separated from the B blade grip. The B blade remained attached to the hub by the blade grip and the drag brace. The B blade exhibited spanwise bending along with

Figure 5. Image showing swashplate drive links, trunnion bearings, and scissors control tubes. Photo US Forest Service.

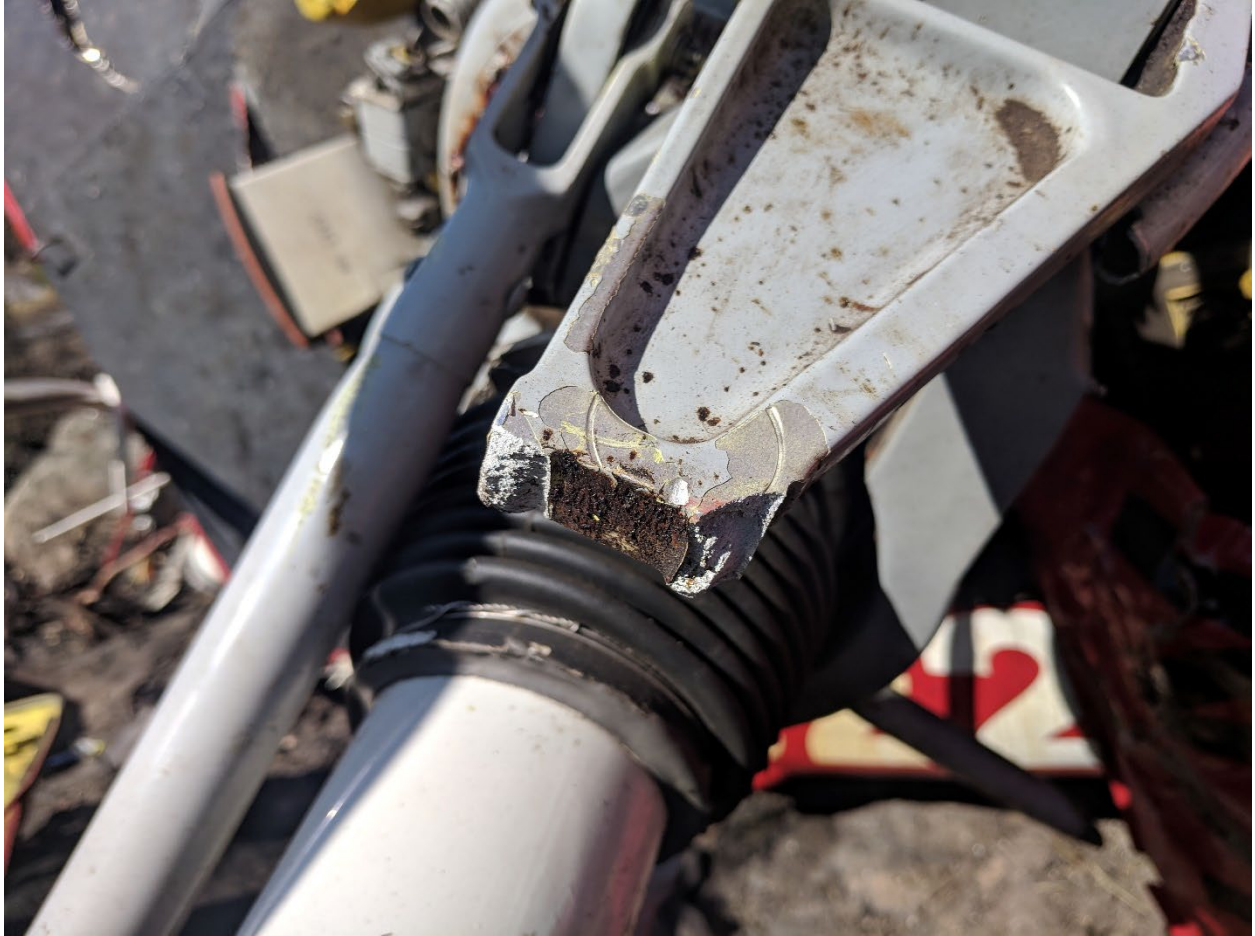
Figure 6. Image showing swashplate drive link A and the area of the missing tangs. Photo US Forest Service.

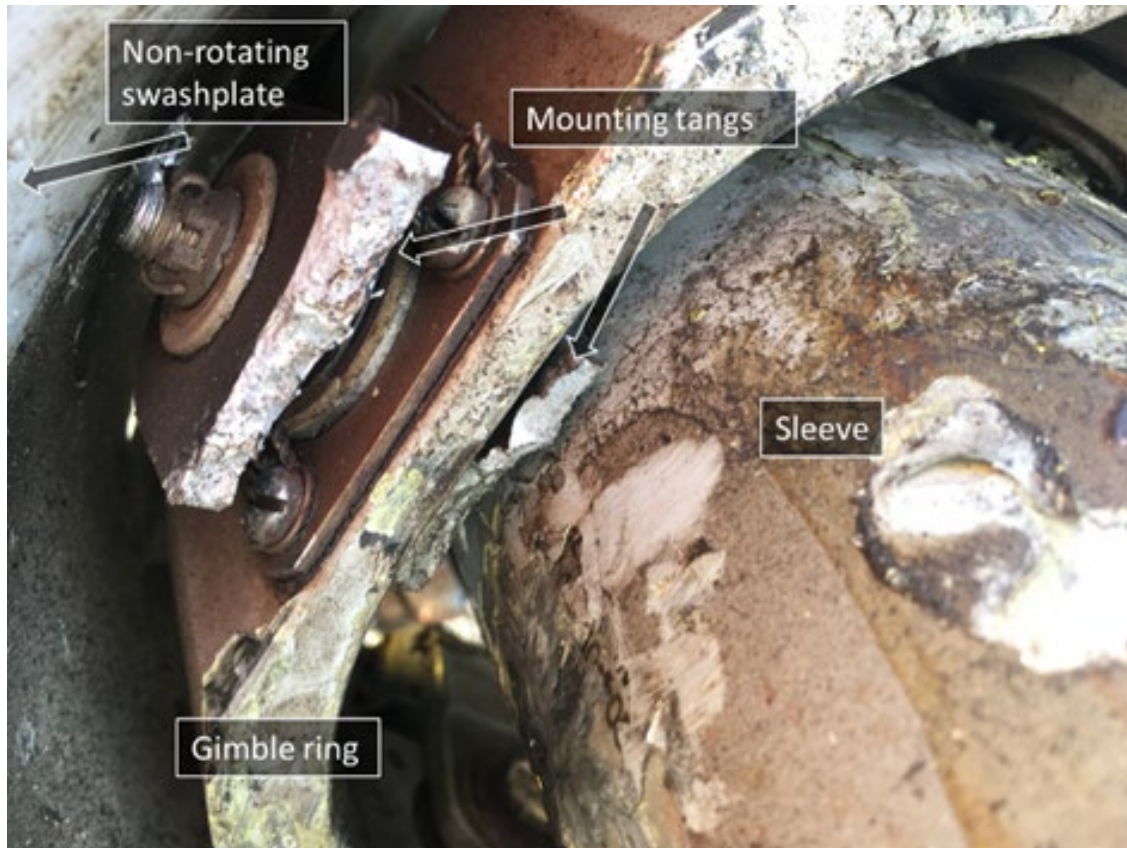
After the field examination, the FAA representative reported this. “The low profile 12-point special bolt heads that connect the gimbal ring to the swashplate support and the inner ring show evidence of battering the collective sleeve for some time in flight, as the swashplate support ears

~ Significant damage to the collective sleeve from the free movement of the gimble ring around the sleeve after the gimble had become free of the swashplate support. Damage indicative of pre-impact separation of the gimble ring from the swashplate support.

Figure 7. Image showing one side of the gimble ring and the attached swashplate support tangs. The contact marks on the collective sleeve are in view. Photo FAA

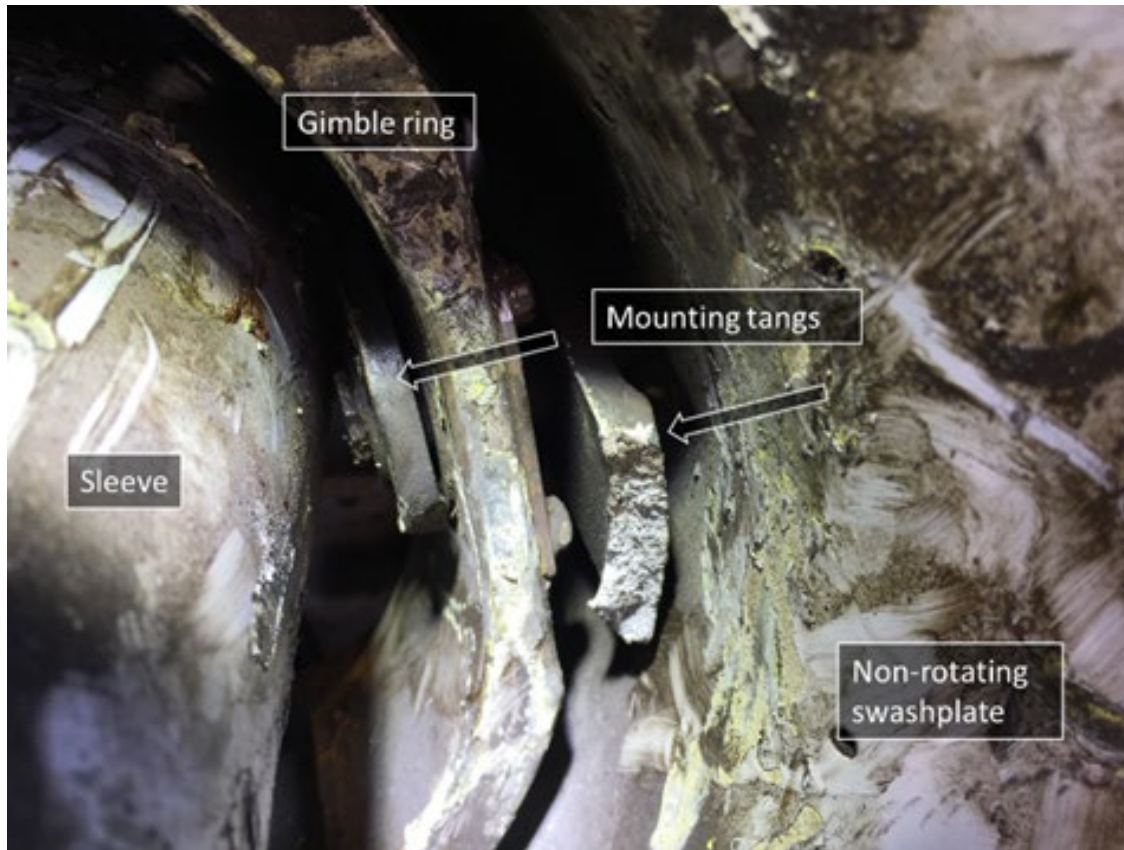
Figure 8. Image showing the other side of the gimble ring and the attached swashplate support tangs. The contact marks on the collective sleeve are in view. Photo FAA

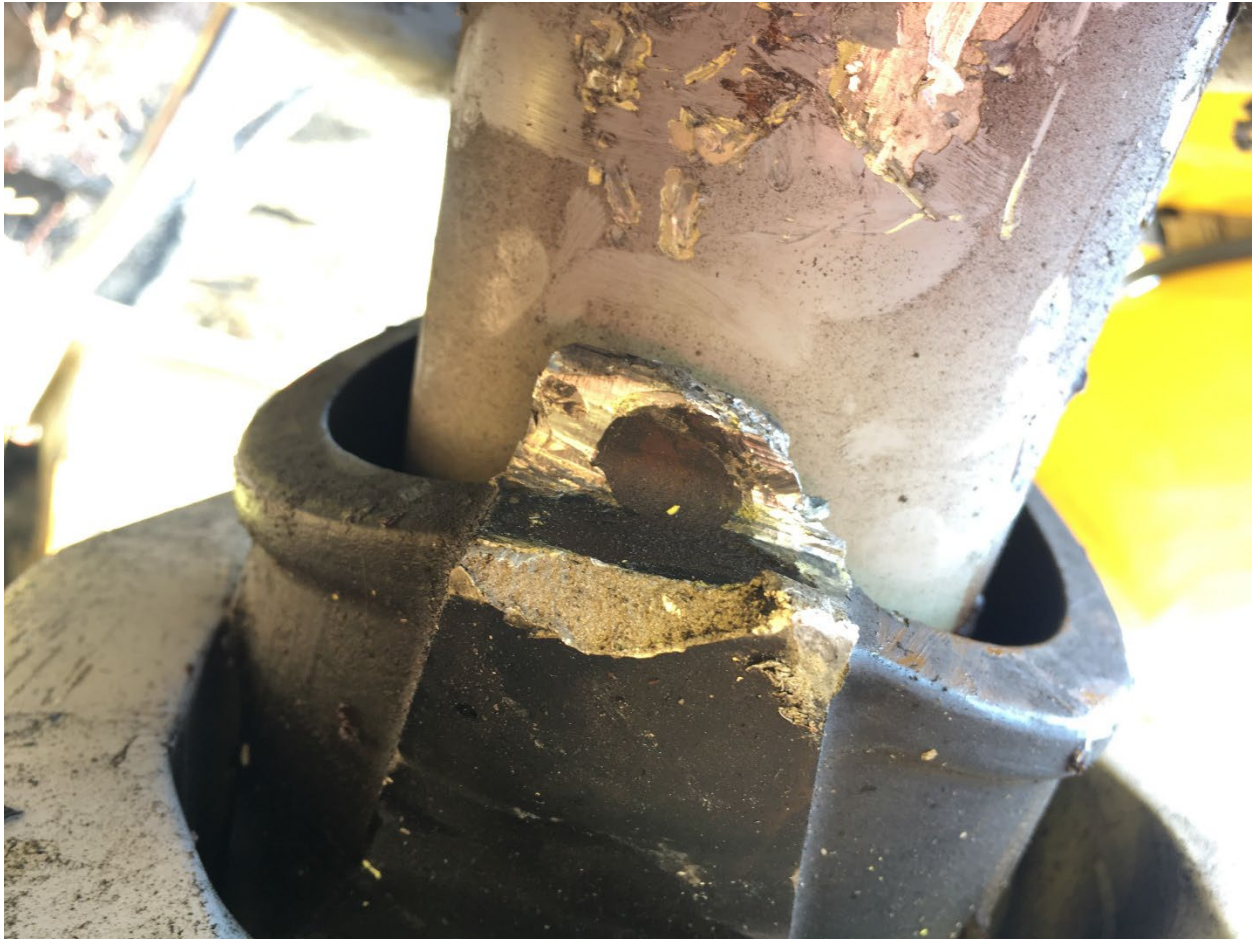
~ Significant damage and metal transfer/deformation to the area where the swashplate support to gimble assembly mounts were previously located, this type of damage is indicative of pre-impact damage.

Examination of the main rotor controls from the non-rotating swashplate and below revealed the swashplate separated from the swashplate support at the four tangs. The four tangs remained attached to the gimble ring. All hardware for the tangs remained attached to the tangs and the gimble ring. The swashplate support remained attached to the top of the transmission. Both the inboard tangs exhibited a smearing of the fractured metal that created a shiny appearance. The collective sleeve exhibited damage consistent with multiple contacts from the gimble ring. One of the two bearings that joined the collective levers to the collective sleeve had separated and released the ball bearings. Both the lateral and longitudinal arms of the non-rotating swashplate exhibited a dent or dents and scratches with shiny metal exposed. The blade tracking mount, attached to the longitudinal arm, was bent over.

Figure 9. One side of the swashplate support, showing the area of the missing tangs and smearing of the fractured metal. The contact marks to the collective sleeve are in view at the top. Photo FAA.

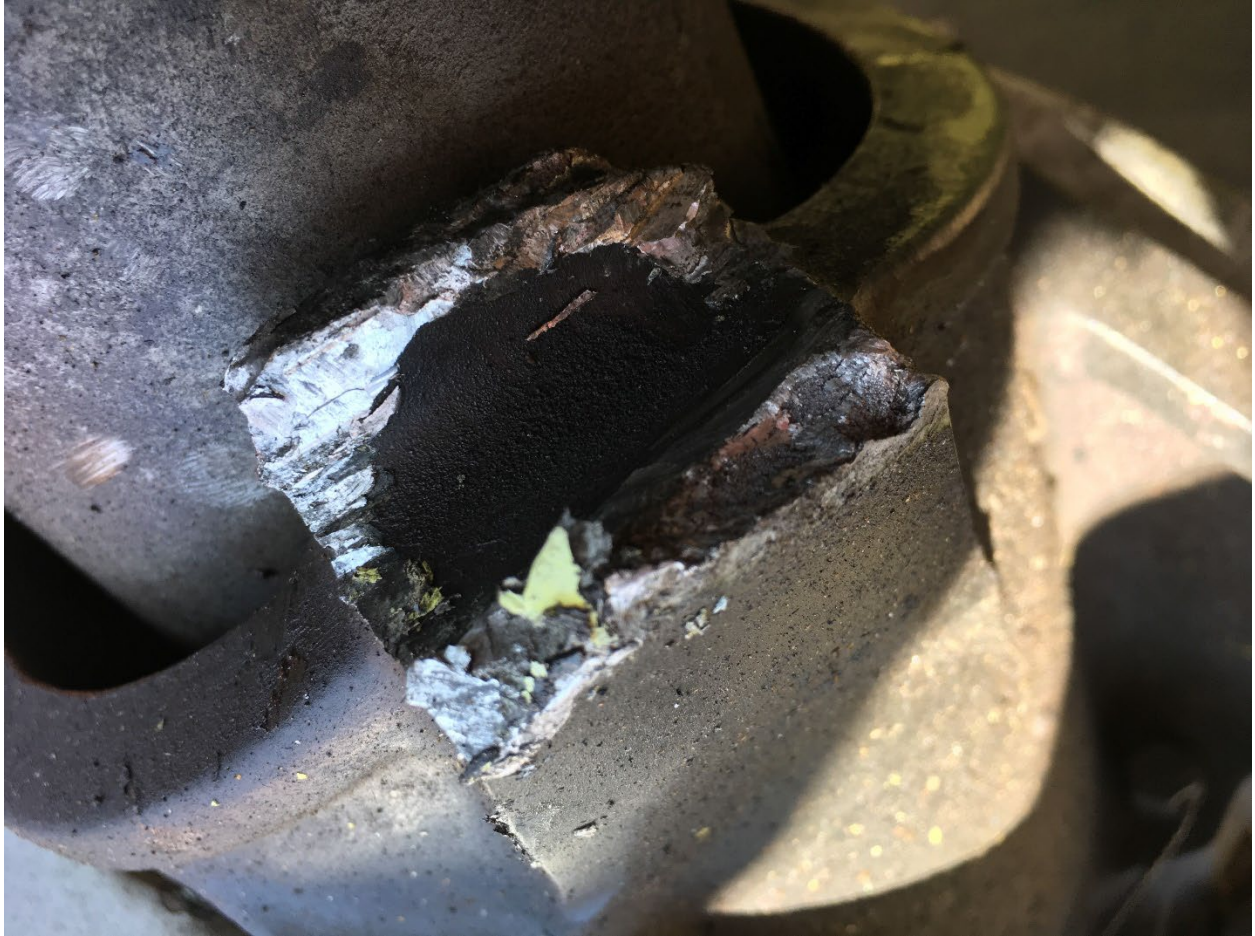
Figure 10. The other side of the swashplate support showing the area of the missing tangs and smearing of the fractured metal. Photo FAA.

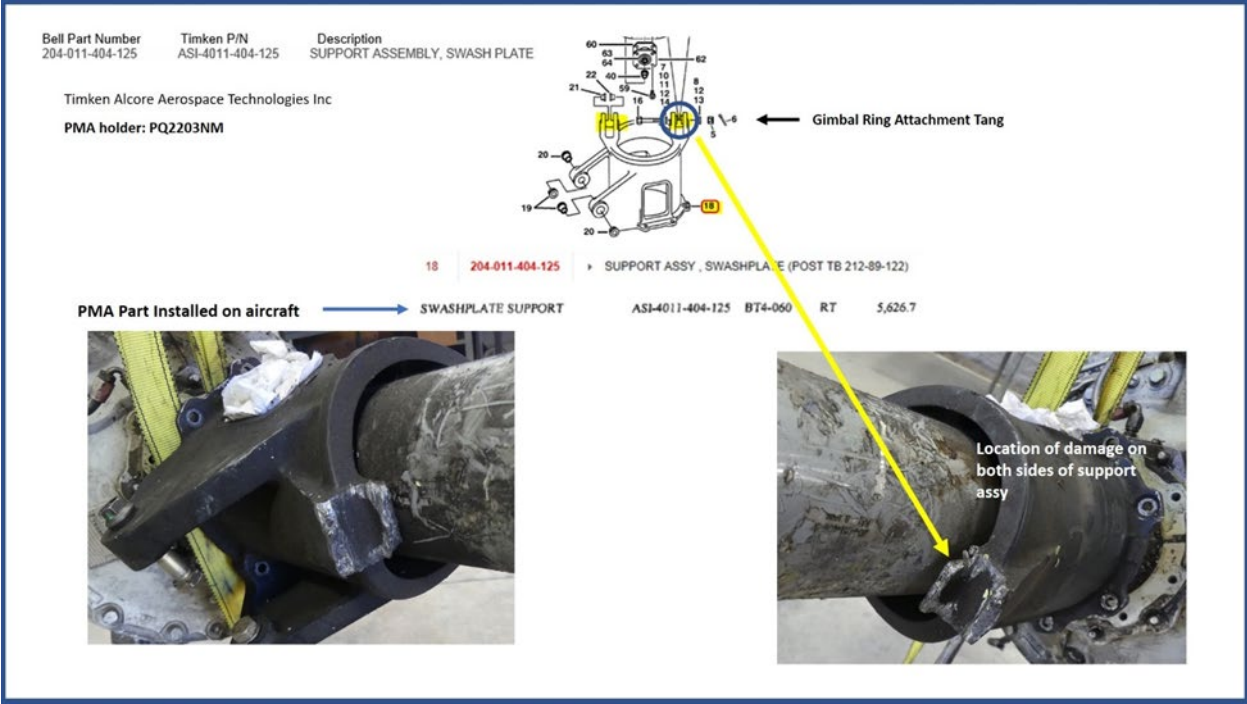
Figure 11. Image showing the location of the swashplate support and highlights showing the tangs. Photo Bell.

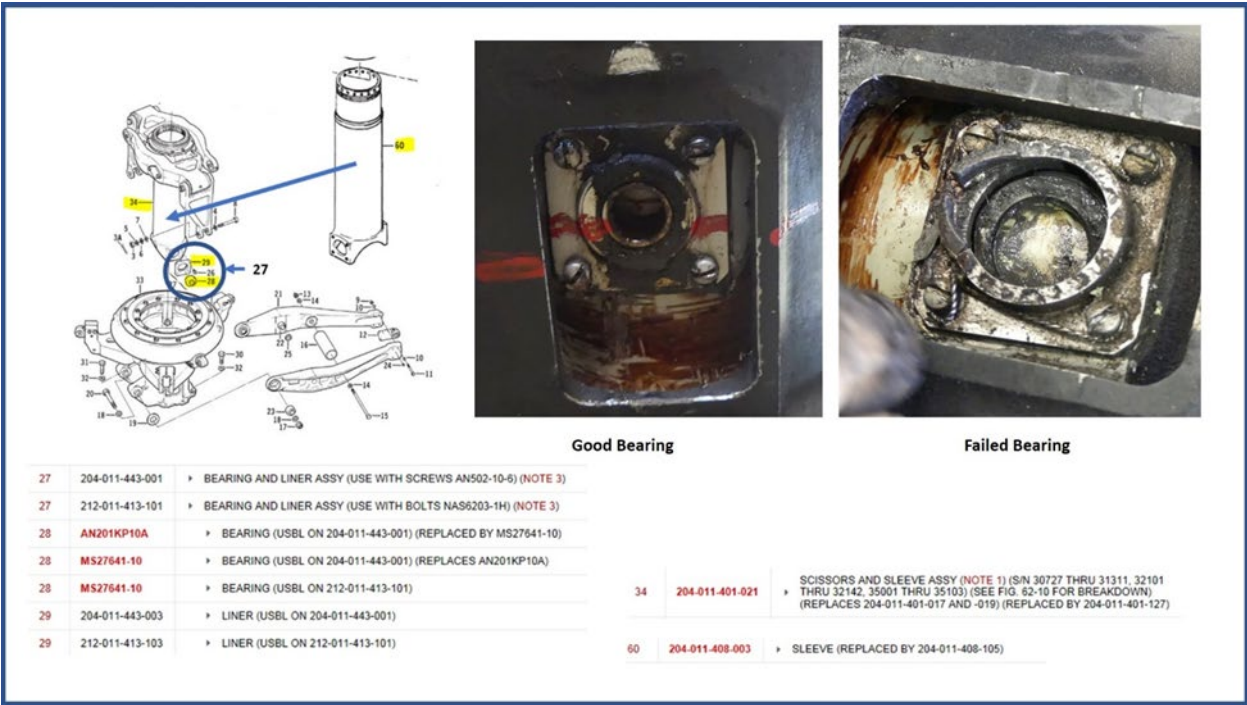
Figure 12. Image showing the location of the bearings. Photo Bell.

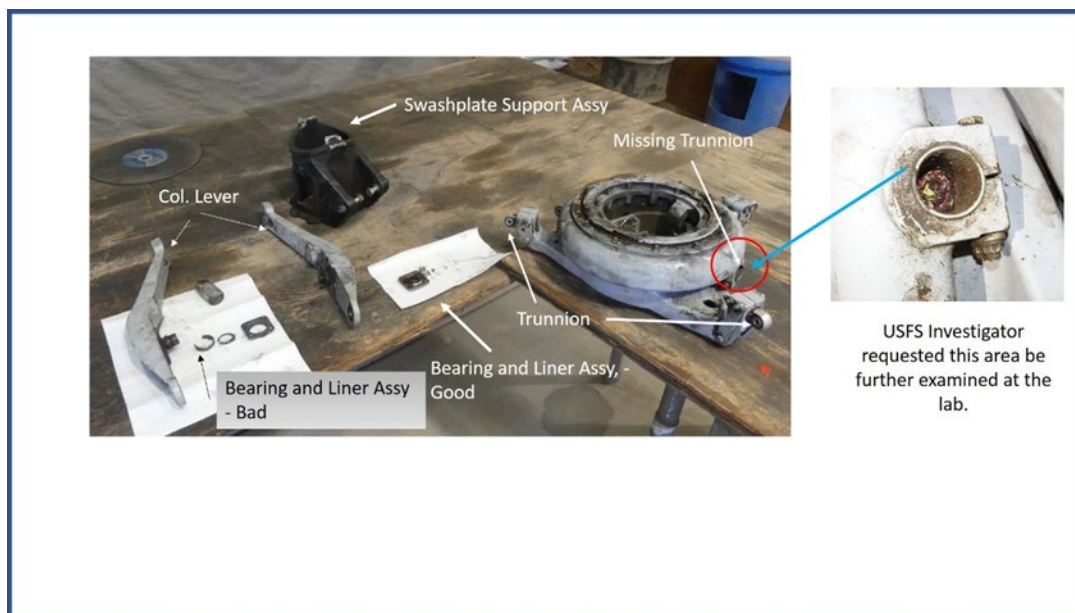
The swashplate, inner ring, gimble ring assembly, swashplate support, collective levers, and bearing and liner assemblies were examined by the National Transportation Safety Board's Materials Laboratory. All damage to all submitted components were determined to be a result of overload. Examination of the swashplate drive links and the outer sleeve of trunnion bearing A, by the manufacturer's laboratory revealed that the tangs for drive link A failed in overload. Examination of the outer sleeve of trunnion bearing A revealed brinelling on the interior and an overload fracture on the outer end of the sleeve.

Figure 13. Image showing the components submitted for further examination. Not shown are the two swashplate drive links and the outer sleeve of trunnion bearing A. Photo Bell.

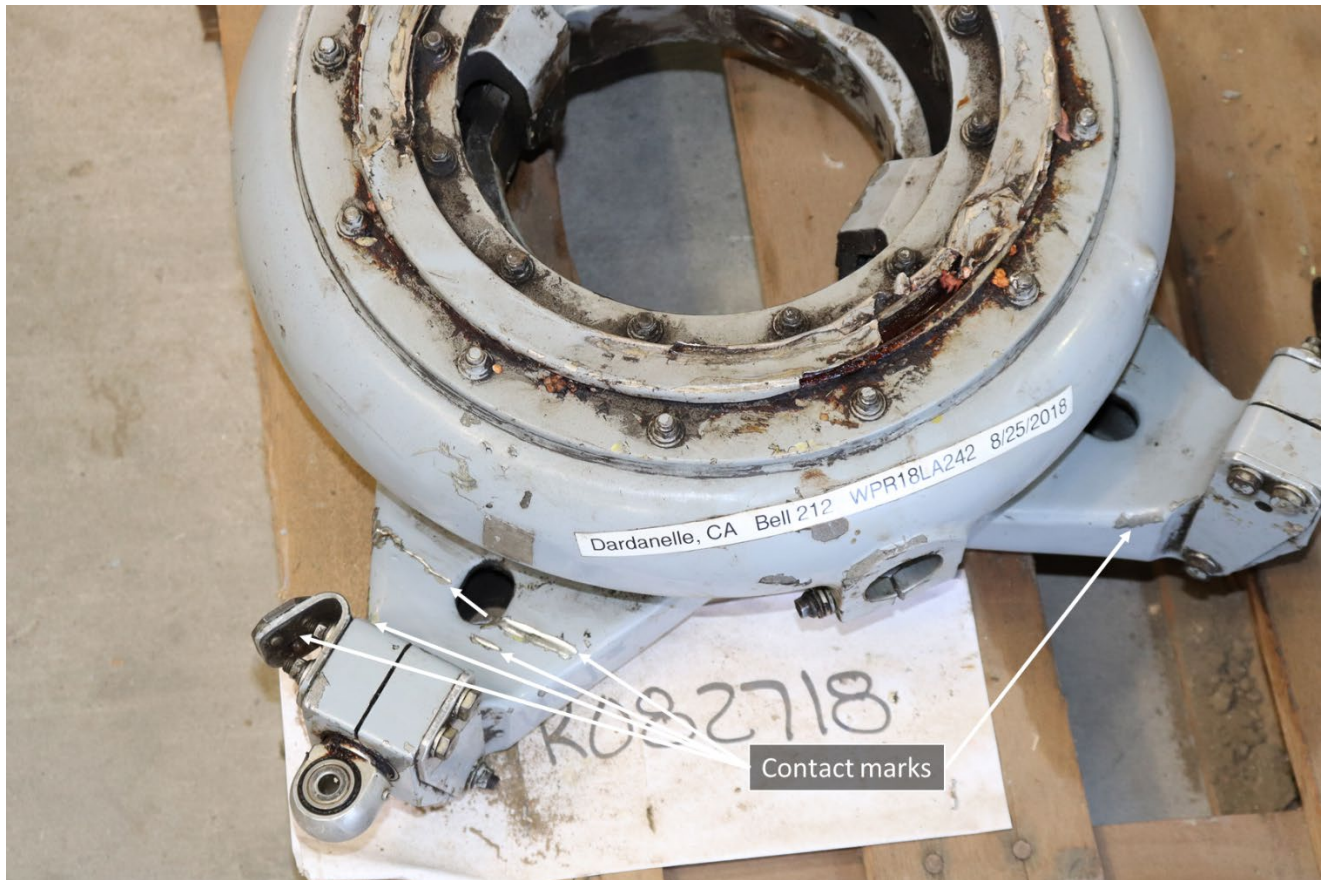
Figure 14. Image showing contact marks made to the non-rotating swashplate arms.

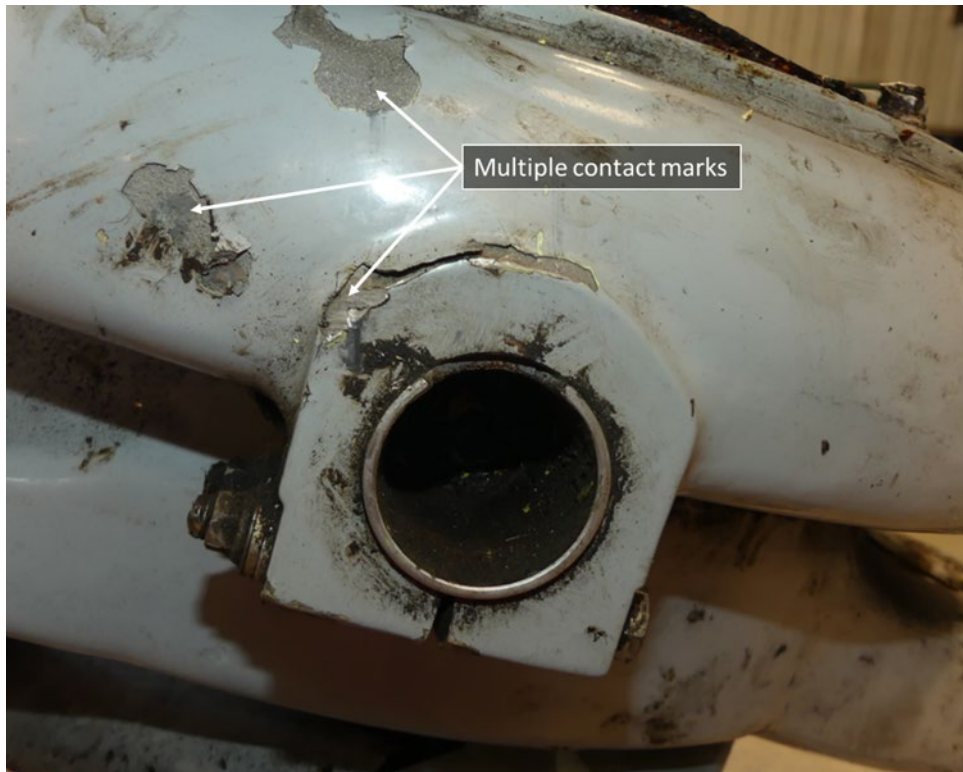
Figure 15. Image showing contact marks made to the rotating swashplate. The trunnion bearing A outer sleeve is visible.

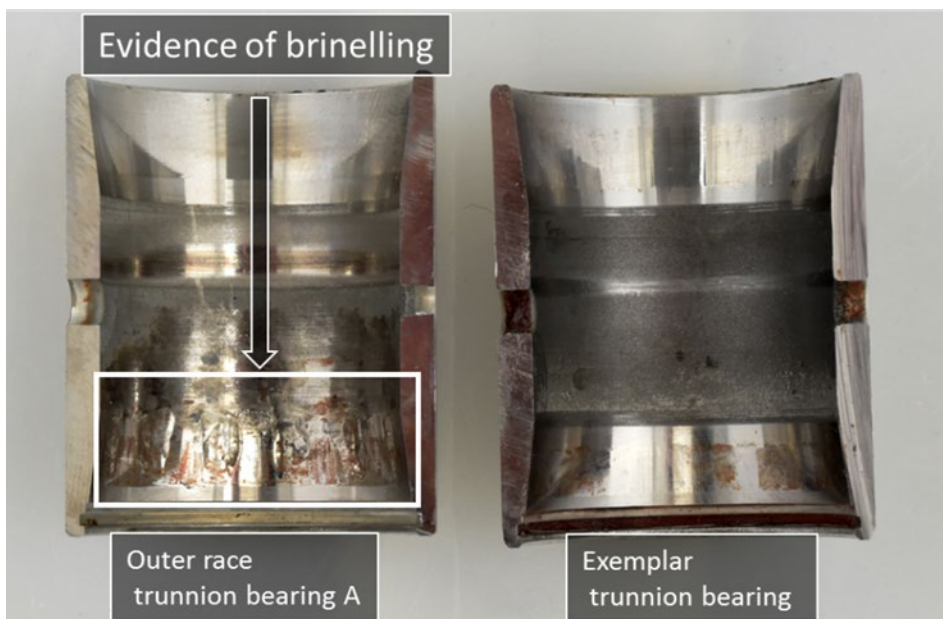
Figure 16. Image showing the outer sleeve of trunnion bearing A on the left that shows brinelling. An exemplar outer sleeve is shown on the right. Photo Bell.

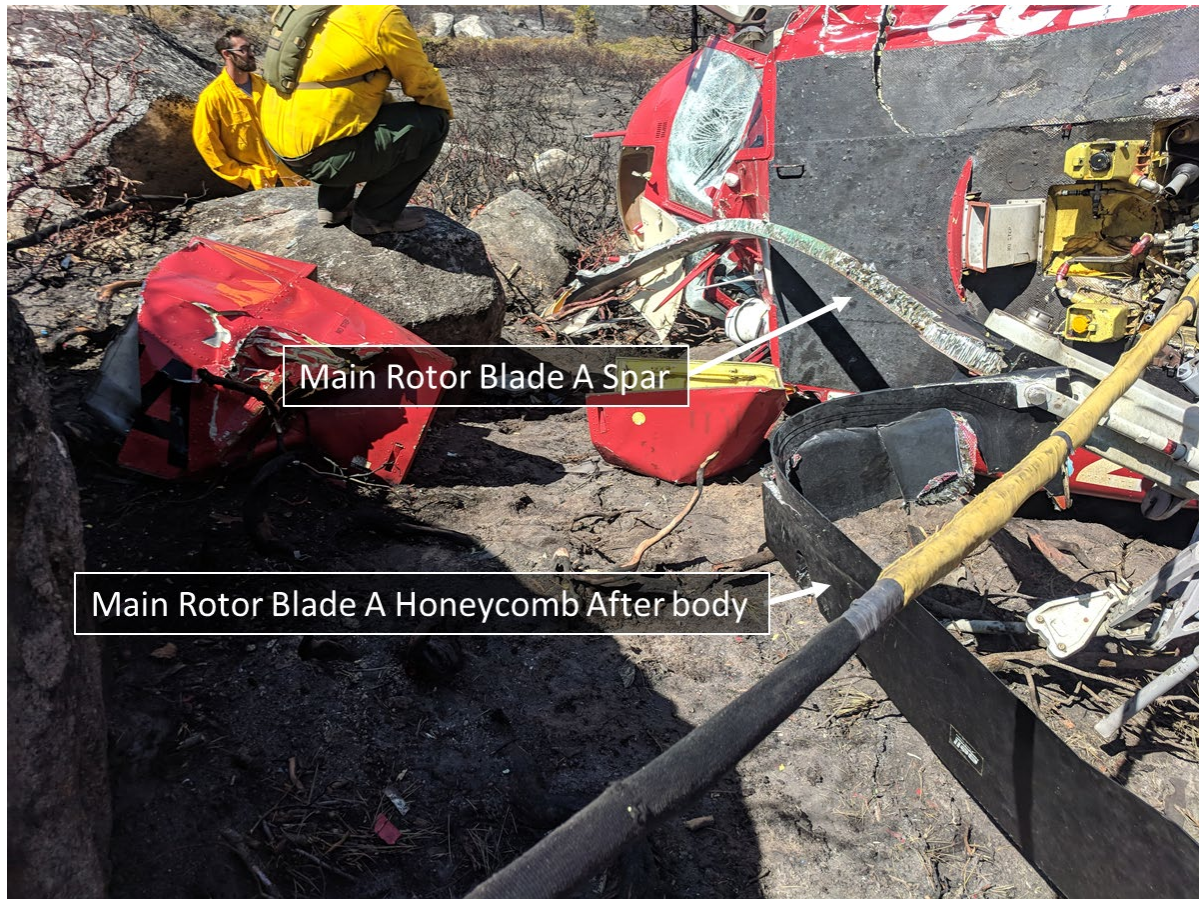
Figure 17. Image showing how Blade A separated into two long halves, a spar half, and a honeycomb after body half. Photo US Forest Service.

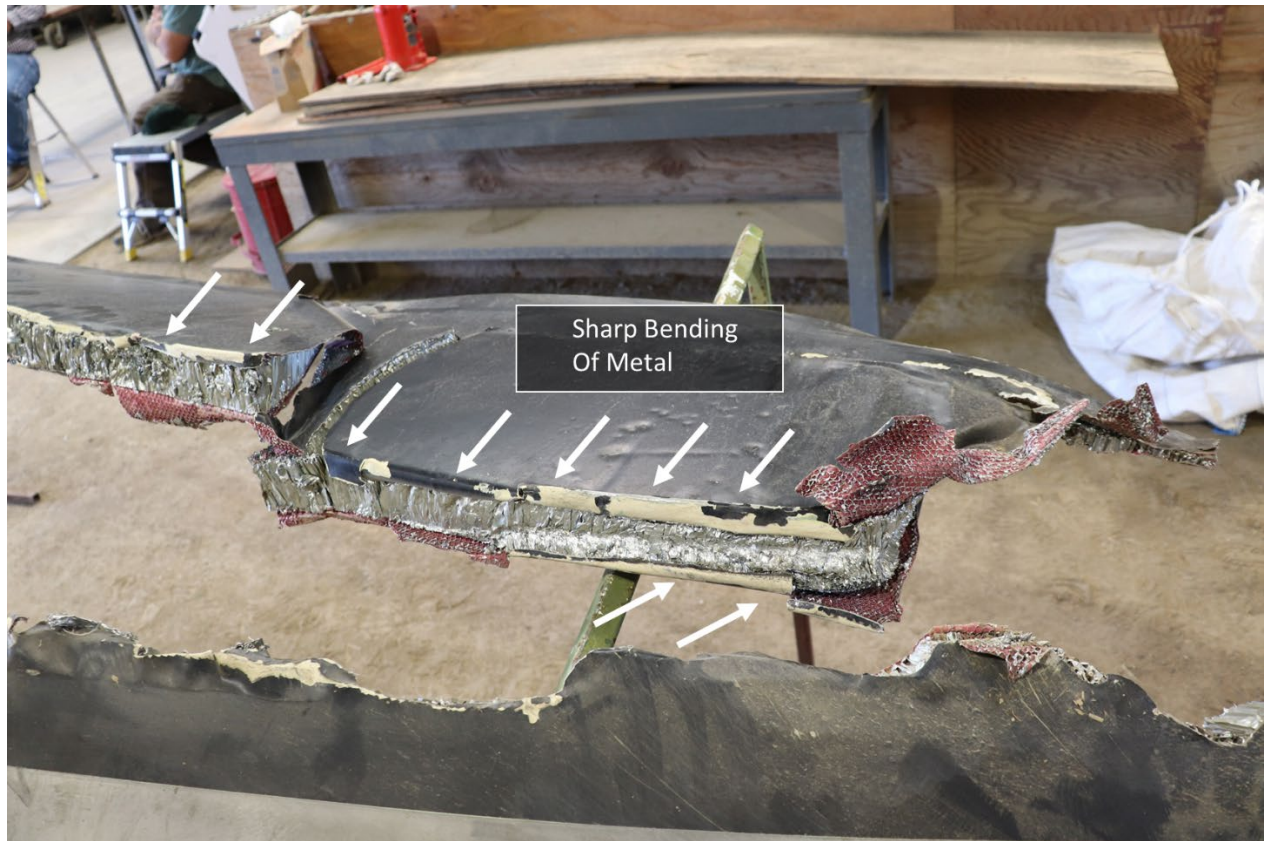
Figure 18. Image of the honeycomb half of blade A, showing the skin bent over 90° and black paint removed.

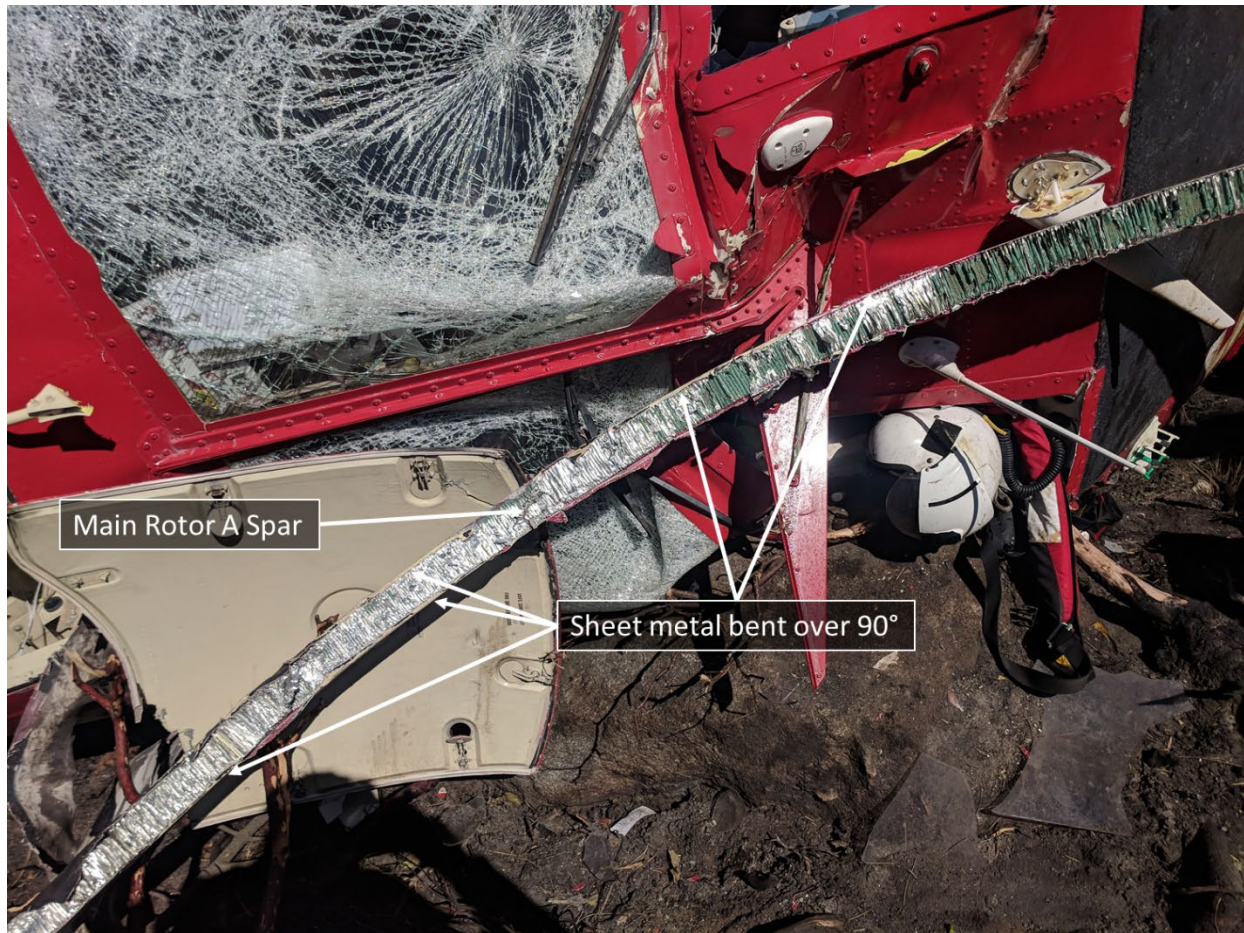
Figure 19. Image showing the spar half of blade A with skin bent over 90°. Photo US Forest Service.
