**NATIONAL TRANSPORTATION SAFETY BOARD**

**AIRFRAME & ENGINE EXAMINATION REPORT**

**WPR18LA242**

## **Roberts Aircraft Company (Bell) 212 – N512TA**

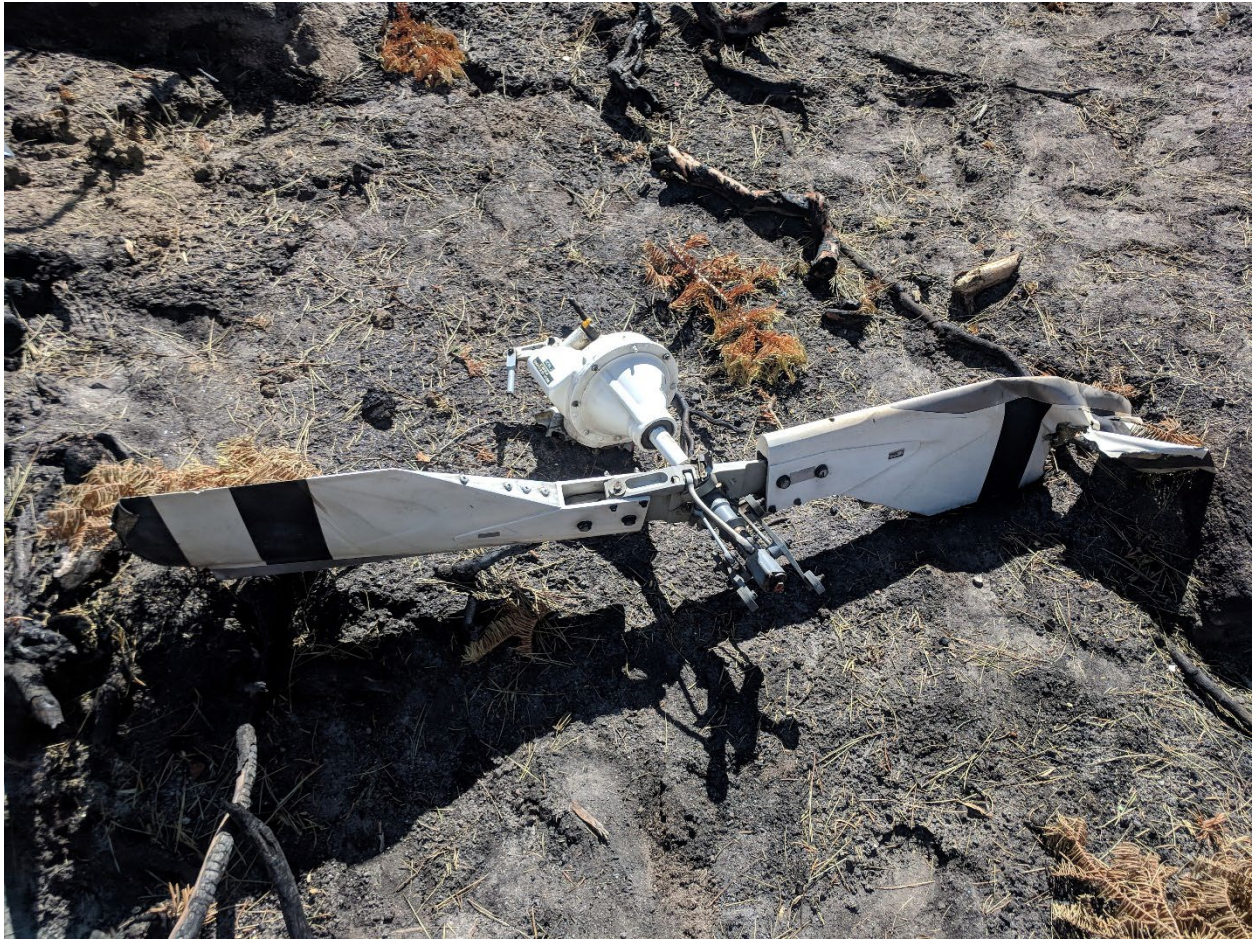
The tail rotor assembly had separated from the top of the vertical stabilizer and was found in the wreckage. The tail rotor assembly was complete. Both tail rotor blades remained attached to the hub and exhibited damage at the blade tips inboard to about mid-span. One blade exhibited a 90° bend about ten inches from the tip. The other blade exhibited a separation of the tip about eight to ten inches inboard of the tip. Both pitch change rods remained attached at both ends. One pitch change rod exhibited an outward bend. The other appeared straight. The counterweights remained attached to the pitch change rod. The 90° gearbox remained intact with no evidence of oil leakage. The oil filler cap remained attached to the port. The bellcrank remained attached to the 90° gearbox, and the control rod from the bellcrank appeared to have separated from the control tube at the threads of the control rod.

Figure 23. Tail Rotor Assembly and 90°gearbox. Photo US Forest Service.
