# NATIONAL TRANSPORTATION SAFETY BOARD

## MATERIALS LABORATORY FACTUAL REPORT

Report No. 20-007

Place : Dardanelle, California  
Date : August 25, 2018  
Vehicle : Bell 212, N512TA  
NTSB No. : WPR18LA242  
Investigator : Fabian Salazar, AS-WPR

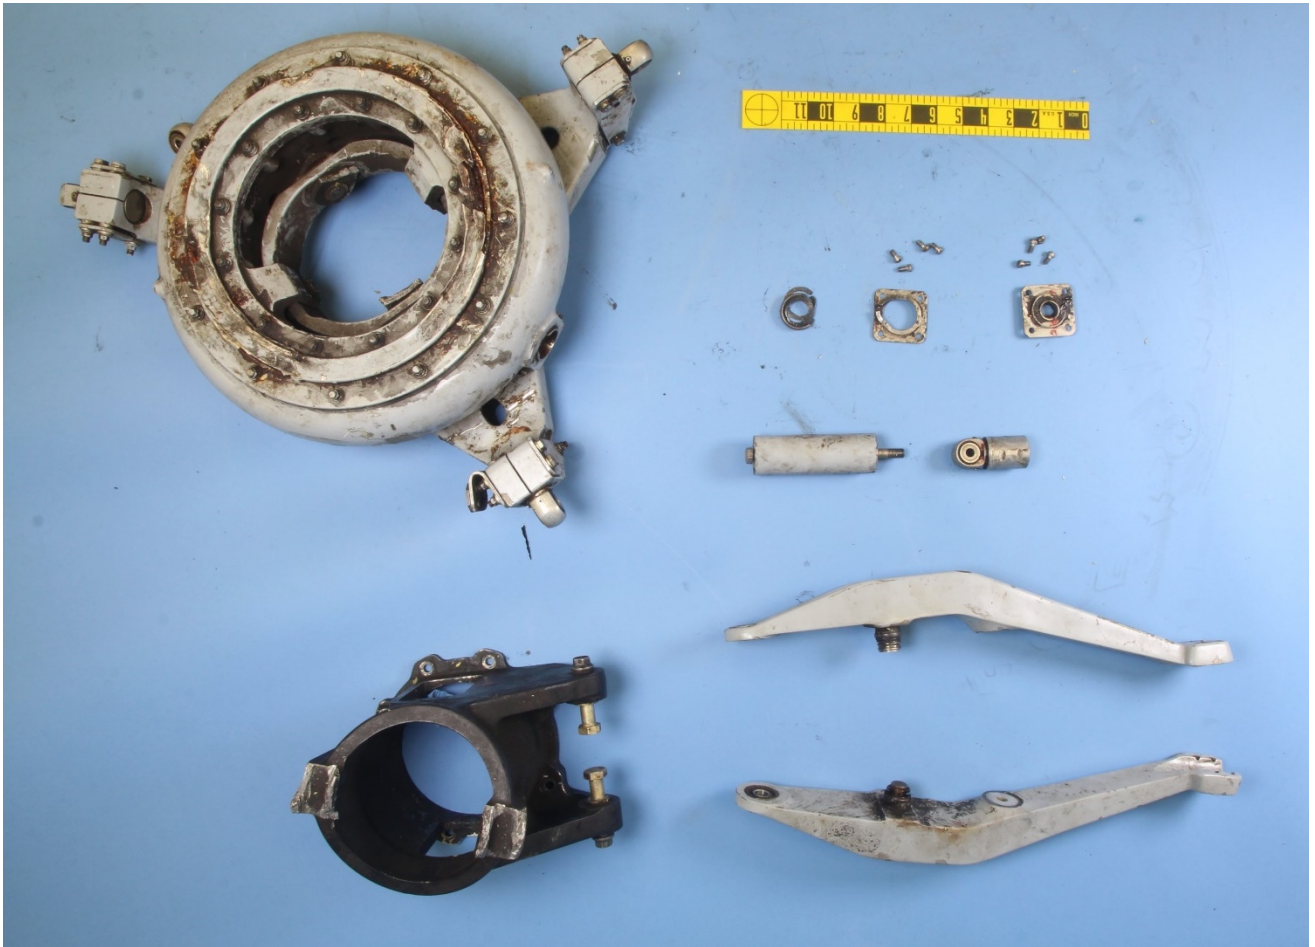
Figure 1 shows the components from the swashplate and support assembly, as received. Of note were the fractured clevises of the collective support, still attached to the gimble ring assembly in the swashplate assembly, along with a fractured bearing liner and ring.

Figure 1 – The components from the swashplate and sleeve assembly, as received.

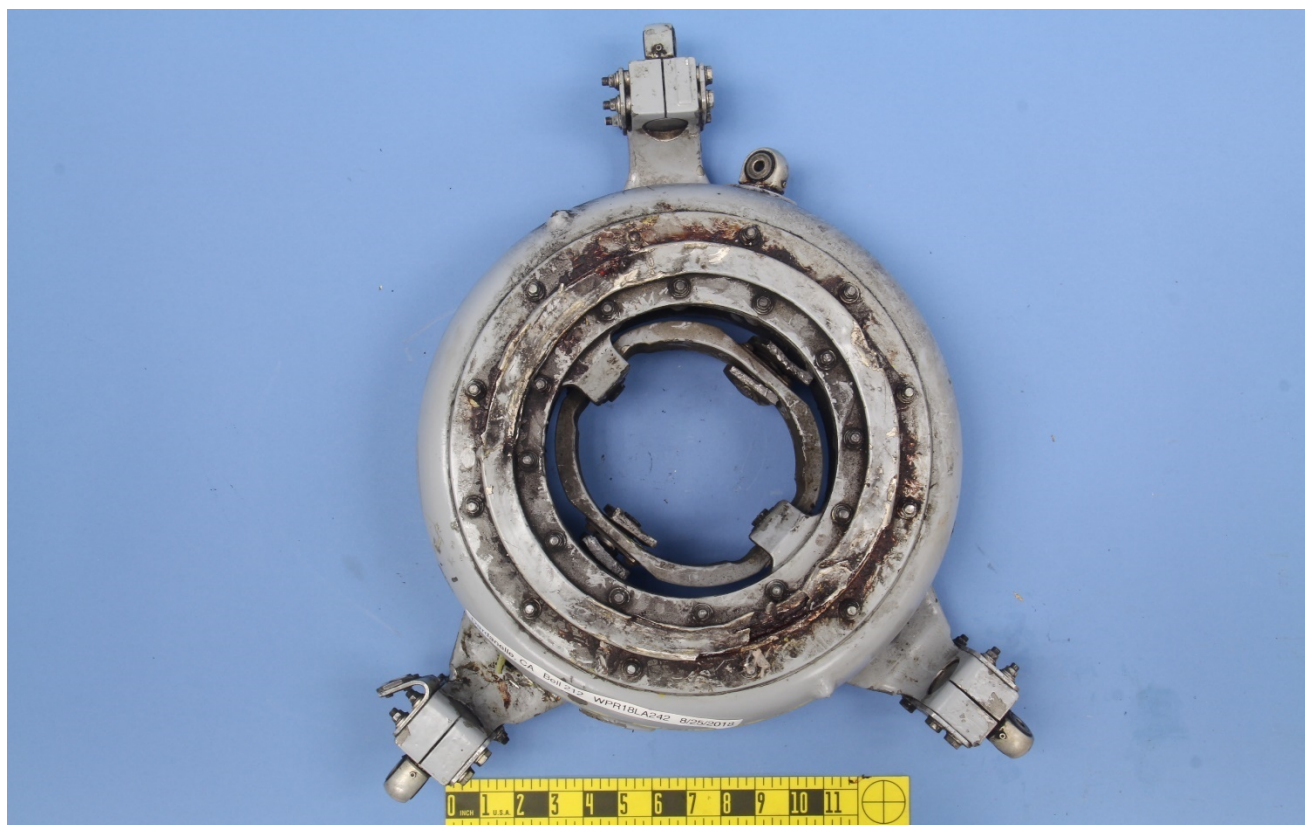
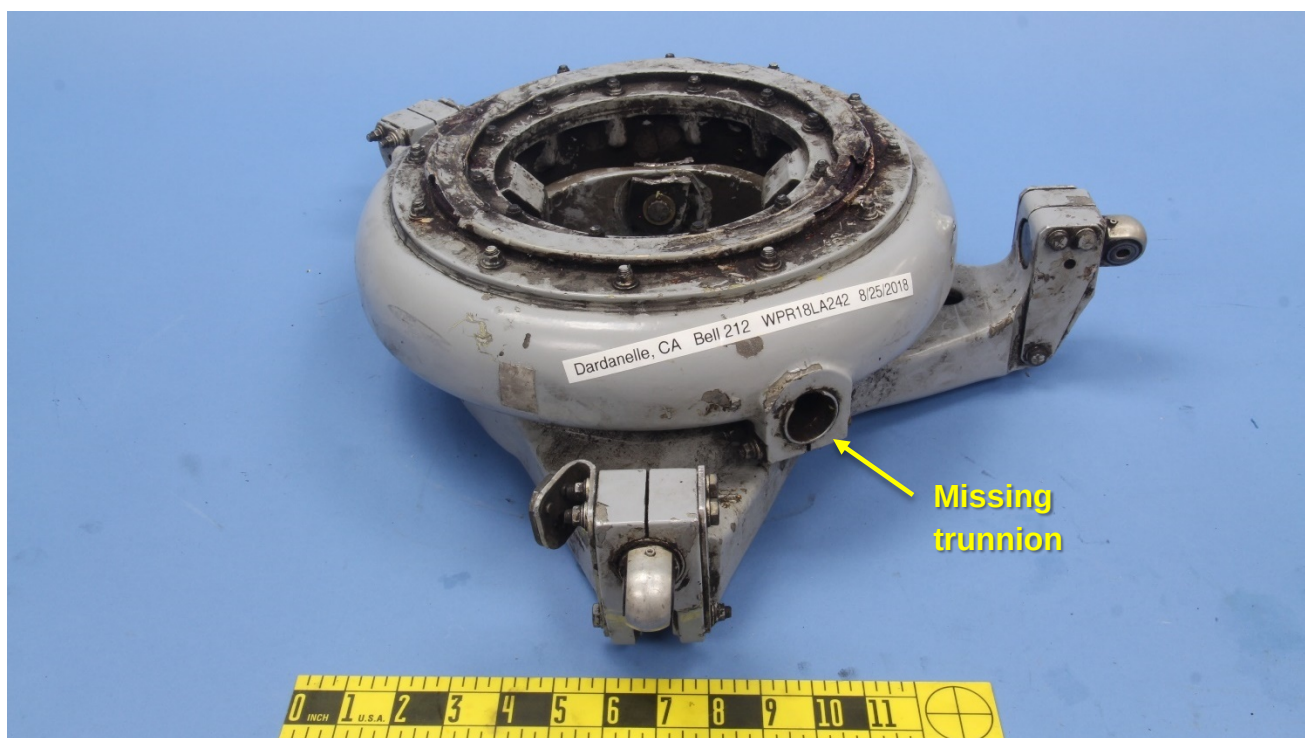
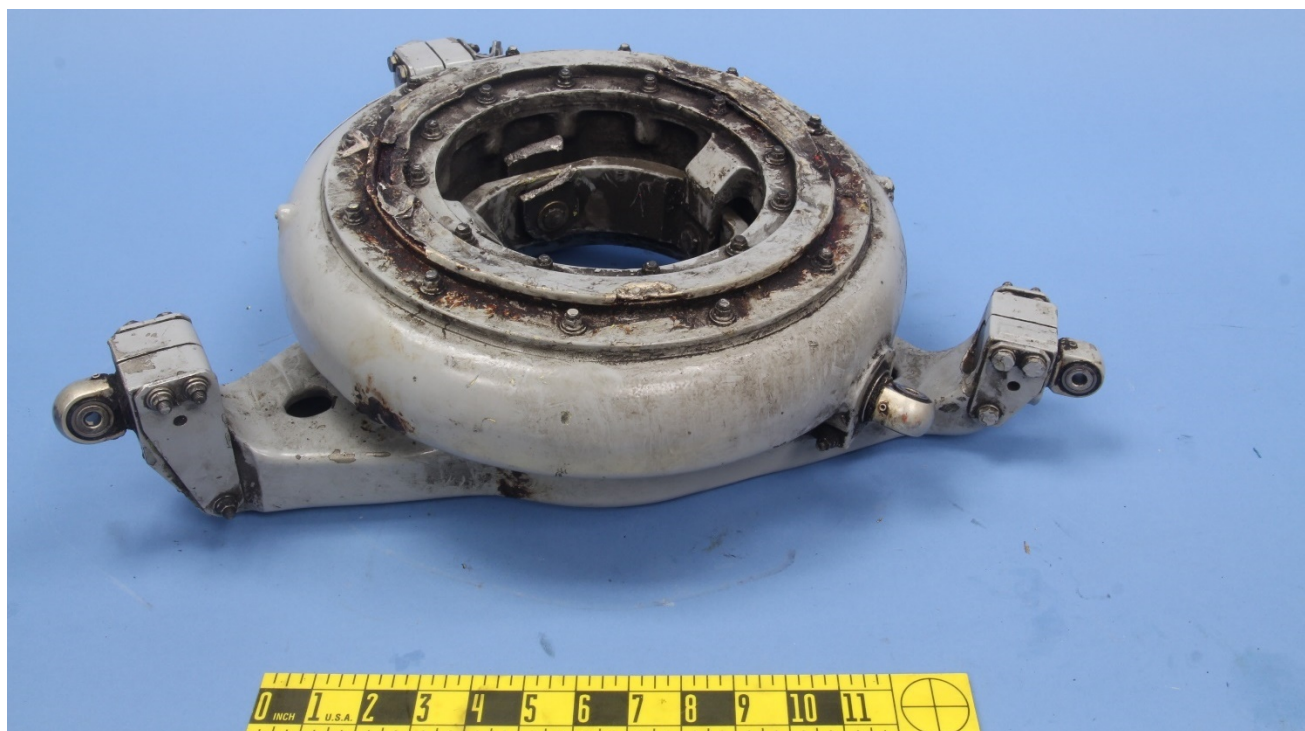
Figures 2 through 4 show the swashplate support assembly from three different angles, as received. In general, the outer housing and surfaces of the swashplate were intact and relatively undamaged. Of note were a separated trunnion, visible by a dark hole in Figure 3.

Figure 2 – The swashplate assembly, viewed from the upper face.

Figure 3 – The swashplate assembly, angled view from the side.

Figure 4 – Angled view of the swashplate assembly, rotated 180° from Figure 3.

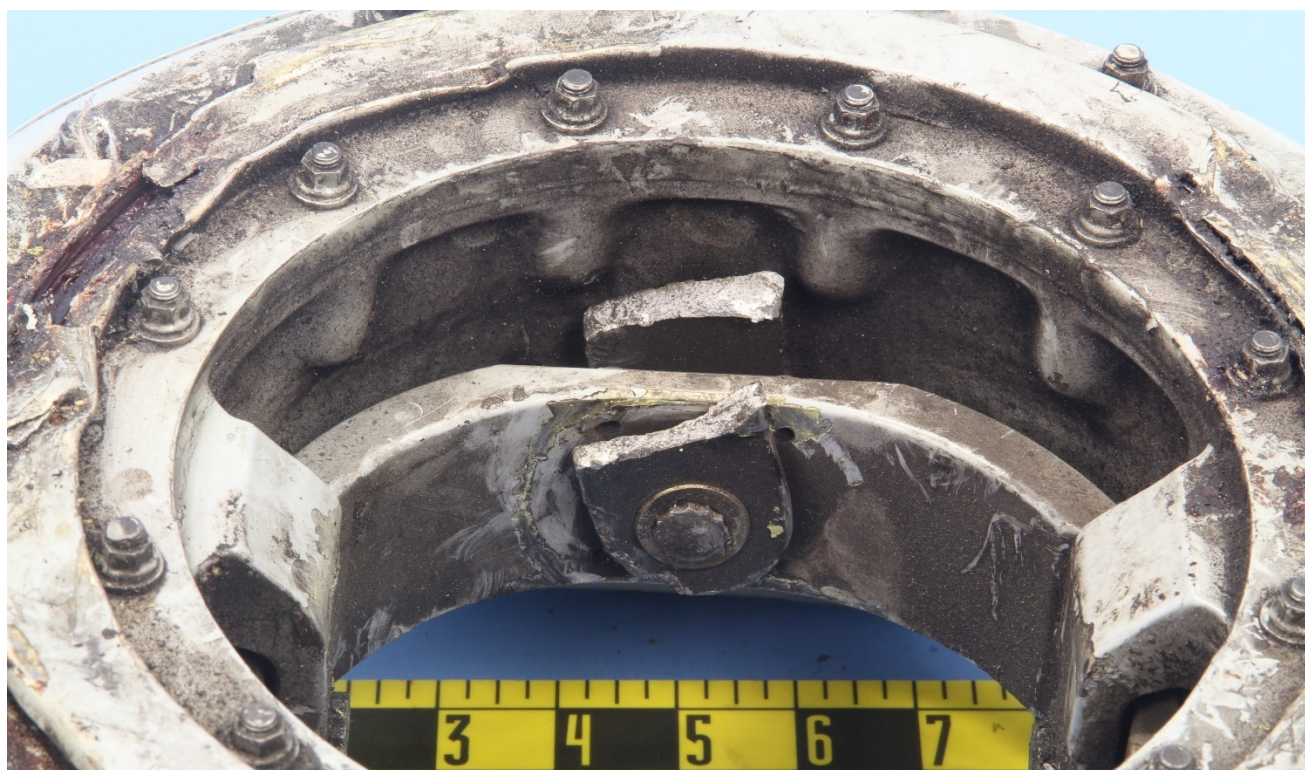
Figure 5 shows the interior surfaces of the swashplate assembly. This view shows two fractured clevises from the collective support, still attached to the gimble ring assembly. The gimble ring was able to be actuated up and down, as received. The opposite view is shown in Figure 6—similar to Figure 5, this side of the gimble ring also exhibited two fractured clevis fragments from the support affixed to the gimble ring by an attachment bolt. On both sides, the clevises had fractured approximately 0.5 to 1 inches from the attachment bolt.

Figure 5 – View of two of the fractured clevises from the collective support, attached to the swashplate assembly through the gimbal ring assembly, as received.

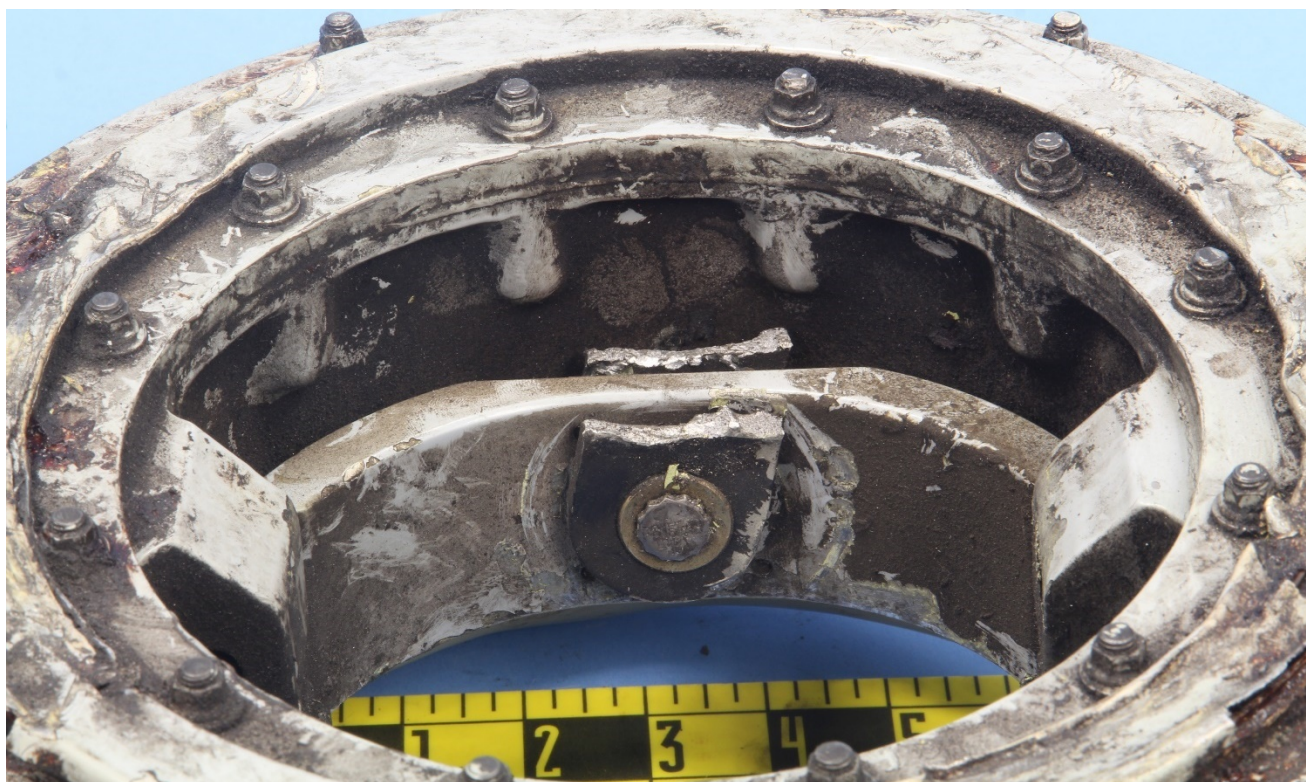
Figure 6 – View of two of the fractured clevises from the collective support, attached to the swashplate assembly through the gimbal ring assembly, as received.

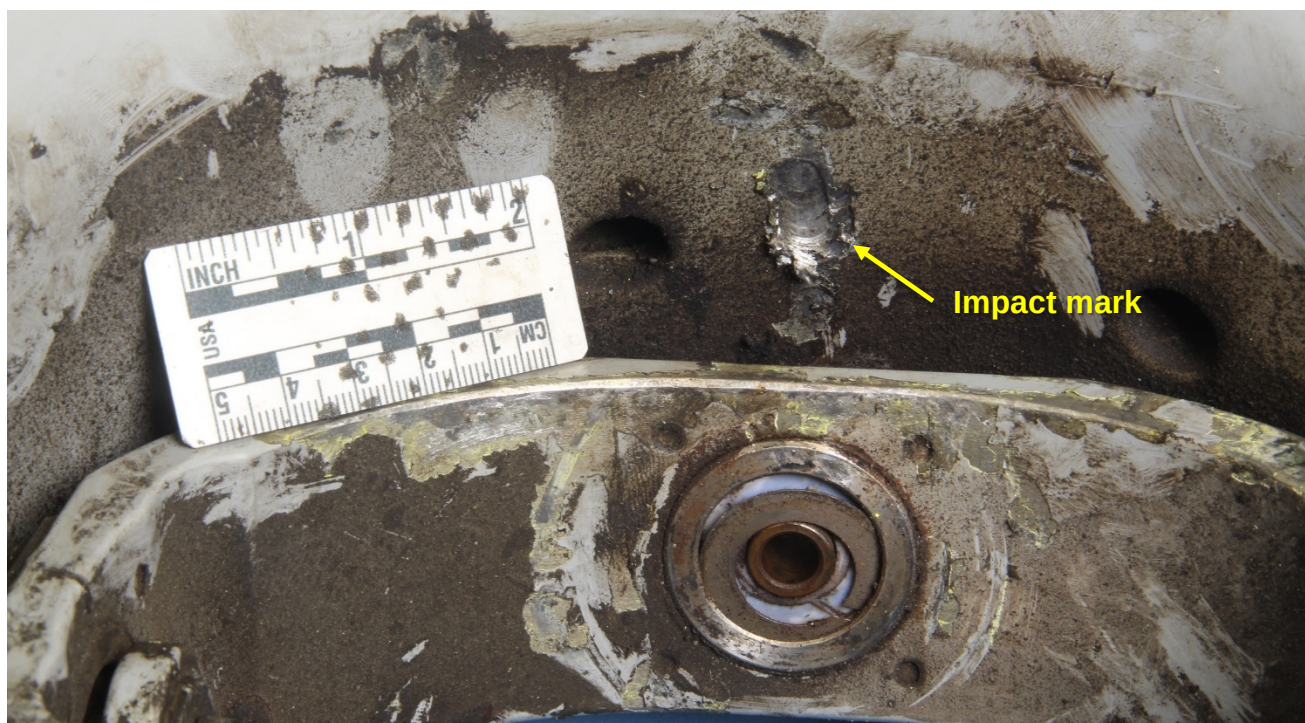
The bolts in the gimble ring were disassembled and the clevis fragments were removed from the swashplate assembly. Figures 7 and 8 show the inner faces of the swashplate housing after removal of the clevis fragments. On both sides, areas with smeared metal were observed. Each of these areas of smeared metal were approximately 1 inch long and 0.25 inches in width. The shapes of the smeared metal were consistent with impact marks from collision with an adjacent metallic part.

One of the bearing liners holding the attachment bolt of the fractured clevises had fractured on the inner surface, as shown in Figure 7. The bearing liner on the opposite side had fractured in several locations, on the inside and outside surfaces as shown in Figures 8 and 9. This bearing liner exhibited fractures in radial and circumferential directions.

Figure 7 – View of the area in Figure 6, after removal of the bolt and clevises. With the gimble ring pushed down, impact marks were present on the inner surface of the swashplate housing.

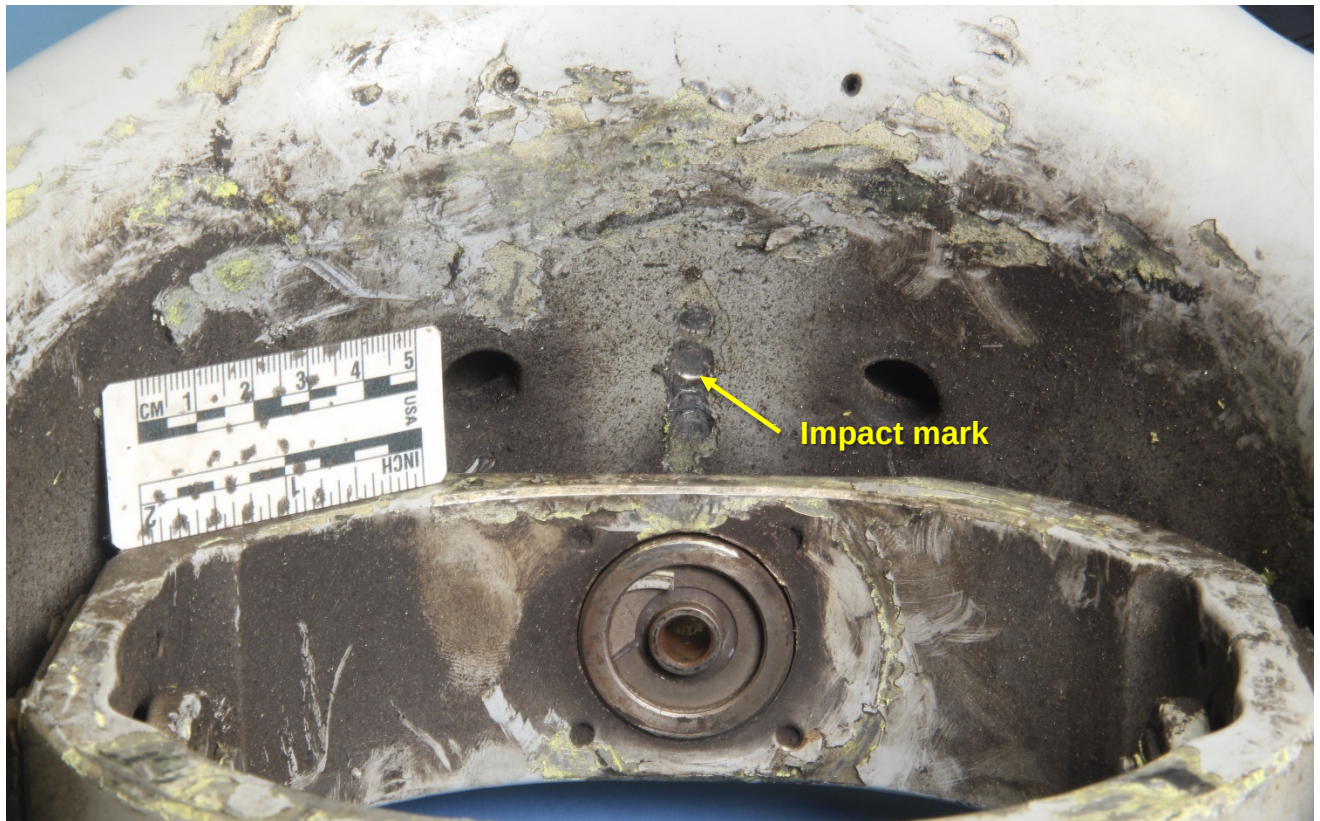
Figure 8 – View of the area in Figure 5, after removal of the bolt and clevises. With the gimble ring pushed down, impact marks were present on the inner surface of the swashplate housing.

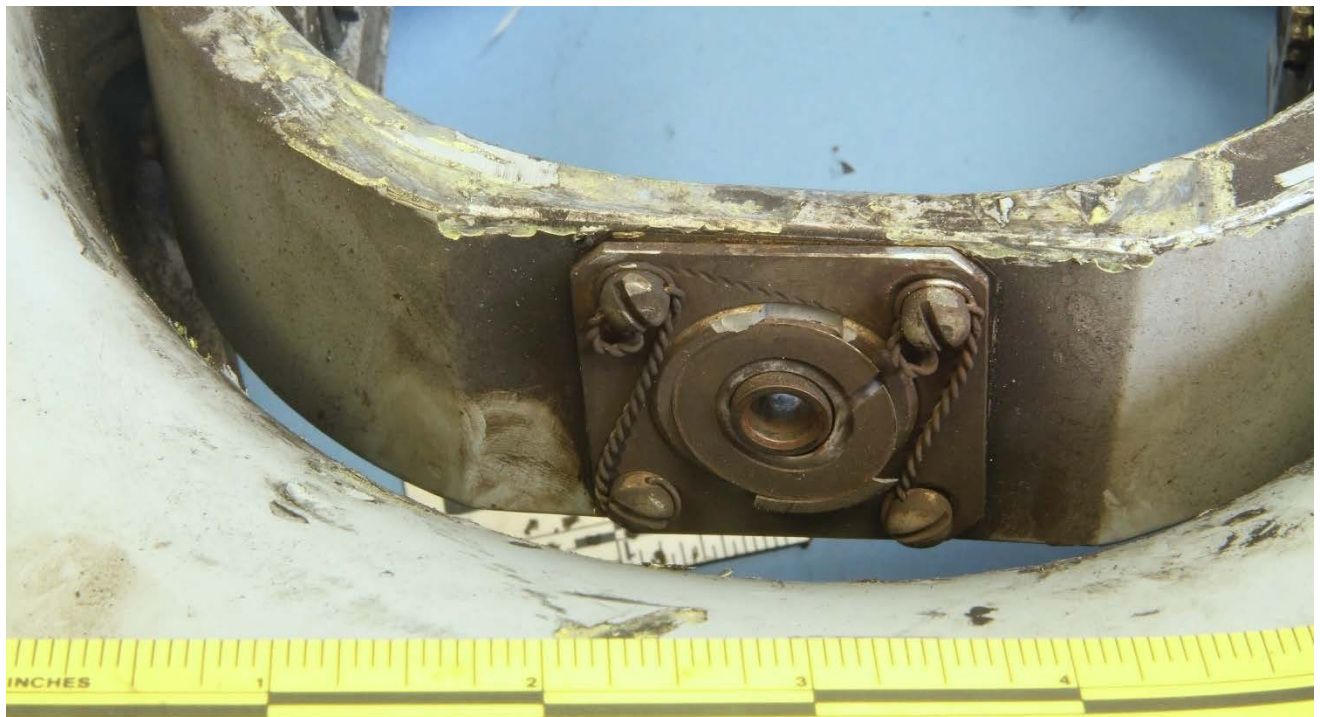
Figure 9 – View of the fractured bearing and liner on the gimble ring opposite Figure 8.

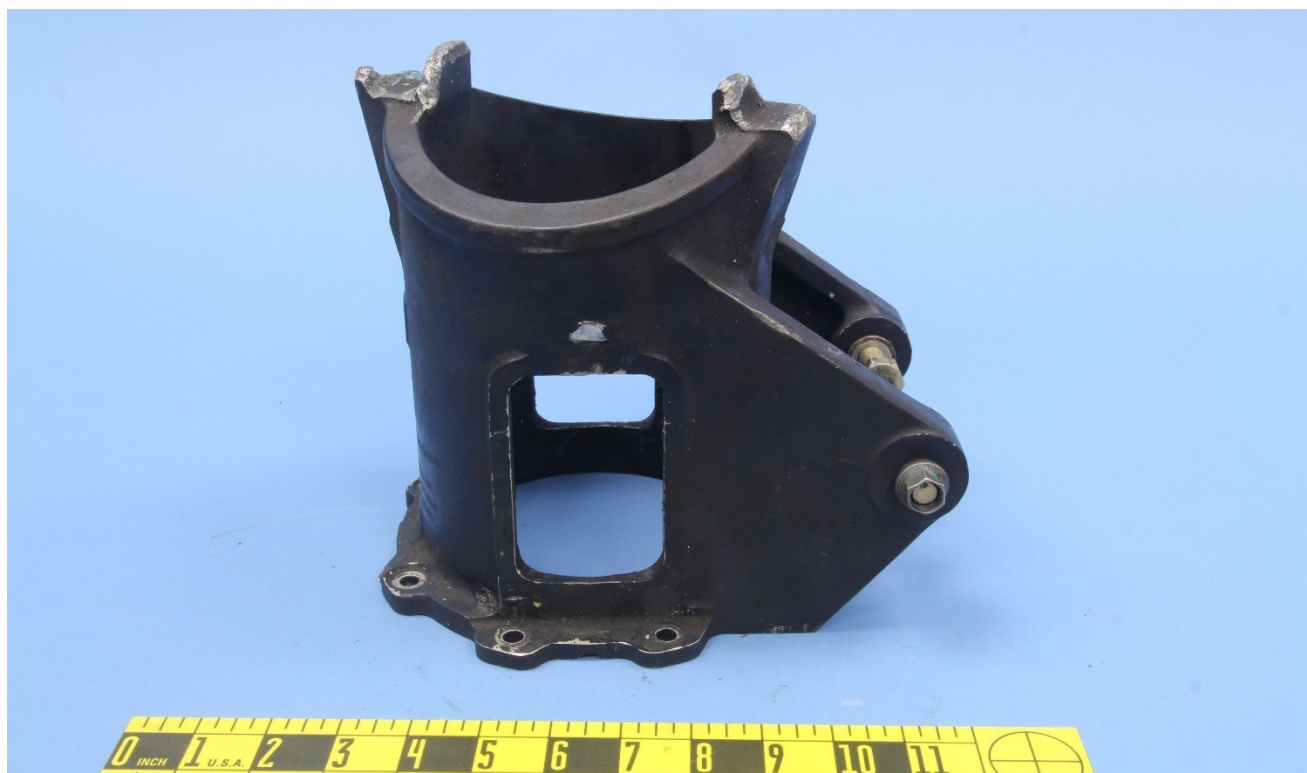
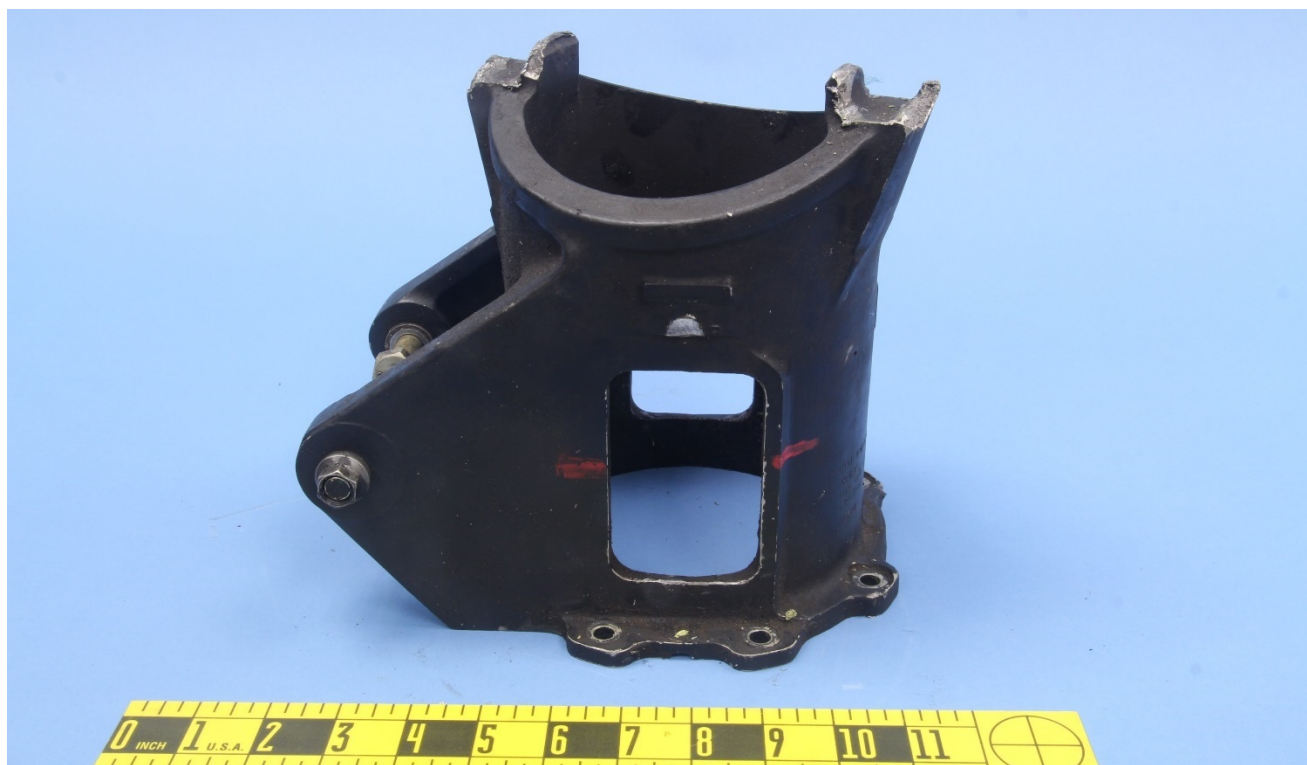
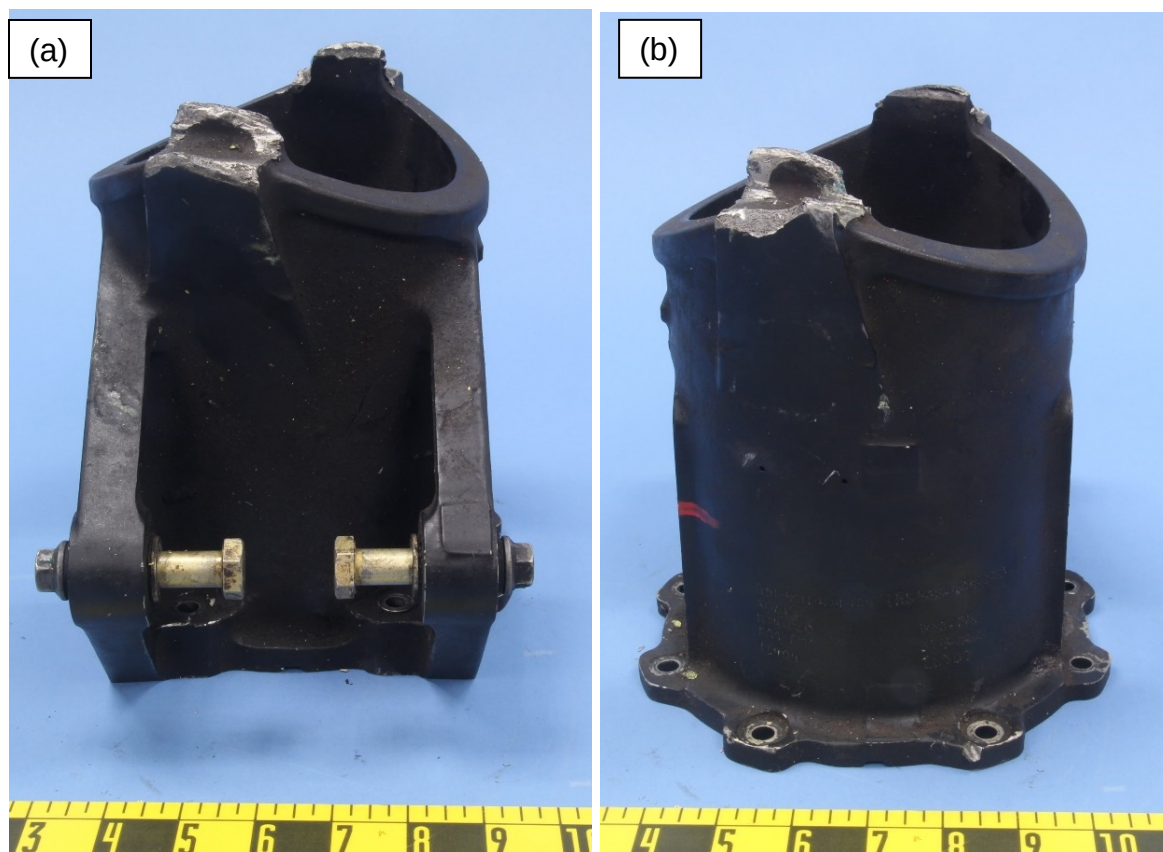
Figures 10 through 12 show the collective support from four different faces, as received. The support exhibited the following markings: ASI-4011-404-125 REV F BT4-060 FAA-PMA IL909. Other markings were present on the part, but they had been disfigured with X-marks, consistent with vibroetched markings.

Figure 10 – The collective support, viewed from the right side, showing fractured attachment clevis remnants and an impact mark.

Figure 11 – The collective support, viewed from the left side.

Figure 12 – The support in Figure 10, shown from (a) the forward side and (b) the aft side.

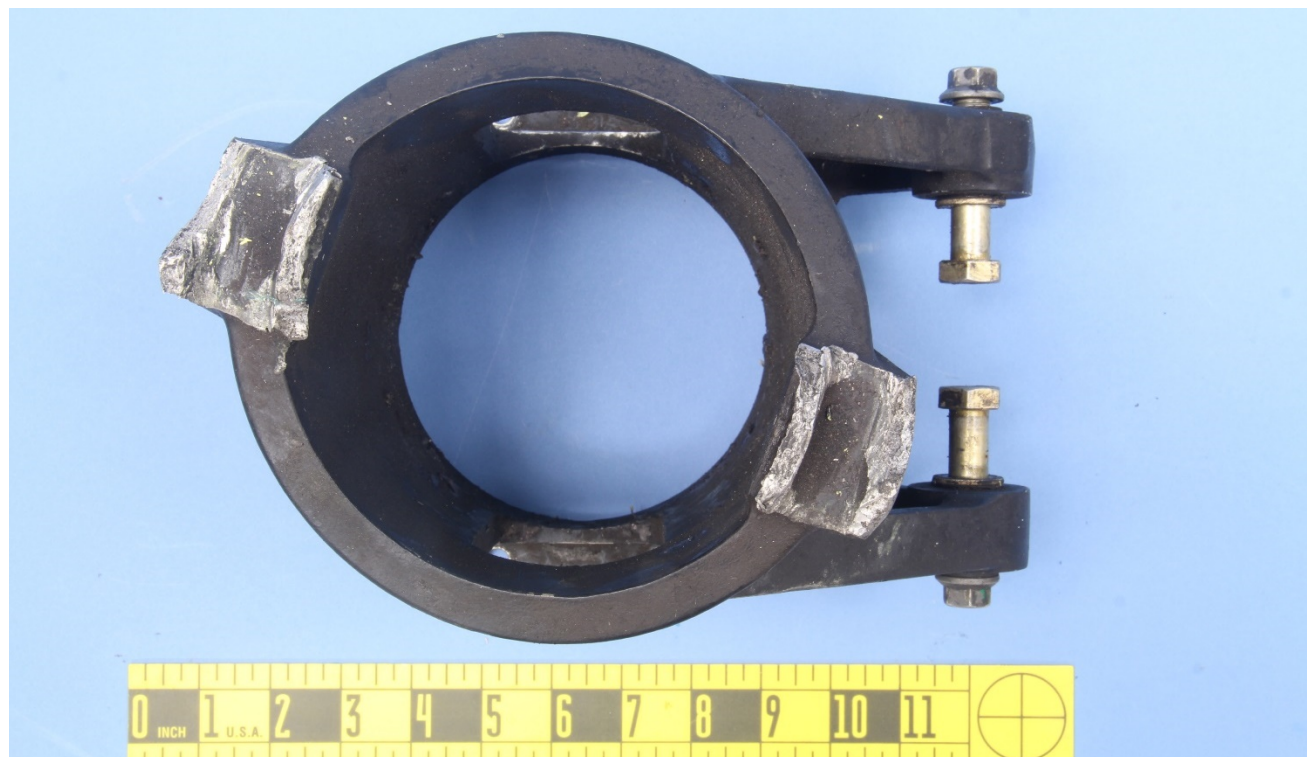
The most notable features on the support were the fractured clevises of the attachment yokes. Figure 13 shows the fracture faces of these clevises and the slot that was adjacent to the gimble ring. As shown in Figure 14, the slots exhibited some wear on the outer edges. There was little visible wear in the middle of the slots.

Figure 13 – A topside view of the support, showing the fractured attachment clevises.

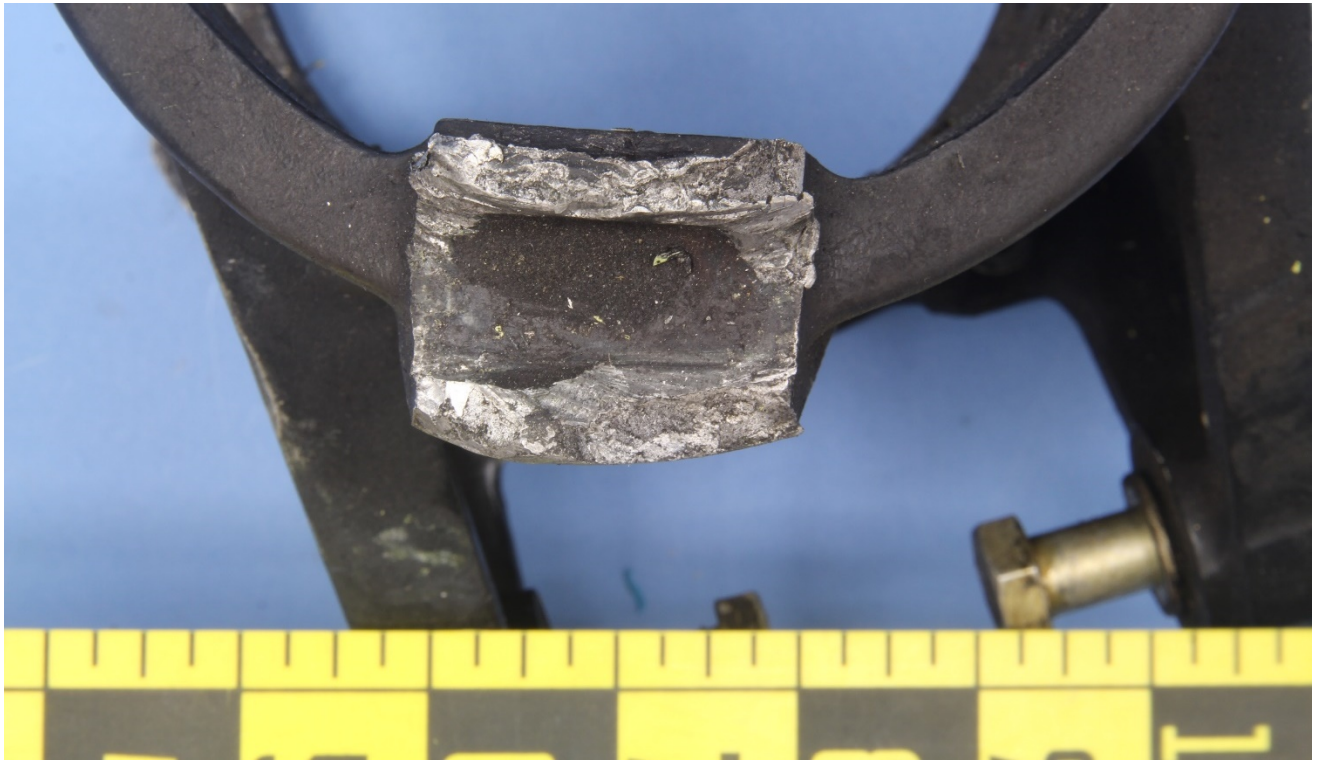
Figure 14 shows the forward side attachment slot of the collective support and fracture faces of the location. The removed clevis fragments from the swashplate were matched with this portion of the support—they are collectively illustrated in reconstructed positions in Figures 15 and 16. These clevis fragments were labeled 1 and 2 for the purposes of this report.

Figure 14 – The forward gimble ring seat of the support, which fractured on the attachment clevis.

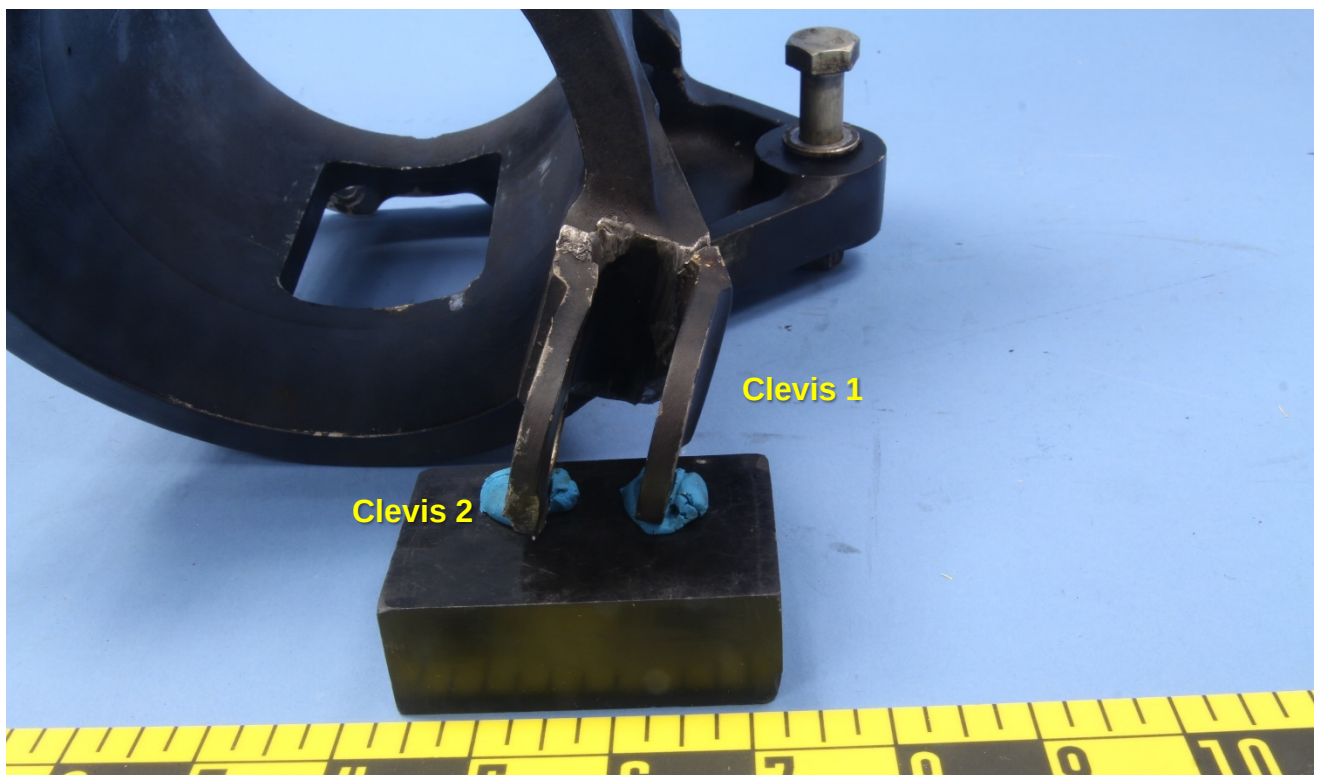
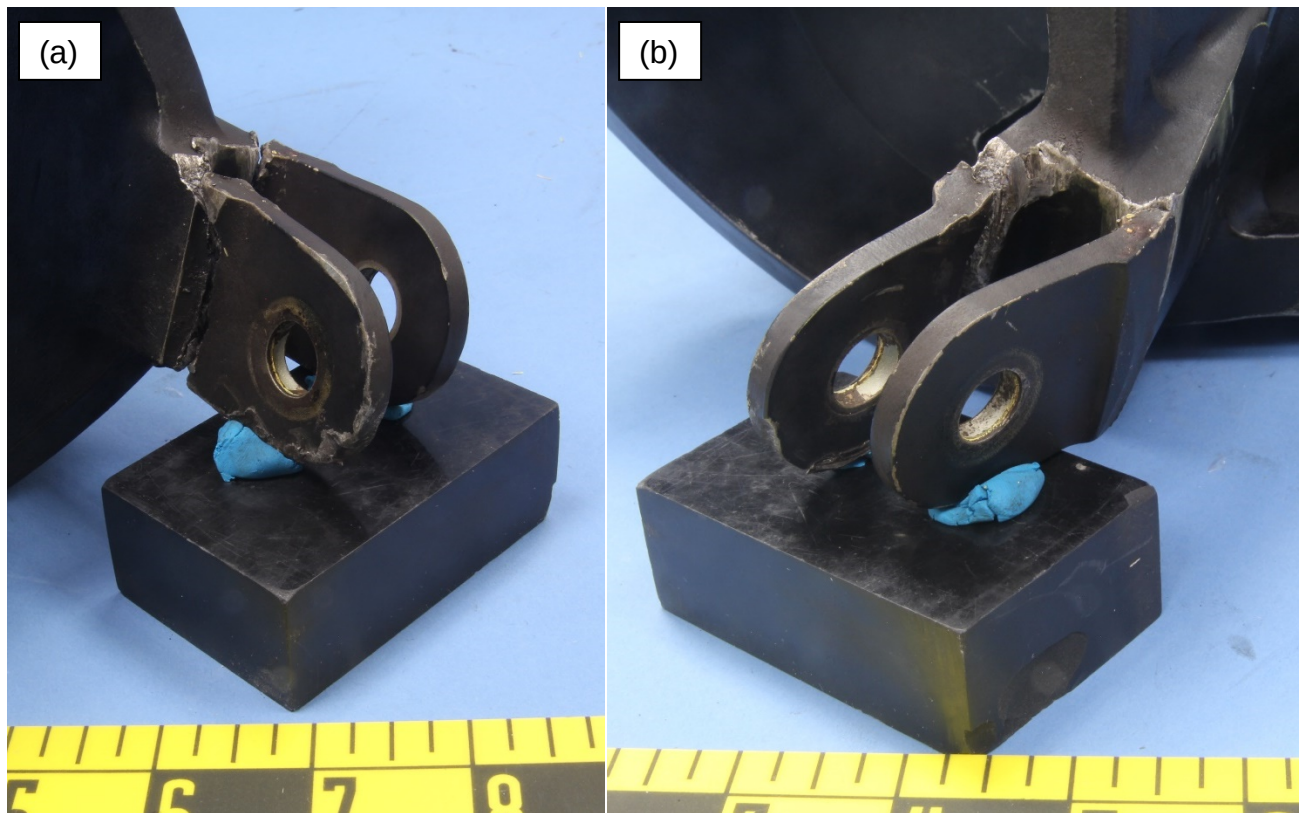
The fracture faces of the fragments did not completely match up with the fracture faces on the support. There were indications of necking and tearing adjacent to the fracture faces, consistent with local plastic deformation. The fracture faces also exhibited batter

and smearing. These features were consistent with post-fracture impact damage between the fragments and the support.

Figure 15 – The forward fractured clevises of the support, staged to show their positions at fracture. The clevis remnants were labeled "1" and "2" for the purposes of this report.

Figure 16 – The repositioned clevises 1 and 2 viewed from (a) the aft side and (b) the forward side.

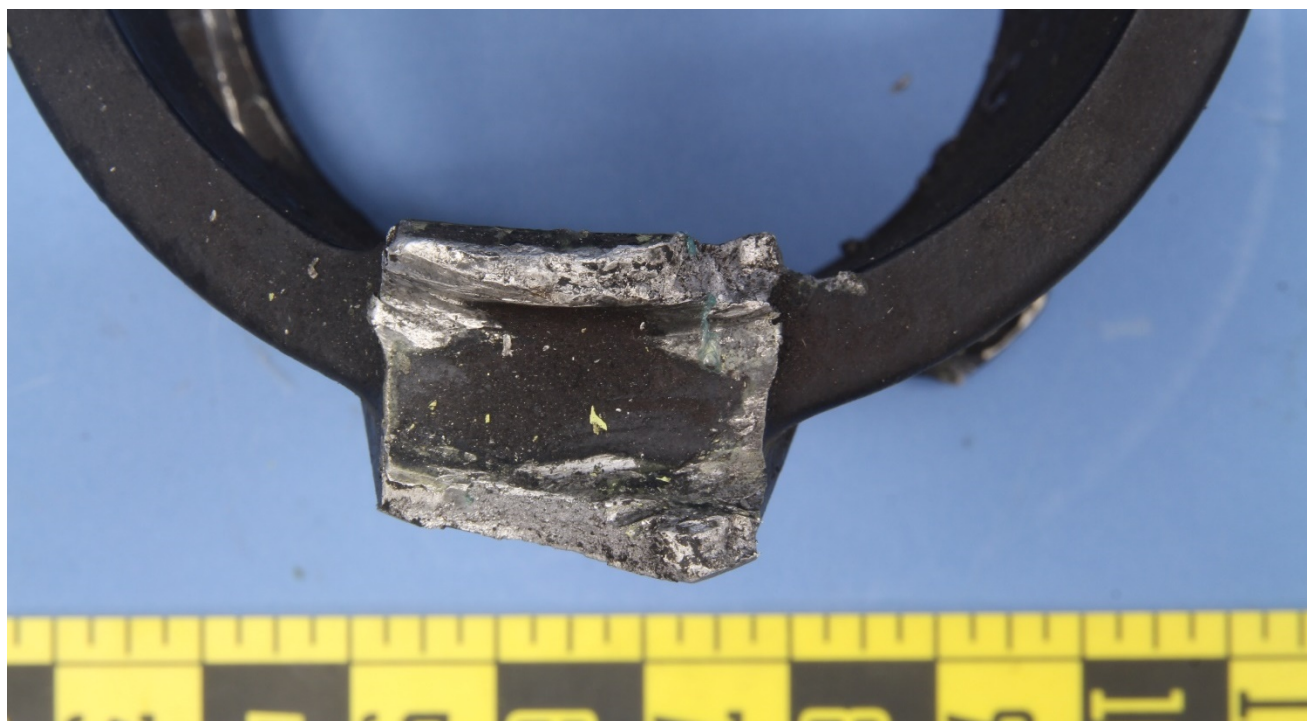
Figure 17 shows the aft side attachment slot of the collective support and gimble ring slot. The damage and wear patterns on this portion of the support were similar to the fractured slot on the forward side. The removed clevis fragments from the swashplate were matched with this portion of the support, and they are illustrated in reconstructed positions in Figures 18 and 19. These clevis fragments were labeled 3 and 4 for the purposes of this report.

Figure 17 – The aft gimble ring seat of the support, which fractured on the attachment clevis.

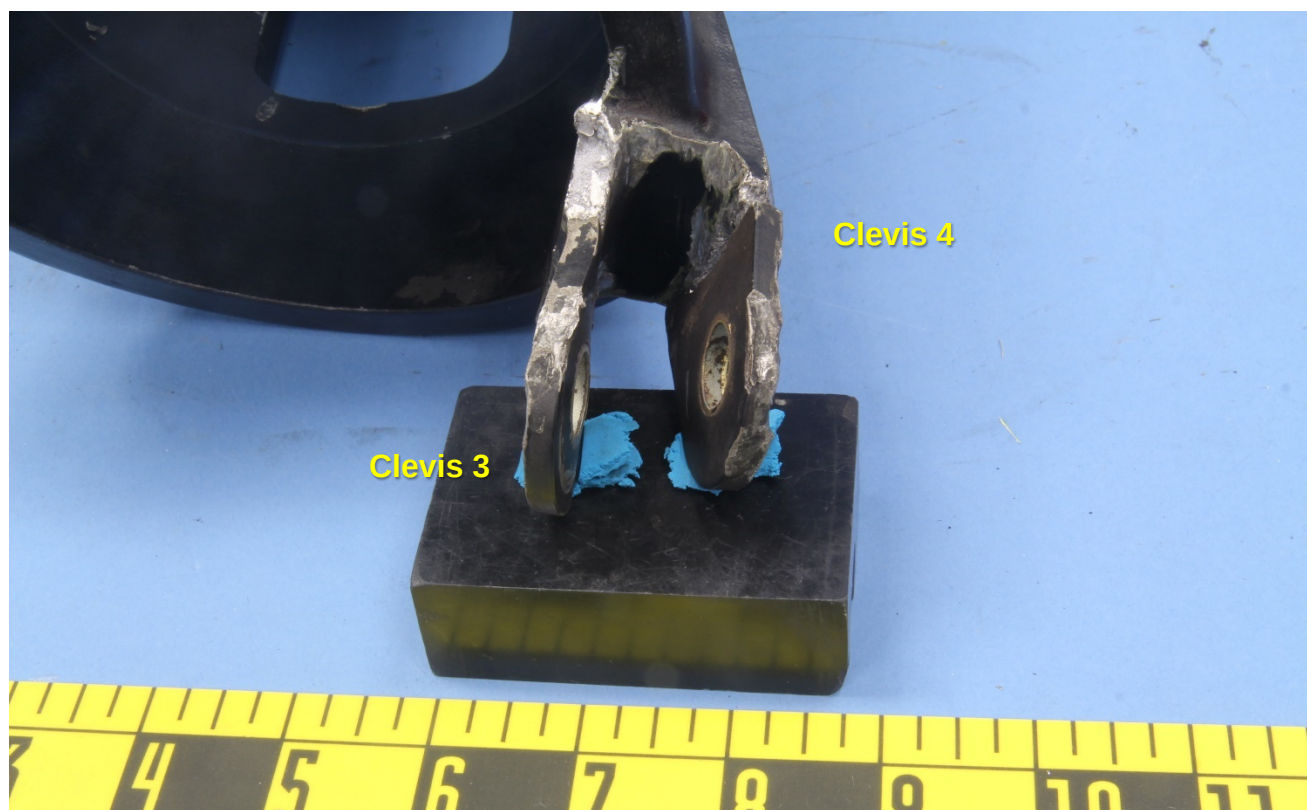
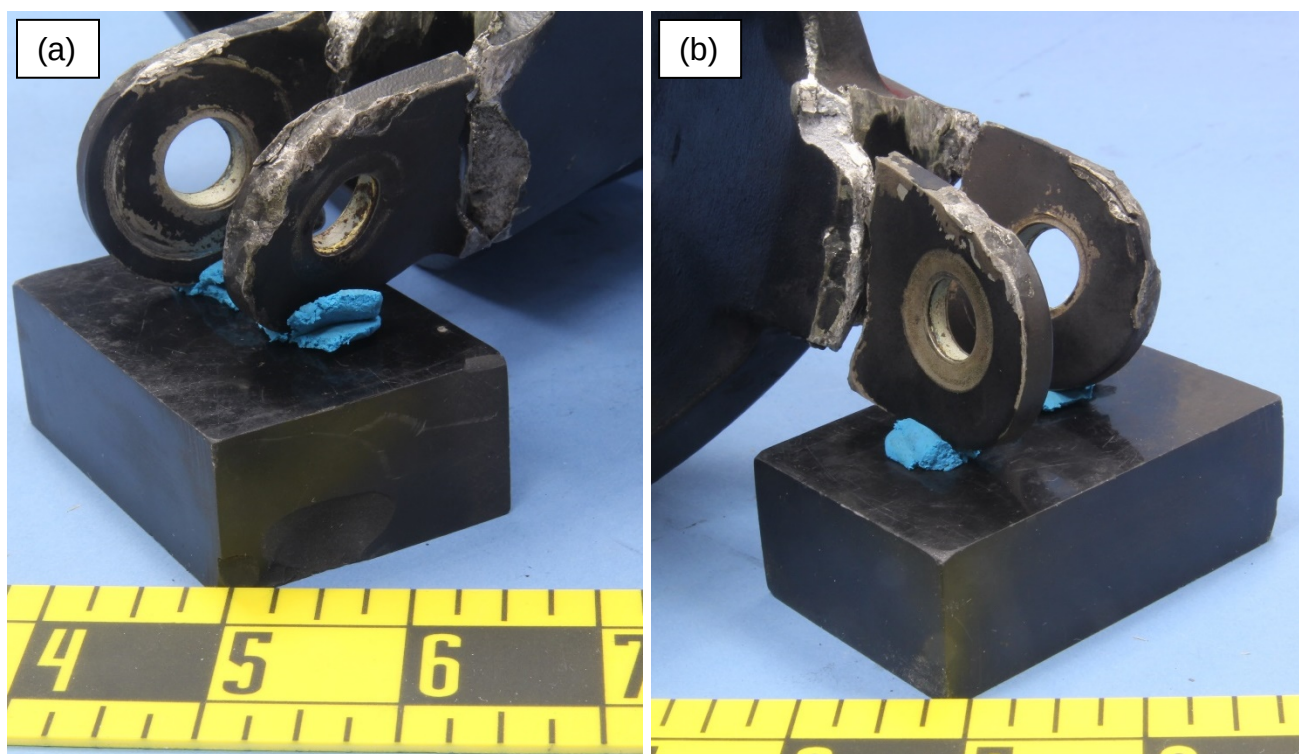
Similar to the forward side, the aft support fracture reconstruction found features consistent with local plastic deformation, such as necking and tearing. In addition, the fracture faces were orientated away from the direction parallel to the support. This misorientation is shown in Figure 18. These features were consistent with a bending component to the fracture of the clevises 3 and 4. Like the forward side, the aft side fracture surfaces exhibited features consistent with post-fracture impact damage, such as smearing and batter.

Figure 18 – The aft fractured clevises of the support, staged to show their positions at fracture. The clevis remnants were labeled “3” and “4” for the purposes of this report.

Figure 19 – The repositioned clevises 3 and 4 viewed from (a) the aft side and (b) the forward side.

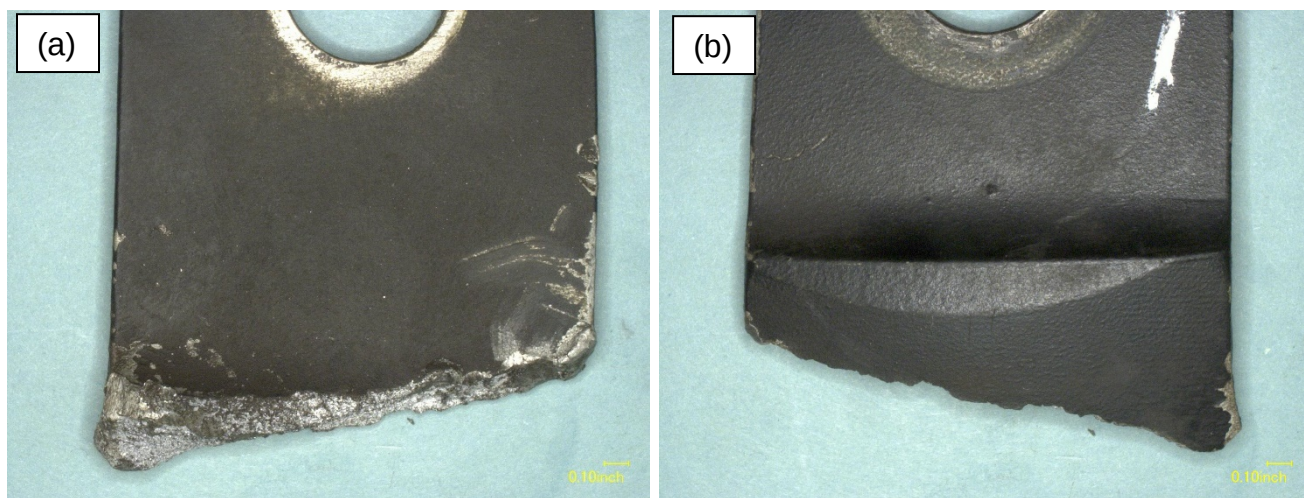
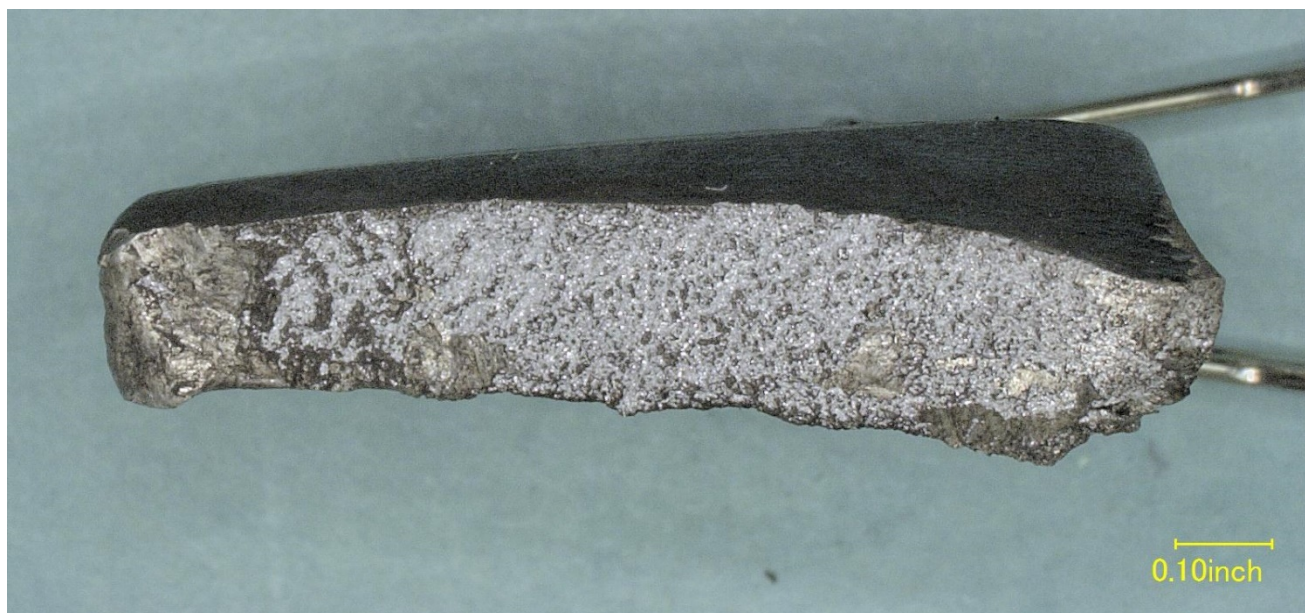
Figure 20 shows the inward and outward faces of clevis fragment 1. The fragment exhibited a slant-angled fracture surface located between 0.12 and 0.25 inches from the shoulder of the attachment piece. Figure 21 shows the fracture surface of this clevis fragment. The fragment was bent on the right side of Figure 21, consistent with a twisting moment on that side. The left side of the fracture surface had been significantly damaged by post-fracture smearing.

Figure 20 – The (a) inward and (b) outward-facing surfaces of the fractured support clevis 1.

Figure 21 – View of the fracture surface of the fractured support clevis 1.
