# NATIONAL TRANSPORTATION SAFETY BOARD

## MATERIALS LABORATORY FACTUAL REPORT

Report No. 20-007

Place : Dardanelle, California  
Date : August 25, 2018  
Vehicle : Bell 212, N512TA  
NTSB No. : WPR18LA242  
Investigator : Fabian Salazar, AS-WPR

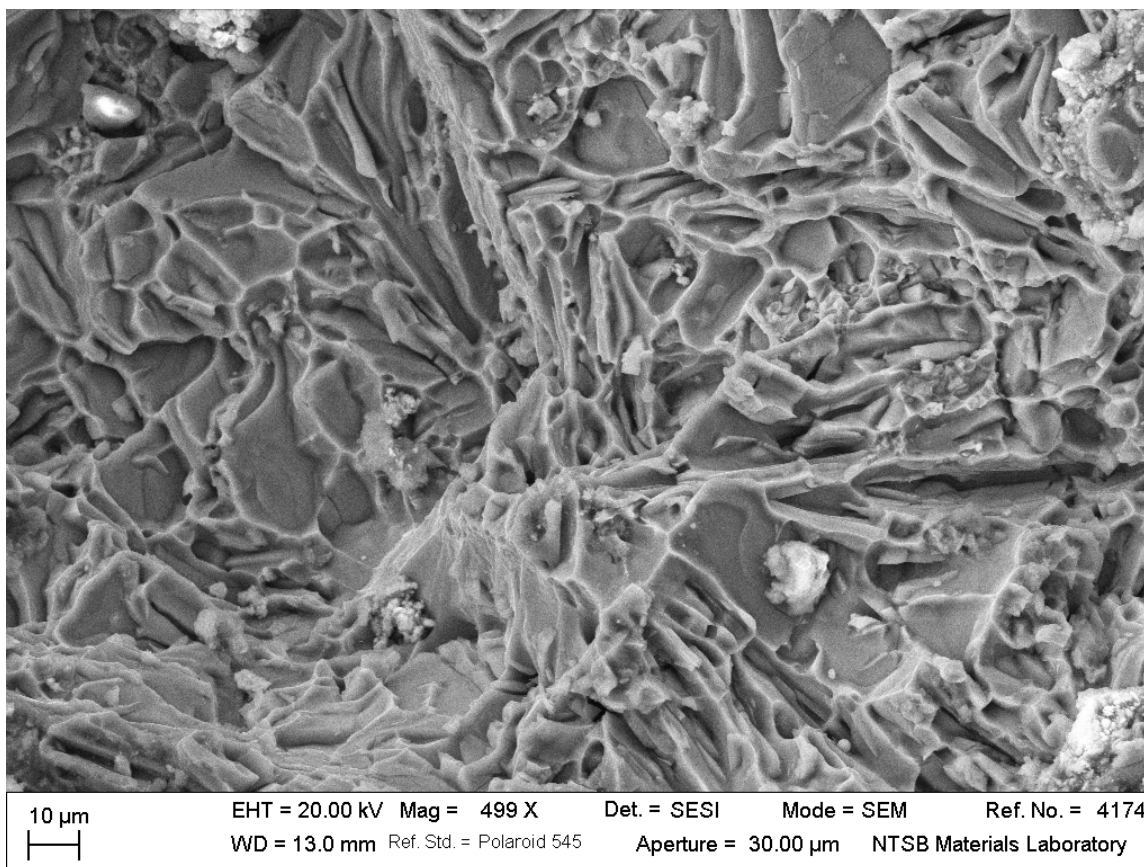
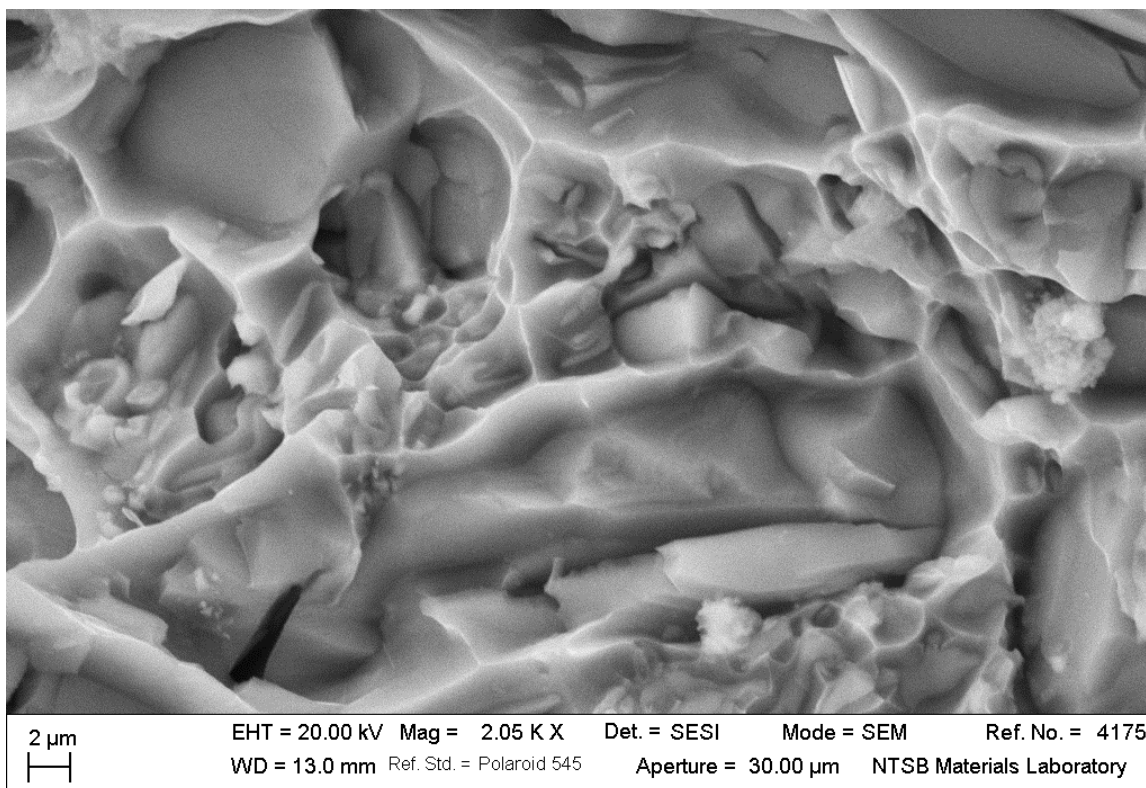
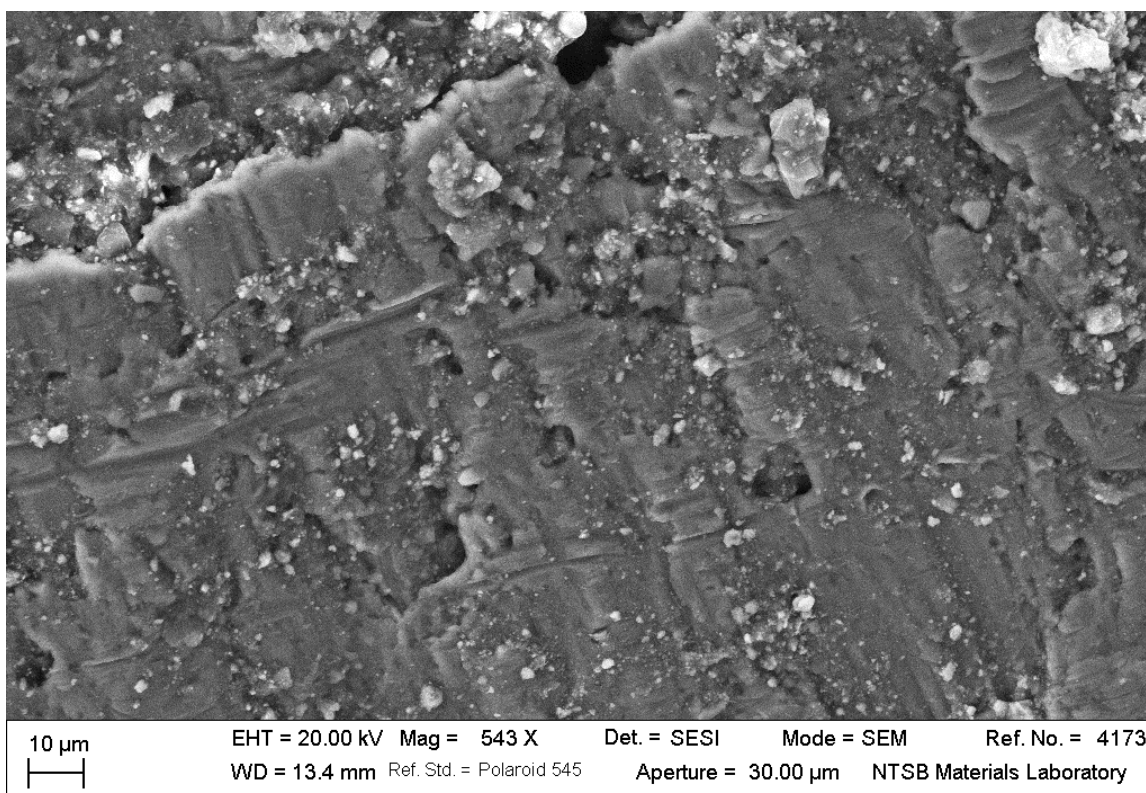
Overall, the clevis 1 fracture surface exhibited a general rough texture, with a dull luster. There were no indications of features consistent with multiple fracture modes or corrosion. This fracture surface was cleaned with acetone and examined using a scanning electron microscope (SEM). The undamaged fracture features on the clevis 1 fracture surface were relatively uniform. Figure 22 shows a typical area of the clevis 1 fracture surface, which exhibited dimple rupture and radiating cleavage features, consistent with overstress fracture of the part. Figure 23 shows a closer view of the dimple rupture features. A typical area in the left side of Figure 21 is illustrated in Figure 24. This figure shows streaks and smoothing, consistent with smearing from post-fracture damage.

Figure 22 – Secondary electron (SE) micrograph of a typical area of the fracture surface of clevis 1.

Figure 23 – SE micrograph of dimple rupture on the clevis 1 fracture surface.

Figure 24 – SE micrograph of typical area of smearing on the clevis 1 fracture surface.

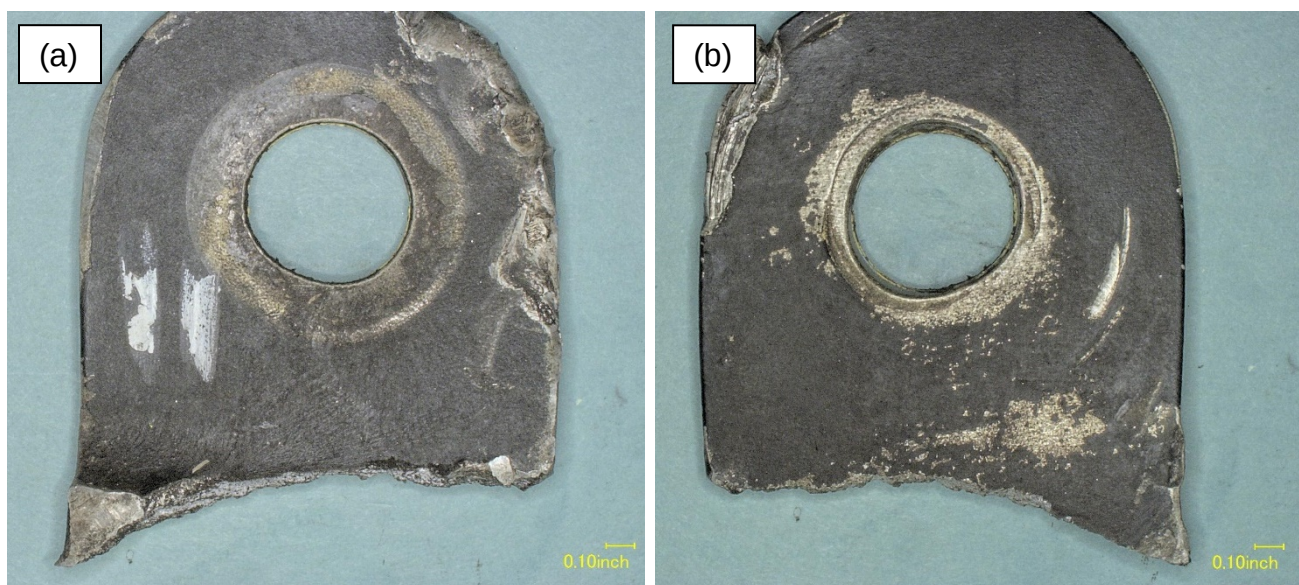
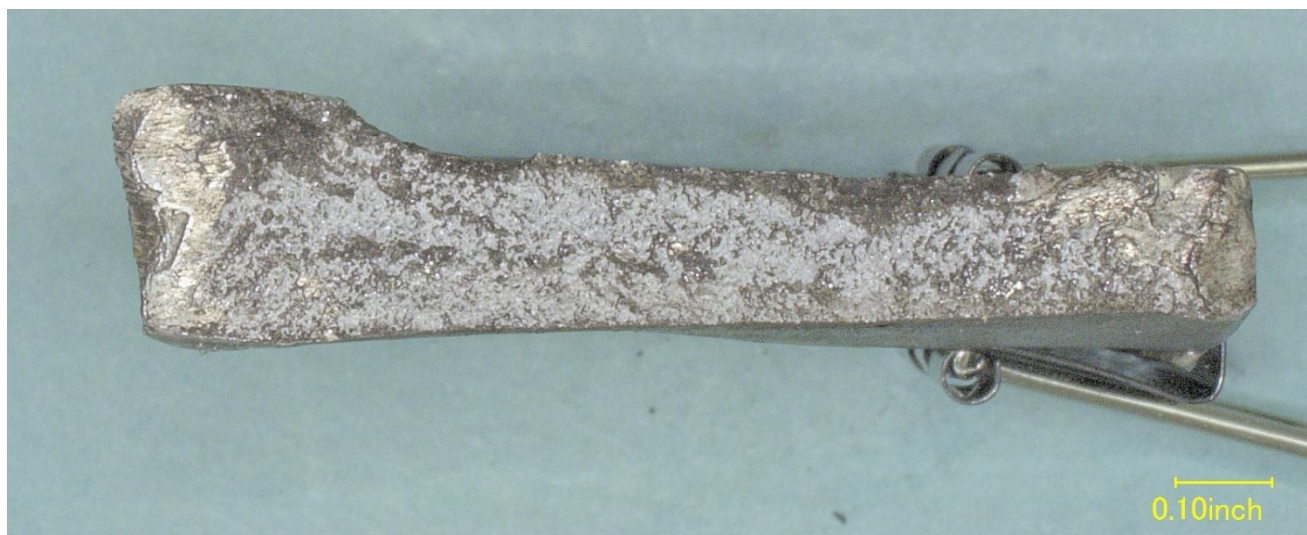
Figure 25 shows the inward and outward faces of clevis fragment 2. The fragment exhibited a curved fracture surface located with a pointed protrusion on one side. Figure 26 shows the fracture surface of this clevis fragment. While not as pronounced as clevis one, there were indications of twisting at the clevis 2 fracture. The left side of the fracture surface had been significantly damaged by post-fracture smearing. Examination of the fracture surface of clevis 2 revealed features consistent with overstress fracture. This is illustrated in Figure 27, showing dimple rupture.

Figure 25 – The (a) inward and (b) outward-facing surfaces of the fractured support clevis 2.

Figure 26 – View of the fracture surface of the fractured support clevis 2.

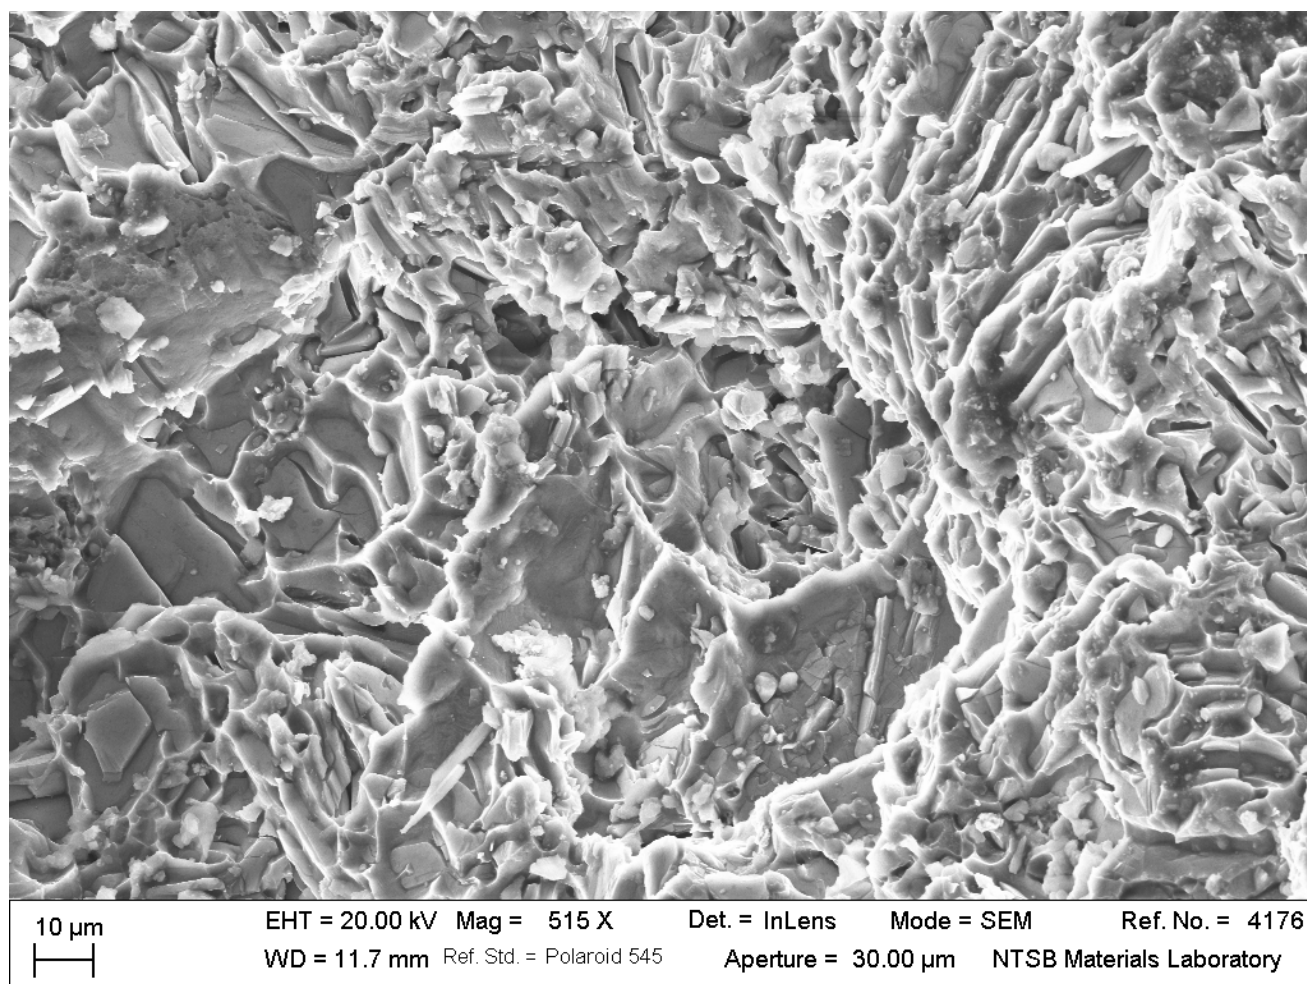
Figure 27 – SE micrograph of a typical area of the fracture surface of clevis 2, showing dimple rupture.

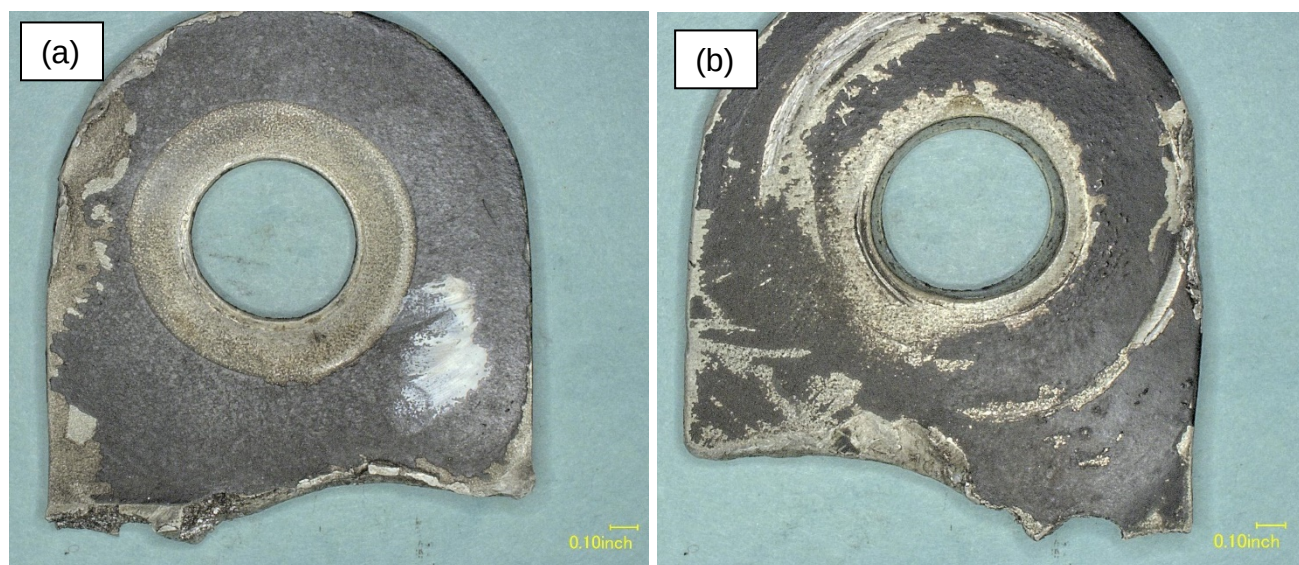
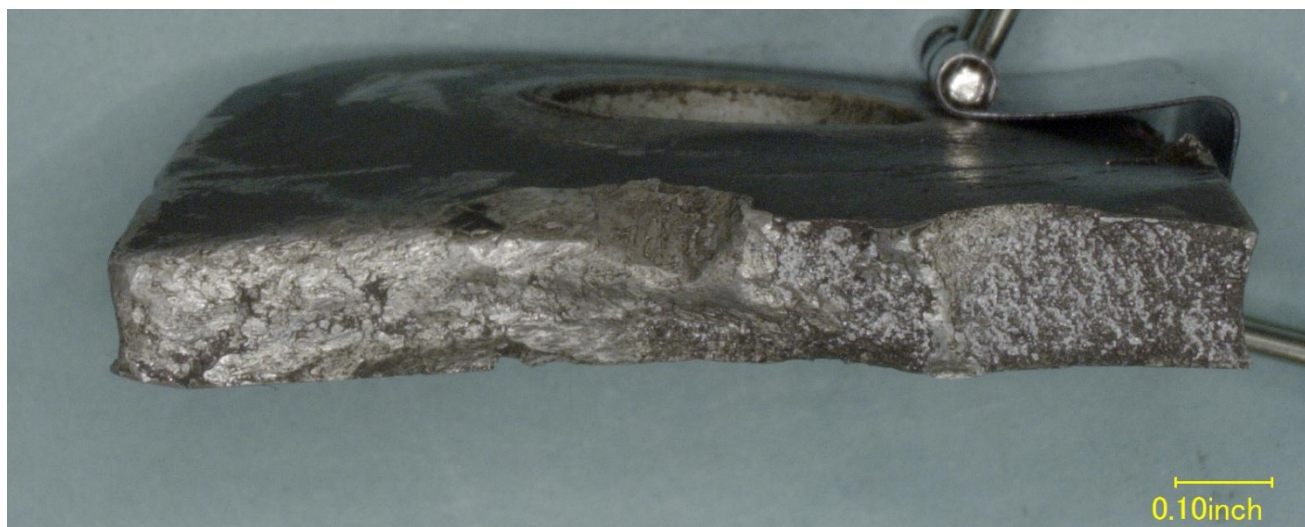
Figure 28 shows the inward and outward faces of clevis fragment 3. The fracture surface of the fragment exhibited two curves; therefore, there were three protrusions on the fracture surface. Figure 29 shows the fracture surface of this clevis fragment. The left

side of the fracture surface showed localized necking as well as severe batter on the inner and outer edges of the fragment. Examination of the fracture surface of clevis 3 revealed features consistent with overstress fracture. This is illustrated in Figure 30, showing dimple rupture.

Figure 28 – The (a) inward and (b) outward-facing surfaces of the fractured support clevis 3.

Figure 29 – View of the fracture surface of the fractured support clevis 3.

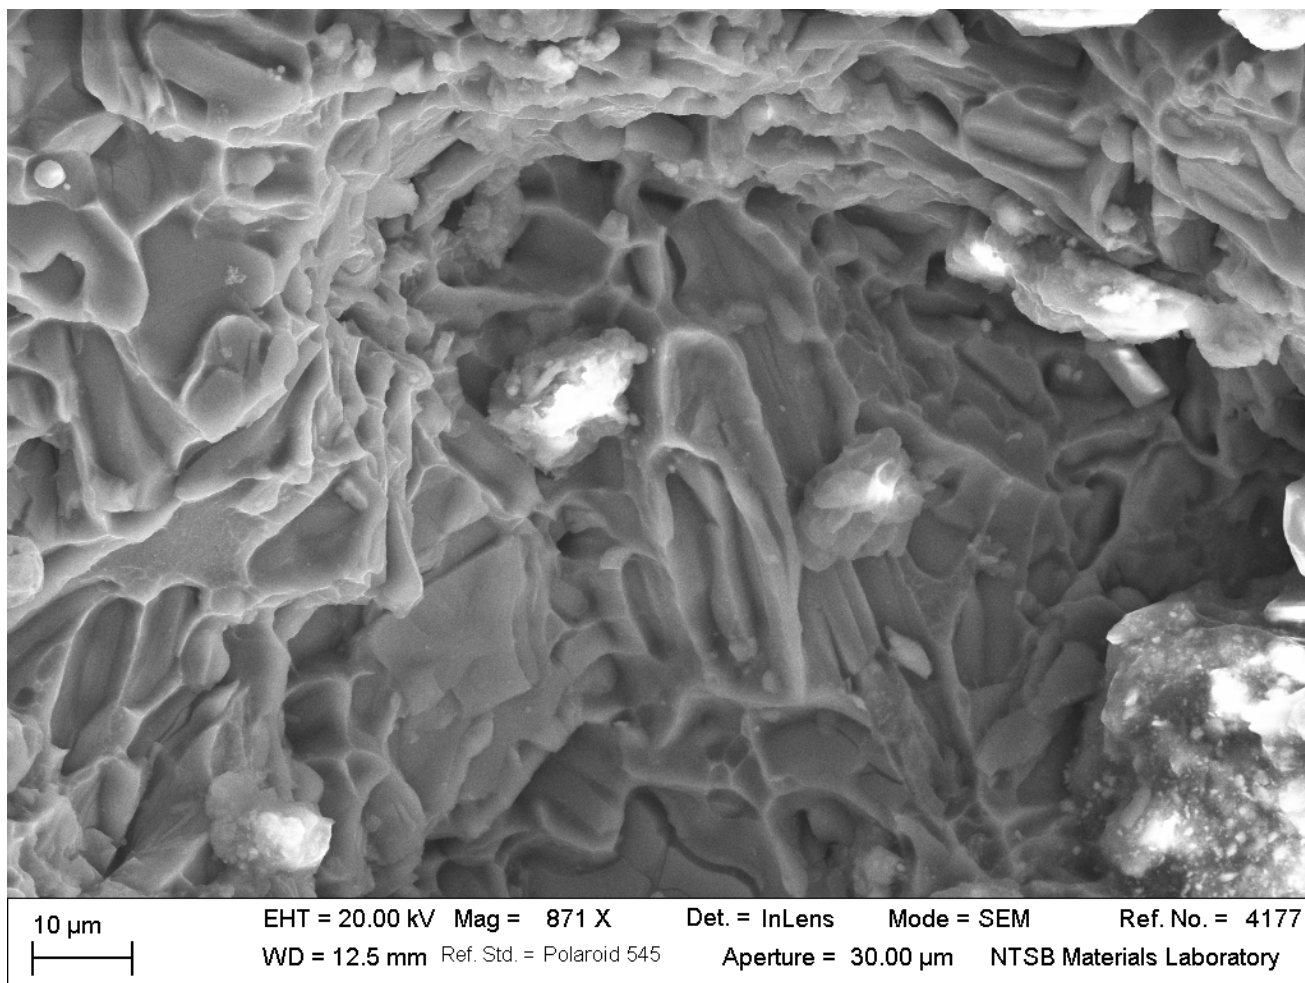
Figure 30 – SE micrograph of a typical area of the fracture surface of clevis 3, showing dimple rupture, with some non-conductive material on the surface.

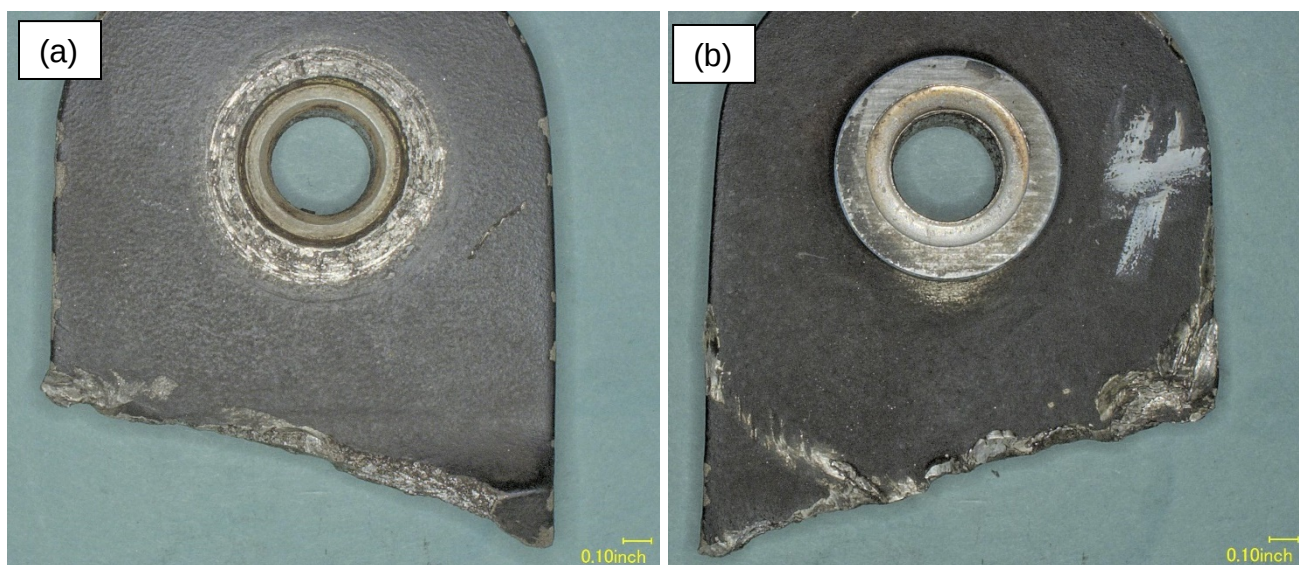
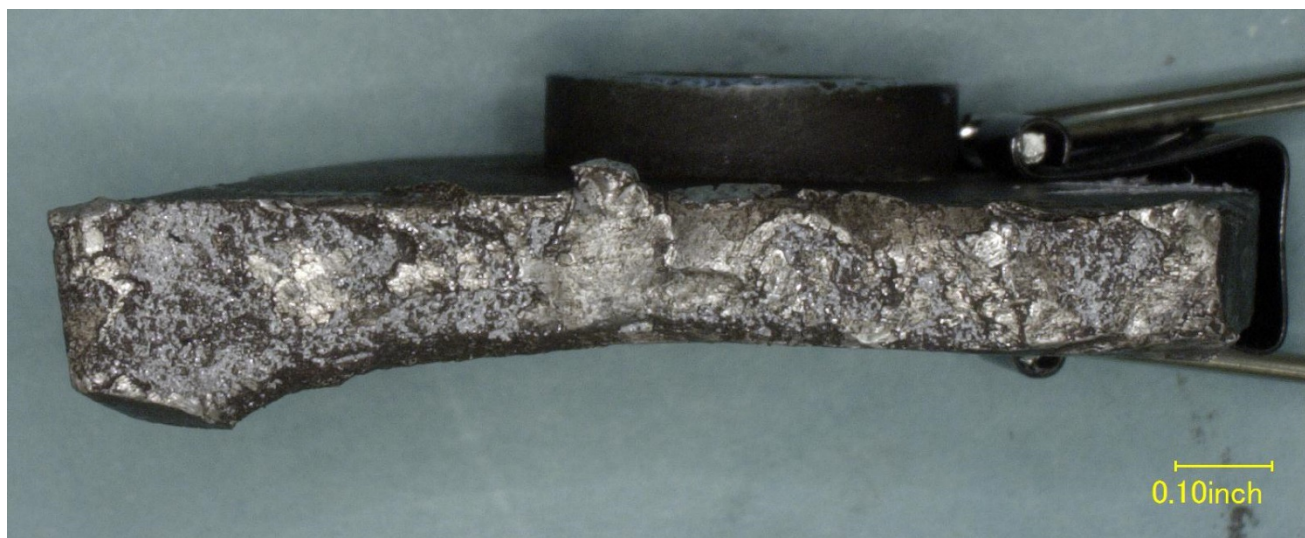
Figure 31 shows the inward and outward faces of clevis fragment 4. The fragment exhibited an angled fracture surface. Figure 32 shows the fracture surface of this clevis fragment. This fracture surface exhibited batter and smearing in multiple locations, consistent with post-fracture impact. Examination of the undamaged portions of the clevis 4 fracture surface revealed features consistent with overstress fracture. This is illustrated in Figure 33, showing dimple rupture. The damaged areas, as typified in Figure 34, exhibited streaks and smoothing. These features were consistent with smearing from post-fracture damage.

Figure 31 – The (a) inward and (b) outward-facing surfaces of the fractured support clevis 4.

Figure 32 – View of the fracture surface of the fractured support clevis 4.

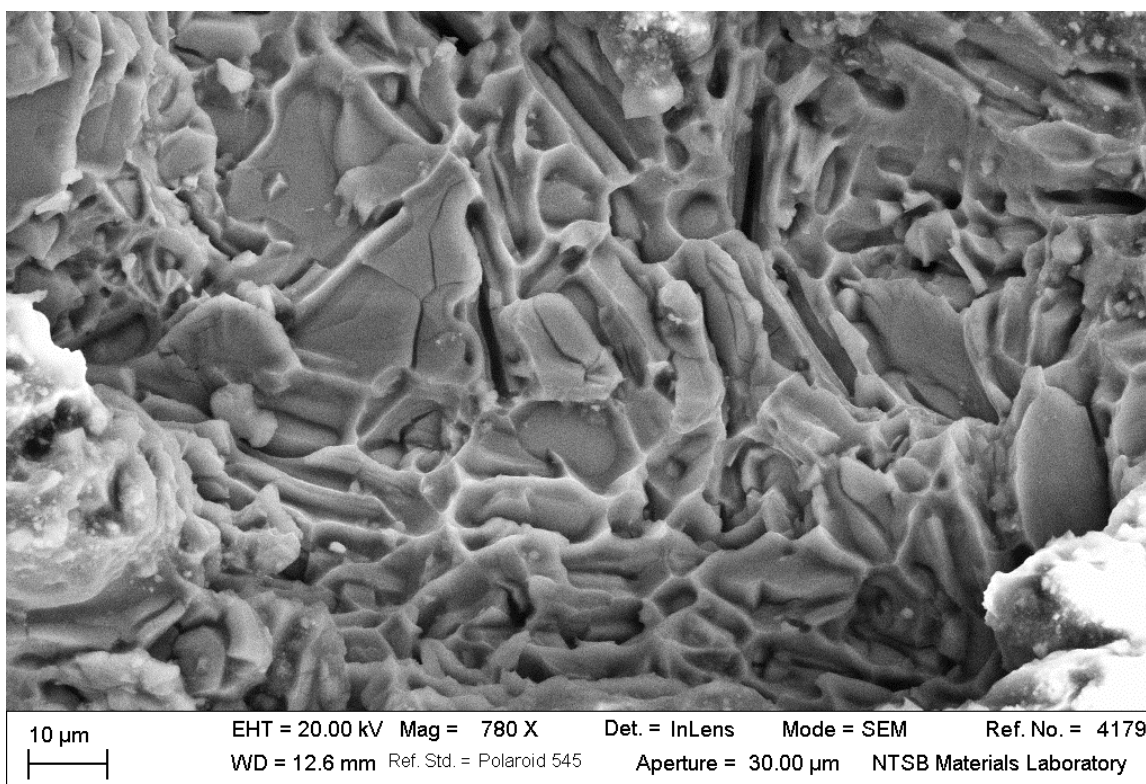
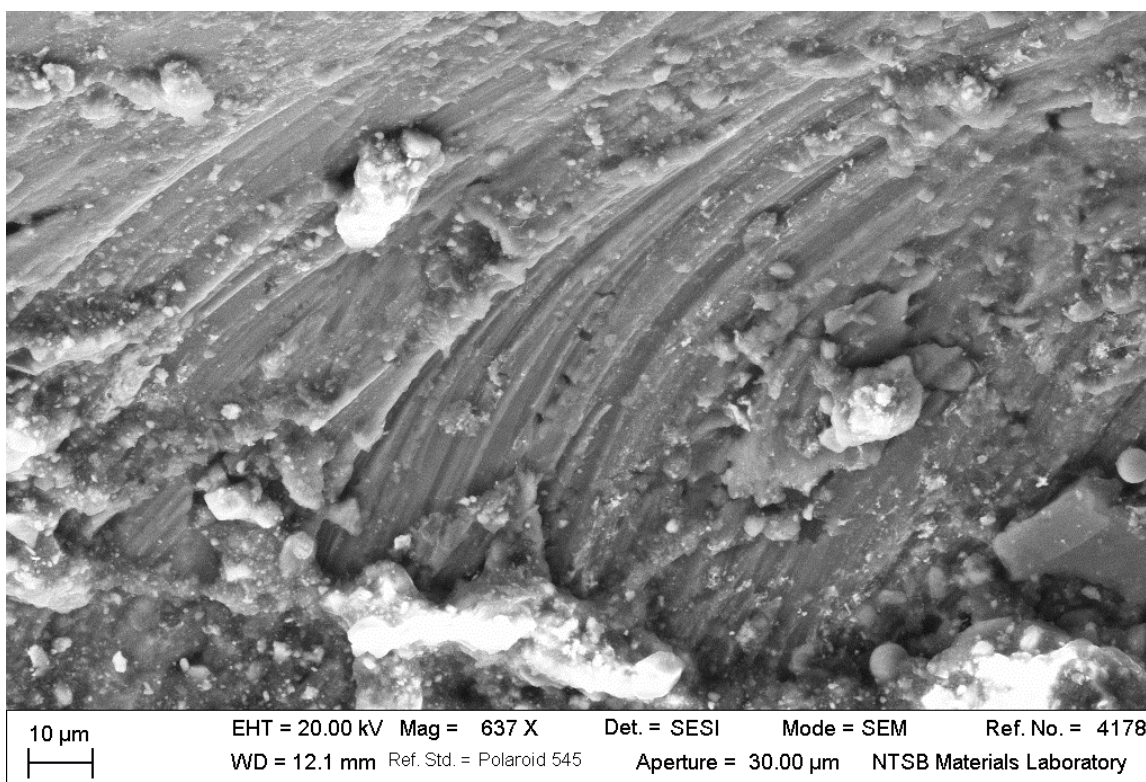
Figure 33 – SE micrograph of a typical area of the fracture surface of clevis 4, showing dimple rupture.

Figure 34 – SE micrograph of typical area of smearing on the clevis 1 fracture surface.

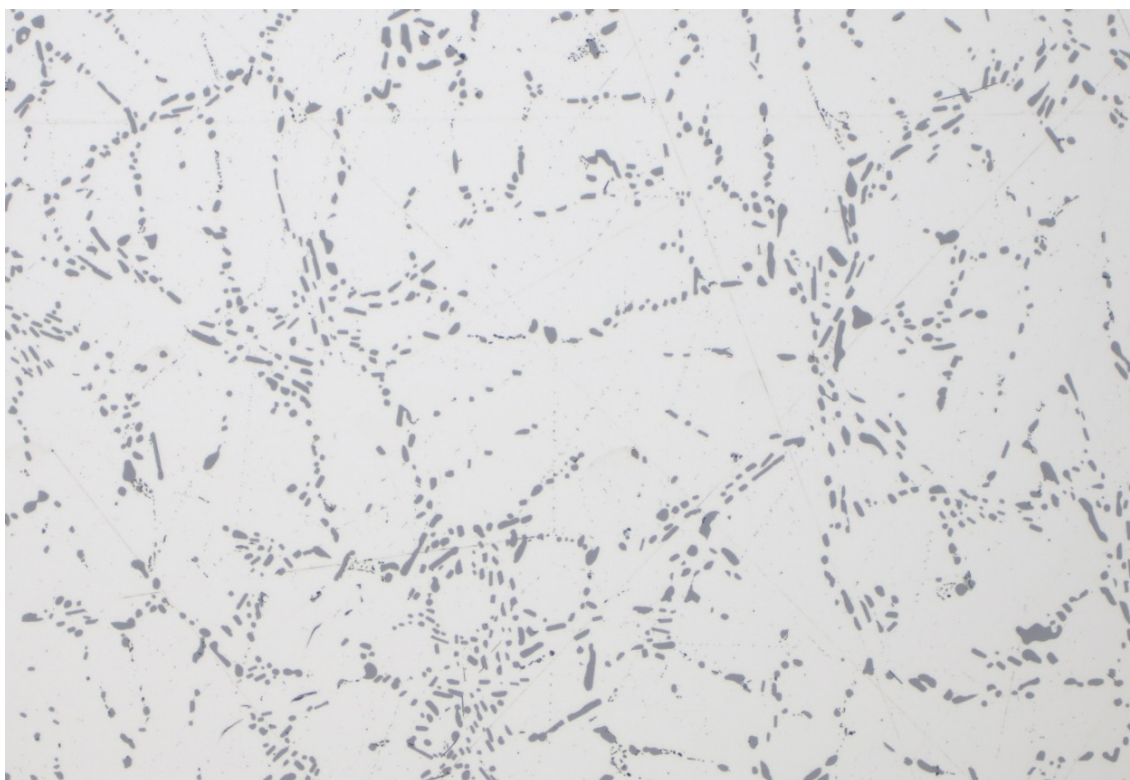
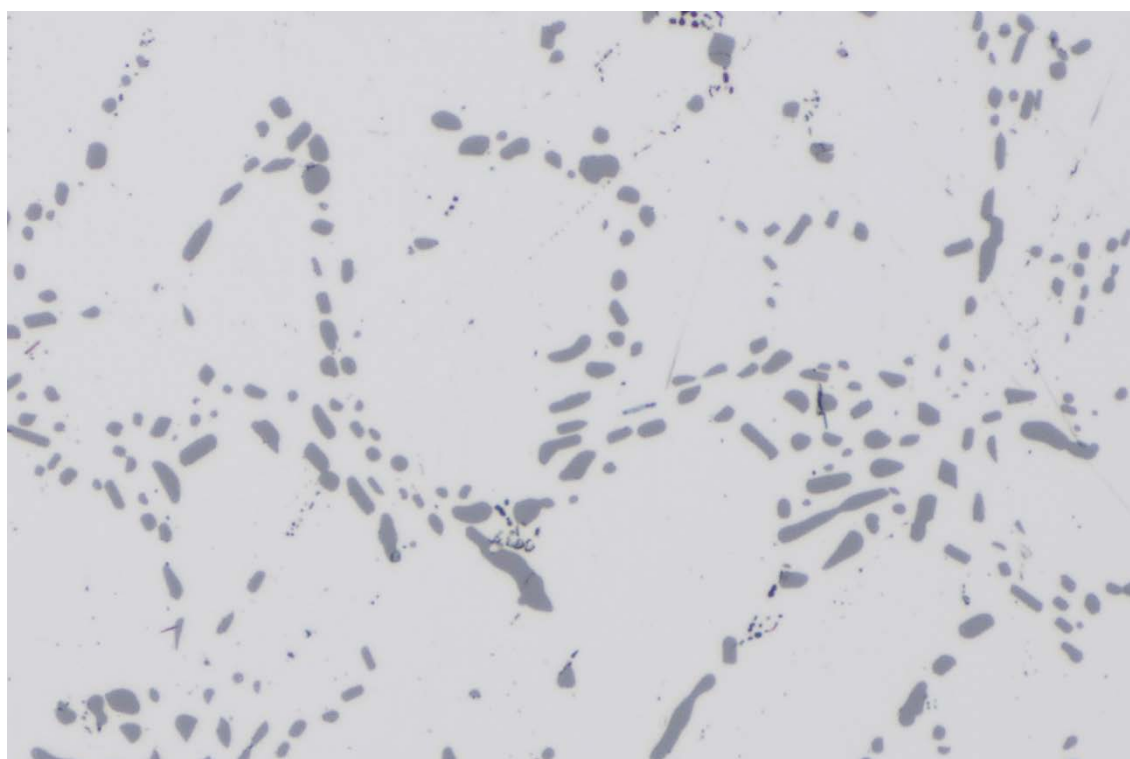
A portion of the clevis 3 fragment was cross-sectioned, mounted, polished and etched to examine the microstructure. Figures 35 and 36 show typical areas of the microstructure of the clevis fragment from the support, after etching with Keller's Reagent.<sup>3</sup> The microstructure shows a general dendritic morphology, consistent with those typical of castings. The lighter regions were the aluminum rich areas of the microstructure, and the dark blue constituents were the silicon-rich interdendritic phases. The microstructure, conductivity, and hardness were consistent with those typical of high-Si aluminum casting alloys. The dimple rupture and radiating cleavage features on the fracture surfaces of the clevis fragments were consistent with those typically observed with overstress fractures in aluminum-silicon castings.

Figure 35 – Bright-field (BF) micrograph of a typical area of the clevis 3 microstructure, (~200X, etched Keller's Reagent).

Figure 36 – BF micrograph highlighting the showing darker interdendritic high-Si phases in Figure 35 (~500X, etched Keller's Reagent) .

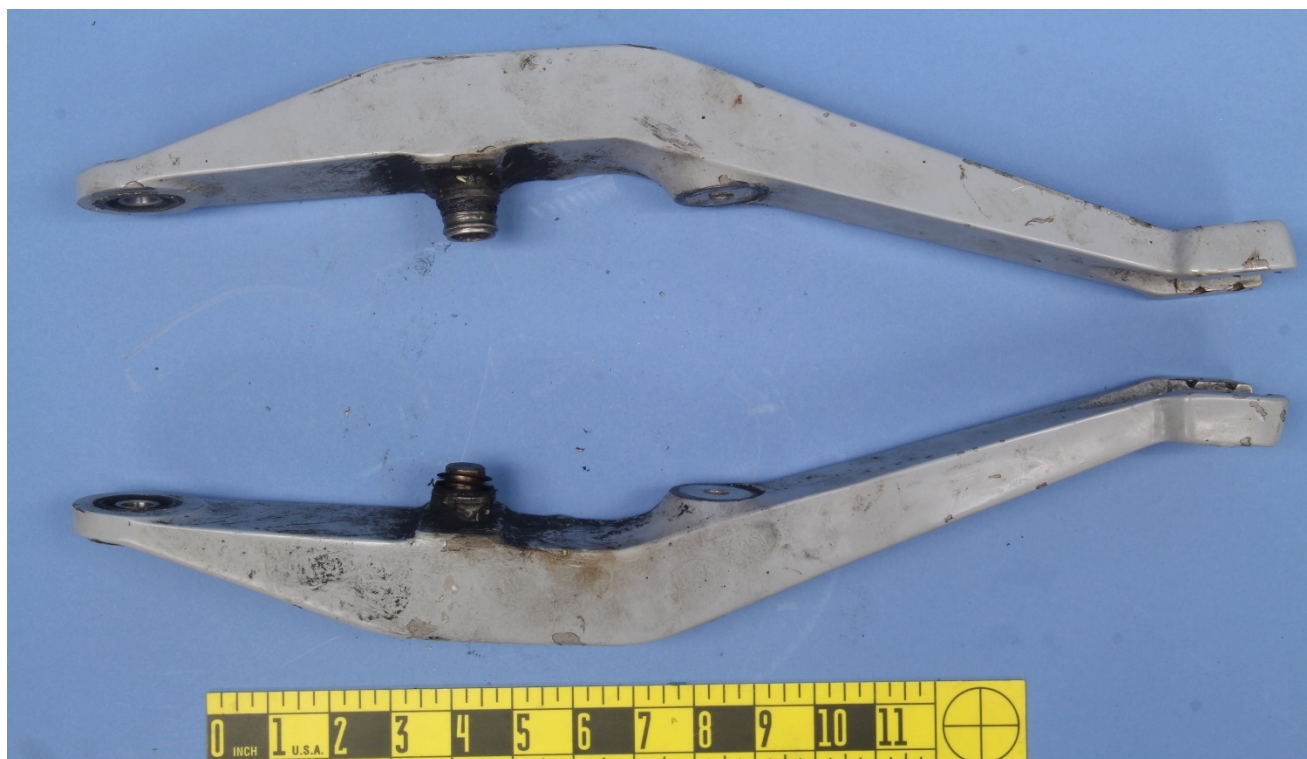
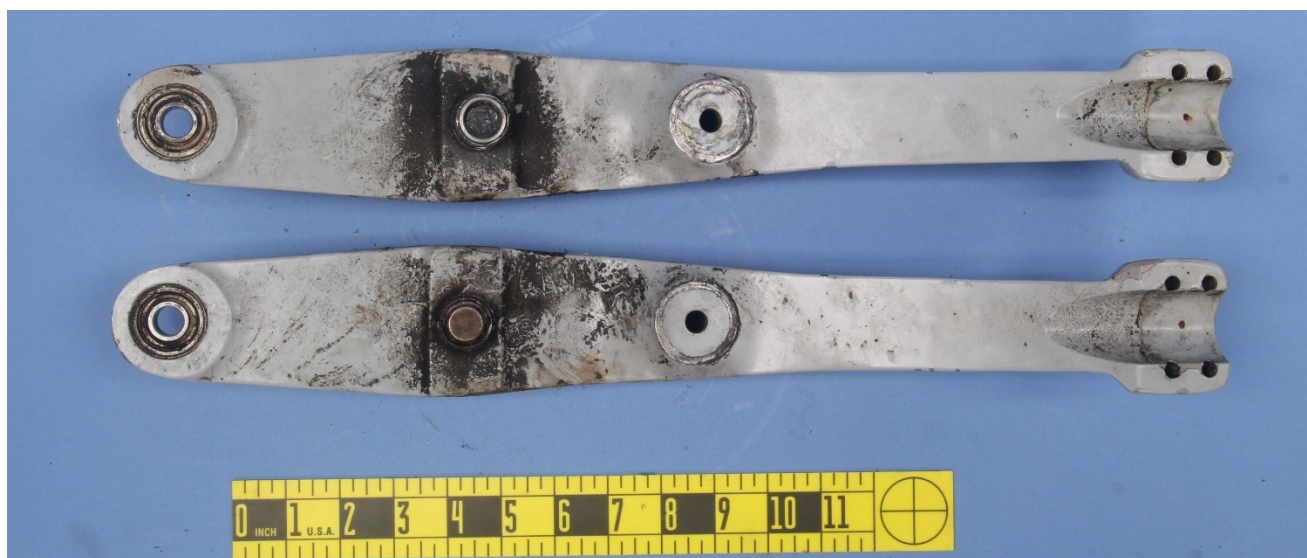
Figure 37 and 38 show the left and right collective arms, as received. The arms had been separated from the rest of the swashplate assembly before receipt by the Materials Laboratory. The markings on the right collective lever arm stated, "P/N = 21 2 010 4035, S/N = 883002426 Bell Helicopter." The markings on the left collective arm stated, "P/N = 2120104035, S/N = 883002354." There were some impact marks on the outer surfaces of the arms. Besides these small impact marks, there were no other indications of damage or deformation on these parts.

Figure 37 – The collective lever arms, as received.

Figure 38 – The faying surfaces of the collective lever arms, as received.

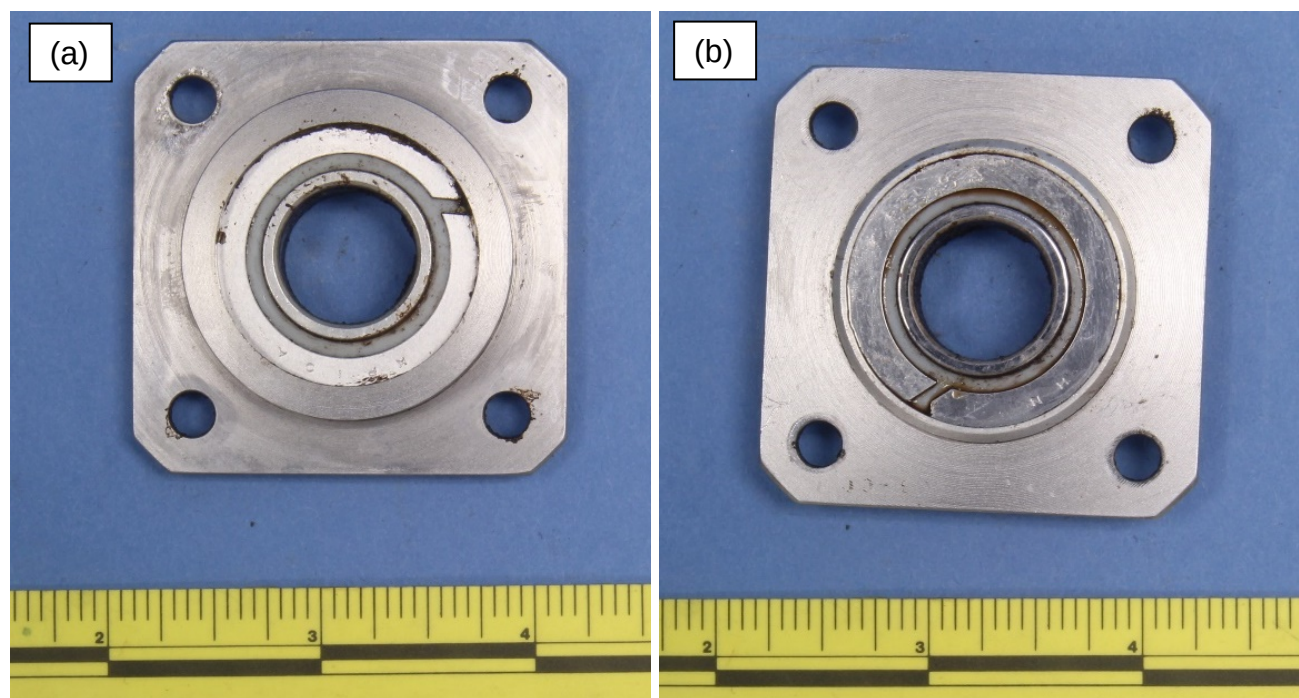
Two bearing and liner assemblies were received separated from the swashplate assembly. As received, these parts were completely covered in grease. The grease had been thickly applied, and they did not exhibit any dark discoloration or foul odors. Figure 39 shows the bearing assemblies after degreasing and cleaning. This bearing assembly was generally intact. There was a fracture in one of the bearing races, as shown in Figure 39a and 39b. These fractured parts were completely contained inside the assembly.

Figure 39 – The intact bearing and liner assembly, from the (a) outer and (b) inner surfaces.

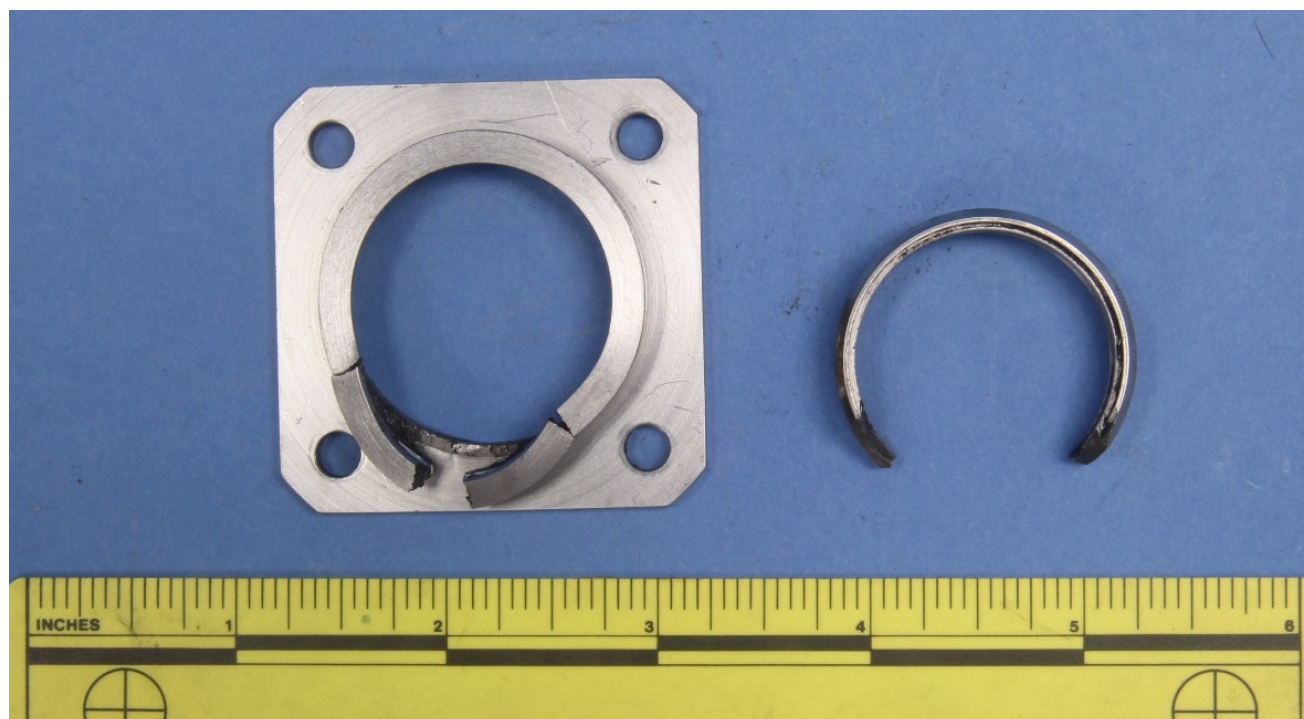
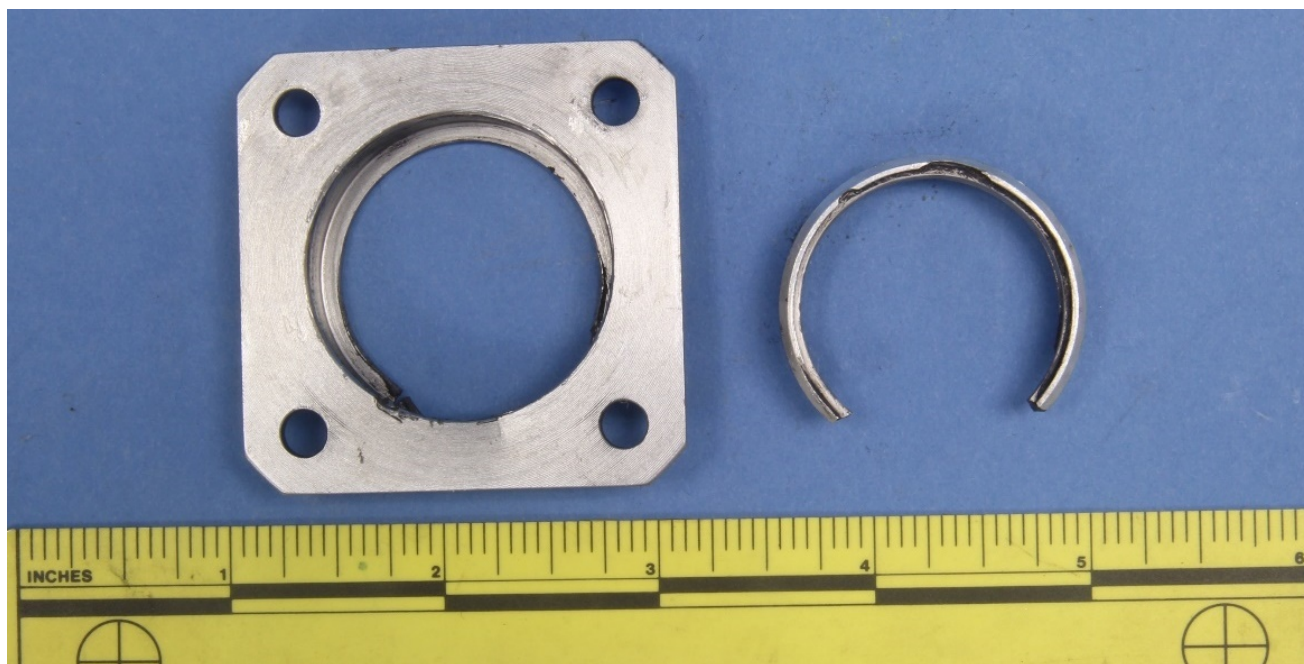
Figure 40 and 41 shows the bearing other bearing liner and bearing race, after degreasing and cleaning. As shown in Figure 40, the outer housing of the bearing liner had fractured outward. This portion of the part exhibited plastic deformation and multiple fracture locations. These features were consistent with overstress in an outward direction.

The bearing race in Figures 40 and 41 was consistent with one that would have sat inside the bearing liner in Figure 40. This race exhibited two fracture surfaces, consistent with those of the liner. These fracture surfaces were examined using a SEM. The fracture surfaces exhibited dimple rupture, consistent with overstress fractures.

Figure 40 – The fractured bearing liner and bearing race, after cleaning and grease removal.

Figure 41 – The bearing liner and race, viewed from the faces opposite those in Figure 40.

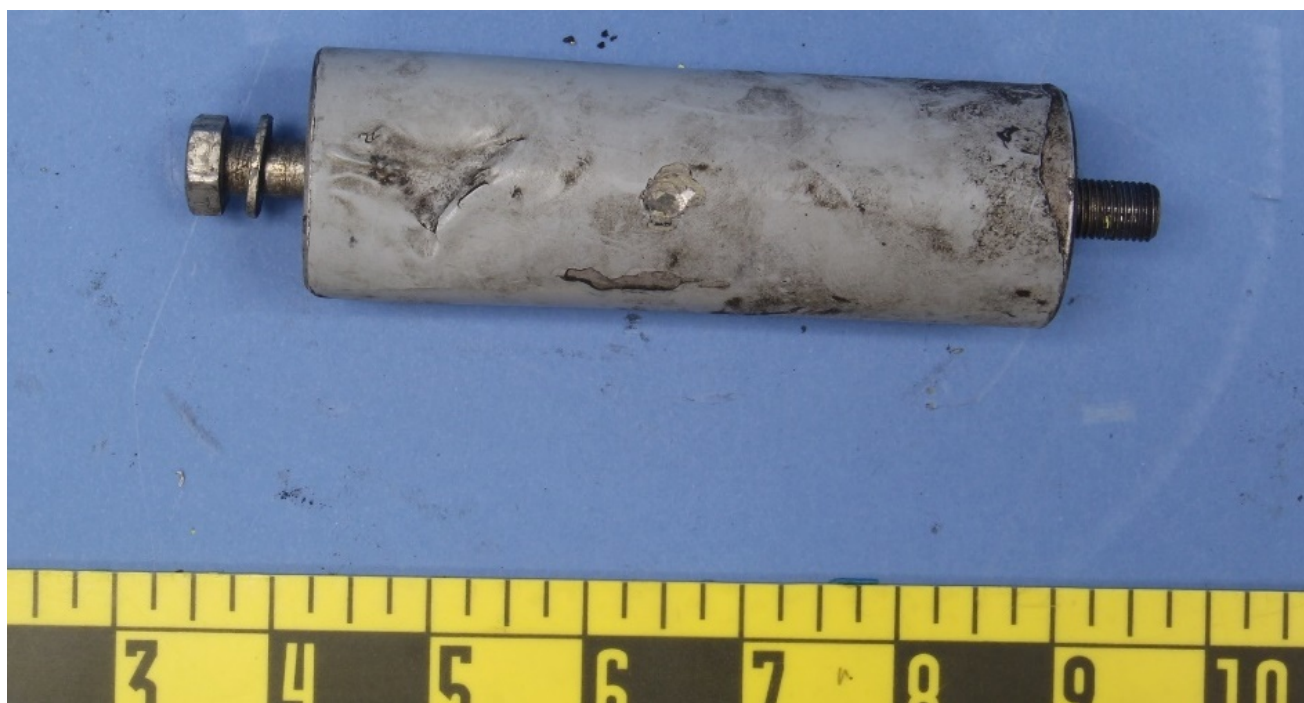
Figure 42 shows the spacer and attachment bolt, as received. As shown in Figure 43, the outer surface exhibited some impact marks, consistent with localized inward buckling at those locations. The attachment bolt is shown after disassembly in Figure 44. As shown in the figure, the bolt had bent approximately 2 inches below the bolt head.

Figure 42 – The attachment bolt and spacer, as received.

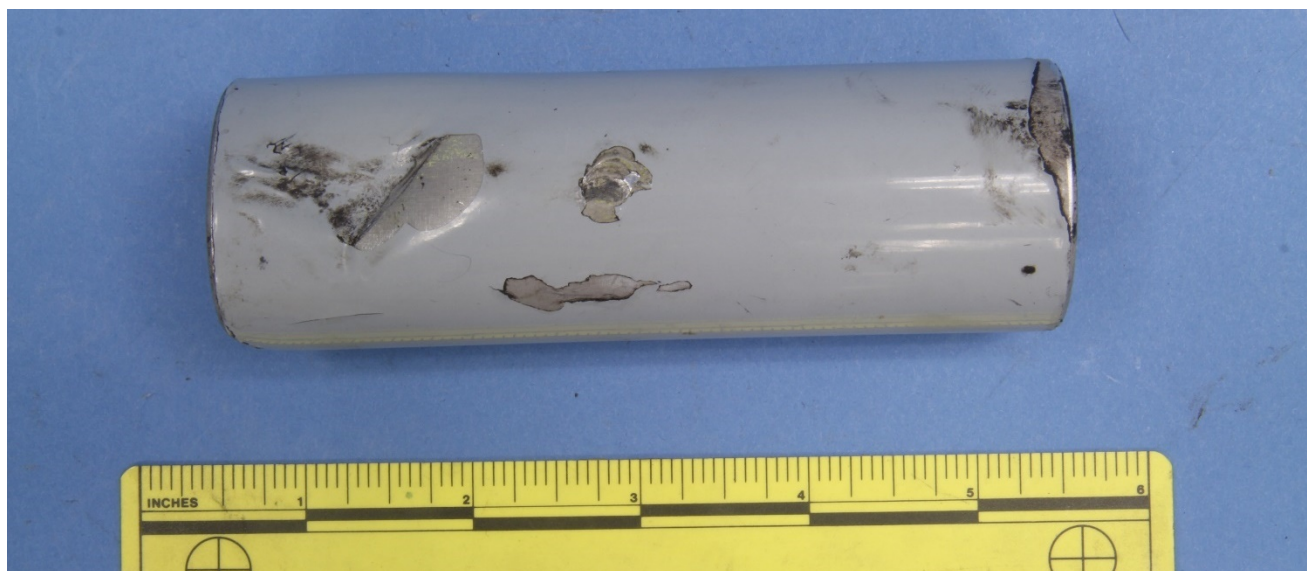
Figure 43 – View of the spacer, after disassembly and cleaning, showing a dent on the side.

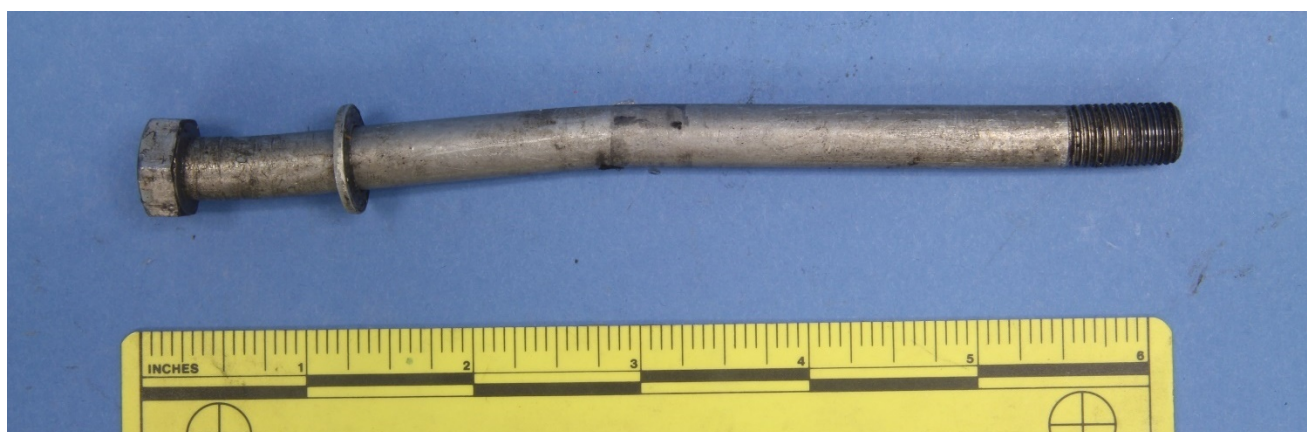
Figure 44 – View of the attachment bolt, after disassembly, showing the bend in the shaft.

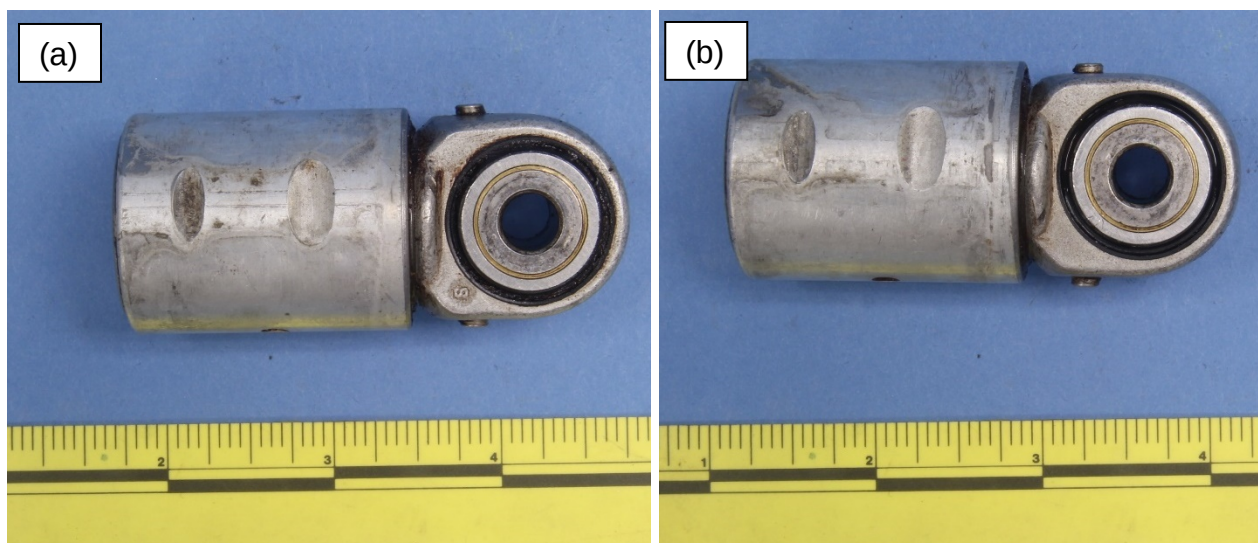
Figure 45 shows the loose trunnion, viewed from both sides. The bottom of the trunnion (to the left in both figures) exhibited stamped markings. The markings stated, "SHAFER YD2414 204-011-451-1 MADE IN USA PAT." The trunnion exhibited longitudinal marks on the sides, consistent with sliding out of its retainer. There were no other indications of damage on the loose trunnion.

Figure 45 – View of the loose trunnion, shown after cleaning from opposite sides.
