# NATIONAL TRANSPORTATION SAFETY BOARD

## MATERIALS LABORATORY FACTUAL REPORT

Report No. 19-059

Place : Casa Grande, Arizona  
Date : August 29, 2018  
Vehicle : Piper PA-28-181, N4139A  
NTSB No. : WPR18LA248  
Investigator : Stephen Stein, AS-WPR

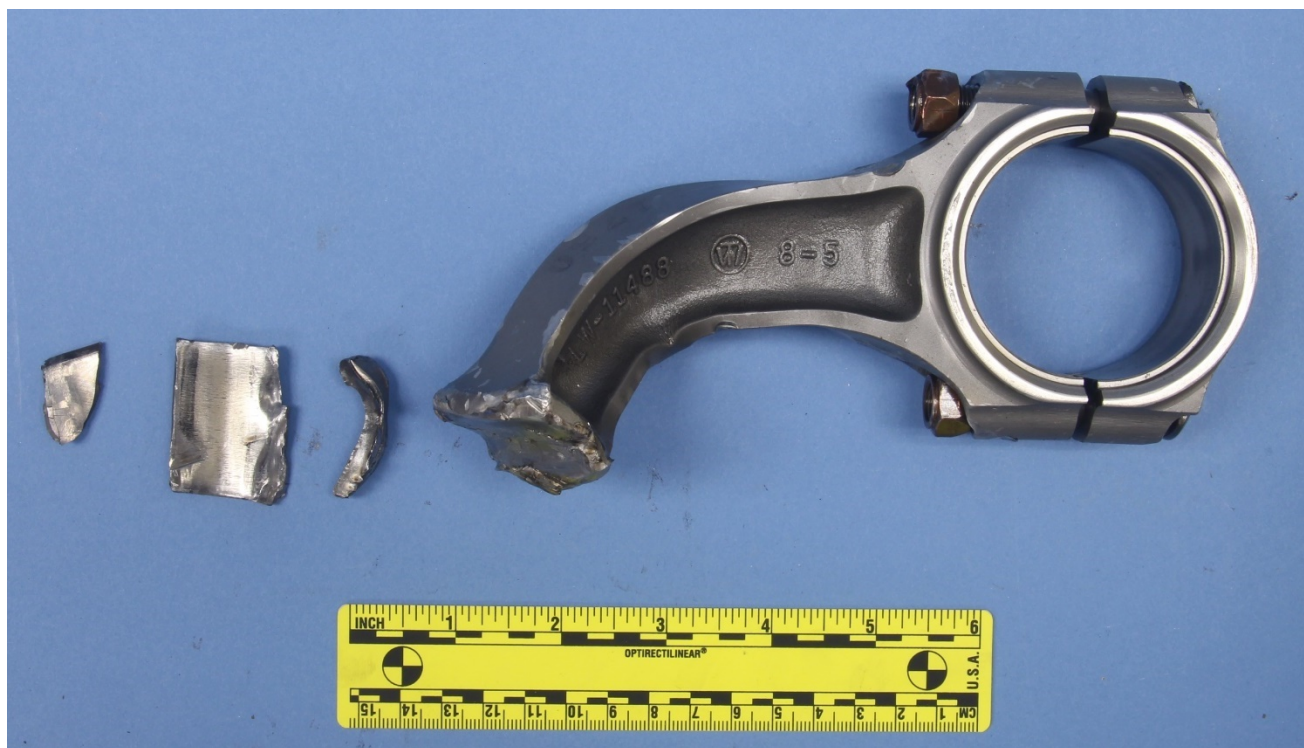
Figure 1 shows the remnants of the connecting rod assembly from the #4 engine position, as received. The crankshaft side of the connecting rod assembly was generally intact, with the attachment bolts and nuts submitted together. The pin side of the rod assembly had broken into multiple pieces, and the neck of the rod was bent down and backward. Three smaller fragments of the connecting rod assembly were found; these pieces were consistent with having made up the piston pin bore of the rod.

Figure 1 – The fragments of the connecting rod from the engine, as received.

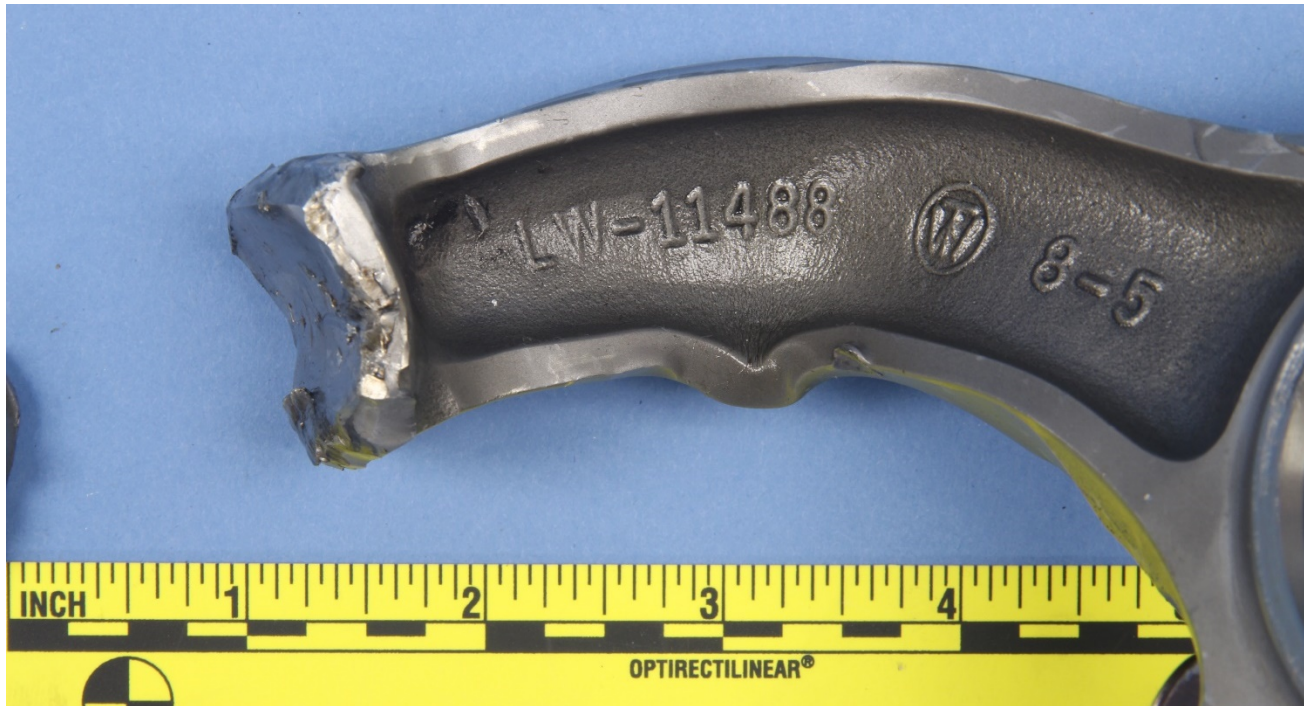
Figure 2 shows the raised markings of the connecting rod of the web of the neck. The markings state "LW-11488 TW 8-5". The raised markings on the reverse side stated, "A35 B". There were also faded stamped markings on the side of the part, which stated, "LW 11750".

Figure 2 – The markings on the web of the connecting rod neck remnant.

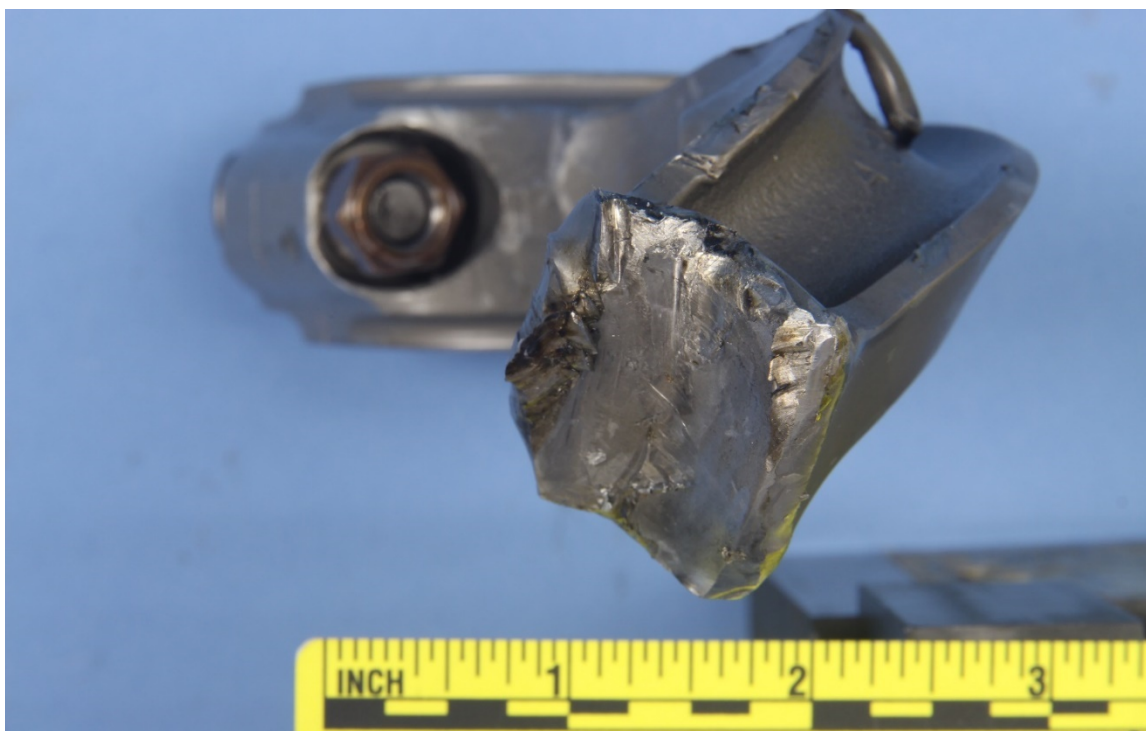
Figure 3 shows the piston pin bore surface remnant on the connecting rod fragment, as received. This figure also illustrates the degree of bending in the neck of the rod. This bore face of the rod was sectioned away from the neck and is displayed in Figures 4 through 6. As shown in Figure 4, the surface facing the pin and internal bushing was heavily gouged, battered, and scraped. This damage was consistent with post-fracture impact damage with adjacent parts.

Figure 3 – View of the piston pin bore surface remnant on the connecting rod fragment.

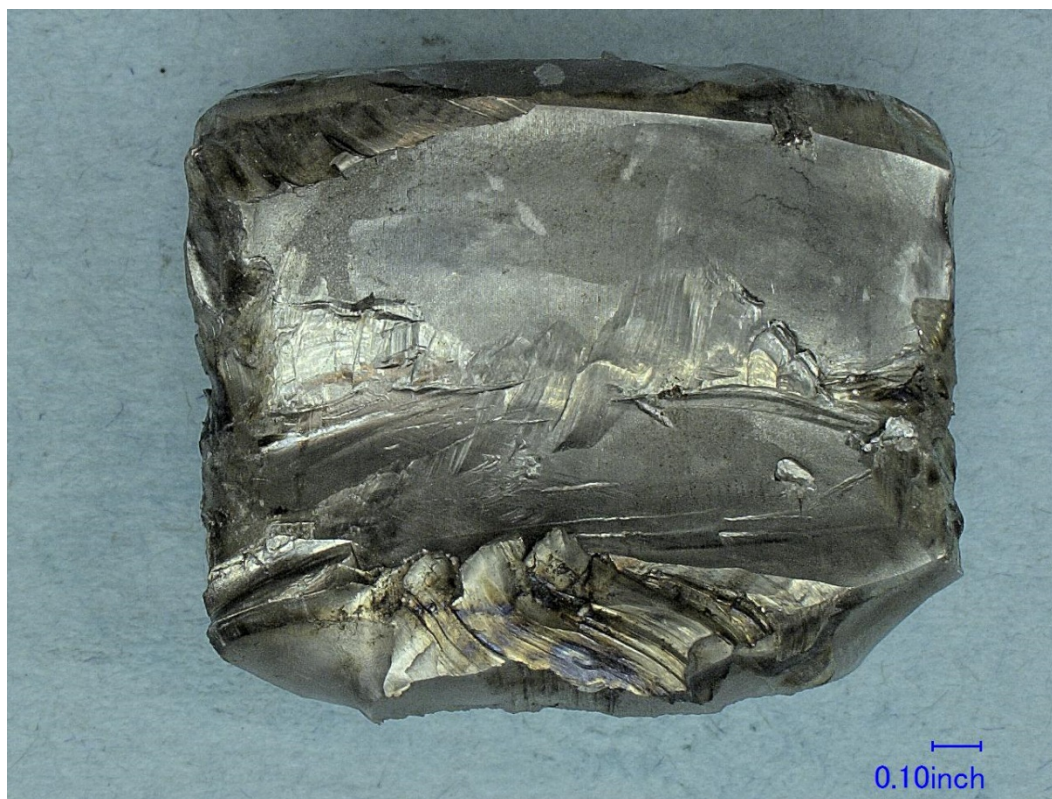
Figure 4 – The bore surface in Figure 3, after sectioning.

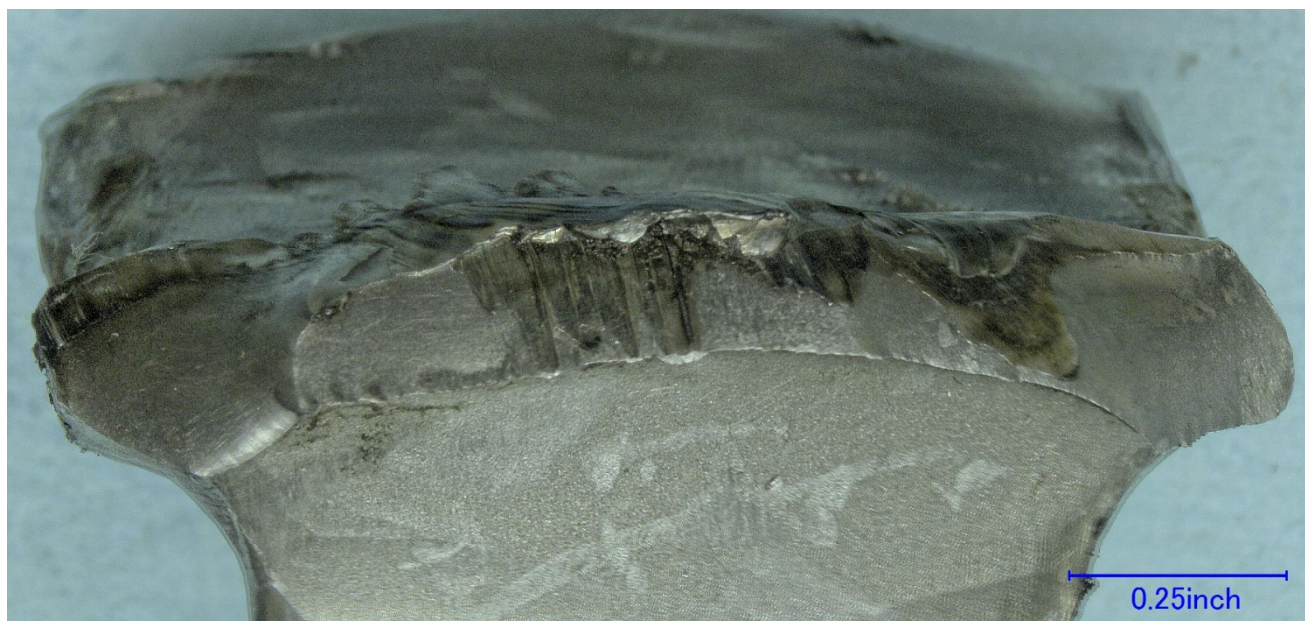
Figure 5 shows a closer view of one of the fractured sides of the pin bore. Any fracture features that may have been present were obliterated by post-fracture impact with adjacent components. Figure 6 highlights some of this damage—there was gouging in multiple directions, batter of the fractured corner, and material flow from heavy deformation of the pin bore face.

Figure 5 – The side of the connecting rod pin bore remnant, showing the fractured area with post-fracture batter and impact.

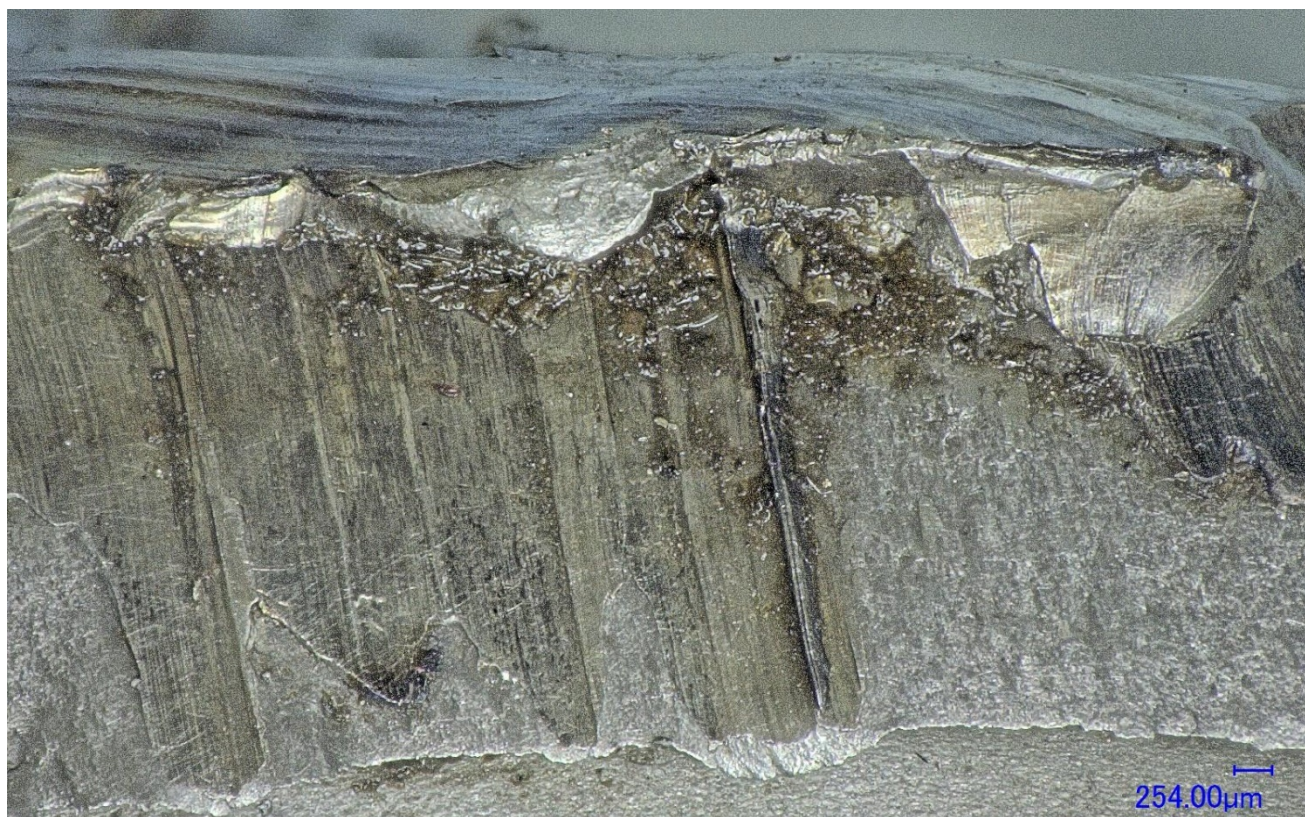
Figure 6 – Closer view of the damaged fracture in Figure 5, showing gouging, impact marks, and heat tinting.

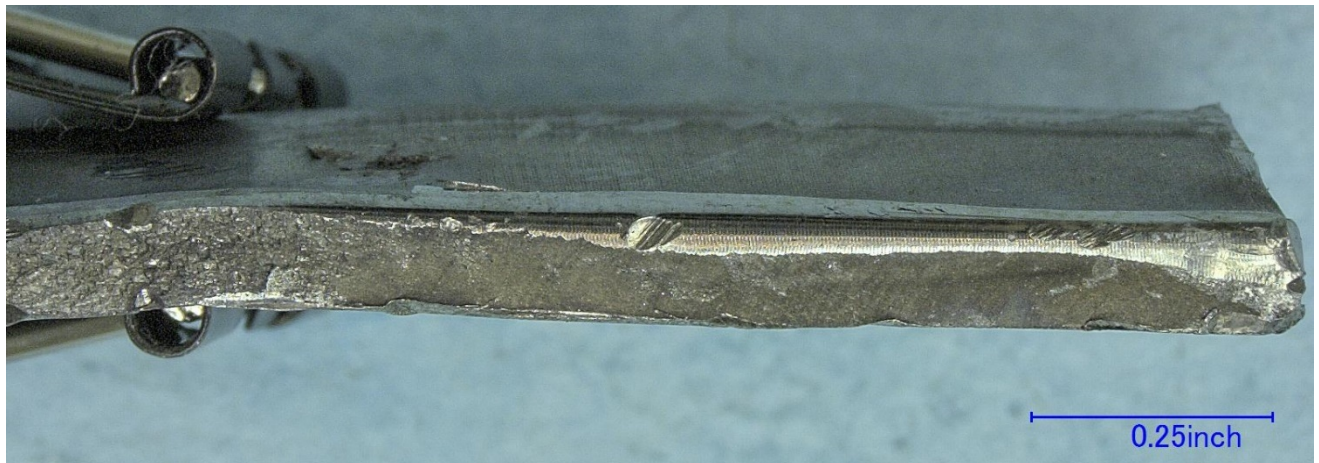
One of the of the fragments of the connecting rod pin bore walls is highlighted in Figure 7. This was the middle piece of the three small fragments in Figure 1. Figure 7 shows a relatively undamaged fracture surface. This fracture surface exhibited crack arrest marks on the entirety of the undamaged surface. The part was examined using a scanning electron microscope (SEM). As demonstrated in Figure 8, the fracture surface exhibited fatigue striations, consistent with fatigue crack propagation. These striations exhibited varied spacing, consistent with spectrum loading in high cycle applications, typical of reciprocating engines.

Figure 7 – View of the fracture surface of one of the smaller connecting rod pin bore remnants, showing crack arrest marks consistent with crack propagation from right to left.

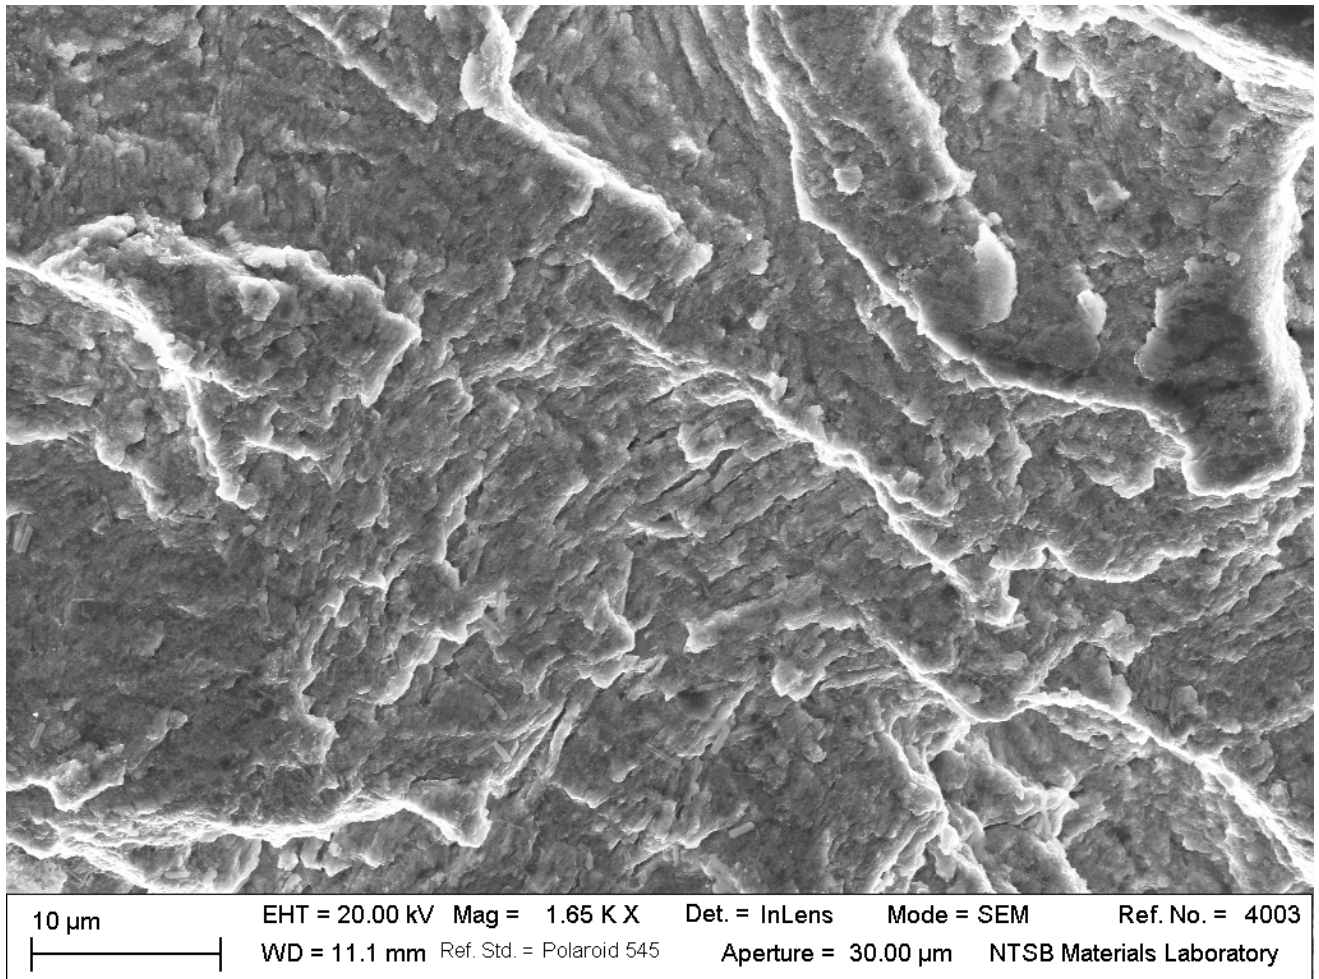
Figure 8 – Secondary electron (SE) micrograph of a typical area of the remnant fracture surface in Figure 7, showing fatigue striations.

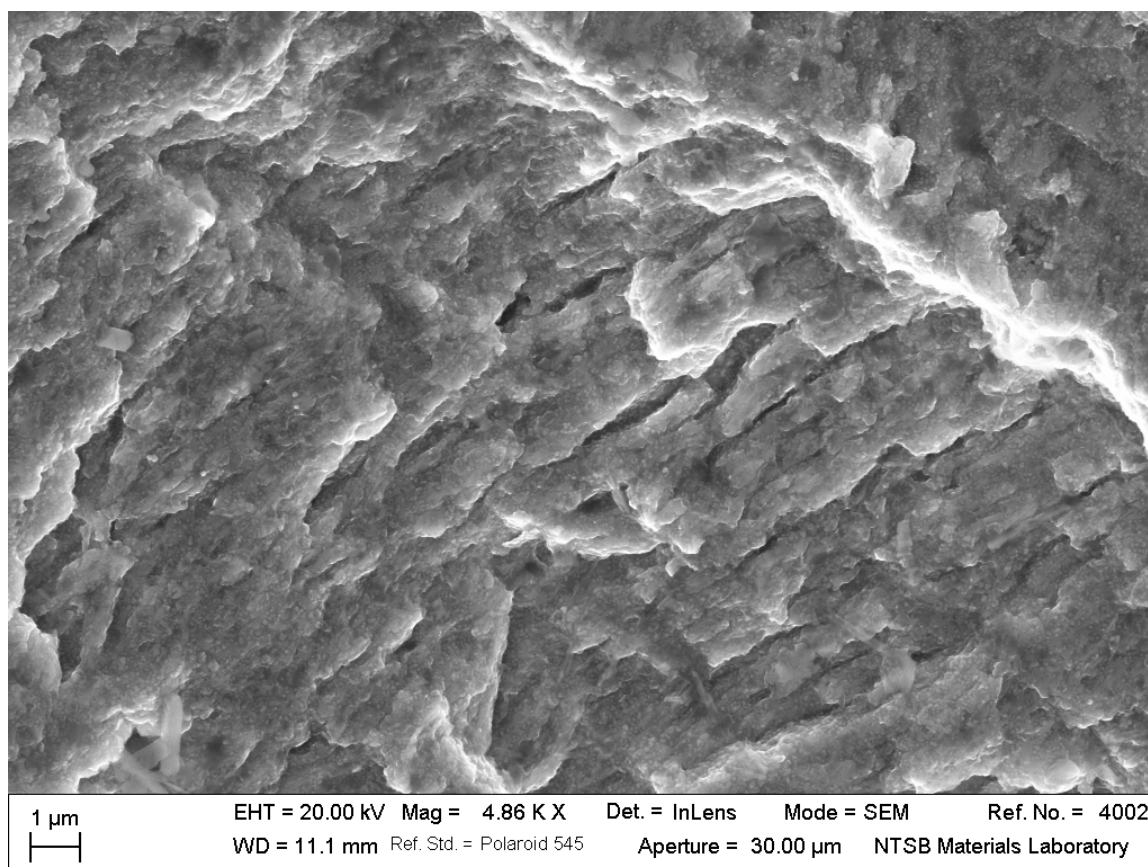
Figure 9 – SE micrograph of a closer view of the fatigue striations in Figure 8.

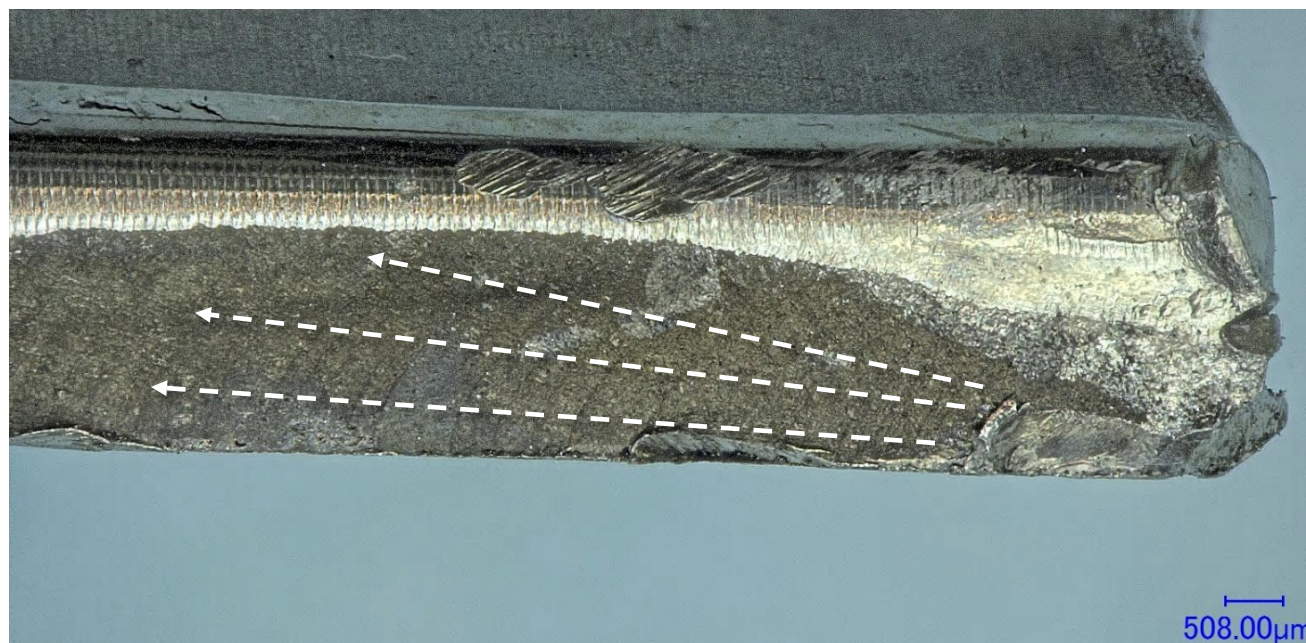
Figure 10 shows the initiation area of the pin bore wall remnant. As illustrated in Figure 10 and Figure 11, any of the initiation features in this corner had been obliterated by inward smearing of the part. However, the nature of the visual features and fatigue striations was consistent with propagation from the lower right corner in Figures 10 and 11. This area was consistent with the inner face of the pin bore corner of the connecting rod.

Figure 10 – View of the fatigue crack origin region of the connecting rod remnant. The arrows denote the general crack propagation direction.

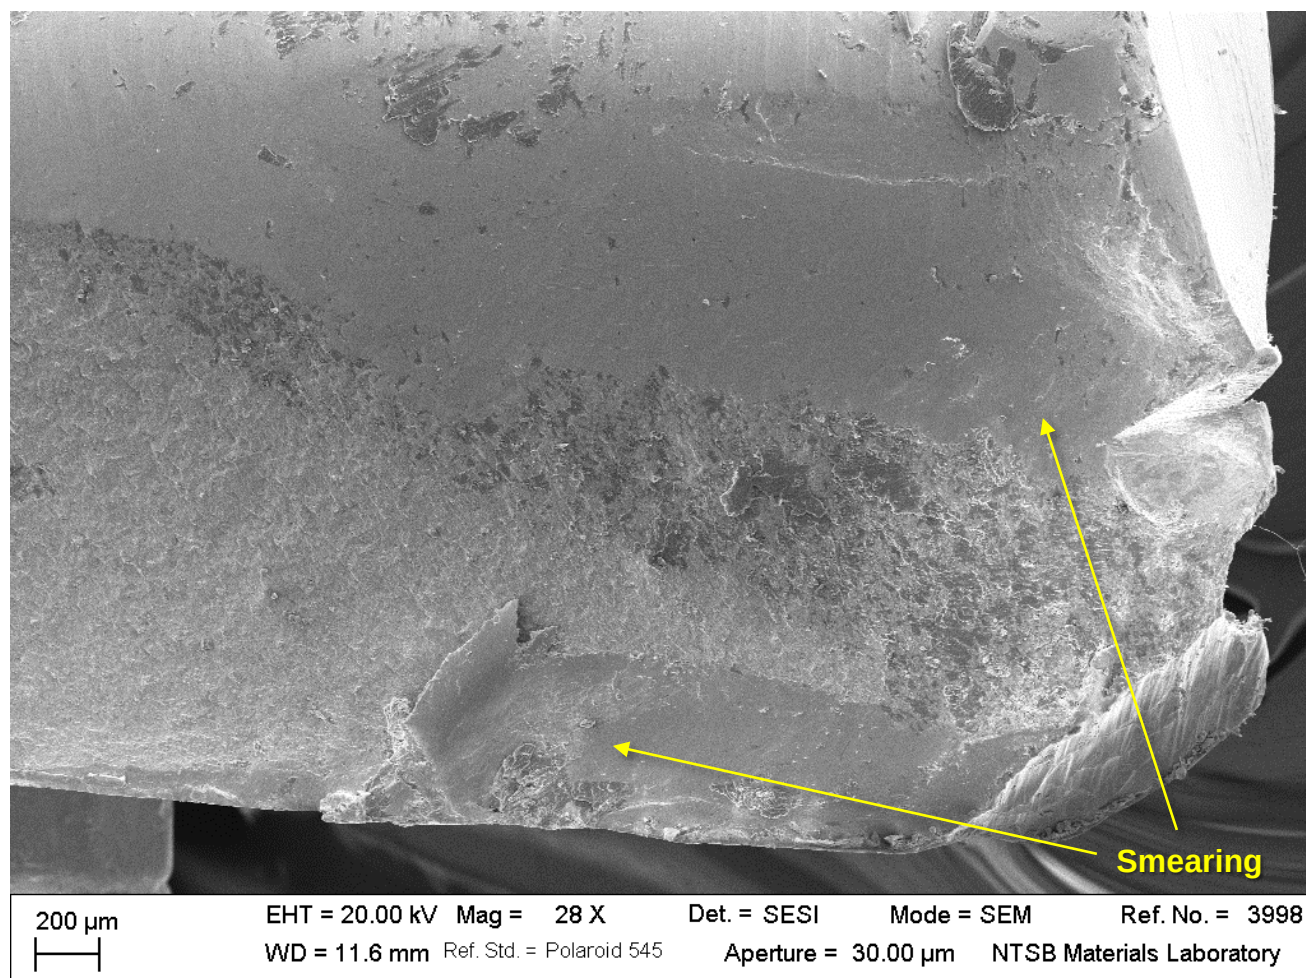
Figure 11 – SE micrograph of the fatigue crack origin area, showing smearing and post fracture damage.

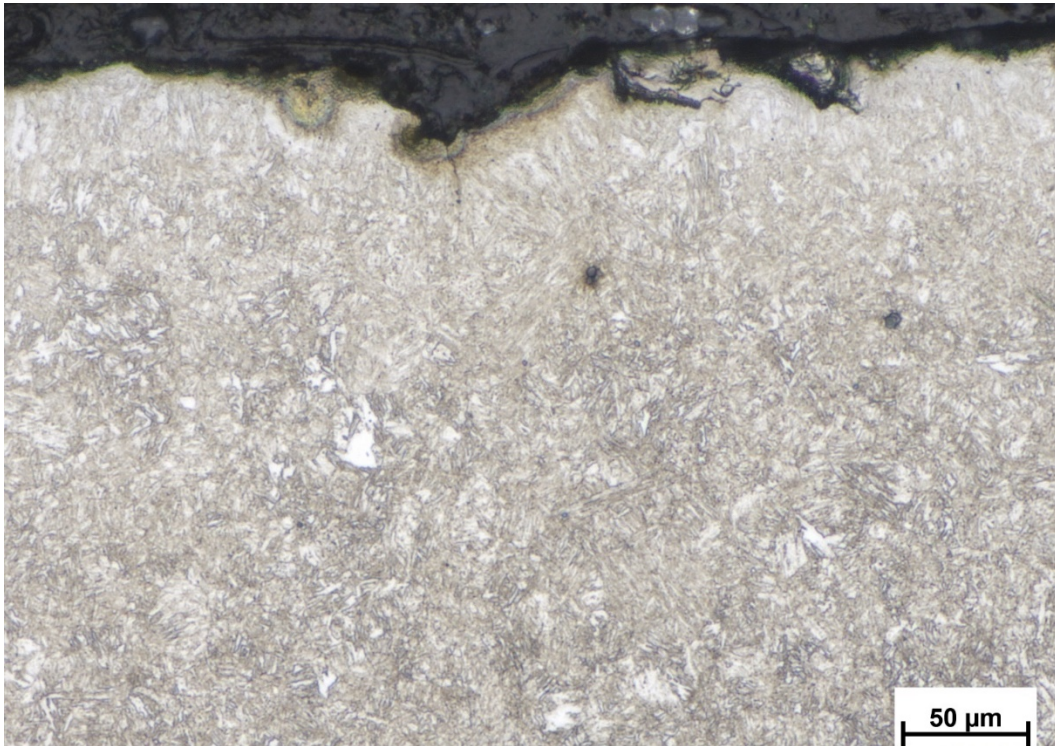
microstructure exhibited a structure consistent with tempered martensite. The surface was undulating and rumped, consistent with the service use and damage experienced by the part. There were some small surface cracks, as evidenced in Figure 12. These cracks were no more than 0.002 inches deep, as observed. Figure 13 shows a white area on the surface. This area was consistent with martensite (that had not been tempered). The presence of this phase on the surface suggests this area was subject to elevated temperature (greater than 1340 °F / 727 °C) and then rapidly cooled. This process is common in steels under rapid and localized friction forces.

Figure 12 – Bright-field (BF) optical micrograph of a typical cross-section of the surface of the connecting rod remnant, showing a tempered martensite microstructure. (~200X, etched 2% Nital).

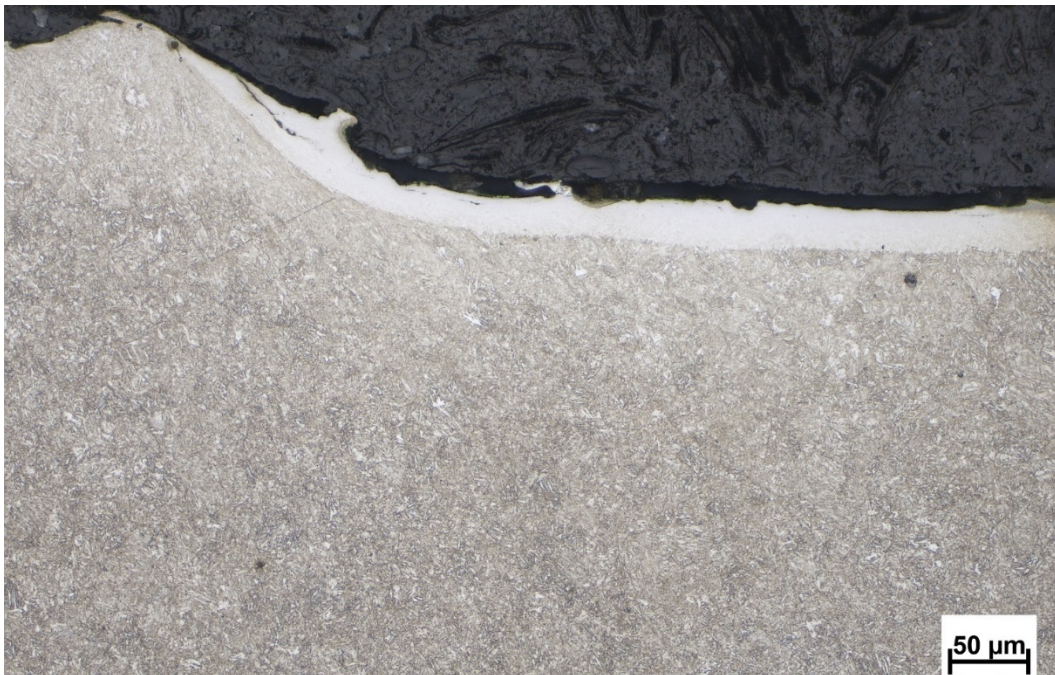
Figure 13 – BF micrograph of part the surface of the connecting rod remnant, showing a surface layer of untempered martensite, consistent with an area that experienced elevated temperatures and rapid cooling (~200X, etched 2% Nital).

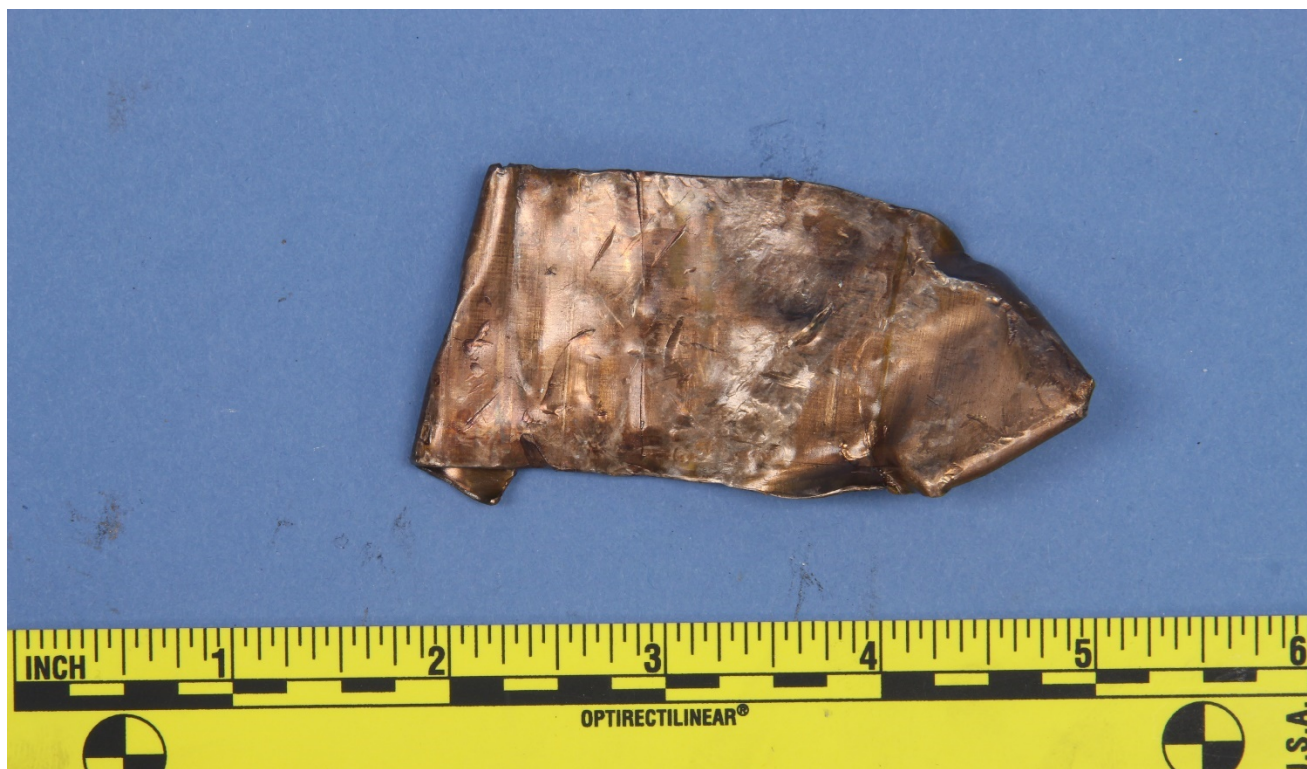
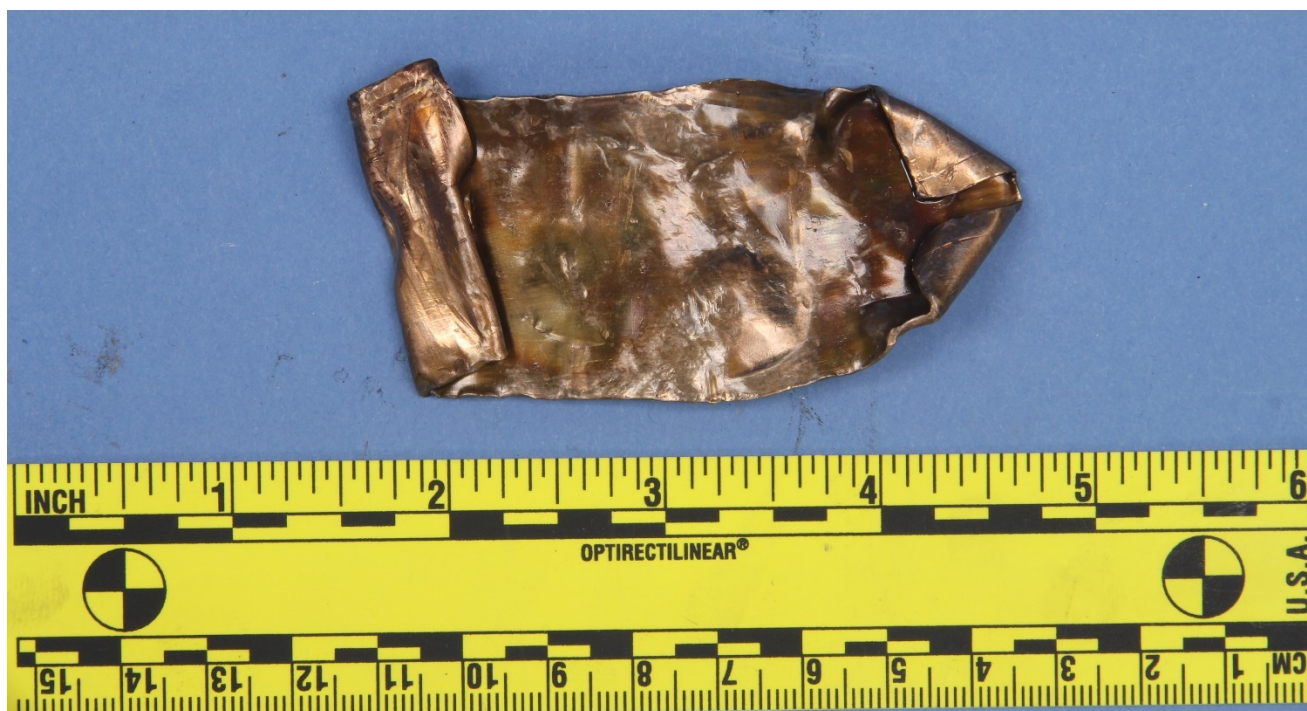
Figures 14 and 15 show the bushing remnant that had been present in the connecting rod pin bore. The bearing remnant exhibited severe plastic deformation, with material at the part ends having been folded over onto one side, and material repeatedly rolled over on the other end. Both surfaces of the bushing remnant exhibited gouges and impact marks. This damage was consistent with repeated impact with adjacent components.

Figure 14 – The remainder of the bushing from the connecting rod pin bore, as received.

Figure 15 – View of the bushing remnant from the side opposite Figure 14.

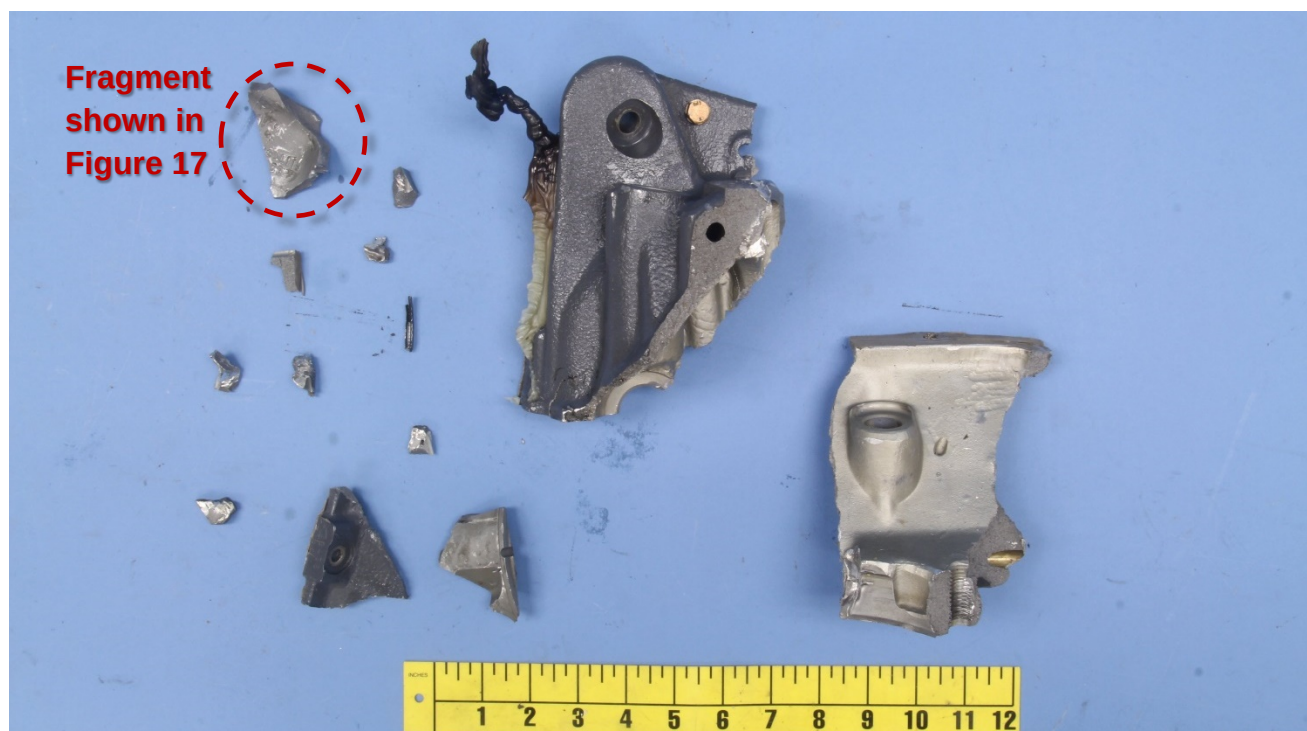
Figure 16 shows some other fractured remnants submitted to the NTSB Materials Laboratory. These fragments were all gray in color, with at least one fracture surface. All the fragments were non-magnetic. The fracture surfaces exhibited a dull luster and were erratic in orientation with a rough texture. These features are exemplified in Figure 17. These features were consistent with fracture from overstress fracture. These remnants were consistent with being aluminum fragments from the piston and/or cylinder.

Figure 16 – Miscellaneous pieces of the housing submitted with the other engine parts.

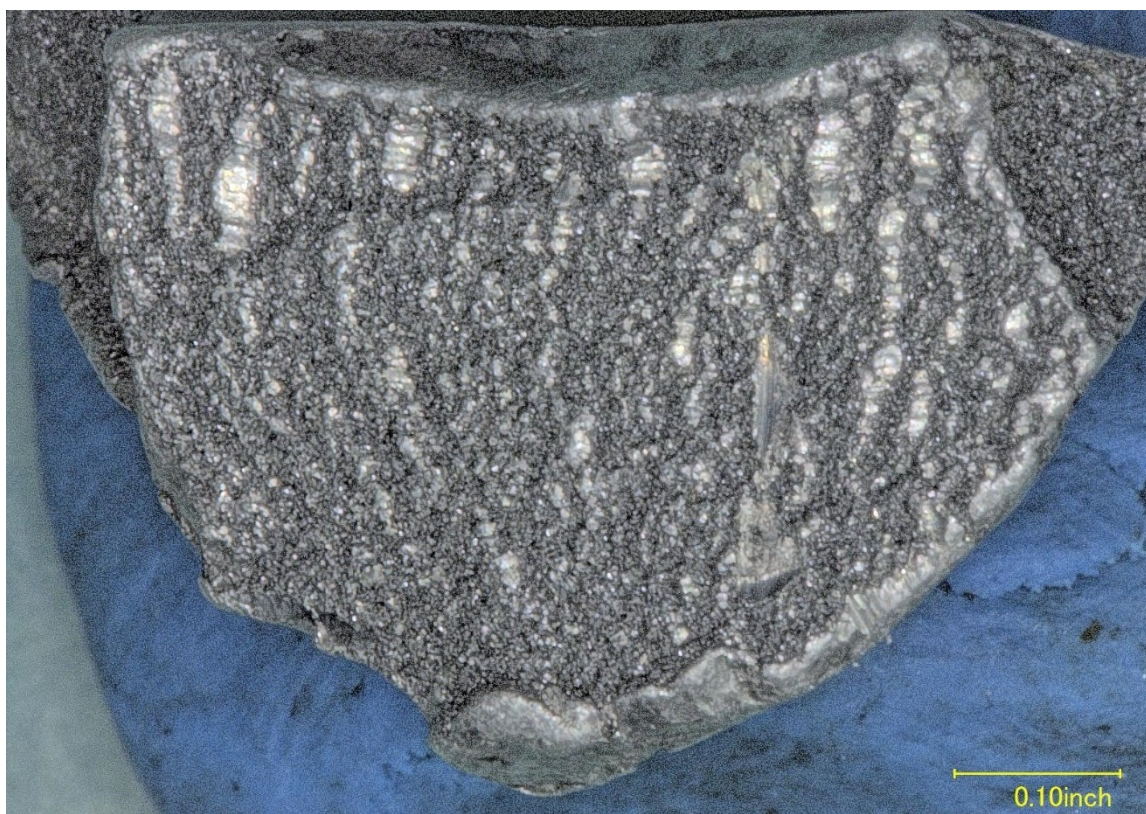
Figure 17 – One of the fracture surfaces of the fragment circled in Figure 16.

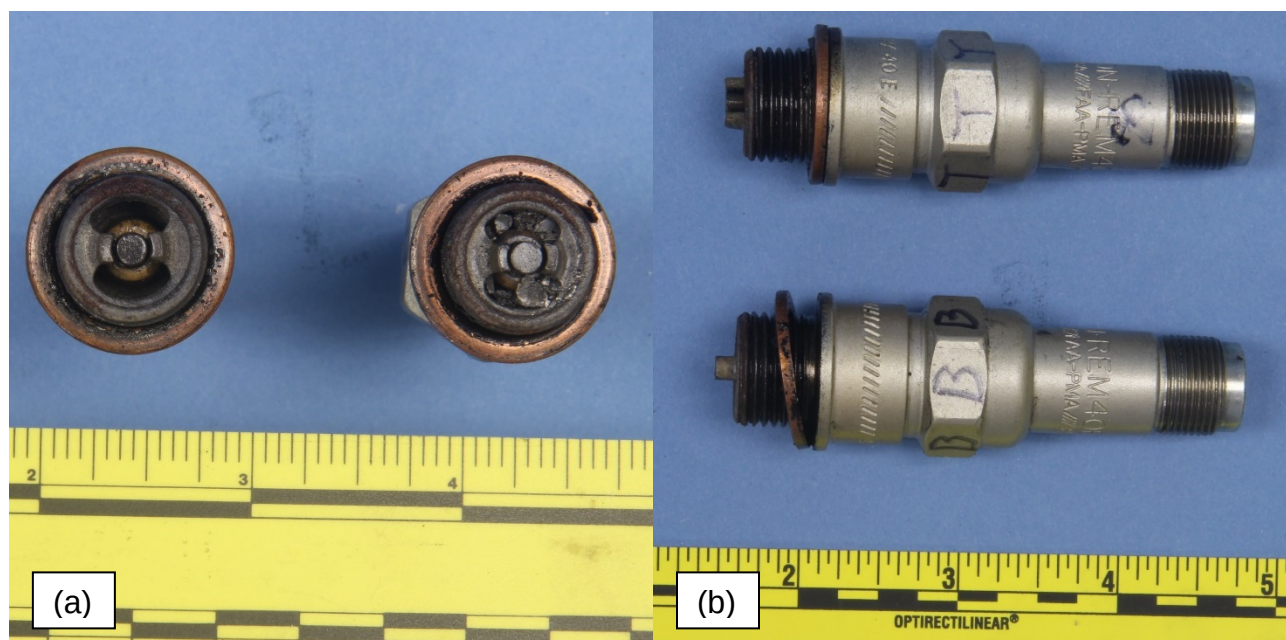
Figure 18 shows the two spark plugs submitted from the #4 cylinder position. The right spark plug on Figure 18a exhibited some dimpling features, consistent with impact from an adjacent object. While there were some dark compounds on the internal surfaces of the plugs and their electrodes, there was no indication of excessive fouling compounds or arcing damage.

Figure 18 – View of the #4 spark plugs from (a) the electrode and (b) the sides.
