## ***Piper Exam Notes***

### ***N4139A, PA-28-181, SN 2843115***

On 08/29/2018 at about 1740 AZ, a 1998 Piper PA-28-181 *Archer III* was substantially damaged during a forced landing on a road about 18 miles southwest of Casa Grande, AZ. There was no fire. The Private Pilot occupying the front left seat and the Student Pilot/owner occupying the front right seat reported no injuries.

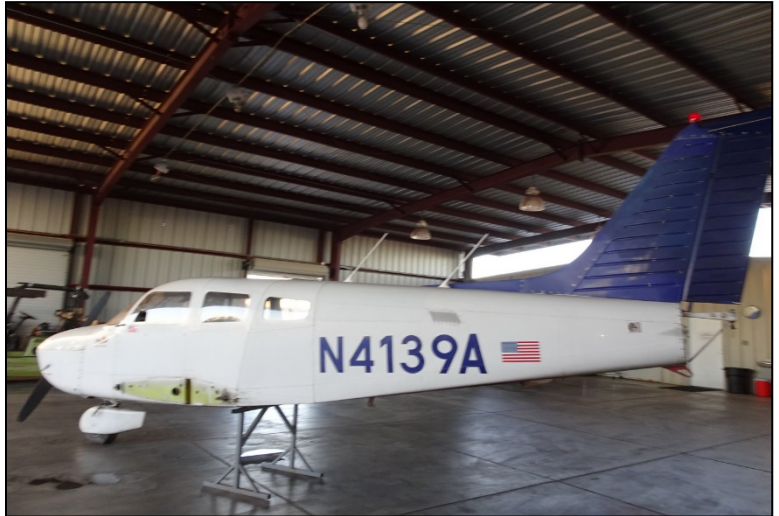
The yokes appeared undamaged. Aileron control cable continuity was established from the yoke chains to the turnbuckles aft of the main wing spar; the forward aileron cables had been disconnected from the wing aileron control cables at the turnbuckles to allow for disassembly of the aircraft. Rudder cable continuity was established from the rudder pedals to the rudder. The stabilator cables remained attached to the control tee bar and continuity was established through the fuselage to the aft clevises, which had been removed from the stabilator balance weight during recovery. The flap lever was in the flaps up position. The pitch trim indicator pointed to aircraft nose down, and rudder trim indicated approximately neutral.

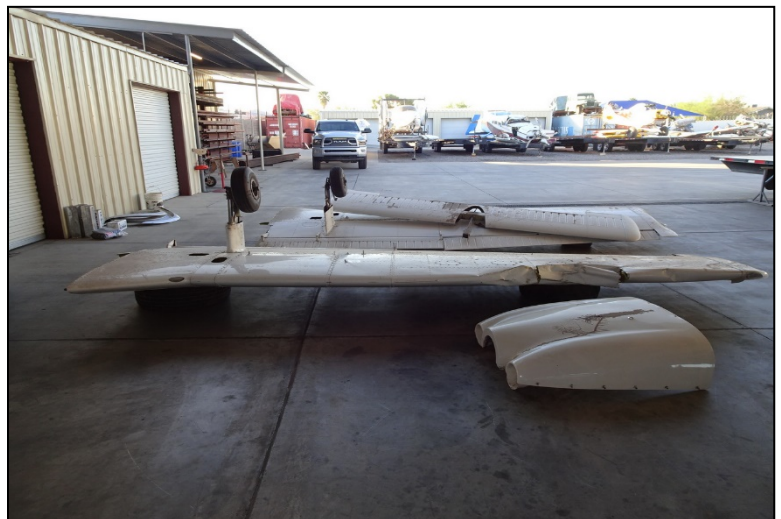
The right wing was removed from the fuselage. The leading edge between wing stations (WS) 172 and WS 128 (approx.) was crushed aft about 4-6 inches. The right main gear remained attached to the wing and no defects were observed. The landing gear fairing had been removed.

The aileron cables remained in place in the wing and were disconnected at the wing root. The aileron control bellcrank and stops remained in place and were apparently undamaged. The aileron and flap remained attached to the wing. The aileron showed no obvious damage. The flap lower skin was punctured and scraped at approximately WS 60-64.

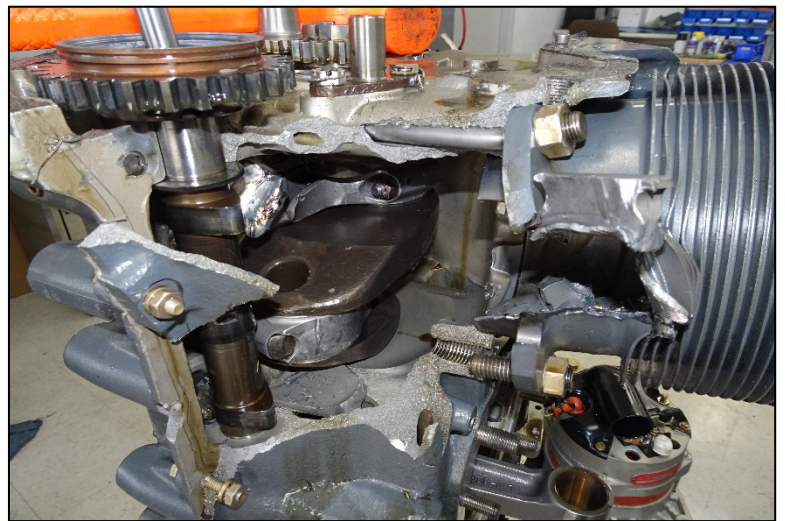
The engine cowlings remained installed. The upper engine cowl, though intact, was cracked in the center, and oil had oozed and streaked aft. When the engine top cowl was removed, it revealed extensive damage to the engine crank case between the base of the #4 cylinder and the upper case flange. The crank case was fragmented, pieces were apparently missing, and the camshaft and crankshaft were exposed. The engine was seized, and the propeller could not be rotated.

The crank case was broken apart from the split line down to the #4 cylinder. The #4 connecting rod remained attached to the crankshaft; it was bent, and the piston end was damaged. The #4 piston wrist pin lay within the crank case; it was scratched, but otherwise undamaged. The #4 cylinder mounting flange was broken apart. All the #4 cylinder base nuts were missing or finger loose. The #4 piston skirt was missing, and the top of the piston remained at the top of the cylinder. There were no signs of heat distress found within the engine, and none of the oil galleries were found blocked.
