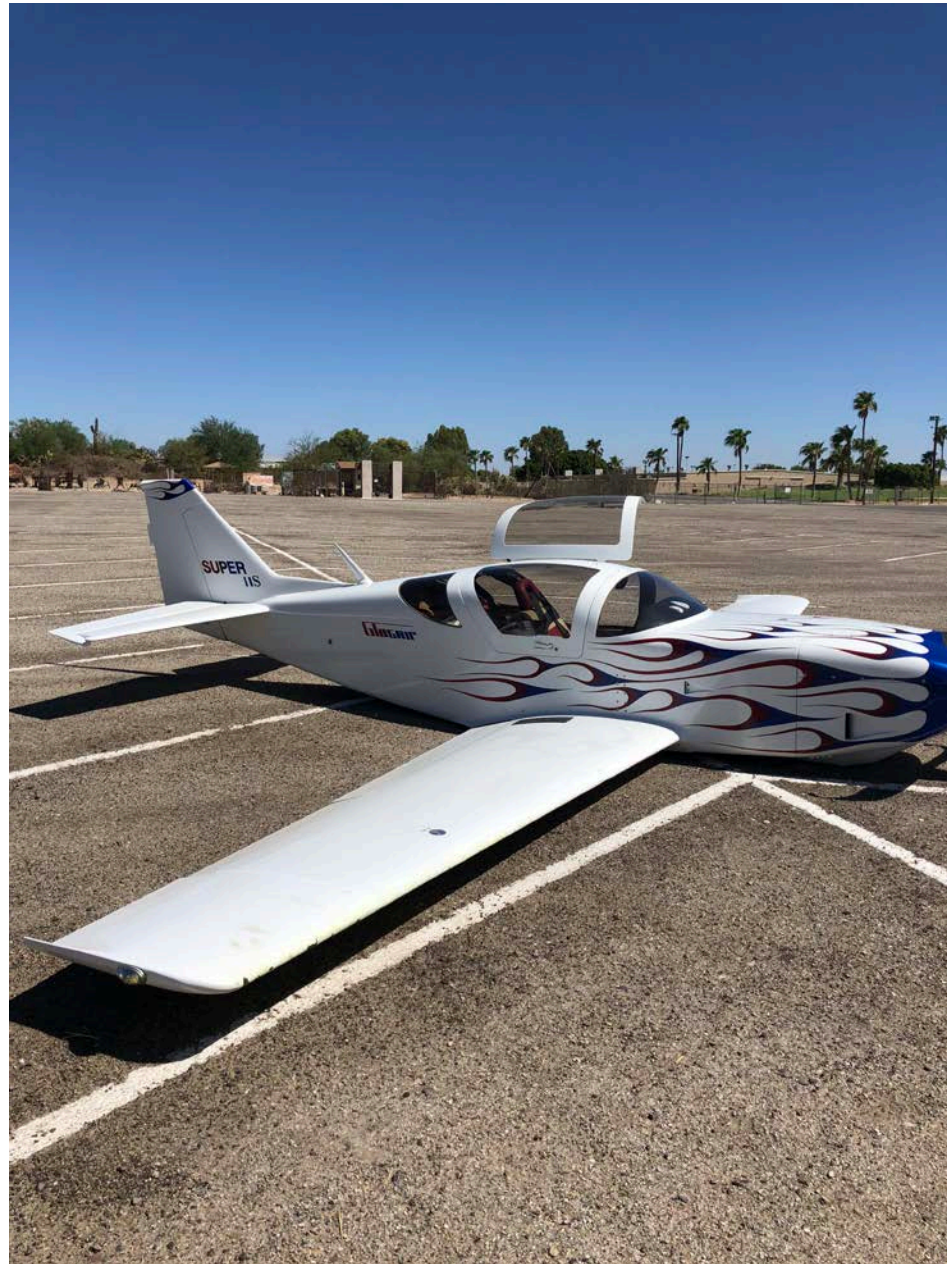
**Photo 1 – Airplane at Accident Site**

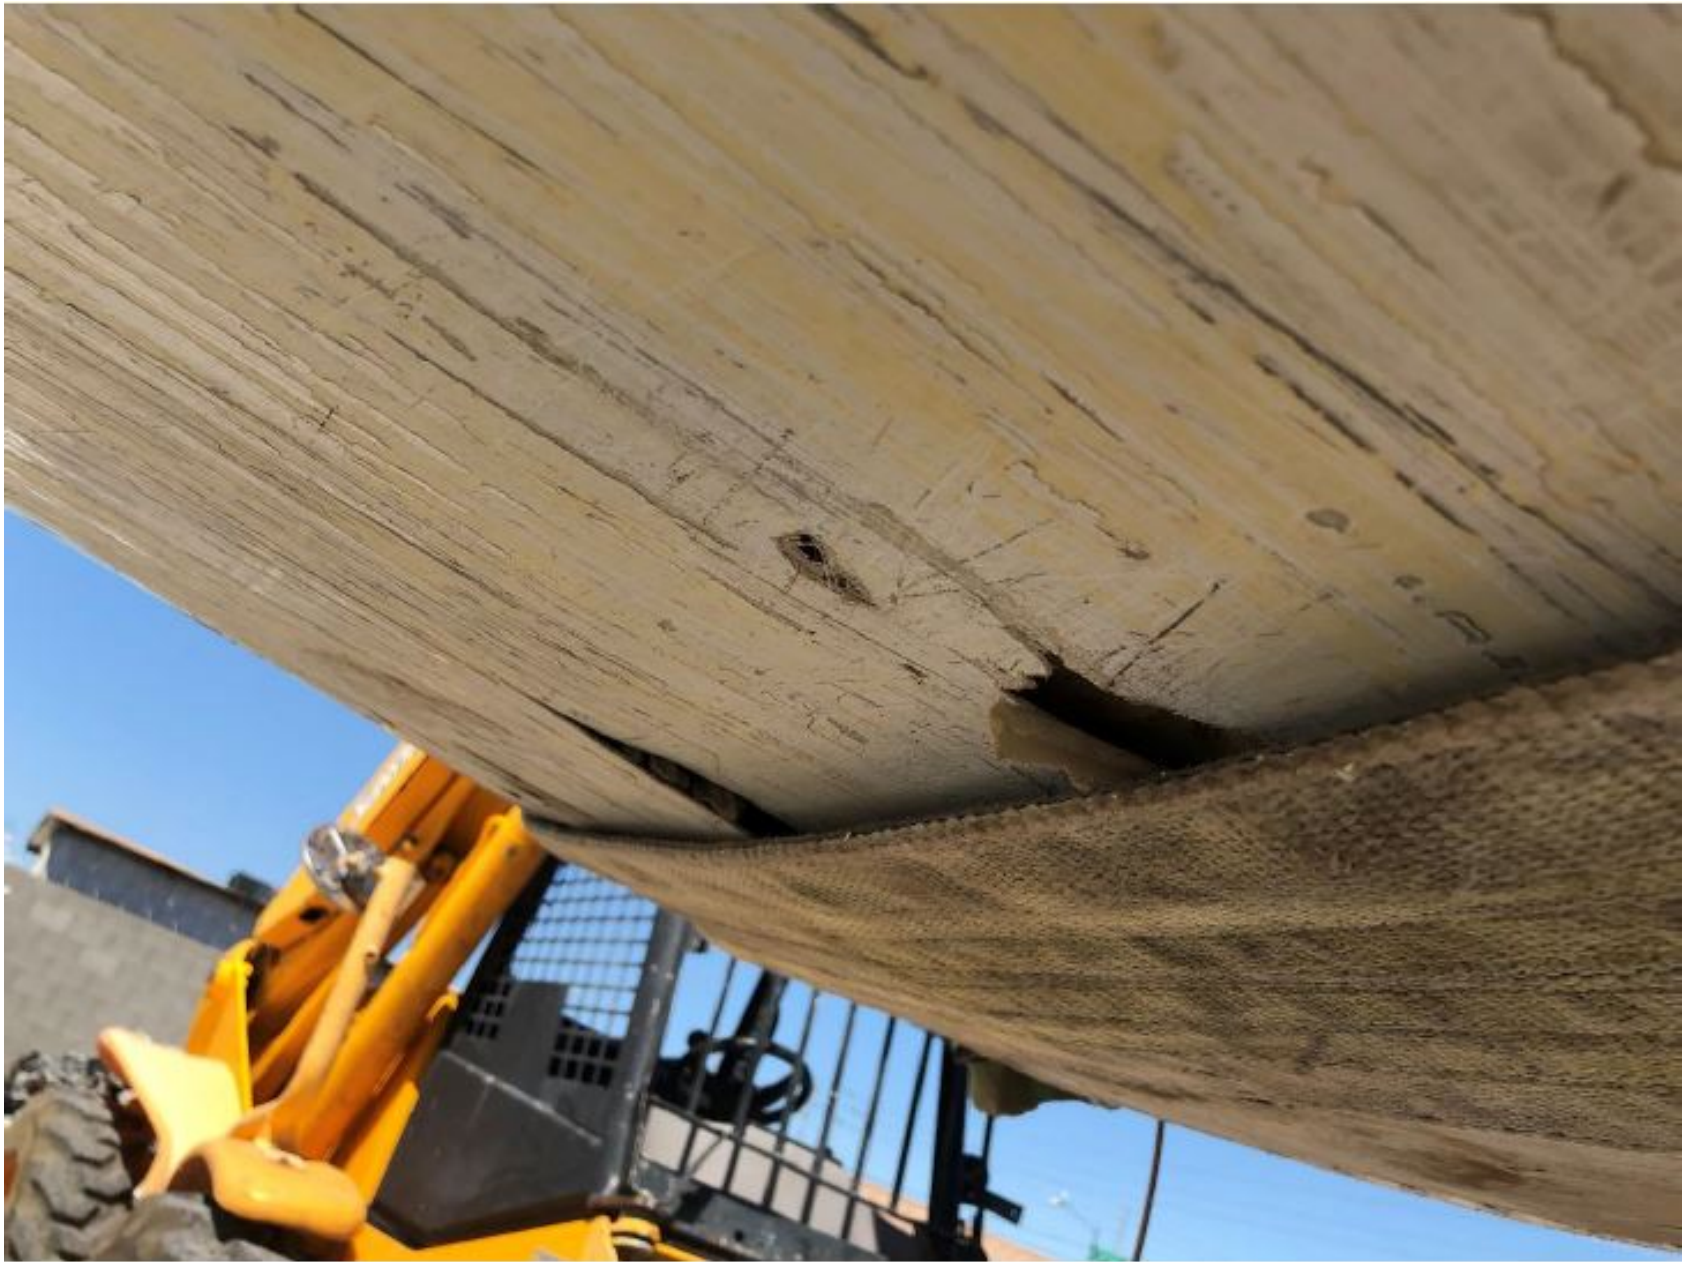
**Photo 2 – Damage to Lower Aft Fuselage**

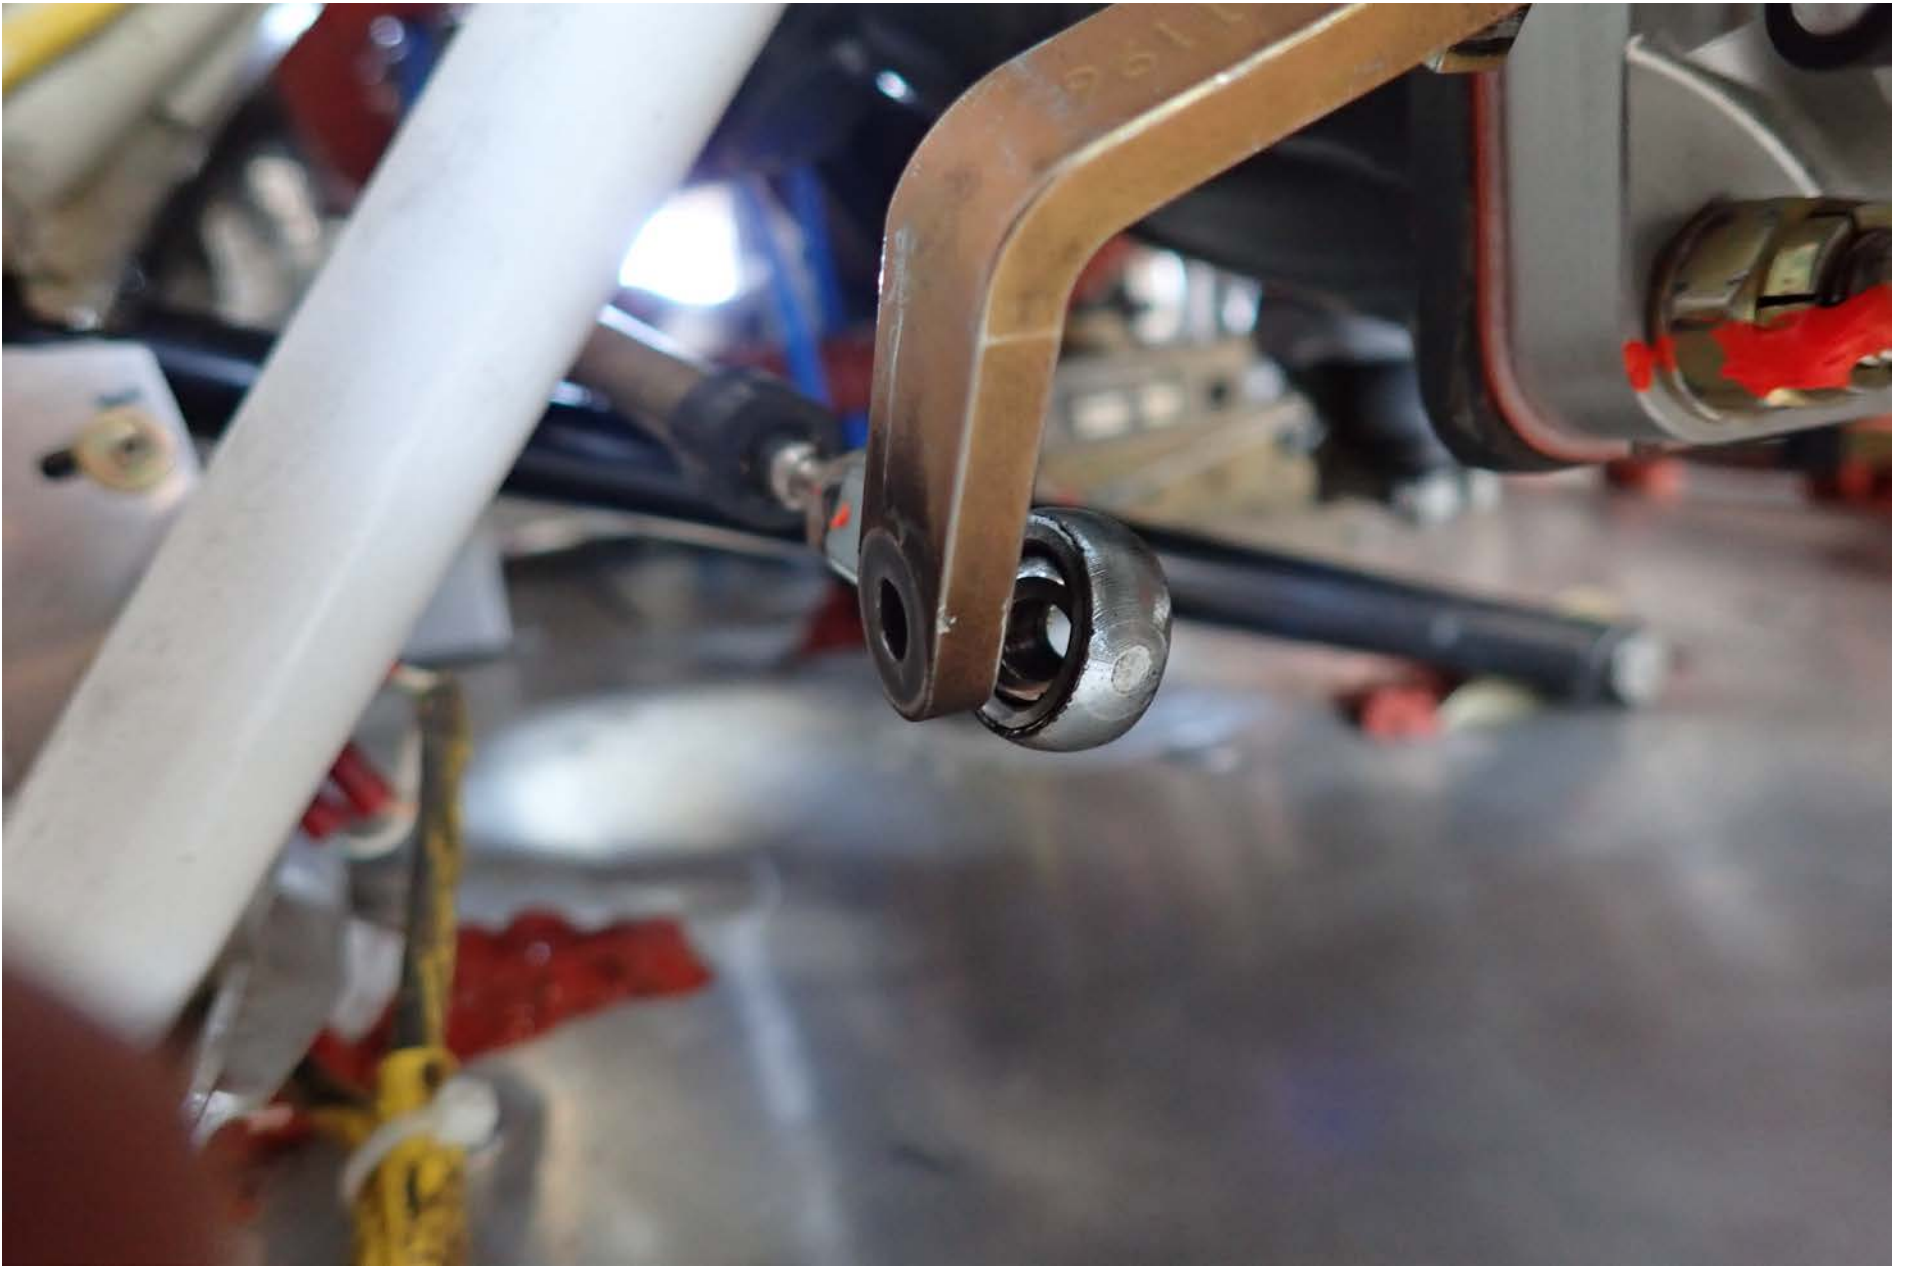
**Photo 3 – Throttle Linkage at Fuel Injection Servo**
