# **HELICOPTER EXAMINATION REPORT**

**WPR18LA252**

**Santa Ana, California**

**Guimbal Cabri G2; N401SH**

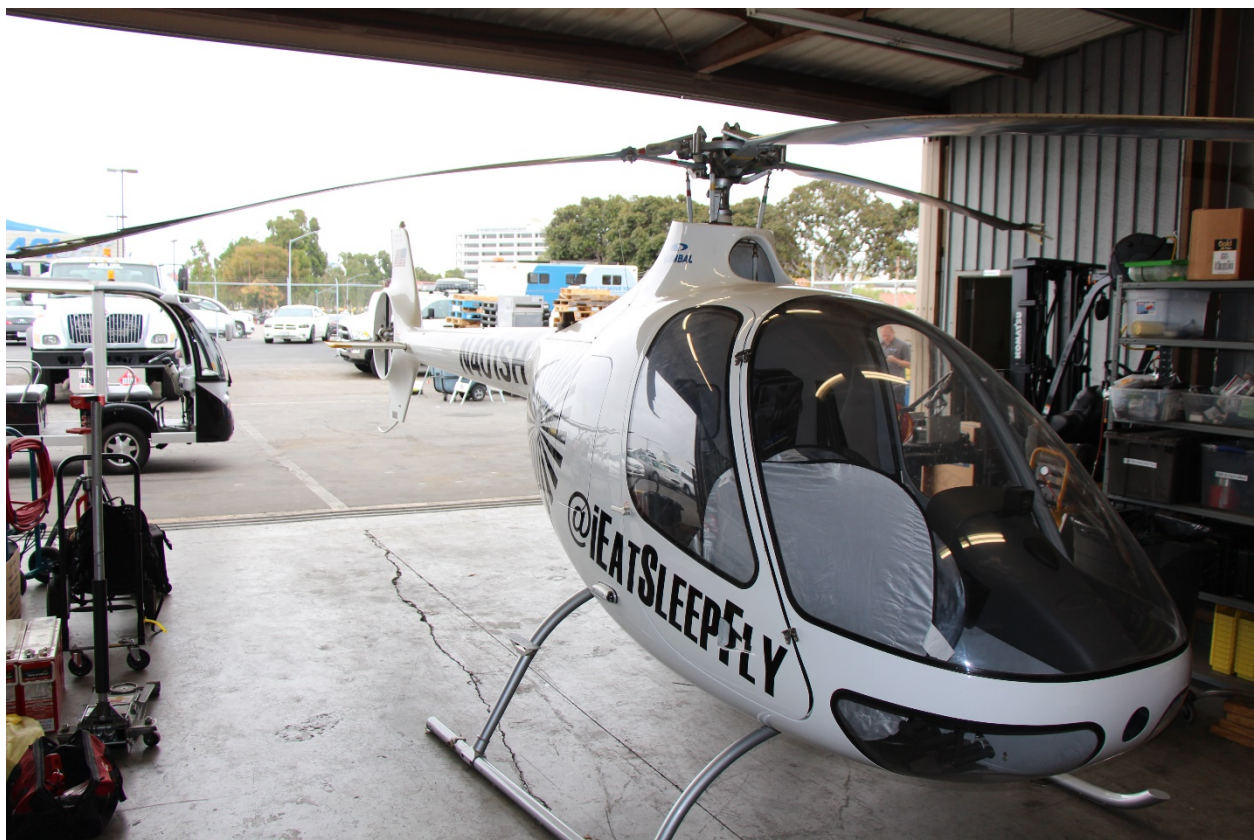
Photograph 1: Forward Quartering View of Helicopter

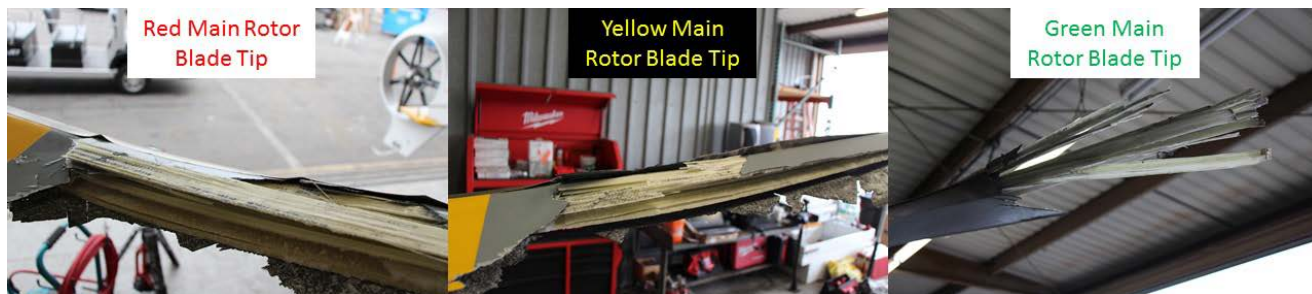
The airplane came to rest on its left side on runway 20R at SNA. Photographs of the accident site displayed all major sections of the helicopter; however the helicopter rolled onto its left side but remained attached to the landing skids' forward and aft crossbars. All three main rotor blade tips were destroyed (see photograph 2).

blades tips were destroyed and the blades exhibited some bending opposite the direction of rotation. An examination of the main rotor mast and hub did not show any abnormalities as the pitch change links were connected each of their respective main rotor hub brackets. The elastomeric bearings were normal in appearance did not exhibit any extrusion. The anti-torque pedals moved normally and were continuous to the tail rotor blades at the fenestron.

Photograph 2: Main Rotor Blade Tip Damage

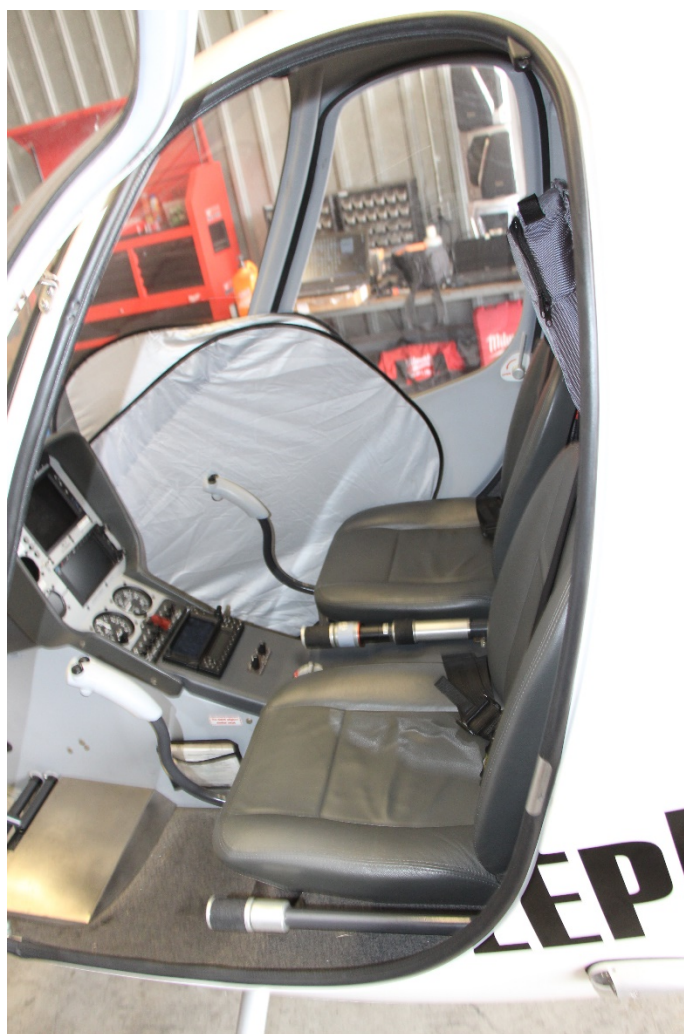
Photograph 3: Cockpit Before Center Console was Removed

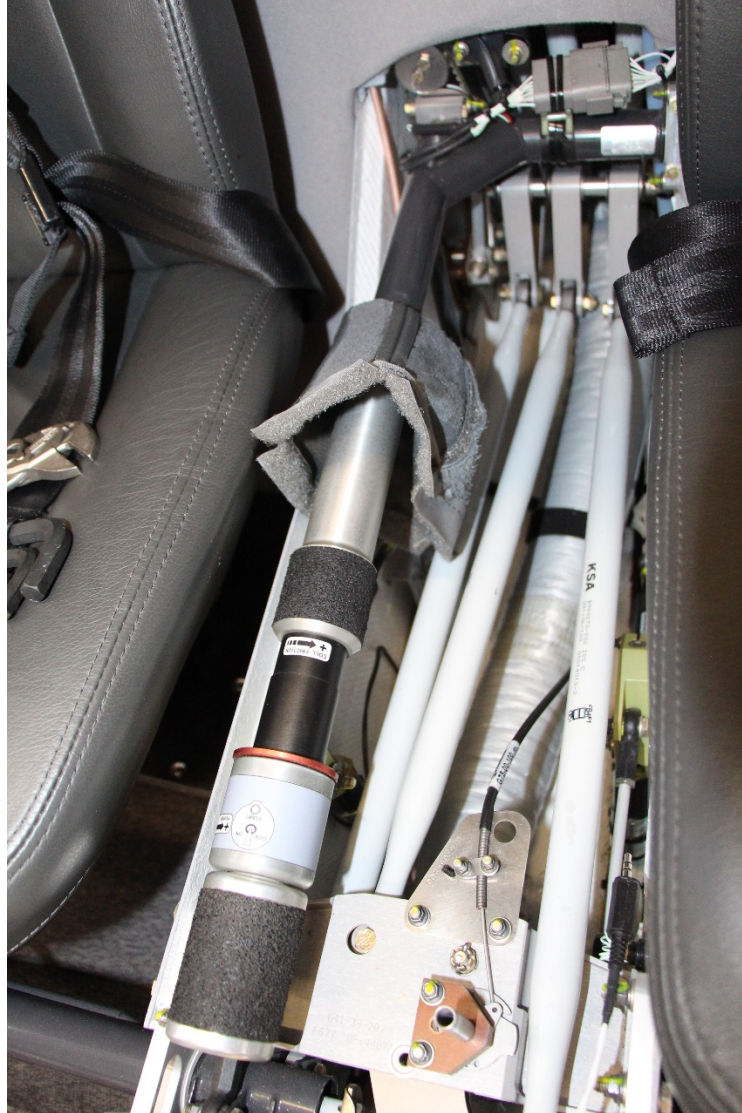
The collective twist grip was advanced to the full power position multiple times from the closed position. Greater resistance was felt when the twist grip was moved to the CLOSED position, but it did not preclude the throttle from closing. During each attempt, the collective twist grip, with the collective control arm in the down position, was rotated to the full left position; however, this required a re-grip of the throttle at an intermediate position. Once the collective control arm was pulled, the carburetor throttle started to open and the correlator cam engaged.

Photograph 3: Center Console without Cover, Right Seat Collective Control, Correlator (top of photo), and Governor Adjustment (top of photo)

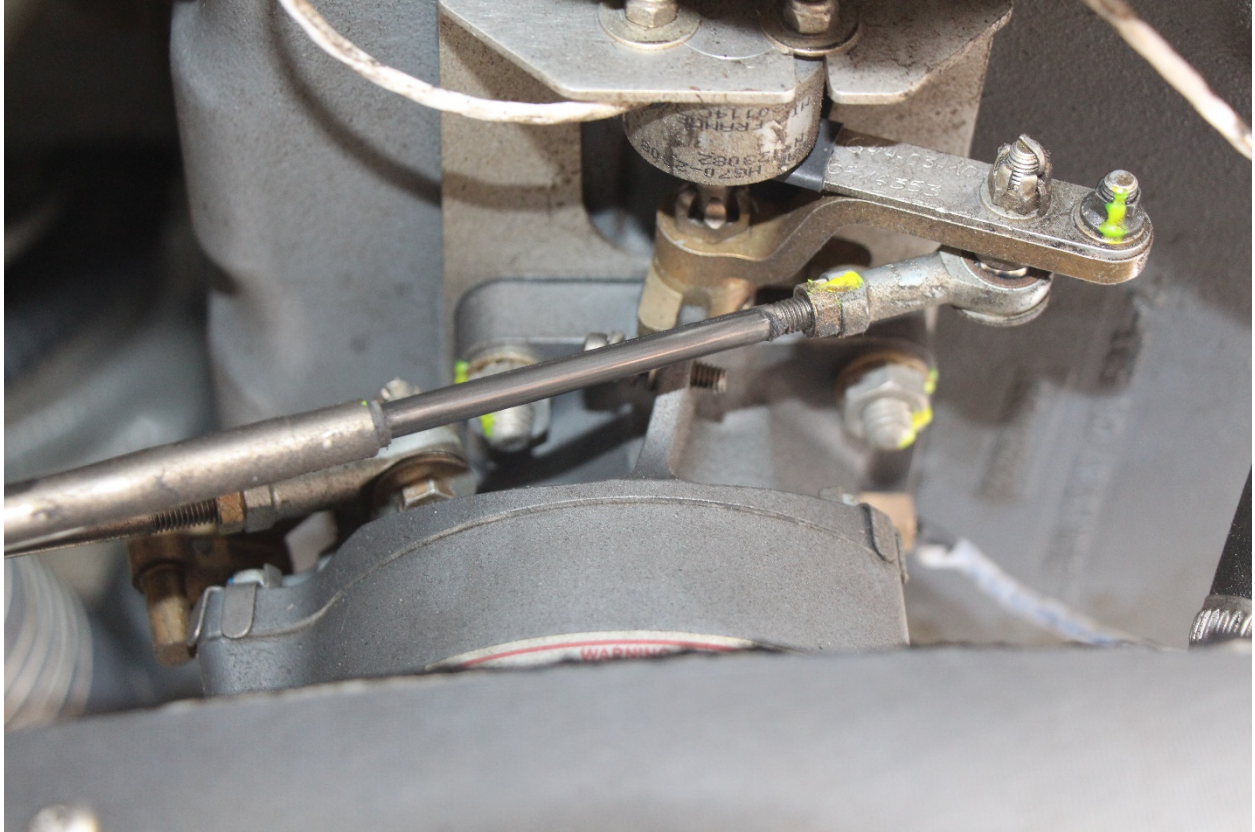
The throttle arm of the carburetor moved in conjunction with the throttle to the idle, intermediate, and full power positions. Please note, the intermediate position is selected when the twist grip has been rotated to the FULL OPEN position and the collective control is at the lower stop position.

Photograph 5: Throttle Arm Actuated to Full Power Position
