## **NATIONAL TRANSPORTATION SAFETY BOARD**

# **ENGINE EXAMINATION SUMMARY REPORT**

**WPR18LA263**

Location: Bullhead City, Arizona  
Date: September 15, 2018  
Aircraft: N573BV  
NTSB IIC: Andrew Swick

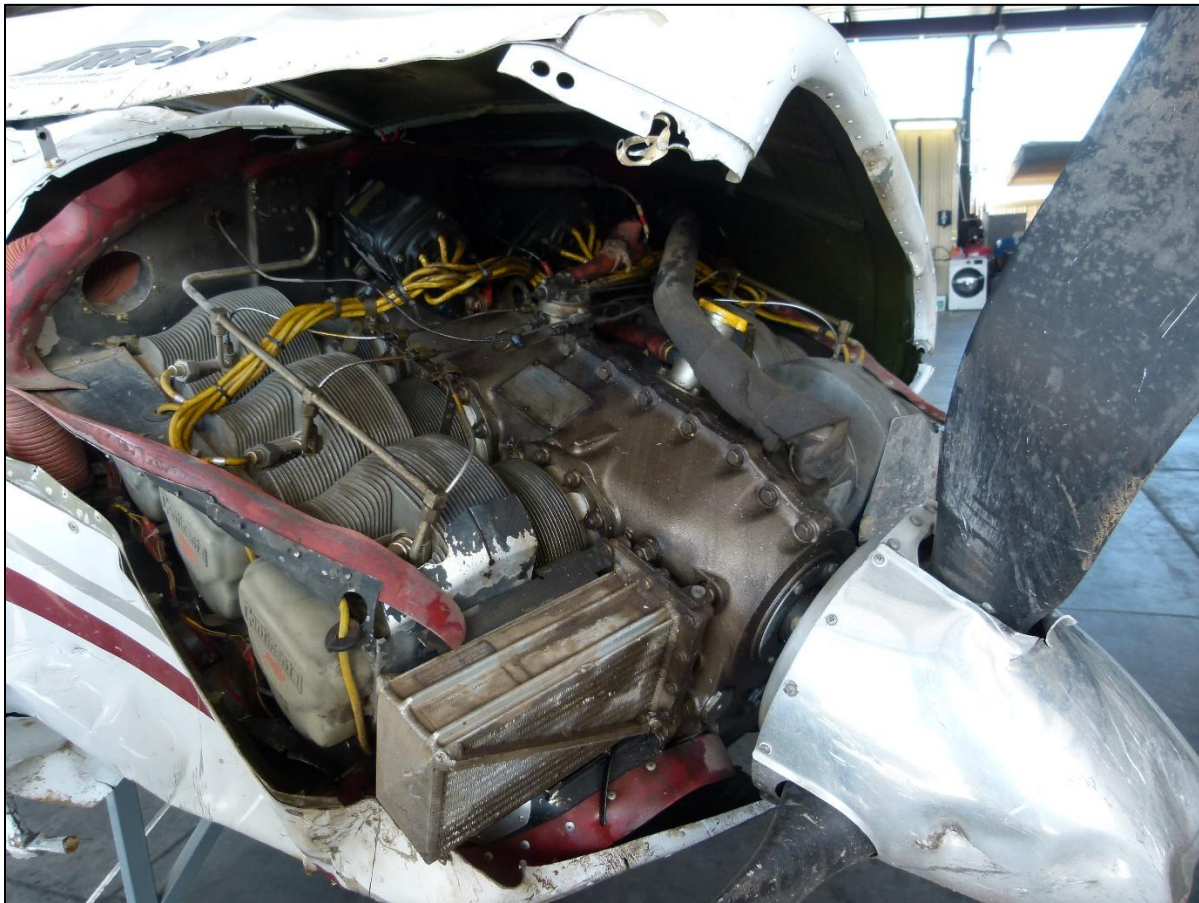
The engine remained in the airframe during the examination. The exterior of the engine was intact, and no indications of catastrophic engine failure was noted. The upper spark plugs were removed and showed normal wear and combustion deposits in the electrode areas. The valve covers were removed, and the crankshaft was rotated by hand from the propeller assembly. Gear and valve continuity was established throughout the engine and cylinder thumb compression was observed at each cylinder. The fuel delivery system was examined and was free of contaminants. The ignition leads produced spark during the magneto impulse coupling engagement. The turbocharger turbine blades were undamaged and spun freely by hand.

Figure 1-Engine installed on the airframe (courtesy of Continental Motors).

The propeller assembly remained attached to the engine and had impact damage. The propeller blades had deep grooves and missing material from their tips and s-type bending. Spinner was crushed.

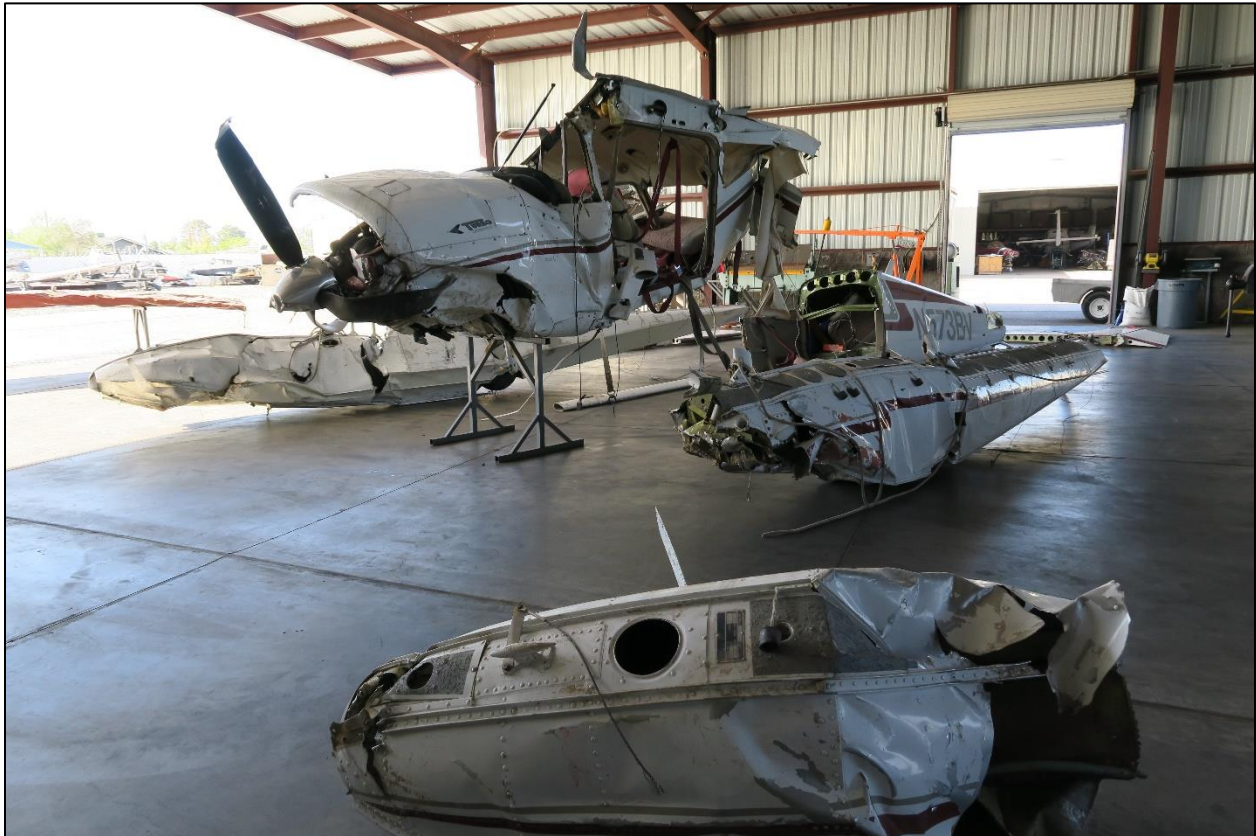
The amphibious floats, wings and empennage were separated during the recovery of the wreckage. The amphibious float gear wheels and water rudders were found in the retracted position. The flight control surfaces remained secured to their attachments. The engine and propeller remained attached to the firewall and forward fuselage.

The airframe was examined and revealed substantial damage throughout.

Figure 2-Wreckage Examination Layout (courtesy of Textron Aviation)

The fuel selector handle was found in the “BOTH” position. The fuel boost pump switch was found in the “OFF” position and the fuel pump was in the “LOW” position. The airplane’s fuel system revealed no abnormalities. The right seat shoulder harness stitching was separated from the inertia reel. The harness was also cut by first responders.
