## **NATIONAL TRANSPORTATION SAFETY BOARD**

# **AIRFRAME AND ENGINE EXAMINATION**

**WPR18LA265**

Location: Granada Hills, CA  
Date: September 15, 2018 at 1220 PST  
Aircraft: Schweitzer; N2128T  
NTSB IIC: Andrew Swick

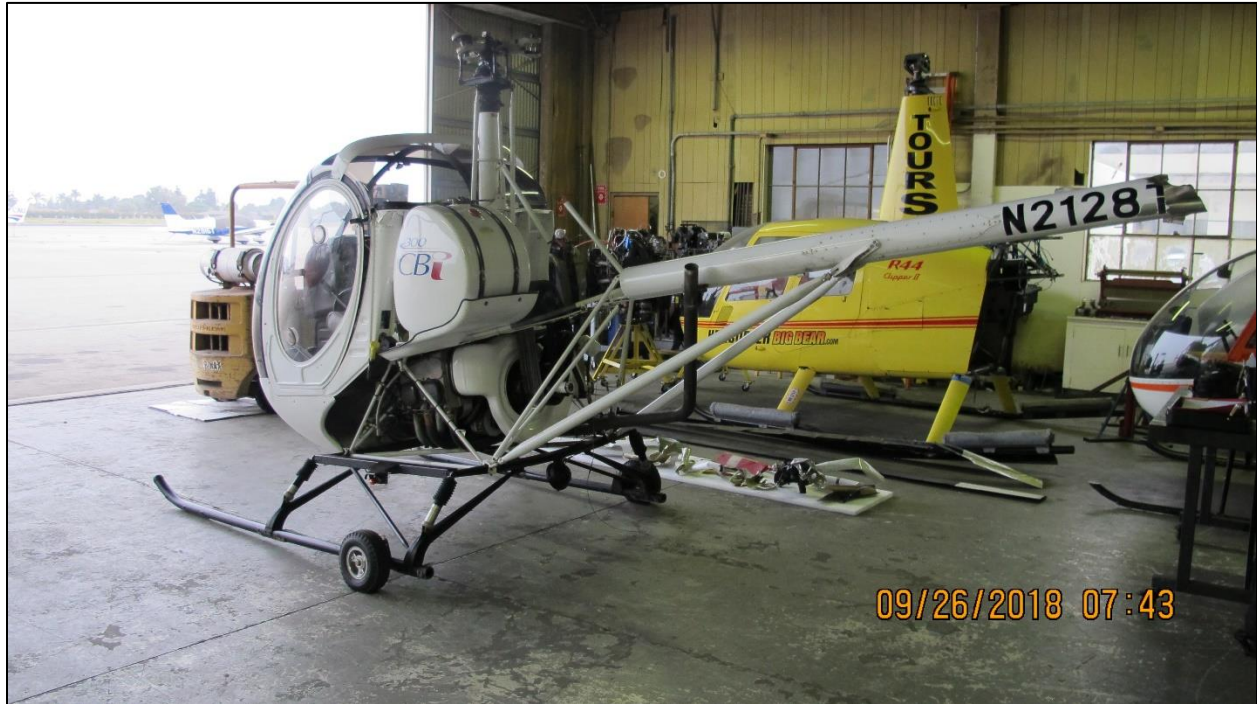
Figure 1-Main Wreckage

The airframe remained secured on the landing gear (skids). The main rotor blades were removed from the airframe during the relocation of the wreckage and were damaged. The cabin structure was damaged on the upper left door frame. The cabin controls and instrumentation were undamaged. The upper tailboom to main rotor drive shaft housing support rod separated with overload signatures, midspan.

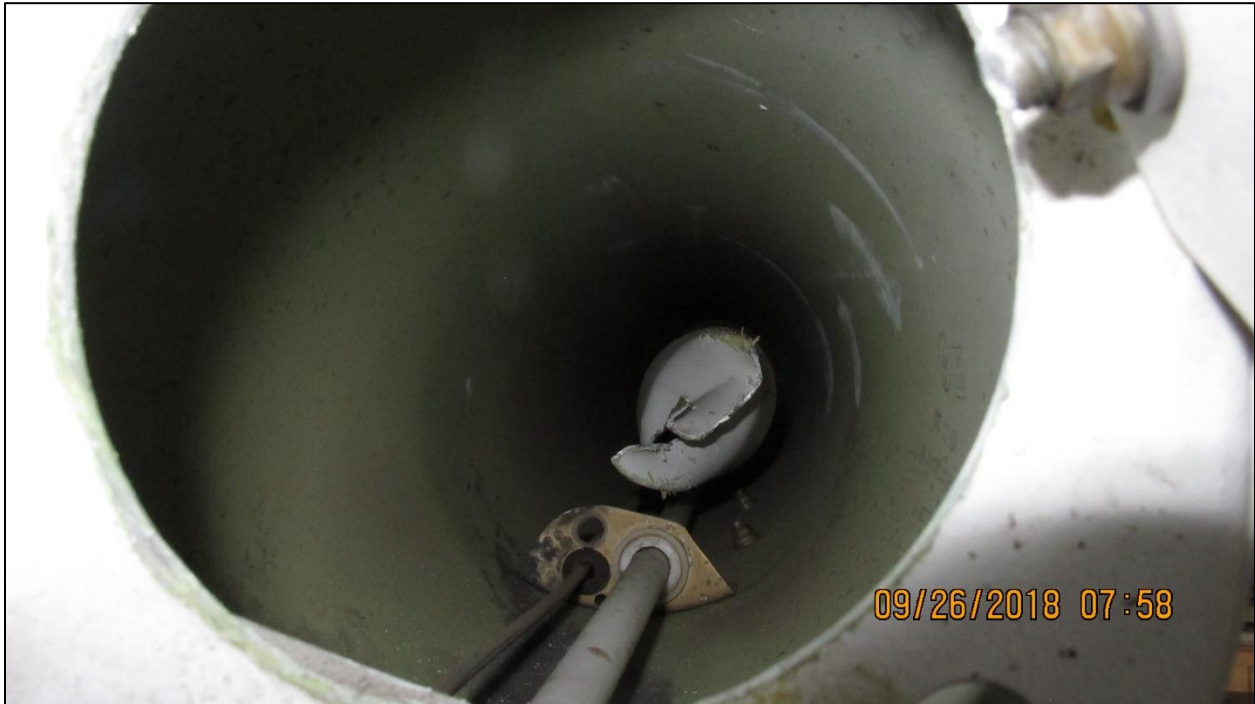
**Figure 2-Driveshaft Separation in the Tailboom**

The drive shaft separated about 2 feet from the engine spline shaft attachment. The separated ends were twisted. The tailboom remained attached to the fuselage and was separated near the tail rotor transmission.

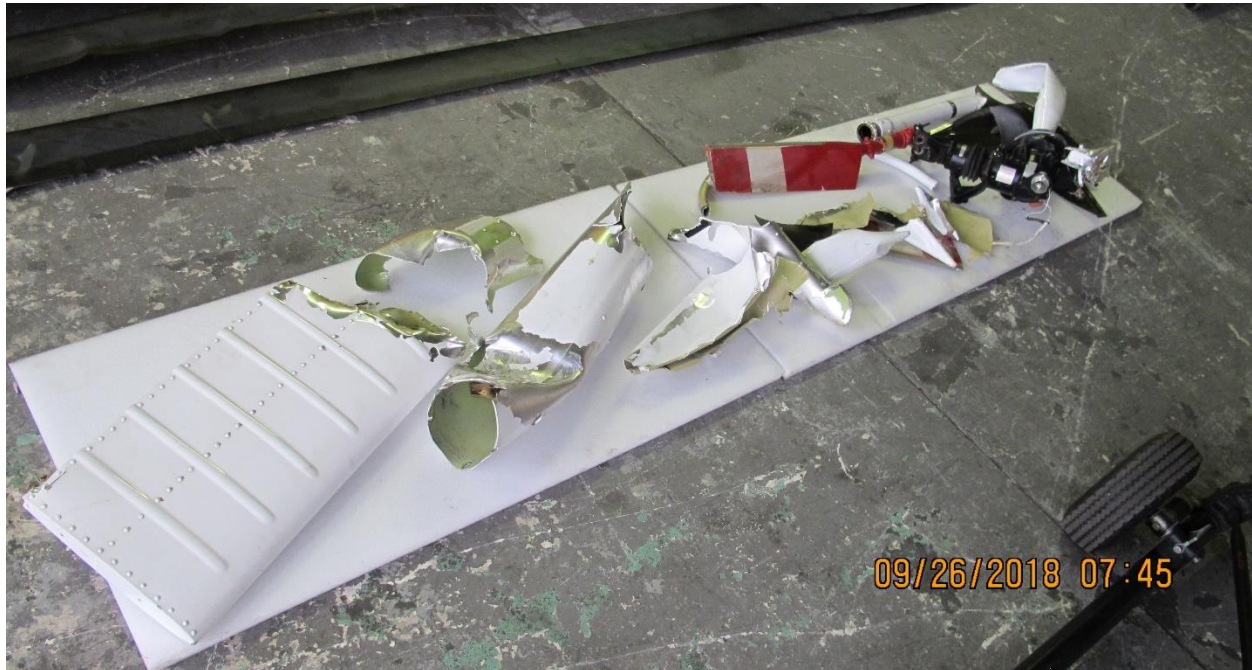
Figure 4-Separated Tail Rotor Gear Box and Flight Control Surfaces

The separated tail rotor gear box and flight control surfaces were found displayed on the hangar floor. The two separated drive shafts were about equal in length and showed twisting near the separation surfaces. One tail rotor blade separated from the gear box assembly. The tail rotor blades were undamaged.

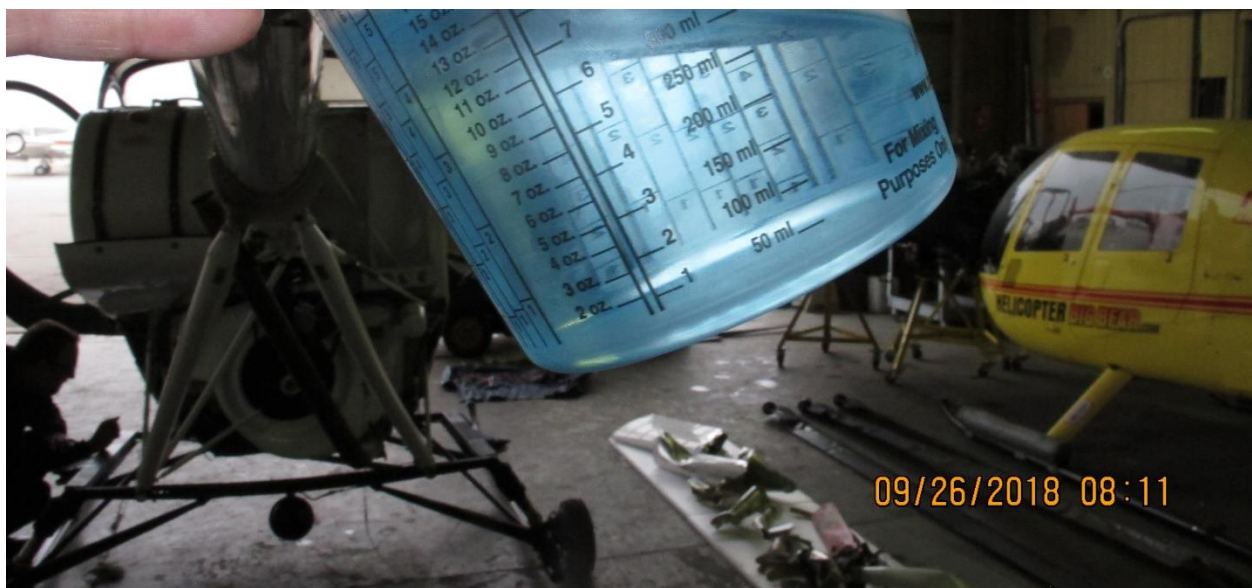
Figure 5-Fuel Collected from the Fuel Strainer

The fuel tank had about 1/2 tank of 100LL fuel. The fuel strainer sump valve was opened and about 1/2 an ounce of blue fuel was collected. The fuel shutoff valve was positioned from the shutoff position (out) to the full in position and fuel flowed freely from the gascolator. No water or debris was visible in the fuel.

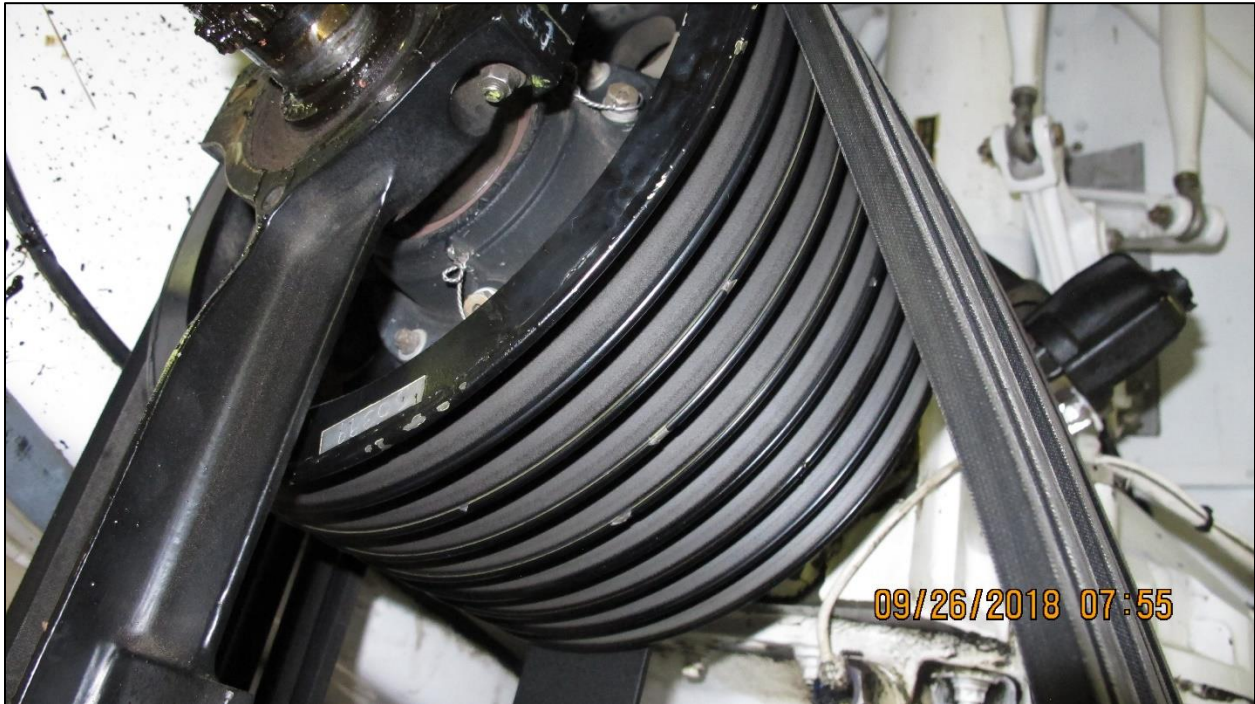
**Figure 6-Drive Belts and Belt Sheave**

The drive belts were removed to facilitate the rotation of the crankshaft. The drive belts showed light amount of wear and were undamaged. The belt sheaves were undamaged. The drive shaft spine shaft had damage to one side of the spines.

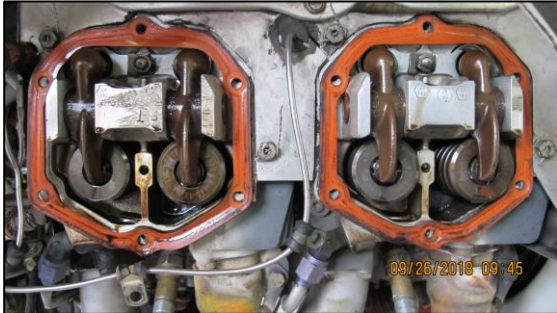
Figure 8-Cylinder Overhead Components, No. 3 and 1

Examination of the Lycoming HIO-360-G1A engine (Serial #RL-35157-51A) revealed that the engine remained attached to all four engine mounts. The engine remained secured to the airframe and was undamaged. The oil dipstick revealed just above 6 quarts. The engine control cable attachments were secure, and no anomalies noted. The drive belts remained attached to the sheaves and showed normal wear. The belts were removed to freely rotate the engine crankshaft. The cylinder rocker covers were removed, and all cylinder overheads were undamaged and lubricated.

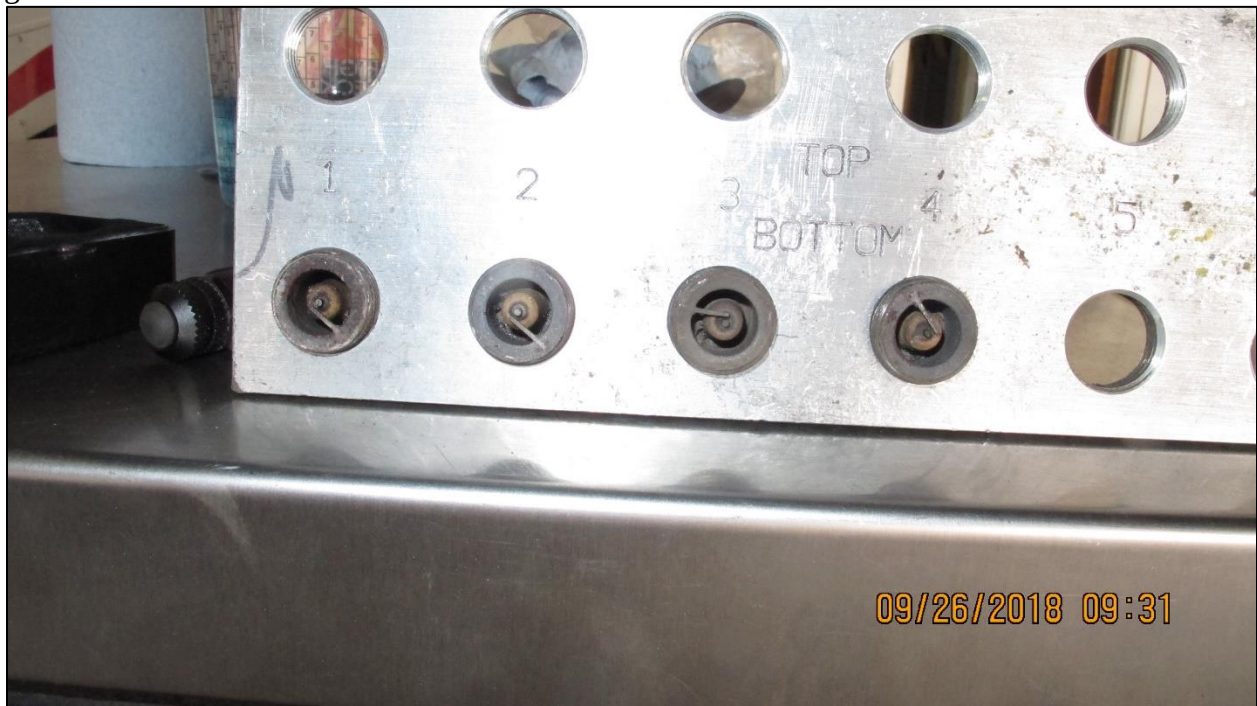
Figure 10-Lower Spark Plugs

The lower spark plugs were removed from the cylinders, and the electrode areas showed normal wear conditions and combustion deposits. The no. 4 spark plug revealed metal marks on the ground electrode.

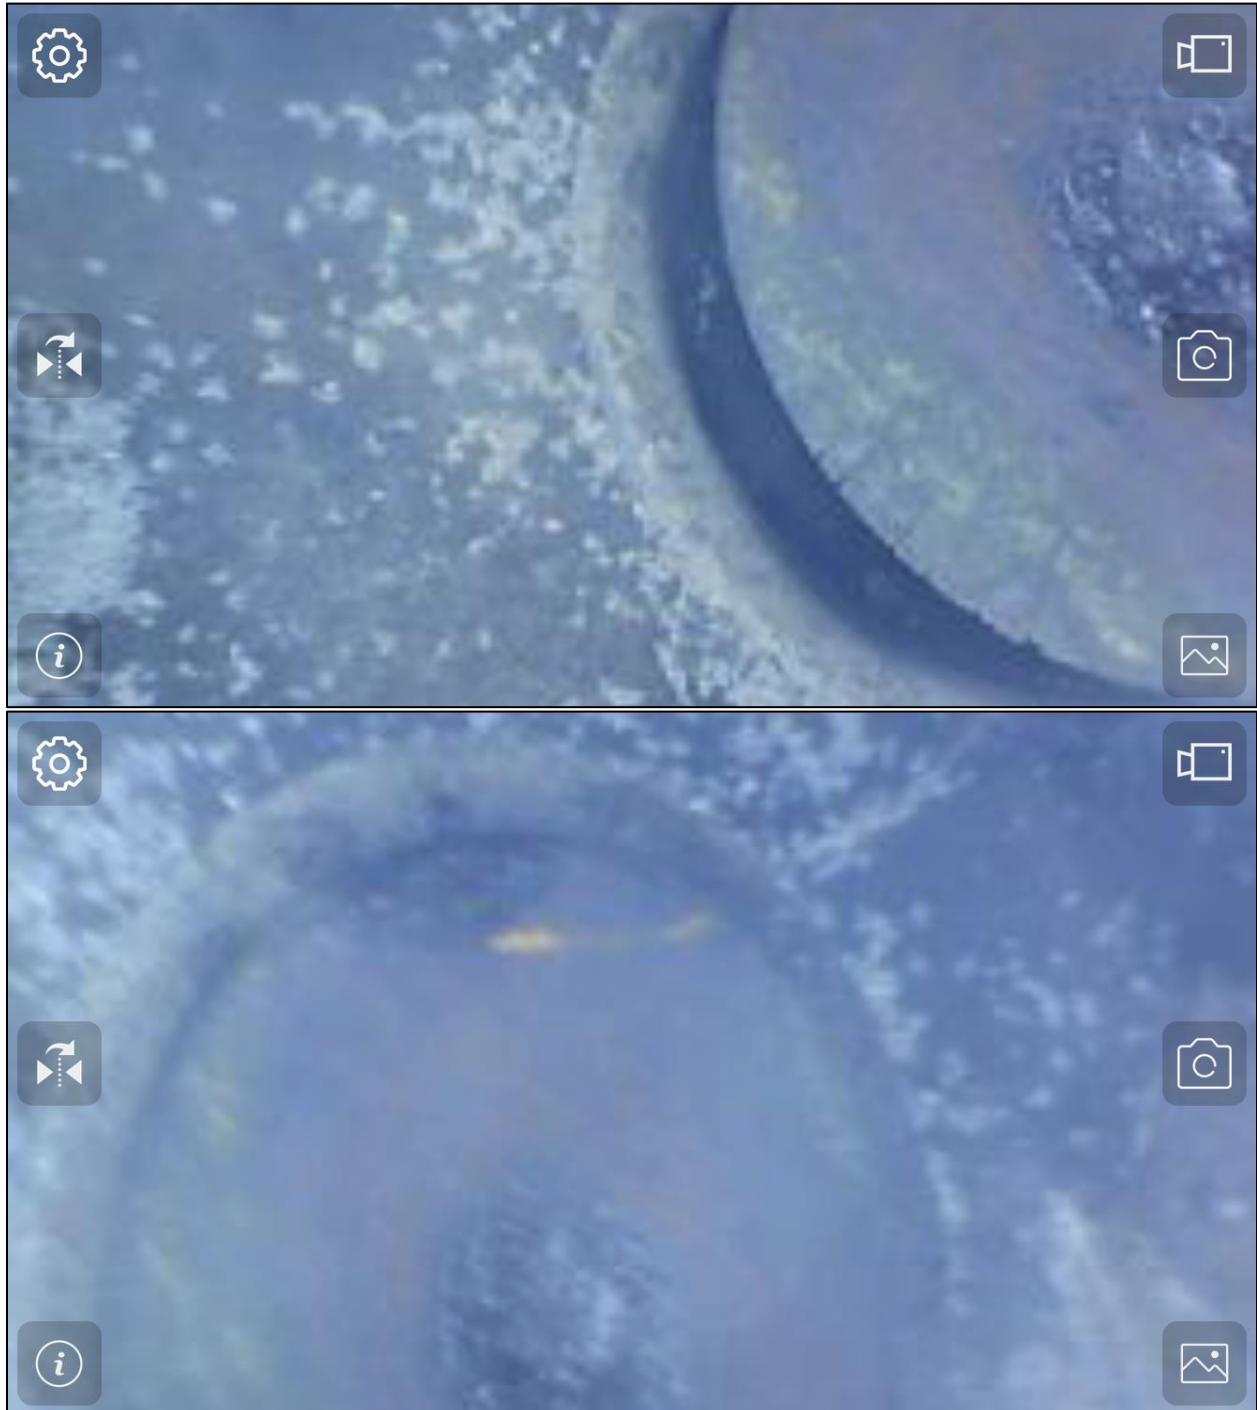
**Figure 11-Boroscope Images of the No. 1 Cylinder Exhaust Valve**

The crankshaft was rotated and thumb compression was attained on no. 2 and 3 cylinders. A rubber mallet was used to tap the rockers on cylinders no. 1 and 4. Thumb compression was still not attained. A boroscope examination of the no. 1 cylinder combustion chamber revealed the piston head and combustion chamber exhibited normal deposits. The exhaust valve head showed thermal discoloration in three areas consistent with combustion blowby. Cracking was visible on the valve head near the edge and a small amount of missing material from the outer edges of the valve head.

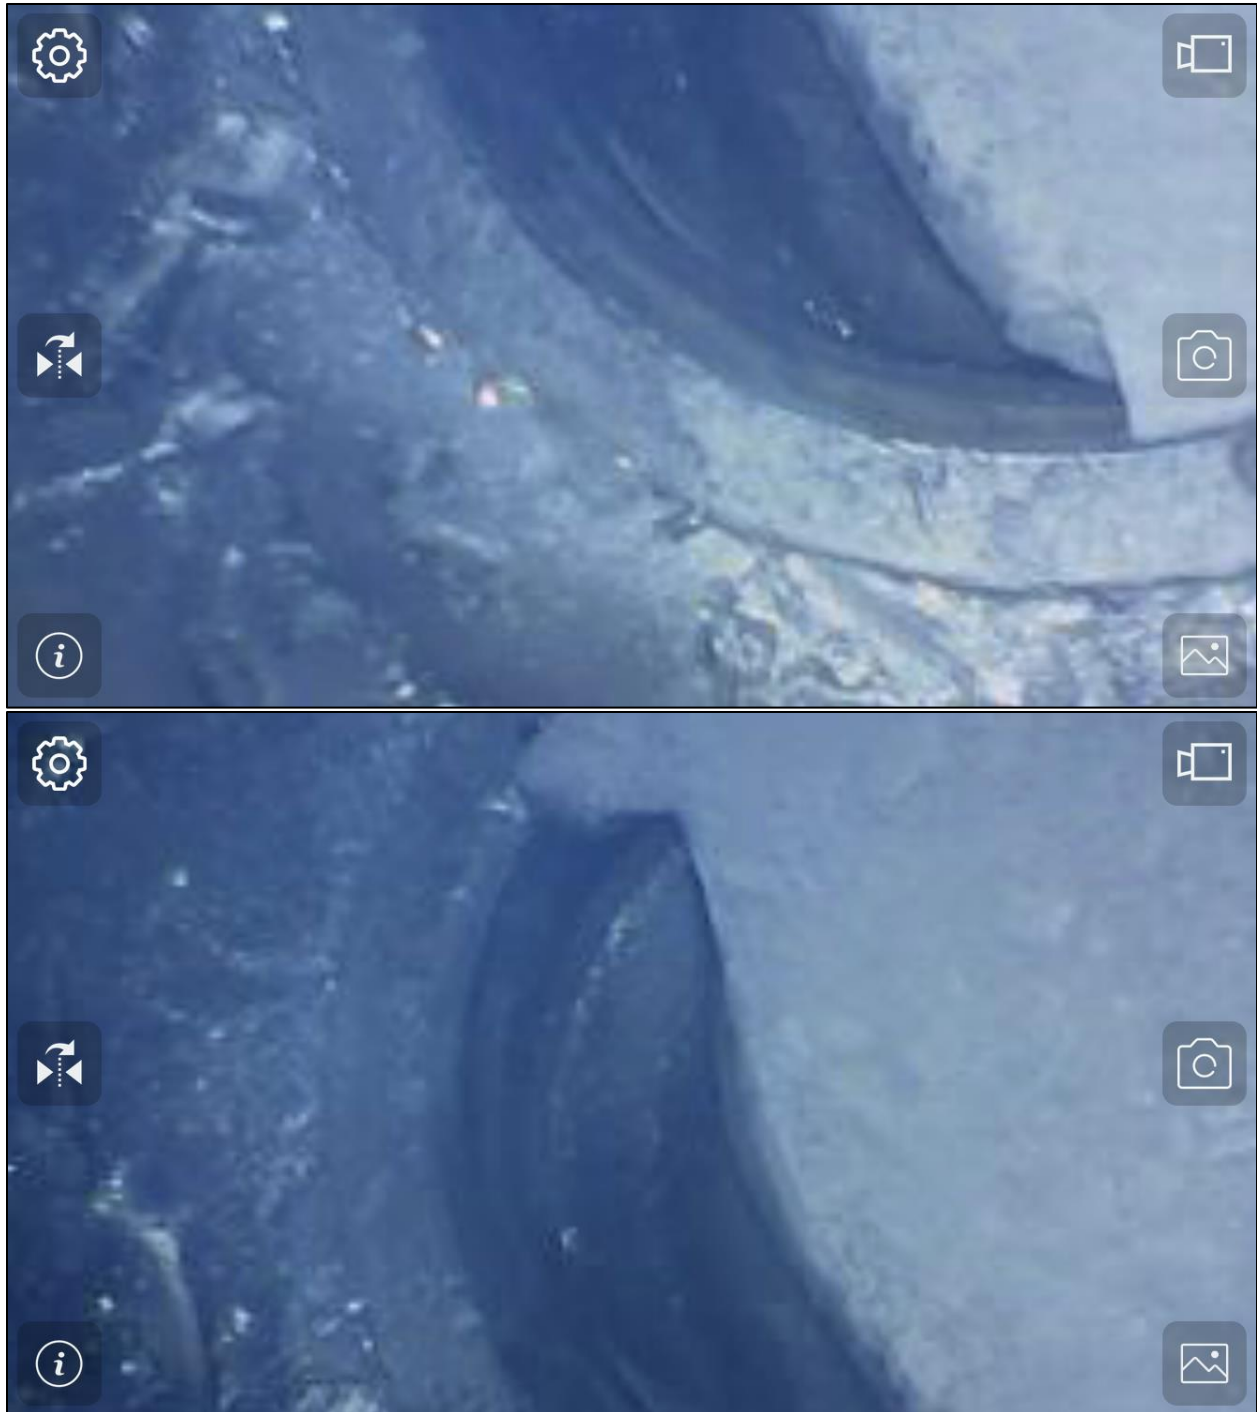
**Figure 12-Boroscope Images of the No. 4 Cylinder Exhaust Valve**

The no. 4 cylinder did not have any compression during a thumb compression test. A boroscope examination of the no. 4 cylinder combustion chamber revealed the piston head and combustion chamber revealed mechanical damage to their surface areas. The exhaust valve head was missing about 1/3 of its material.
