**From:** [REDACTED]  
**To:** [REDACTED]  
**Subject:** N632W  
**Date:** Tuesday, September 25, 2018 1:09:26 PM  
**Attachments:** [REDACTED]

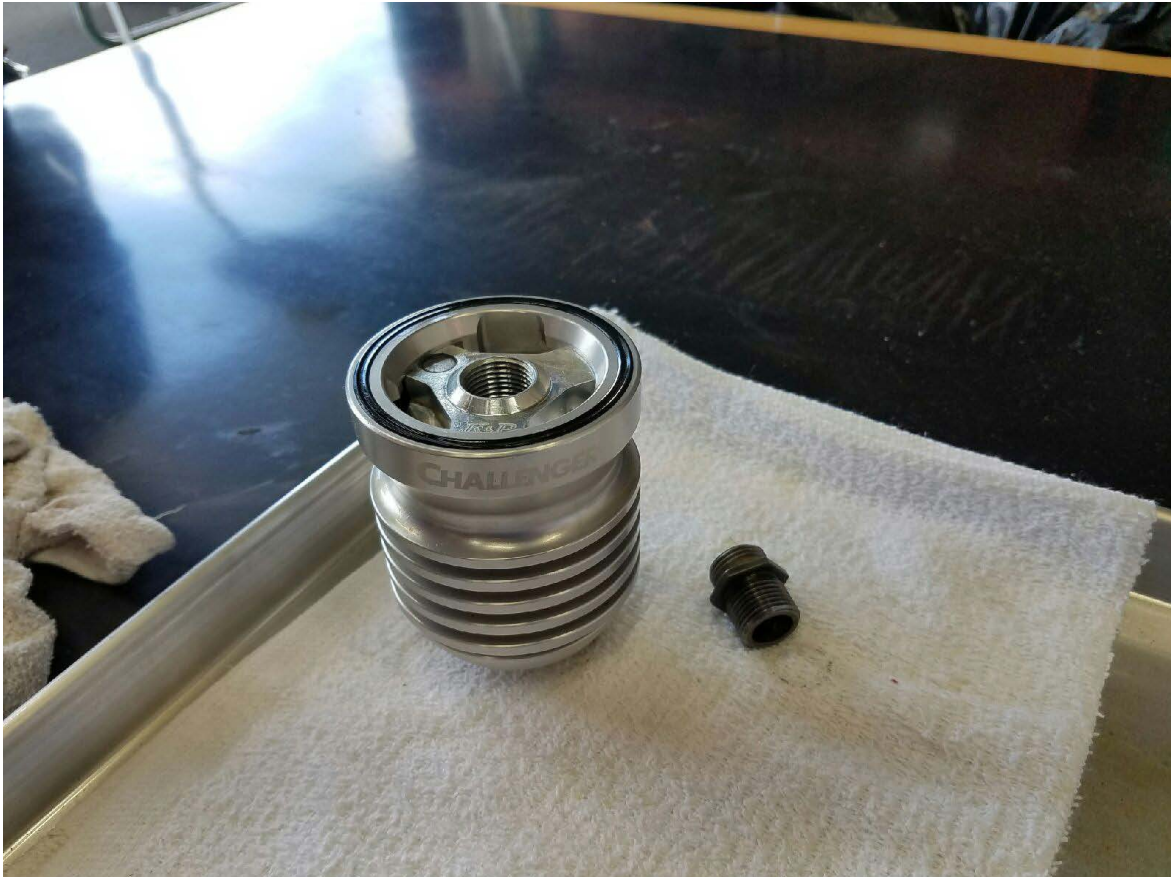
On Monday it was found some oil leaking out of filter. When filter was removed we found that fitting (fig 3, page 5 of 5) was loose and case empty (no oil). This fitting got worked only during overhaul by the manufacture or an approve R/Station. This fitting being not torque properly it will cause the filter not sitting properly into the housing and "O" ring not sealing properly. I attached a picture and some reference for you. As per overhaul manual this fitting requires 245 in.lb of torque and torque seal. See also copy of email from Tech. Rep.
