# NATIONAL TRANSPORTATION SAFETY BOARD

## MATERIALS LABORATORY FACTUAL REPORT

Report No. 20-016

Place : Heber, Utah  
Date : September 25, 2018  
Vehicle : Smith Aerostar 601P, N90339  
NTSB No. : WPR18LA272  
Investigator : Zoë Keliher, AS-WPR

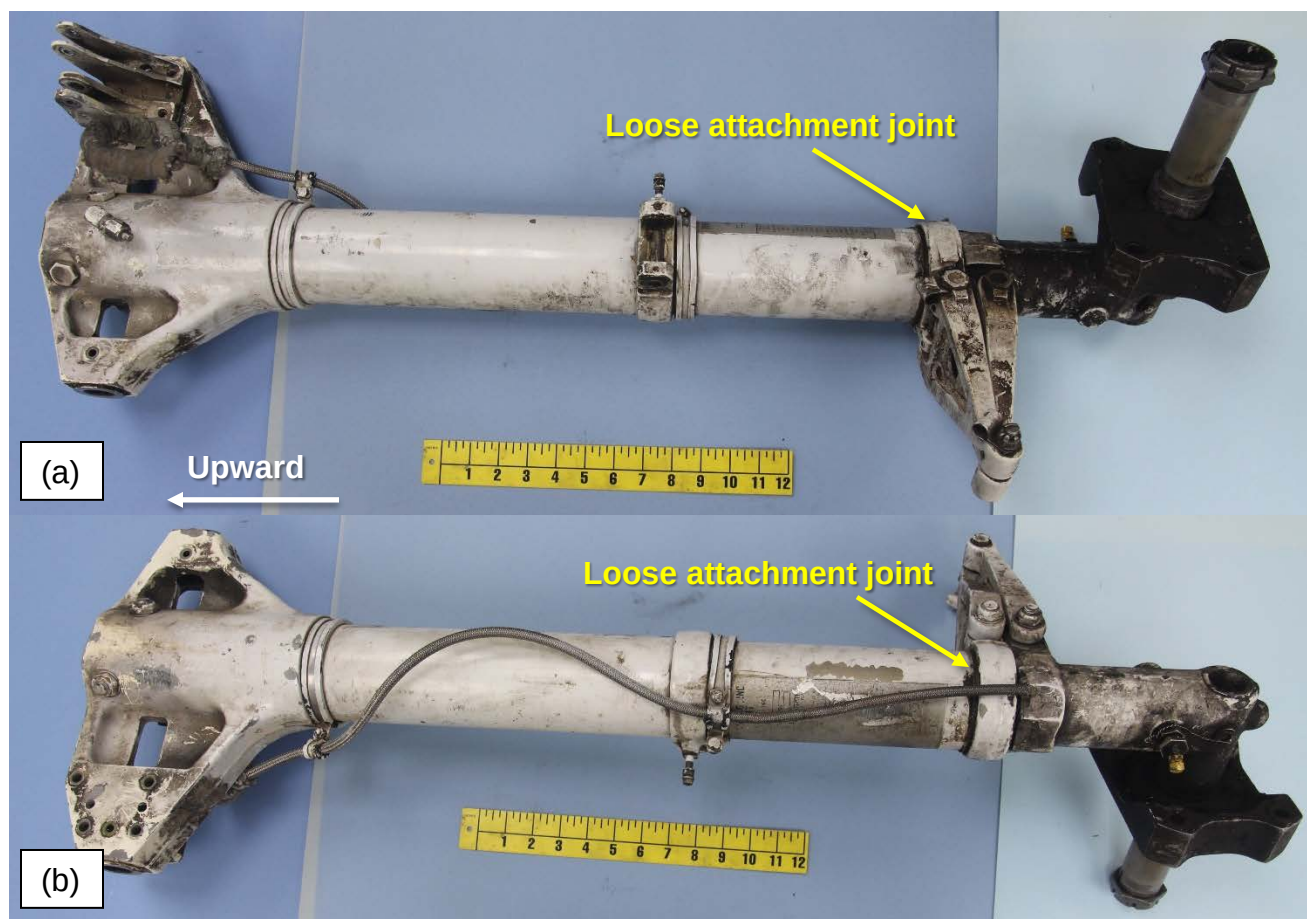
Figure 1 shows the left main landing gear strut assembly remnants, as received. The figure shows the strut cylinder assembly and adjacent attached components from the forward and aft faces of the component. The damaged components and subcomponents of note were a sectioned hydraulic line, a damaged marking plate, and an intermediate link attachment joint that was loose and able to be moved about the cylinder. Figure 2 shows the remainder of the external marking plate on the cylinder, with the cut hydraulic line moved out of the way for illustrative purposes. All of the markings on the plate had been removed and could not be discerned, consistent with abrasive wear during the landing sequence.

Figure 1 – The landing gear strut assembly, as received, viewed from opposite 180° sides (a) forward looking aft and (b) aft looking forward. The loose attachment joint affixed to linkage assembly is annotated on both figures.

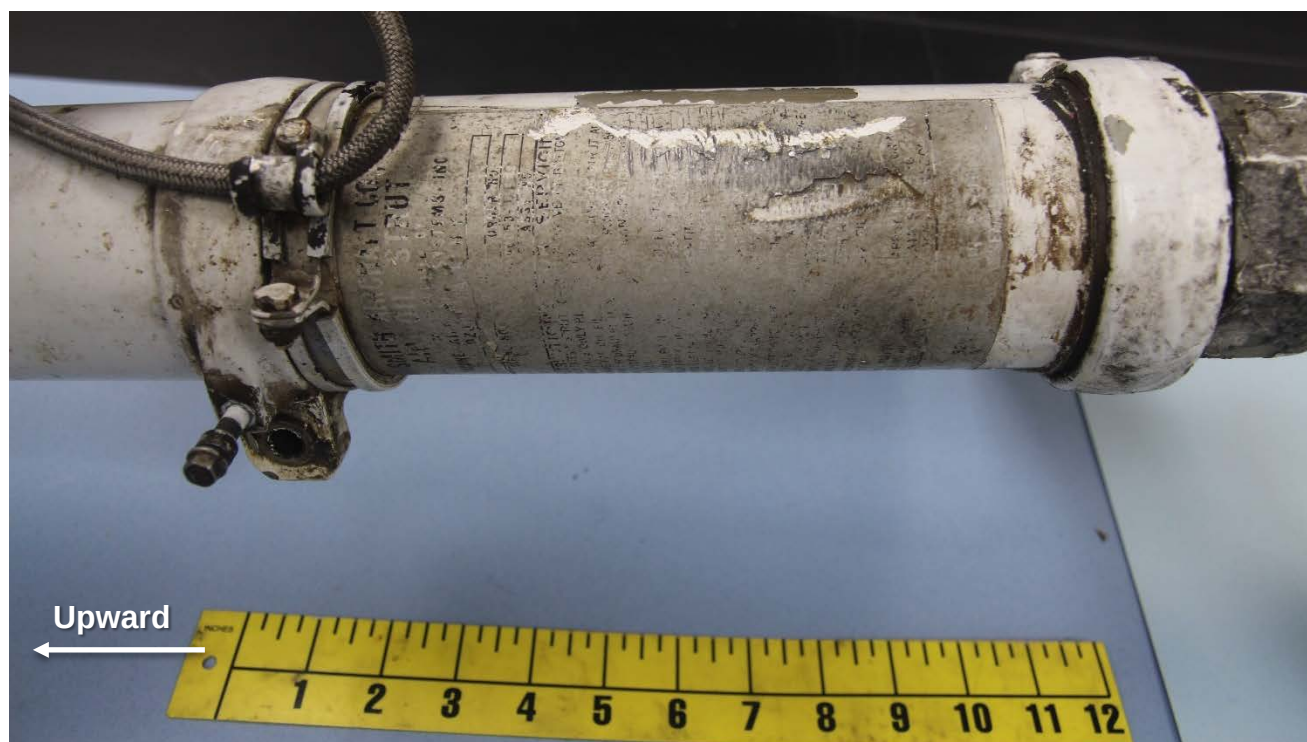
Figure 2 – The label on the landing gear strut cylinder outboard side, showing the damage to the text.

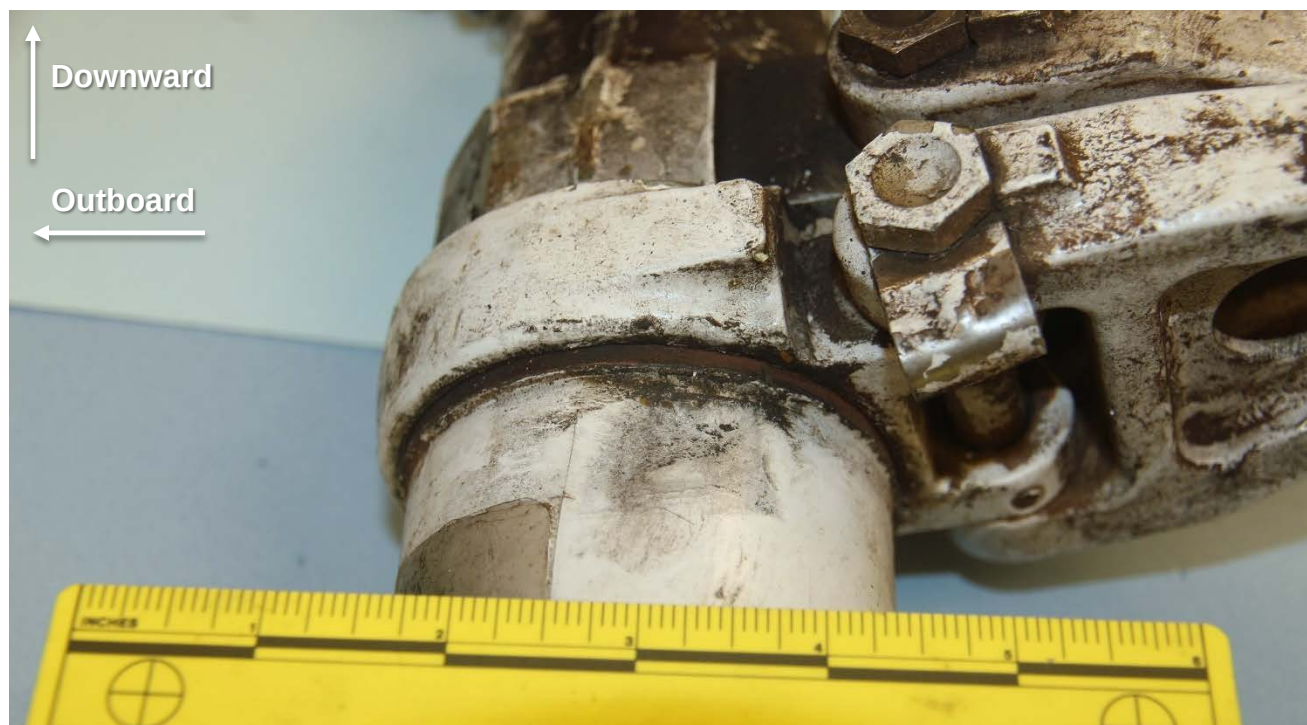
Figures 3 through 5 show a closer view of the coupling between the cylinder assembly exterior and the attachment joint. This joint had been welded to the cylinder exterior and contained a bushing assembly (with scrapers, washers, rings and a gland) driven against the cylinder. The inboard fitting of the joint was affixed to a linkage assembly by an attachment bolt. This joint was loose where it attached to the cylinder, and it could be rotated against the cylinder exterior. The adjacent hexagonal cap below the loose joint was still tight against the cylinder assembly (Figure 5).

The loose joint revealed a small gap, approximately 0.25 inch in longitudinal length. This gap, seen in Figures 3 and 4, exhibited a reddish-brown color, consistent with the underlying copper-based alloy bushing. The cylinder exterior and the edge of the upward-facing surface of the joint exhibited an undulating, rough fibrous texture, which mirrored each face. These features were consistent with mating fractured surfaces.

Figure 3 – View of the loose attachment joint, looking downward, showing the gap consistent with a fractured weld.

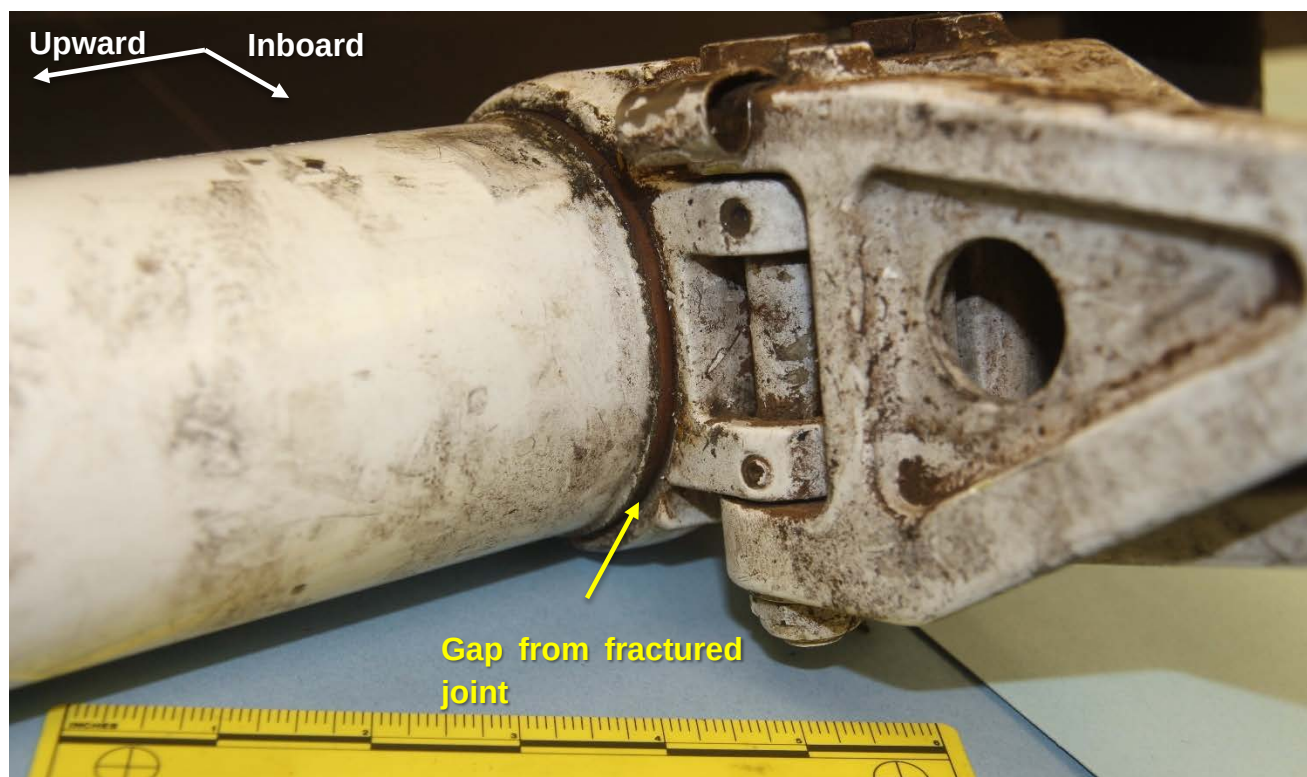
Figure 4 – The gap between the joint and strut cylinder, from an angled inboard view.

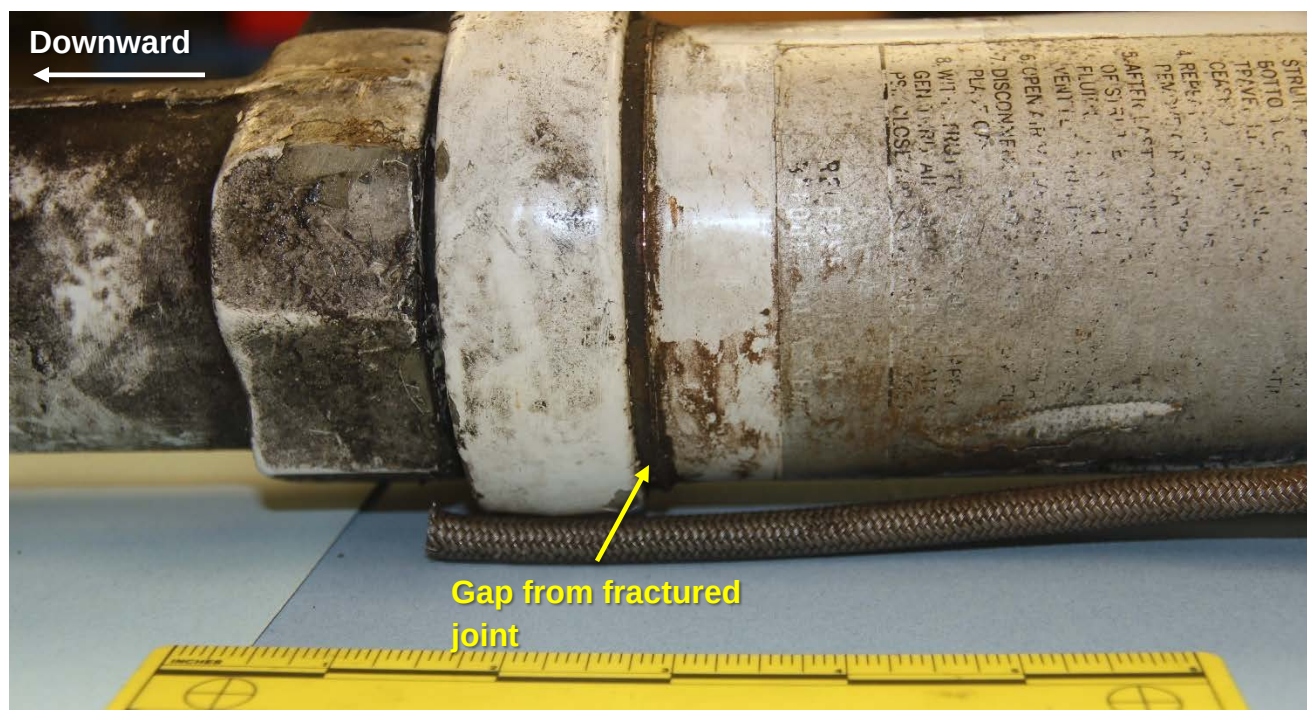
Figure 5 – The gap between the joint and cylinder, viewed from the outboard side.

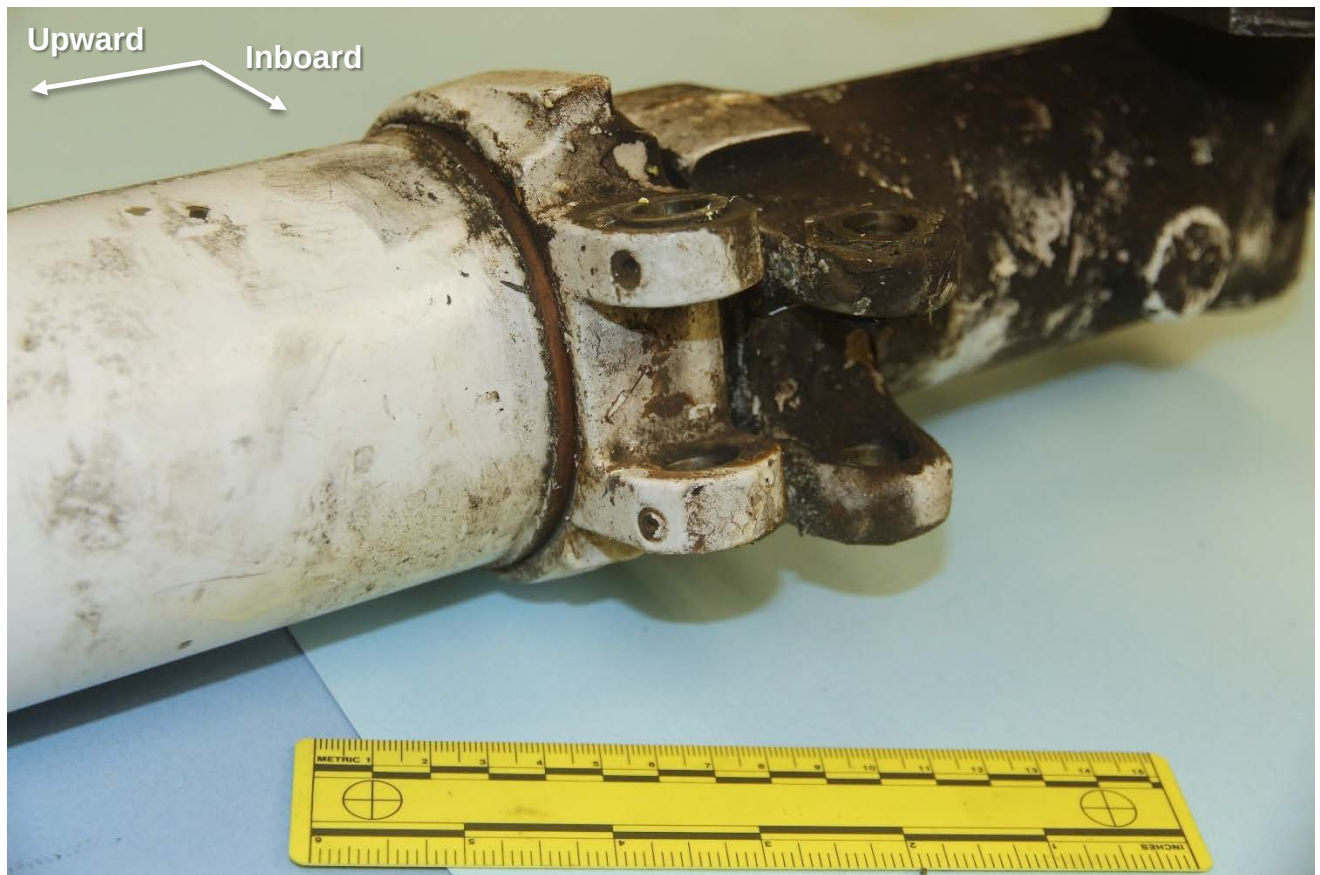
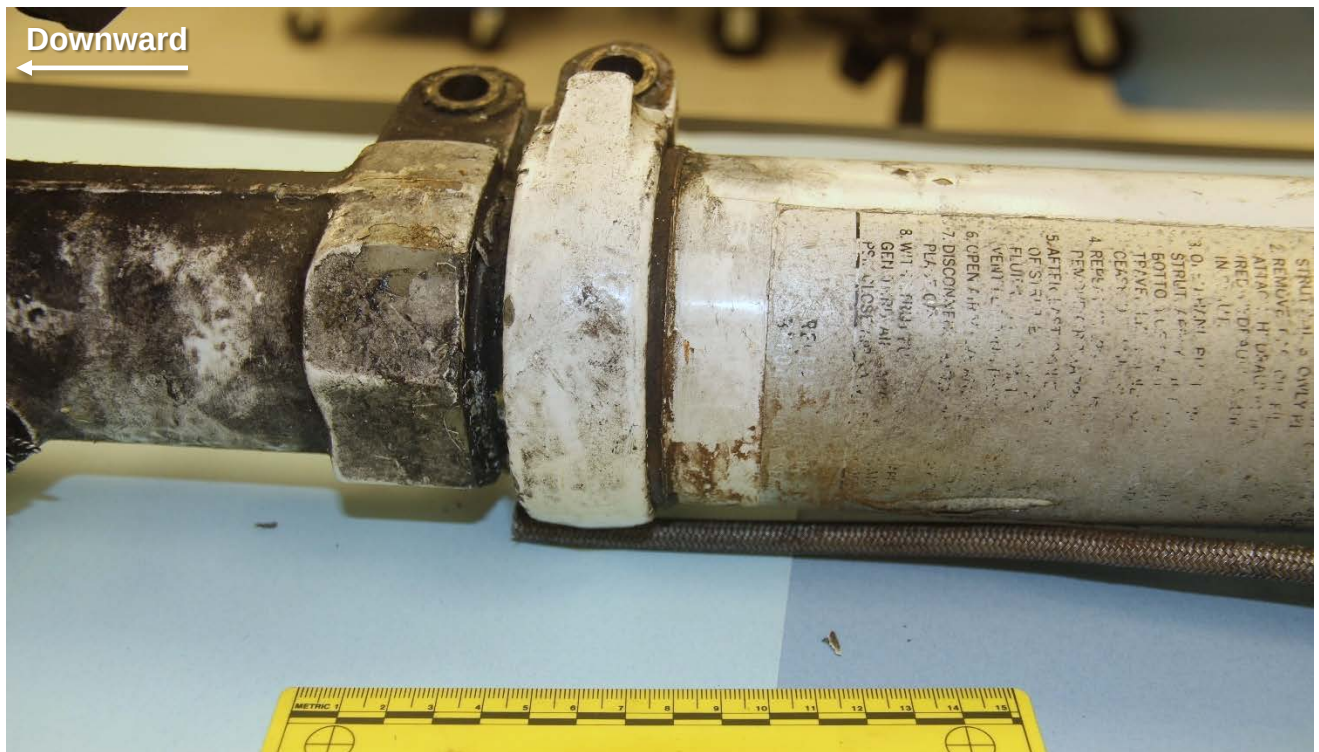
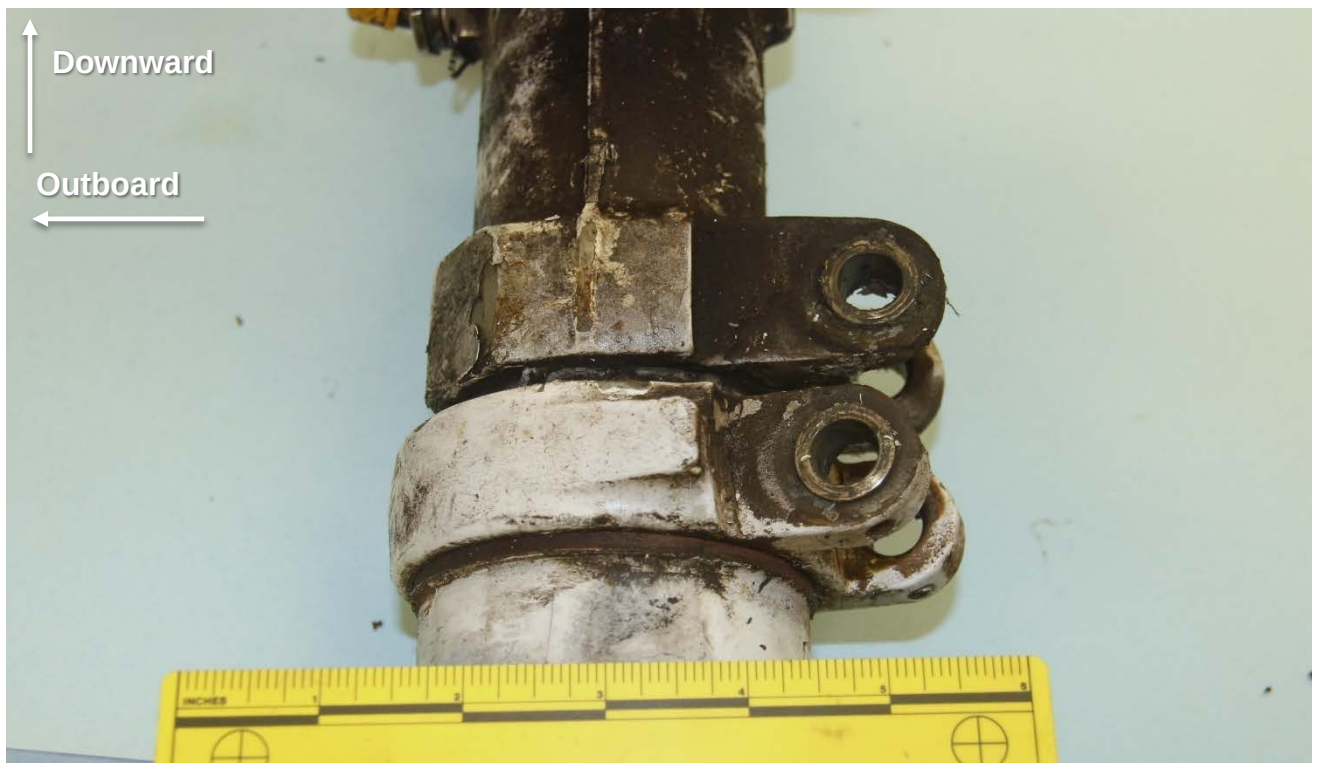
The linkage assembly affixed to the attachment joint was removed by disassembling and removing the nut, washer, clip, and bolt that held the assembly together. Figures 6 through 8 show the joint against the cylinder after removal of the linkage. The joint could still be moved to the same degree as when the linkage was still attached, and the cap located downward from the loose joint was still tight against the cylinder, unable to be moved.

Figure 6 – View of the loose attachment joint on the strut cylinder from an angled inboard view, after removal of the linkage and connecting bolt assemblies.

Figure 7 – View of the loose joint on the strut cylinder from the outboard surface, after removal of the linkage and connecting bolt assemblies.

Figure 8 – The loose joint after removal of the linkage and bolt assemblies, viewed forward looking aft.

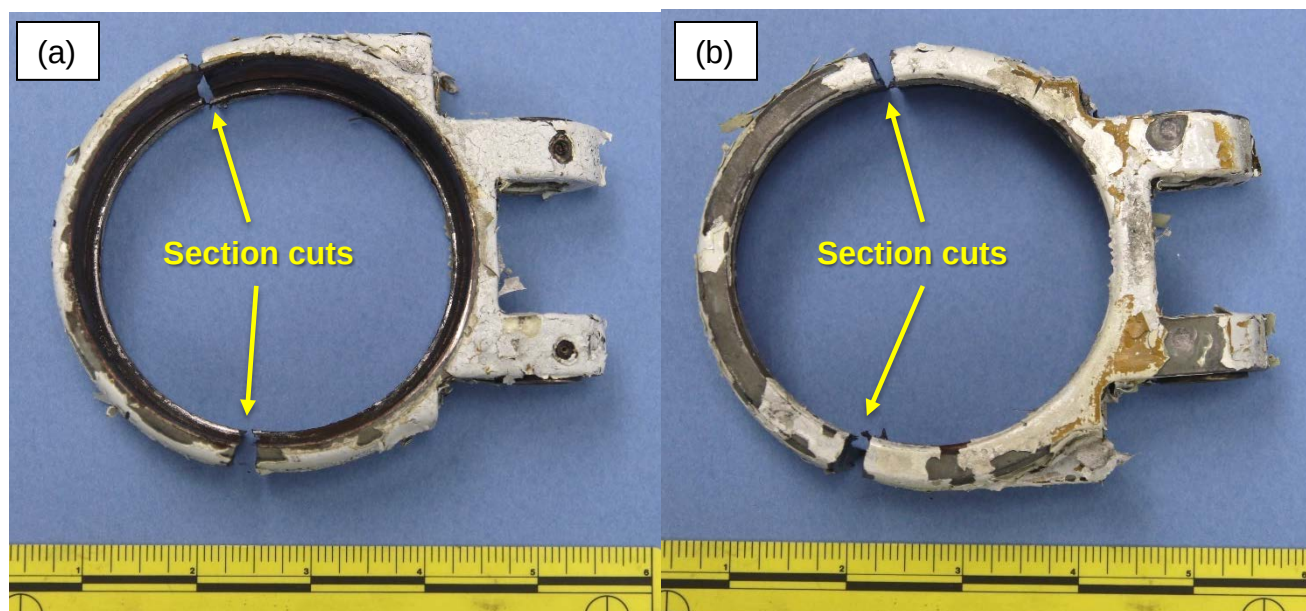
The joint was sectioned in two locations, approximately 180° from each other on opposite sides, in order to remove it from the strut cylinder assembly. Figure 9 shows the removed and cleaned attachment joint from the upward and downward facing surfaces. The upward facing surface was the fracture surface. This surface was examined closer using light and electron microscopy. The sectioned joint was cleaned using a degreasing agent followed by immersion in acetone using an ultrasonic bath.

Figure 9 – View of the joint, after sectioning from the strut cylinder assembly, shown from (a) the upward and (b) the downward face.

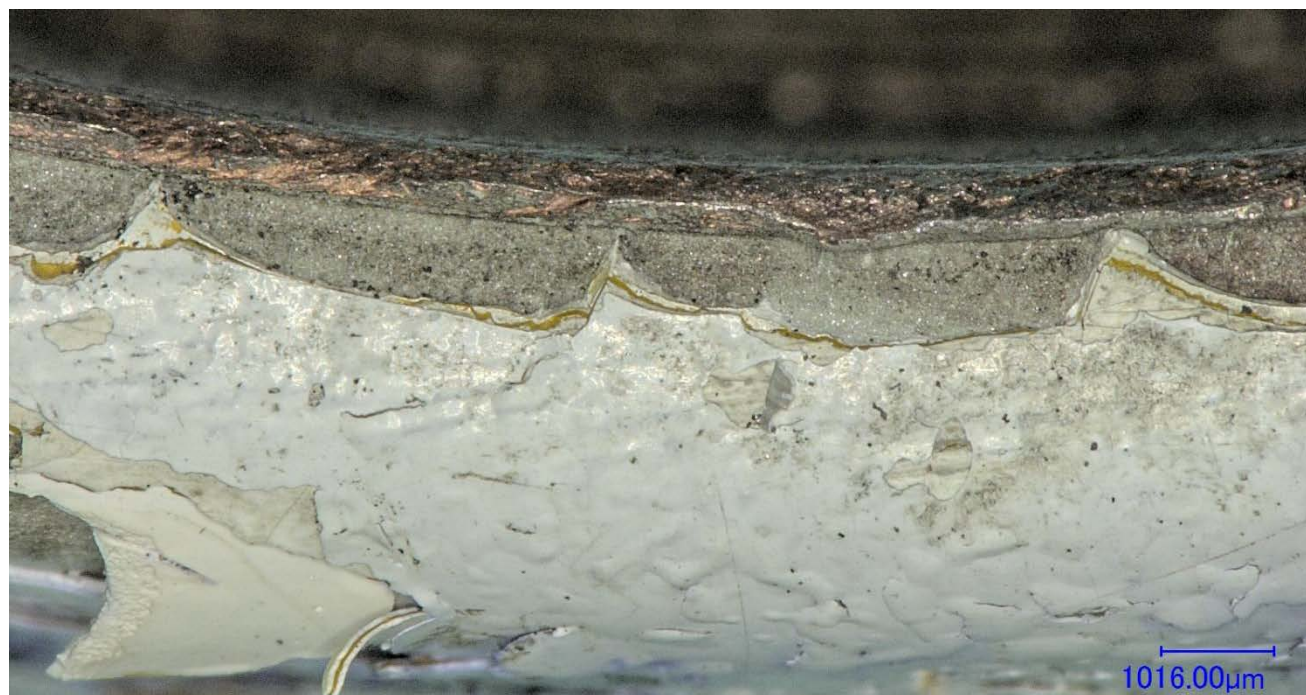
Figure 10 shows a closer view of a typical area of the upward-facing surface of the disassembled joint. The interior consisted of some of the bushing material, surrounded by an external main joint material, consistent with steel (due to its color, luster, and ferromagnetic response in the presence of a permanent magnet). The joint exterior had an external layer of white paint. Figure 11 shows a view of a typical area of the fracture surface from the exterior, showing the protruding lip-shape of the fractured weld remnant, as well as the fractured internal bushing remnant. As can be seen in the figures, the paint layer 0.1 to 0.25 inches closest to the fracture surface was missing. The missing paint pattern consisted of a series of lobes. This pattern in the missing paint was consistent with those typical in parts that separate through an external paint layer.

Figure 10 – View of the upward face of the joint fracture surface, showing the smeared bushing material, the fractured white paint and the underlying joint steel material.

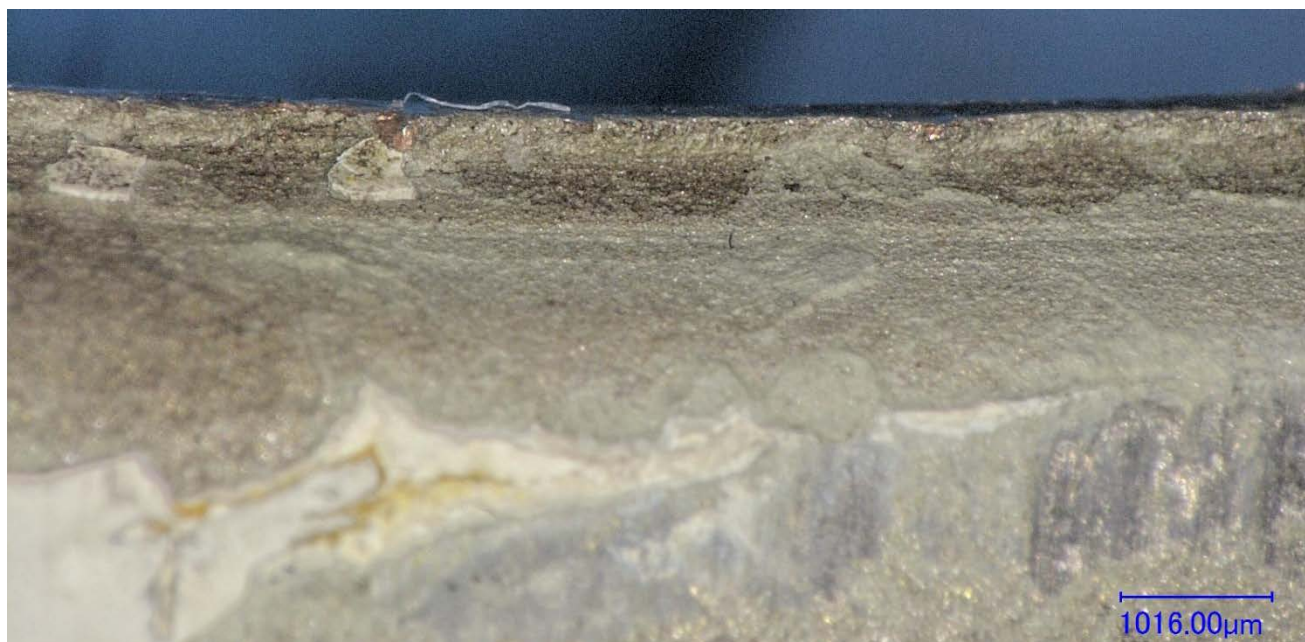
Figure 11 – View of the joint weld from the outer face, showing parallel circumferential lines near the fracture.

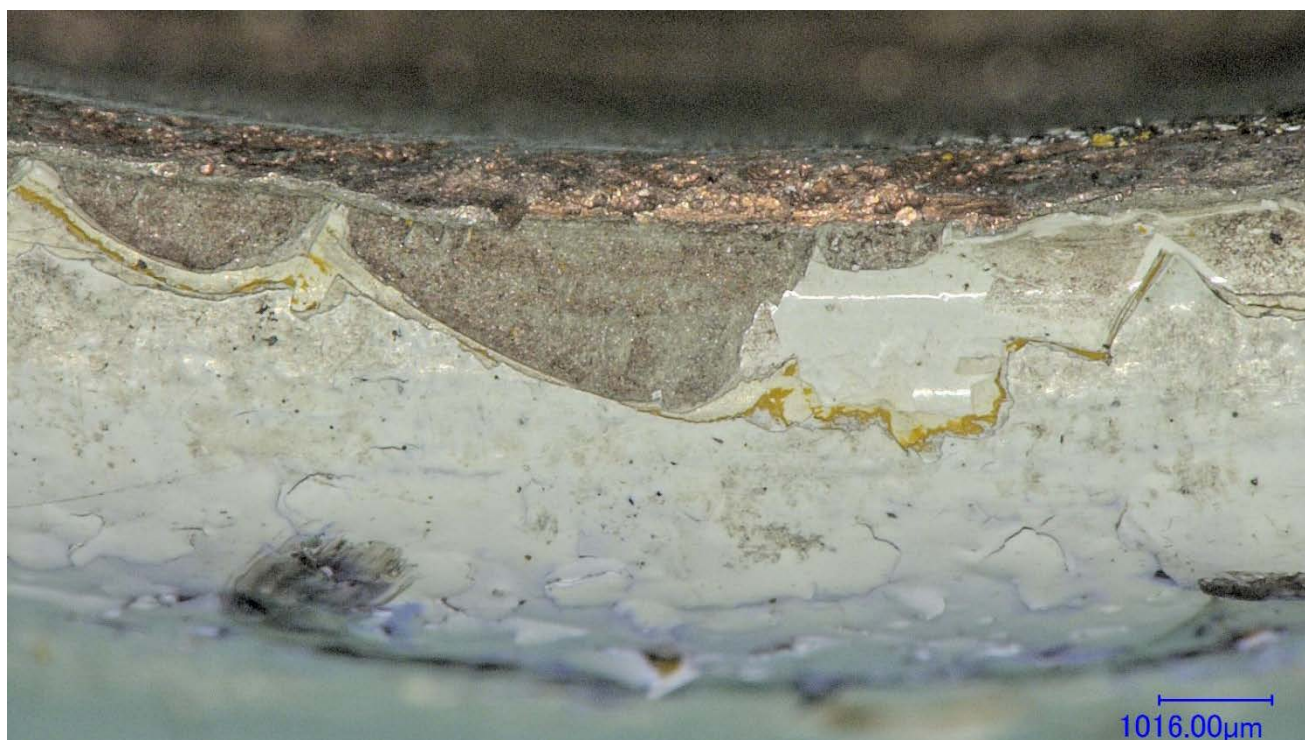
Figure 12 shows an area of the fracture surface that exhibited less post-fracture damage. The general pattern on the bushing remnant was rough and tortuous. The external paint coating had only partially spalled on the right side, revealing multiple layers of white paint, with an intermediate yellow layer. The joint portion of the fracture near the joint is highlighted in Figure 13. As shown on the left side of Figure 12, the welded steel material exhibited an upward-facing protrusion. The areas adjacent to the fracture surface exhibited repeating circumferential lines, oriented parallel to the fracture surface.

Figure 12 – View of fracture features on the bushing portion of the joint fracture surface.

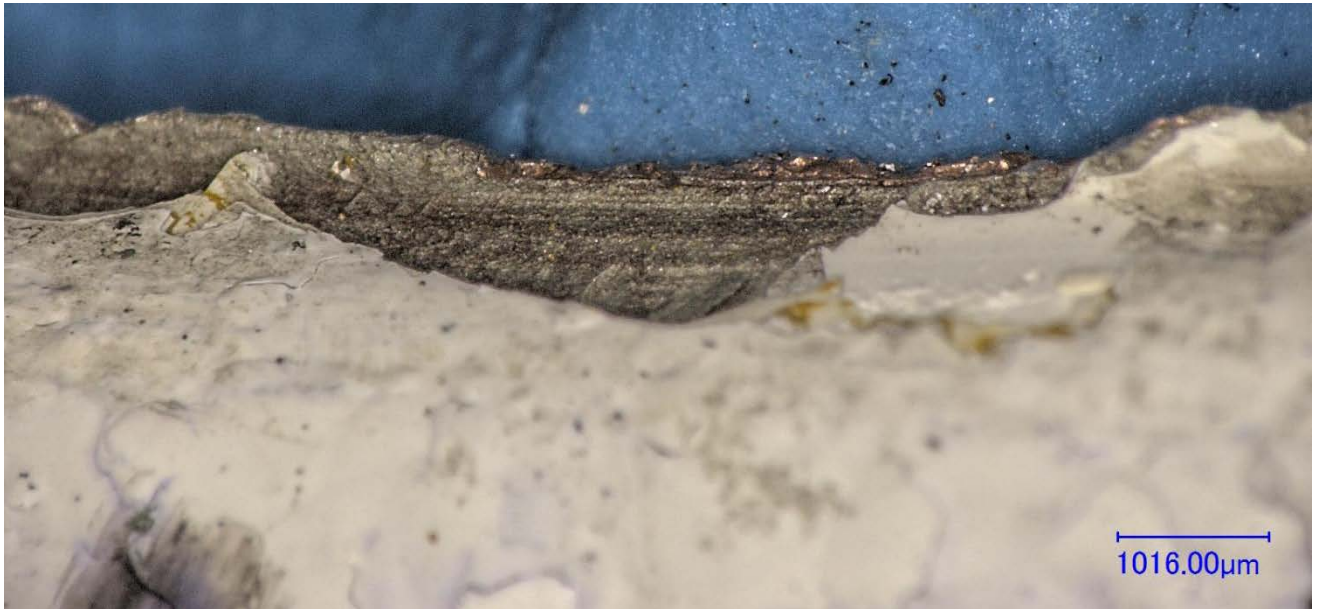
Figure 13 – The outside view of the fracture surface in Figure 12, showing circumferential weld lines parallel to the surface.

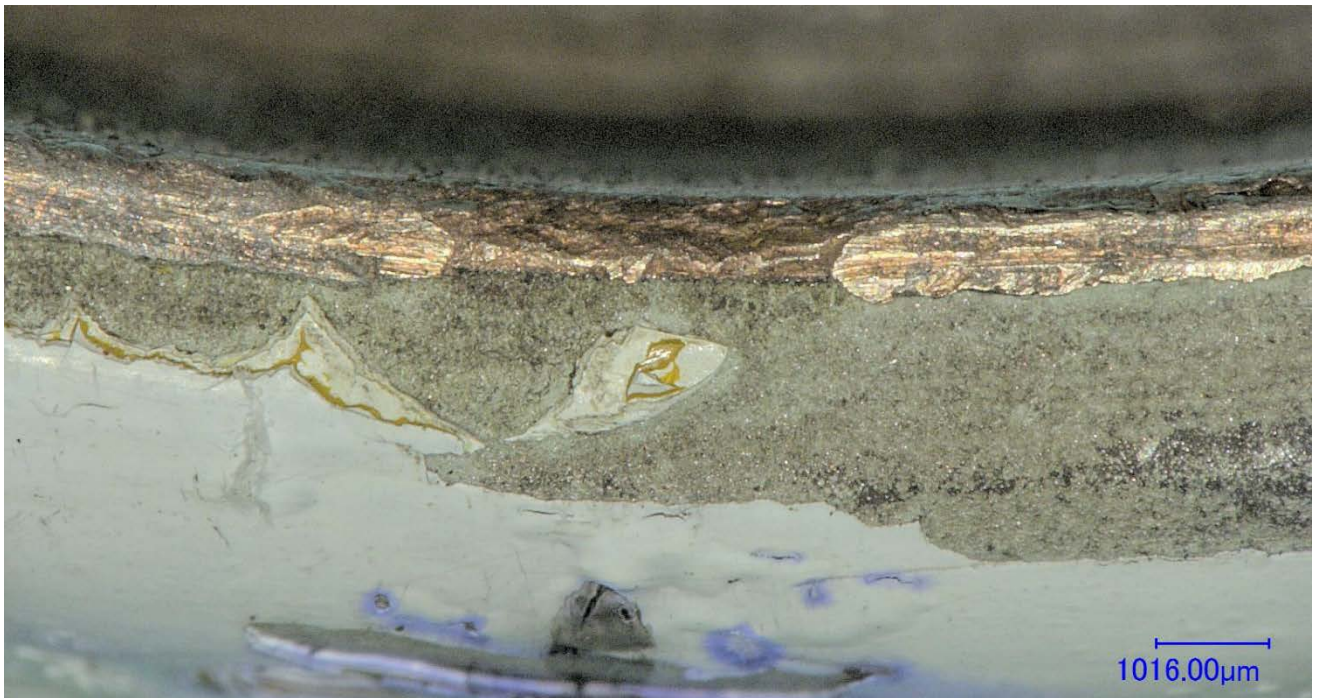
Figure 14 shows an area of the fracture that was partially obliterated by post fracture damage. The middle area of the bushing fracture was undamaged, and exhibited a similar rough, tortuous surface texture as the one illustrated in Figure 12. The areas to either side of this region exhibited smearing, oriented in a rotational direction. This wear pattern was consistent with the tallest portions of the fracture surface grinding on the mating fracture surface. The most severe example of the post-fracture rotational smearing damage is illustrated in Figure 15.

Figure 14 – View of an undamaged fracture area of the removed attachment joint.

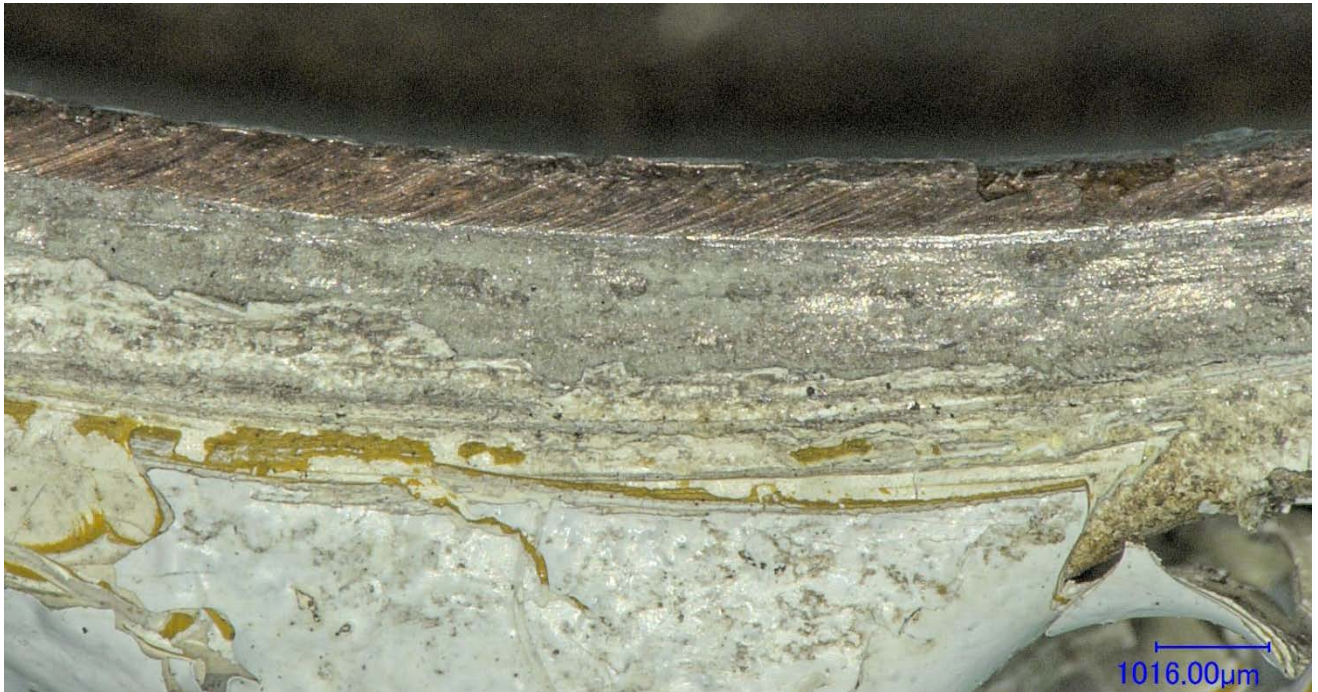
Figure 15 – View of the joint fracture surface from the inboard side, showing complete obliteration of the fracture surface.

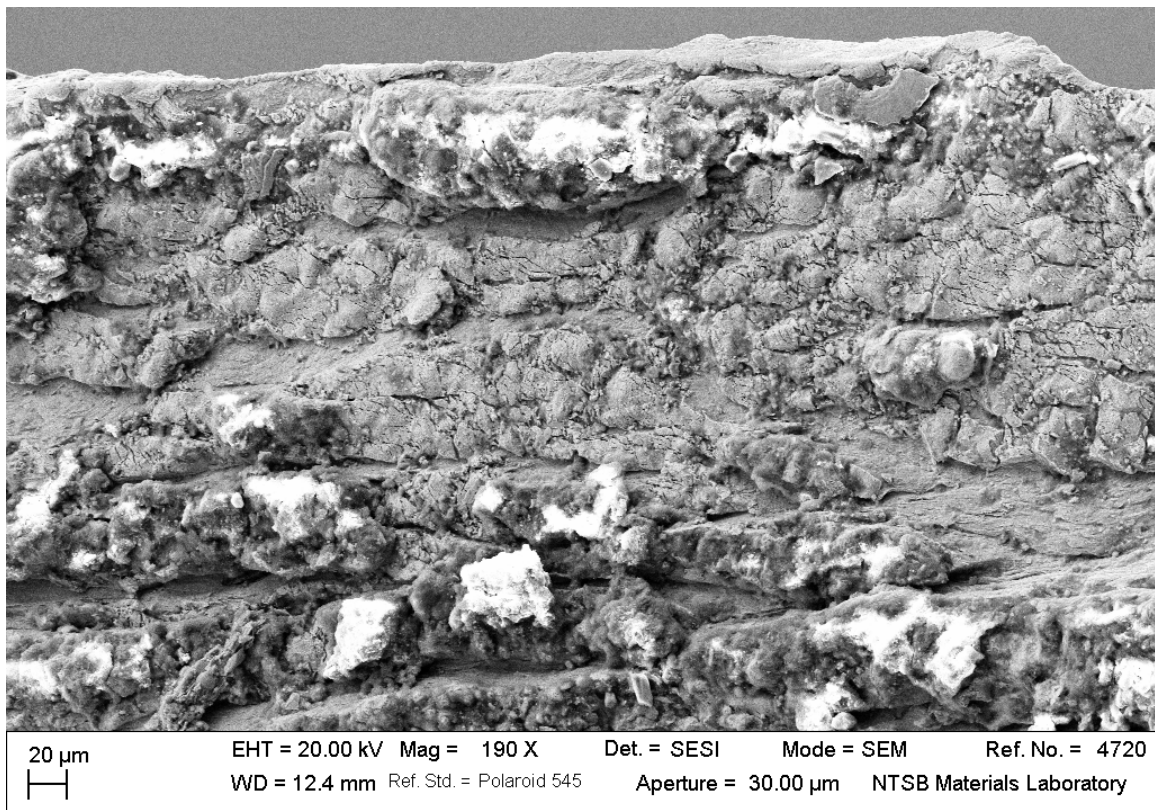
Portions of the joint fracture surface were examined using a scanning electron microscope (SEM). Figure 16 shows a closer view of the circumferential marks seen in Figures 11 and 13. These lines exhibited rounding and folding, consistent with multiple passes from the weld process. The folds exhibited some spreading and separation, consistent with limited local deformation adjacent to the fracture surface.

Figure 16 – Secondary electron (SE) micrograph of the outside weld area in Figure 13, showing wrinkling on the surface (fracture surface faces upward).

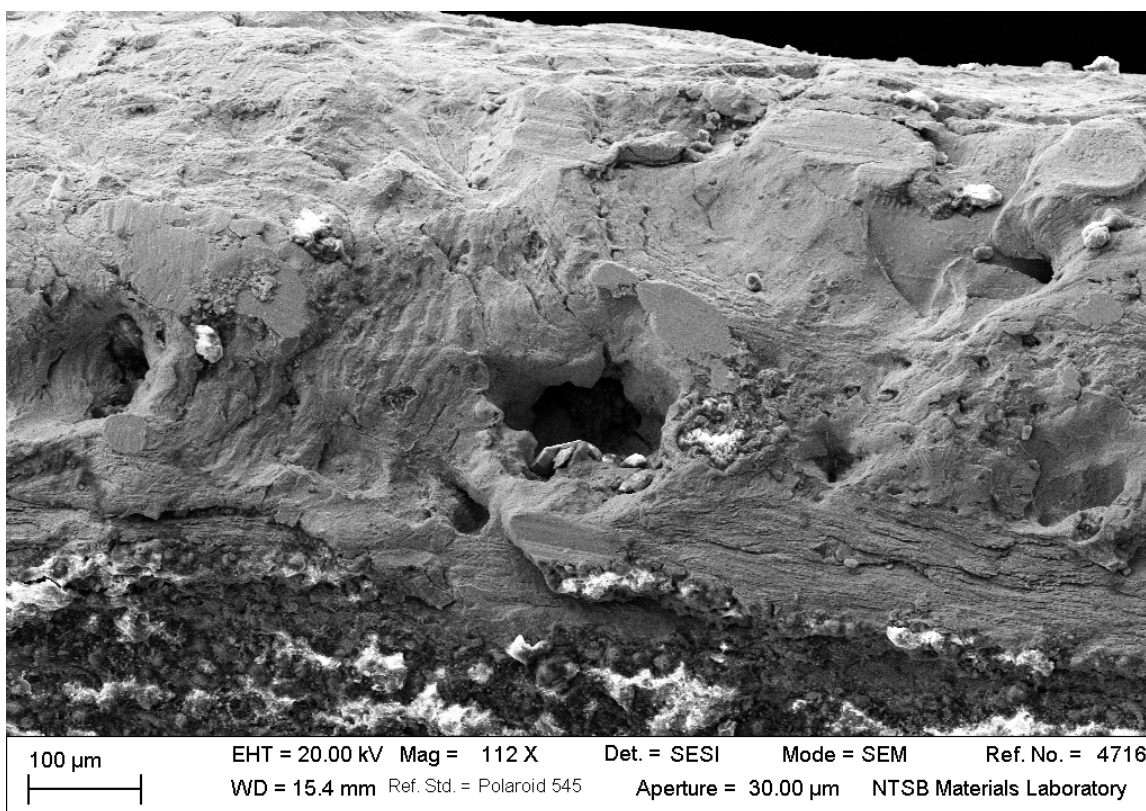
Most of the fracture surface had been damaged to an extent that any common fracture features were obliterated. This was true in both the bushing and welded regions of the steel joint fracture surface. Figure 17 shows portions of the fracture surface that were undamaged, although most of this region had been destroyed by post-fracture smearing. This damage was most prominent towards the interior of the bushing area. The lower right exhibited circumferential parallel marks consistent with the solidification from multiple passes of the welding process.

Figure 17 – SE micrograph of the damaged fracture surface, showing voids.

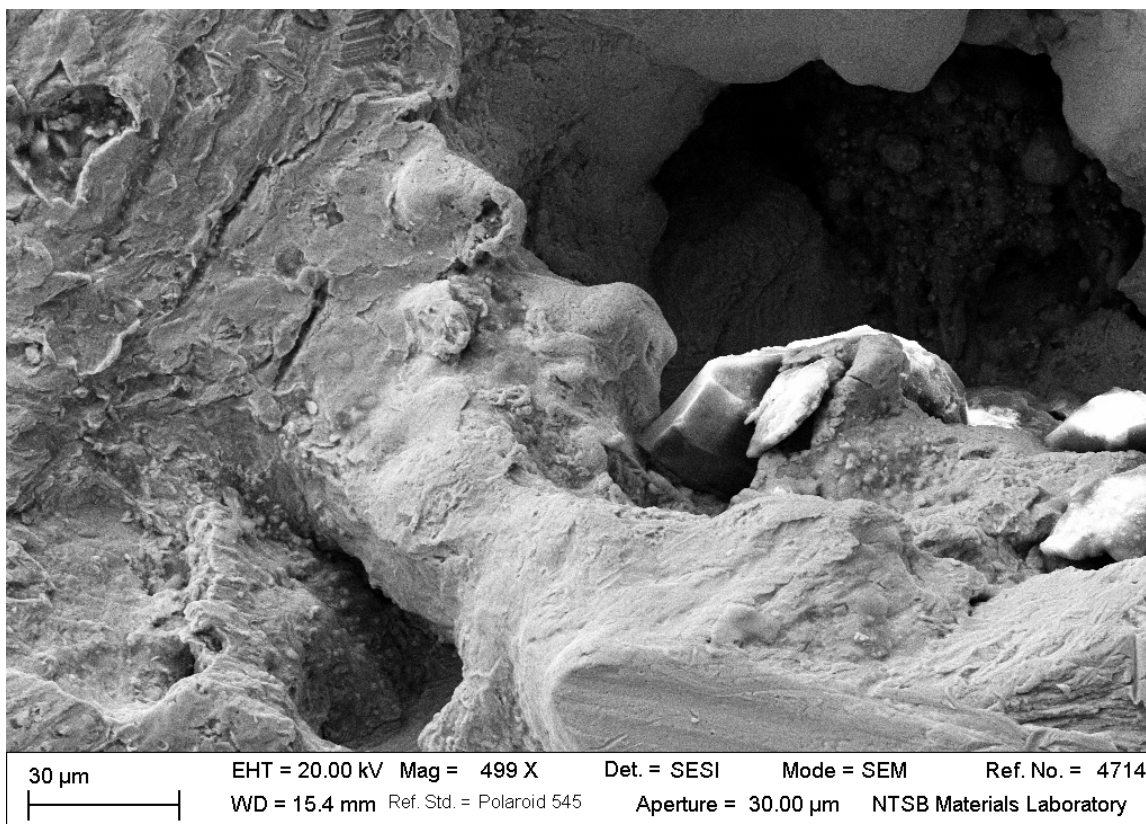
This material also exhibited multiple holes or divots, consistent with pores from the welding process. Closer examination did not reveal any cracking, striations, or other progressive fracture features emanating from the pores (see Figure 18). Any repeating linear features were found to be consistent with post-fracture smearing (lower left and right in Figure 18). There were some nonconductive compounds in and around the weld pores. This material was consistent with foreign material that became embedded into the fracture surface while the mating fracture surfaces were in repeated contact.

Figure 18 – SE micrograph of a closer view of Figure 17, absent pore cracking.

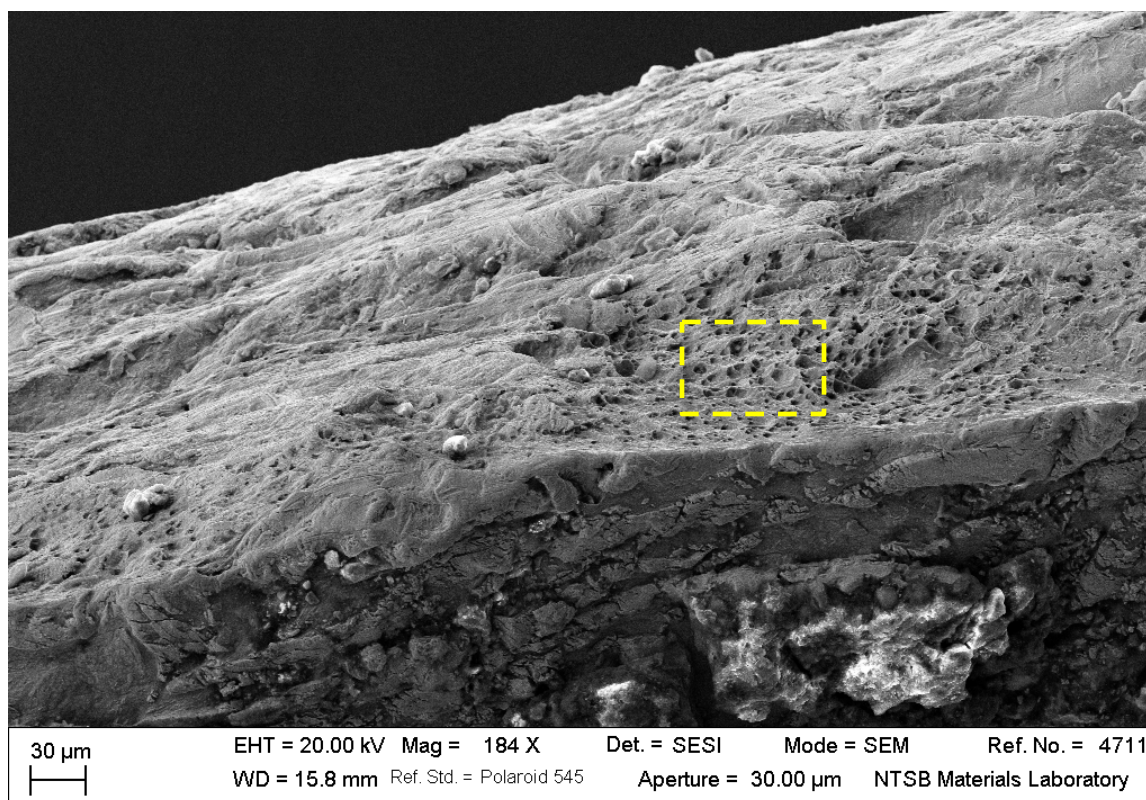
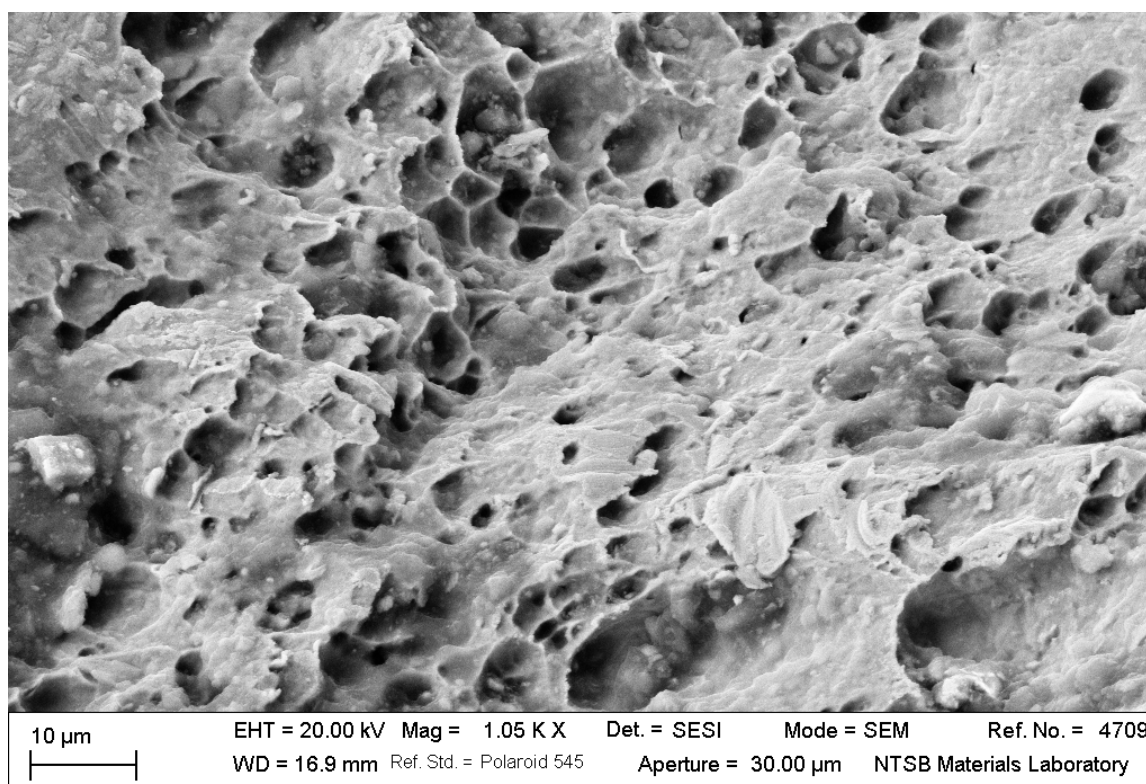
Figures 19 and 20 show closer views of the tortuous areas of the fracture features shown in Figures 12 and 14. The fracture features were consistent with dimpled rupture, consistent with overstress fracture of these regions. The dimpled rupture features were observed in both the bushing material and the steel joint weld material. No indications of features consistent with progressive crack propagation were found on the fracture surface.

Figure 19 – SE micrograph of the undamaged area in Figure 14.

Figure 20 – SE micrograph of a closer view of the boxed area in Figure 19, showing dimpled rupture.
