# NATIONAL TRANSPORTATION SAFETY BOARD

## MATERIALS LABORATORY FACTUAL REPORT

Report No. 20-016

Place : Heber, Utah  
Date : September 25, 2018  
Vehicle : Smith Aerostar 601P, N90339  
NTSB No. : WPR18LA272  
Investigator : Zoë Keliher, AS-WPR

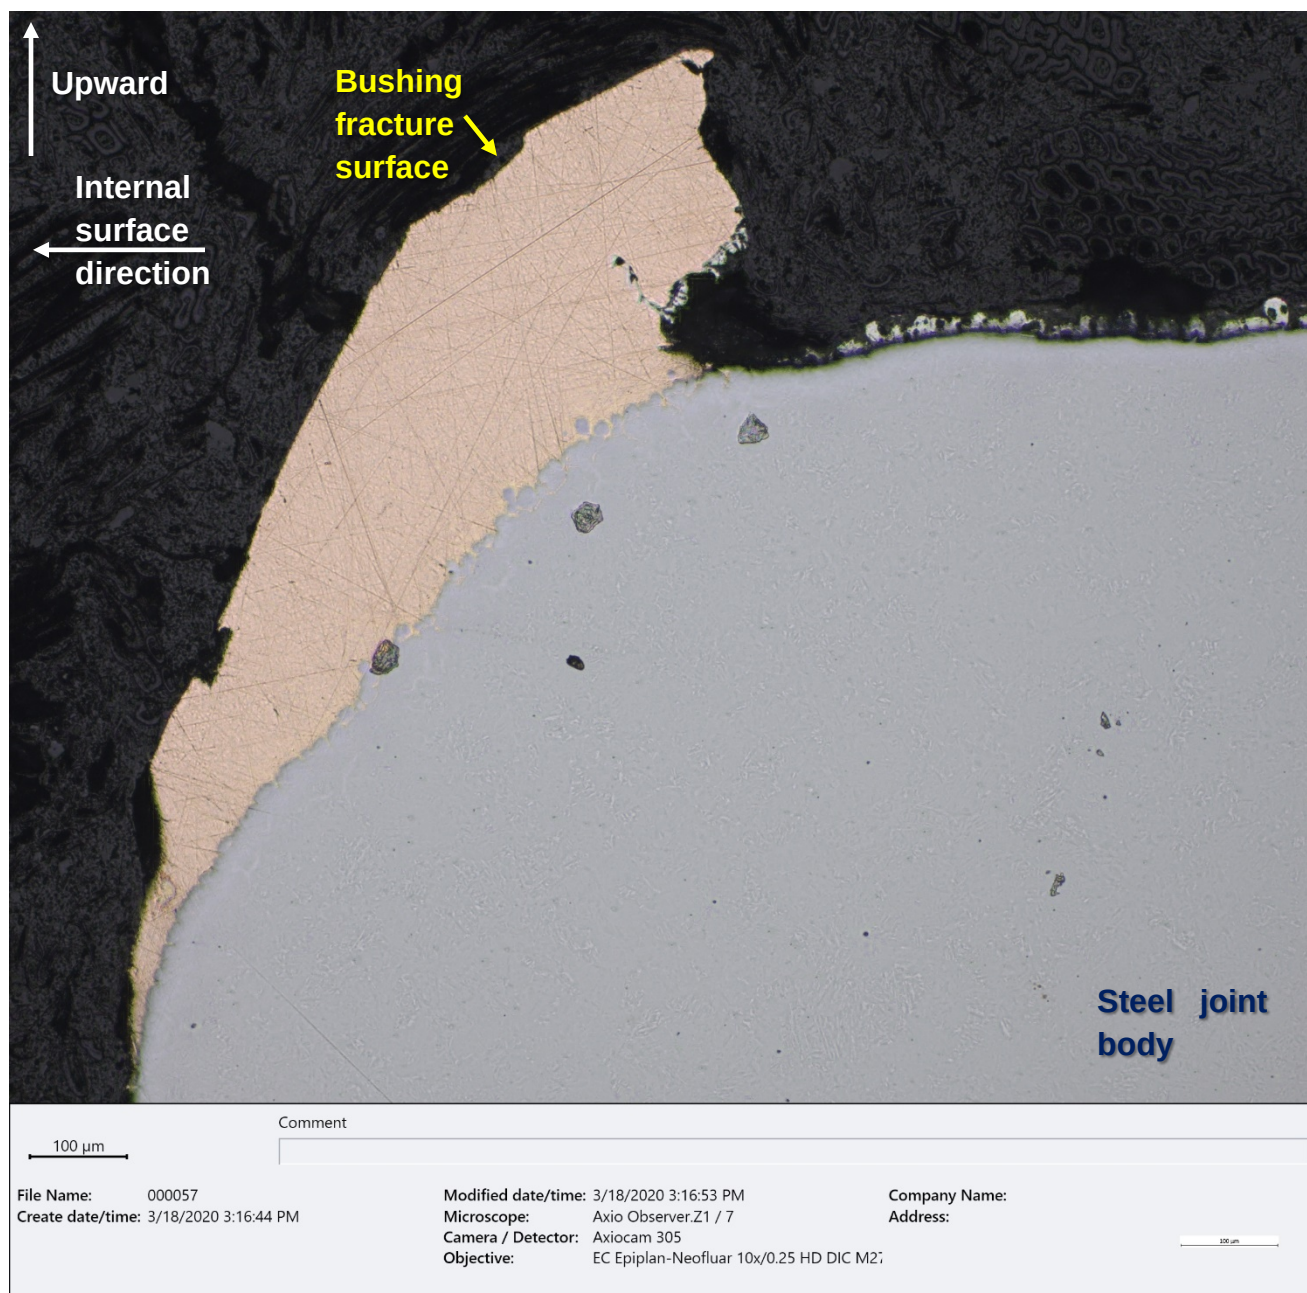
A portion of the joint and bushing remnant was cross-sectioned, mounted, and polished. Figure 21 shows a typical cross section through the fracture surface shown in

Figure 10. The cross section included a portion of copper bushing joined on the internal corner of the fracture surface joint to the steel joint. The rest of the cross section shows the steel joint material.

Figure 21 – Bright-field (BF) optical micrograph cross section of the fracture surface, showing the fractured bushing remnant on the steel substrate (~100X, as-polished).

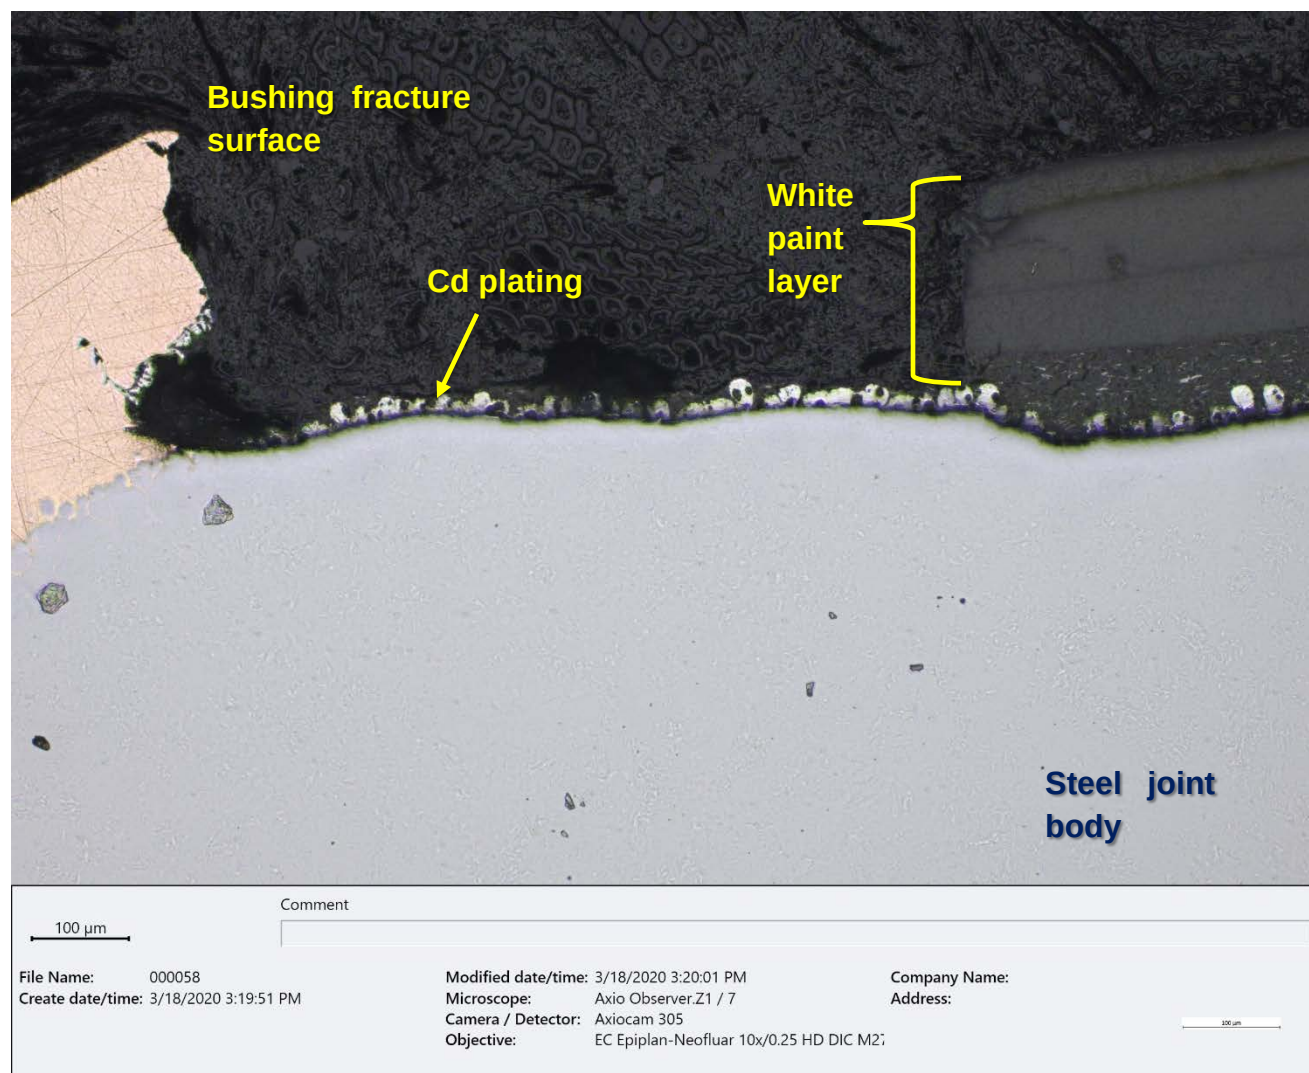
The upper surface in the figure, which was absent the paint in coating in the figure, still included some of the cadmium electrodeposition coating. This coating manifest as thin white lobes on the upper surface in the figure. Figure 22 shows an area to the exterior of Figure 21, demonstrating some of the paint coating layer, present above the cadmium layer. Figure 23 highlights the intact paint coating, overexposed to show the coating layers in cross section. The coating exhibited multiple white-colored layers, as well as the intermediate yellow-orange layer seen in the partially spalled paint. The layers were not entirely parallel to the underlying steel substrate, but rather undulated.

Figure 22 – BF optical micrograph of a view of the area just right of Figure 21, showing the different layers annotated (~100X, as-polished).

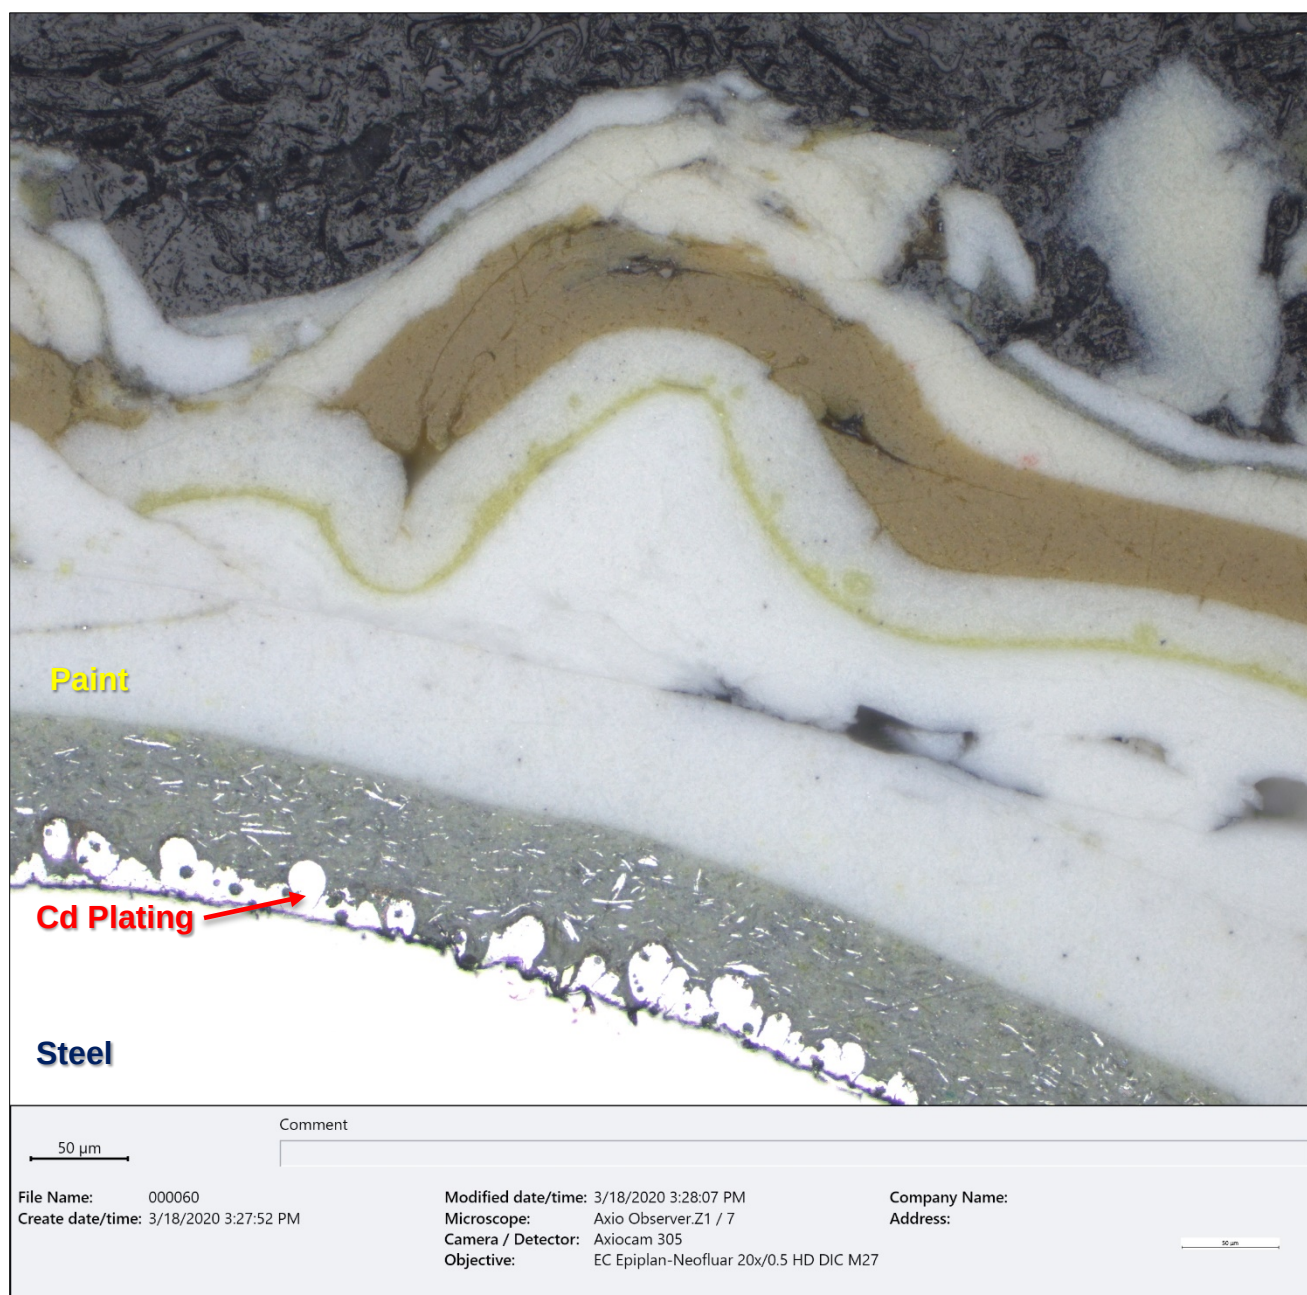
Figure 23 – BF optical micrograph of the undulating layers of coatings on an undamaged area of the joint, showing the underlying paint and Cd-plating layers on the overexposed steel substrate (~200X, as-polished).

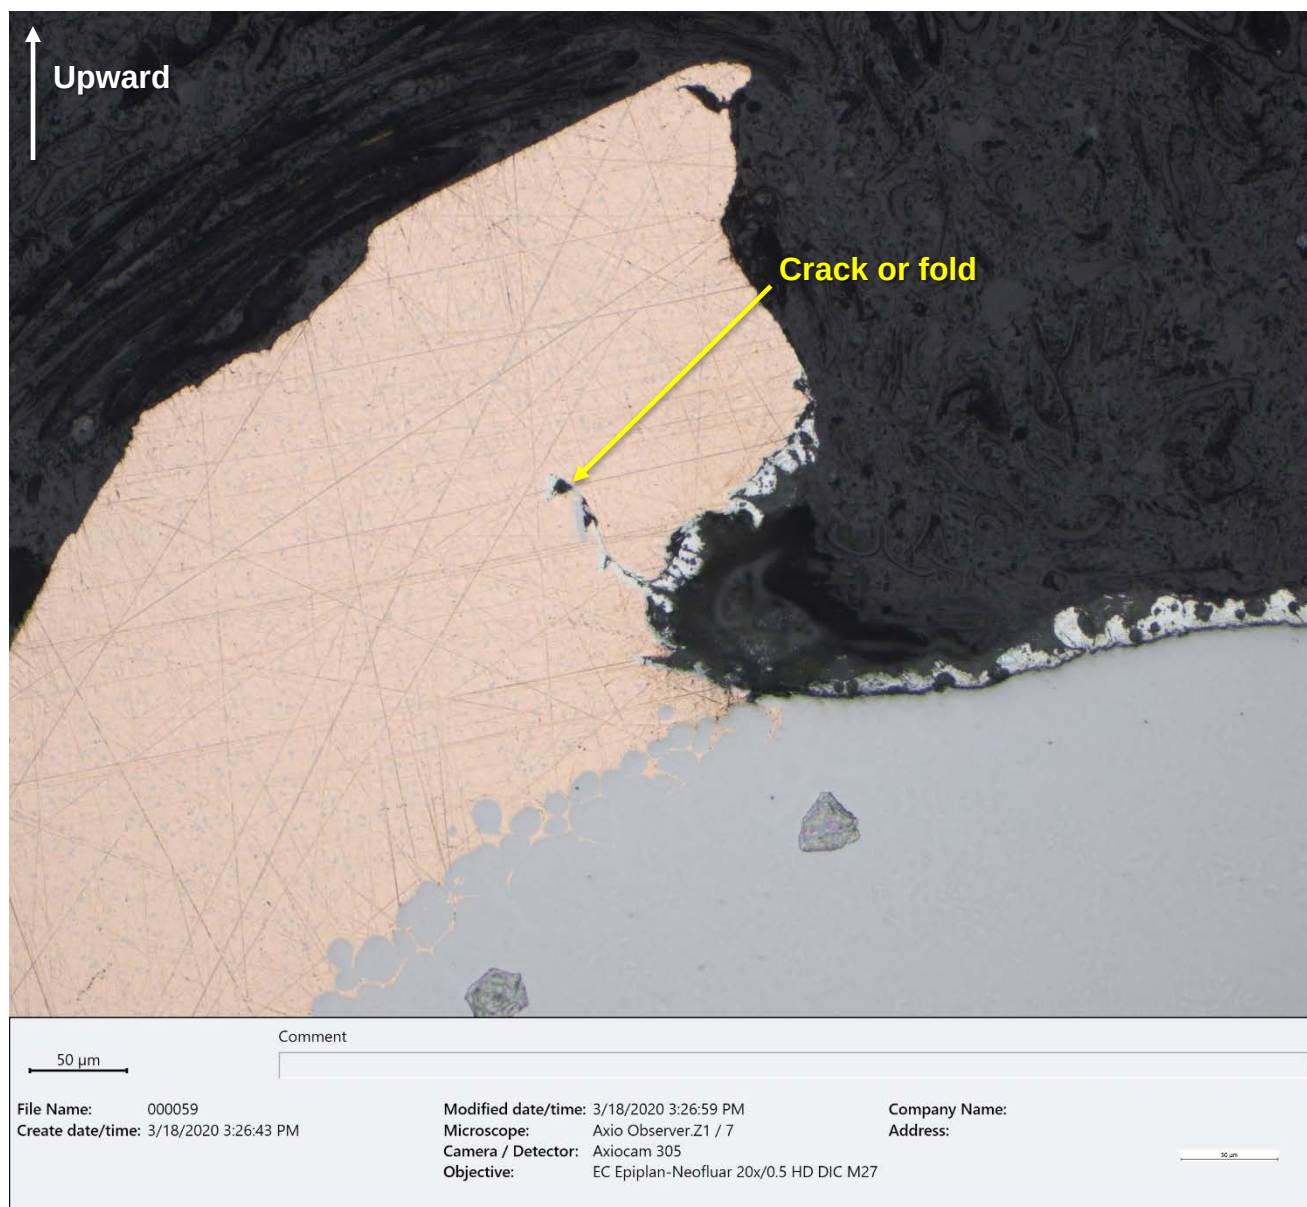
Figure 24 illustrates a closer area of the bushing remnant. This remnant contained a crack or fold which was open to the exterior of the part. This crack contained some dissimilar material, consistent with the cadmium material seen to the right in the figure.

Figure 24 – Closer view of an underlying crack or fold in the fractured bushing material at the fracture surface (~200X, as-polished).

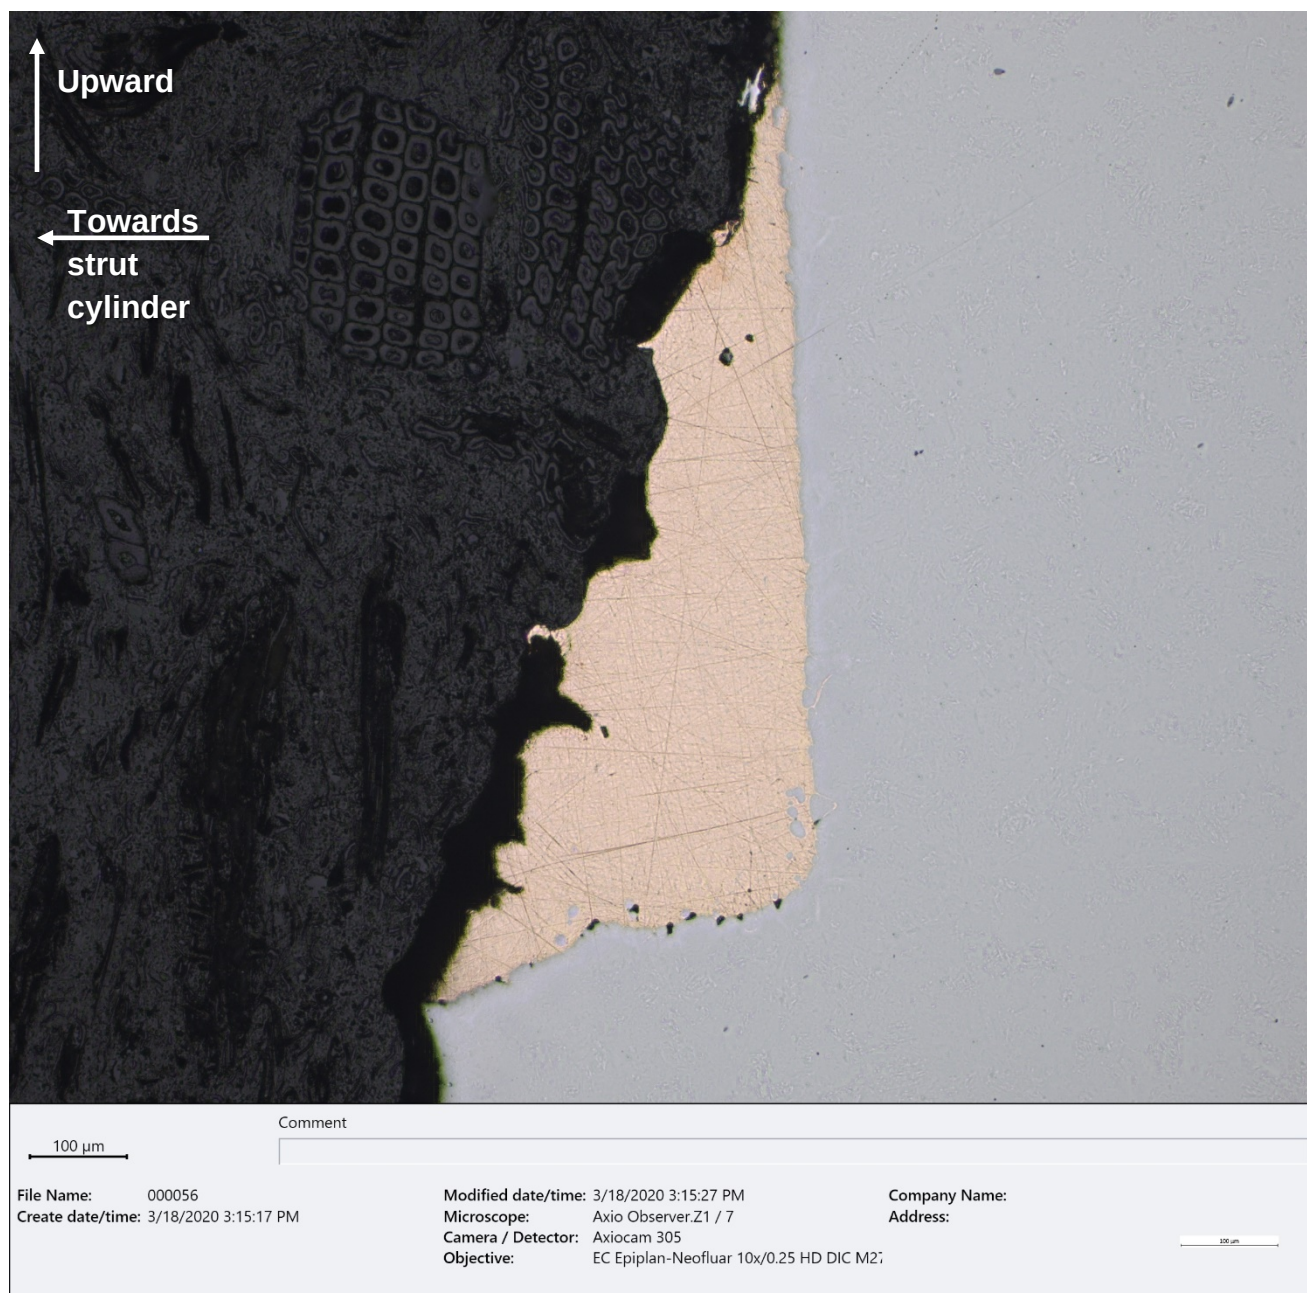
There was another fractured bushing remnant, pictured in Figure 25. This remnant was located downward from the fracture surface, and was present on the interior surface of the attachment joint. There were no indications of internal cracking or large voids on this remnant.

Figure 25 – BF optical micrograph view of another fractured bushing fragment downward from the fracture surface, on the joint interior surface (~100X, as-polished).
